COMPLETION REPORT

Client : **Financial Corporation**

Project Brief : **The Internal Refurbishment of 23 No. Air Handling Units –
Reduced Document**

Covac Ref : **516**

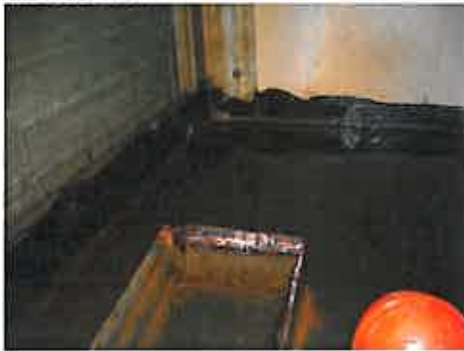
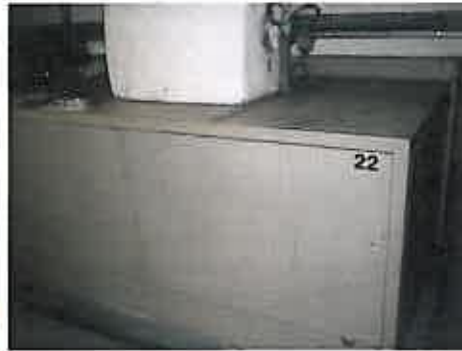
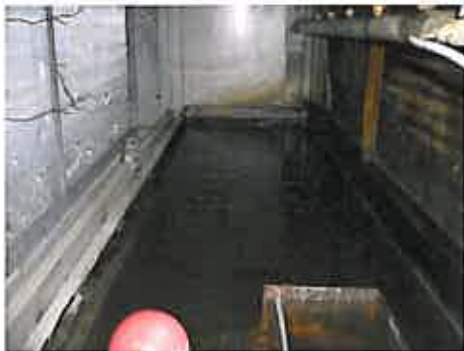
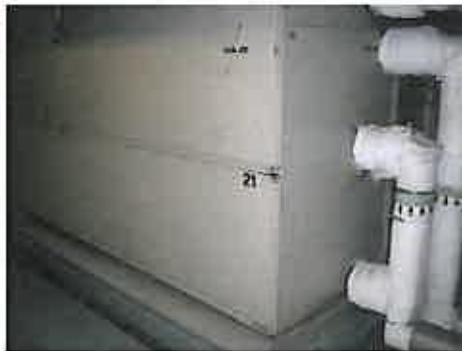
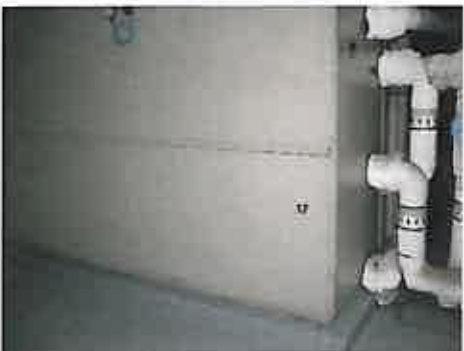
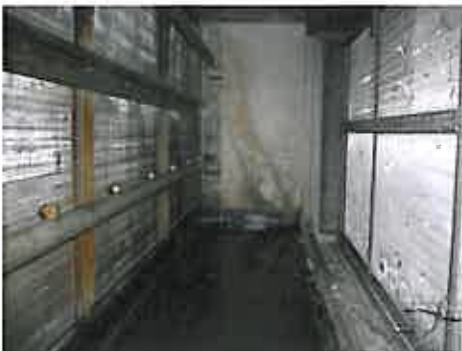
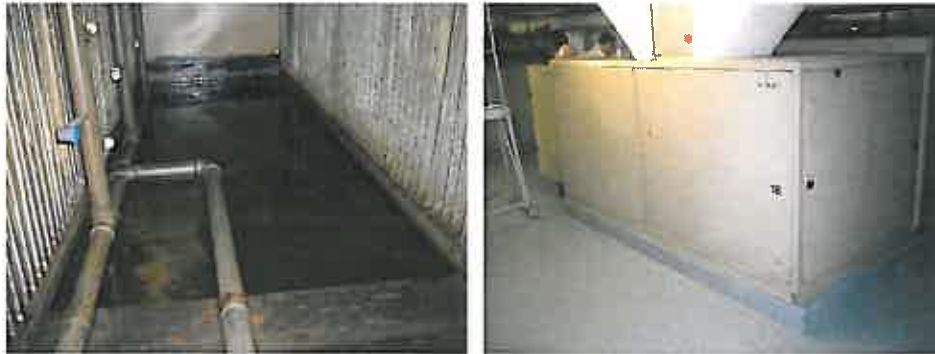
All 23 AHU floor trays had previously been internally coated with bitumastic based coating which has now starting to delaminate due to sub-film corrosion, low film build & general deterioration. (See photographs)

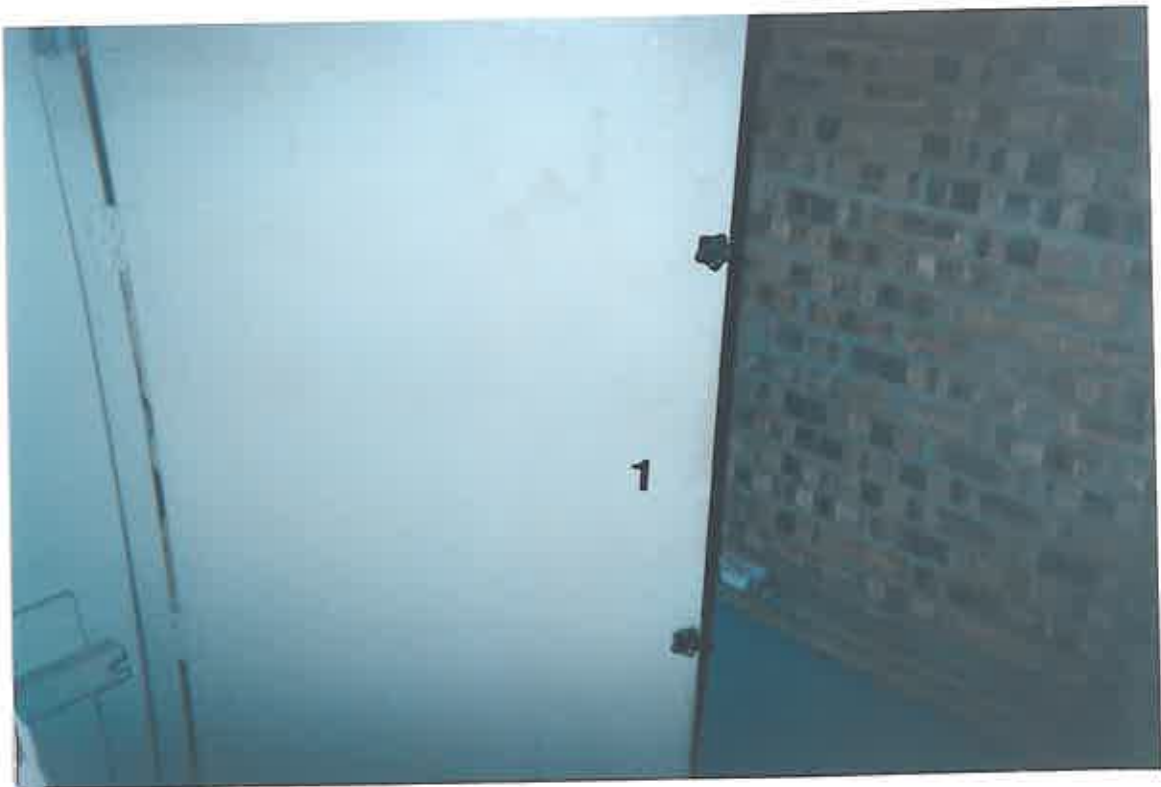
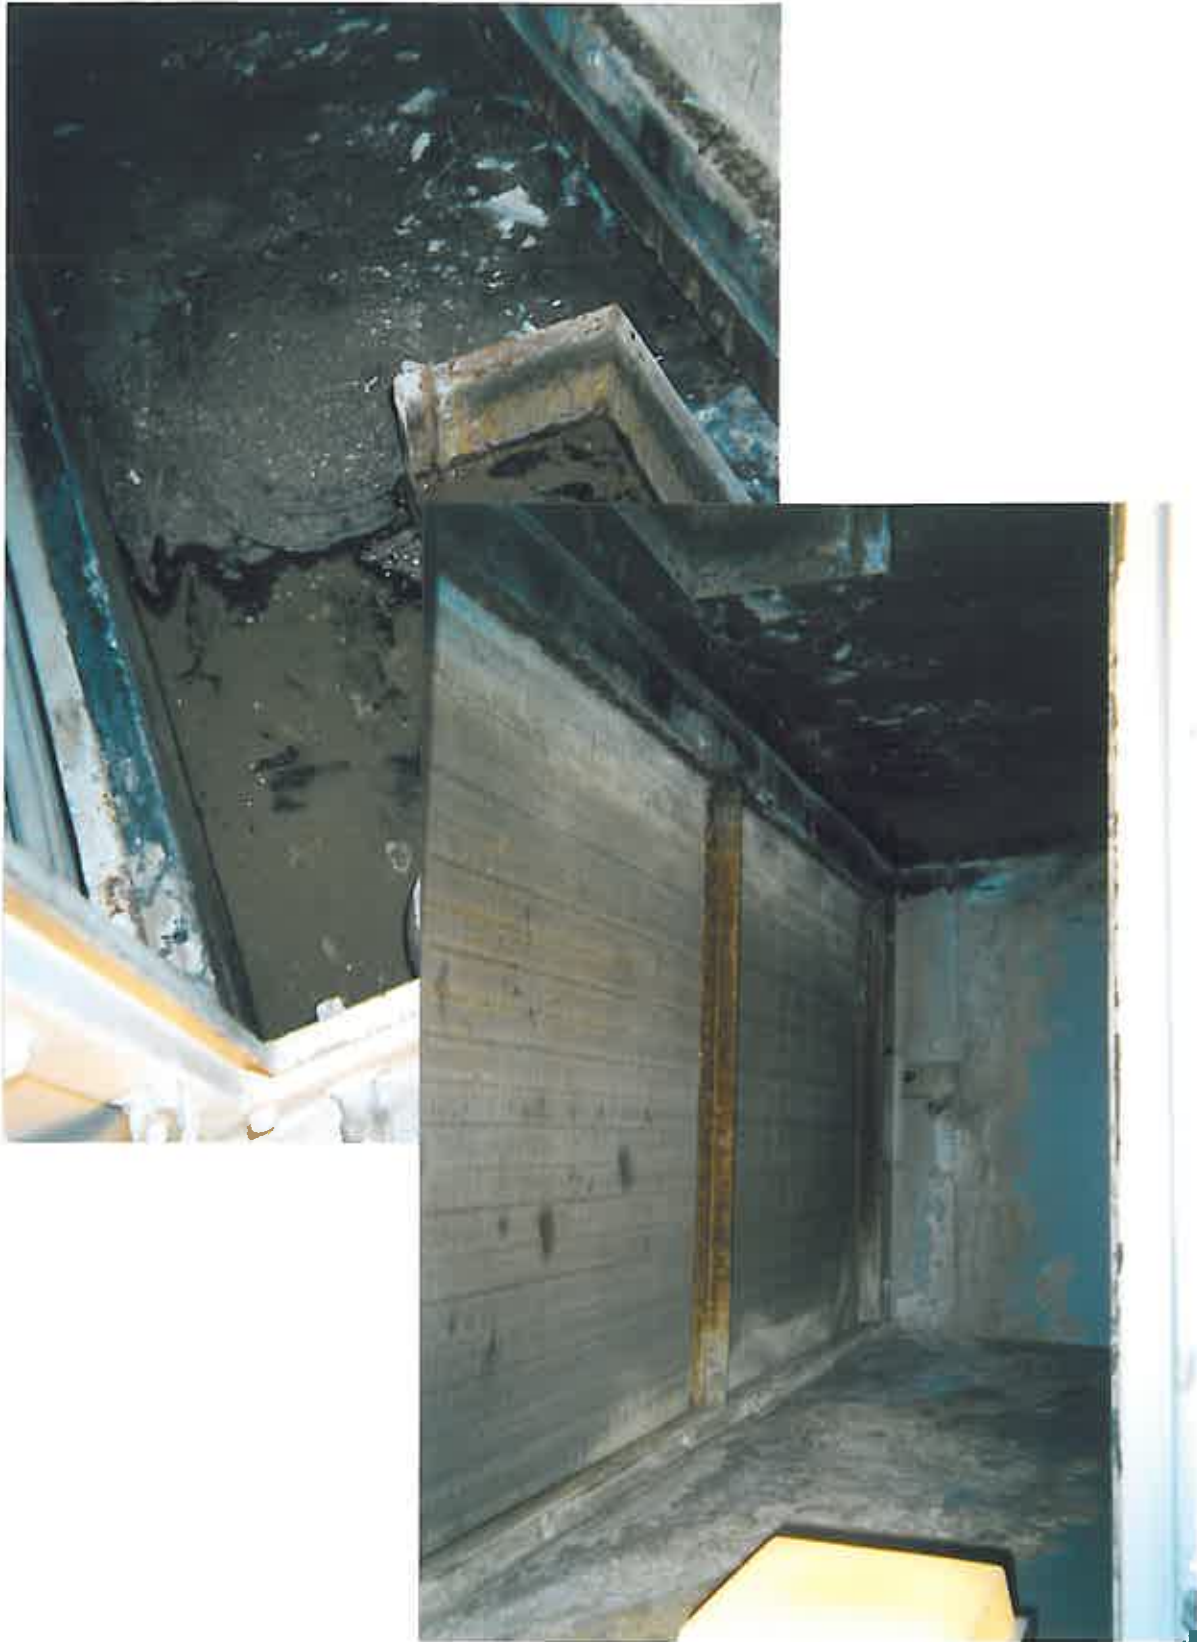
AIR HANDLING UNIT NO. 1

The above photographs show the internal condition of the AHU, prior to any preparation work being carried out. As the photographs clearly show, the existing Bitumen coatings had failed with signs of progressive corrosion, which in areas was applied up to 30mm in thickness.
