# COMPLETION REPORT

Client : **Transport Company**

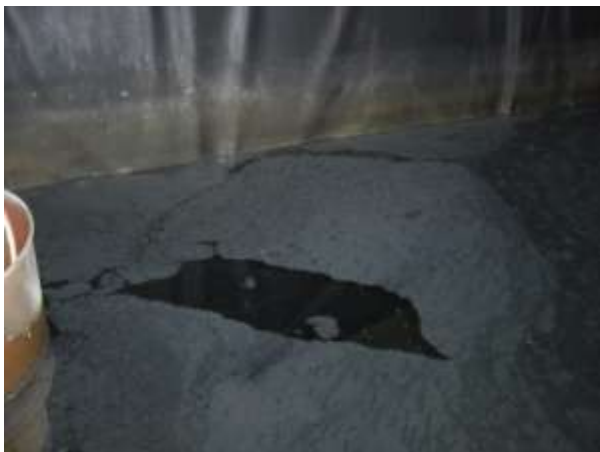
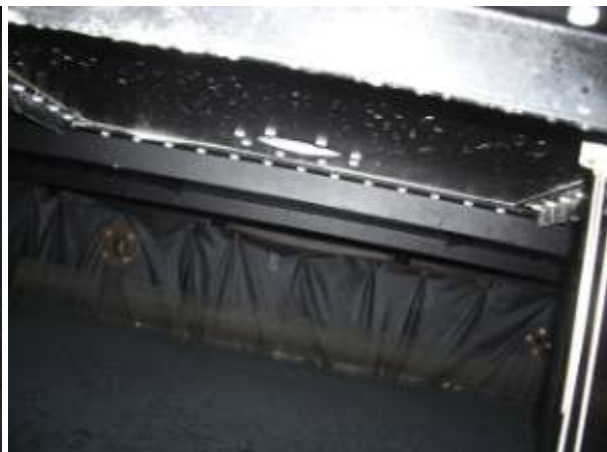
To comply with current regulations, COVAC highly recommended a full internal re-lining to both tank compartments, which will comply fully with current stringent water treatment regulations. We can confident guarantee the scope of works for a minimum of 10 years, with additional benefits of, the client’s peace of mind, ease to regular monitoring and annual cleaning without damage to the coating which would always be an issue with the rubber liner.

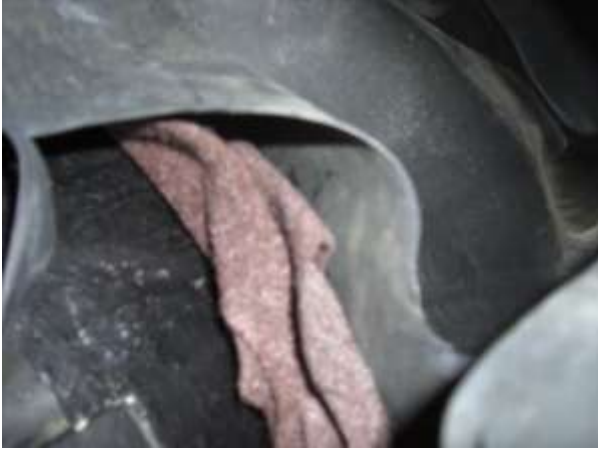
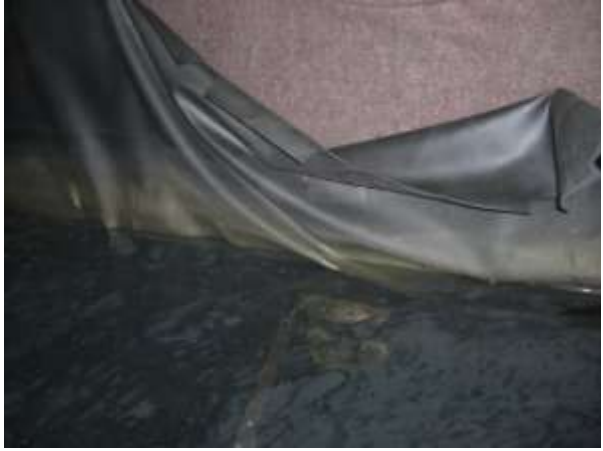
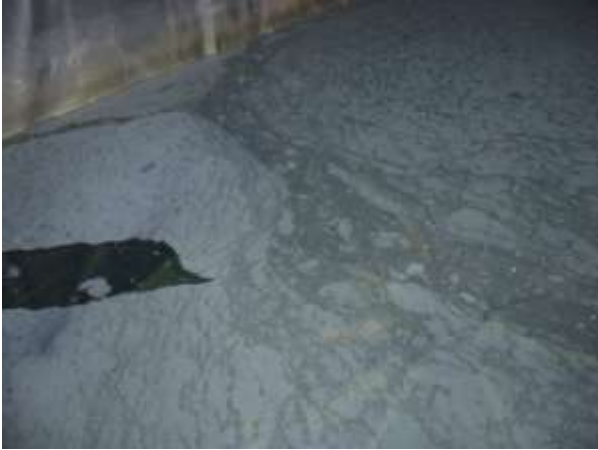
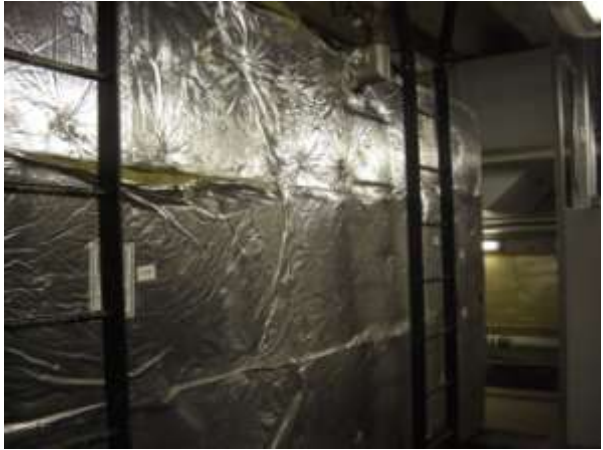
*We, therefore, proposed the following: -*

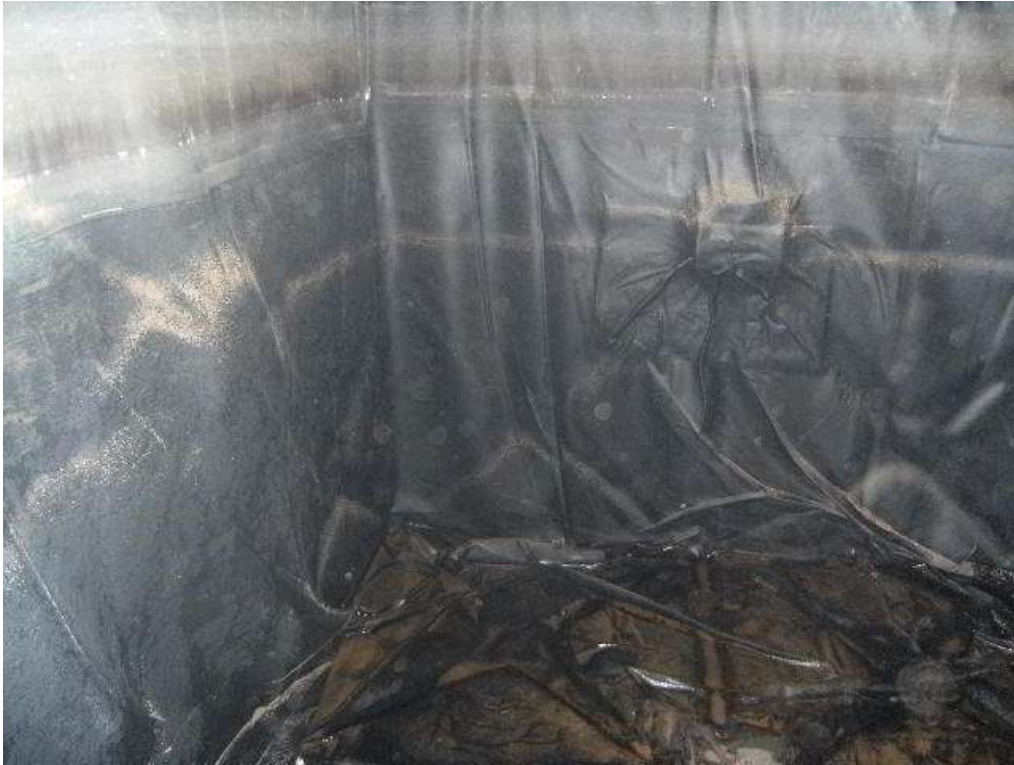
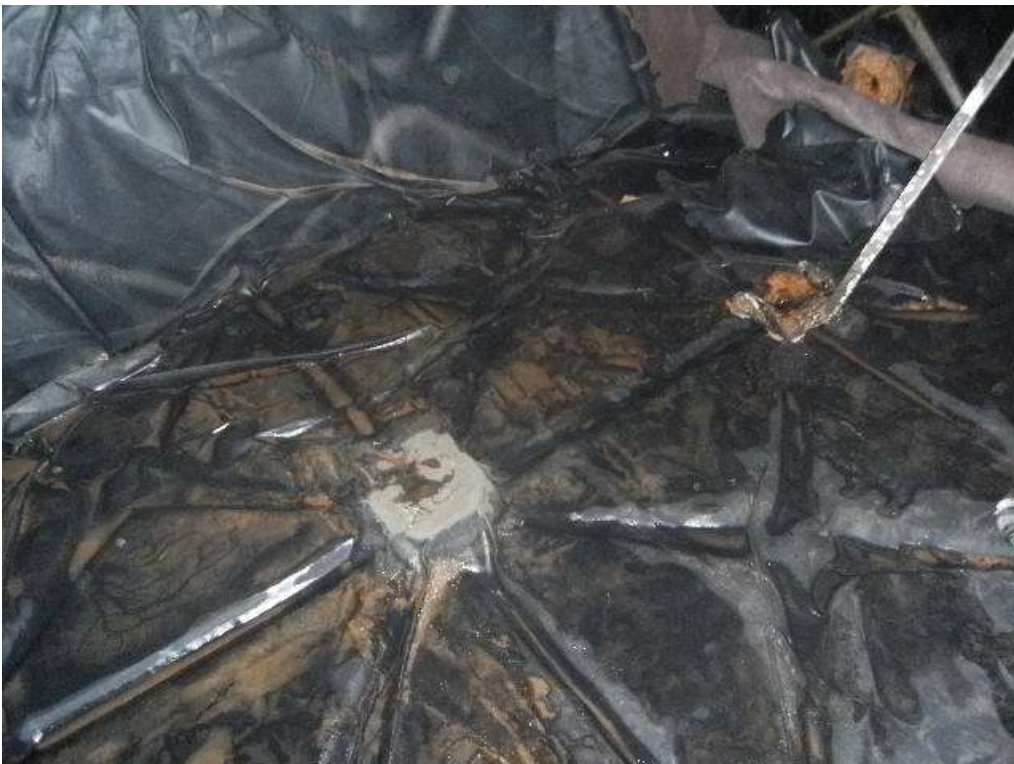
**These images show the tank after being drained of water and before / during removal of the failed butyl liner, felt lining and insulation.**

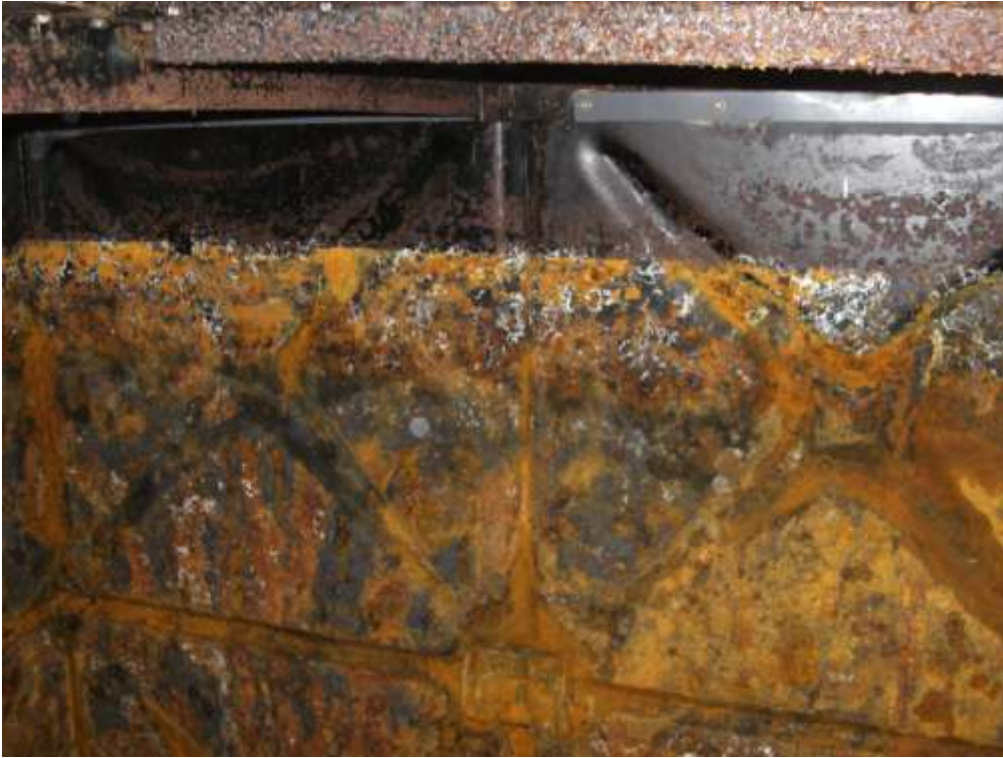
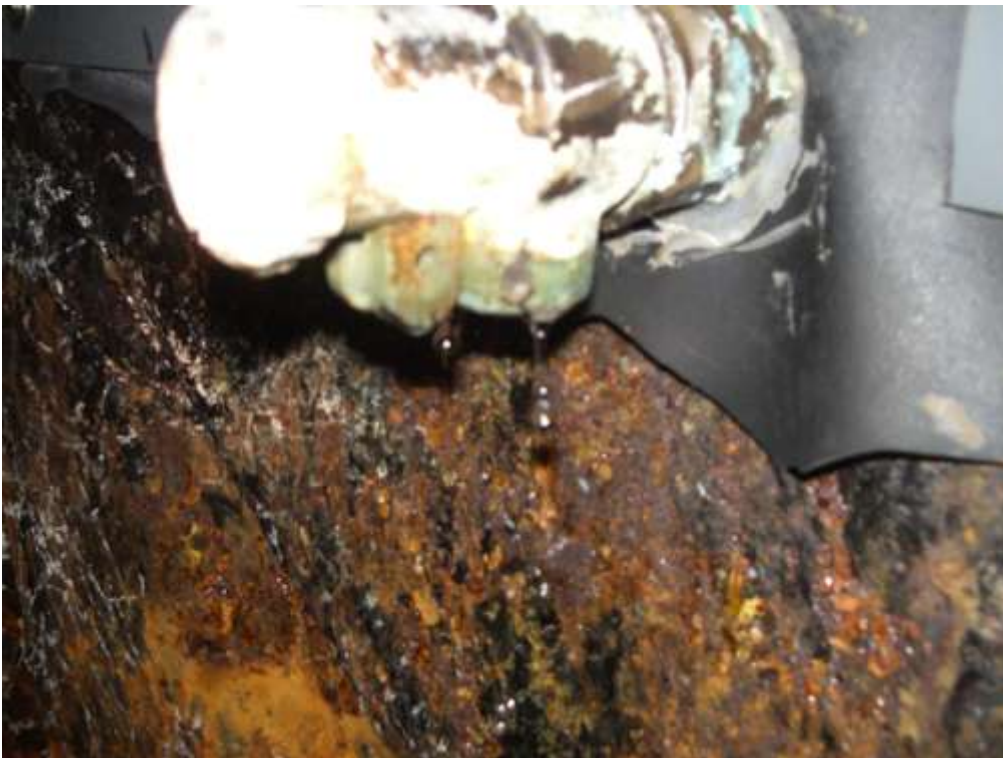
**In some areas, the water trapped between the failed liner and tank substrate had caused severe corrosion.**

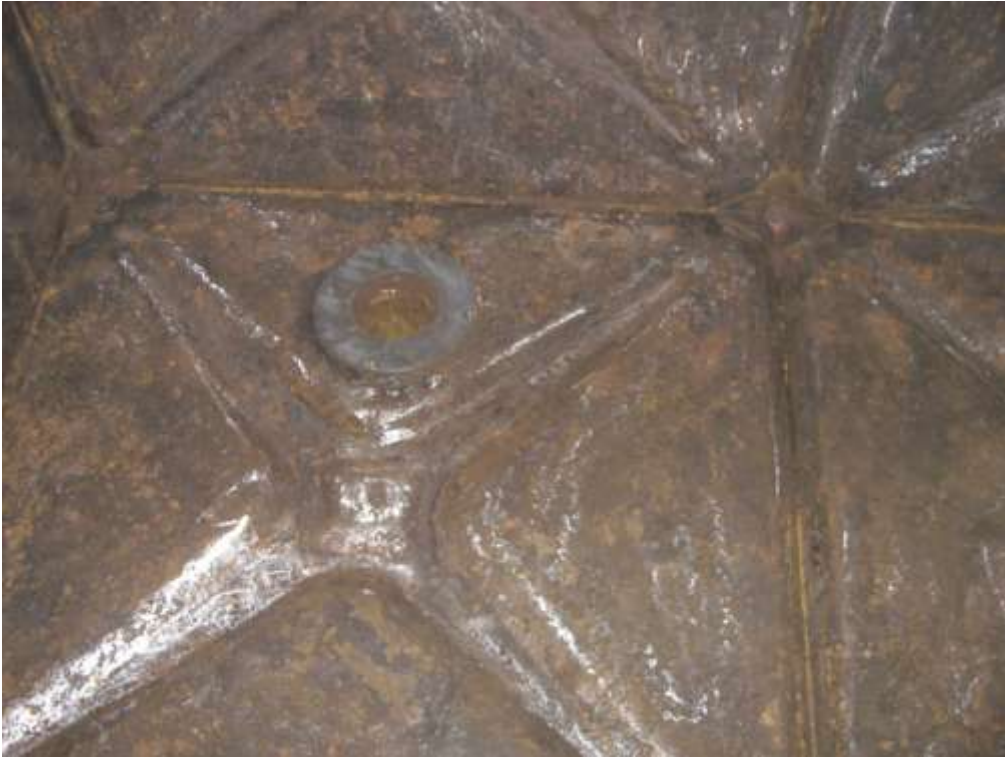
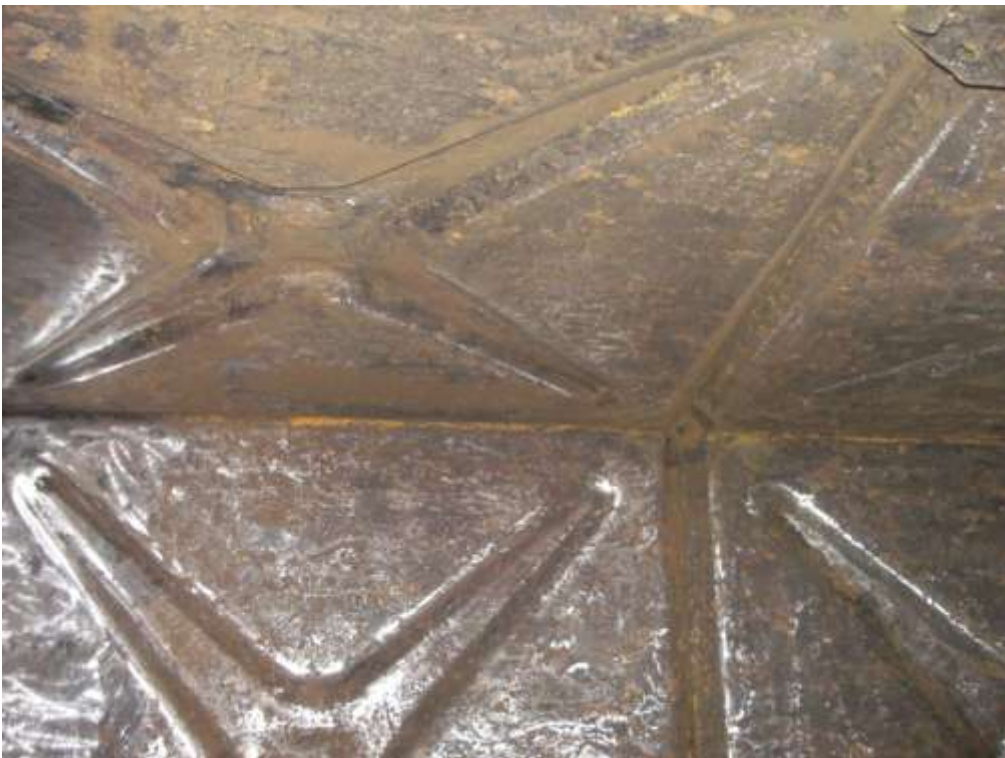
**These pictures show the internal substrate of tank #1 after being prepared by COVAC Operatives.**

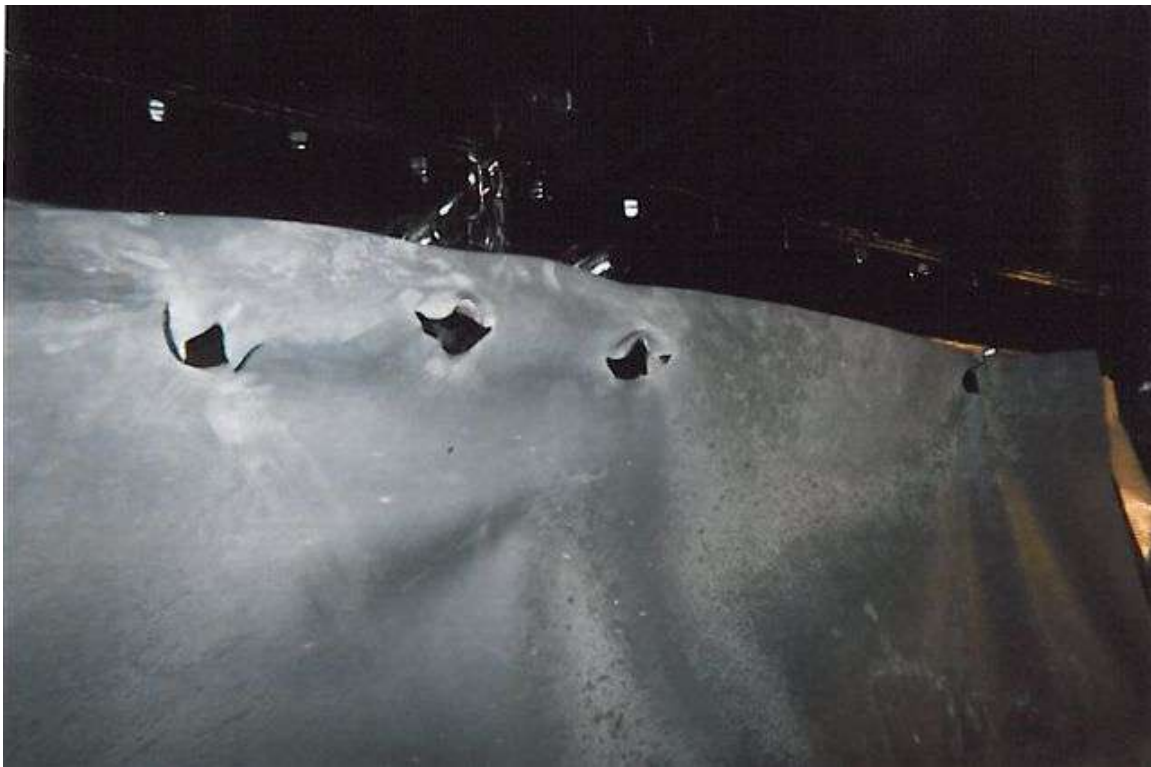
These images show the tank after being drained of water and before / during removal of the failed butyl liner, felt lining and insulation.
