COMPLETION REPORT

Client : **XXXXXX Hospitals NHS Trust**

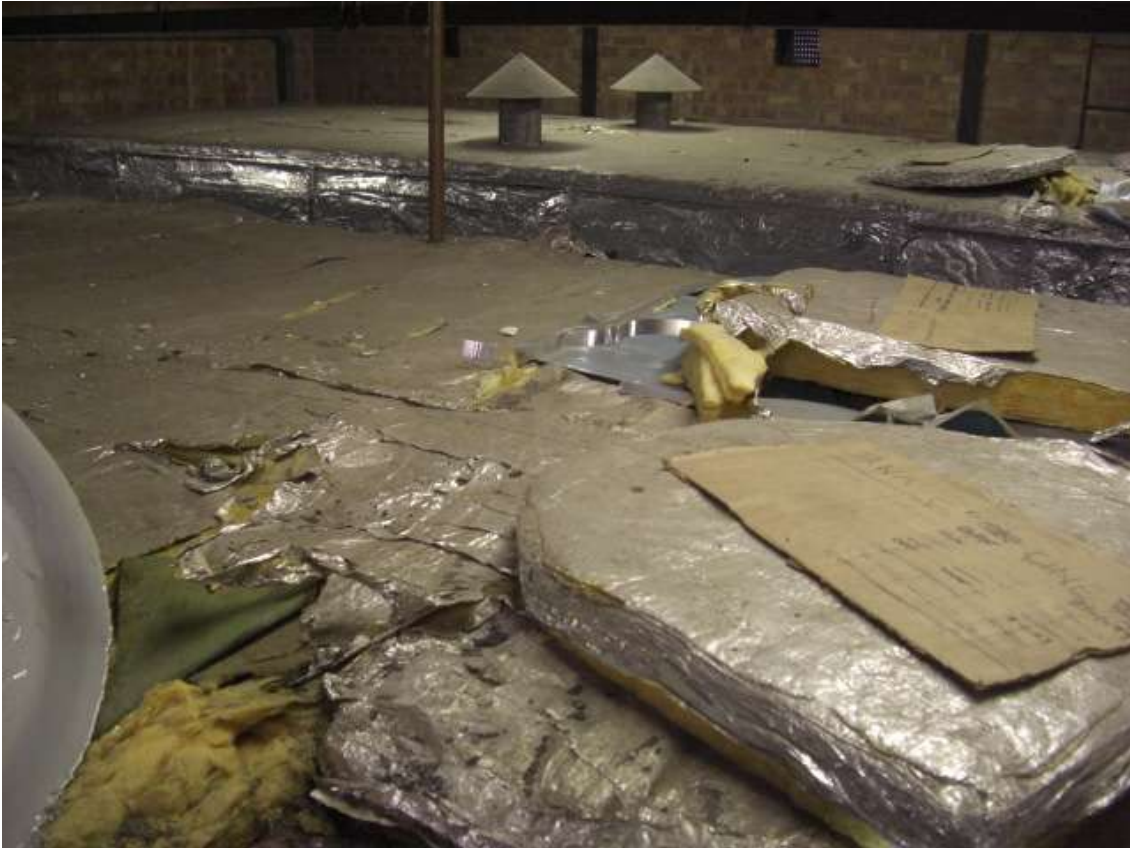
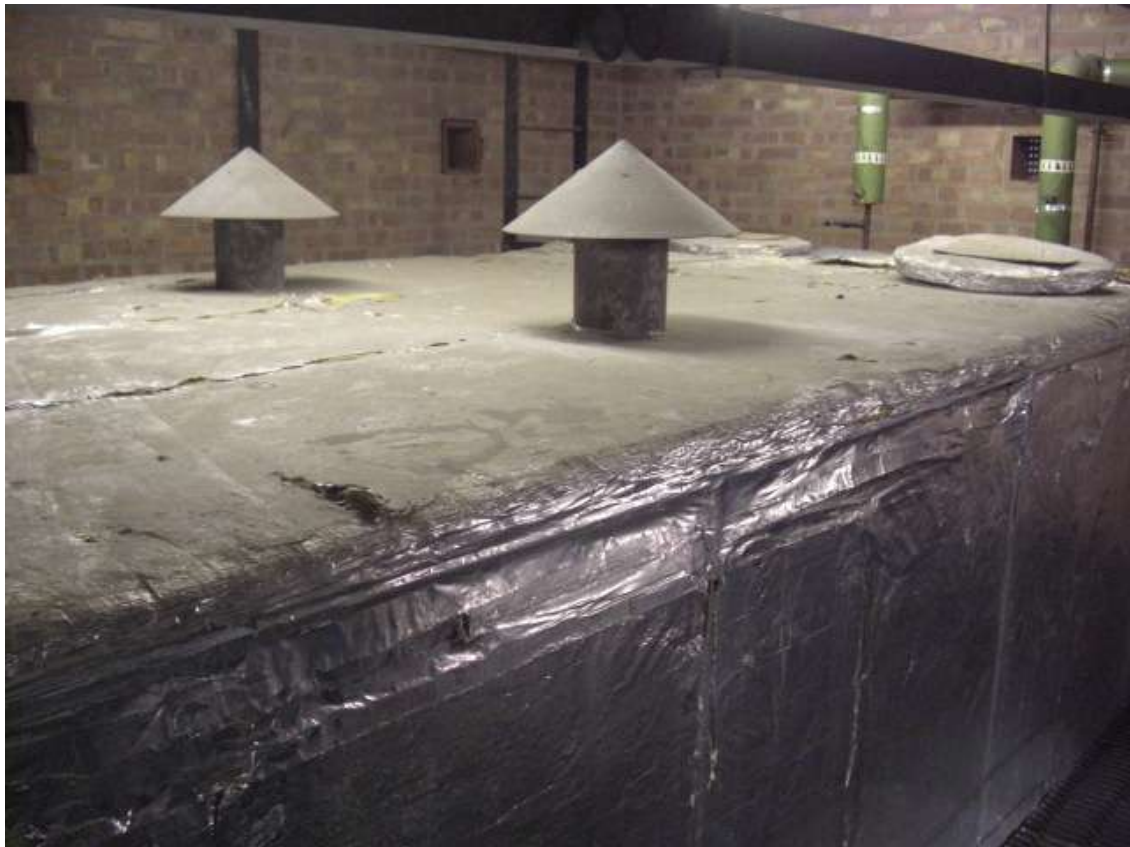
These photographs show the external of the tanks with typical access.

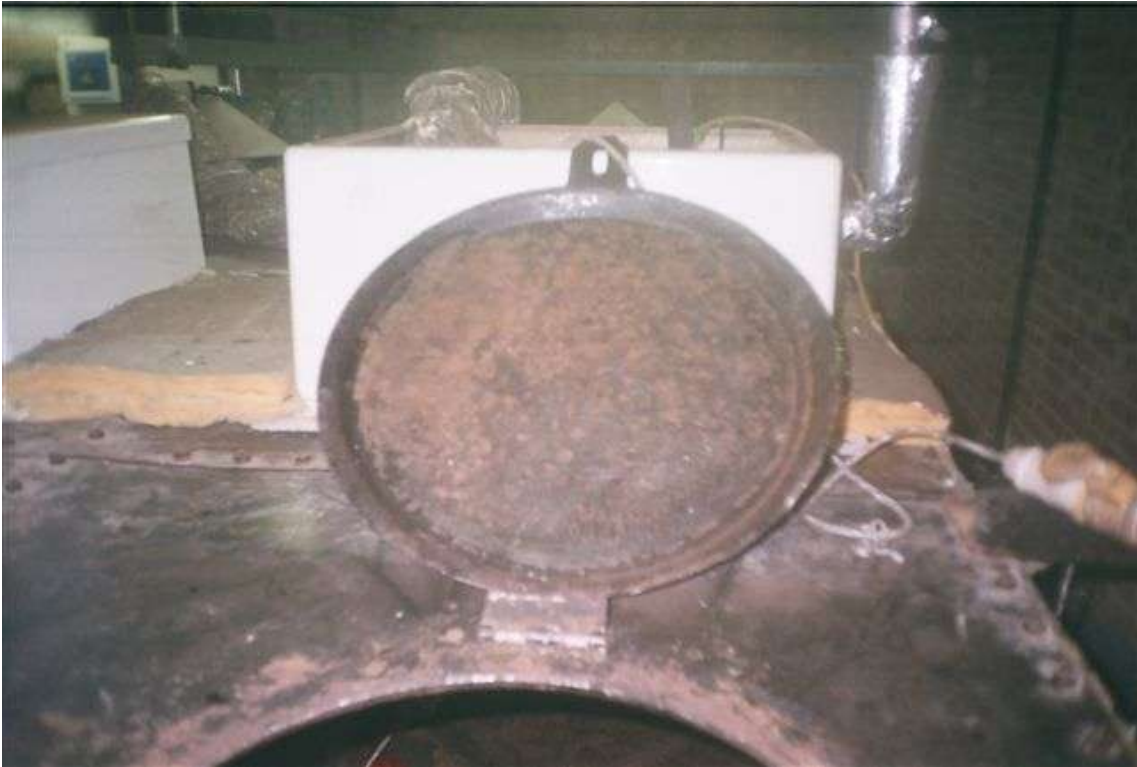
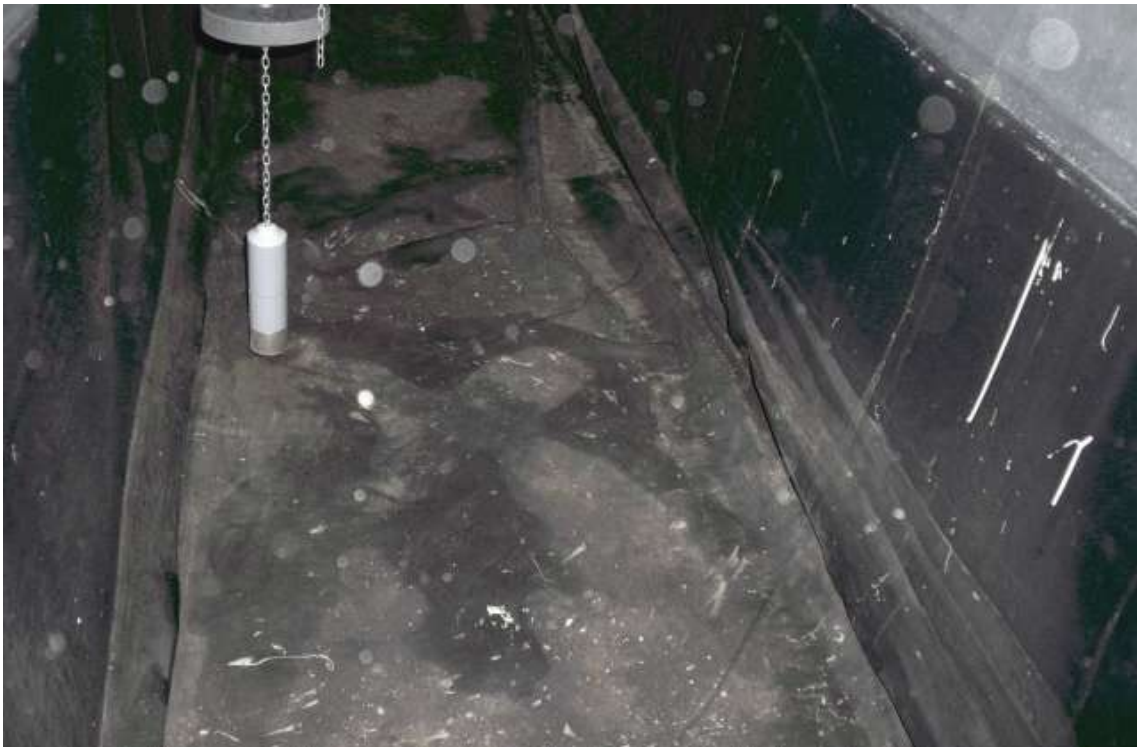
The above and following images show the internal of the structures before removal of the failed rubber liners.

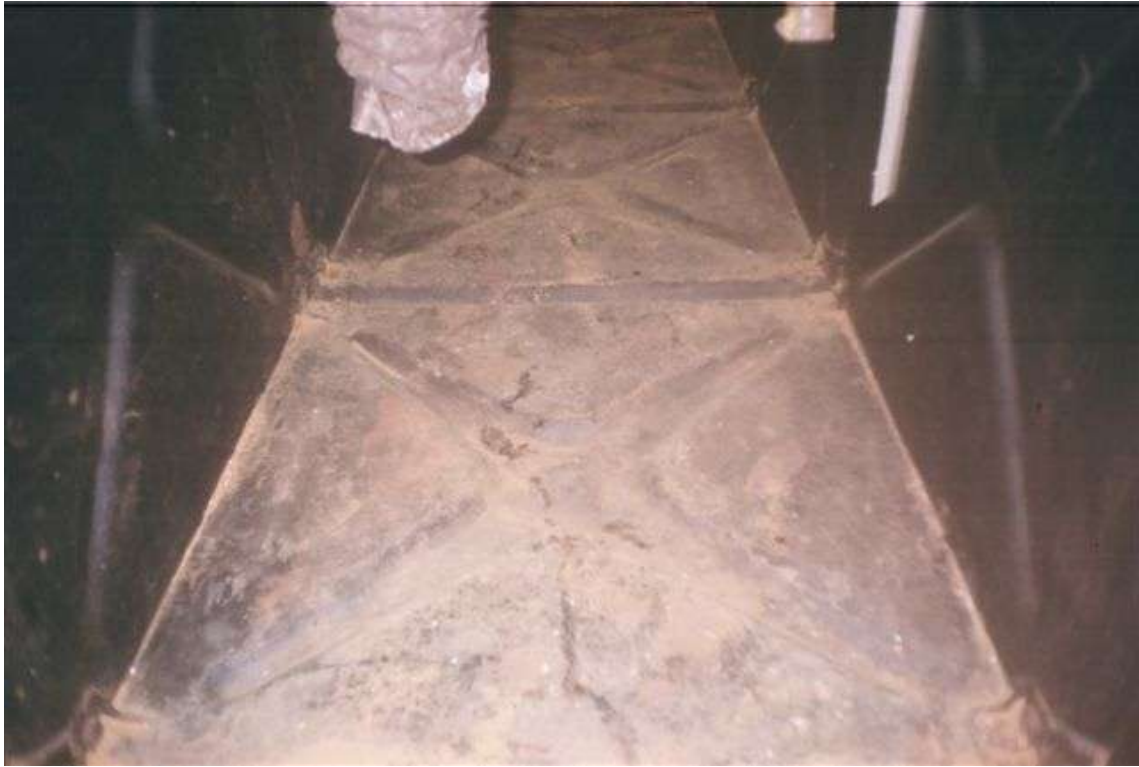
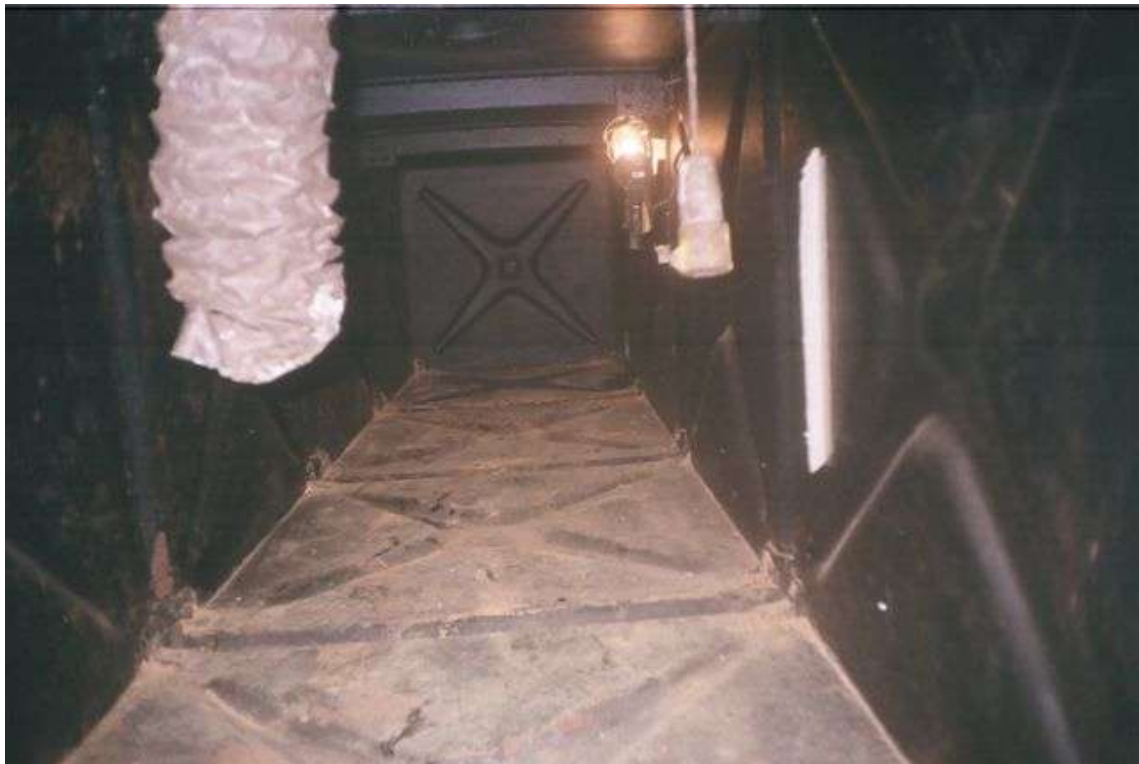
These photographs show the internal surfaces of the vessels having been drained of water with the rubber liner removed exposing the steel substrate which had been previously coated in a non (WRAS / DWI) approved bitumen paint.

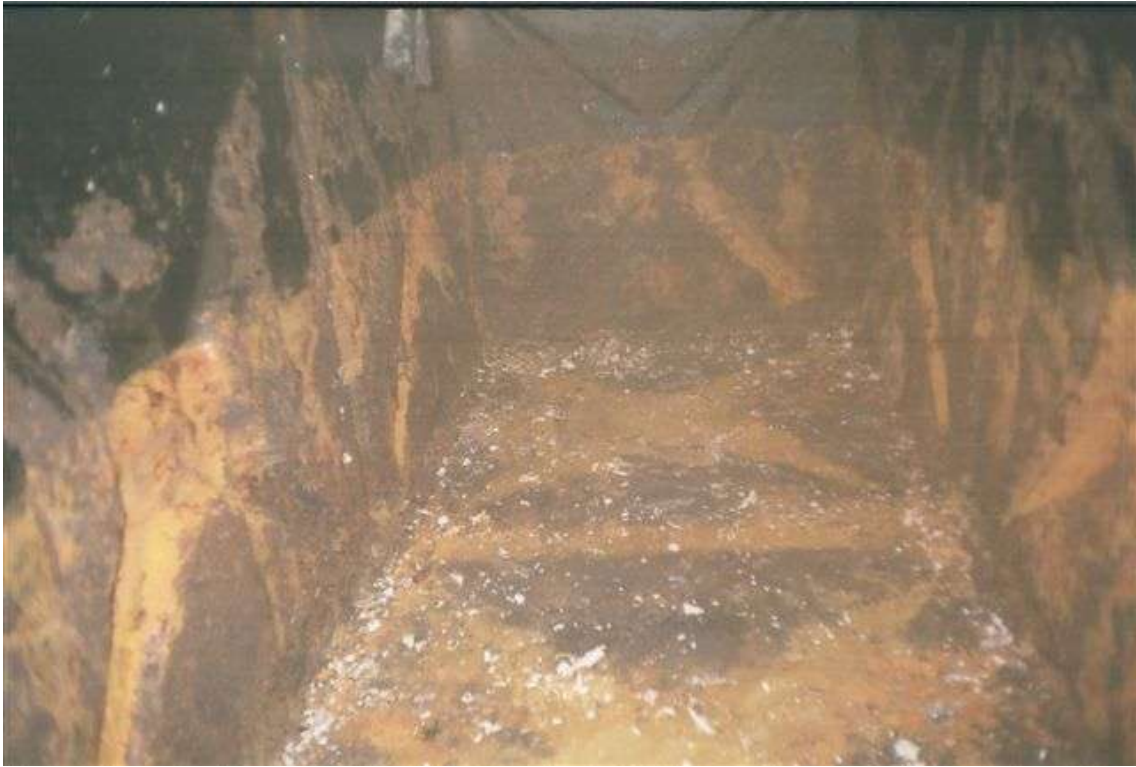
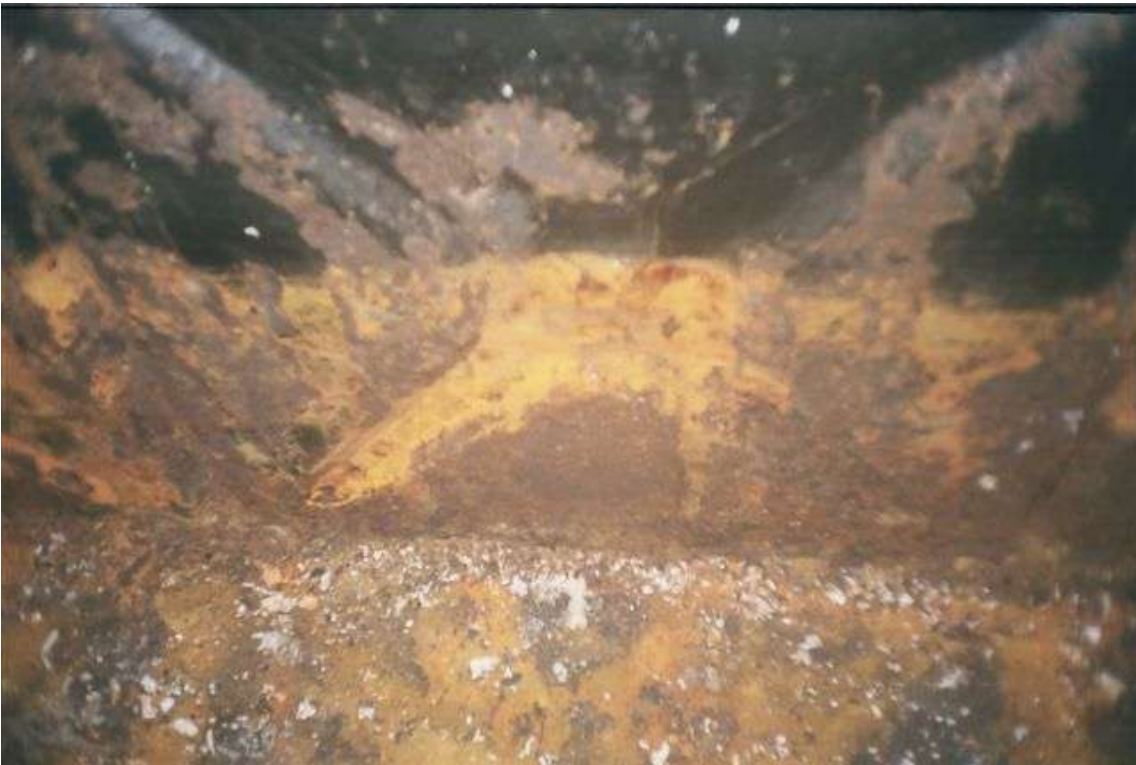
Corrosion is clearly evident as a result of water leaking behind the failed liner.

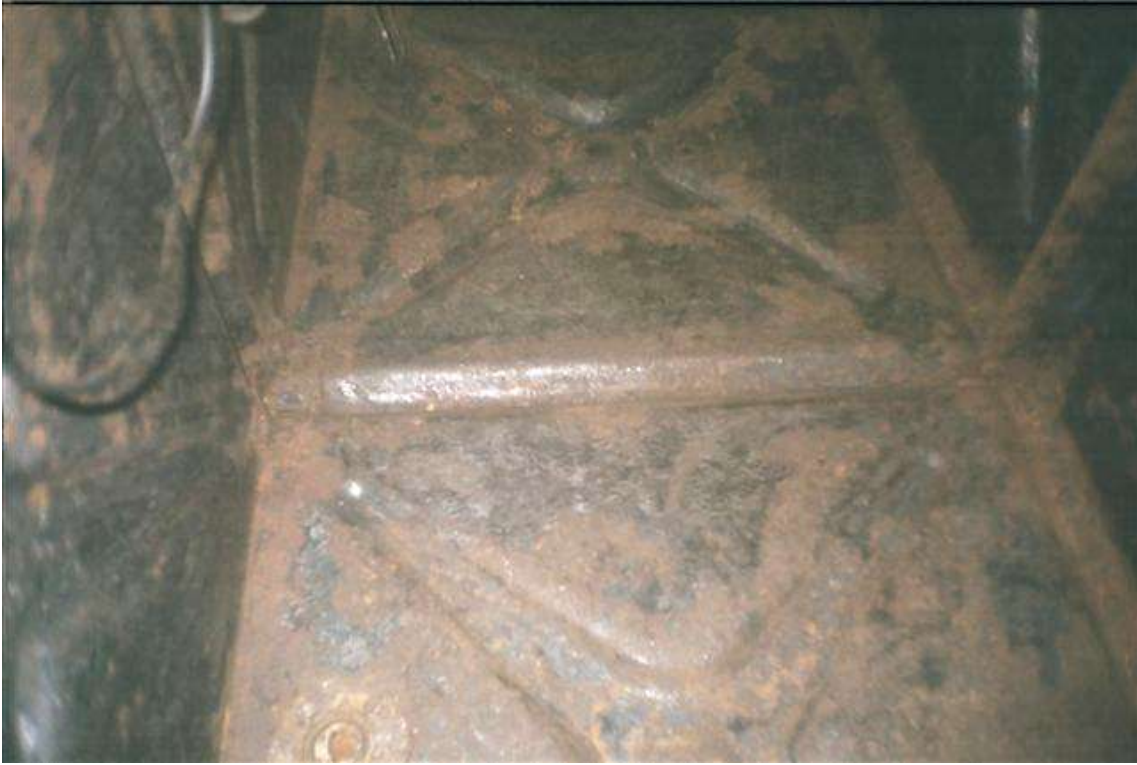
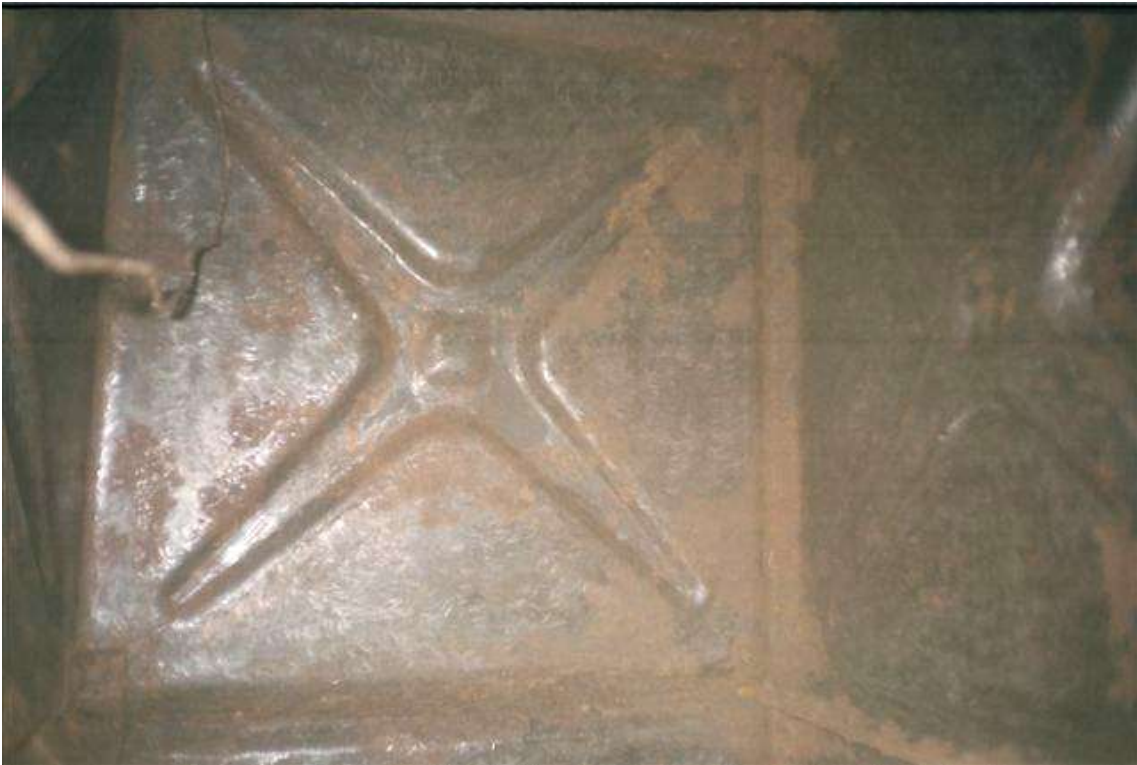
These pictures show the internal substrate after being prepared by COVAC Operatives.
