COMPLETION REPORT

Client : **University of XXXXXXXXXXXX**

Project Brief : **The Internal Relining of 1 No. Concrete CWS Tank**

Covac Ref : **976**

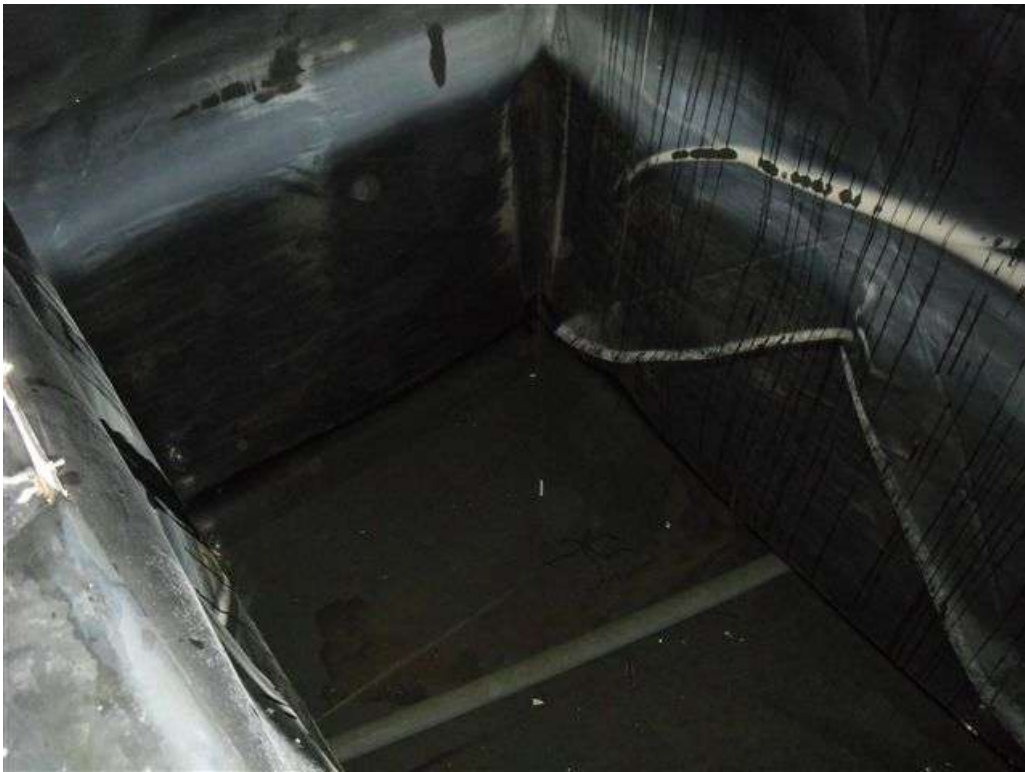
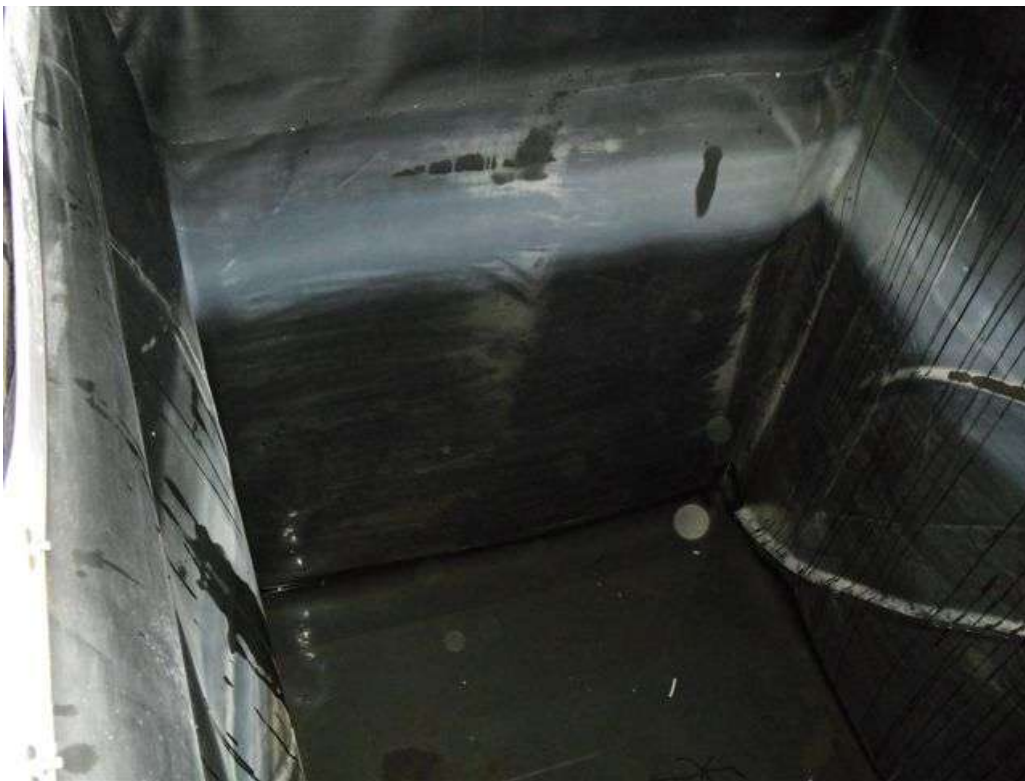
These photographs show the internal surfaces of the structure having been drained of water, but prior to the failed liner being removed and any relining work commencing.

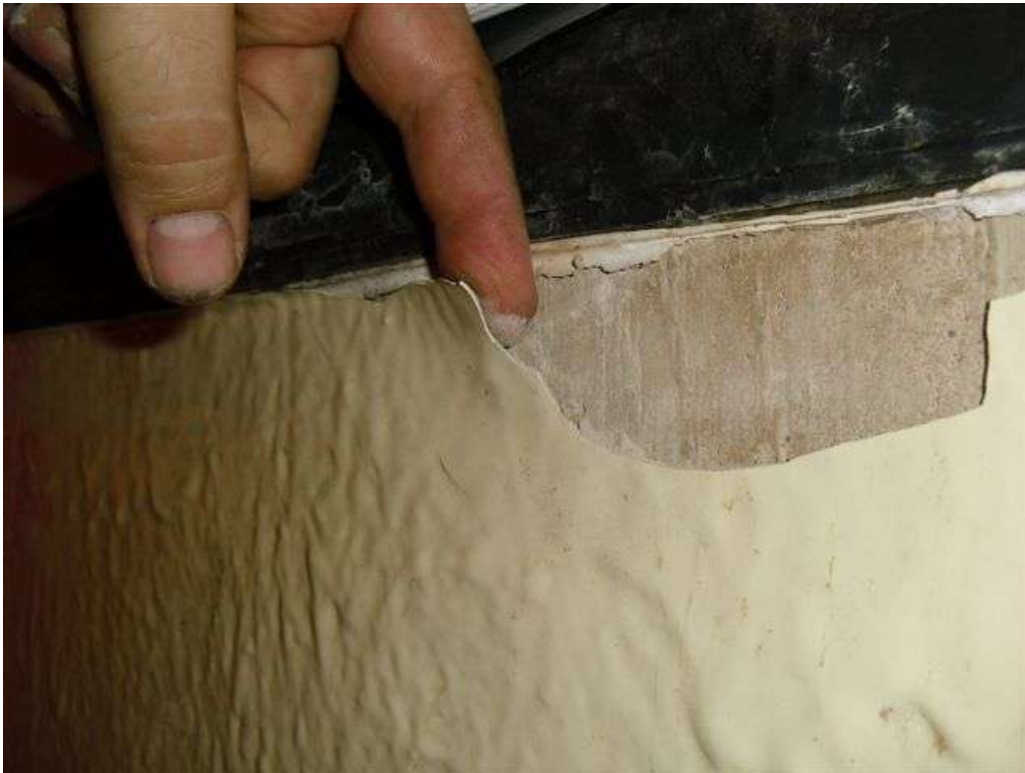
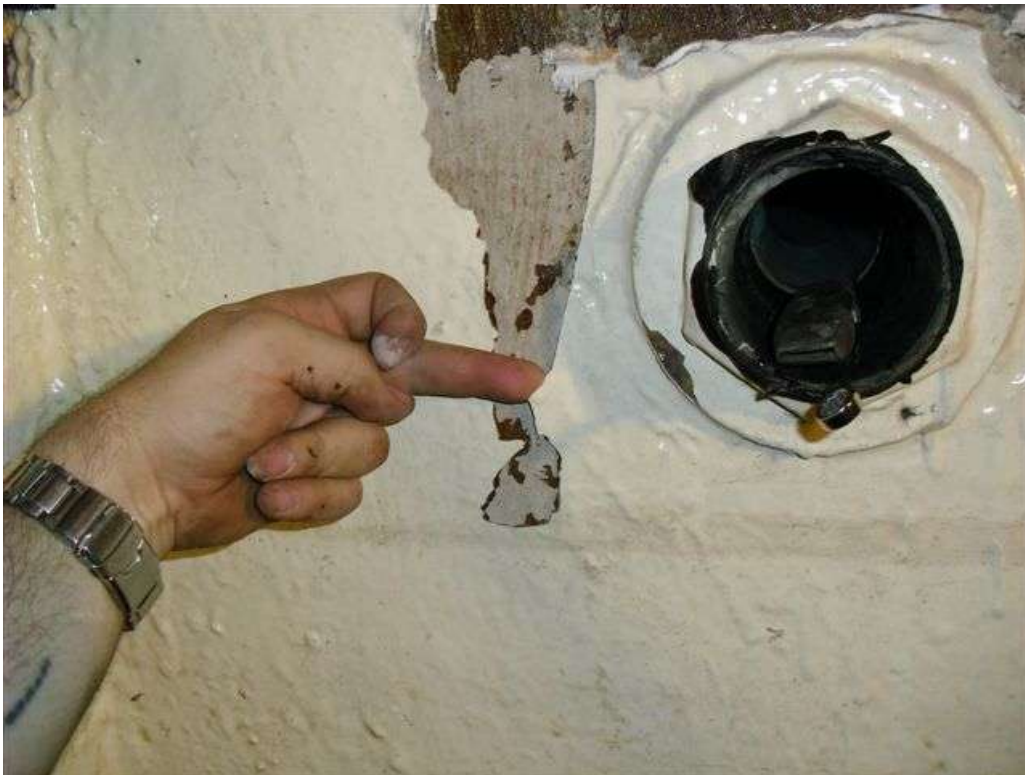
The coating was clearly de-laminating from the concrete substrate.

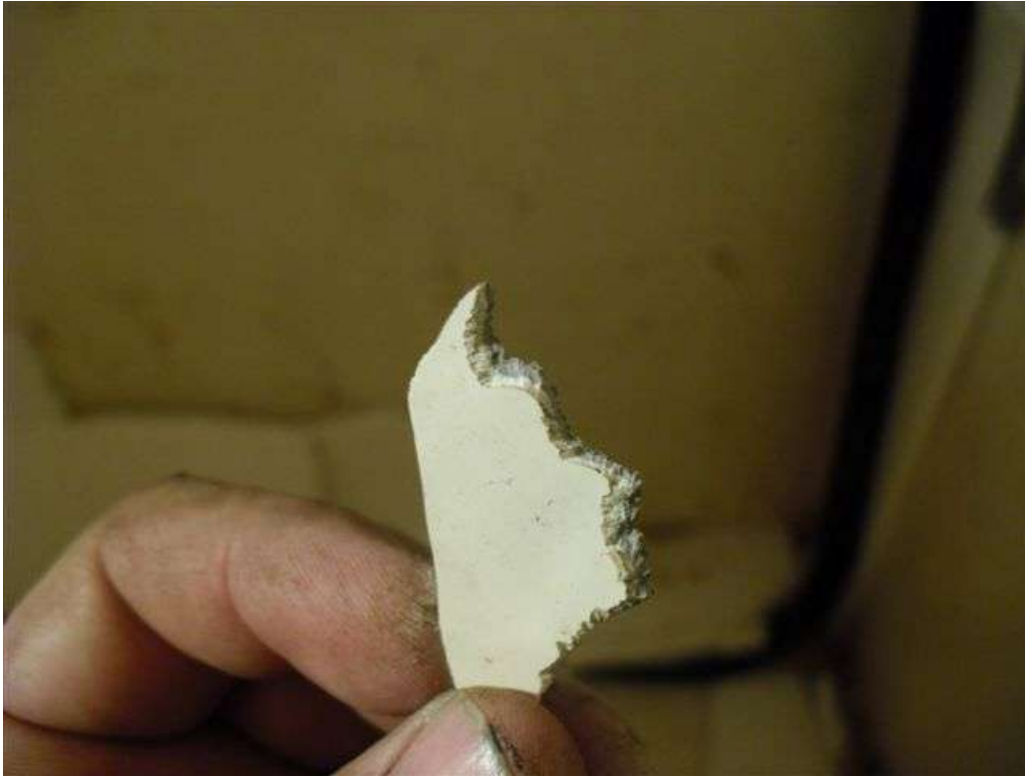
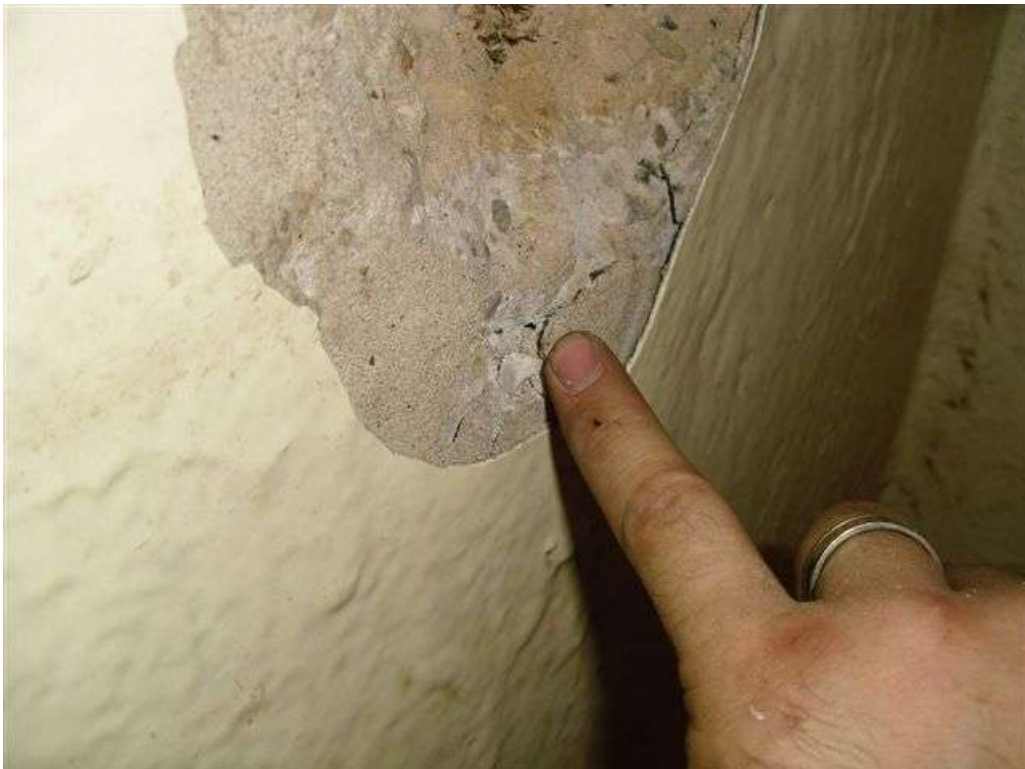
A combination of the failed flexible liner and de-lamination of the failed coating had allowed water to damage the concrete substrate resulting in cracks and pitting.

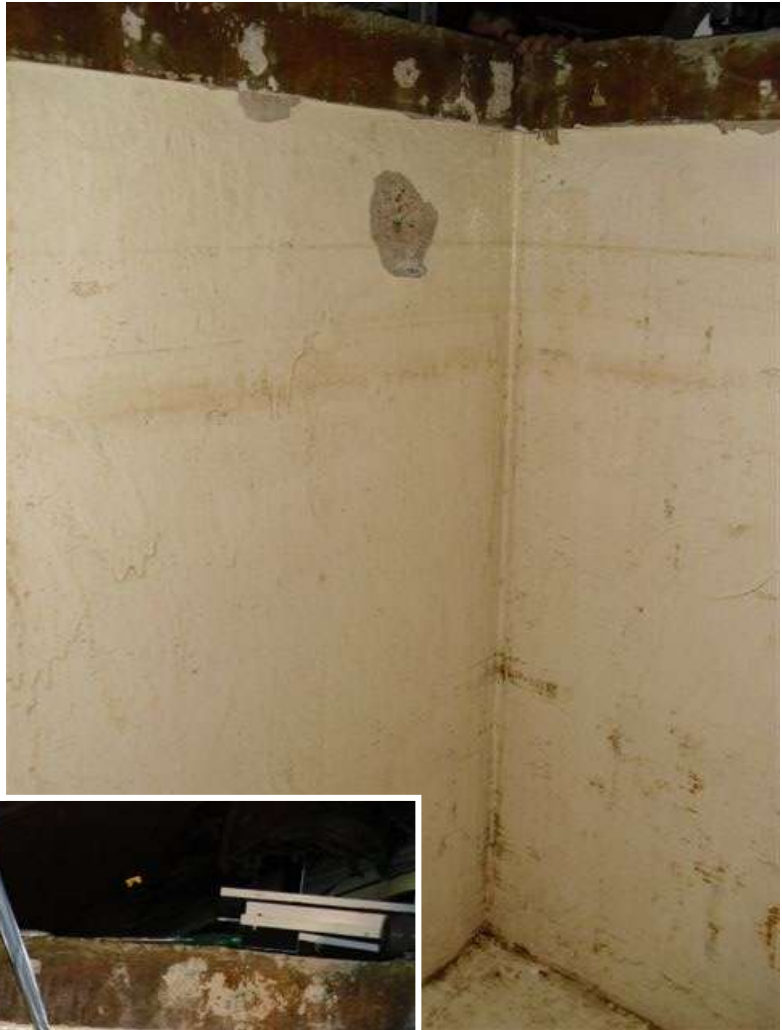
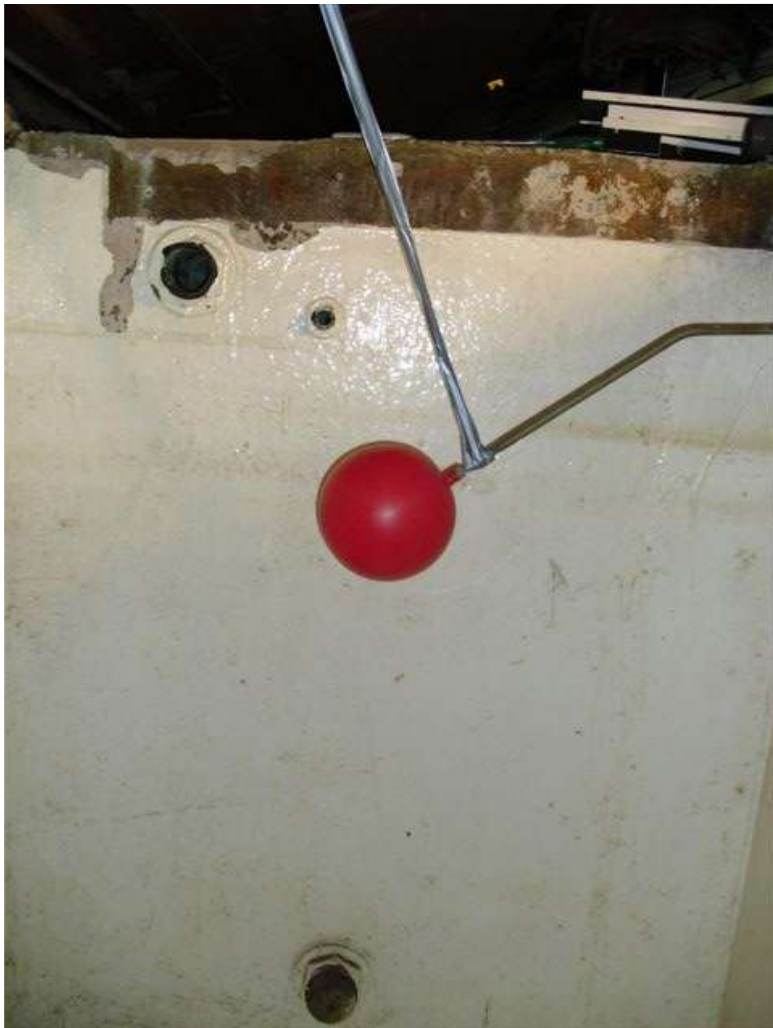
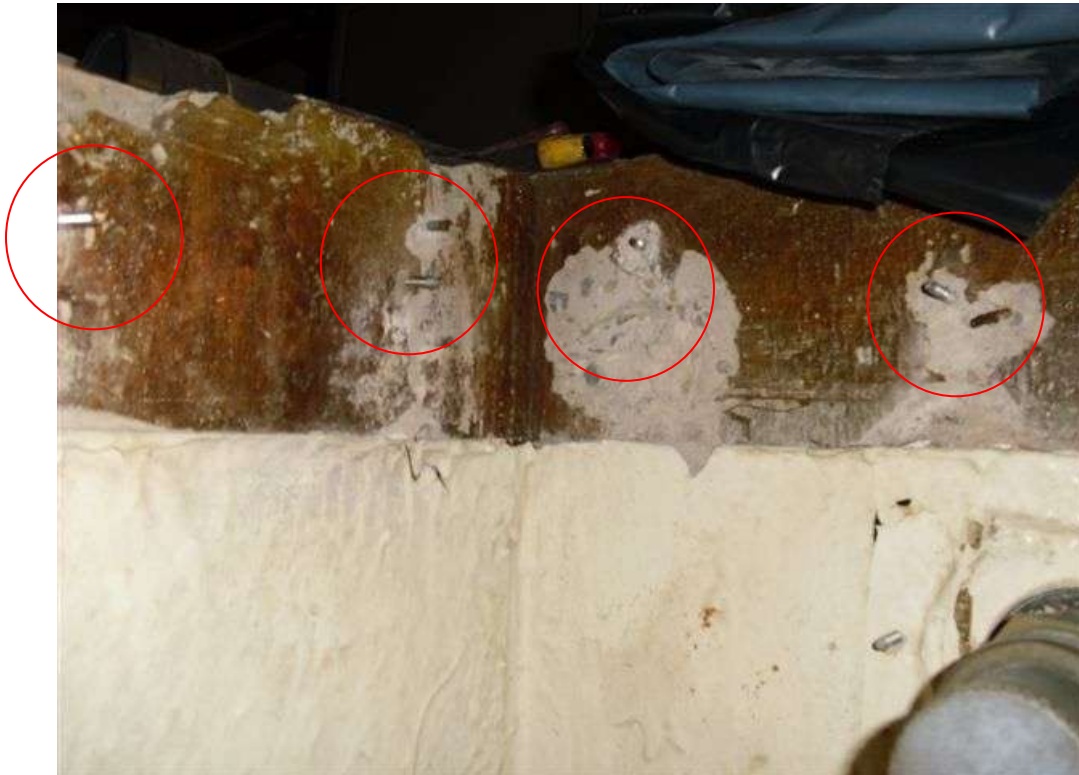
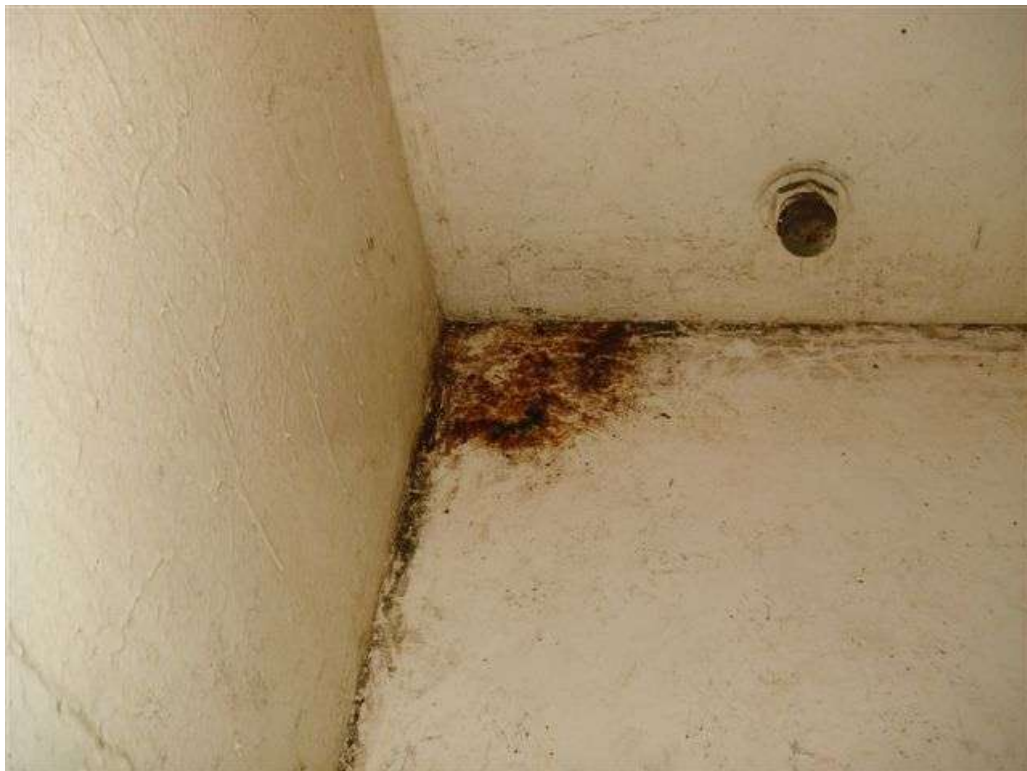
The top image highlights where the previous liner had been secured as well as remedial work to the buildings roof which had been reinforced utilising the concrete tank walls as structural supports that, in turn, had compromised the integrity of the tank.
