# COMPLETION REPORT

Project Brief : **The Repair / Relining of a Concrete Sump Located on the 27<sup>th</sup> Floor**

Site Address : **XXXXX Tower  
Manchester**

System Spec : **3M Scotchkote™ 165PW**  
(Formerly Known as COPON Hycote 165PW)

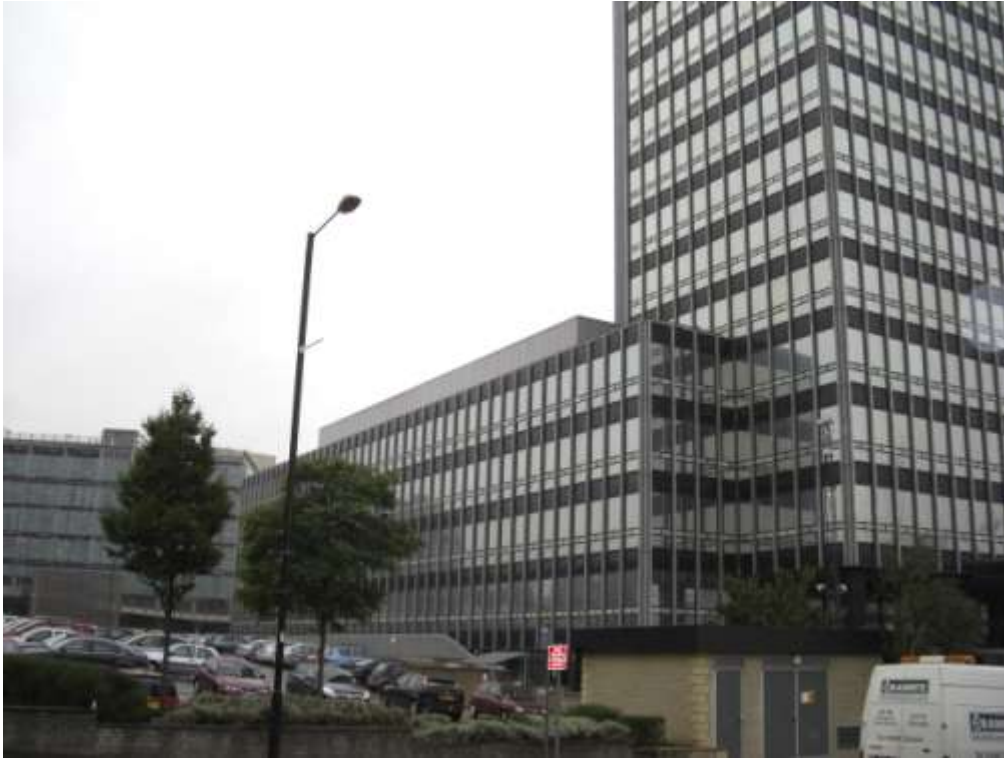
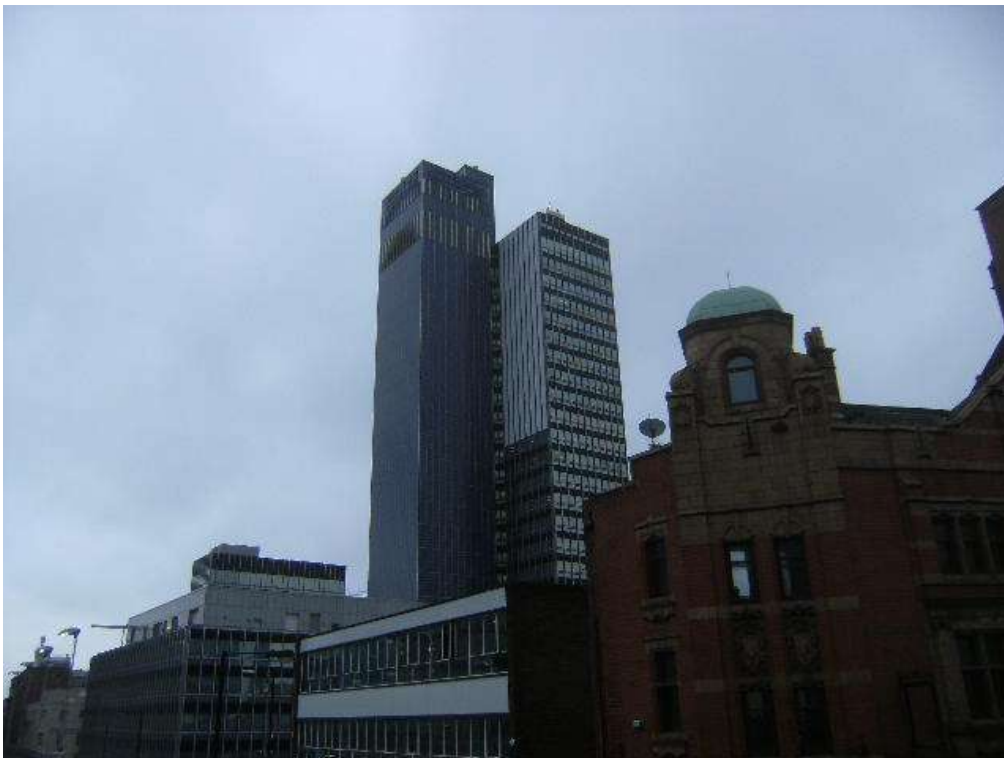
**External views of the Building**

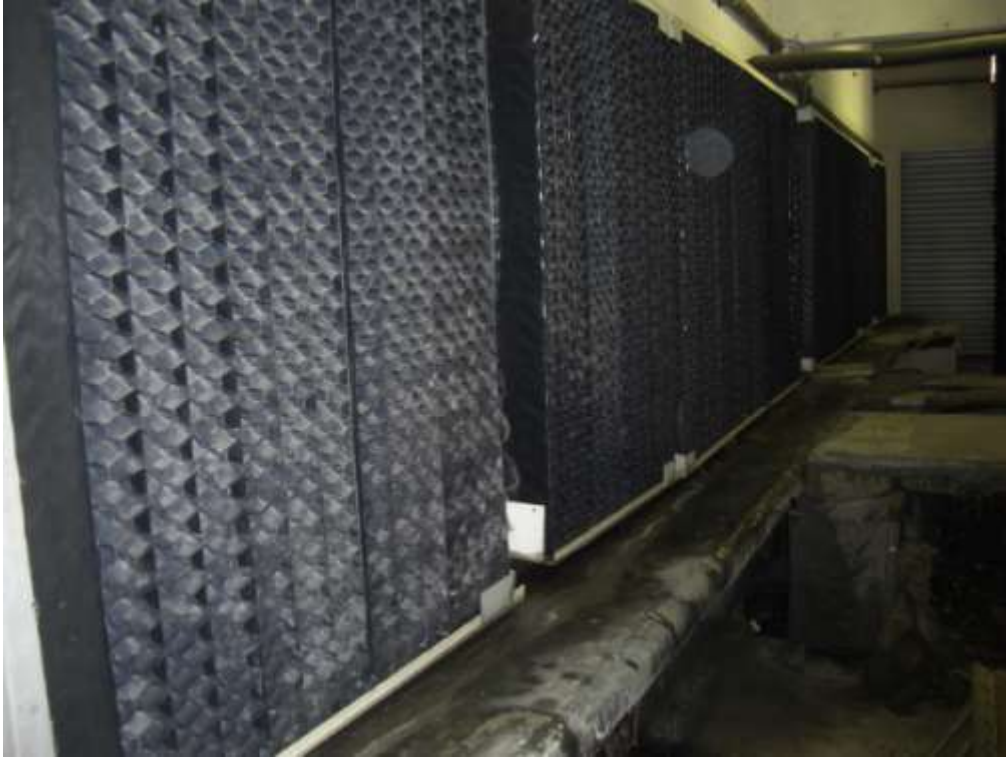
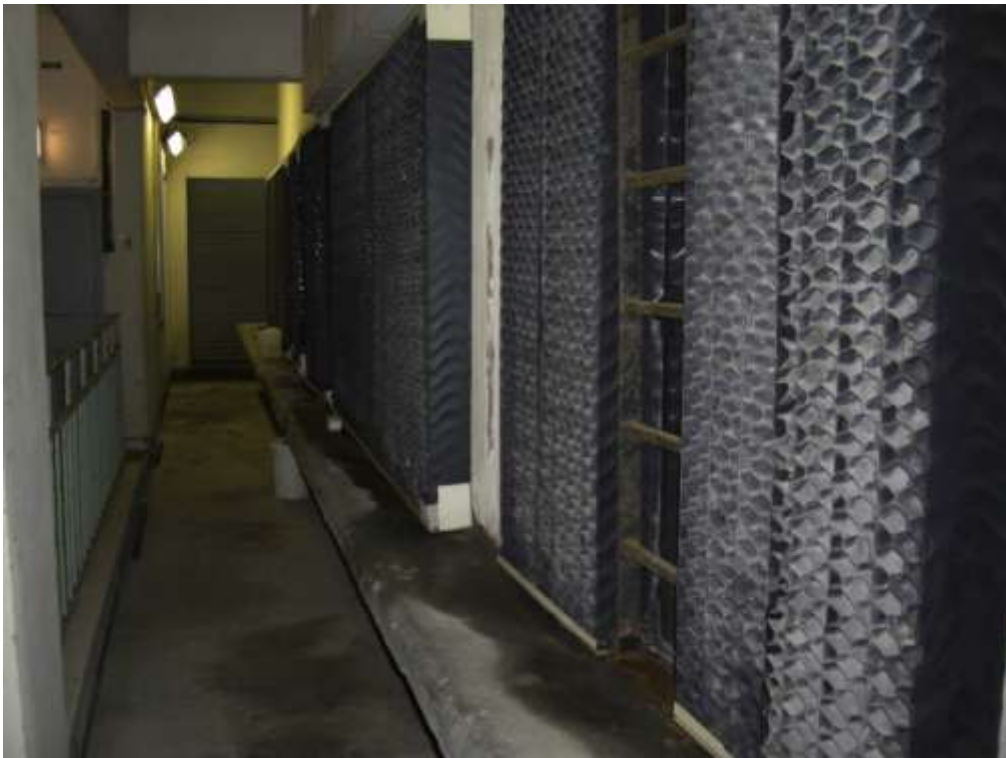
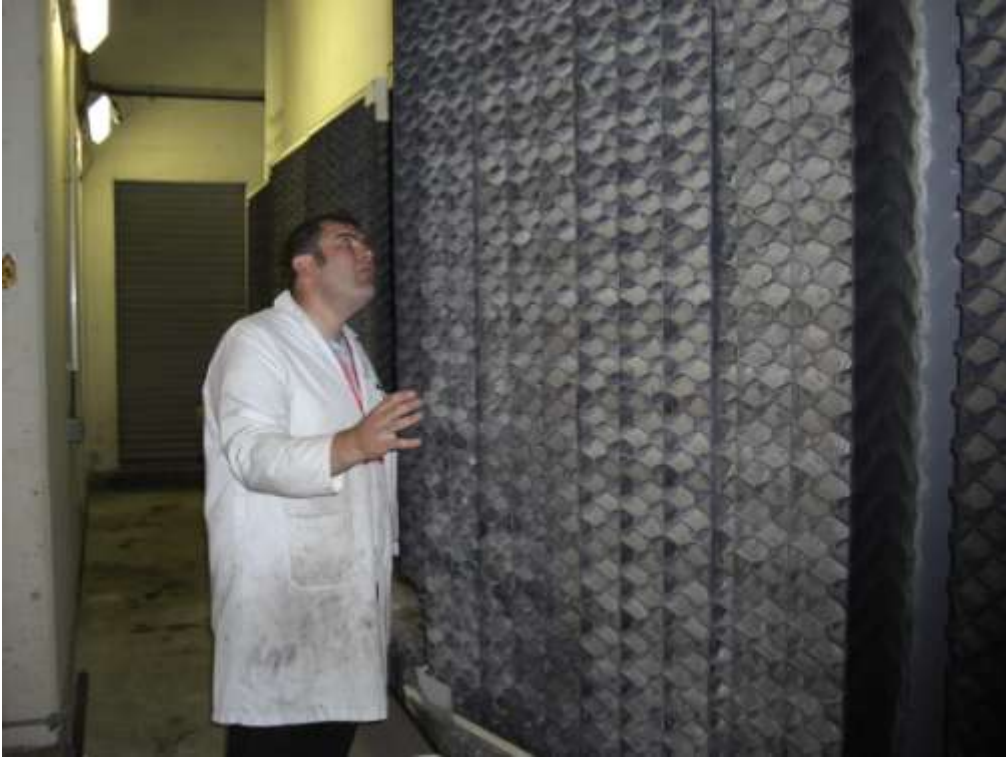
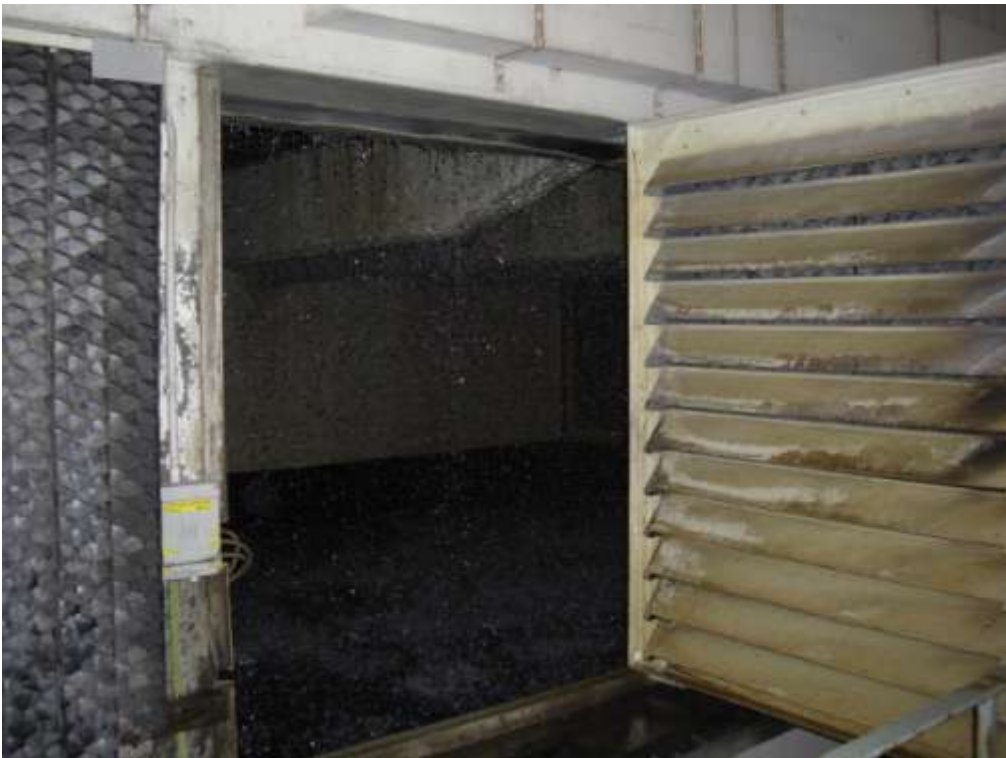
The following images show external views of the Sump.

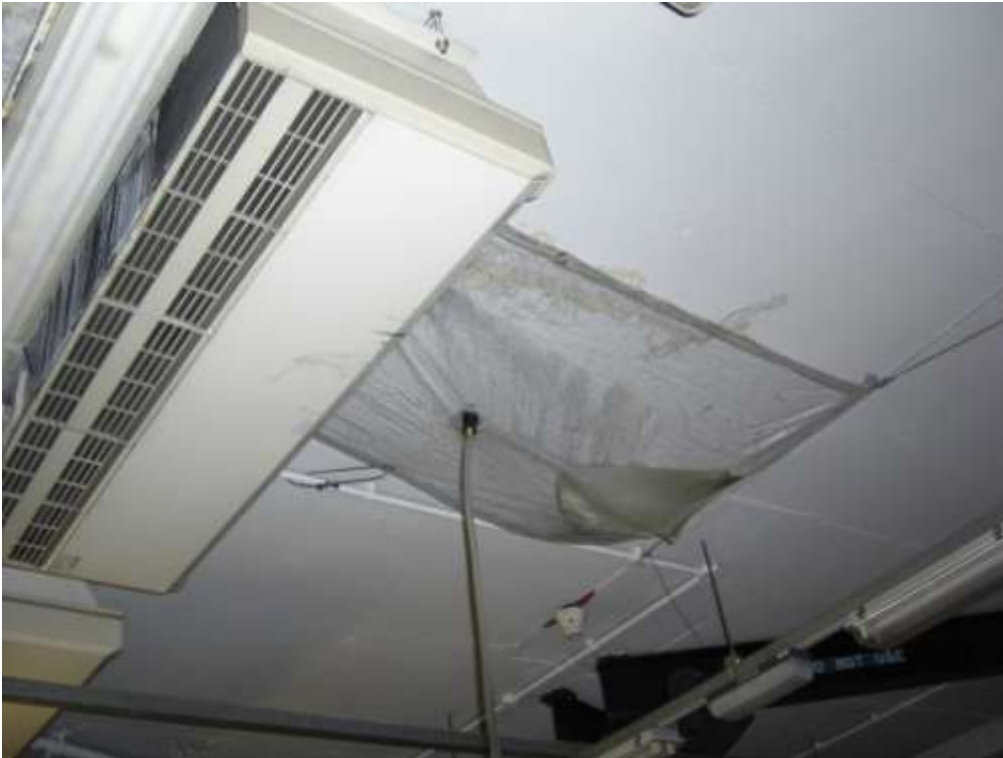
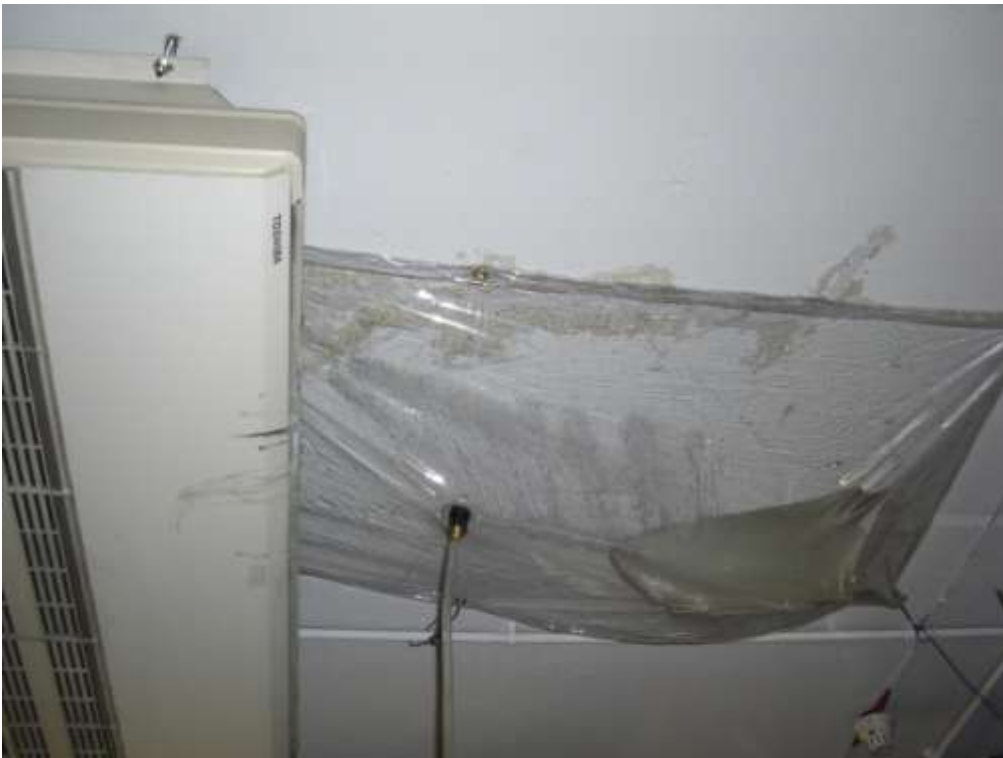
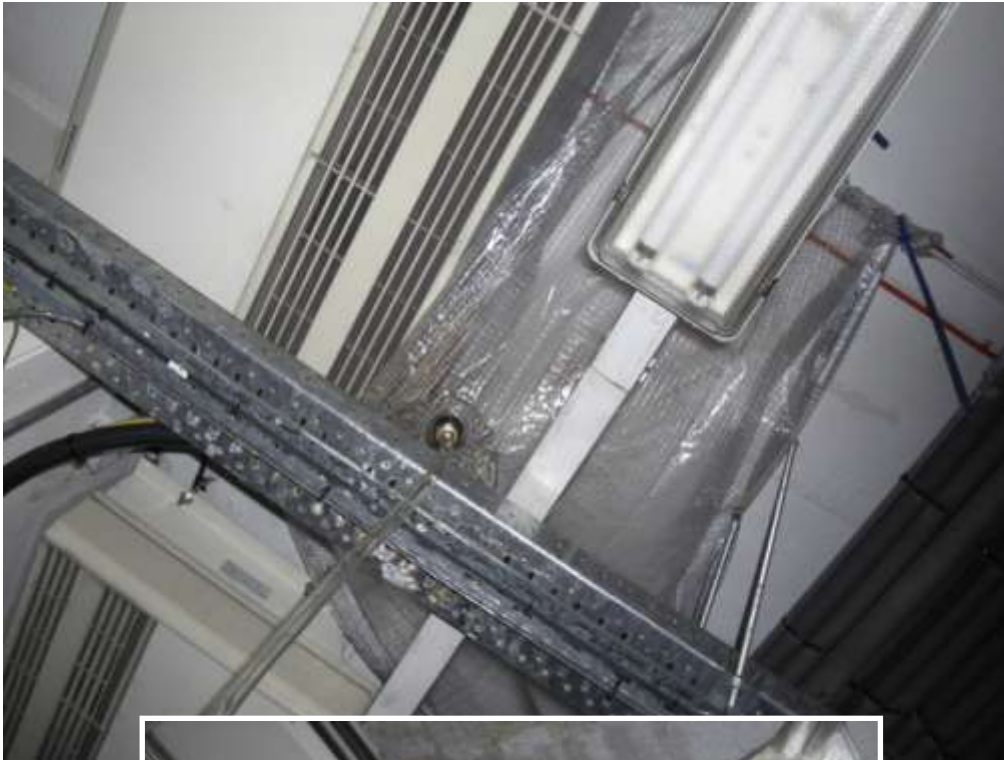
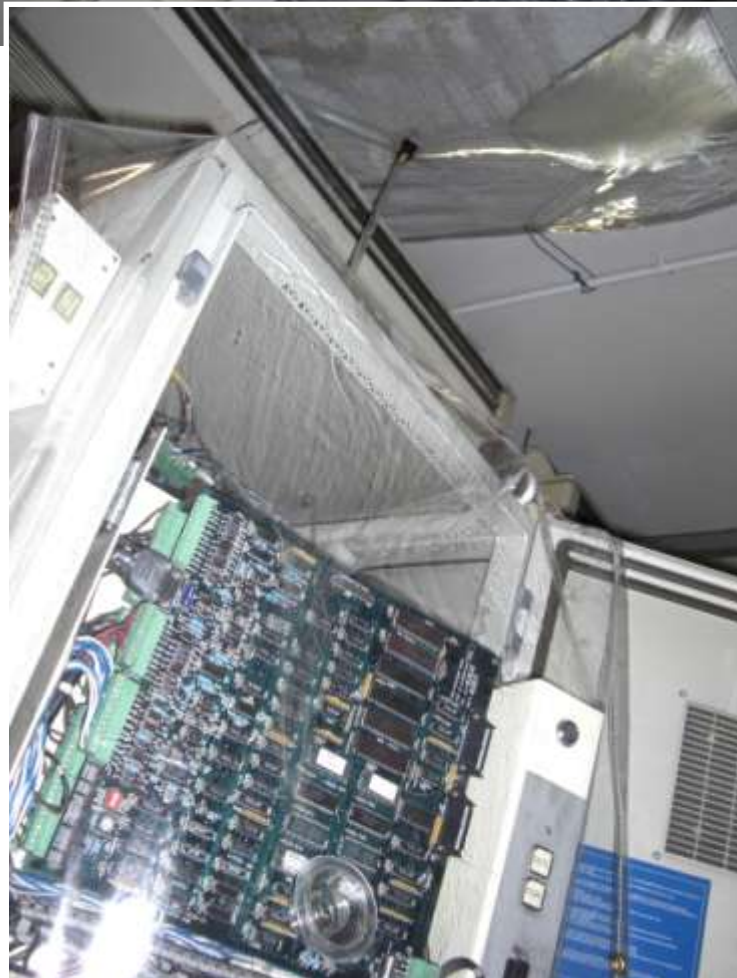
2. Material Failure: - The existing Bitumen Asphalt had failed to the extent that water was ingressing significantly through the Asphalt and 'tracking' through the ceiling below in numerous areas; which could have potentially cause catastrophic problems with (for instance) the lift's electrical switch gear.

The images here show the damaged caused due to the floor of the Sump leaking onto electrical switchgear underneath the Sump area, onto the level below.

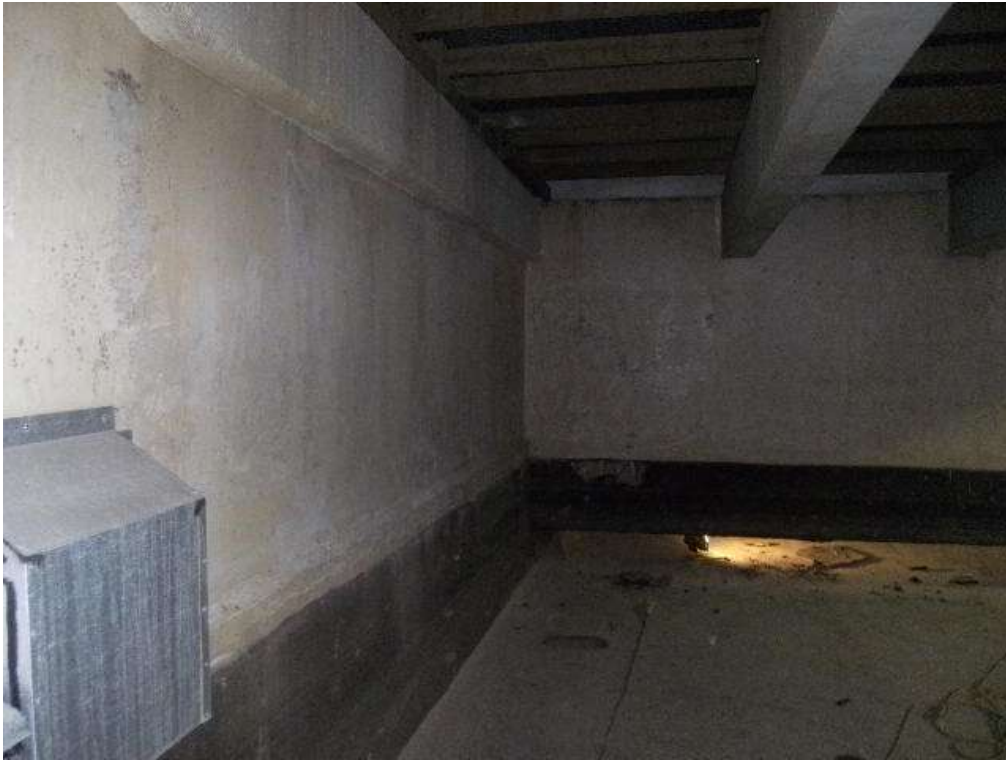
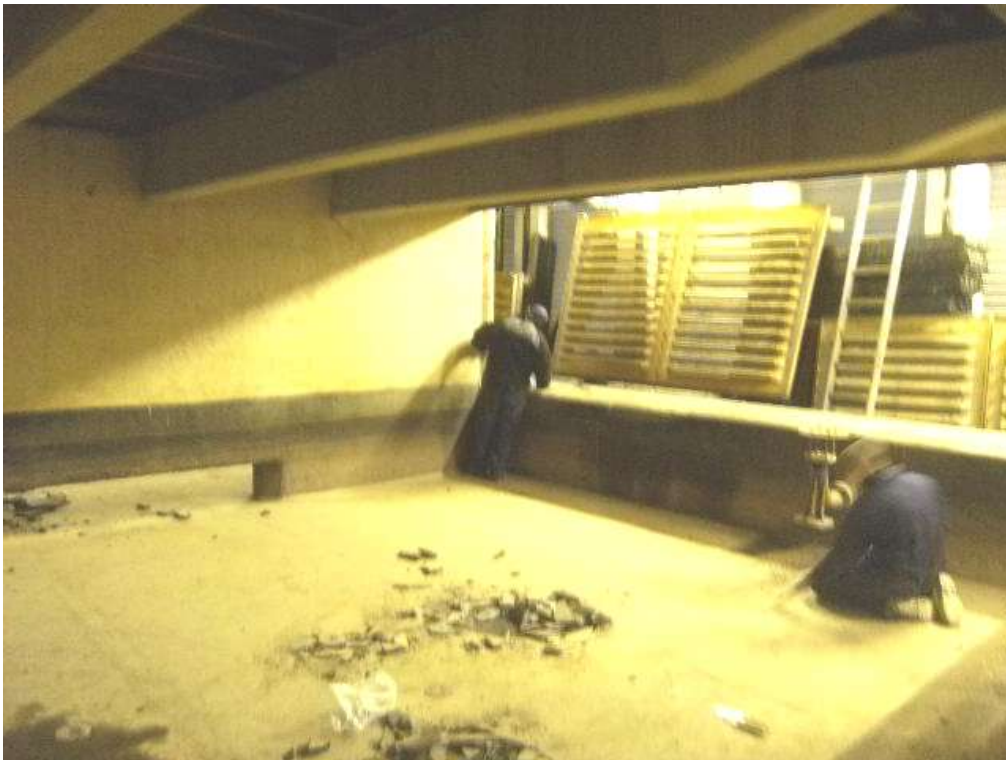
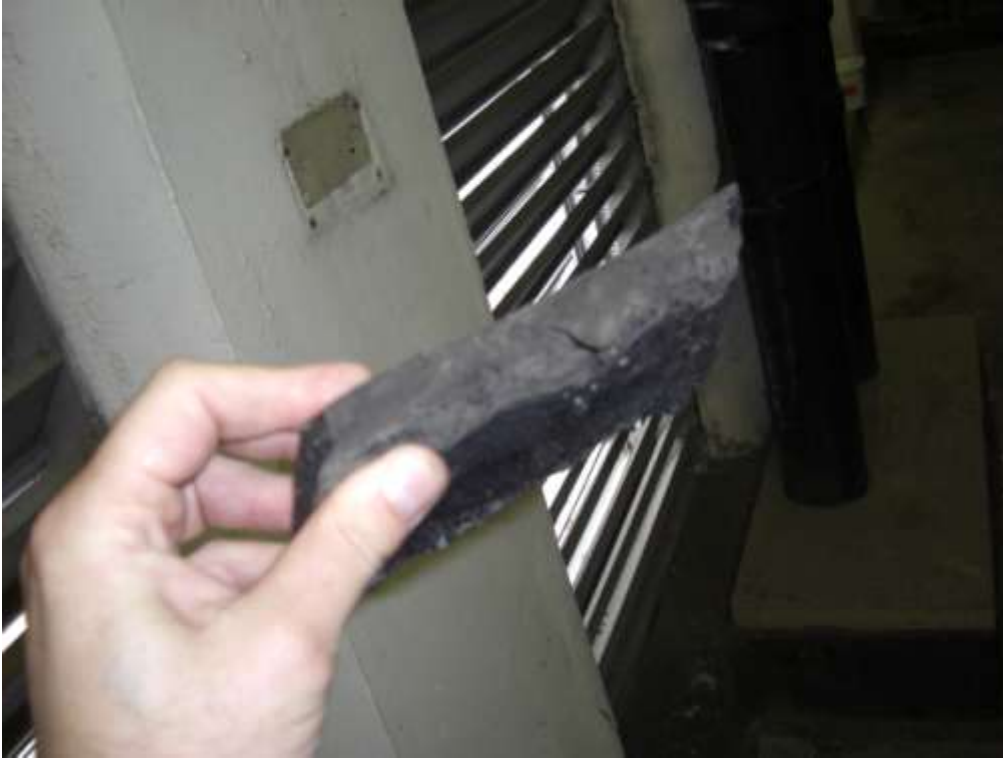
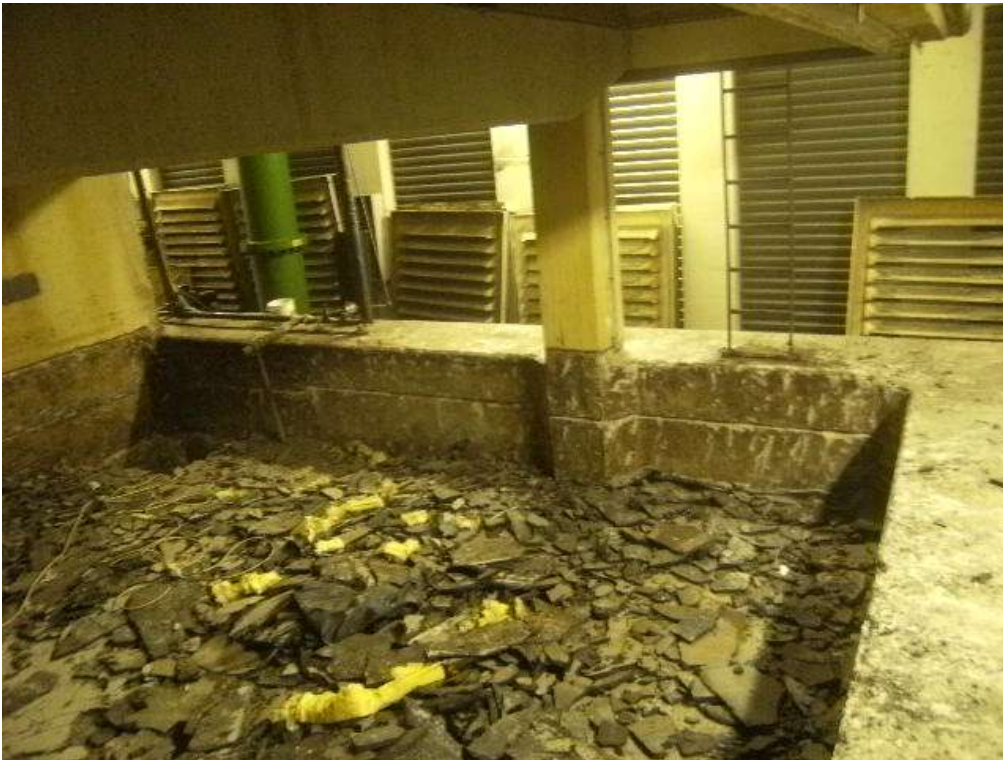
The internal surfaces of the sump (the floor and first 0.9m of the internal walls) had been previously lined with a non (WRAS/DWI) approved bitumen based asphalt, whilst the top (approximately) 2m of the internal divisional concrete walls had been coated with an unknown paint which was showing signs of 'blistering' and general deterioration.

The bitumen based asphalt had reached the end of its useful life due to two fundamental reasons:-

**These images show the Sump area having been drained and the asphalt being removed.**
