COMPLETION REPORT

Client : **University of XXXX**

Project Brief : **The Internal Relining of 1 No. Concrete CWS Tank**

Covac Ref : **976**

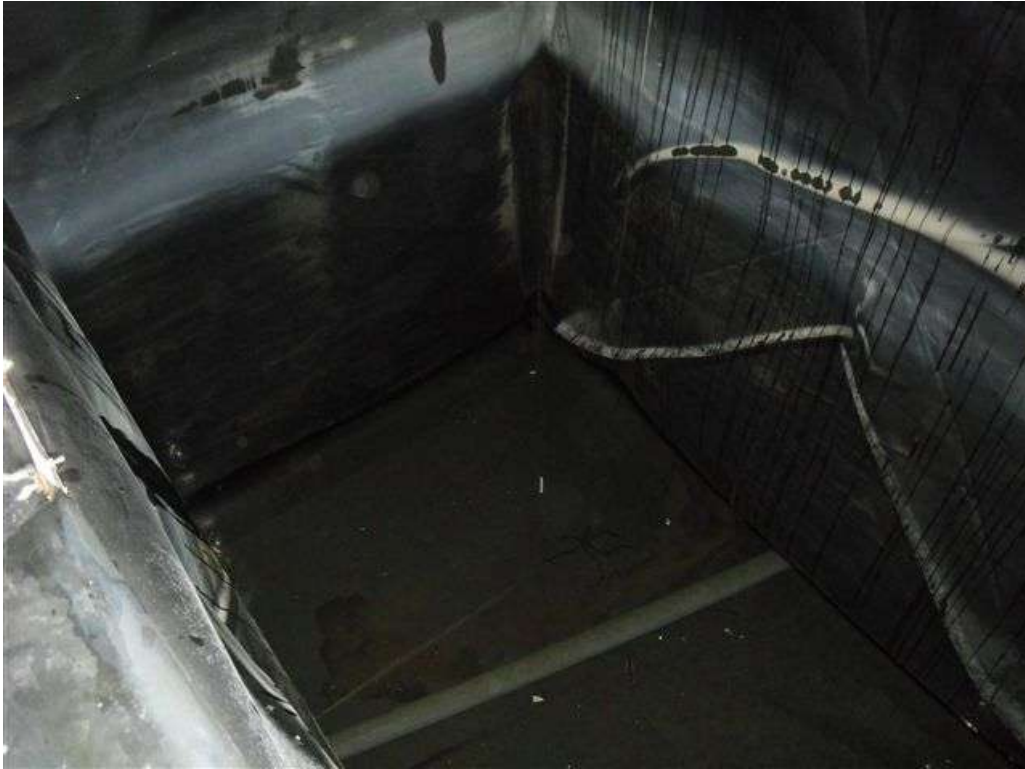
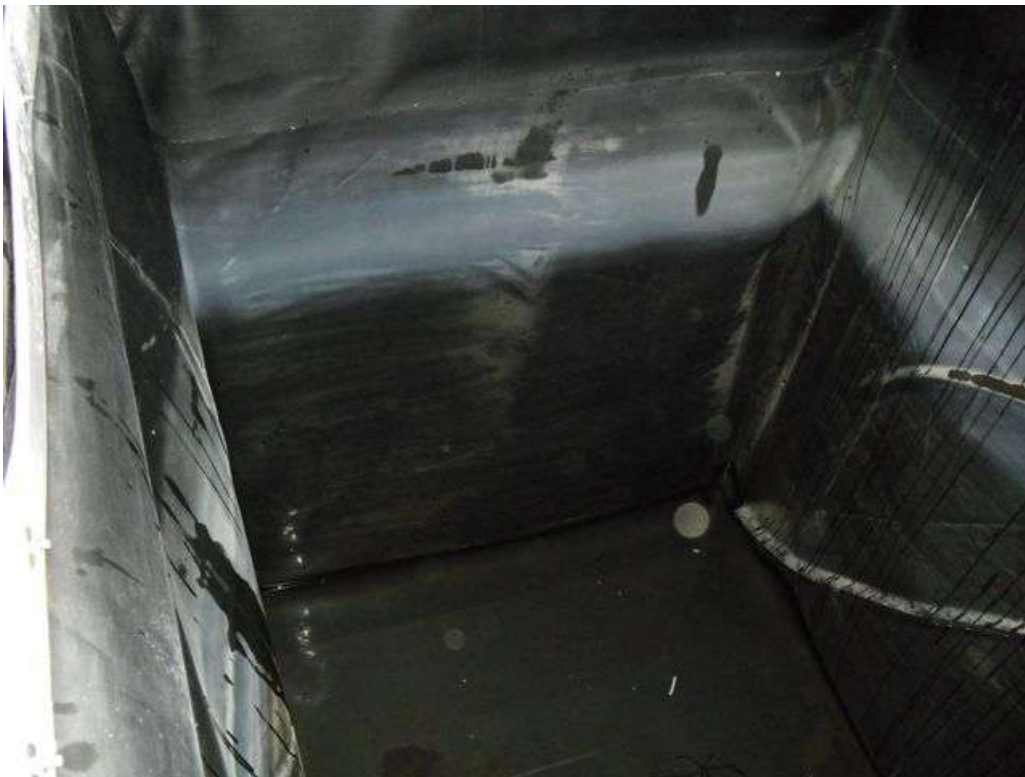
These photographs show the internal surfaces of the structure having been drained of water, but prior to the failed liner being removed and any relining work commencing.

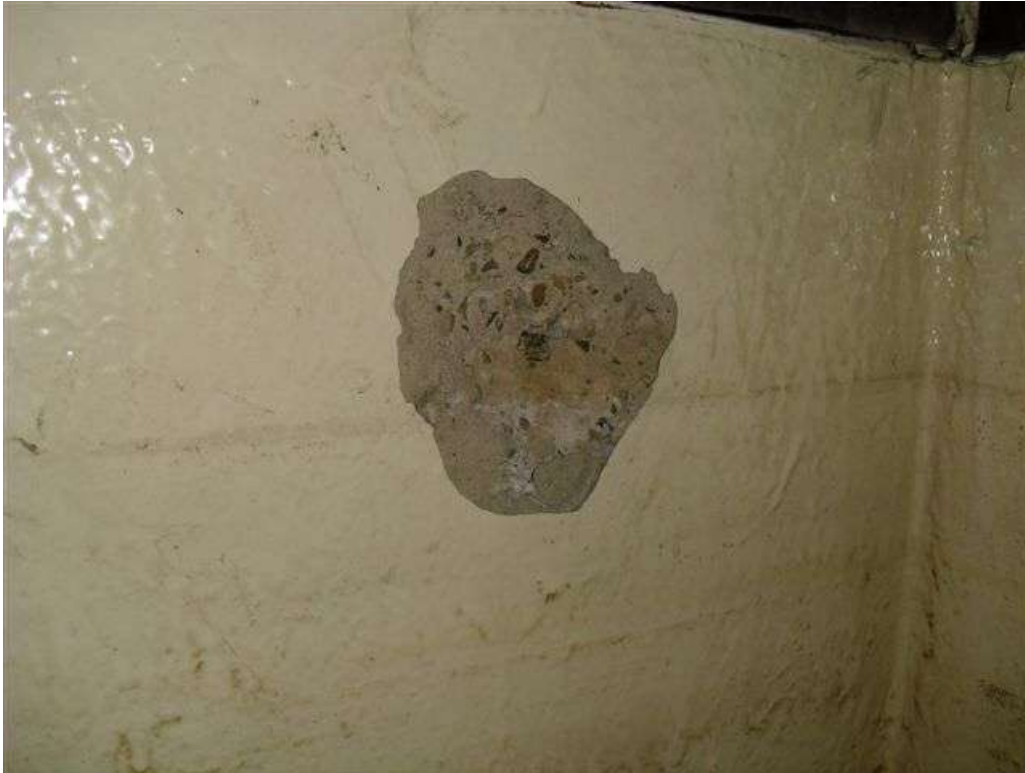
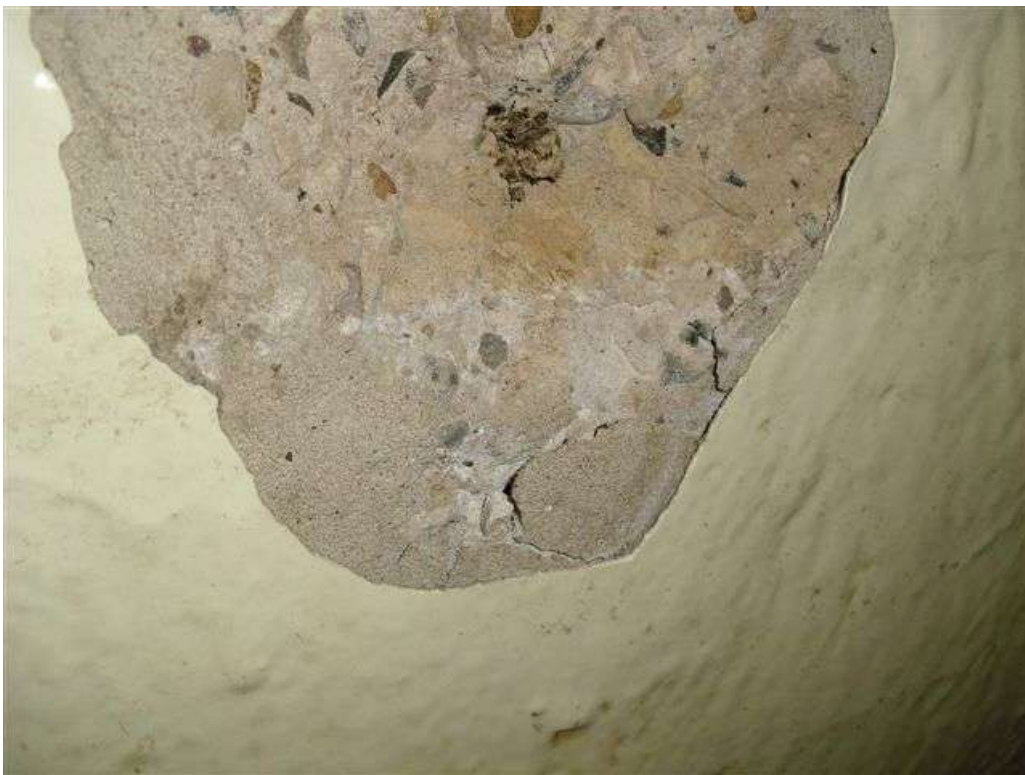
After removal of the failed flexible liner the concrete substrate was found to be painted with an unknown industrial coating. This needed also needed to be removed before any further preparation work could begin.

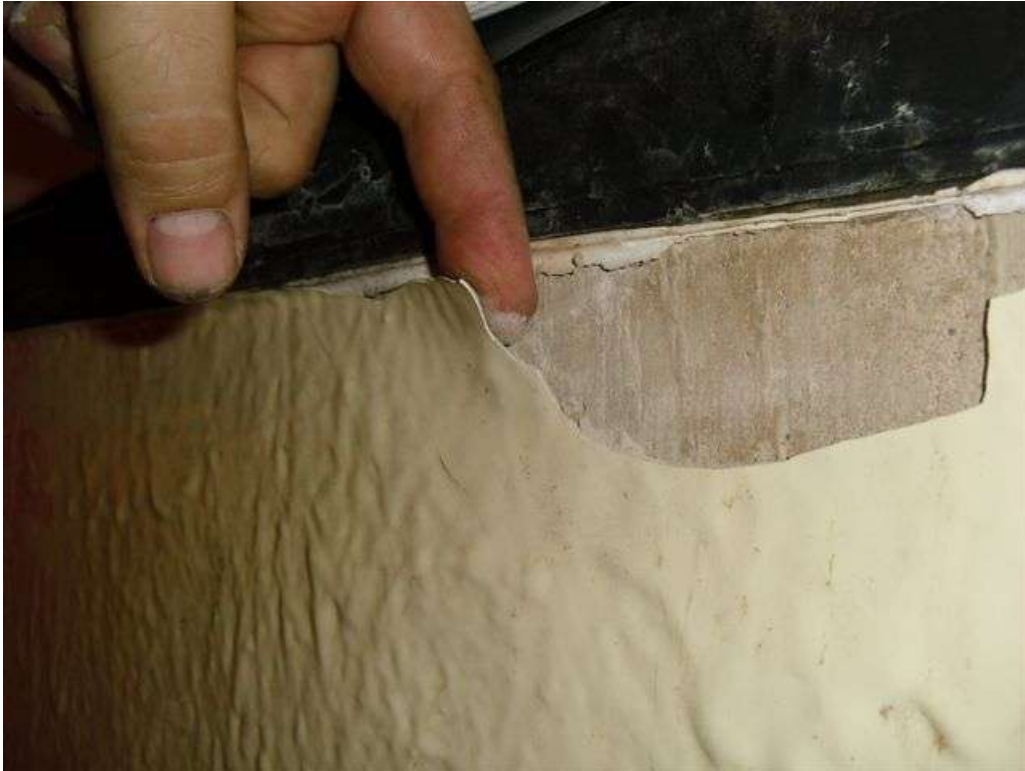
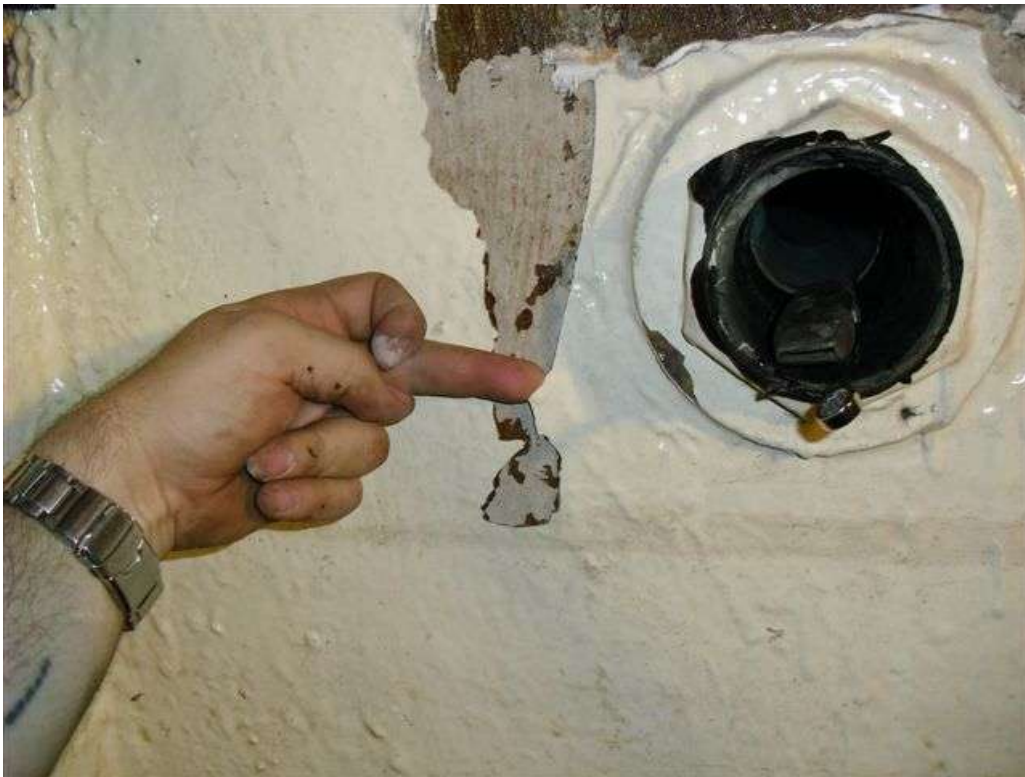
The coating was clearly de-laminating from the concrete substrate.

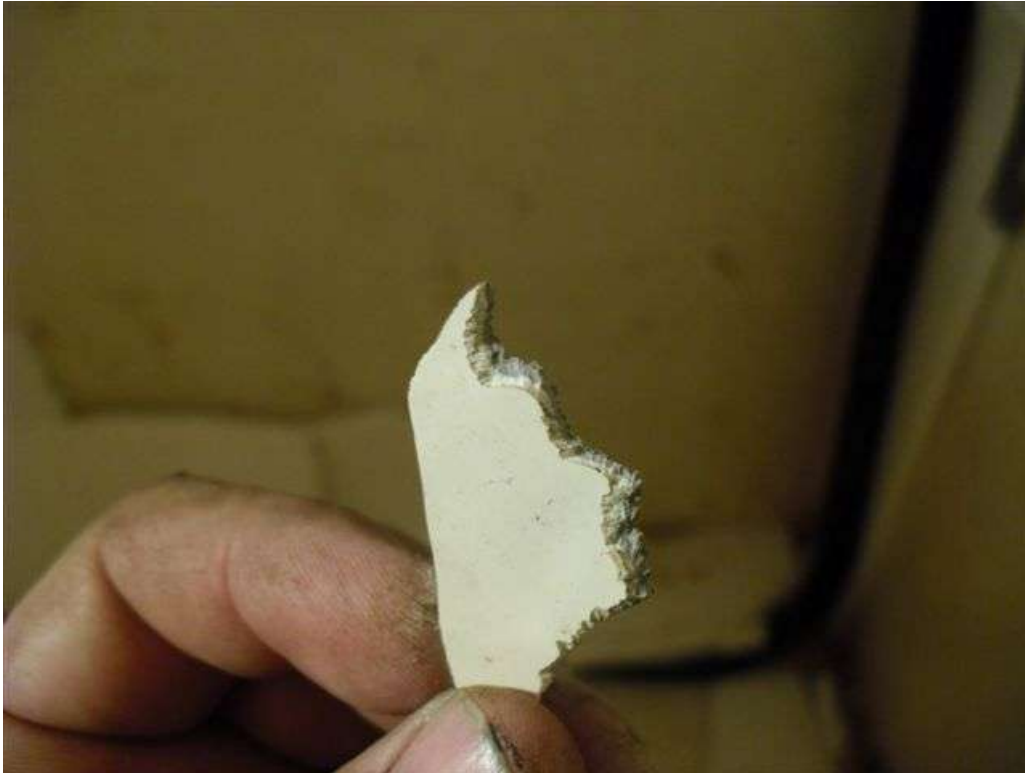
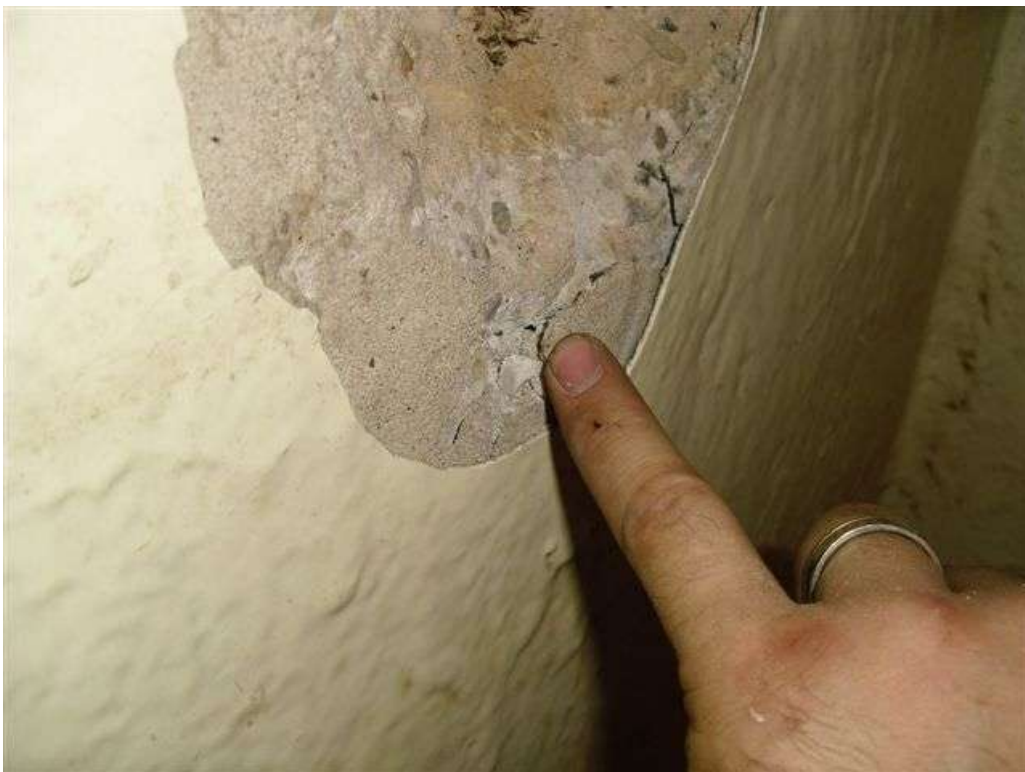
A combination of the failed flexible liner and de-lamination of the failed coating had allowed water to damage the concrete substrate resulting in cracks and pitting.

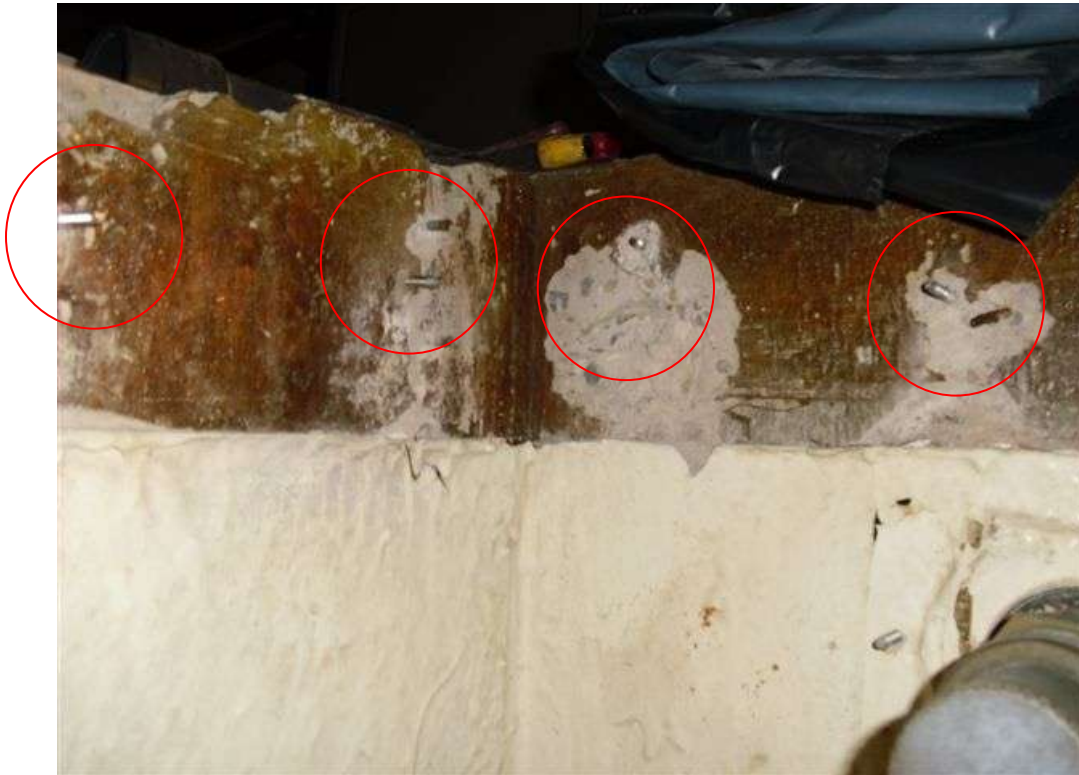
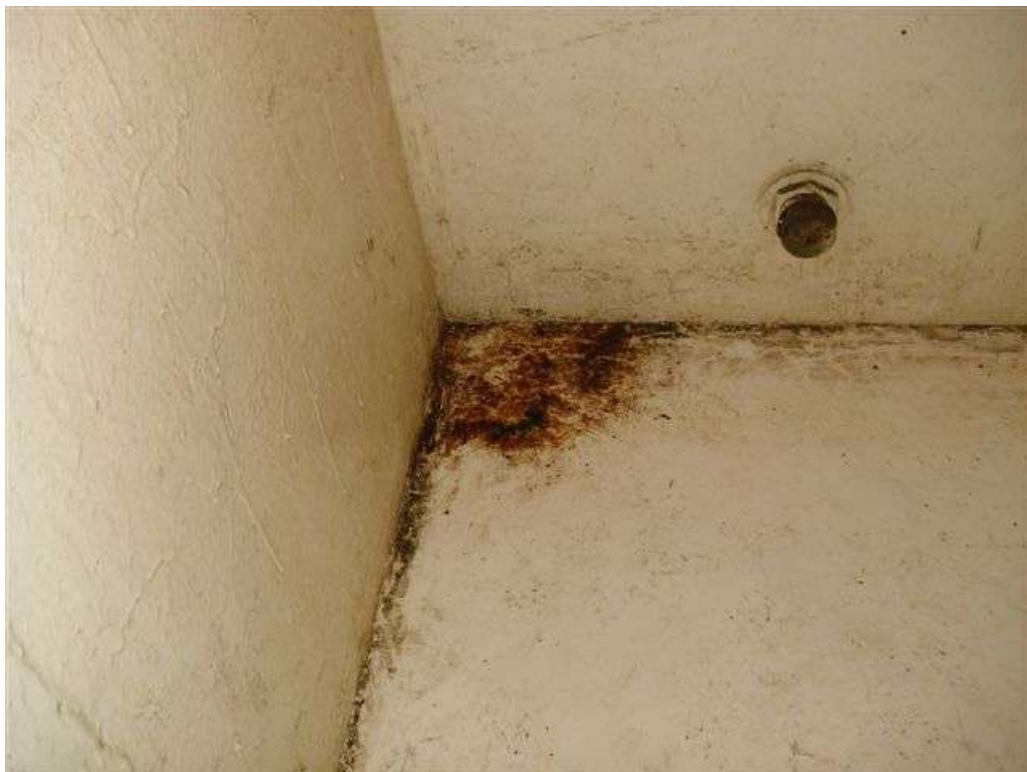
The top image highlights where the previous liner had been secured as well as remedial work to the buildings roof which had been reinforced utilising the concrete tank walls as structural supports that, in turn, had compromised the integrity of the tank.
