COVAC COMPLETION REPORT

Client	-	XXX LTD
Address	-	XXXX XXX XXXXXXXXXX Street London EC2
Client Site Contact	-	XXXXX XXXXXXX
Project Brief	-	The Internal and External Relining of 2 No. BAC Cooling Towers.
System Specification	-	COPON Hycote 165PW Solvent Free Polyurethane.
Nominal Dry Film Thickness	-	1000 Microns (1mm).
Completion Date	-	25th January 2007
Site Supervisor	-	Robin Bailey
Report Prepared by	-	David Snell
COVAC Contract Ref:	-	574

2 No. COOLING TOWERS - INTERNAL

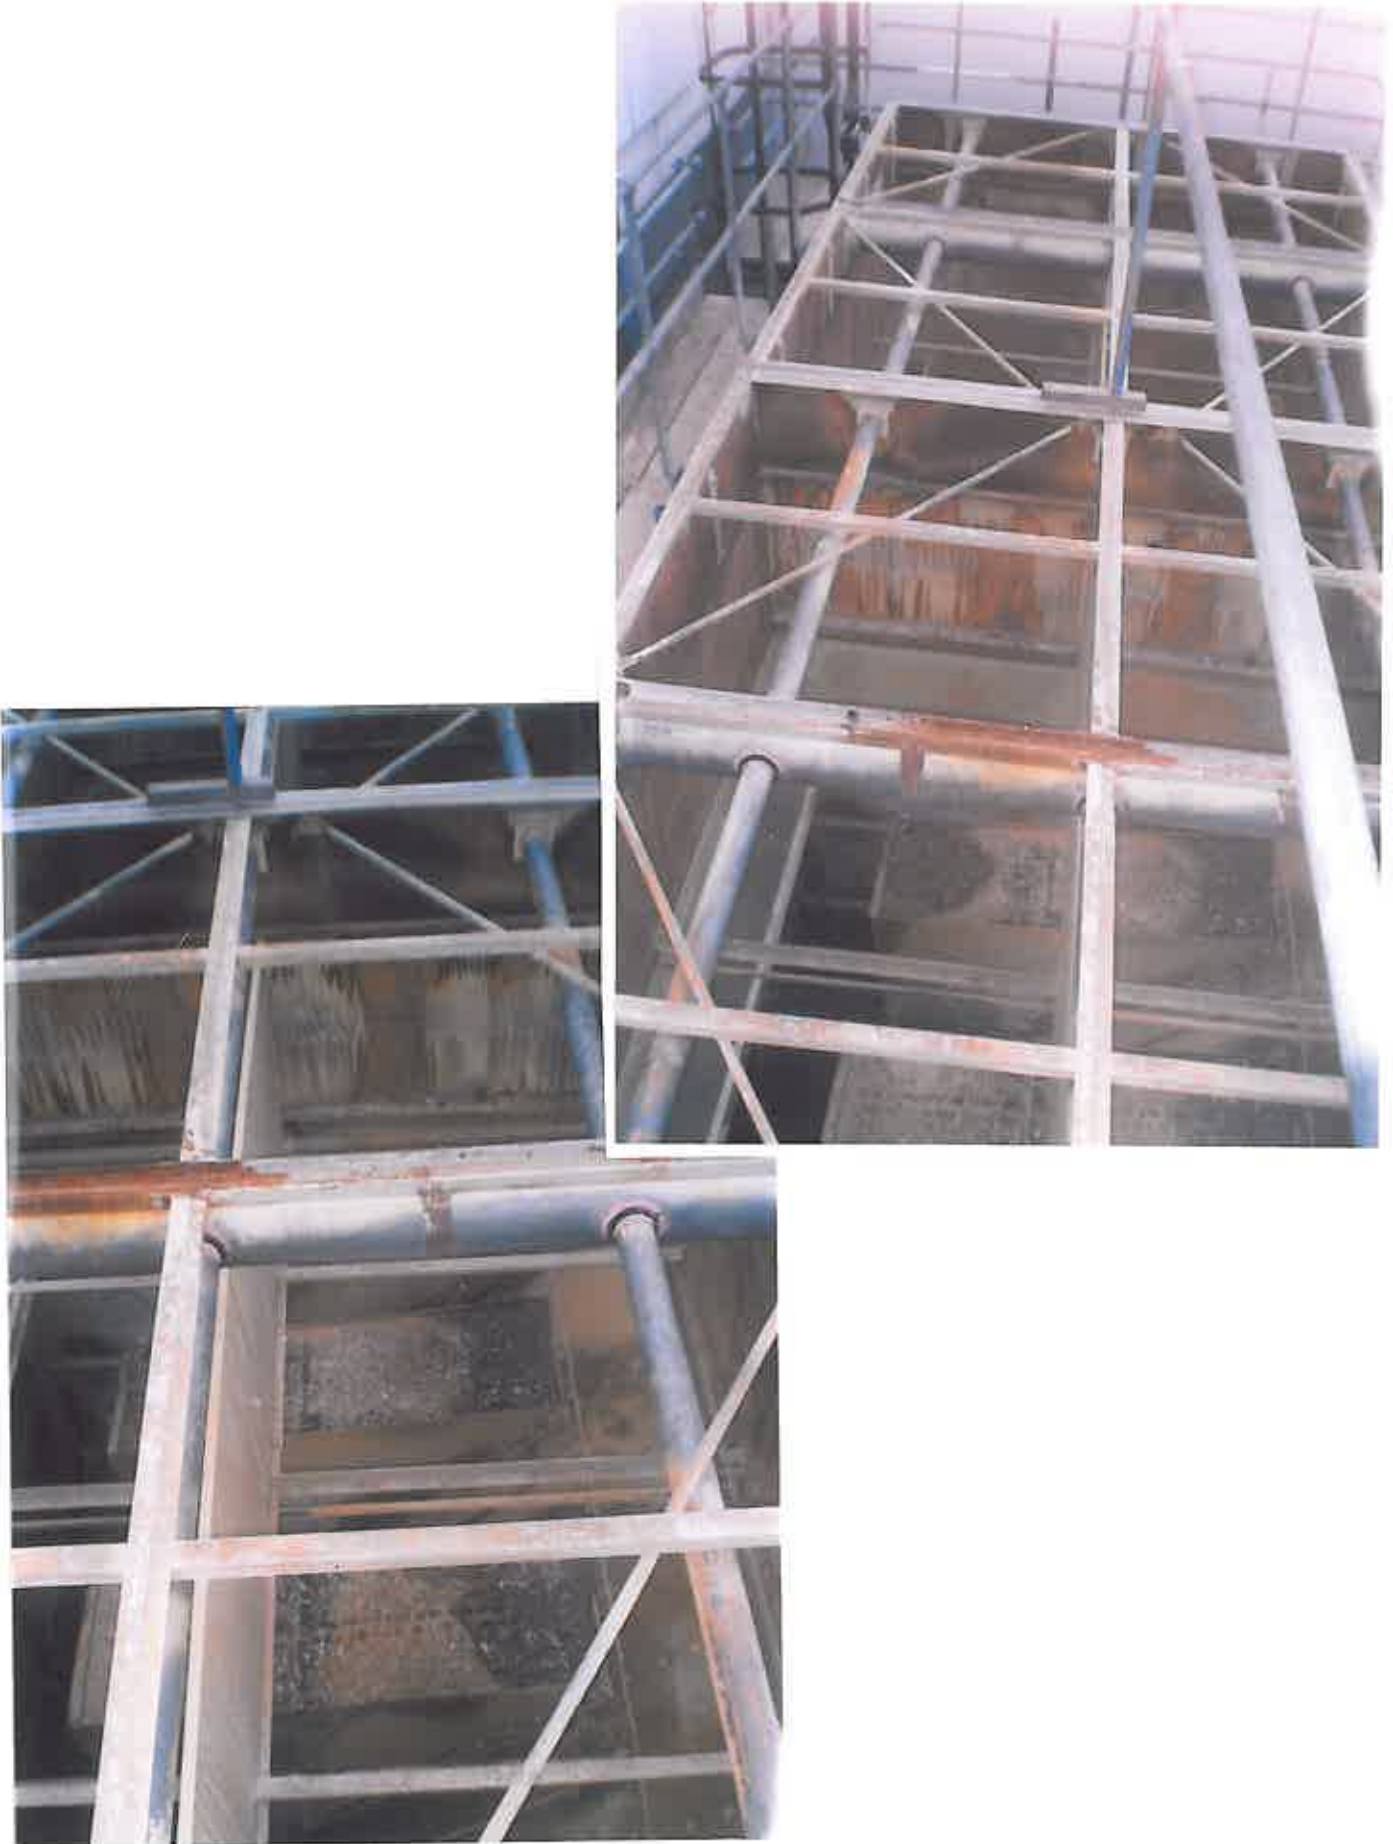
The towers are located 'side-by-side' in an 'open air' plant room. All internals of the towers were previously coated with Baltibond. This coating had reached the end of its useful life due to sub-film corrosion, poor elongation properties and subsequent de-bonding. The externals of the towers were painted with aerosol paint, which had reached the end of its useful life due to excessive sub-film corrosion, low film build and general deterioration.

In areas at the water exchange level, large areas of the internal coating was delaminated from the originally galvanized steel panels that could be removed by hand with minimal effort and which would have only been accelerated by regular power wash cleaning. This along with continual ingress of water beneath the coating would if left untreated, endanger the internal steel substrate with a continued risk from corrosion and micro aquatic bacterial growth including Legionella, Pseudomonas and Biofilm; this can lead to further deterioration in the towers surface structure and contamination with the supply / dispersion of unhygienic and potentially harmful water. We are all now under an obligation to ensure that water retaining structures comply with the practical guidance of ACOP L8 and subsequently, utilize products that comply with WRAS / DWI Regulations and, therefore, maintain "the cleanliness of the system and the water in it" and avoid the "use of materials that harbour bacteria and other micro-organisms or provide nutrients for microbial growth".

The above photographs show the internal substrate of the 2 No. Towers prior to any preparation work involved in removing all of the existing failed non flexible epoxy coating.

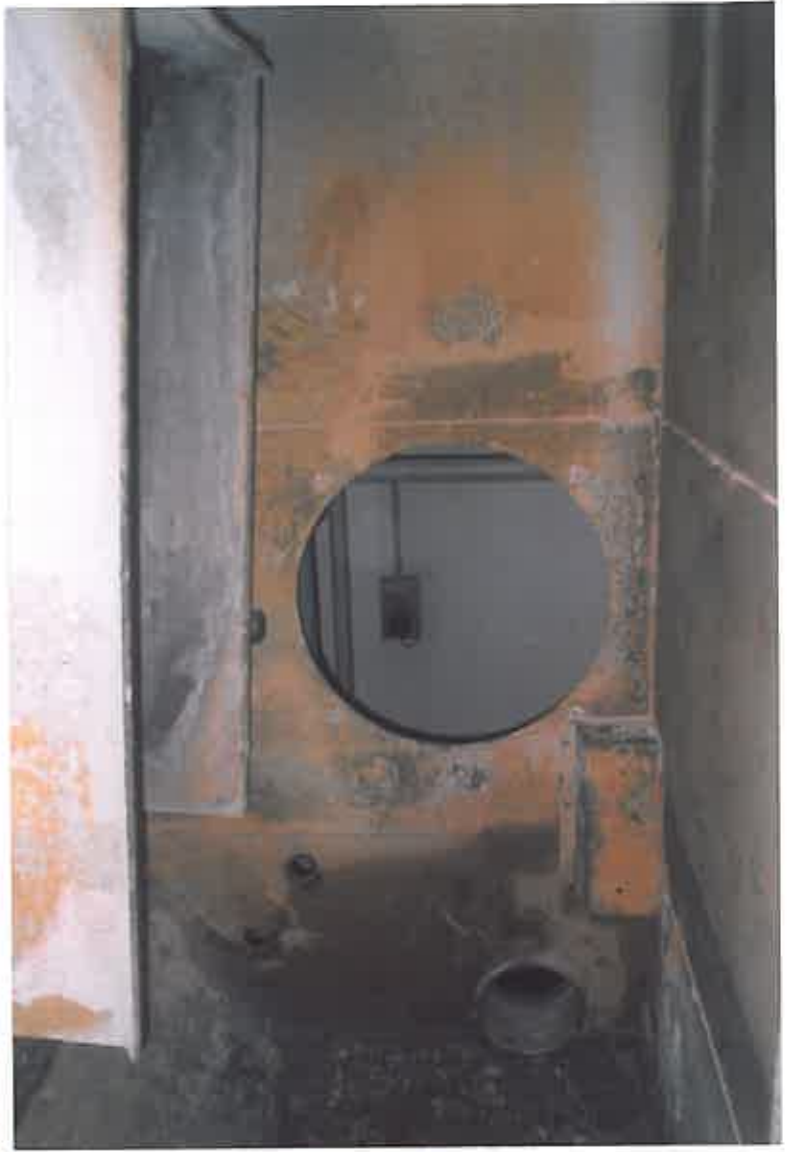
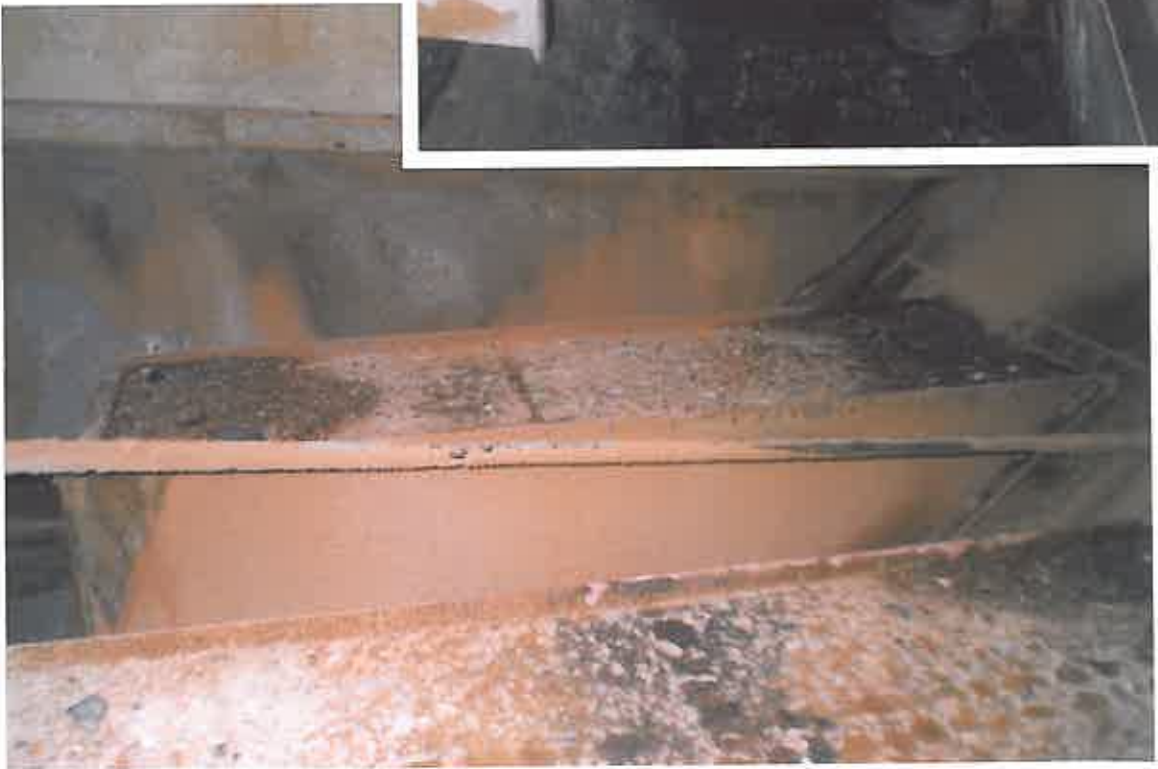
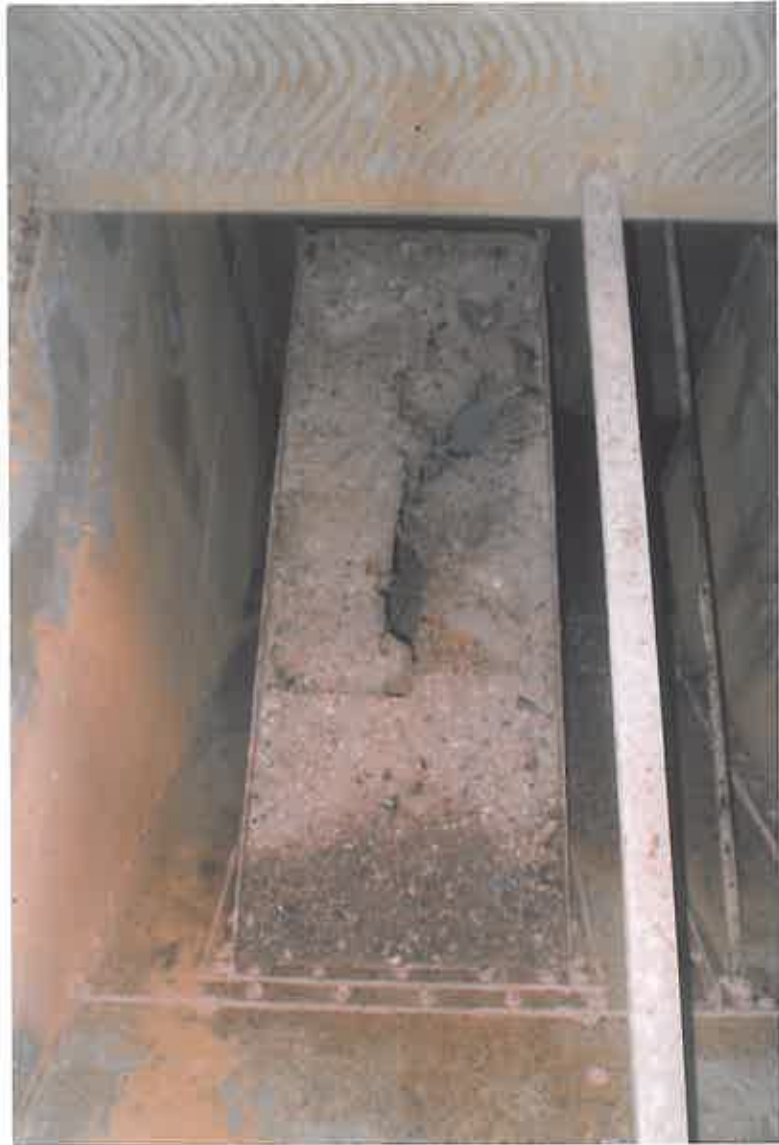
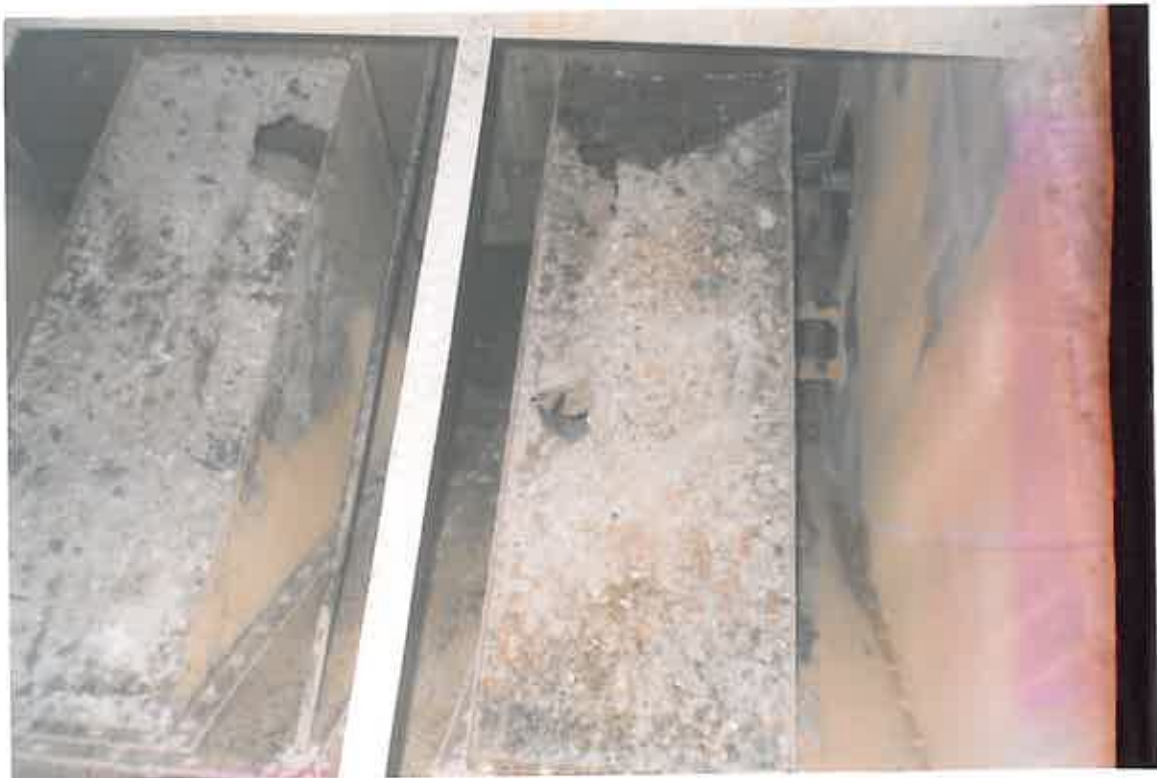
On initial inspection severe corrosion was found to be apparent on numerous components, which were removed & subsequently replaced once the coating process had been completed.

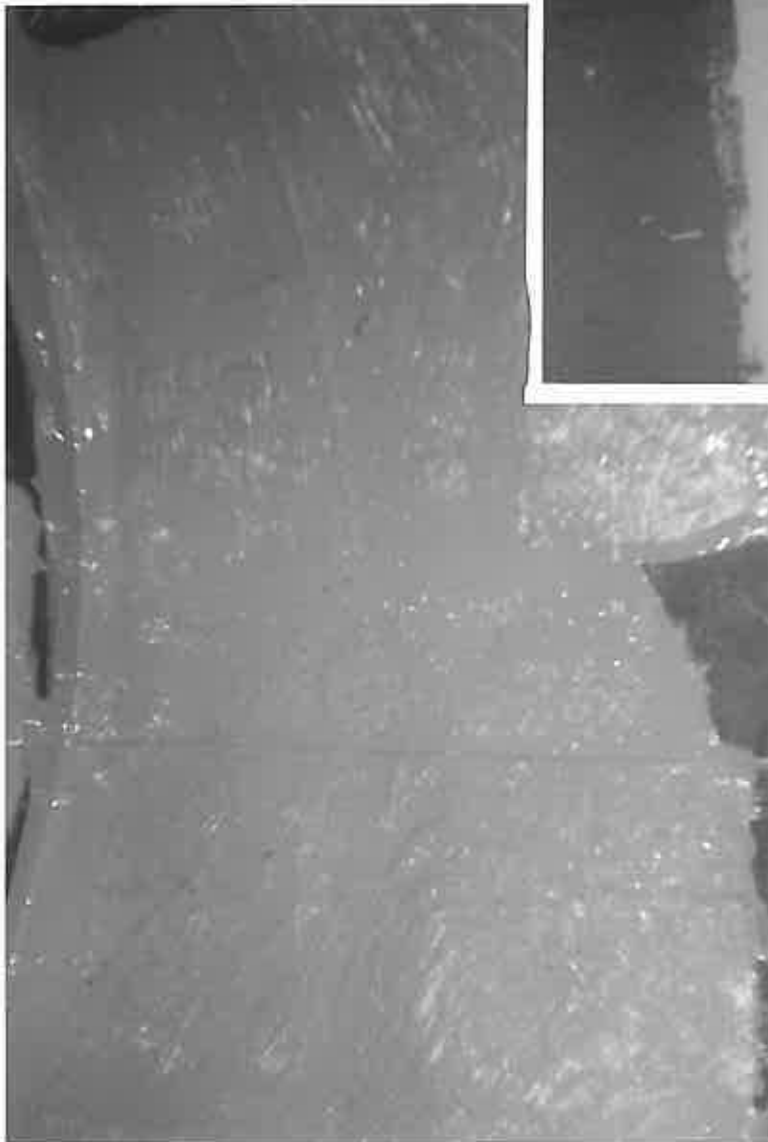
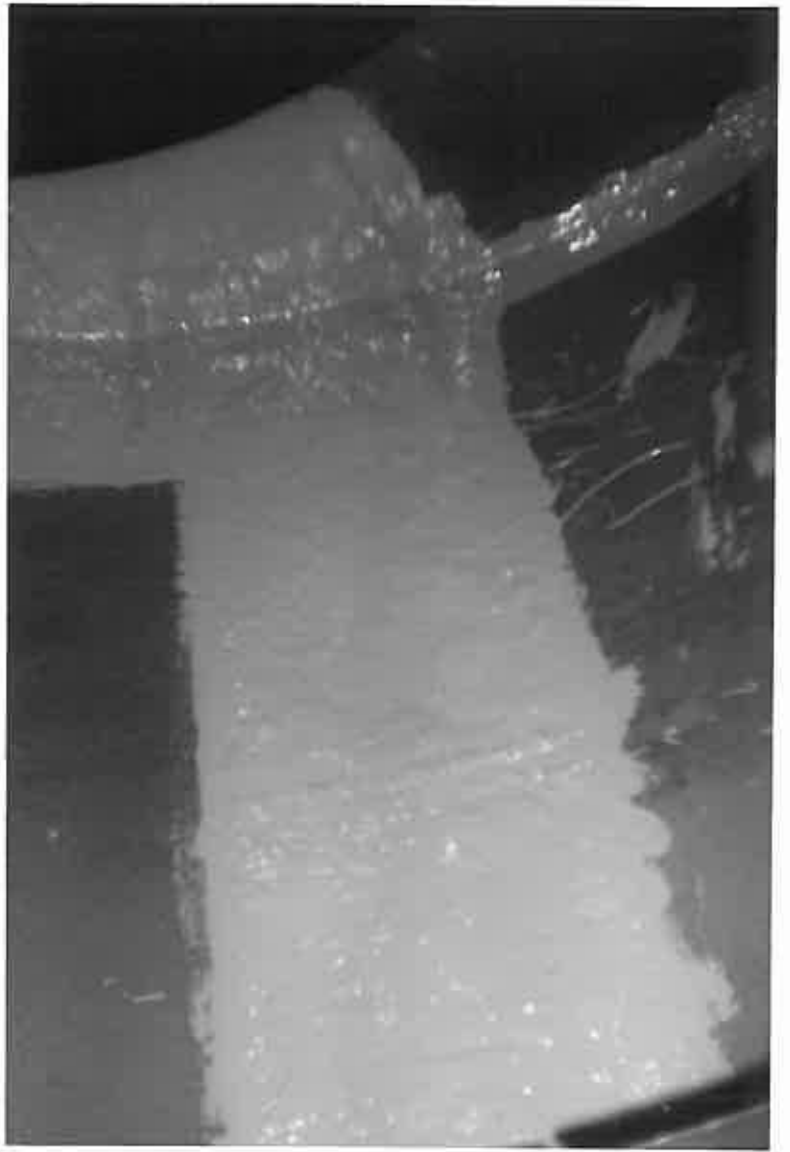
These photographs show fibreglass reinforced bandaging was used in conjunction with a full coating of COPON Hycote 165PW Solvent Free Polyurethane (cream) over severely corroded areas.

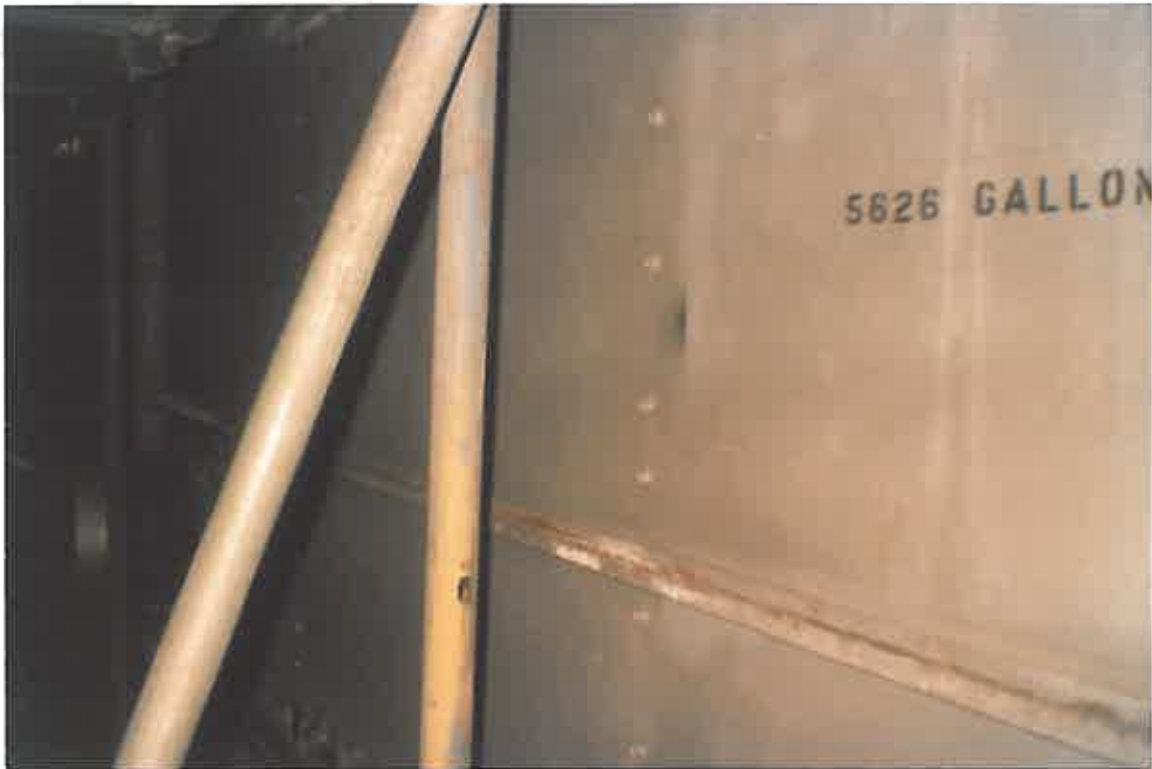
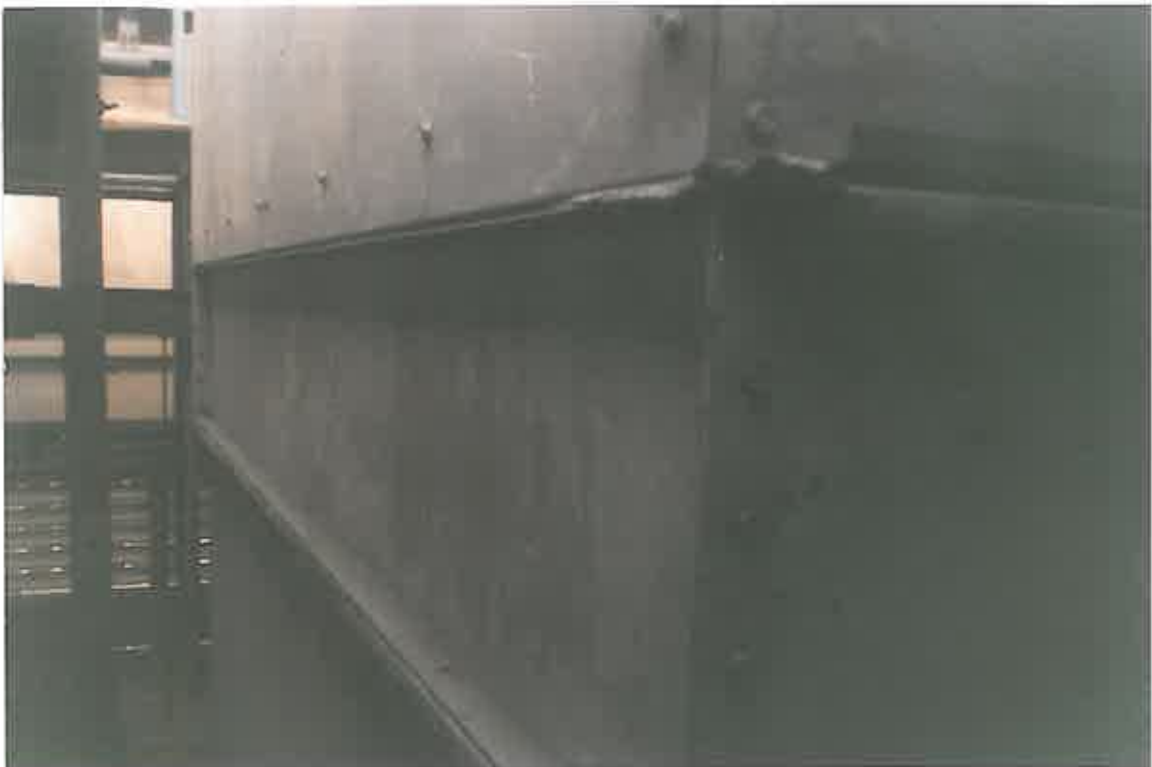
The above photographs show the external substrate of the towers and surrounding associated steel work, prior to the preparation work involving the removal all of the existing failed epoxy Baltibond coating
