## COVAC COMPLETION REPORT

Client	-	<b>Manufacturing Company</b>
Address	-	<b>Gloucestershire</b>
Project Brief	-	<b>The Internal Preparation and Re-Lining of 1 No. Effluent Tank</b>
System Specification	-	<b>COPON Hycote Solvent Free High Performance Coating.</b>
Nominal Dry Film Thickness	-	<b>1000 Microns</b>
Start Date	-	<b>14<sup>th</sup> February 2000</b>
Report Prepared by	-	<b>Adrian Emmett</b>
COVAC Contract Ref:	-	<b>97</b>

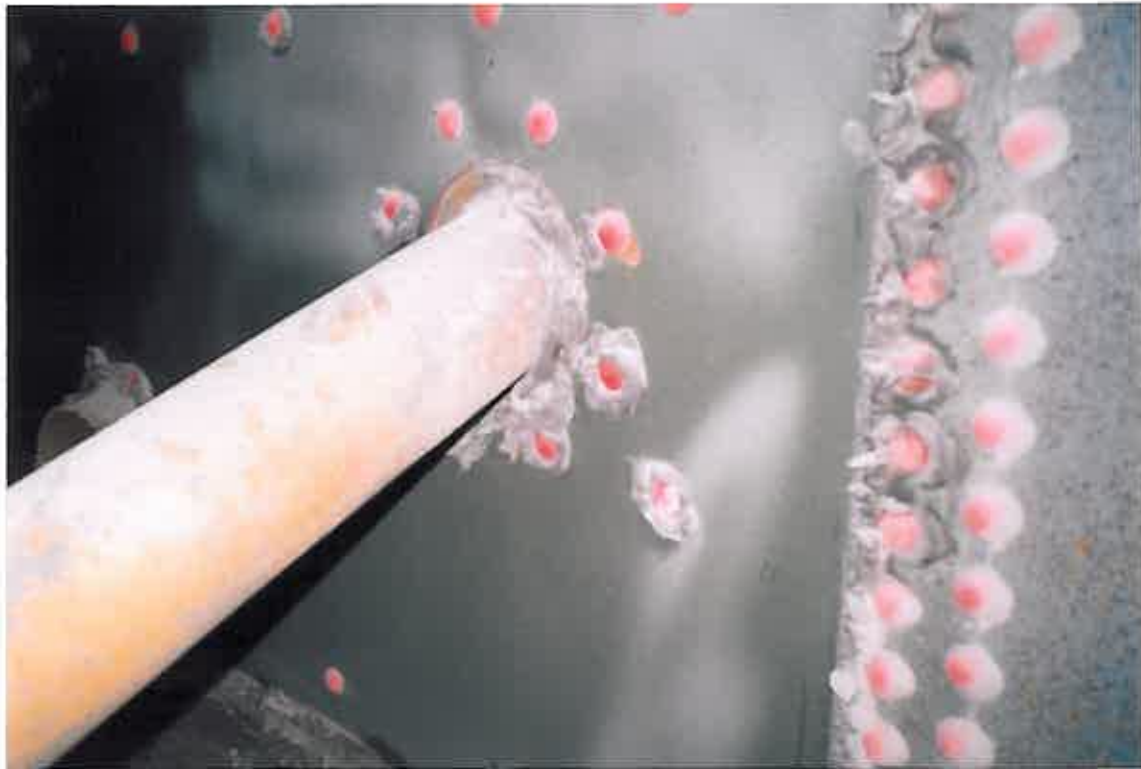
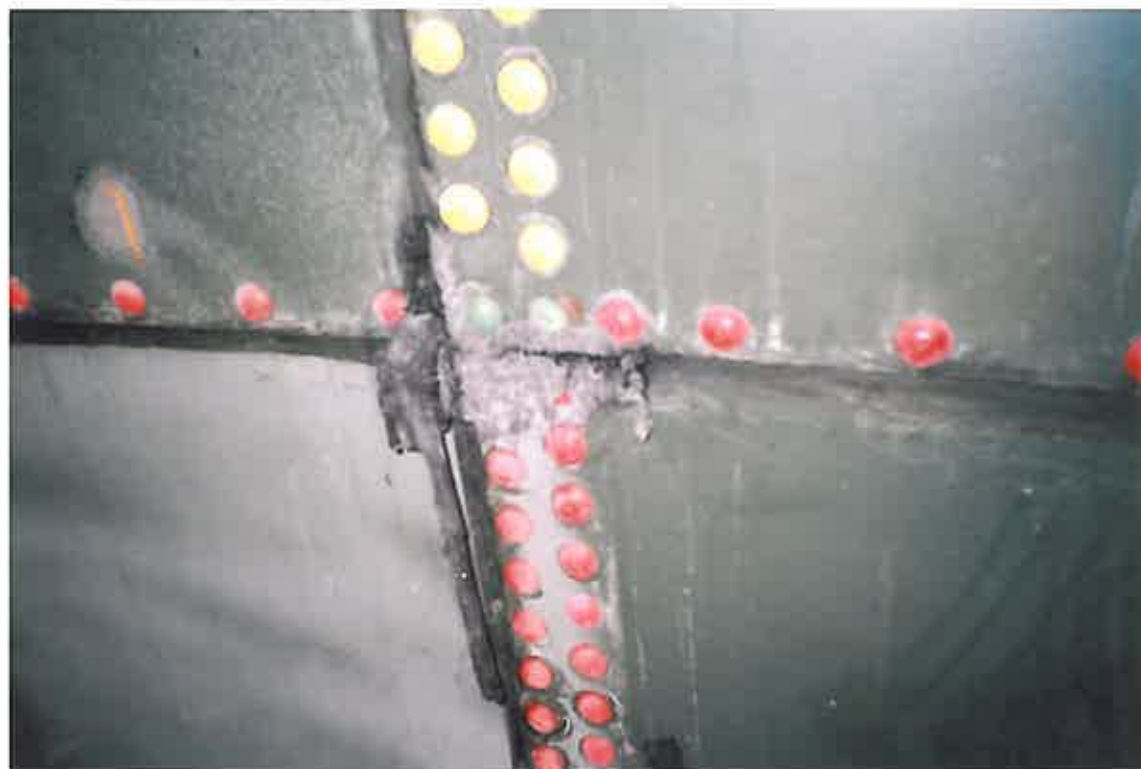
Areas within the panels were badly pitted causing corrosion to develop within the steel plate, creating holes.

**The majority of the corroded areas could be found beneath the existing mastic which was in a swollen state due to attack from the effluent and trapped water behind it causing corrosion to develop.**
