# COMPLETION REPORT

Project Brief : **The Internal Refurbishment of 2 No.  
Flat, Galvanised CWS Tanks**

Covac Ref : **979**

## TANK #1

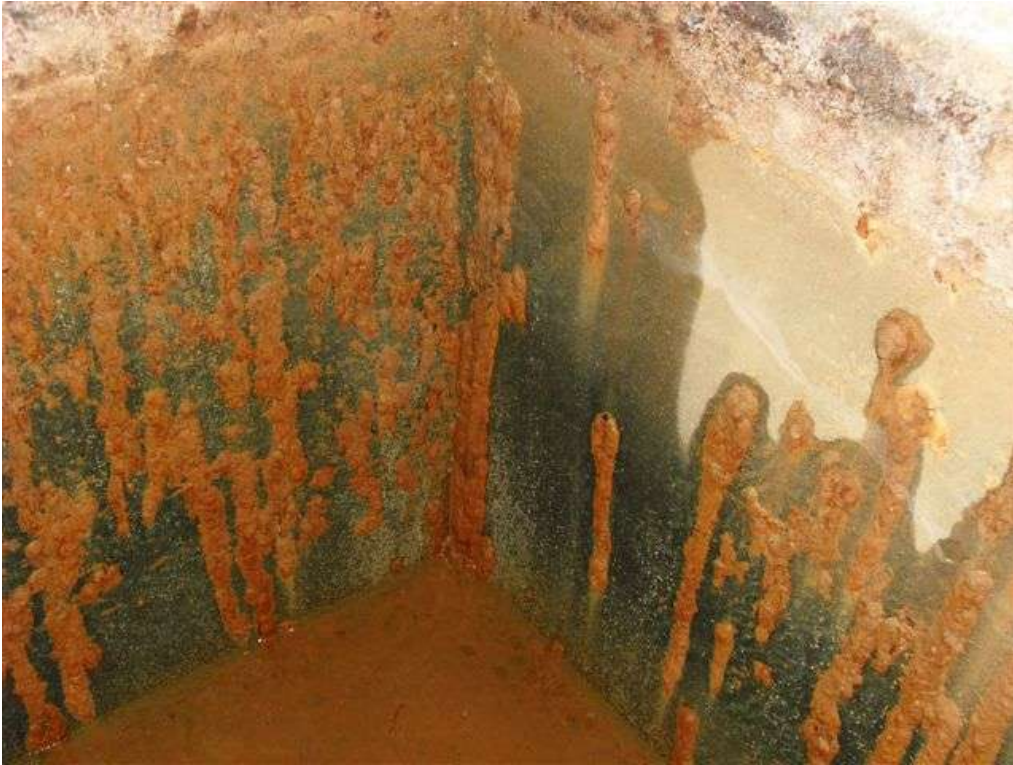
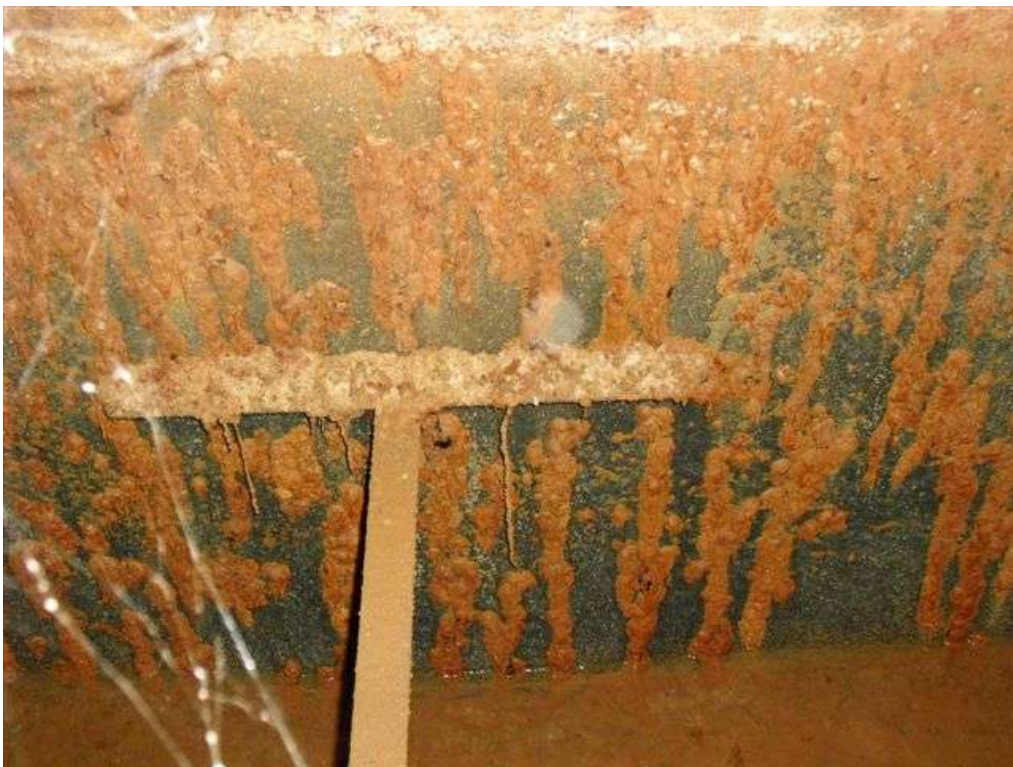
**These photographs show the internal surfaces of the tank having been drained of water, but prior to any work commencing.**

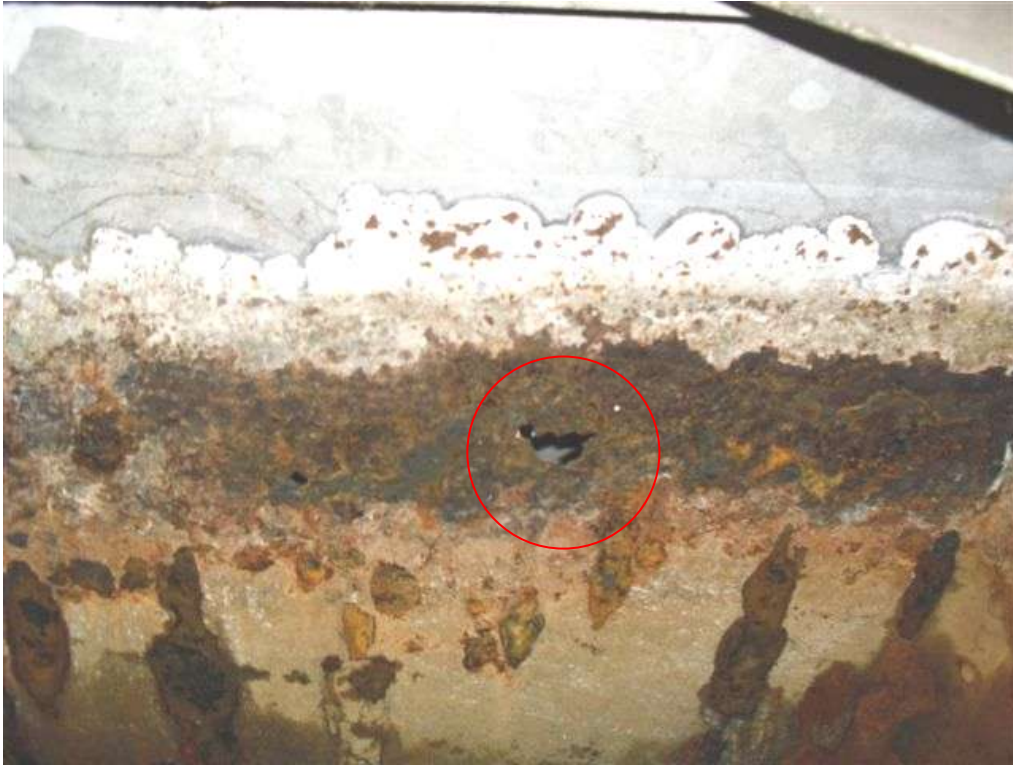
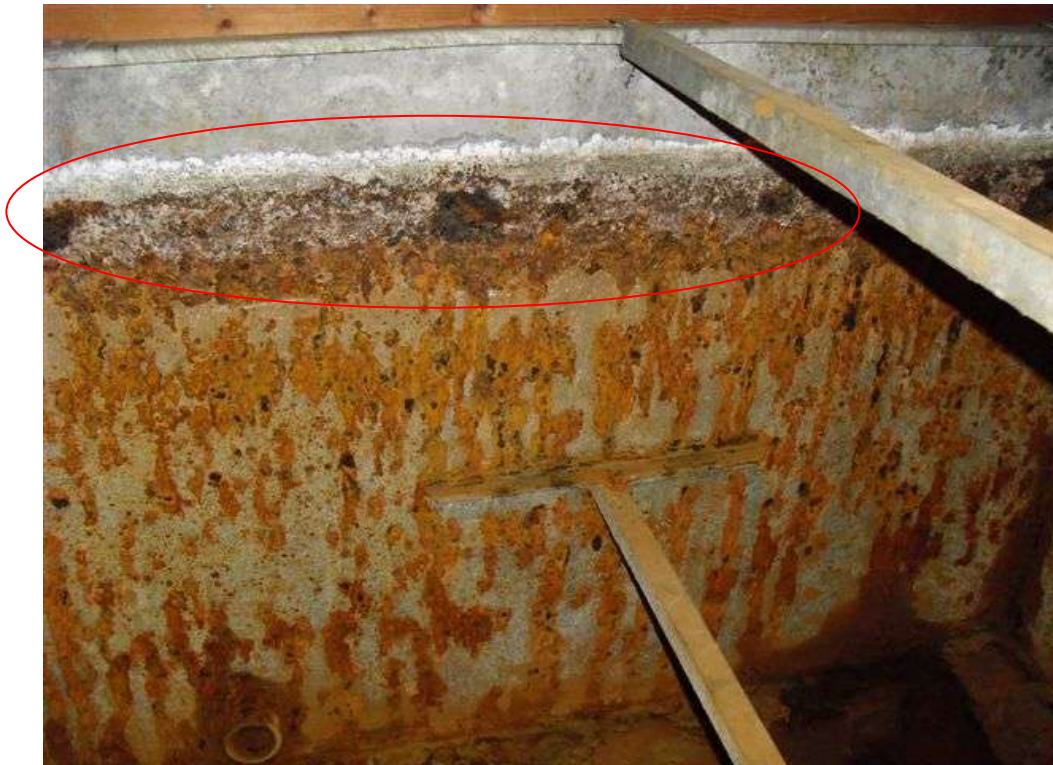
Holes in the substrate at the waterline as a result of the severe corrosion can be seen.

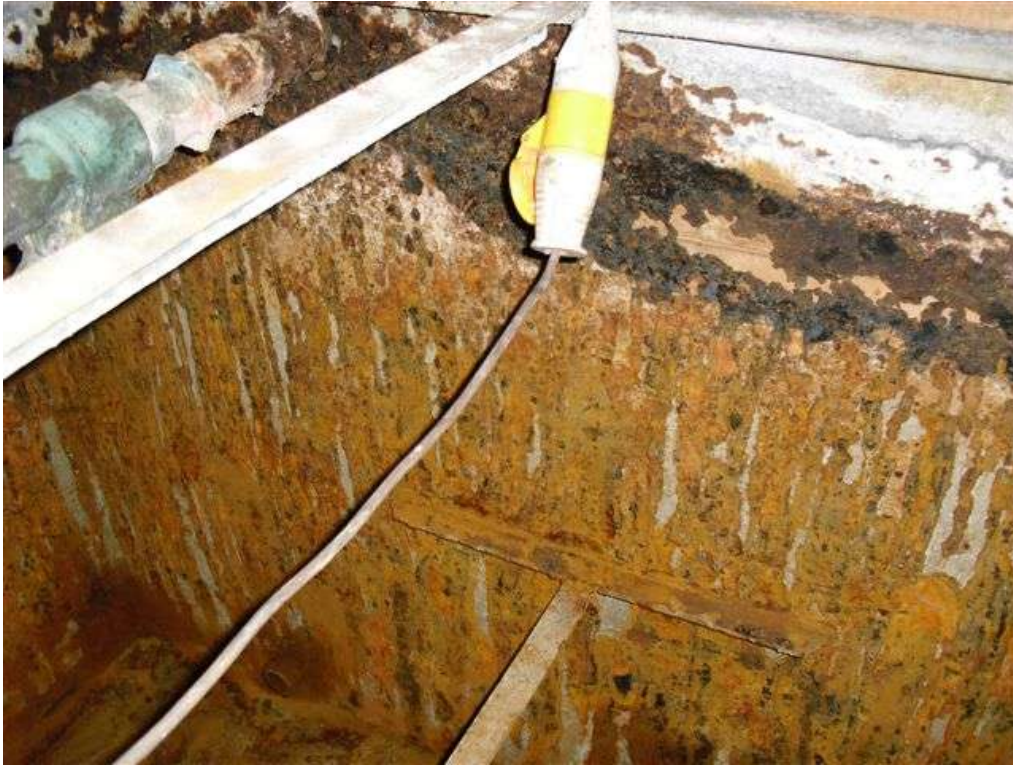
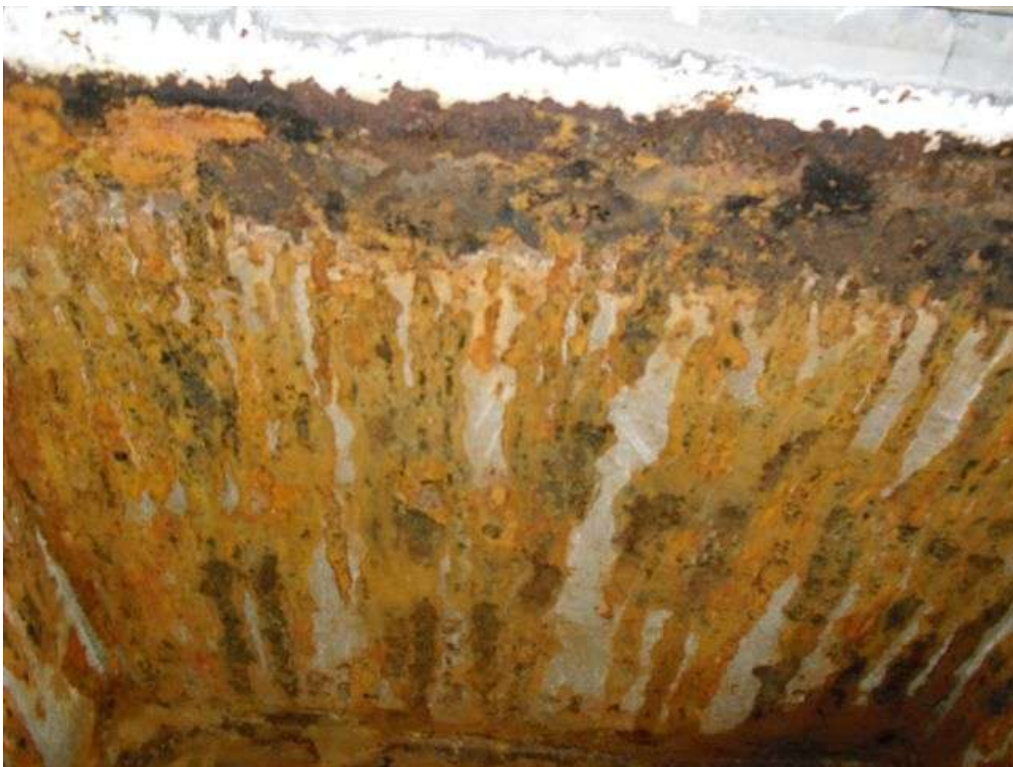
**These photographs show the internal surfaces of tank #2 having been drained of water, but prior to any work commencing. As with tank #1, severe corrosion is evident resulting in holes in the substrate, particularly at the waterline.**

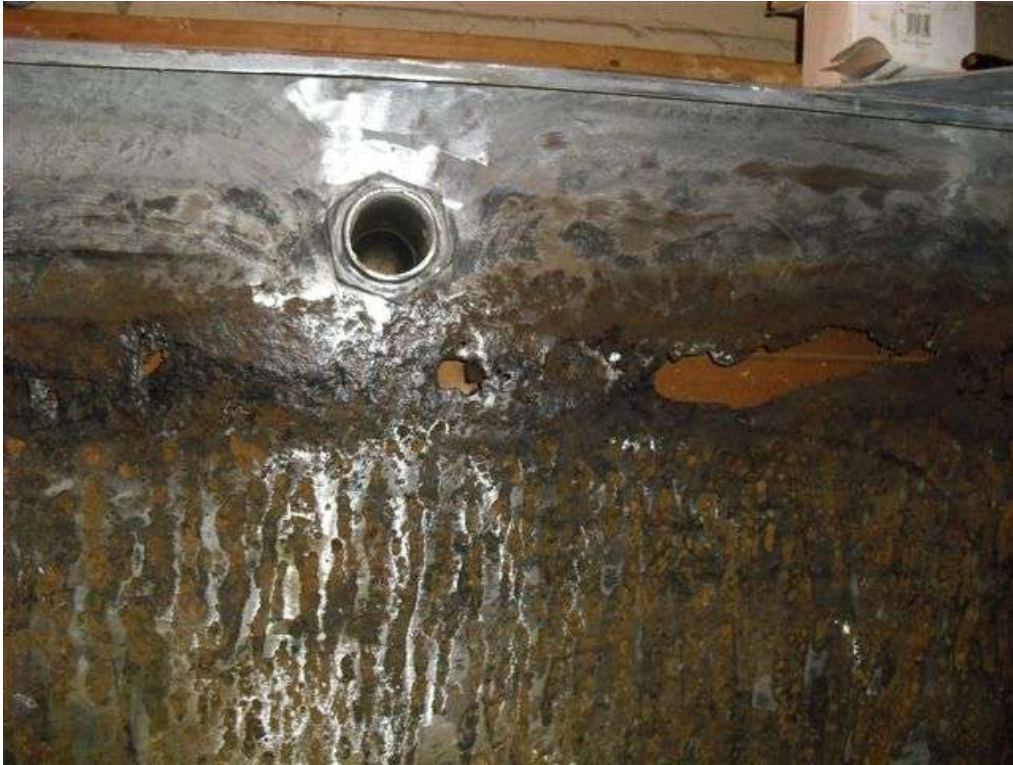
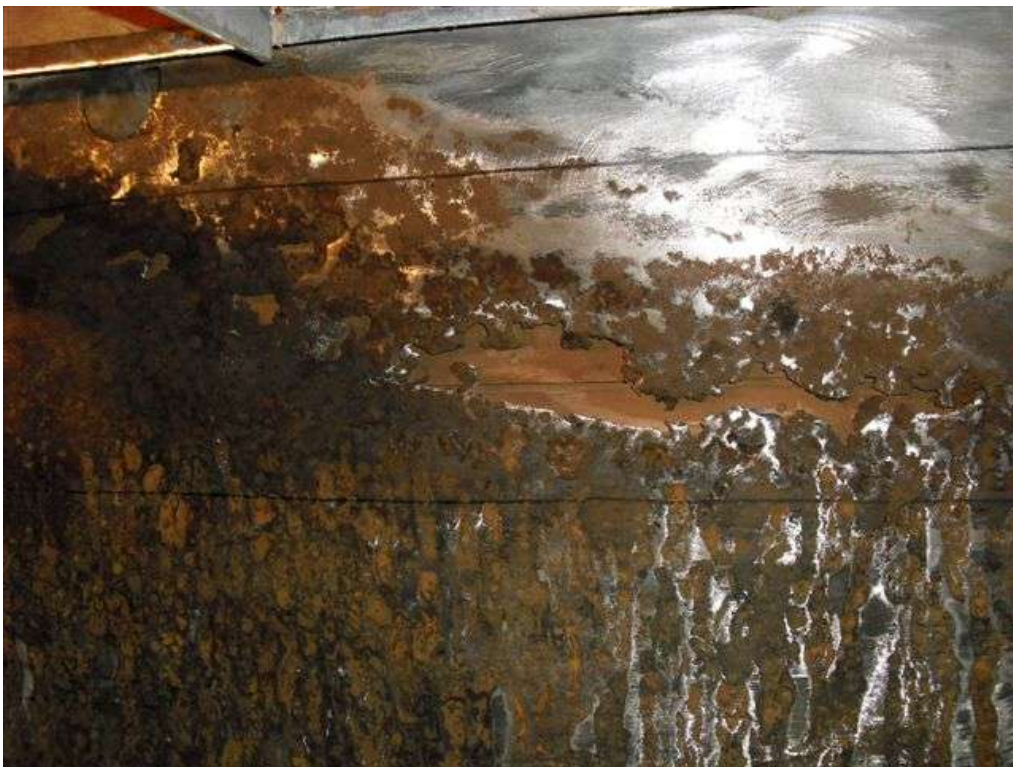
**These pictures show the internal substrate after being prepared by COVAC Operatives, in accordance with ISO 8501-1:2007, utilizing mechanical power tools and manual tools. The holes can be more clearly seen after preparation and were marked out before 'stripe coating' utilising 3M Scotchkote™ 165PW.**
