COMPLETION REPORT

Client : **University Hospitals of XXXXXX**

Project Brief : **The Internal Coating of 1 No. Sectional GRP CWS Tank**

Covac Ref : **1001**

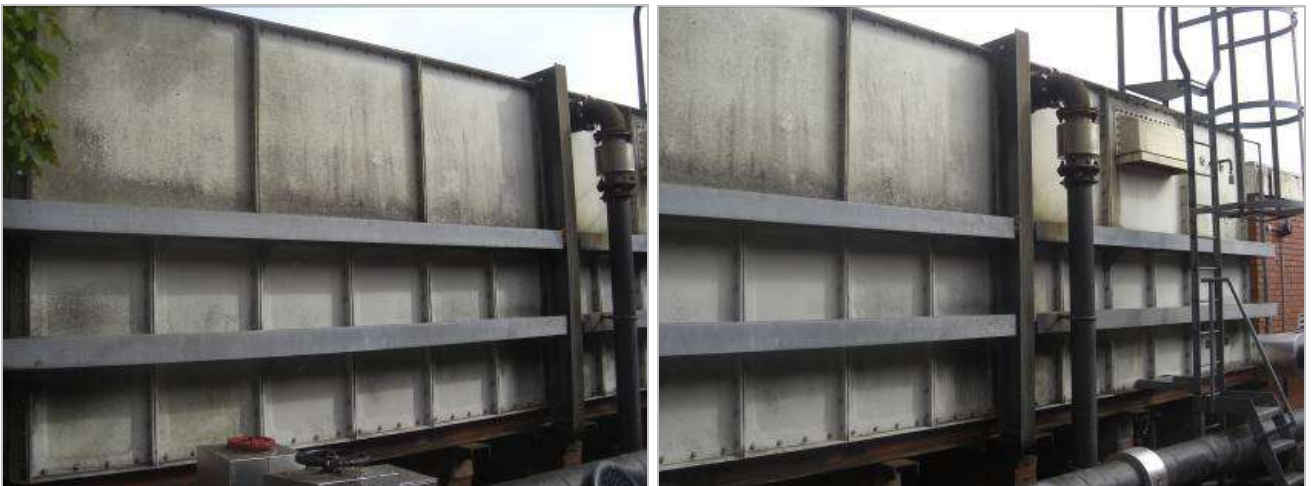
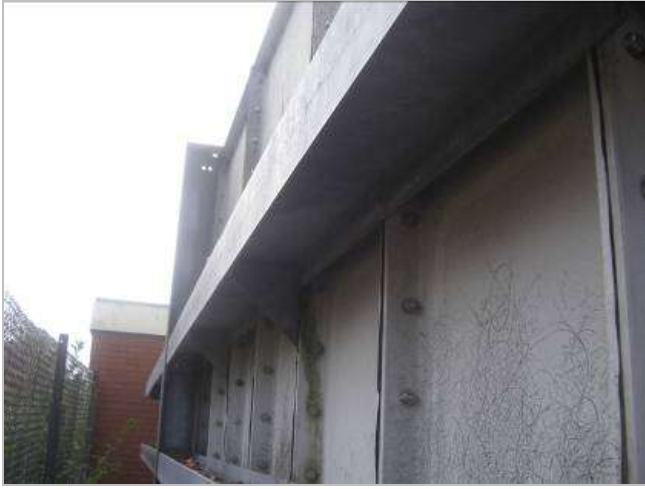
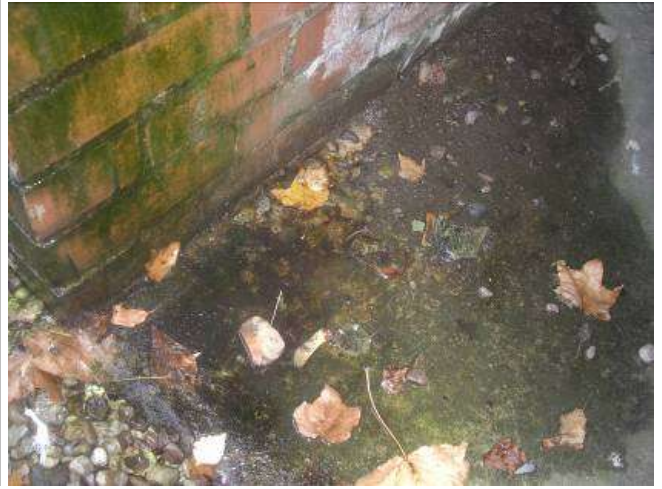
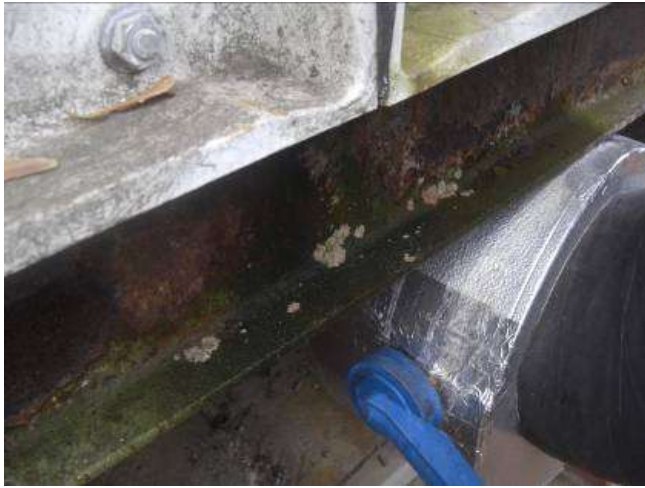
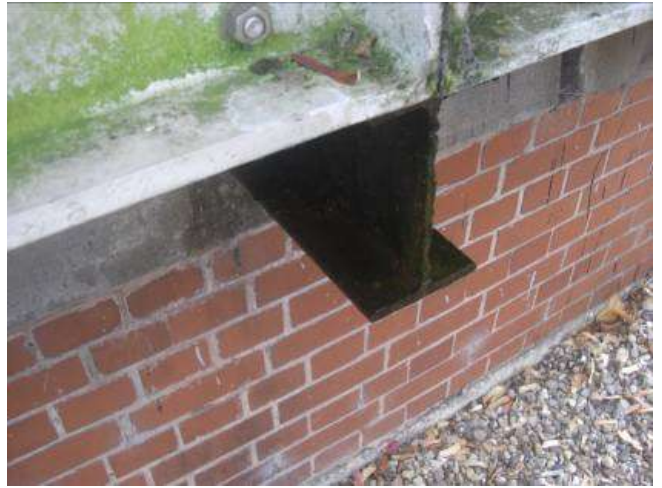
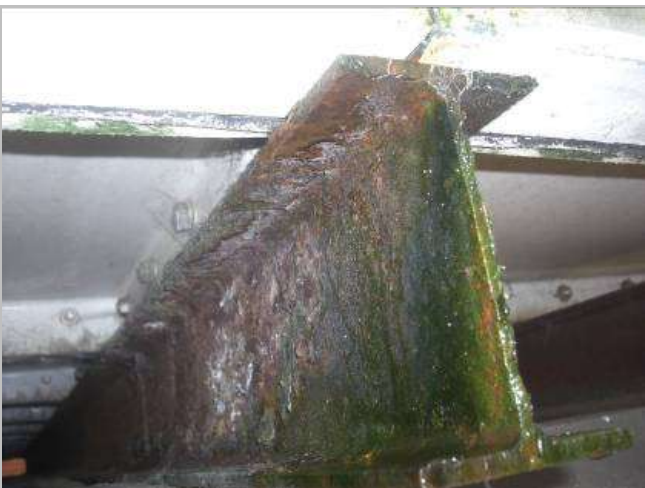
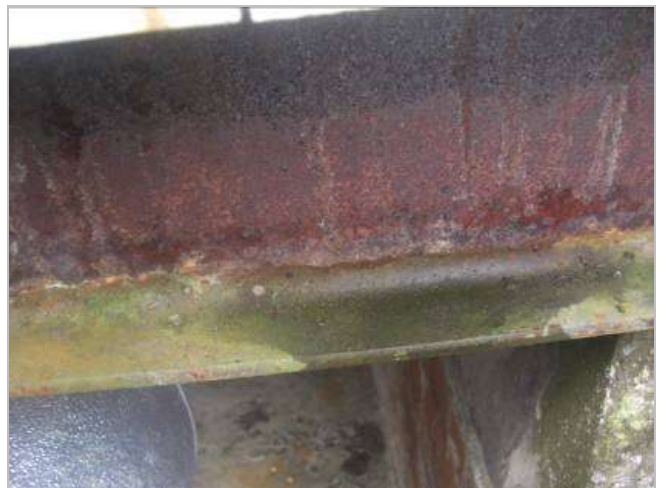
The internal surfaces of the structure were not protected with any coating / lining whatsoever and water was leaking from numerous areas of the joints, due to deterioration of the mastic.

These images showed the leaking areas of the structure:-

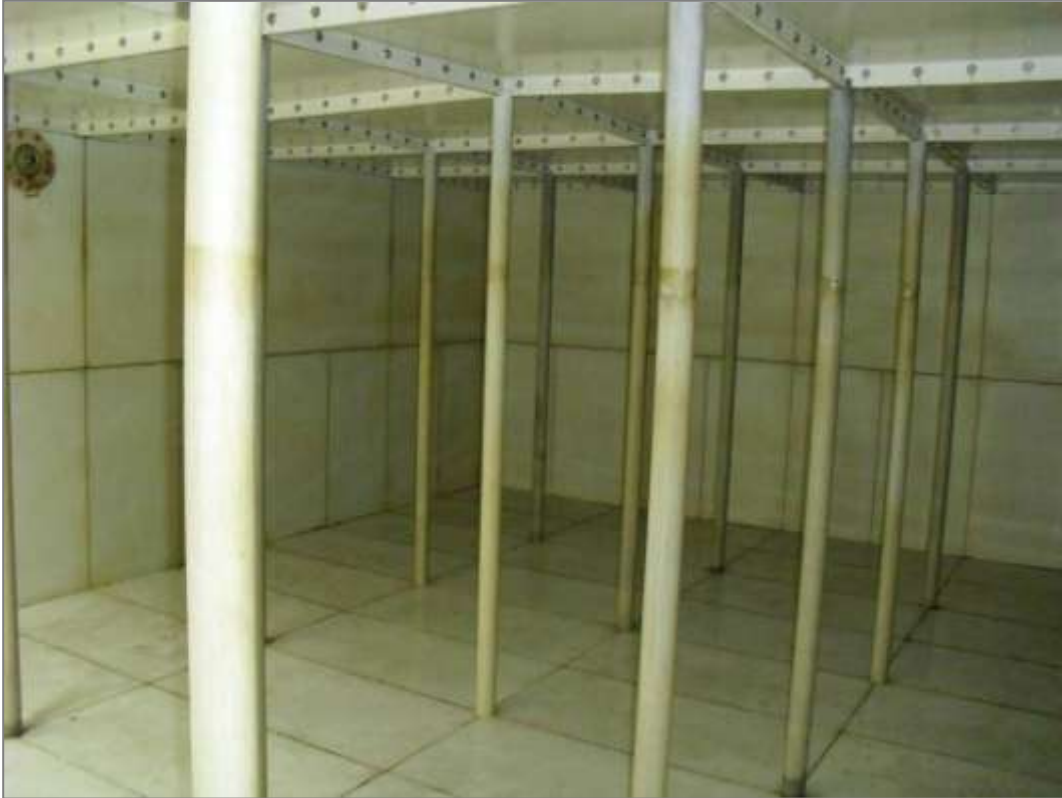
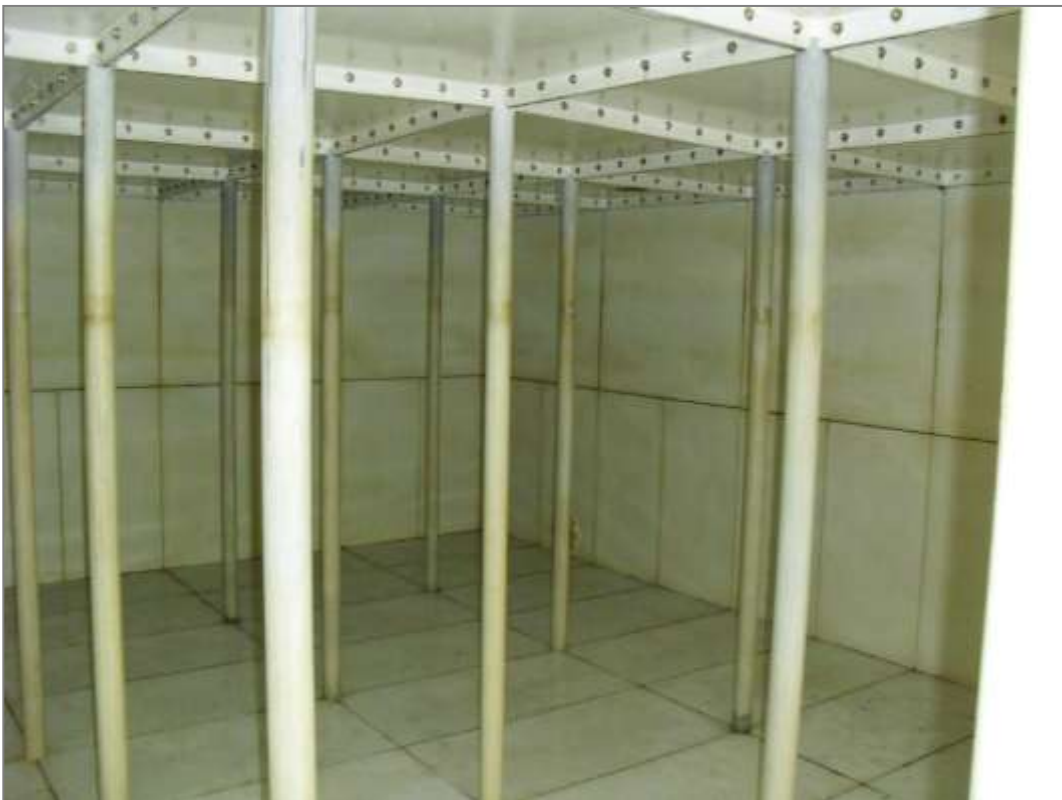
These photographs show the internal surfaces of the Structure having been drained of water, but prior to any work commencing.
