COMPLETION REPORT

Client : **Hospital**

Project Brief : **The Internal Lining of Tank # 1 of 1 No. Split, Sectional GRP Tank**

Covac Ref : **795**

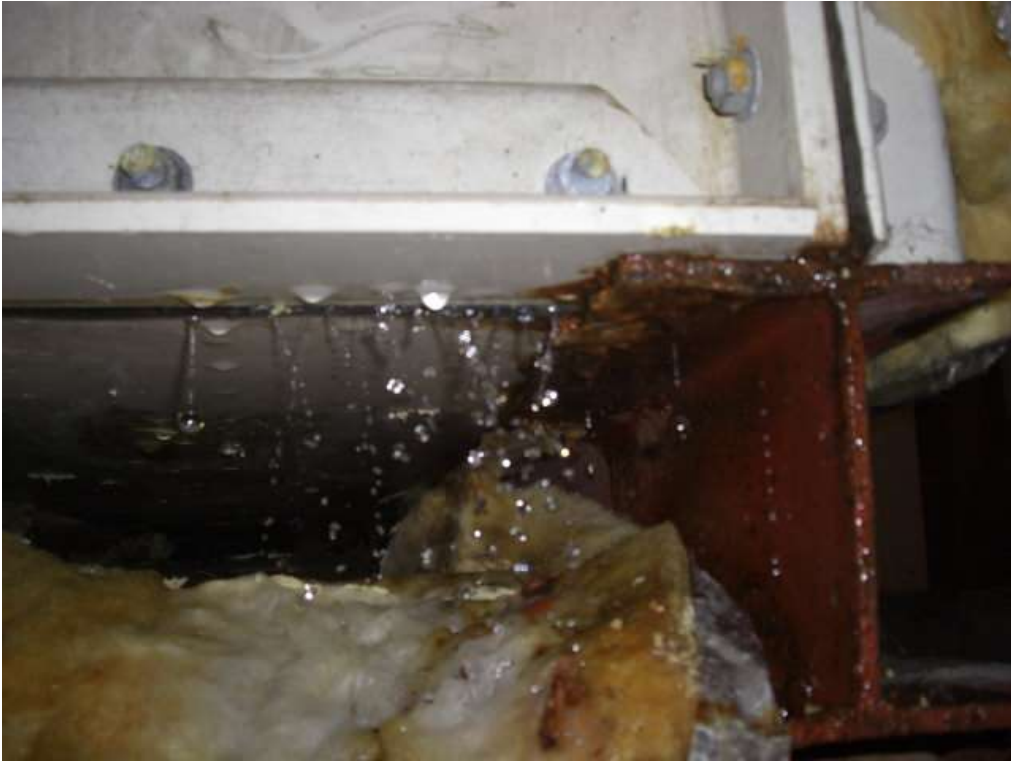
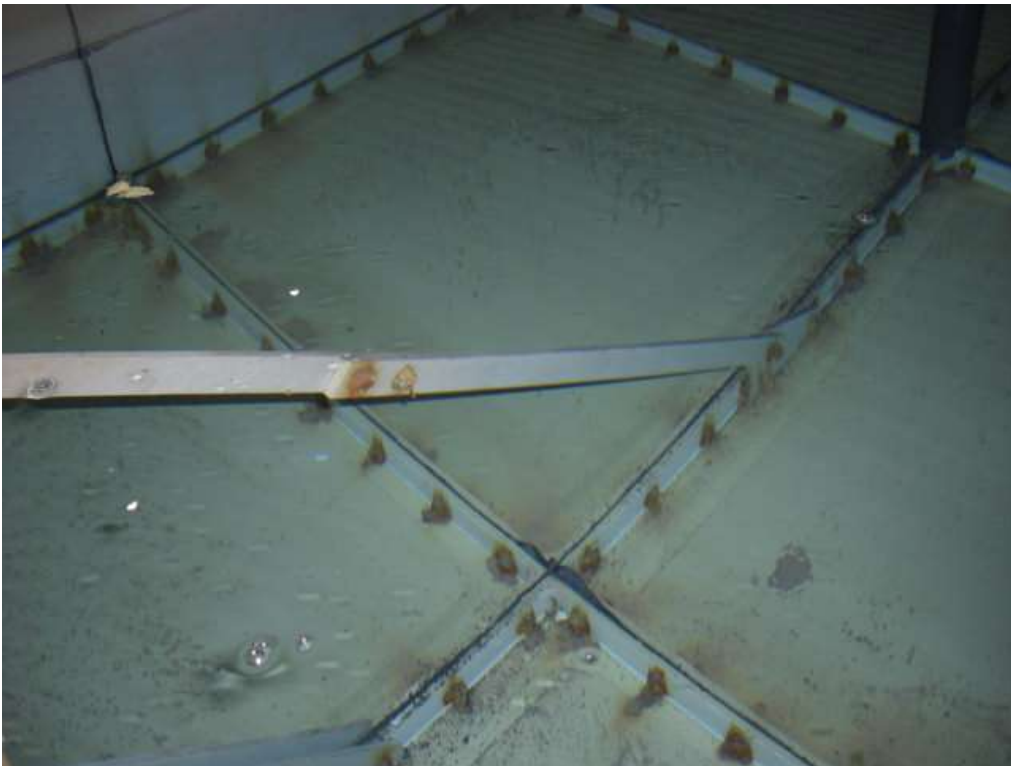
The main concern was that Tank #1, which was being taken out of service due to excessive water loss from various joints on the bottom sectional panels, some of which were serious and needed immediate attention. Leaking from the joints is due to the deterioration of the mastic used between the sectional GRP panels and this, combined with the excessive structural movement of the plastic has led to the eventual leaking of the tank.

There were also signs of the internal gel coat blistering; This problem starts to occur when the water molecules migrating into the GRP encounter other chemicals inside the laminate, primarily water-soluble materials (WSMs) such as the emulsion binders used to hold the glass mat together before it is moulded, or pockets of uncured or only partly cured resins in the moulding. The water molecules can then have a chemical reaction with these substances, forming larger molecules of a new chemical, often acidic – which unlike the original small water molecules cannot carry on passing through the GRP. These larger molecules are then trapped. This is the point at which osmosis actually starts.

These photographs show the leaking tank and the internal surfaces prior to work commencing.

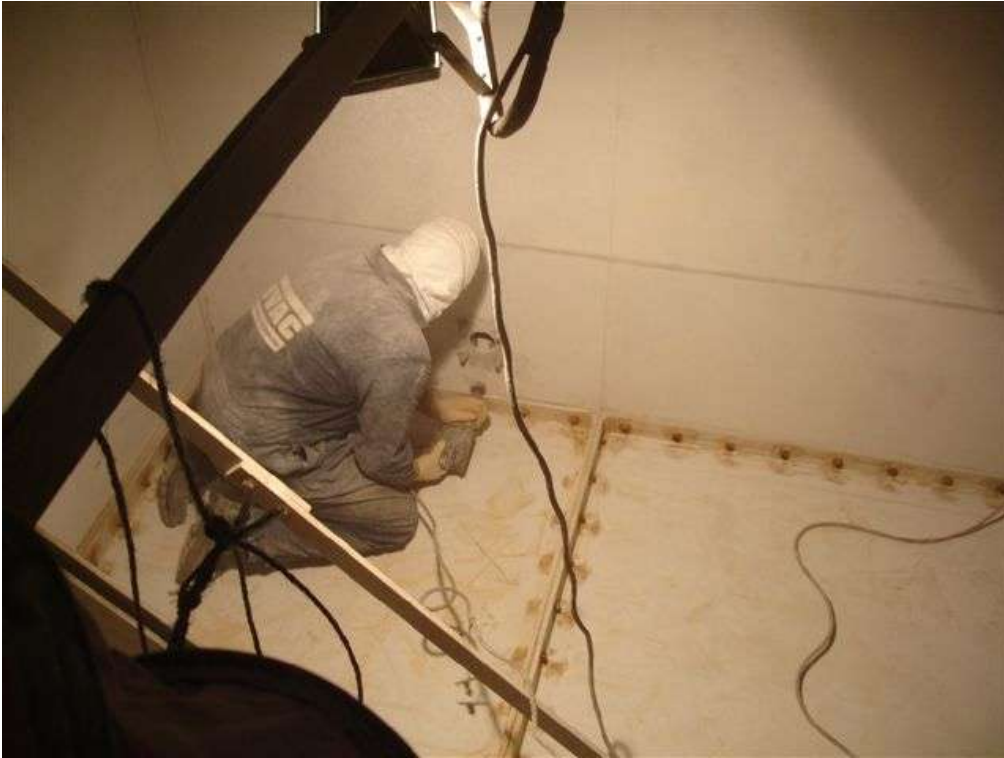
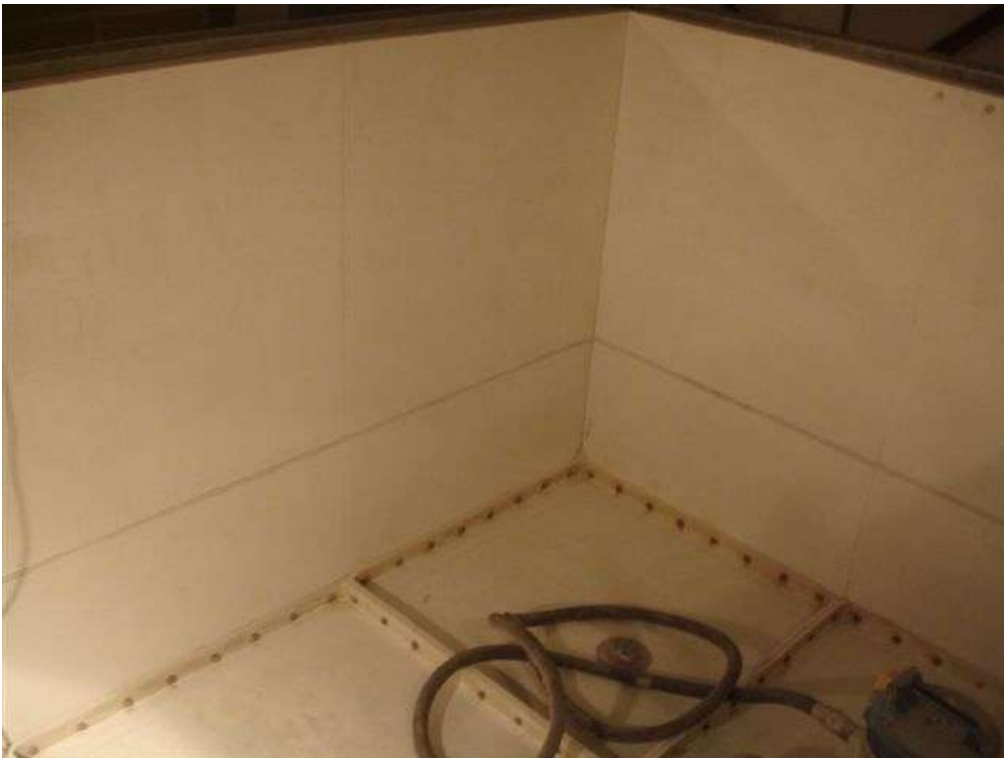
The pictures here show the internal substrate of tank # 1 both during and after preparation by the COVAC Operatives, to ensure that a suitable surface profile was raised for the 3M coating system to adhere to.
