# COMPLETION REPORT

Project Brief : **The Internal Repair & Relining of 1 No.  
Externally Located GRP CWS Tank**

Site Address : **Gwent**

Covac Ref : **824**

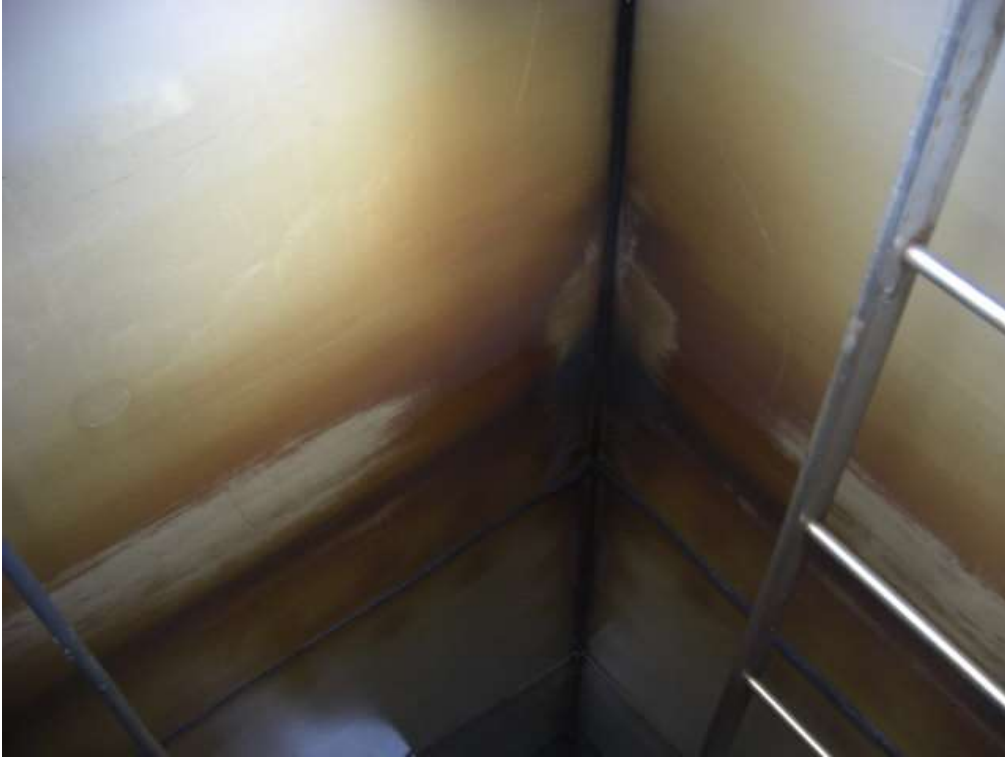
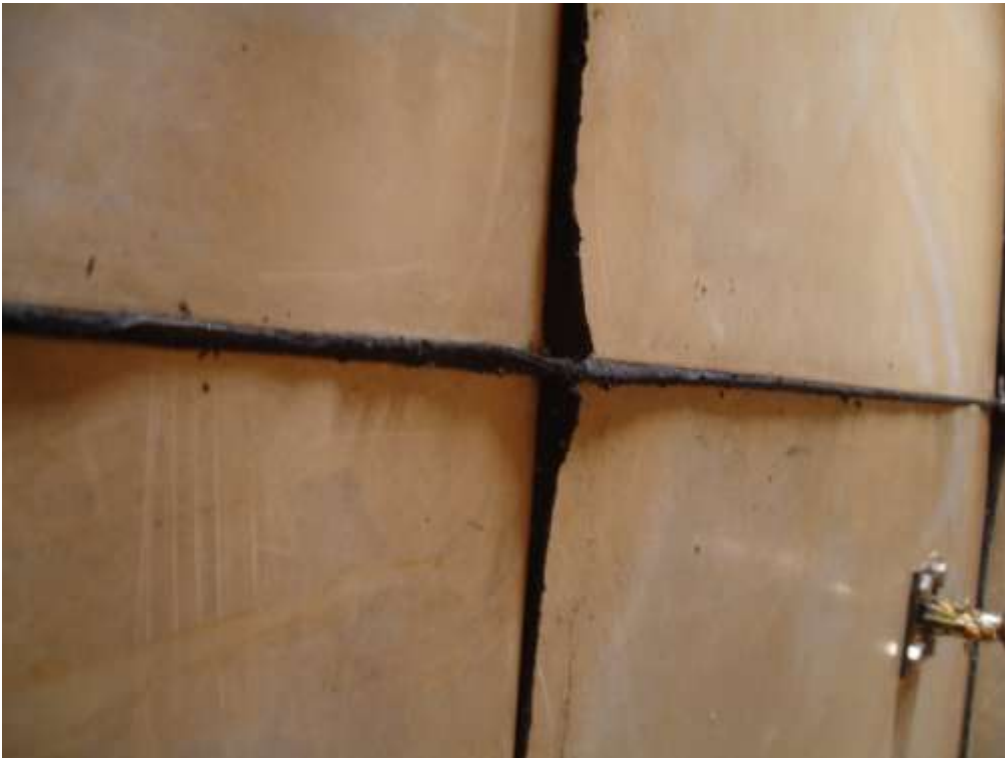
**These photographs show the internal surfaces of the tank having been drained of water, but prior to any work commencing.**

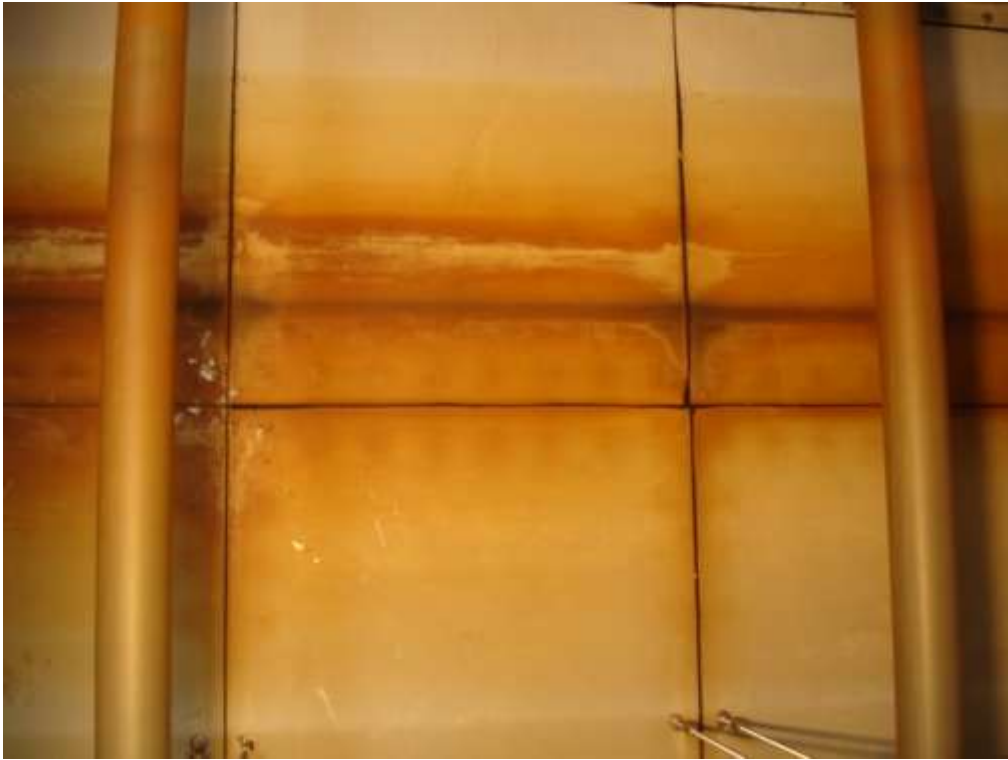
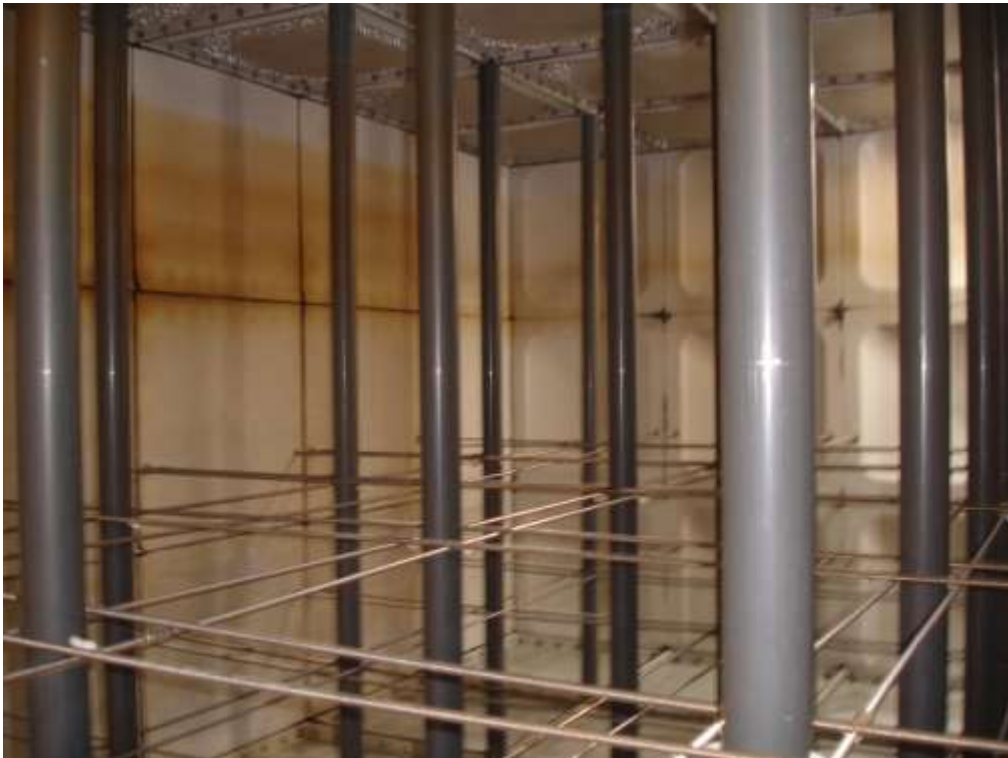
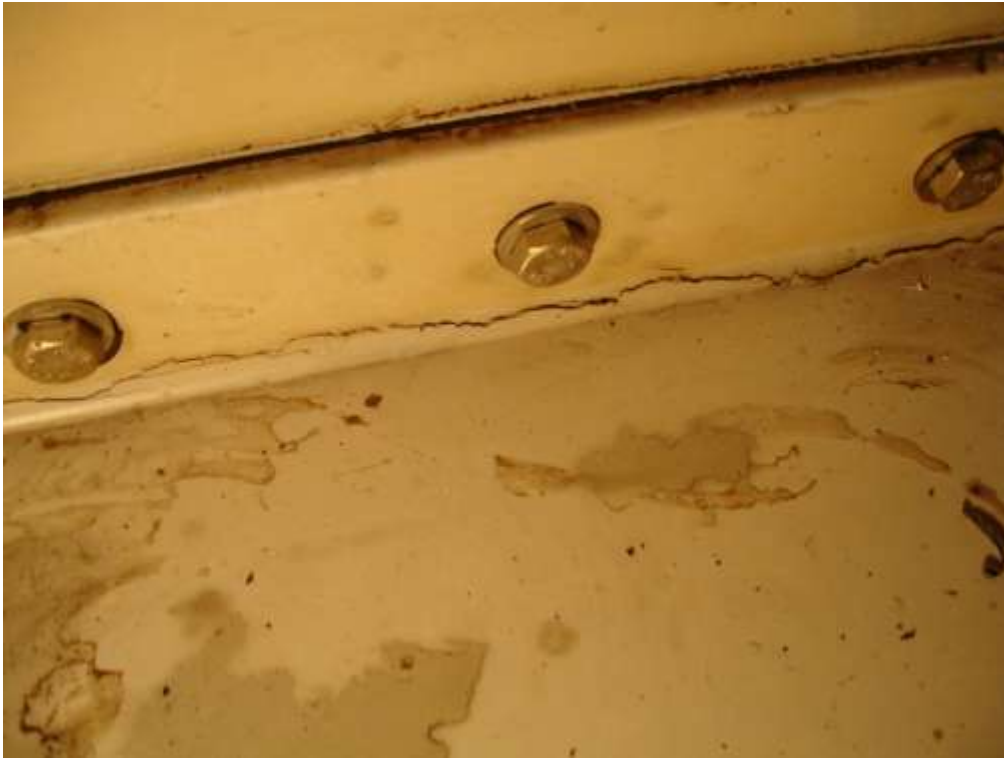
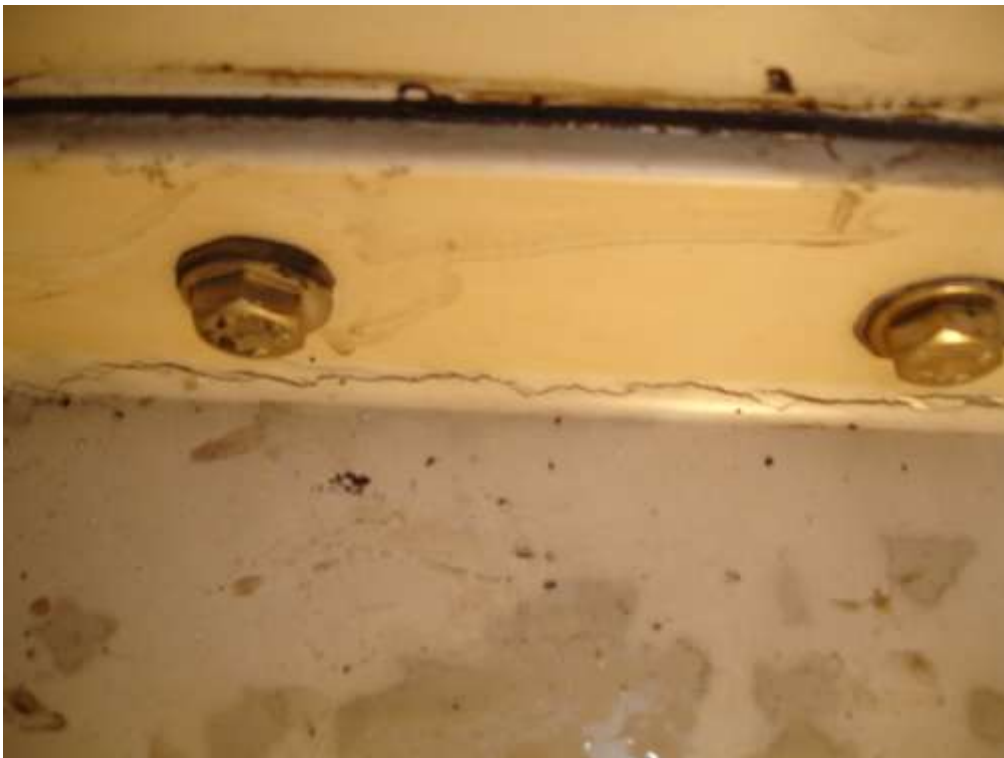
**Due to excessive tightening of the mechanical fixing, as well as stress to the jointed panelling, various cracks have occurred causing water loss from the tank.**
