COMPLETION REPORT

Client : **Media Corporation**

Project Brief : **The Internal Lining of 1 No. Sectional GRP CWS Tank**

System Spec : **3M Scotchkote™ 165PW**
(Formerly Known as COPON Hycote 165PW)

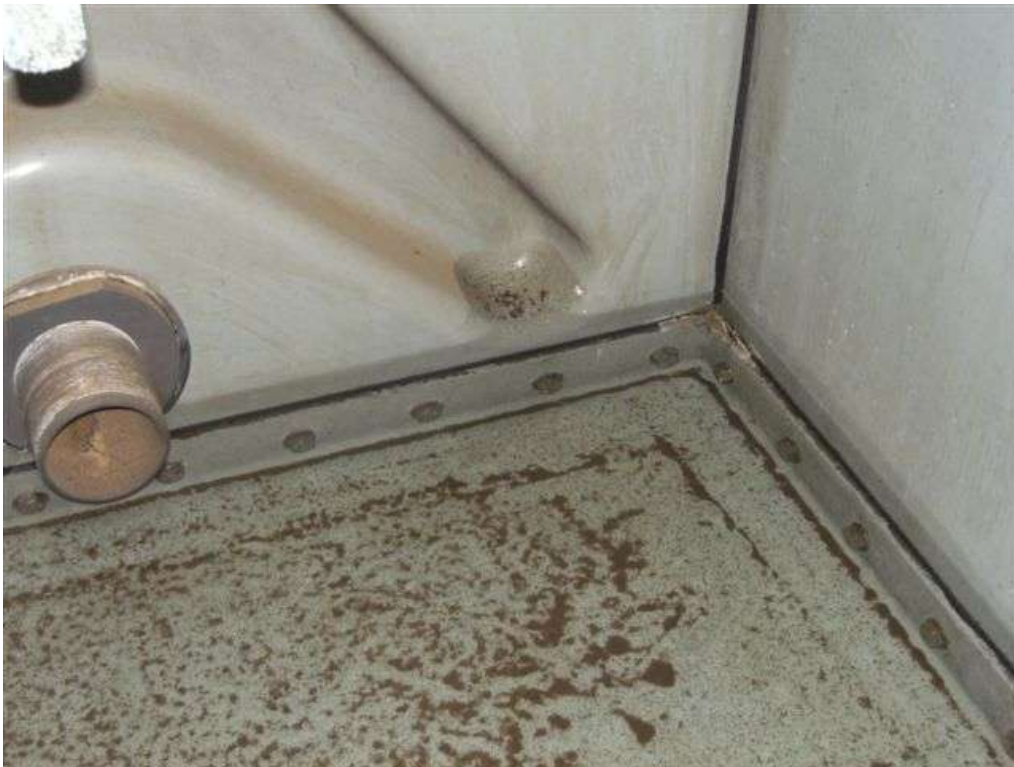
These photographs show the internal surfaces of the tank having been drained of water, but prior to any work commencing.

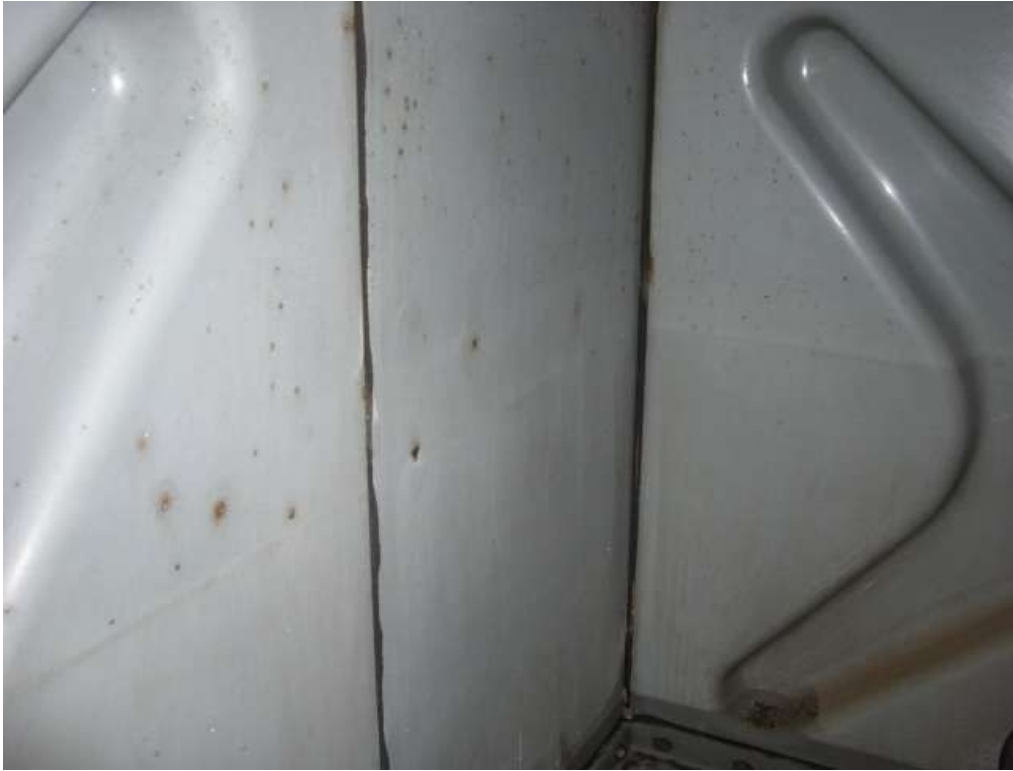
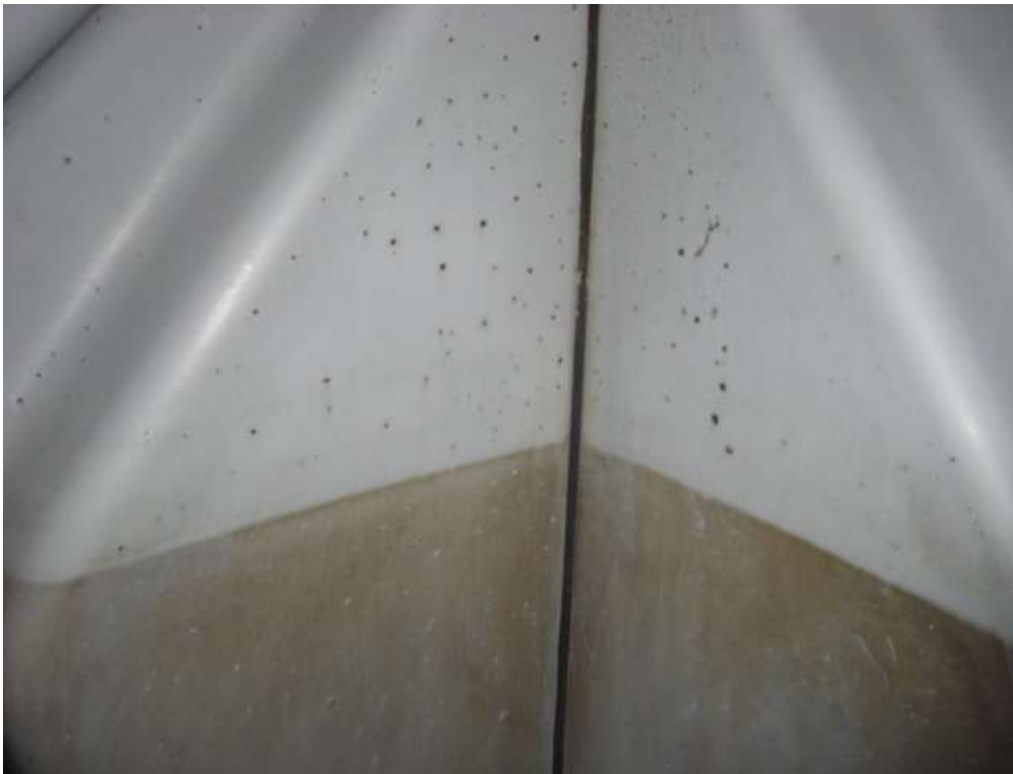
There were several water leaks around the base of the outlet pipe as well as small signs of gel coat blistering and black spore fungi (see pictures), which is notorious for spreading on various grades of GRP, predominantly where there is a combination of water and air at room temperature. The problem faced by all engineers who are responsible for the maintenance of GRP tanks is that even with regular cleaning and chlorination, bacteria such as micro-aquatic organisms will continue to multiply as they are protected by air filled cavities and fine cracks that often cannot be seen with the naked eye.

Black spore fungi can be clearly seen and there is also evidence of small blisters developing in the gel coat.
