# COMPLETION REPORT

Client : **Media Corporation**

Project Brief : **The Internal Lining of 1 No. Sectional GRP CWS Tank**

System Spec : **3M Scotchkote™ 165PW**  
(Formerly Known as COPON Hycote 165PW)

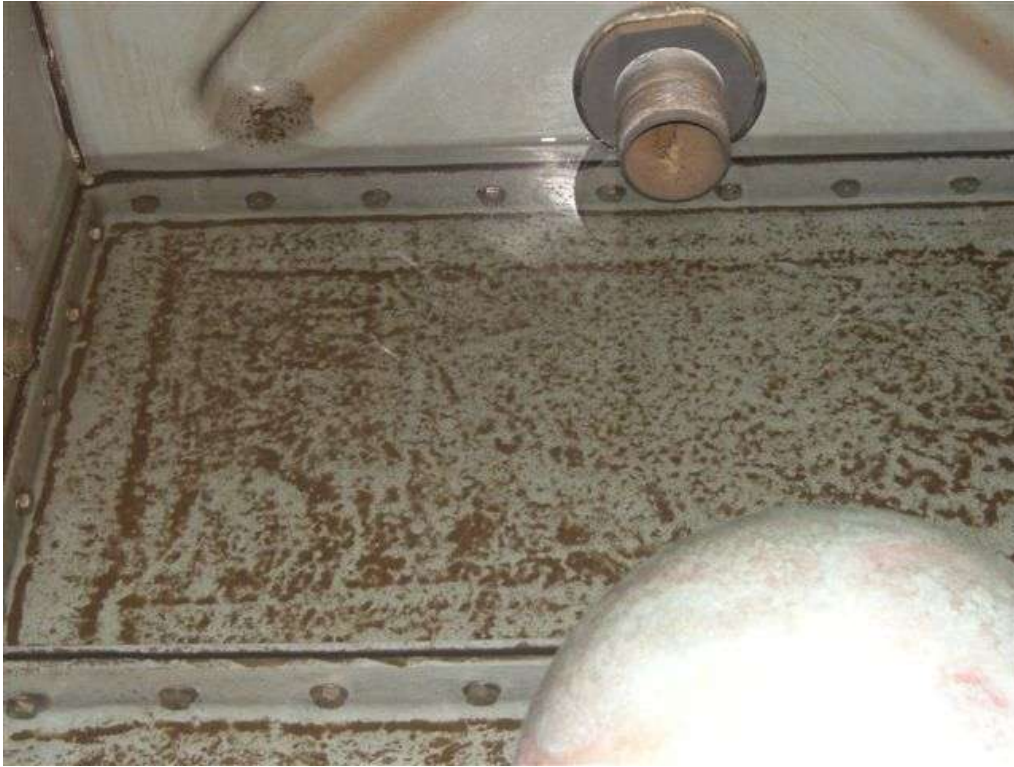
There were several water leaks around the base of the outlet pipe as well as small signs of gel coat blistering and black spore fungi (see pictures), which is notorious for spreading on various grades of GRP, predominantly where there is a combination of water and air at room temperature. The problem faced by all engineers who are responsible for the maintenance of GRP tanks is that even with regular cleaning and chlorination, bacteria such as micro-aquatic organisms will continue to multiply as they are protected by air filled cavities and fine cracks that often cannot be seen with the naked eye.

**These photographs show the internal surfaces of the tank having been drained of water, but prior to any work commencing.**

COVAC would highly recommend a full internal lining to the tank, complying fully with current stringent water treatment regulations with a protective internal coating which we can confidently guarantee for a minimum of 10 years, with additional benefits of ease to regular monitoring, annual cleaning and most importantly, the client's peace of mind.

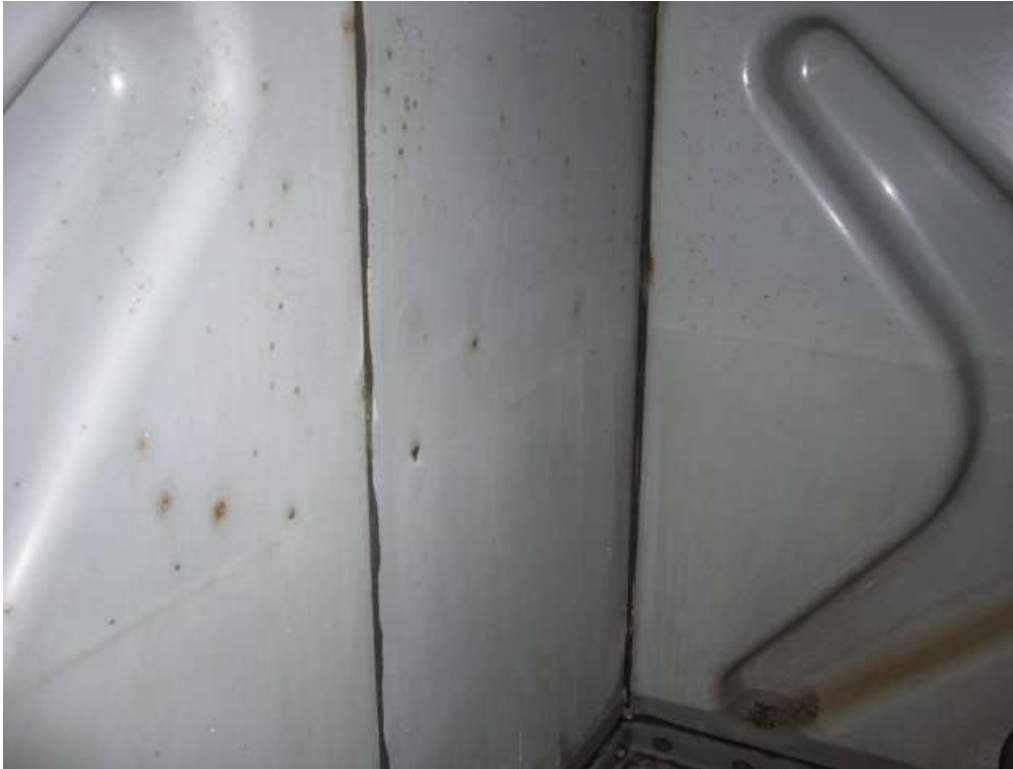
If left untreated, the internal surfaces will continue to be at risk from bacterial growth including Legionella, Pseudomonas and Biofilm; this can lead to further deterioration in the tank's surface structure and contamination of the down services with the supply of unhygienic water to the outlets.

**Black spore fungi can be clearly seen and there is also evidence of small blisters developing in the gel coat.**

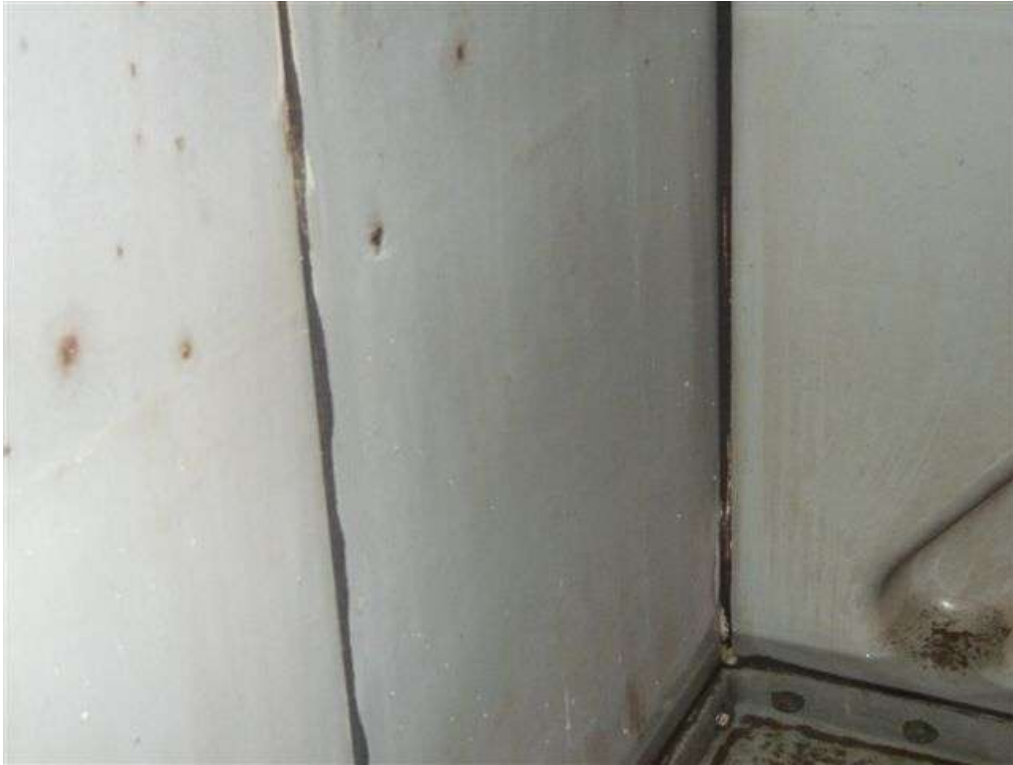
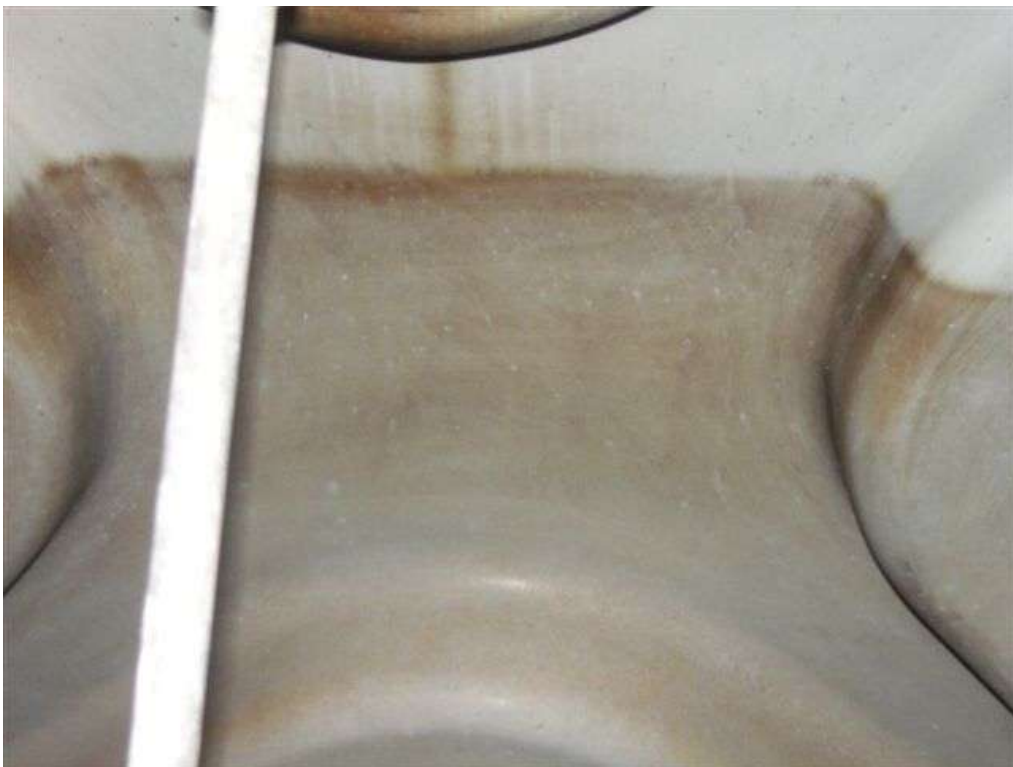
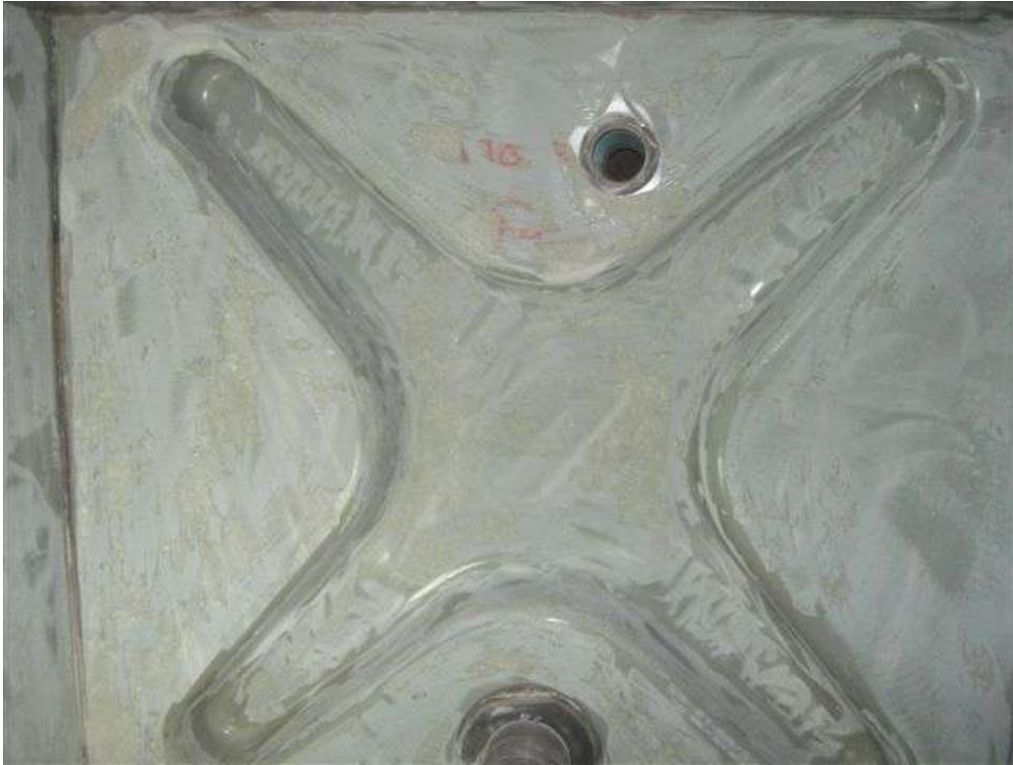
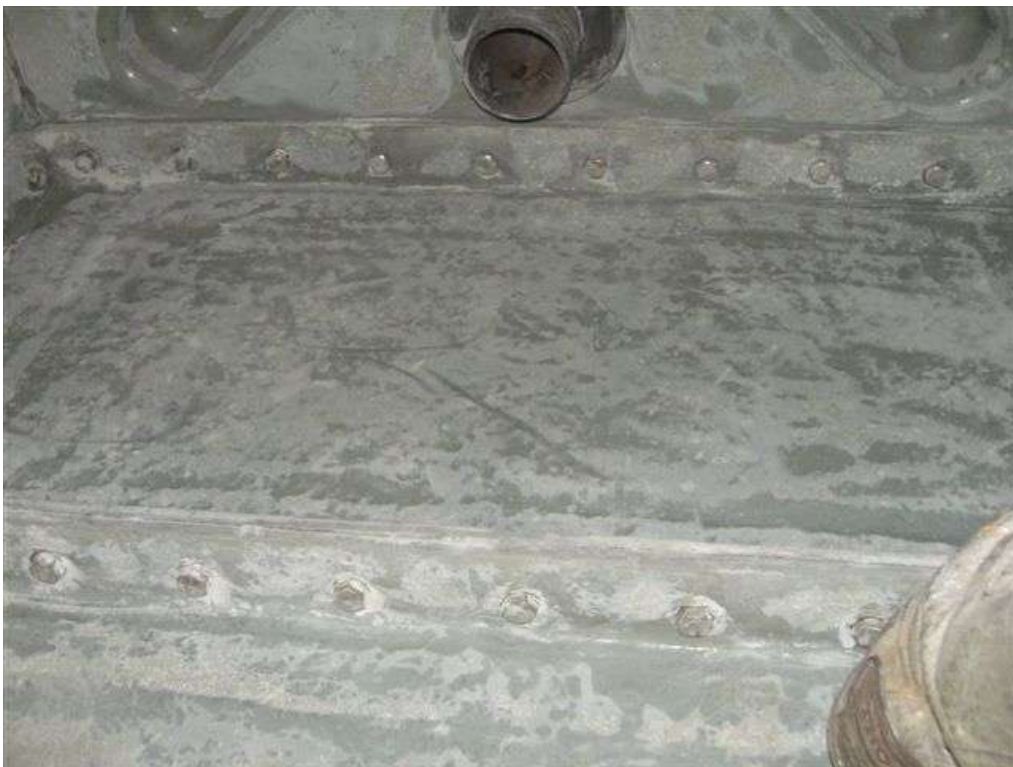
**These pictures show the internal substrate of the tank after preparation by COVAC Operatives, in order to raise a suitable surface profile on the substrate and promote optimum adherence of the 3M Scotchkote™ 165PW lining system.**

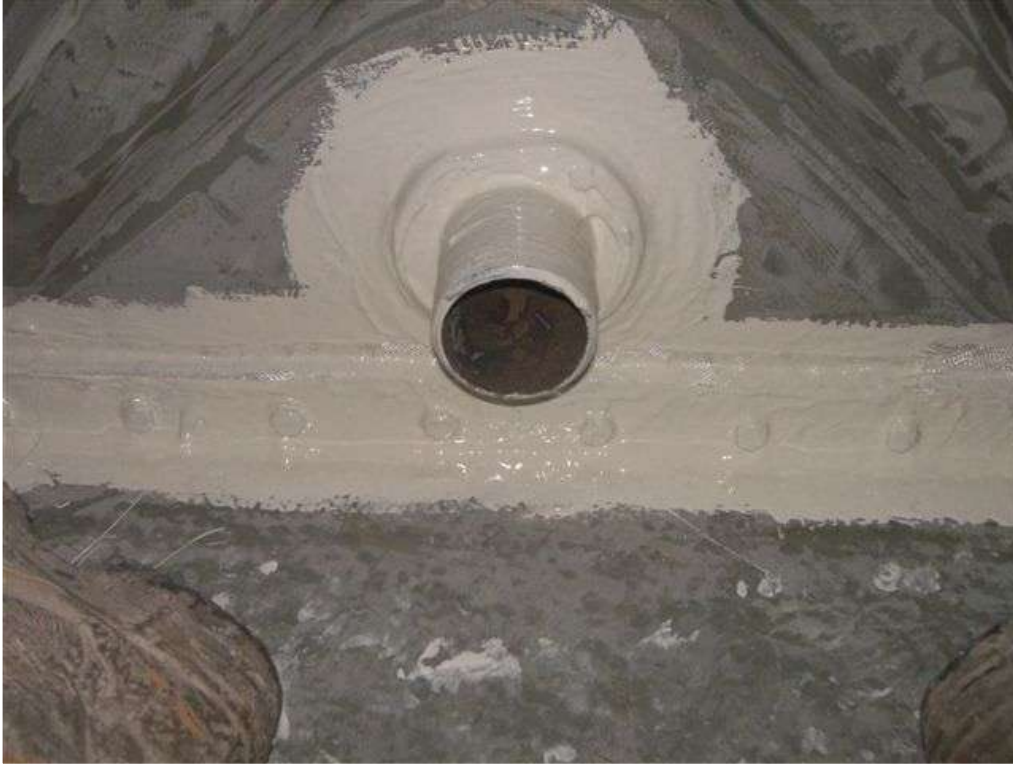
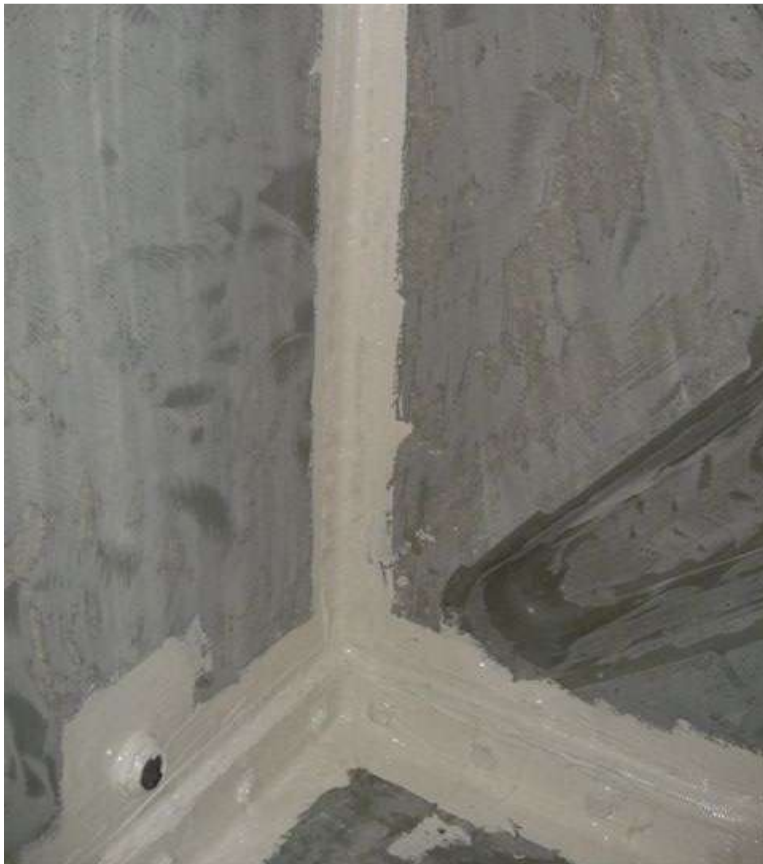
Another common fault associated with GRP tanks, which was the main concern on this tank, is the deterioration of the mastic used between the sectional GRP panels and subsequent leaking of water. The mastic used in these joints often deteriorates rapidly following years (sometimes months) of use and this, combined with the excessive structural movement of the plastic will lead to eventual leaking of the tank. The consequential loss of water through these joints can be catastrophic as highlighted by the damaged ceiling tiles though could have been significantly more if not highlighted early enough.

**All joints were treated to prevent leaks and allowed to cure.**

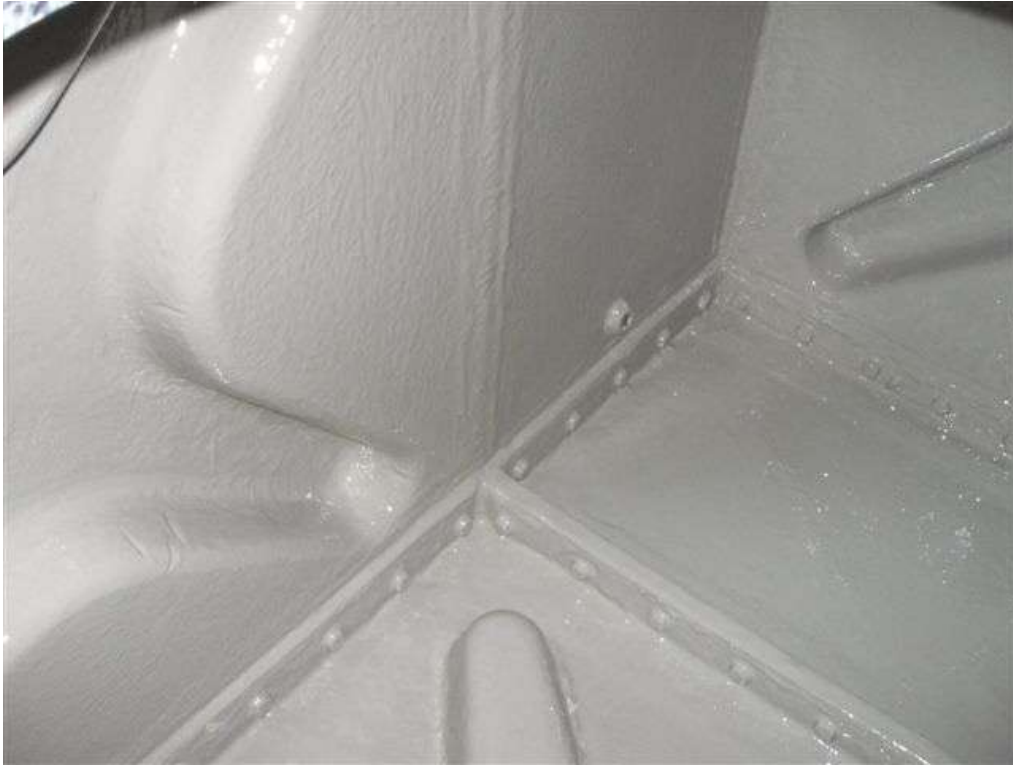
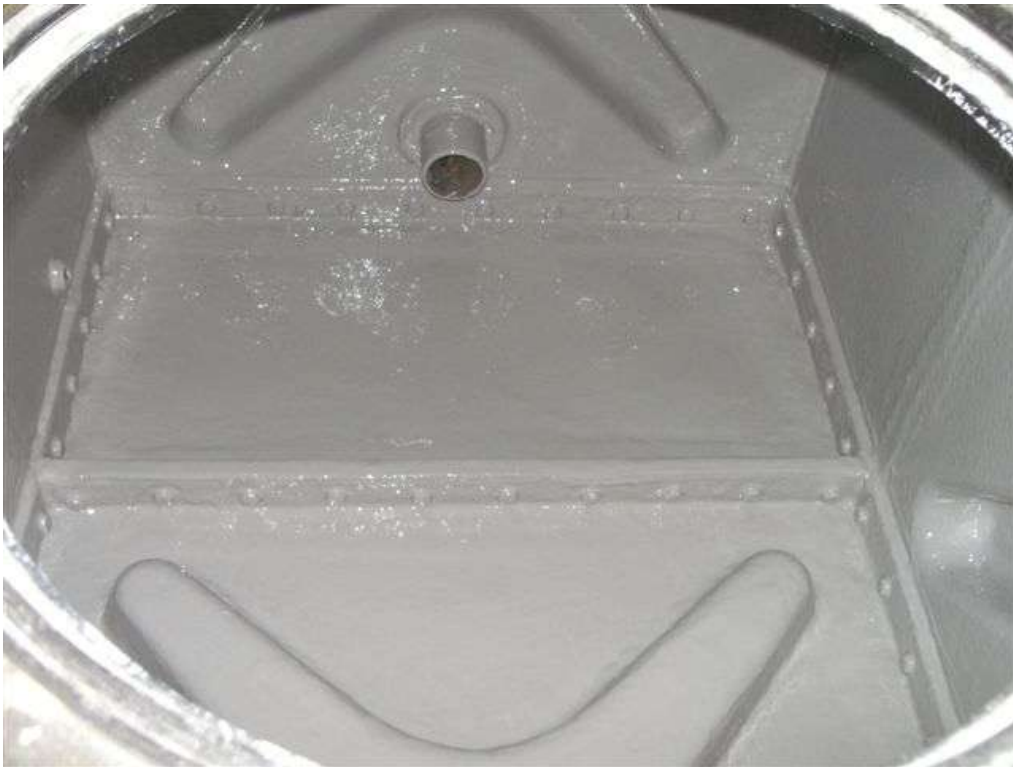
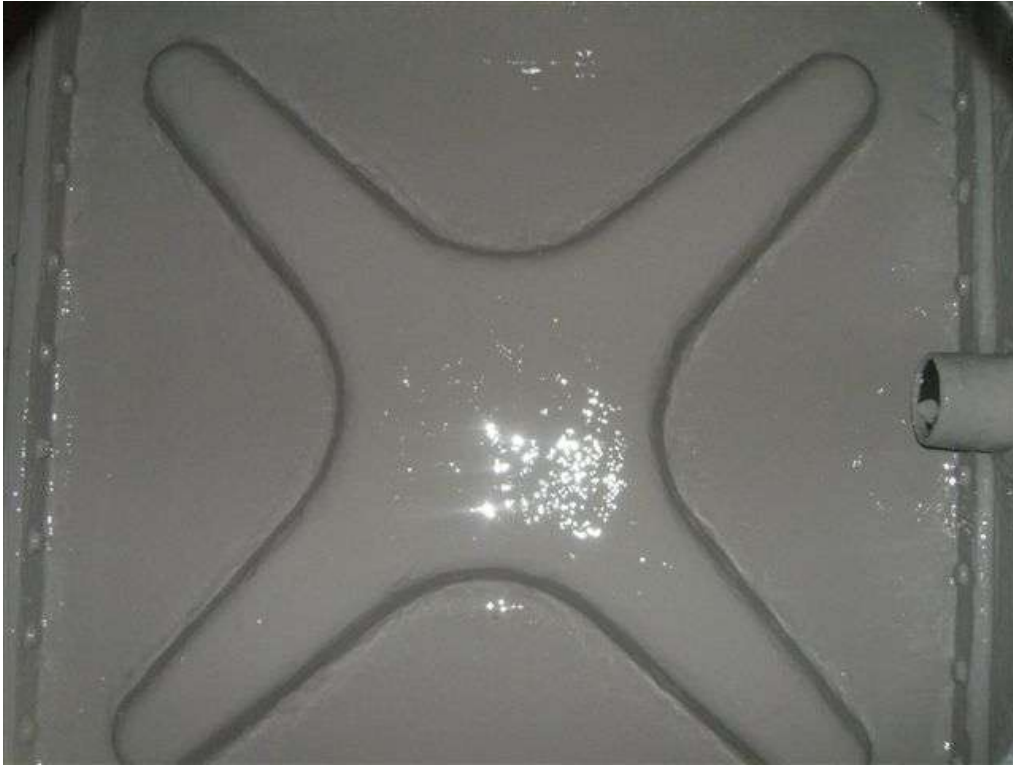
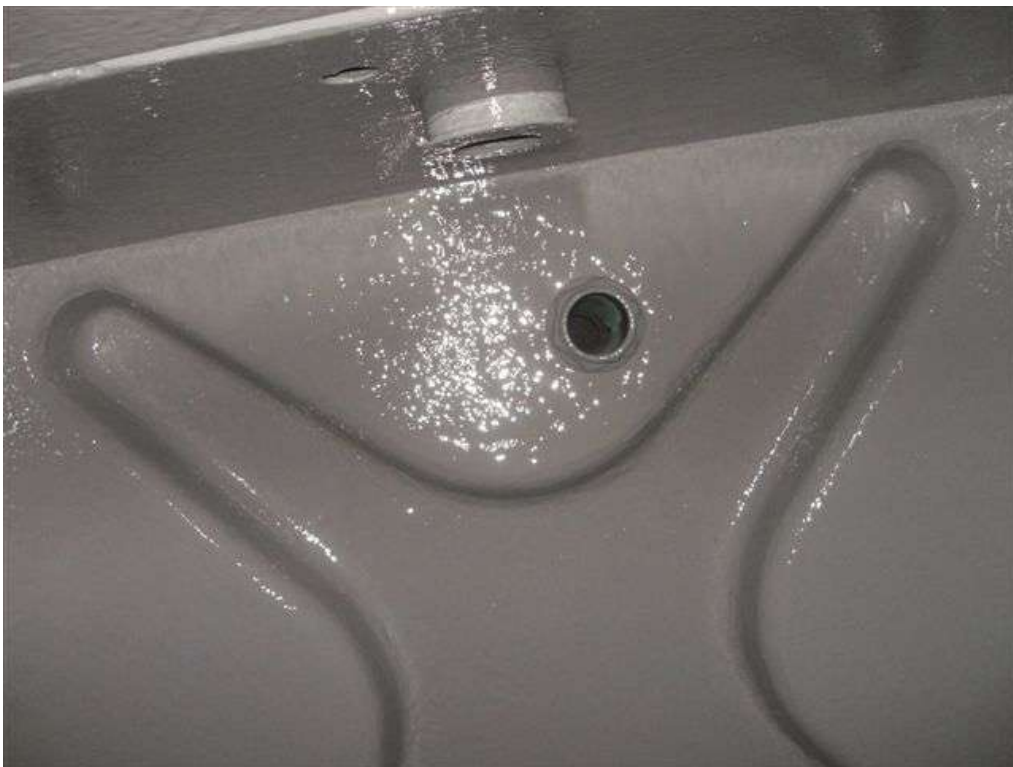
The following photographs show the final application of 3M Scotchkote™ 165PW (grey).
