COVAC COMPLETION REPORT

| Project Details | - | The Internal Re-Lining of 1 No. Sectional Steel Braithwaite Water Retaining Structure |
| System Specification | - | COPON Hycote 165PW Solvent Free Polyurethane |
| Completion Date | - | 27th May 2004 |

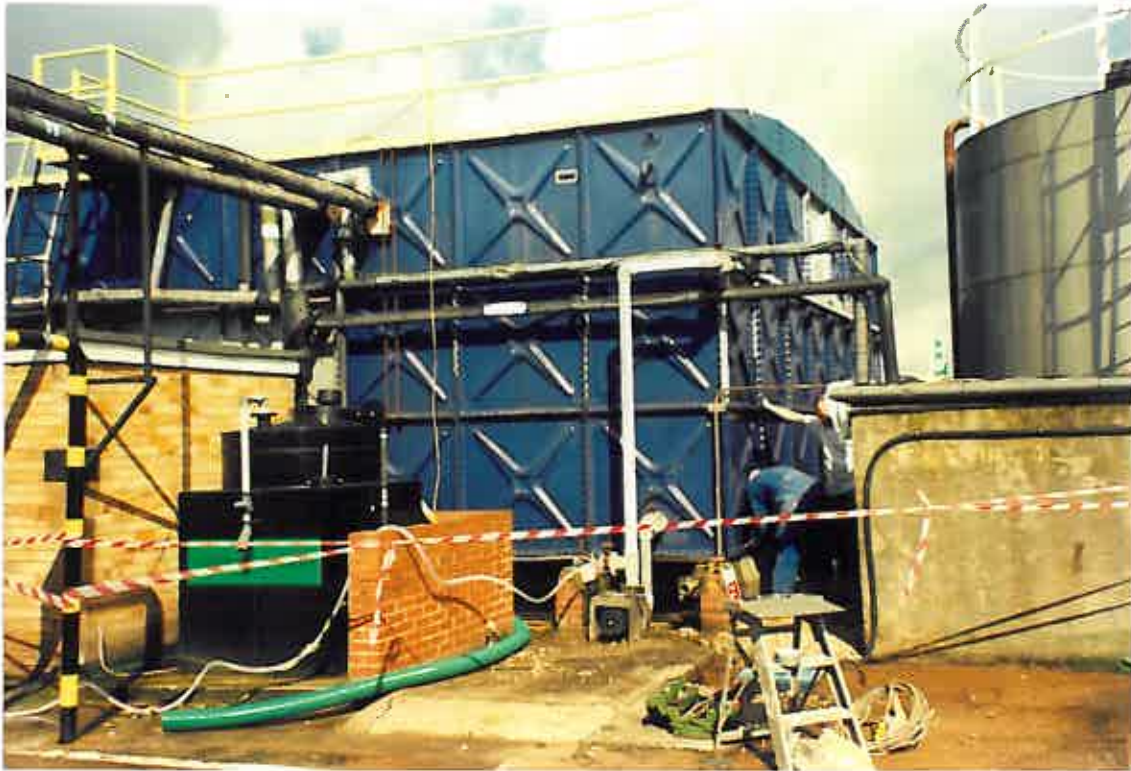
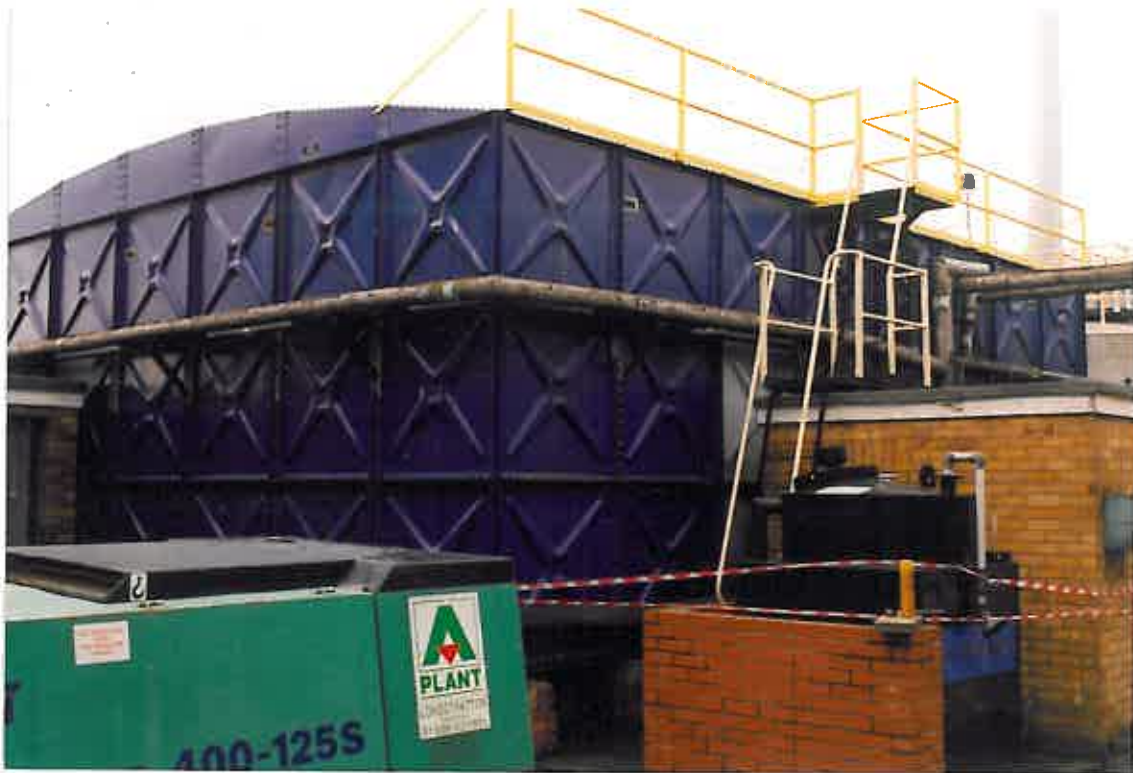
These photographs show the external of the tank

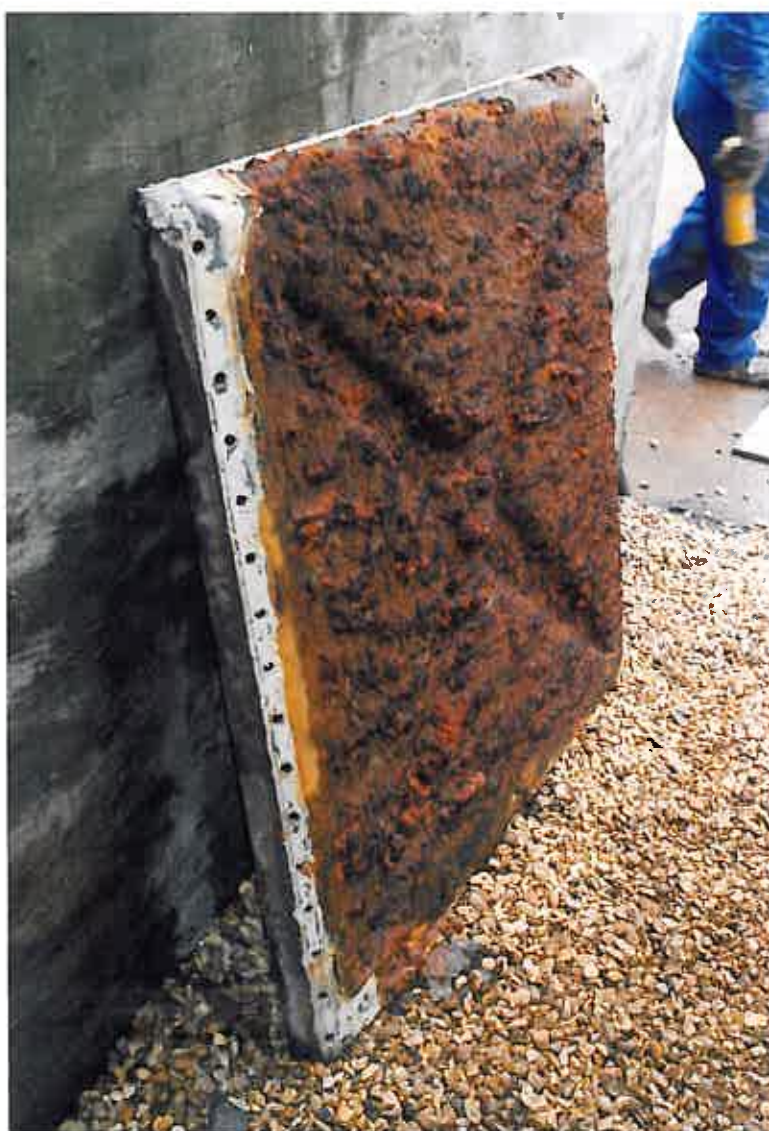
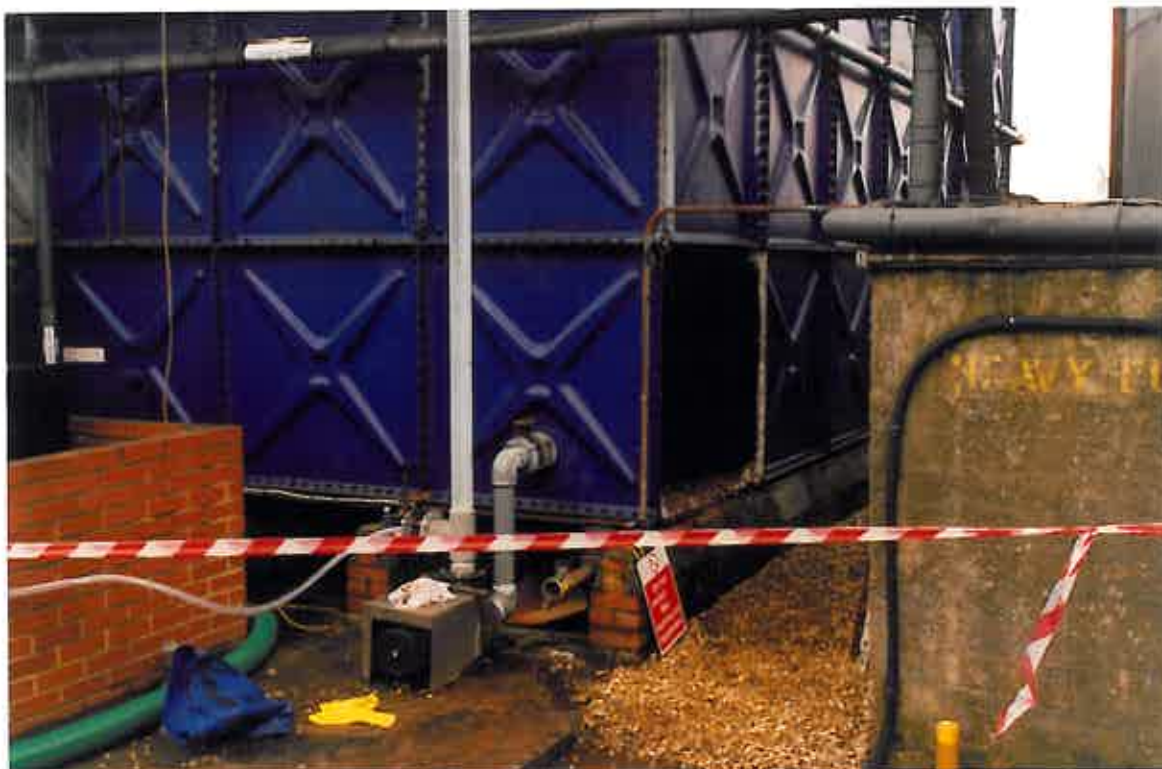
These photographs show the removal of one of the bottom, sectional panels from the tank. This was a vast improvement on the original roof entrance point in terms of ease of access and health and safety aspects.

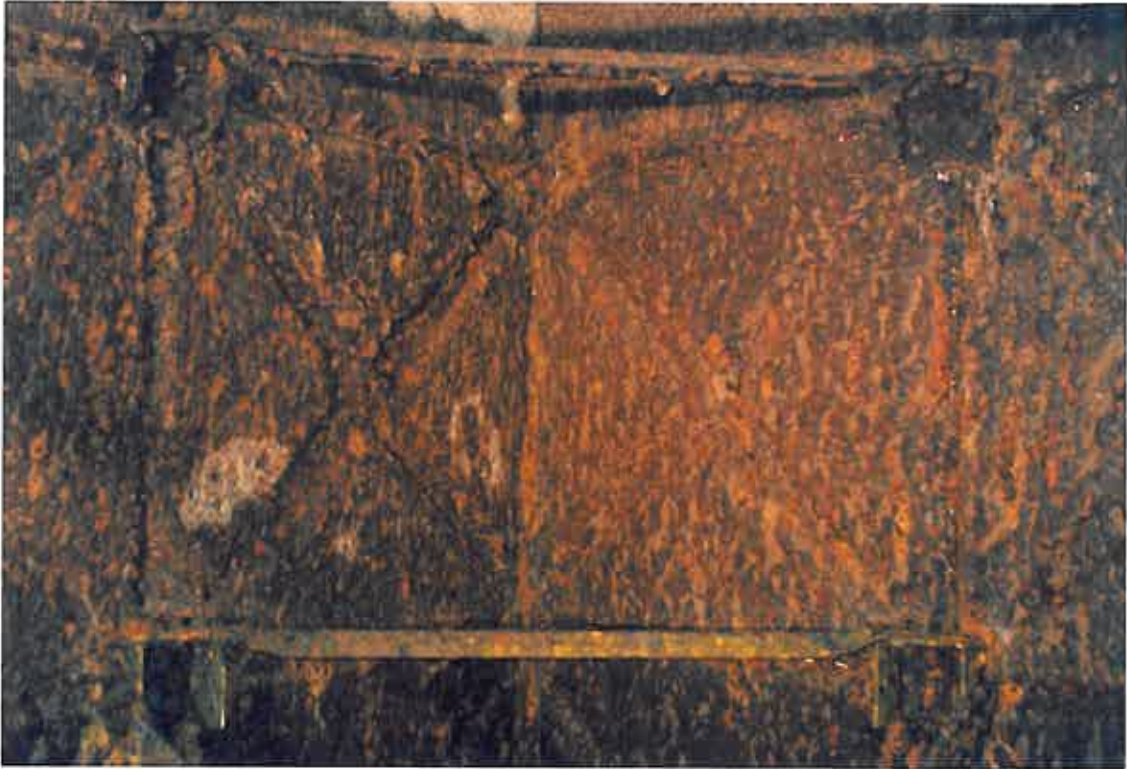
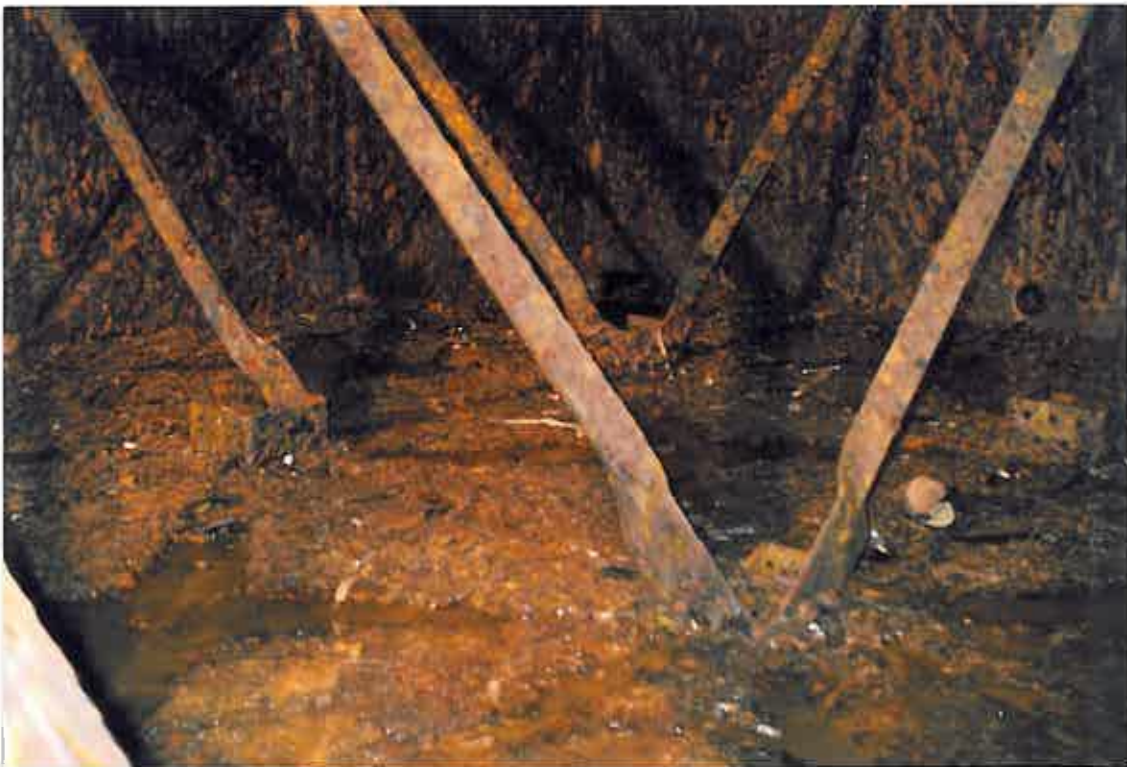
These photographs show the severity of the corrosion to the internal surfaces of the tank.

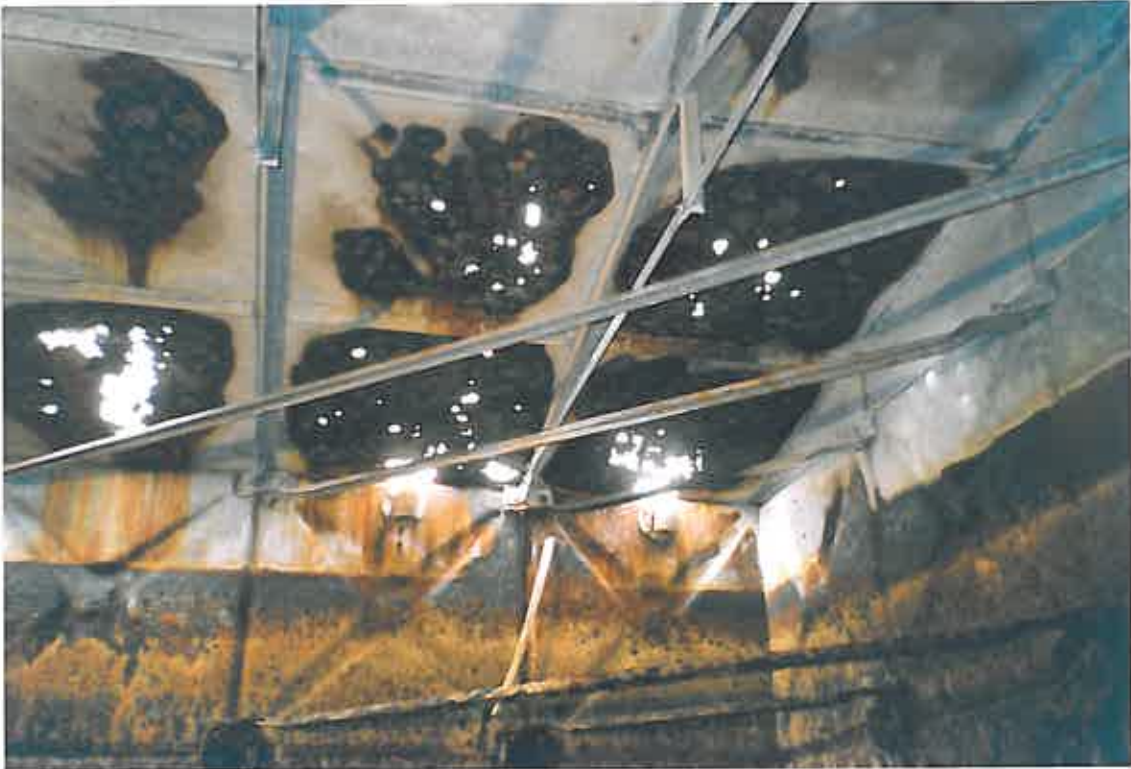
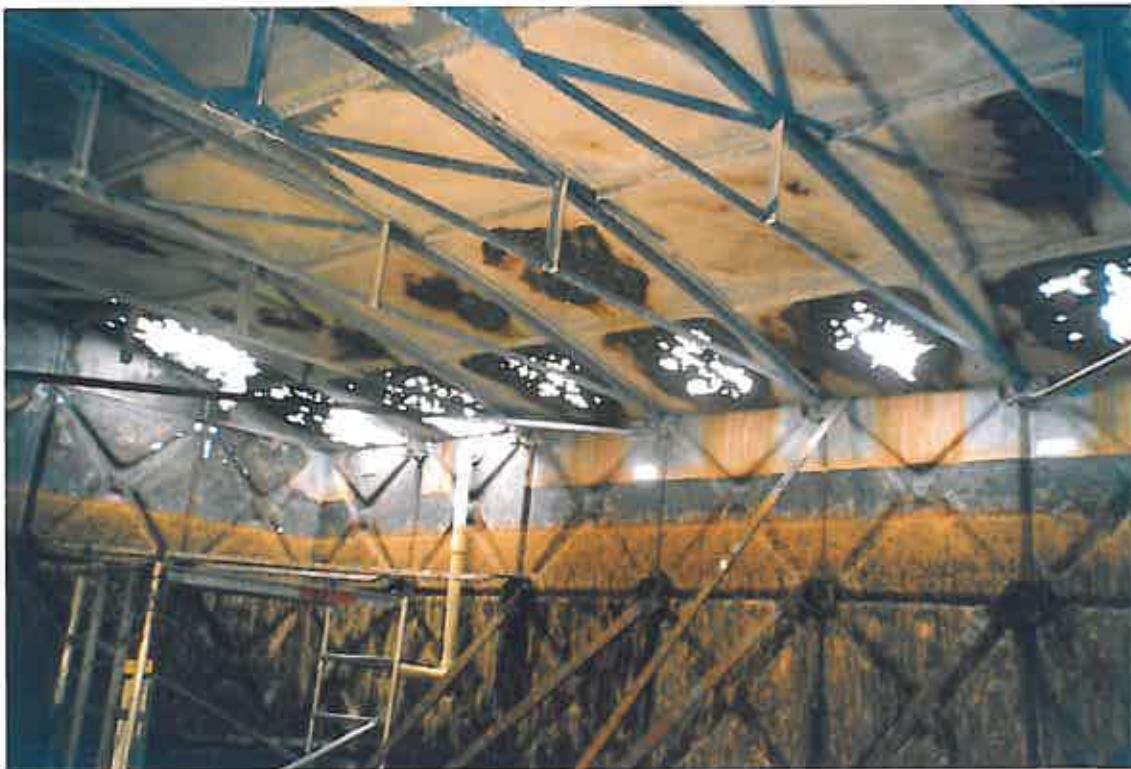
These photographs show how the corrosion had attacked the steel roof. These holes were eventually cut to firm edge, prior to being repaired utilizing new flat, steel, galvanised sheeting.

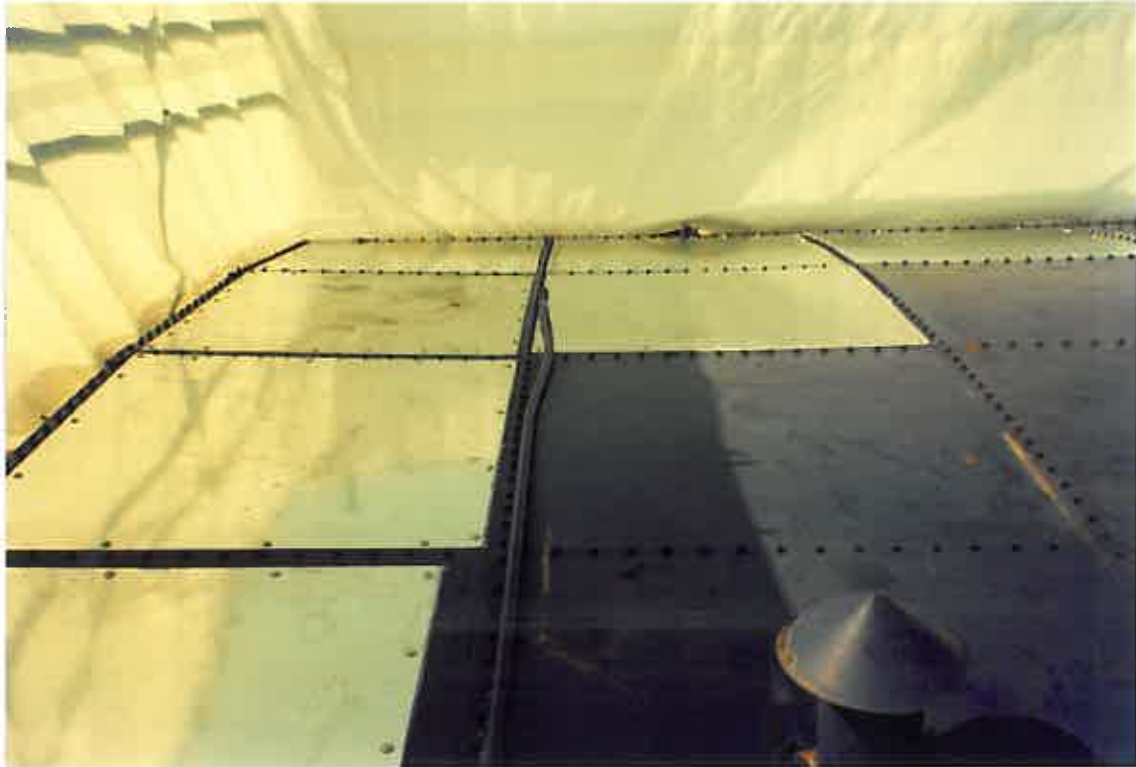
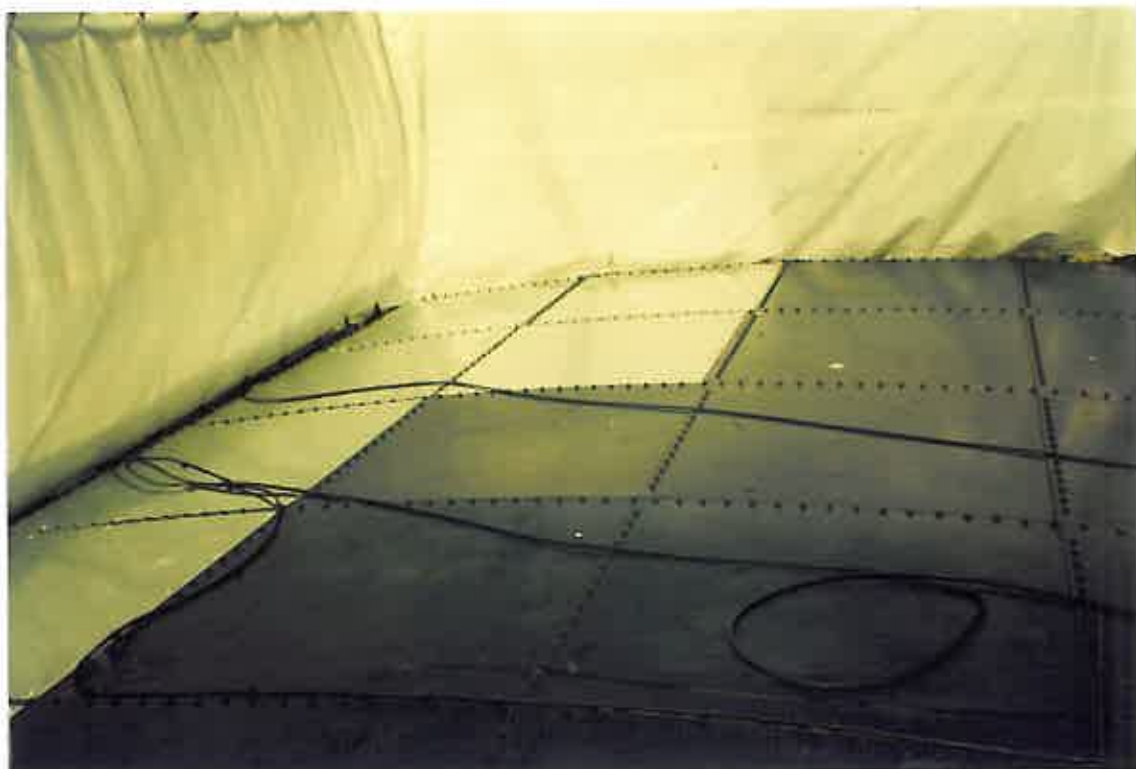
These photographs show the external of the roof of the tank having been repaired utilizing flat steel, galvanised plates.

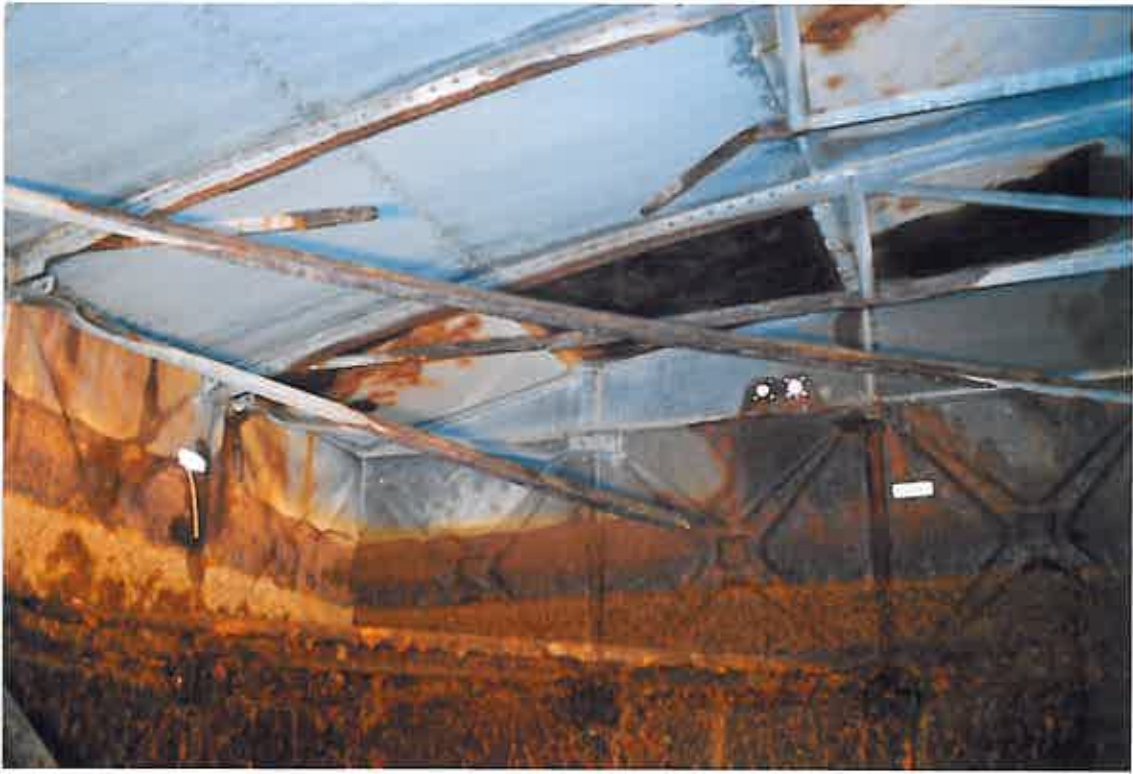
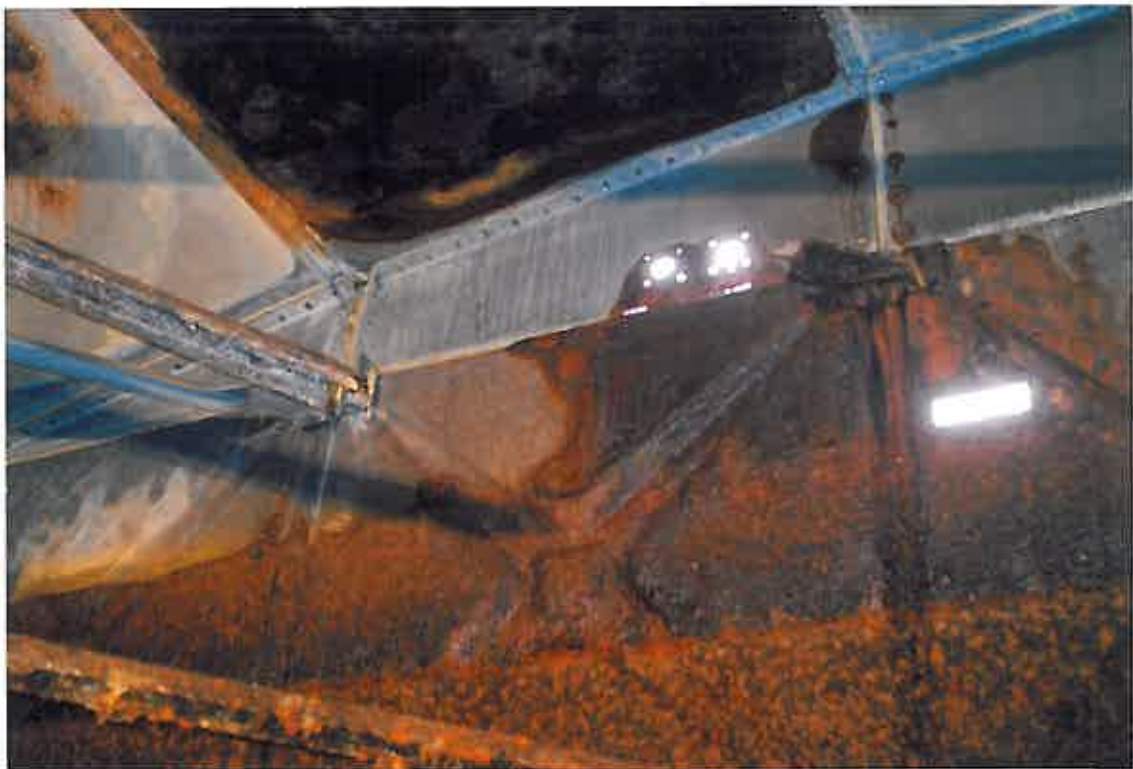
These photographs show the extent of damage caused to at least eight of the steel, support struts of the tank. These struts were made good by welding approximately sized angle iron to damaged areas.

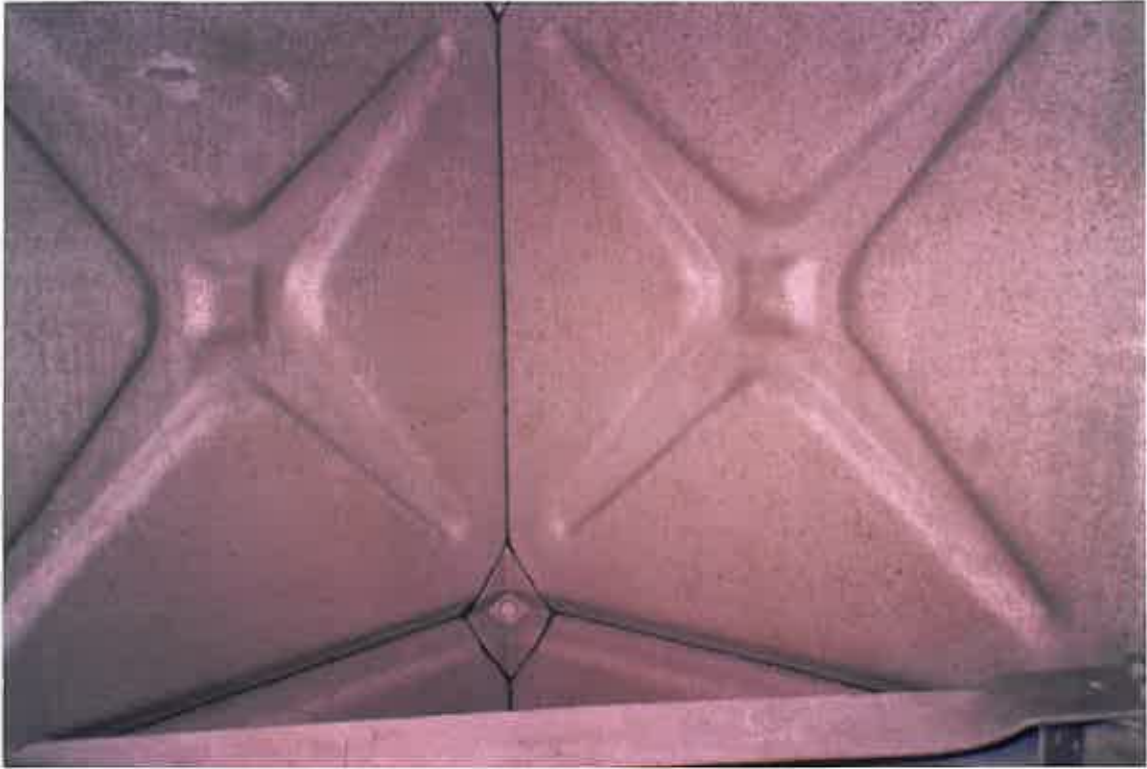
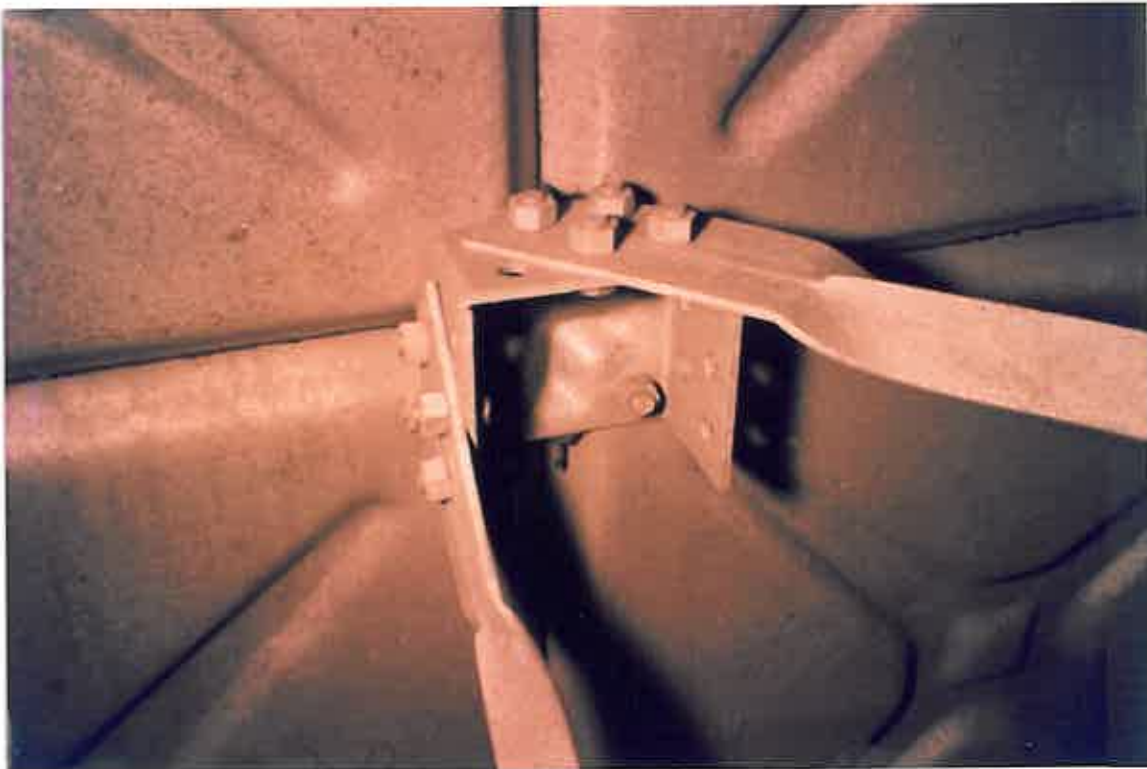
These photographs show the internal surfaces, having been prepared by means of dry abrasive grit blasting equipment.

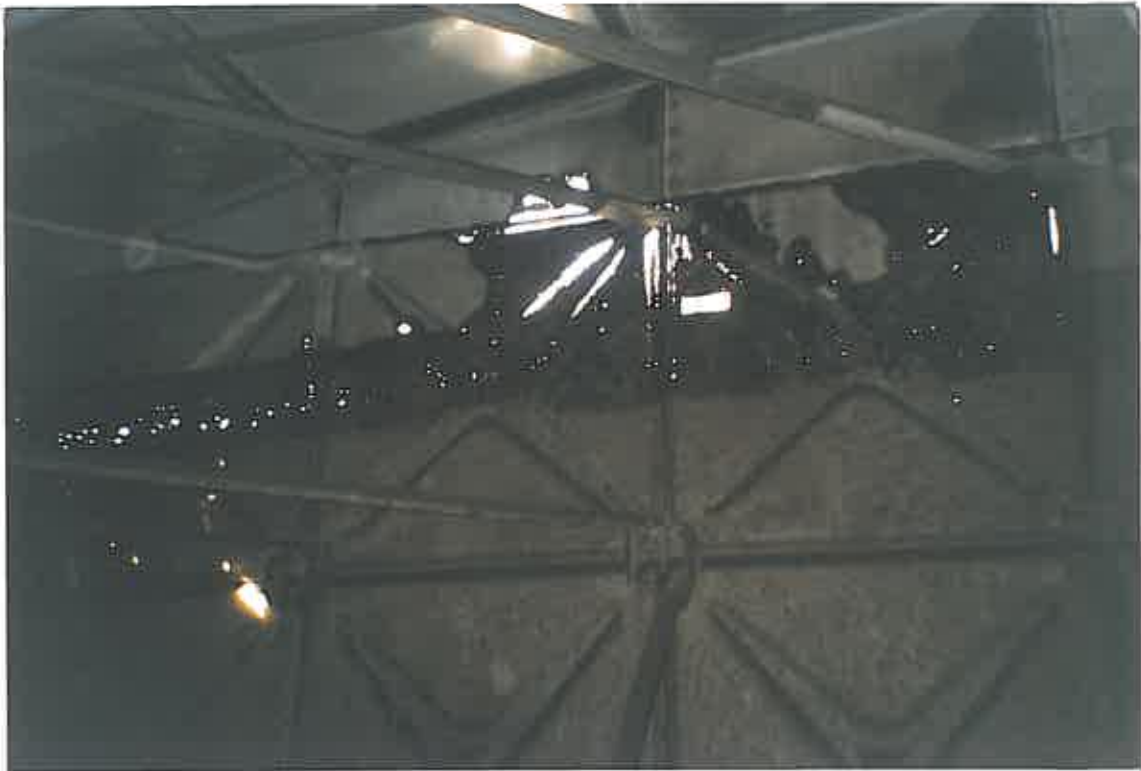
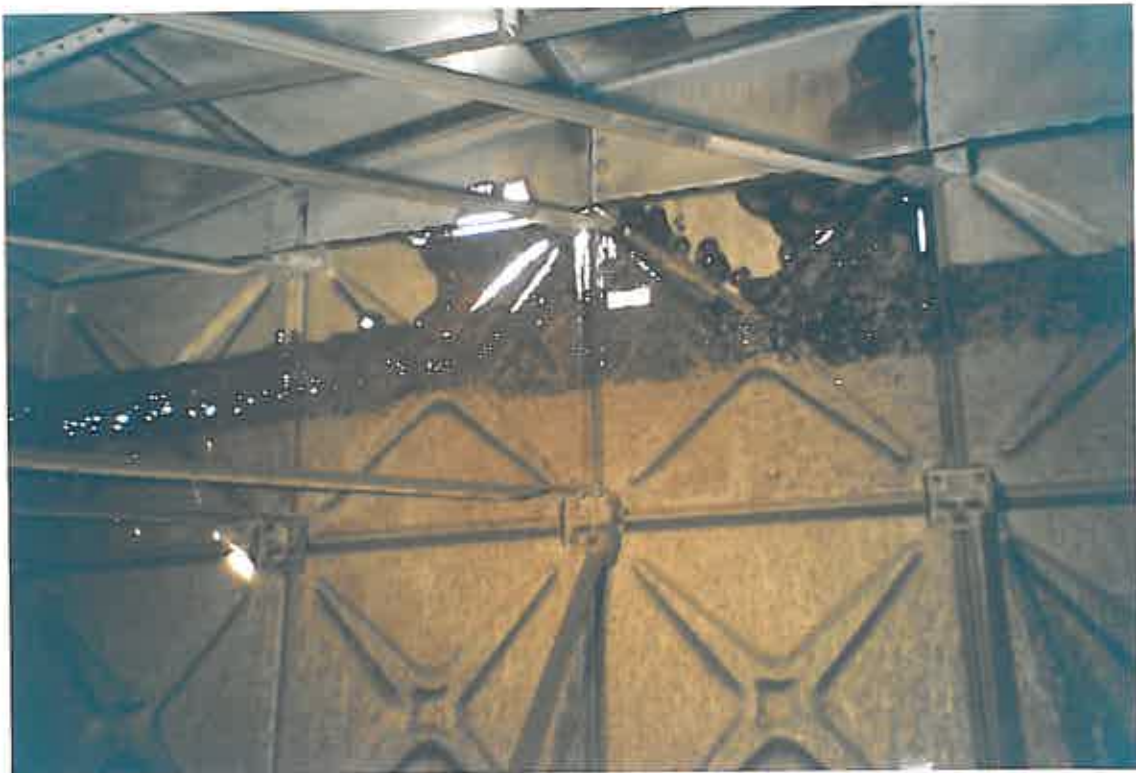
These photographs show the results of extreme corrosion post preparation around the oxygen exchange line of the tank. These areas were heavily pitted with corrosion and holes had formed in the steelwork. Most of these holes were small (approx. 1cm dia.) and were repaired utilizing metal epoxy filler. Some holes, however, were much larger and had to be repaired utilizing a combination of COPON Hycote 165 PW and fibreglass webbing.

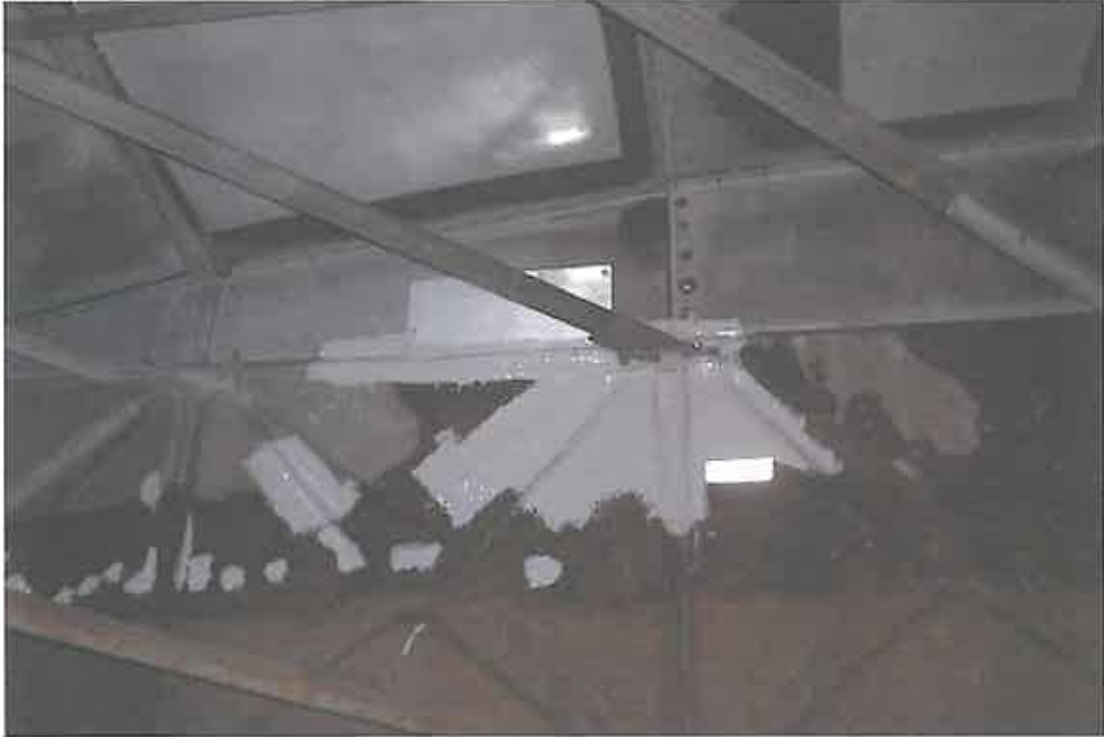
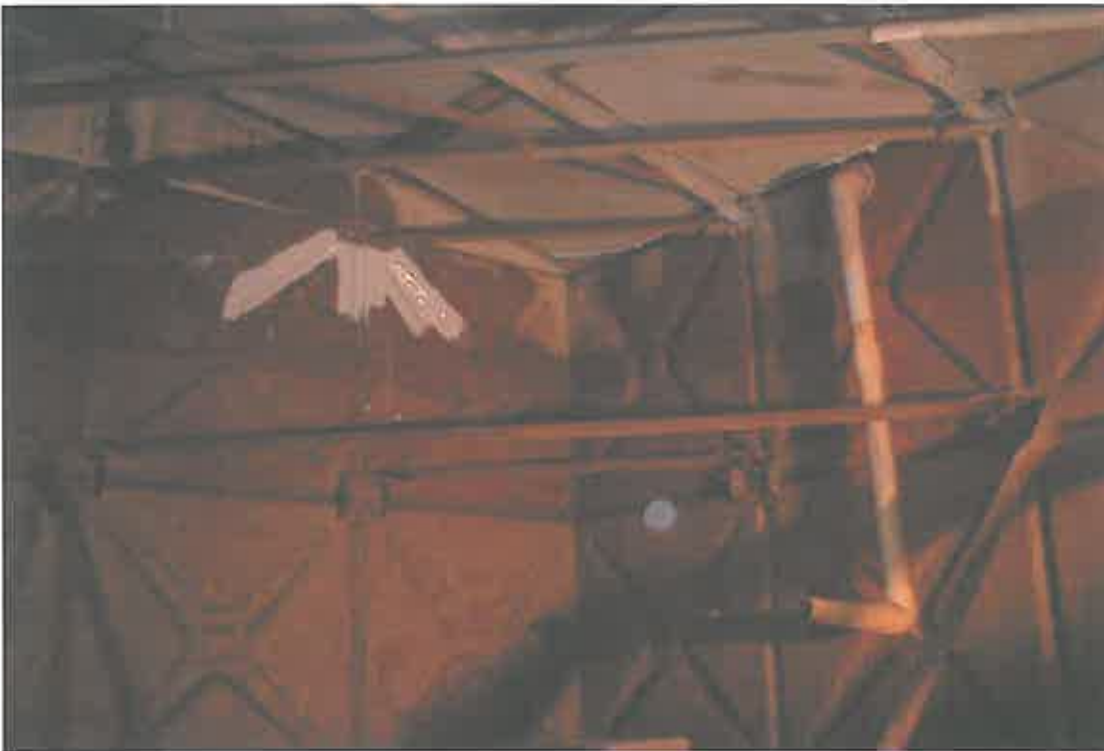
These photographs show the larger holes above the oxygen exchange line being repaired, utilizing a combination of COPON Hycote 165 PW and fibreglass webbing.

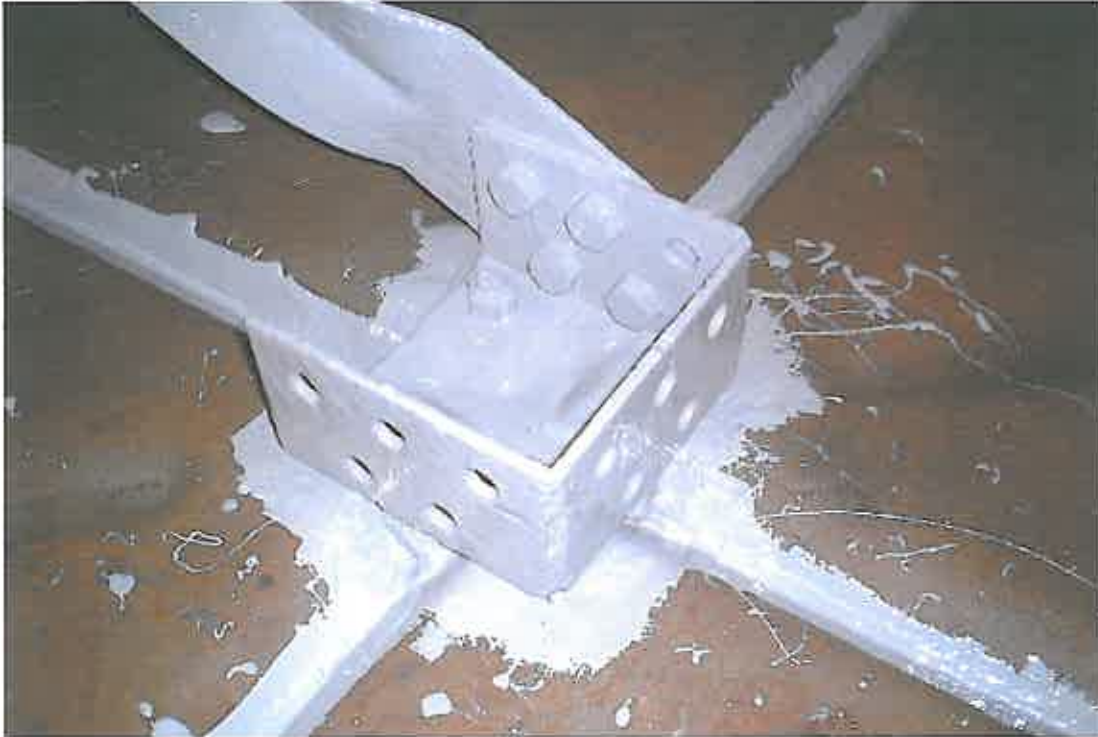
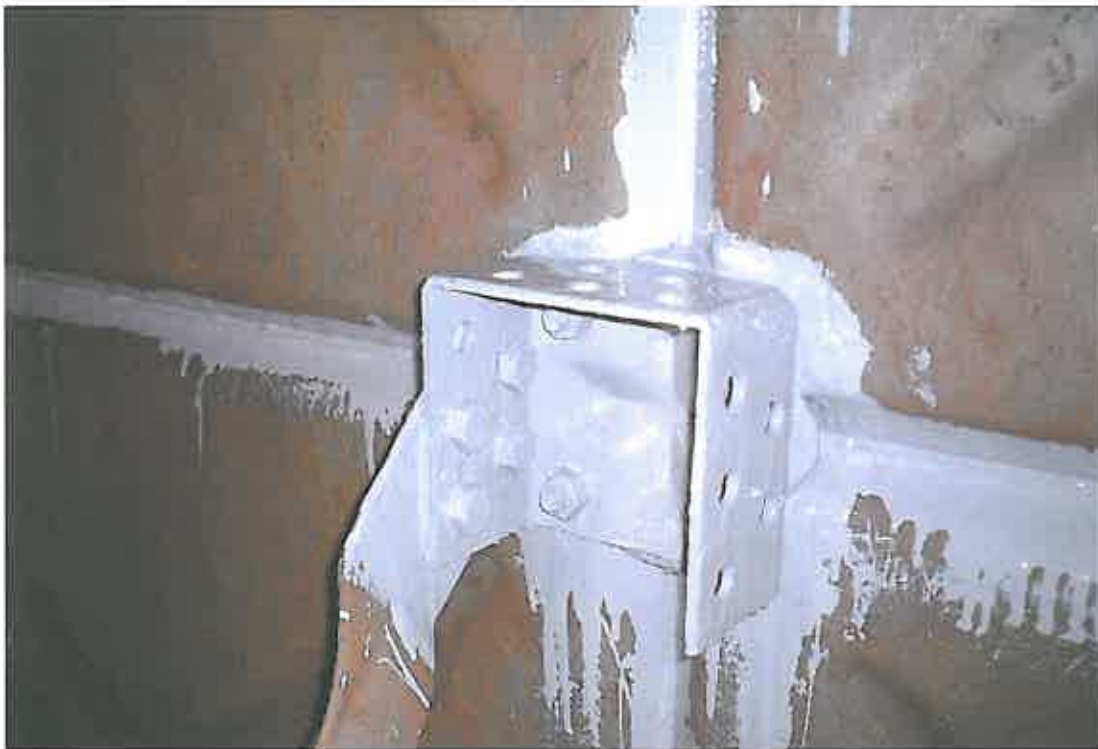
These photographs show the 'stripe coating' (by means of brush) of all welds, joints, edges, bolt heads and other sharp protuberances in order to maintain the specified film thickness to these areas.

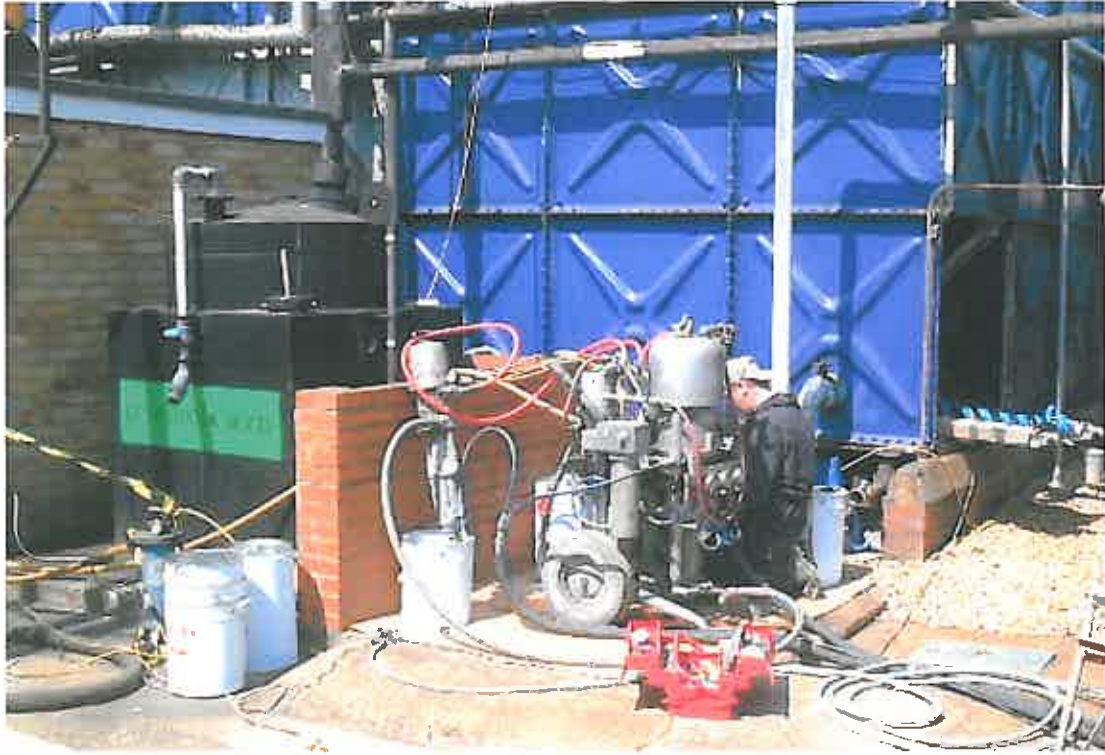
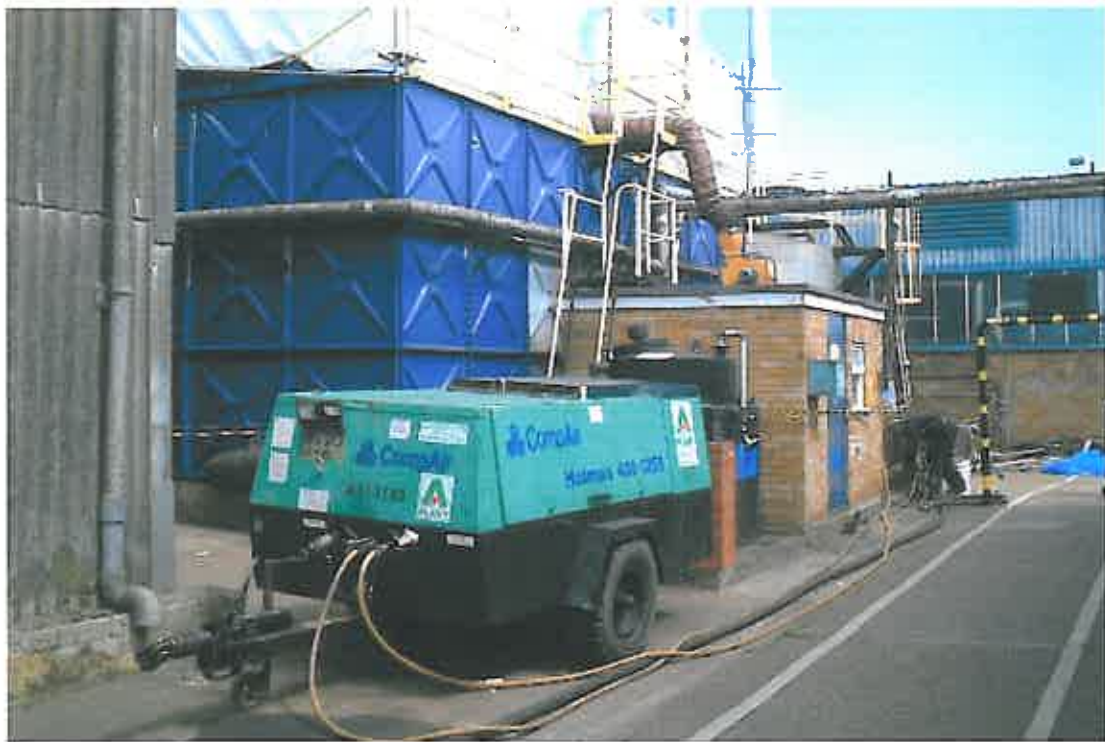
These photographs show the Plural Component, Spraying Equipment, located near to the access point of the tank.

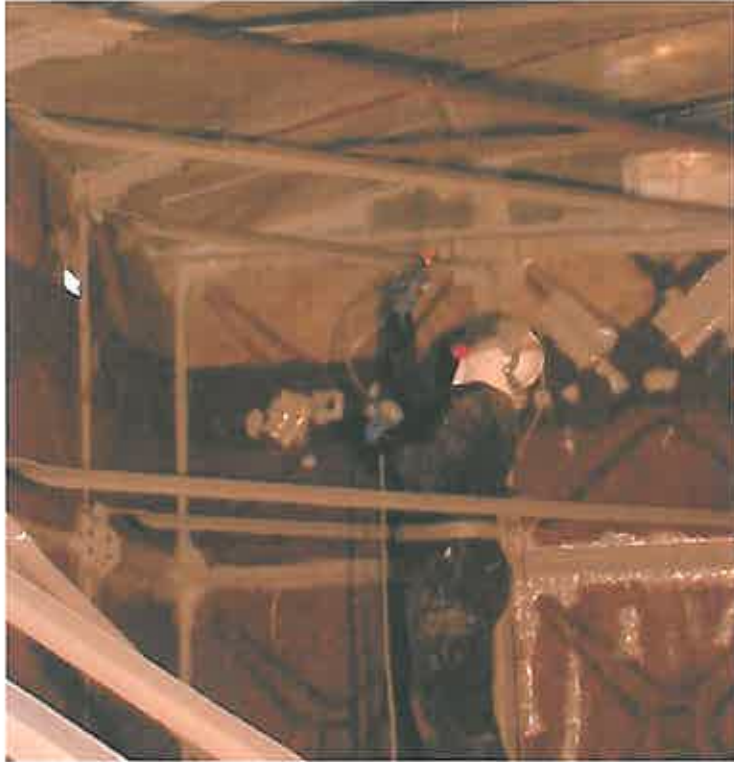
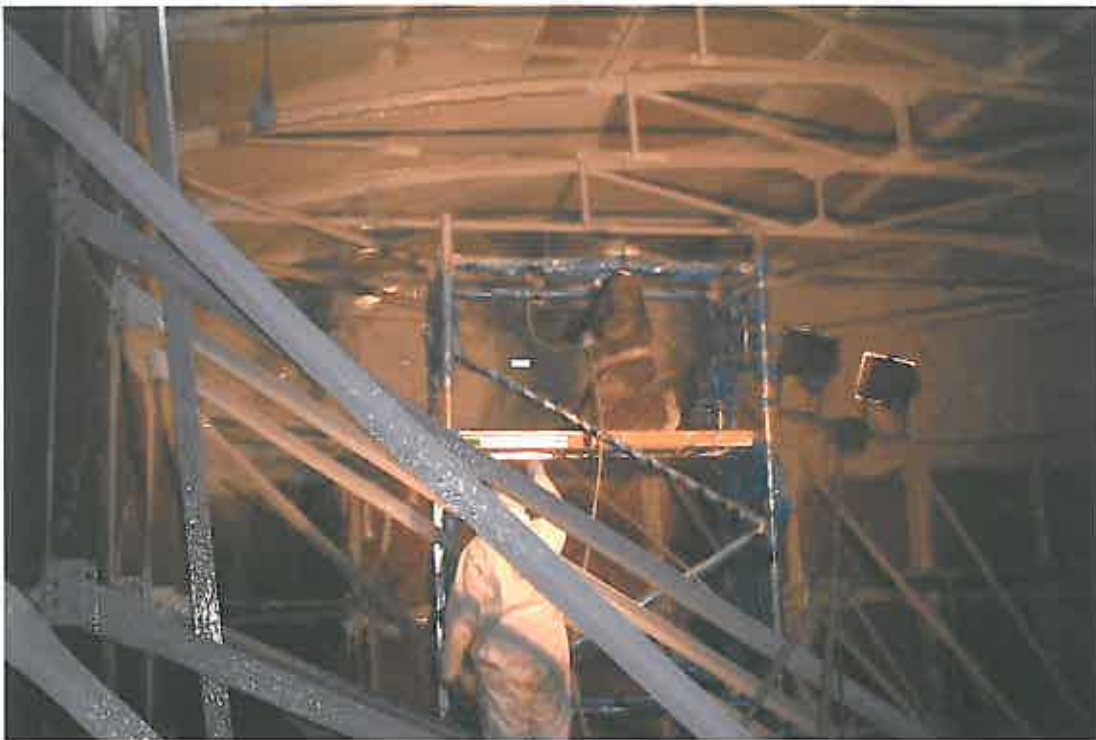
These photographs show COPON Hycote 165 PW Solvent Free Polyurethane being spray applied by means of Plural Component, Hot Applied Spraying Equipment.

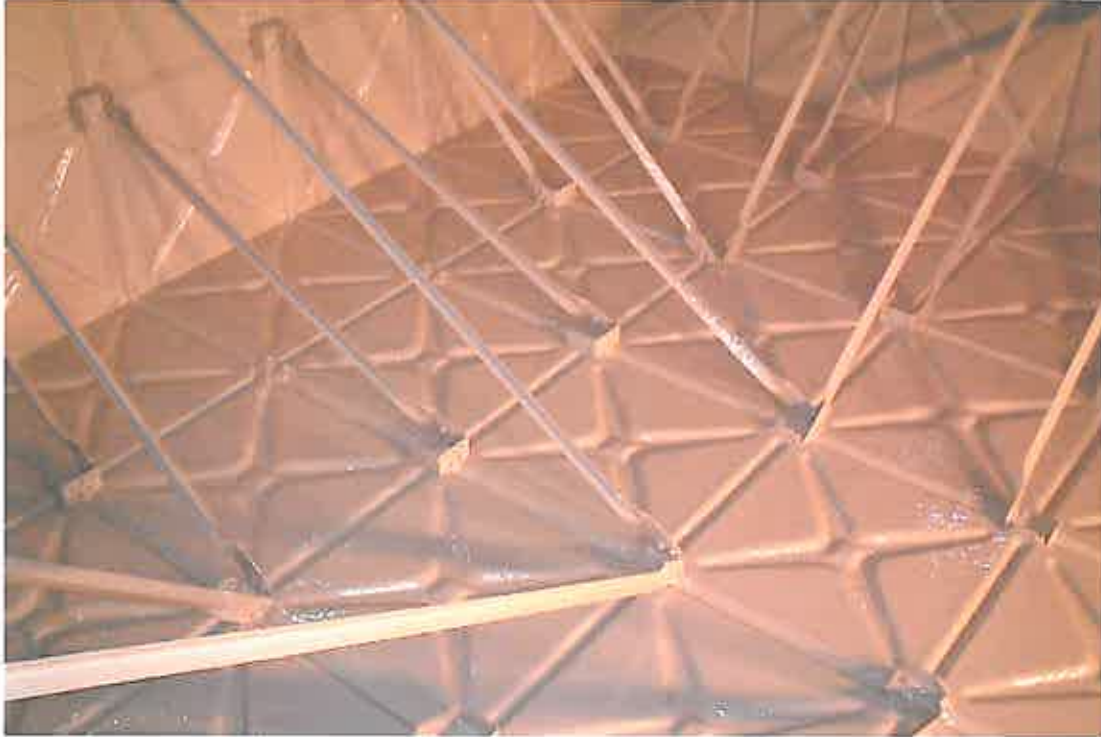
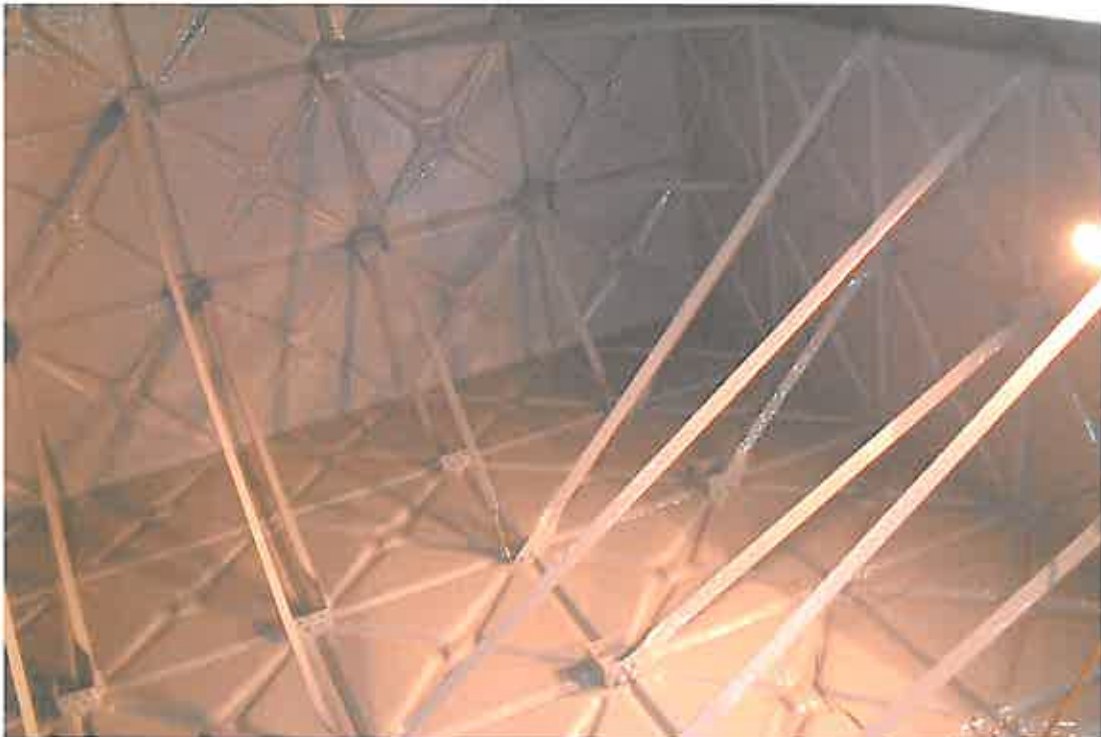
These photographs show the tank completely re-lined with COPON Hycote 165 PW Solent Free Polyurethane.
