COVAC COMPLETION REPORT

| Project Details | - | The Internal Re-Lining of 1 No. Sectional Steel Braithwaite Water Retaining Structure |
| System Specification | - | COPON Hycote 165PW Solvent Free Polyurethane |
| Completion Date | - | 27th May 2004 |

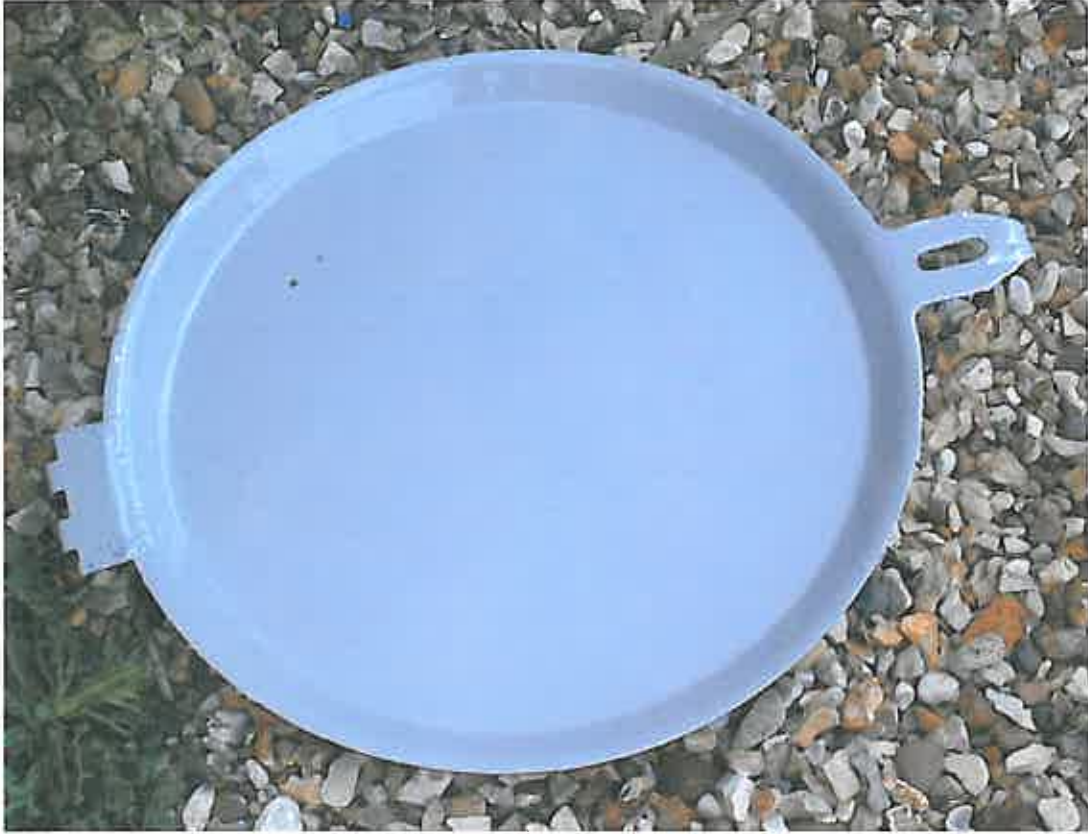
This photograph shows the original, steel roof access hatch having been internally prepared and re-lined with COPON Hycote prior to being re-fitted.

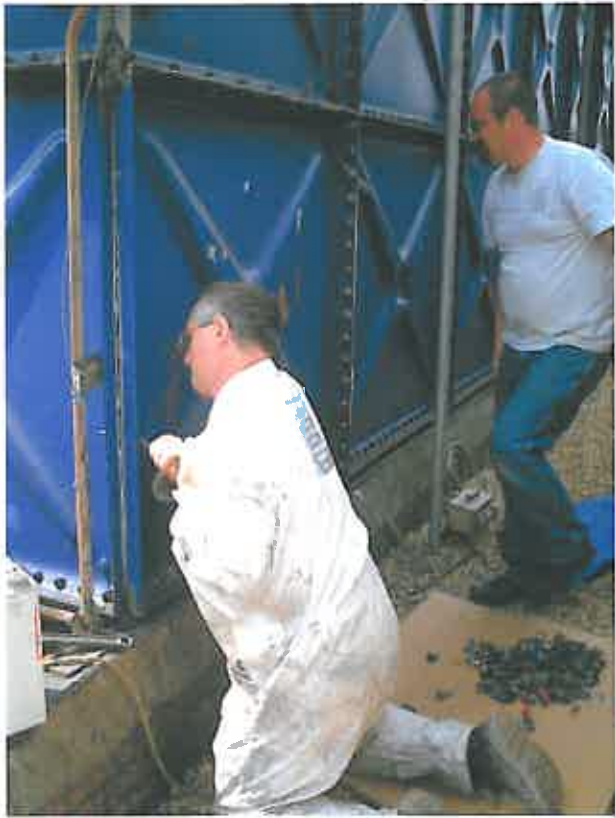
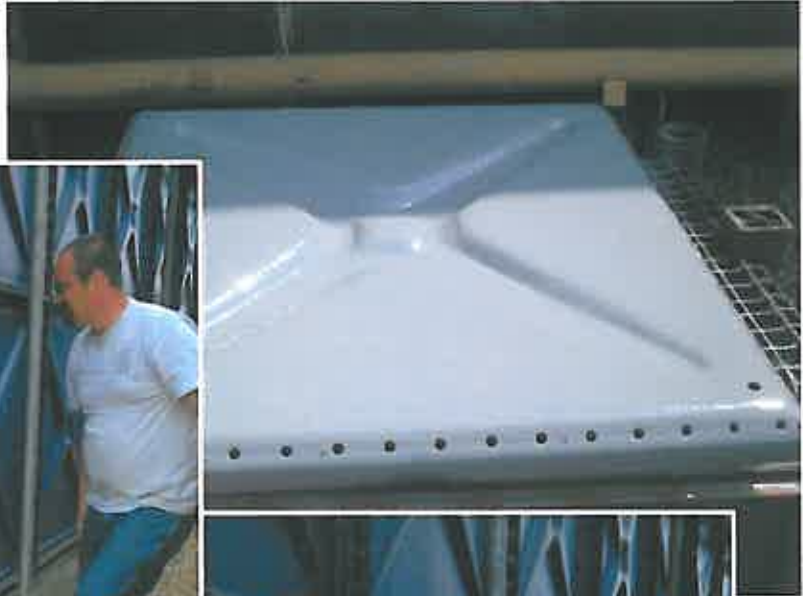
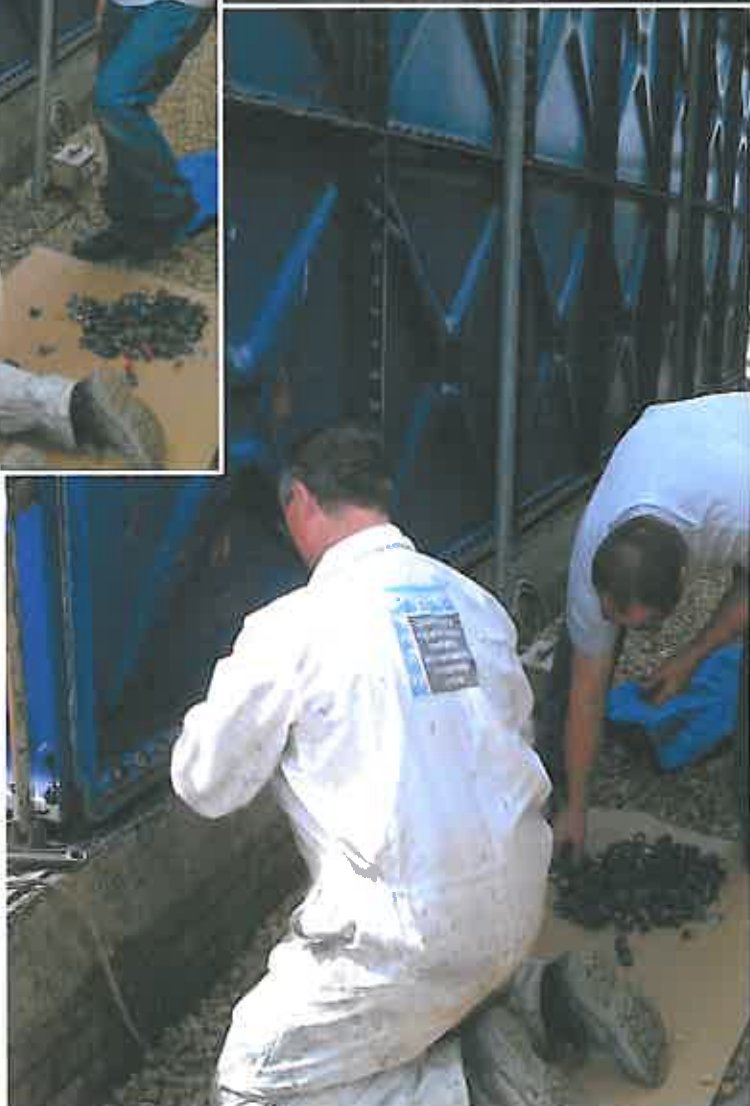
These photographs show the bottom panel (having been prepared and re-lined) being replaced by our operatives.
