## COVAC COMPLETION REPORT

Client	-	<b>Soft Drink Manufacturer</b>
Address	-	<b>Scotland</b>
Site Contact	-	<b>XXXXXXXXXXXXXX</b>
Project Brief	-	<b>The Internal Relining of 1 No. Steel, Water Retaining Structure - 2 No. Compartments</b>
System Specification	-	<b>COPON Hycote 165PW Solvent Free Polyurethane.</b>
Nominal Dry Film Thickness	-	<b>1000 Microns</b>
Completion Date	-	<b>21<sup>st</sup> January 2005</b>
Site Supervisor	-	<b>Tim Ray</b>
Report Prepared by	-	<b>Adrian Emmett</b>
COVAC Contract Ref:	-	<b>376</b>

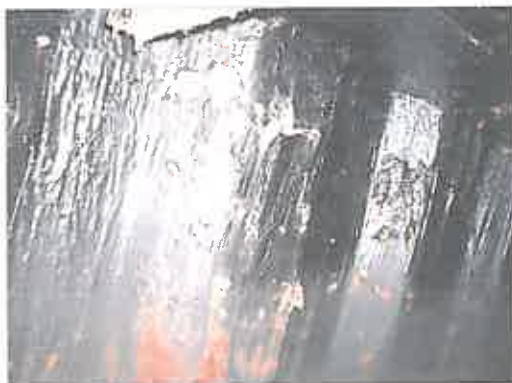
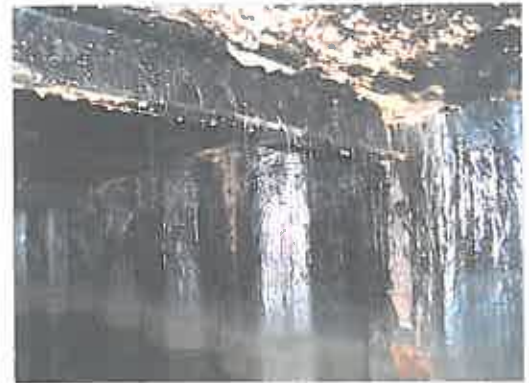
The internals of the structure have previously been painted with Bitumen, which has now approached the end of its useful life due to sub-film corrosion, deterioration and subsequent de-bonding.

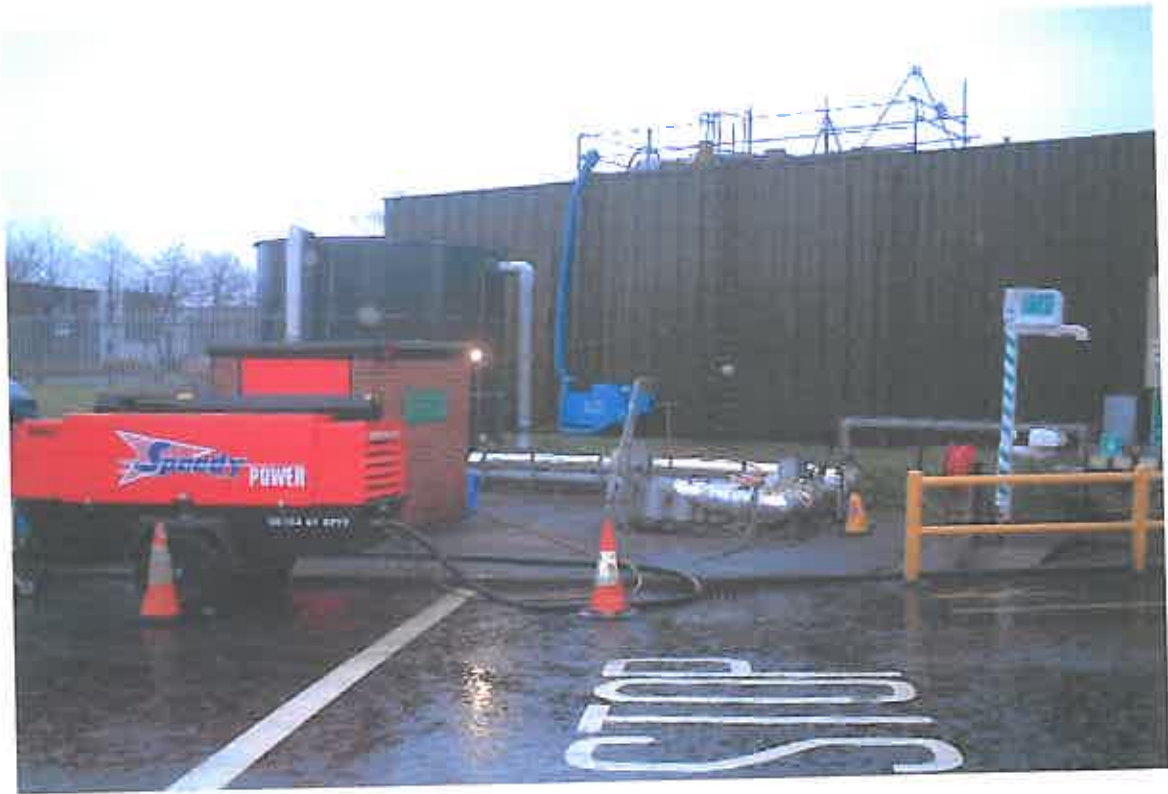
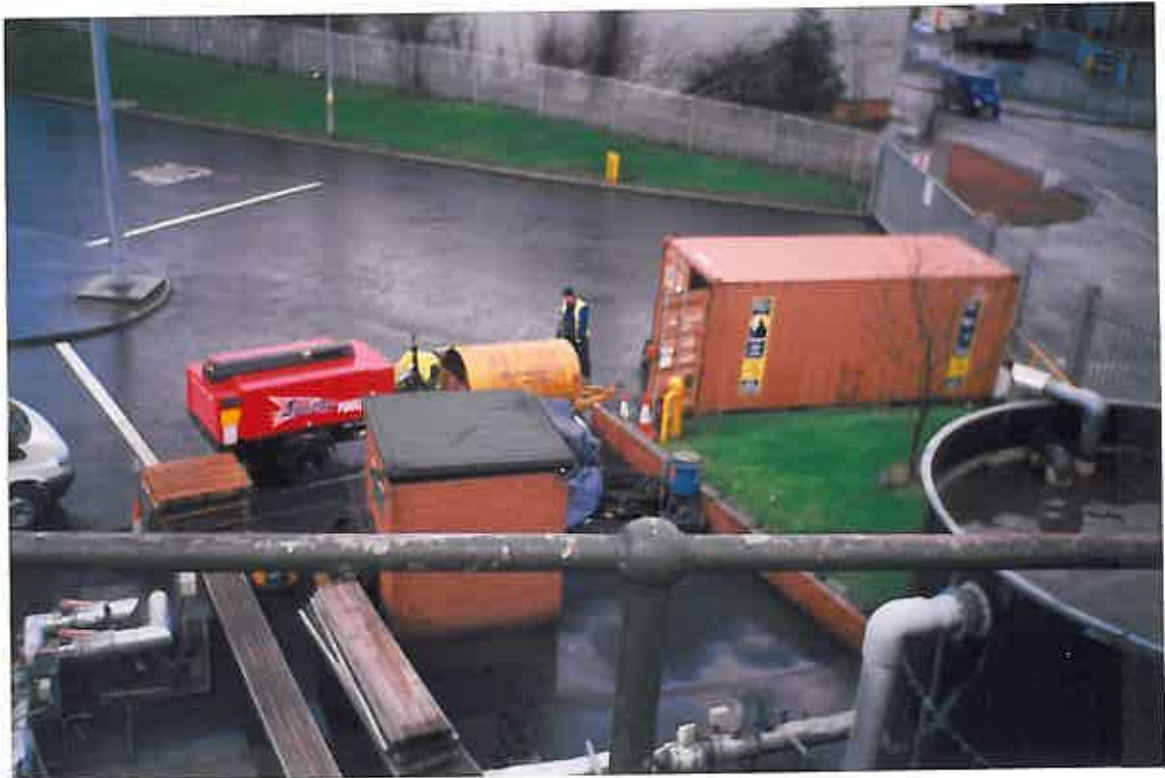
**These photographs show the external of the tank and our equipment and storage set up.**

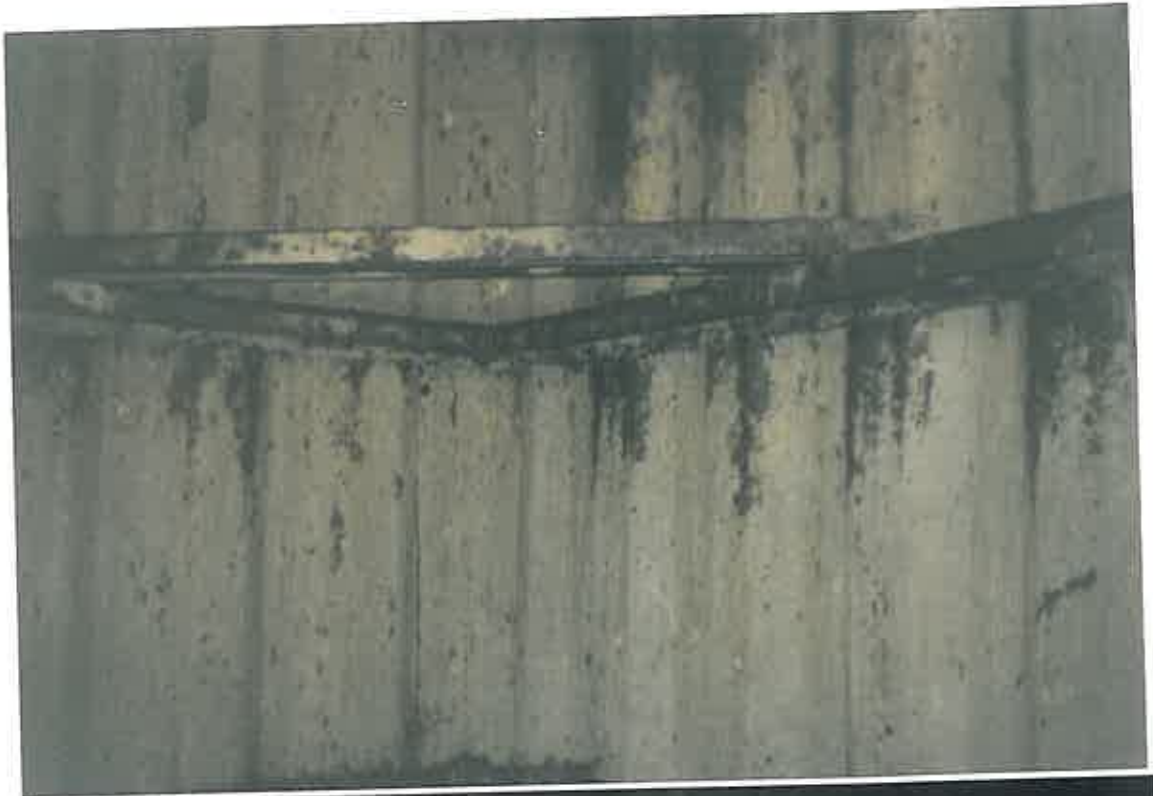
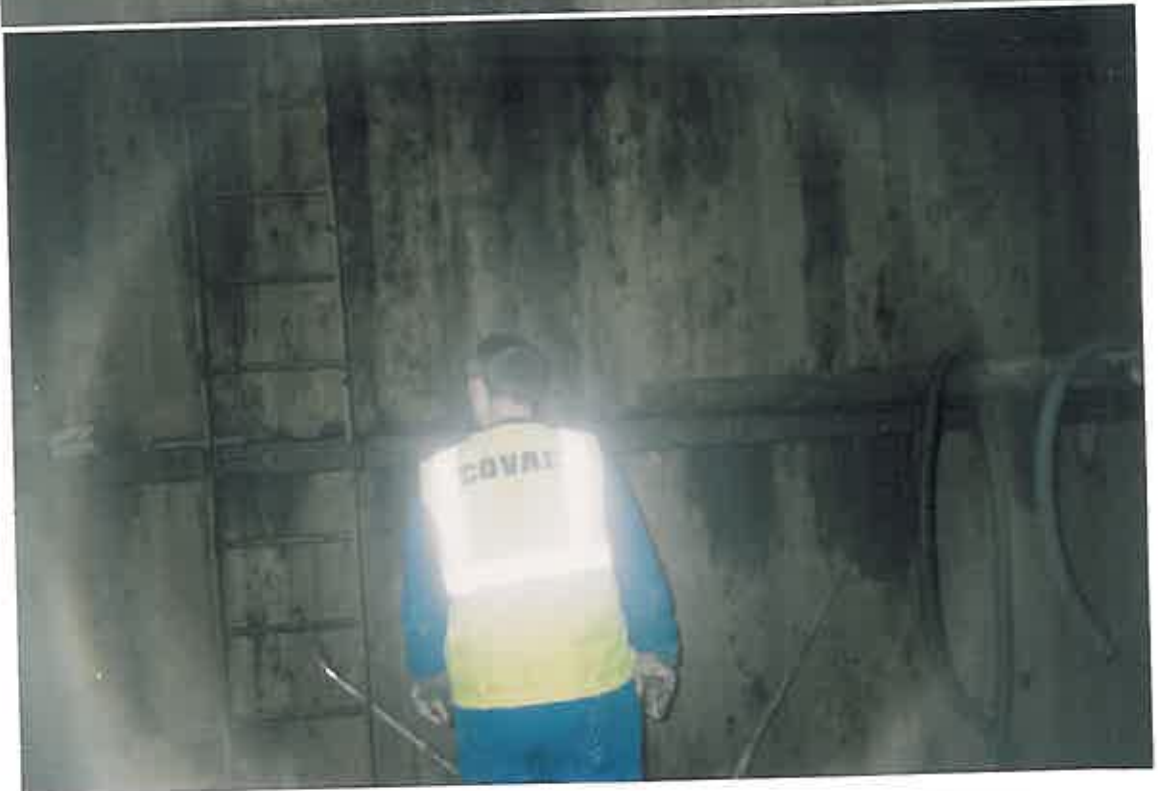
**These photographs show the internals of the tank having been drained of water and prior to any preparation works.**

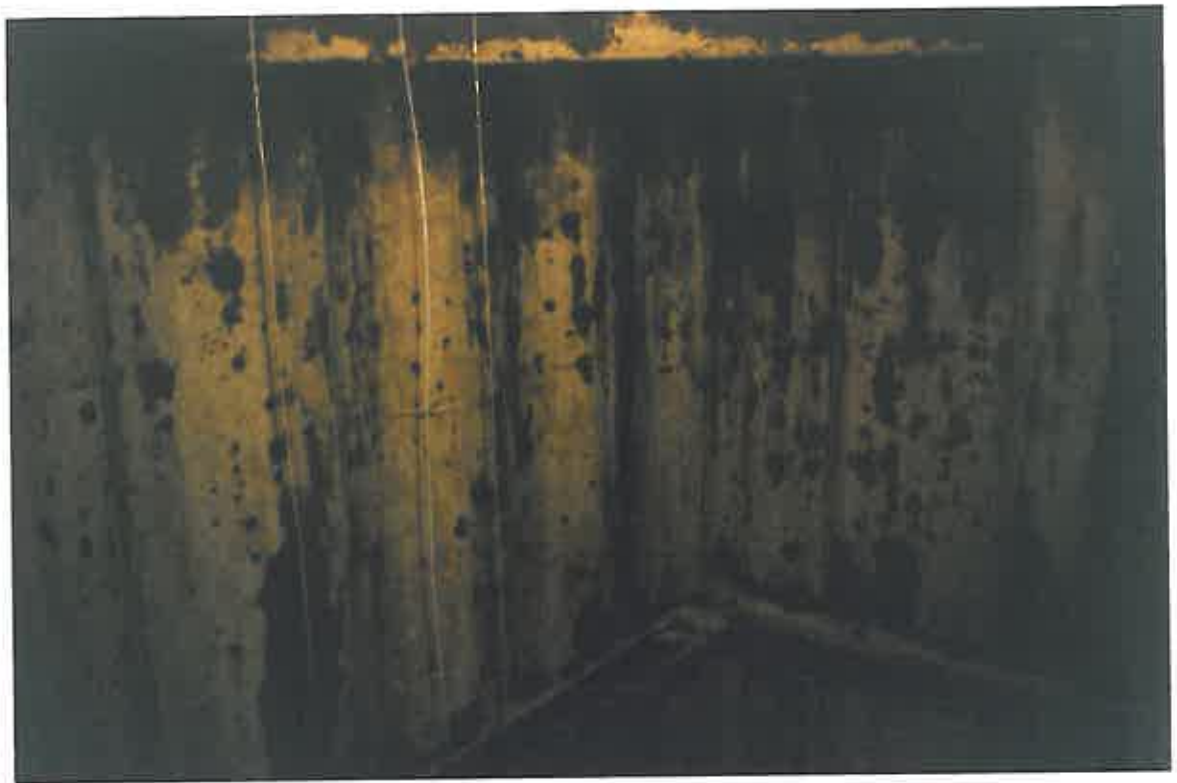
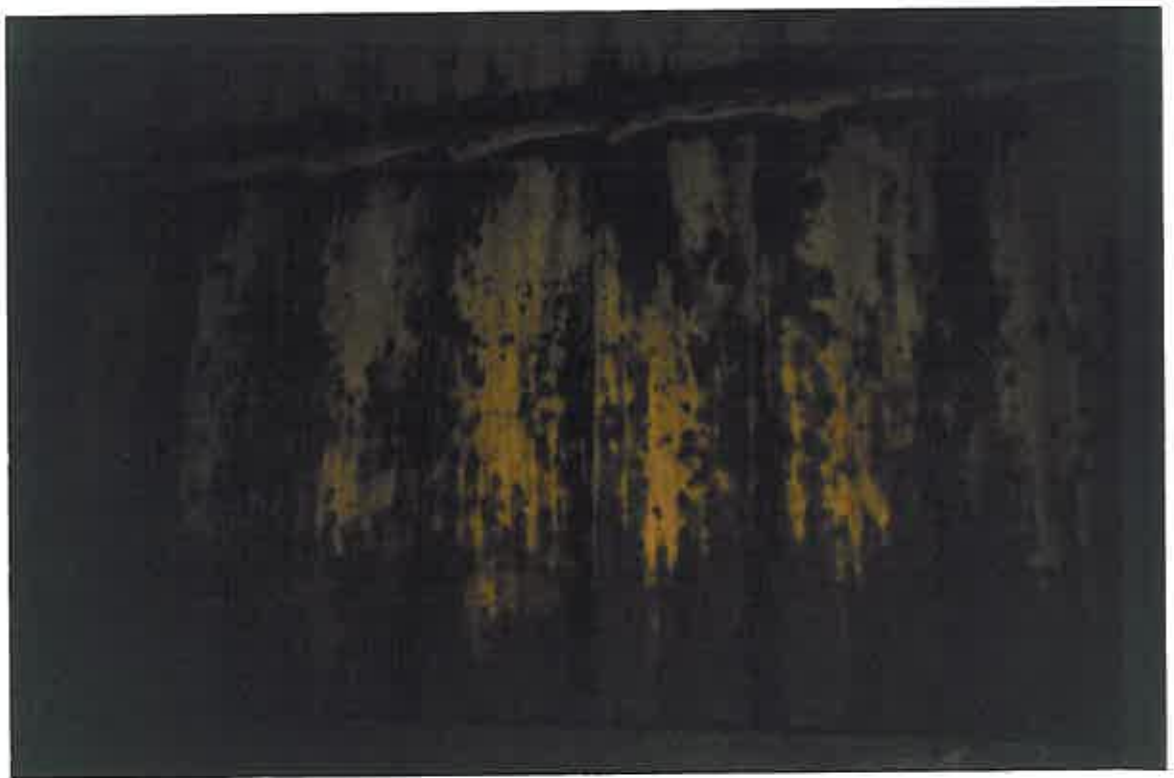
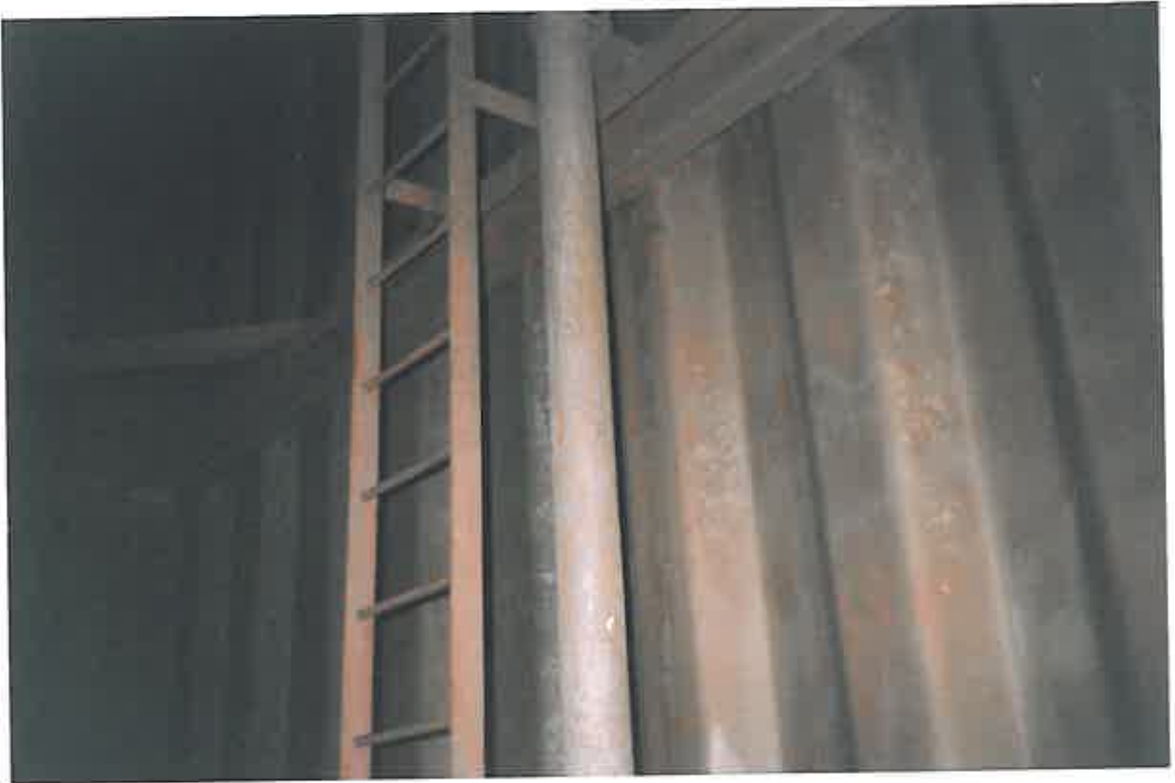
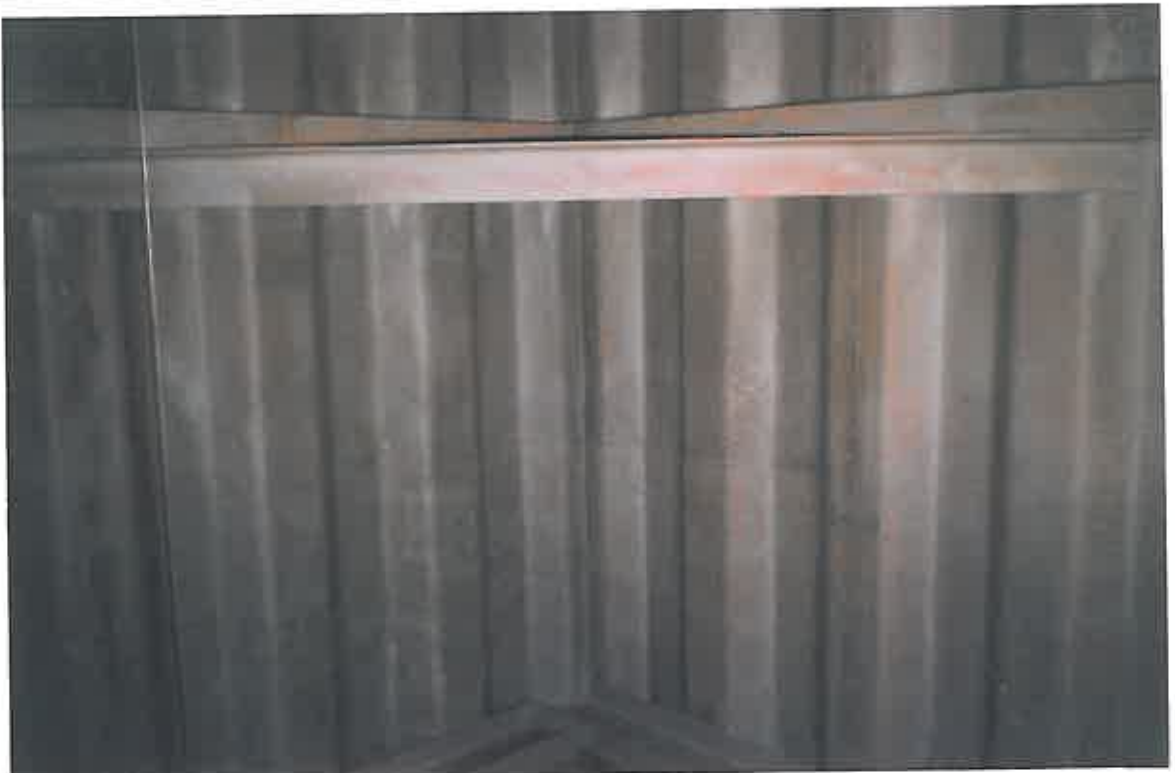
**These photographs show the internal surfaces of the tank having been prepared by means of dry abrasive blasting technique.**

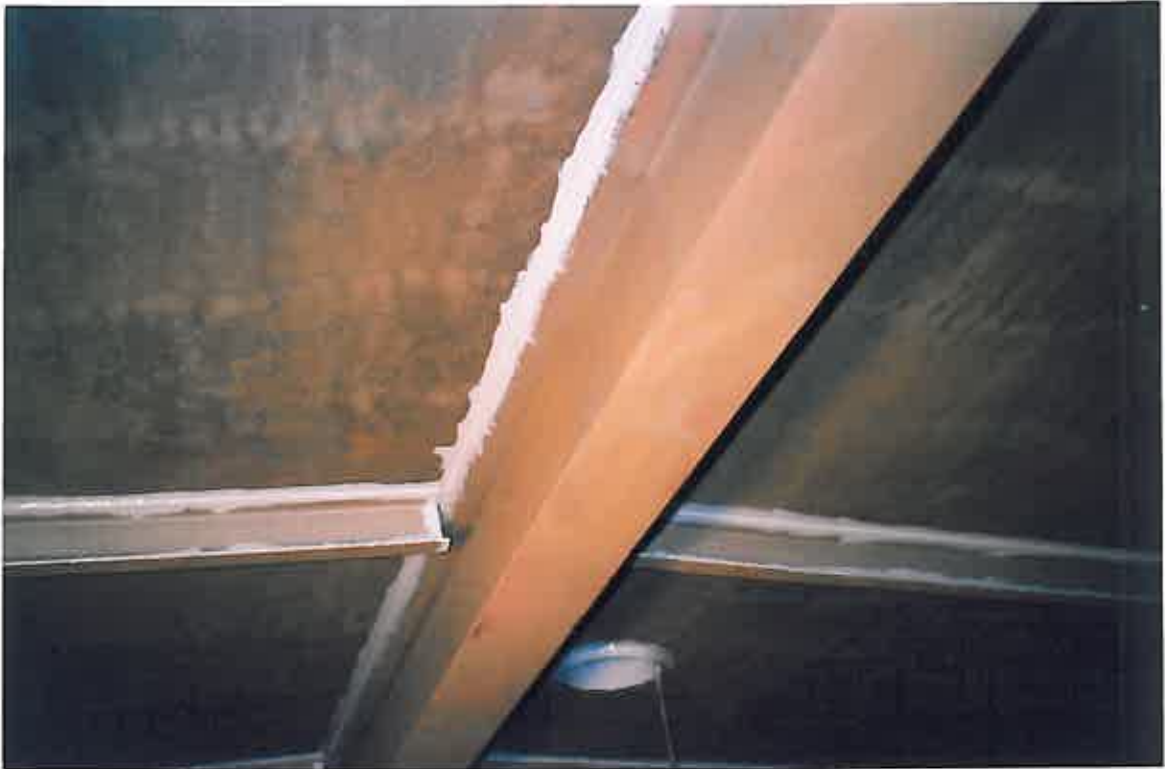
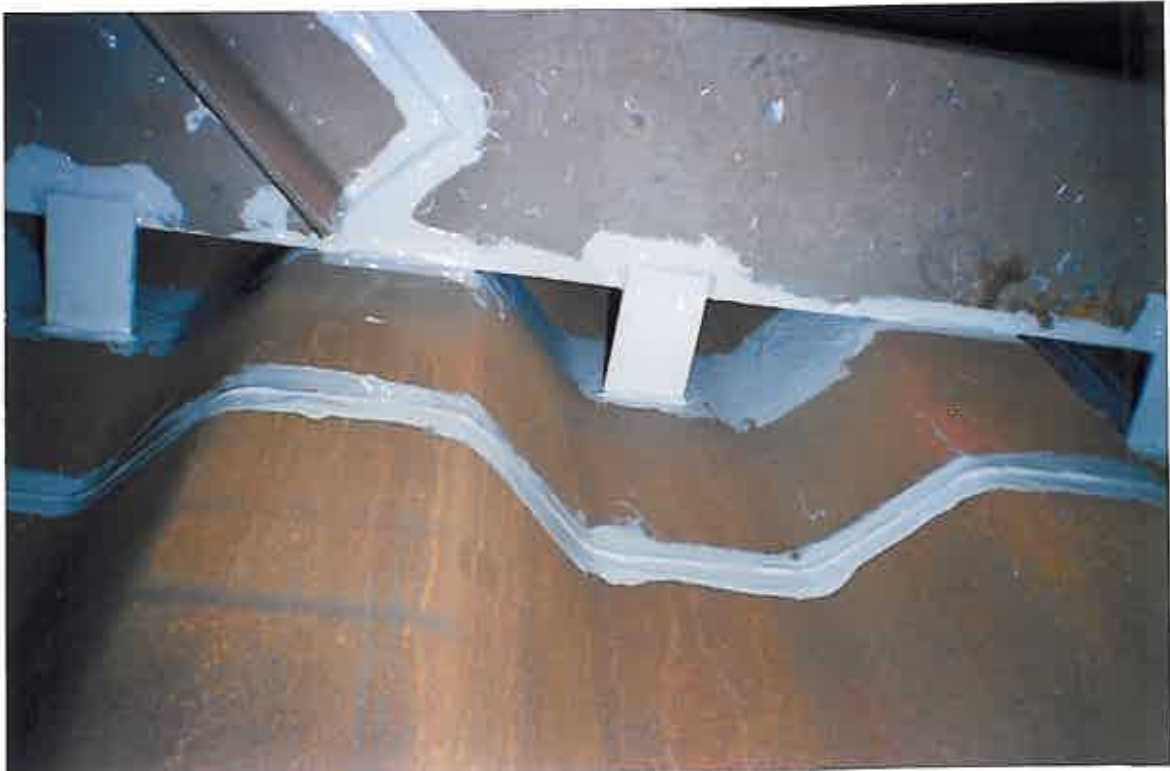
**These photographs show all weld joints, sharp edges, struts, etc having been 'stripe coated' by brush.**

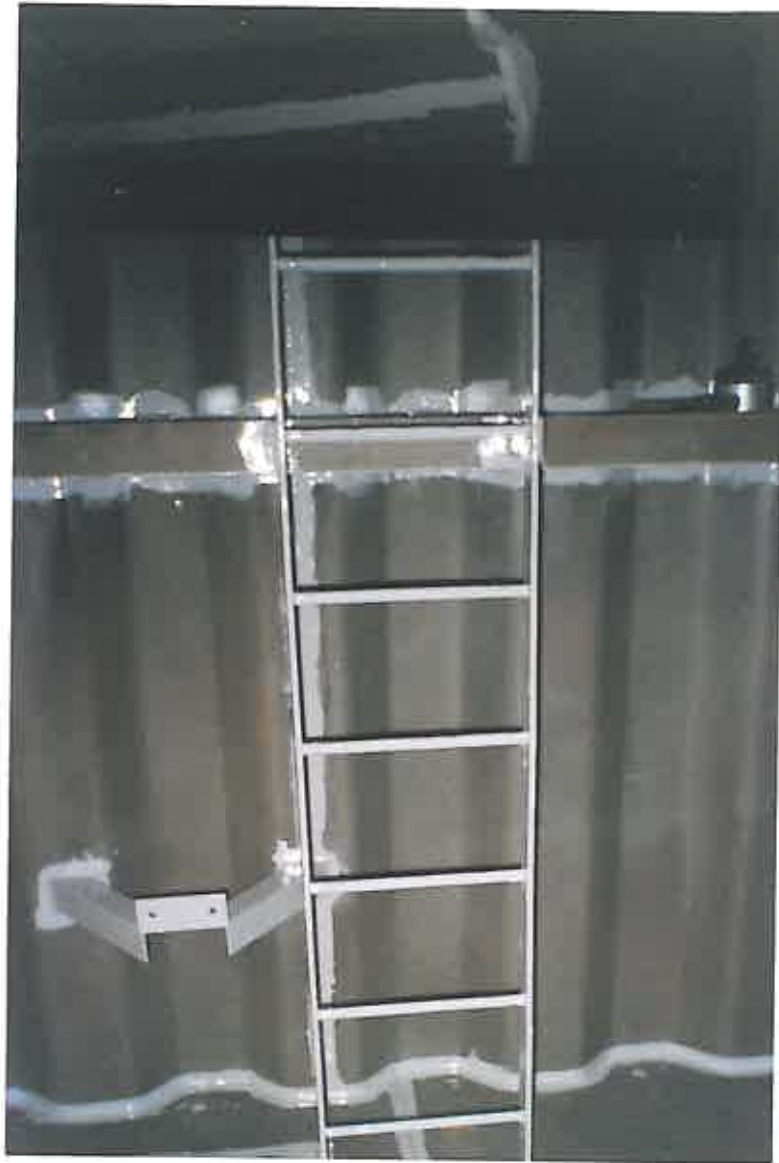
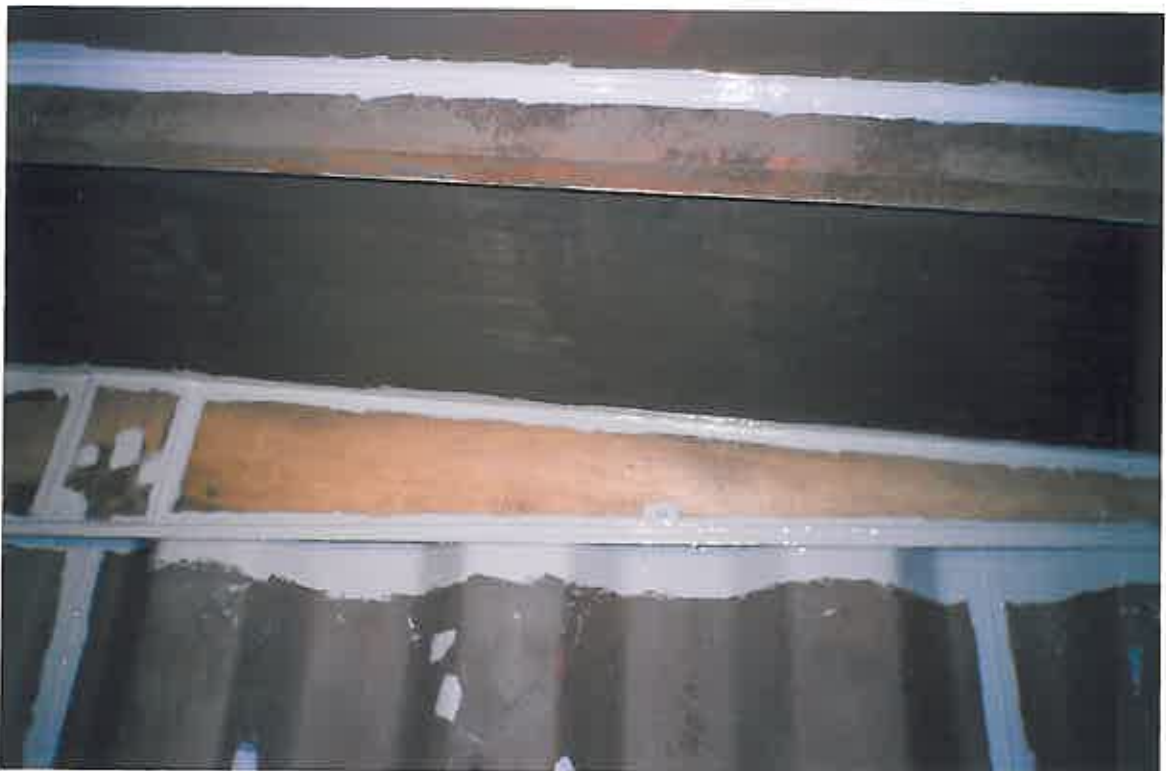
**The above photograph also shows the wooden boarding required in order to prevent cross contamination of the two tank compartments whilst the preparation and re-lining was taking place.**

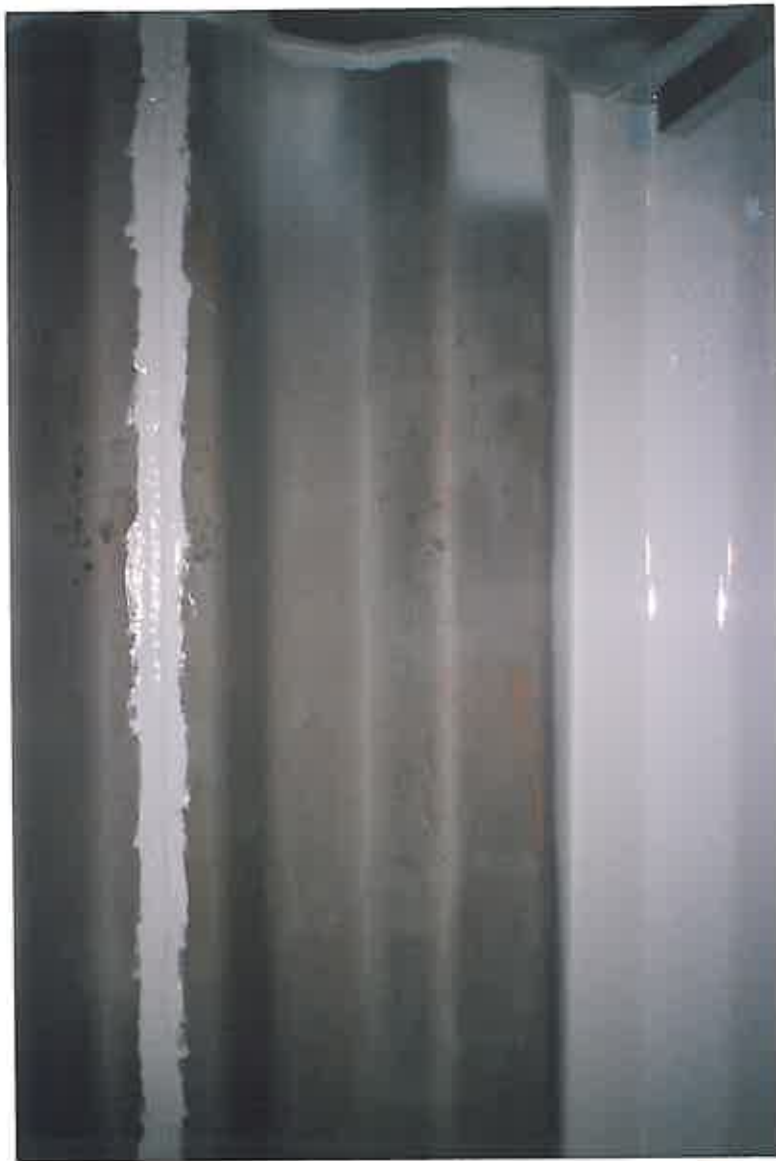
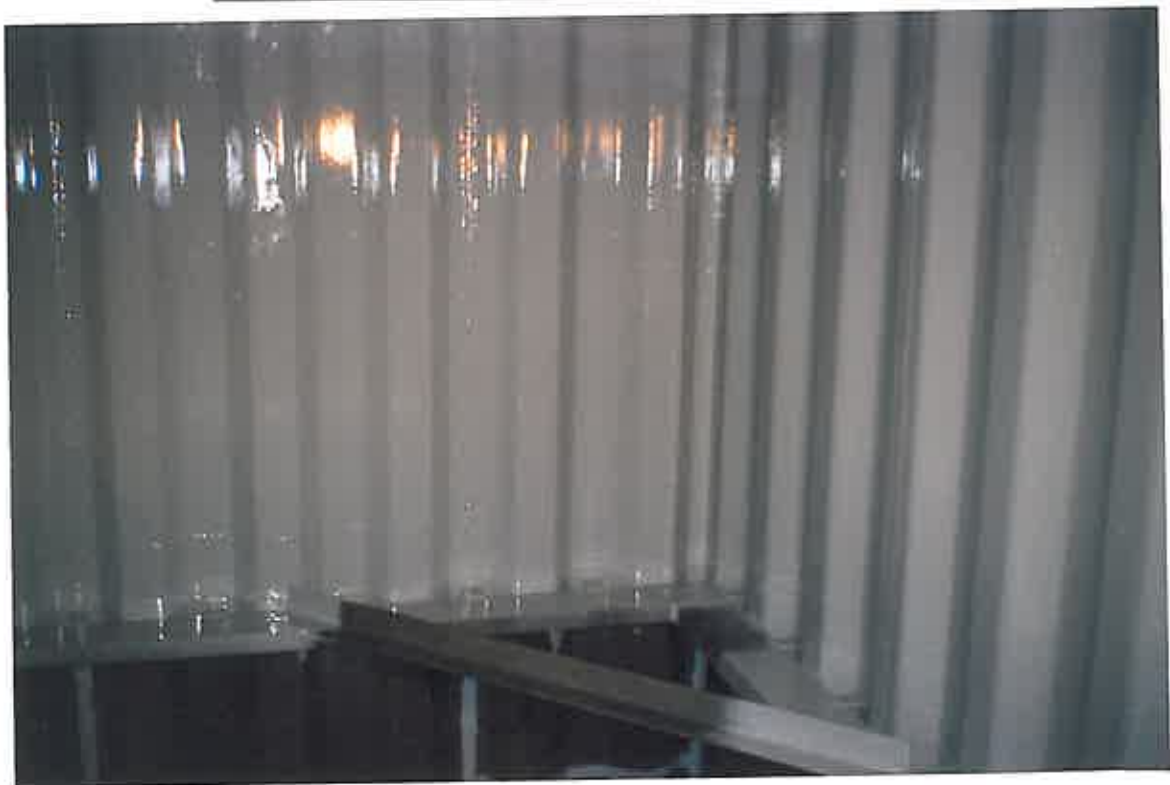
**These photographs show the 'stripe coating' being overcoated with one full coat of 165 PW being applied through twin component, hot applied specialist spray equipment.**

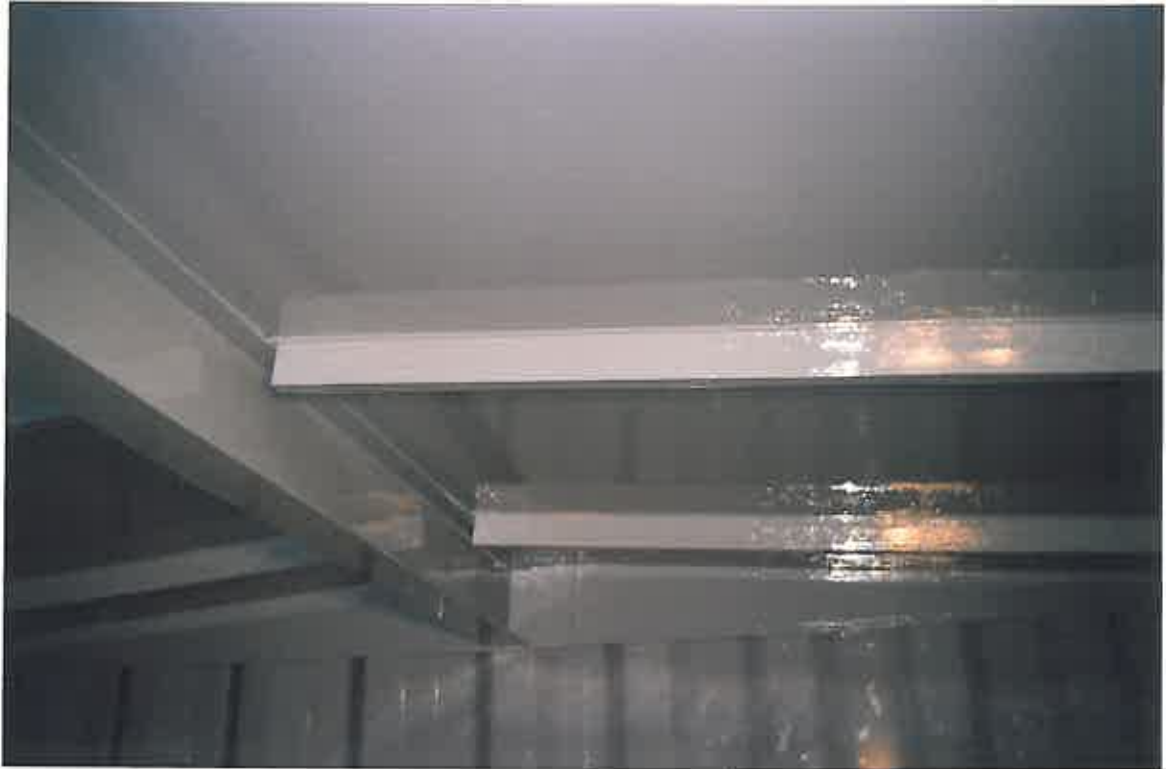
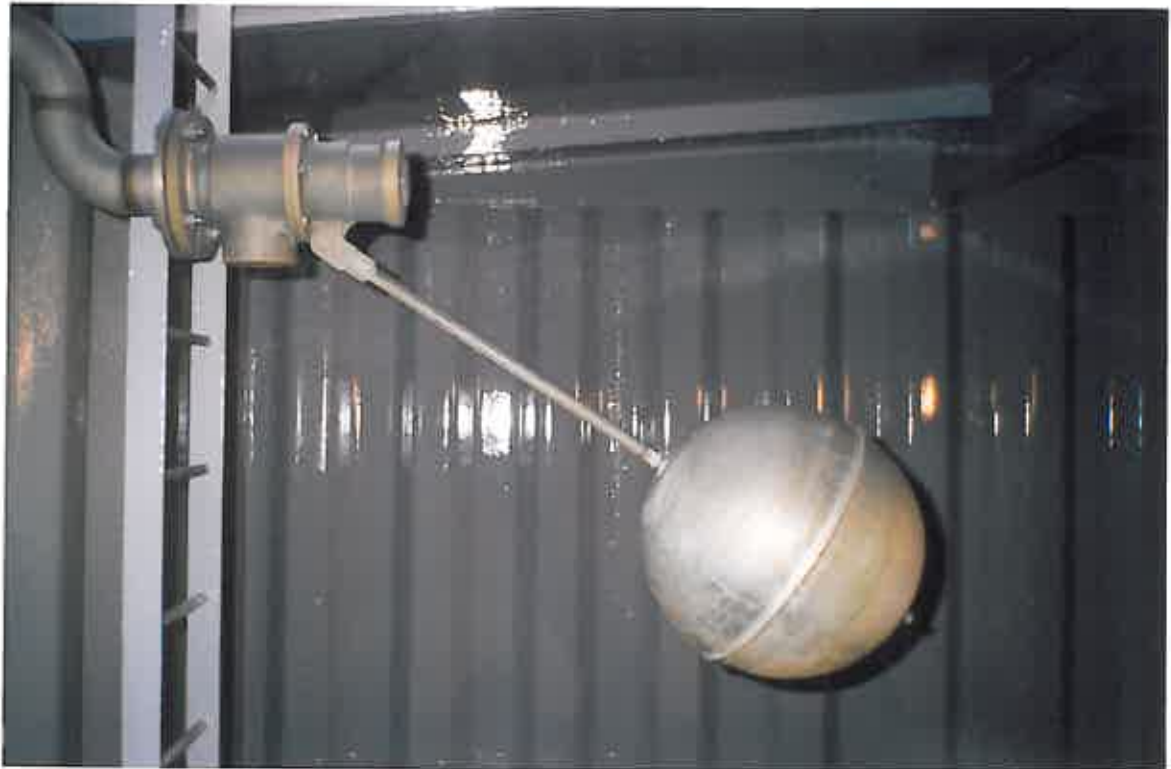
**These photographs show the internal surfaces of the tank having been completely re-lined with COPON Hycote 165 PW Solvent Free Polyurethane utilizing, twin component, hot applied, specialist spray equipment.**

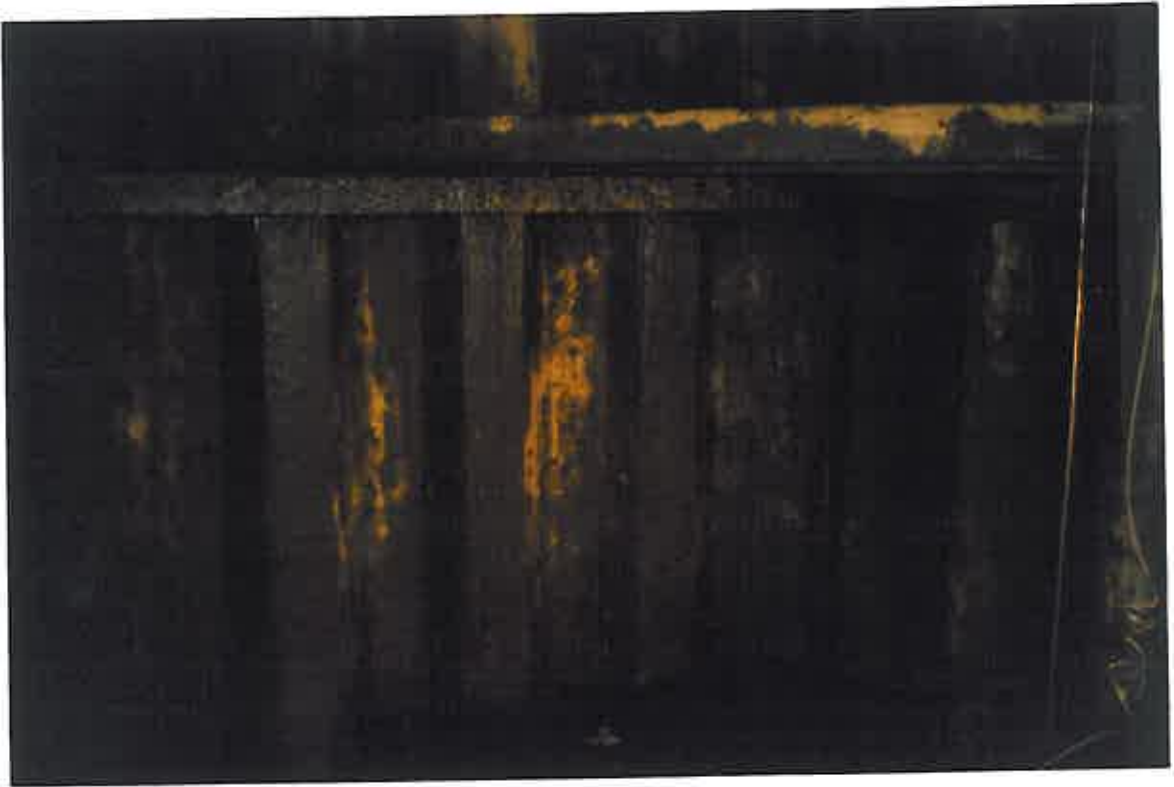
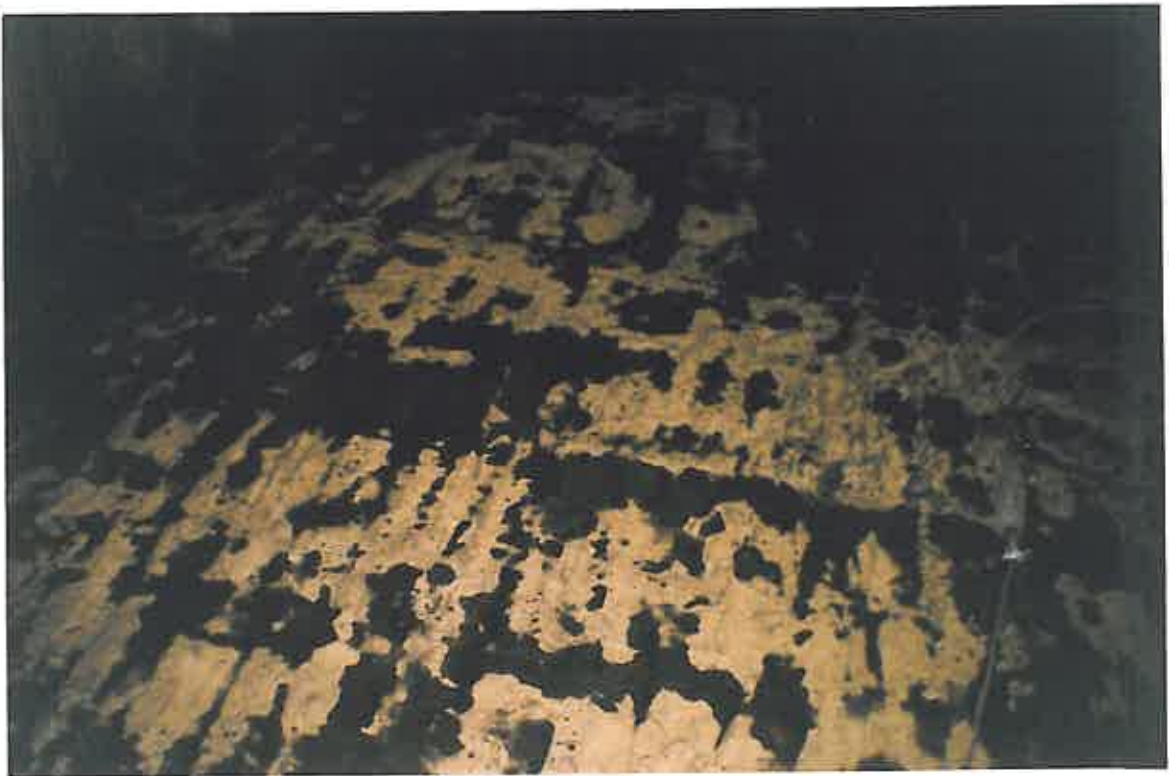
**These photographs show the internals of the tank having been drained of water and prior to any preparation works.**

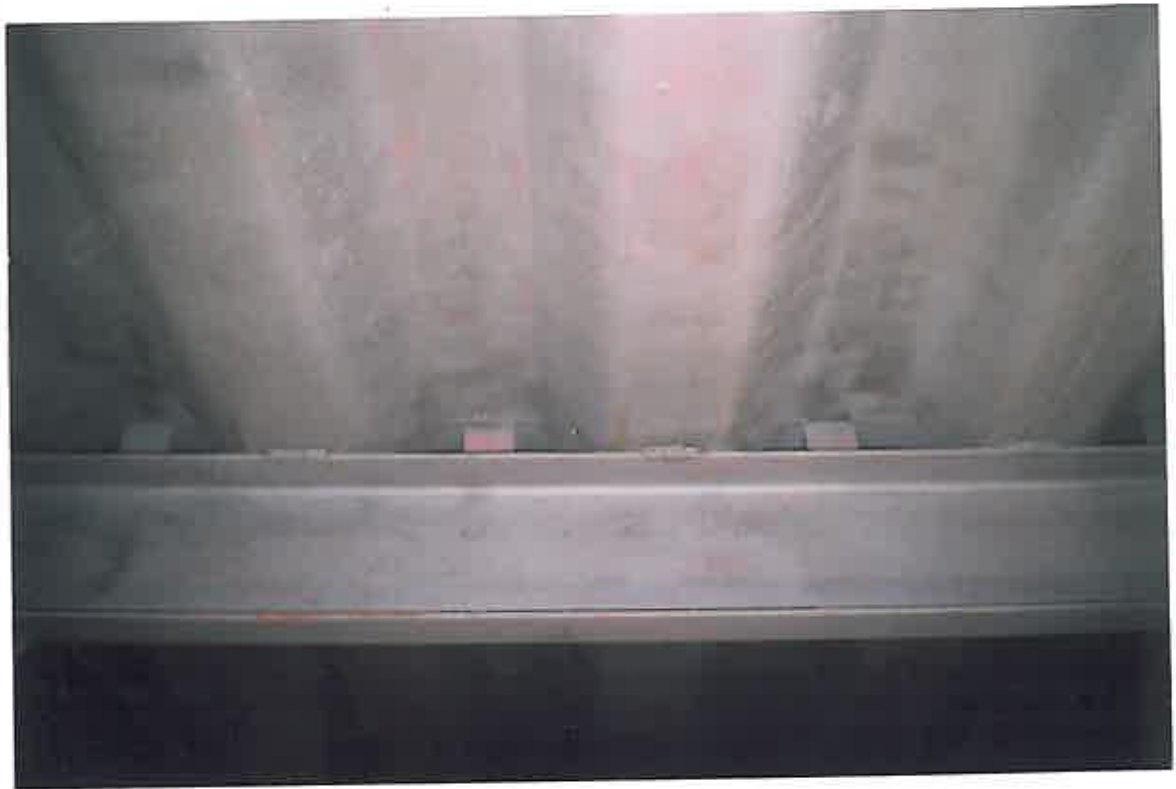
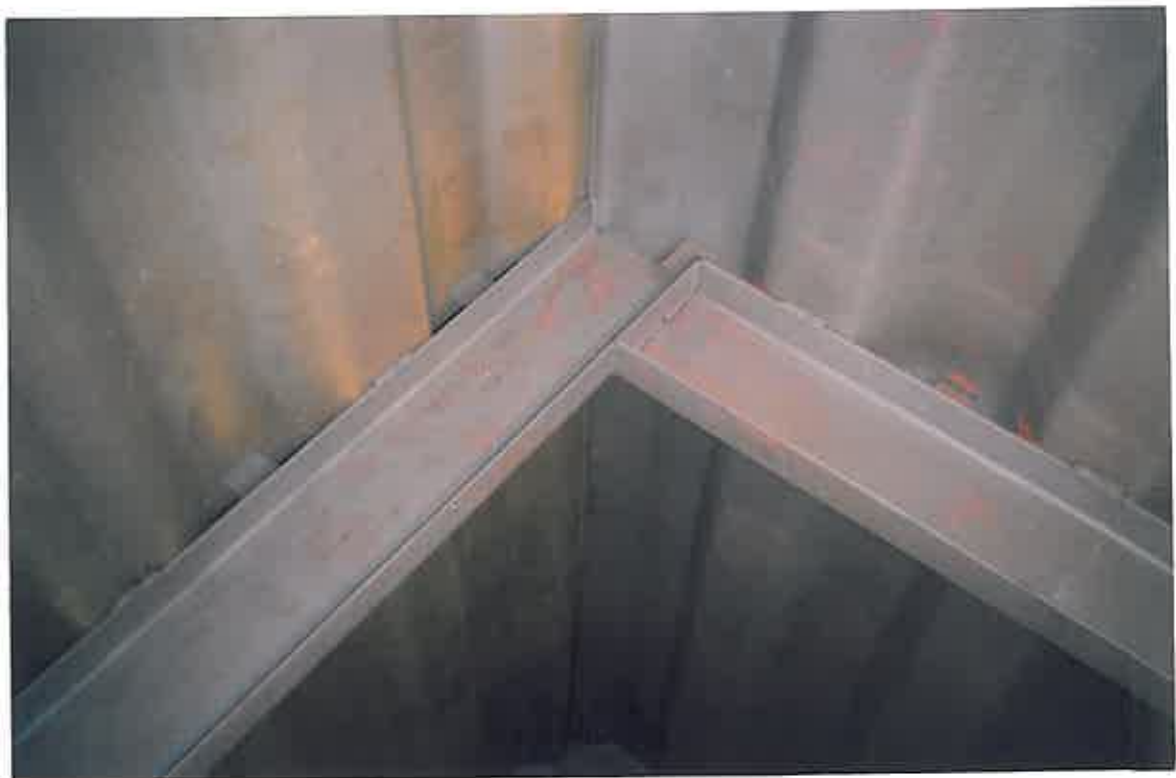
**These photographs show the internal surfaces of the tank having been prepared by means of dry abrasive blasting technique**
