COVAC COMPLETION REPORT

Client	-	XXXXXX NHS Trust
Address	-	XXXXXXXX Hospital Central England
Site Contacts	-	XXXXXXXXXX
Project Brief	-	The Internal / External Refurbishment of 4 No. Truff Tanks
System Specification - <i>Internal</i>	-	COPON Hycote 165PW Solvent Free Polyurethane.
<i>External</i>	-	COPON Hycote 152LV Solvent Free Coating.
Total Film Thickness - <i>Internal</i>	-	1000 Microns
<i>External</i>	-	500 Microns
Completion Date	-	2nd May 2007
Site Supervisor	-	Robin Bailey
Report Prepared by	-	Adrian Emmett
COVAC Contract Ref:	-	548

Internal Re-Lining of 4 Truff Tanks

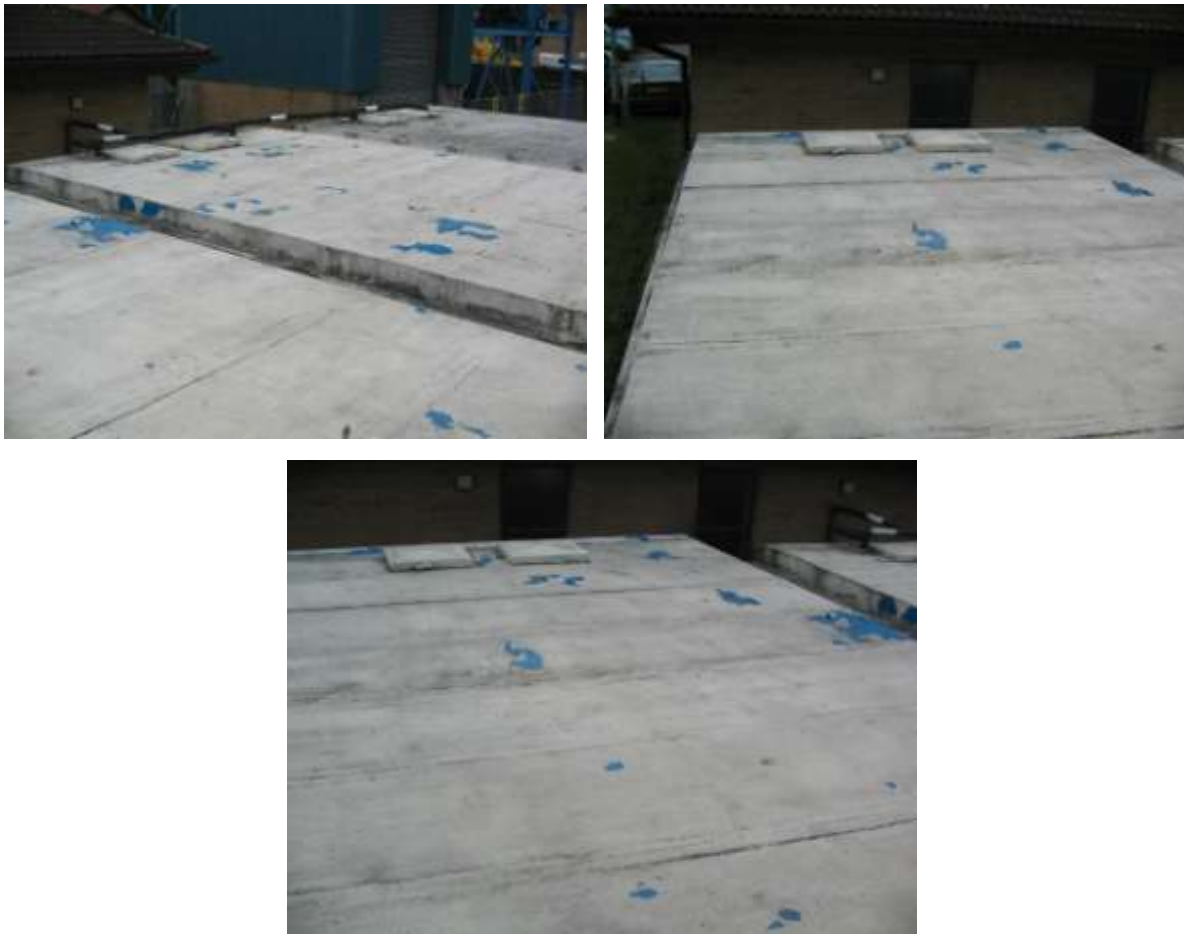
Previously the lids were externally coated with a white epoxy coating, which was delaminating from the original GRP substrate due to poor preparation & the coatings lack of elongation properties. (See photographs)

Therefore we proposed to carry out the following: -

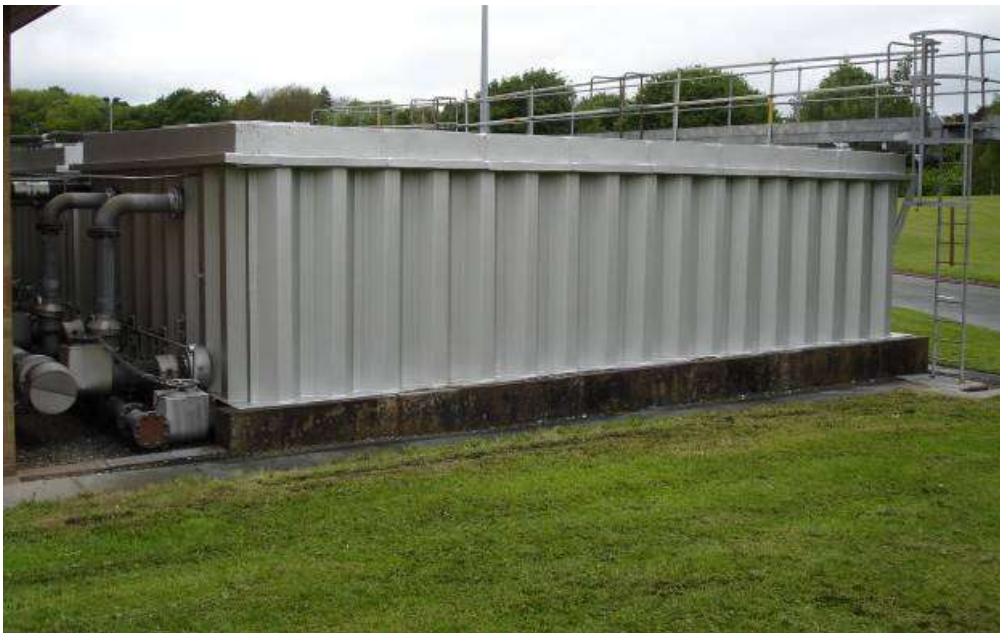
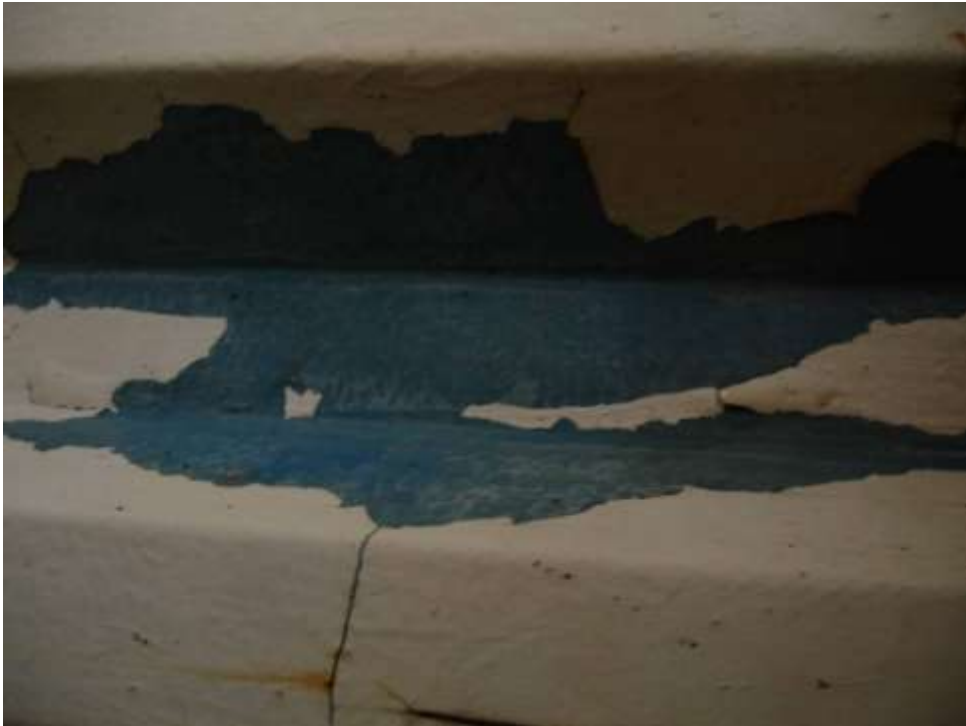
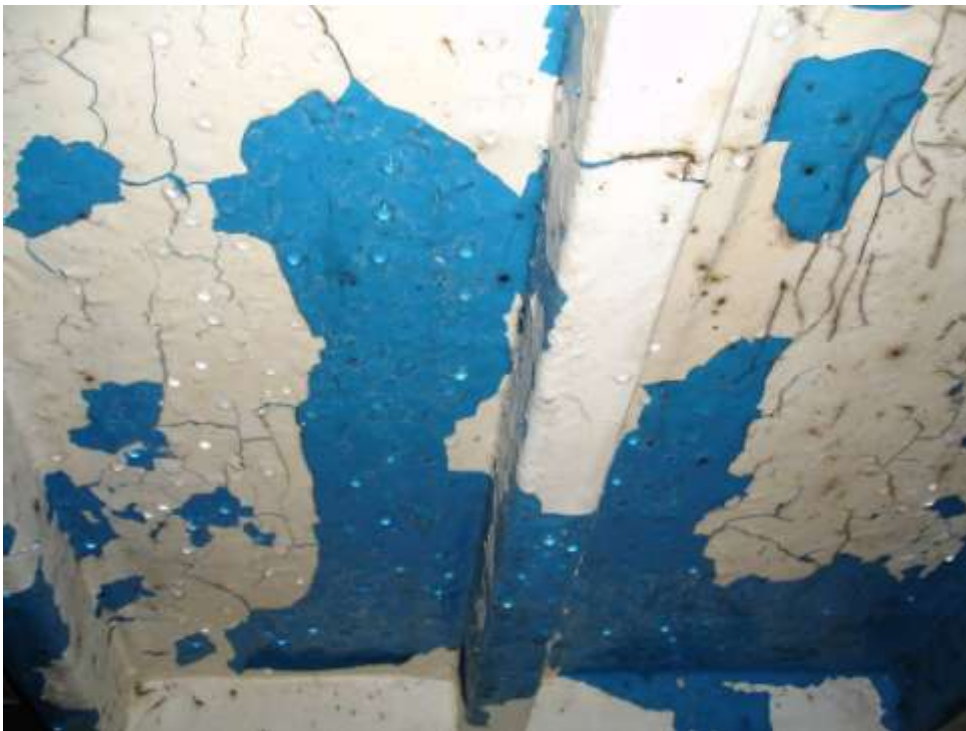
These photographs show the internals of the tanks, prior to any preparation work. The photographs clearly show the deterioration of the epoxy coating and delaminating of the GRP lining.

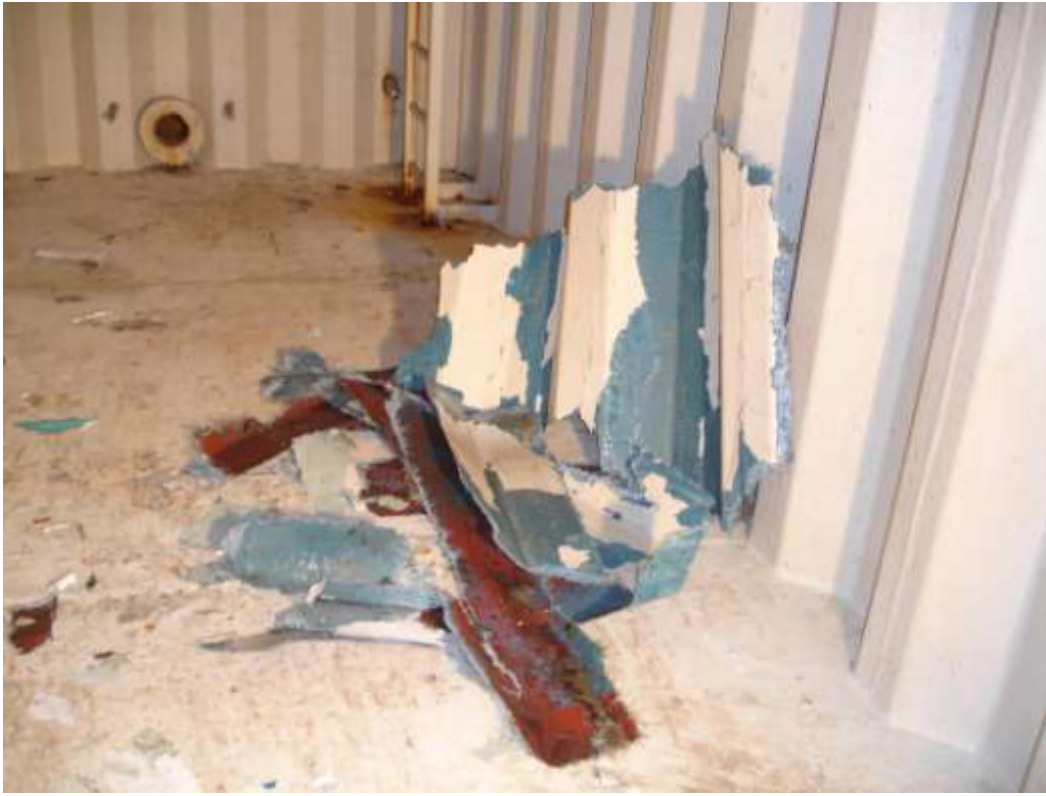
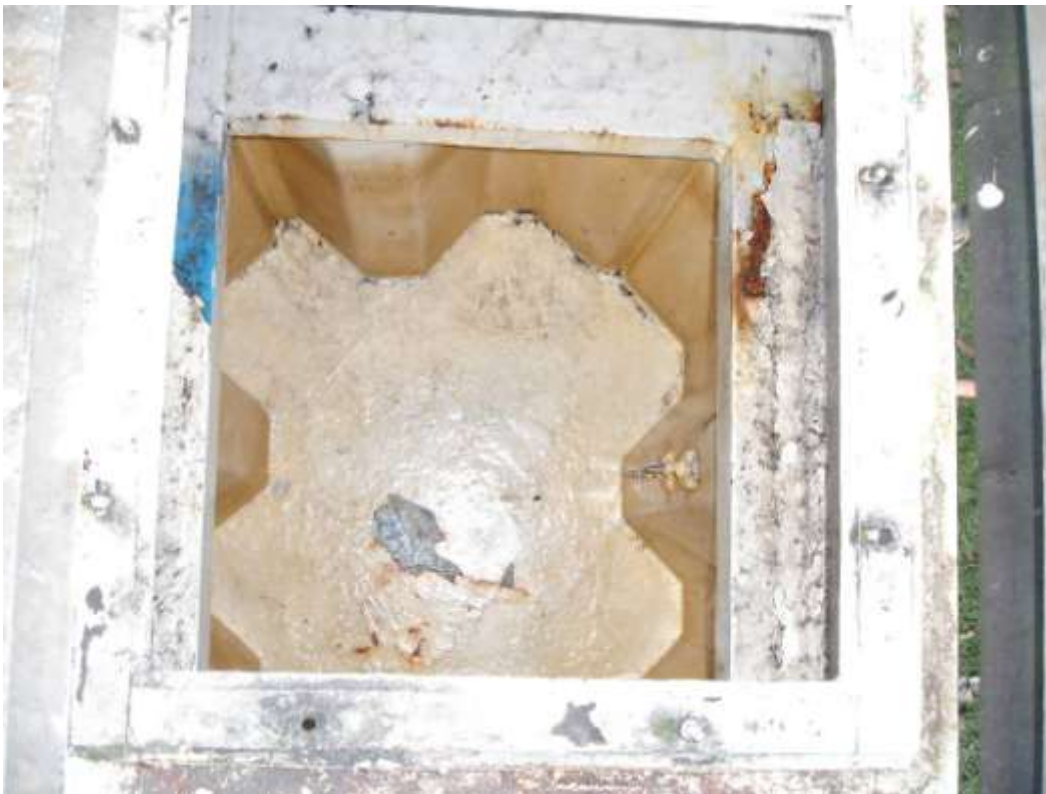
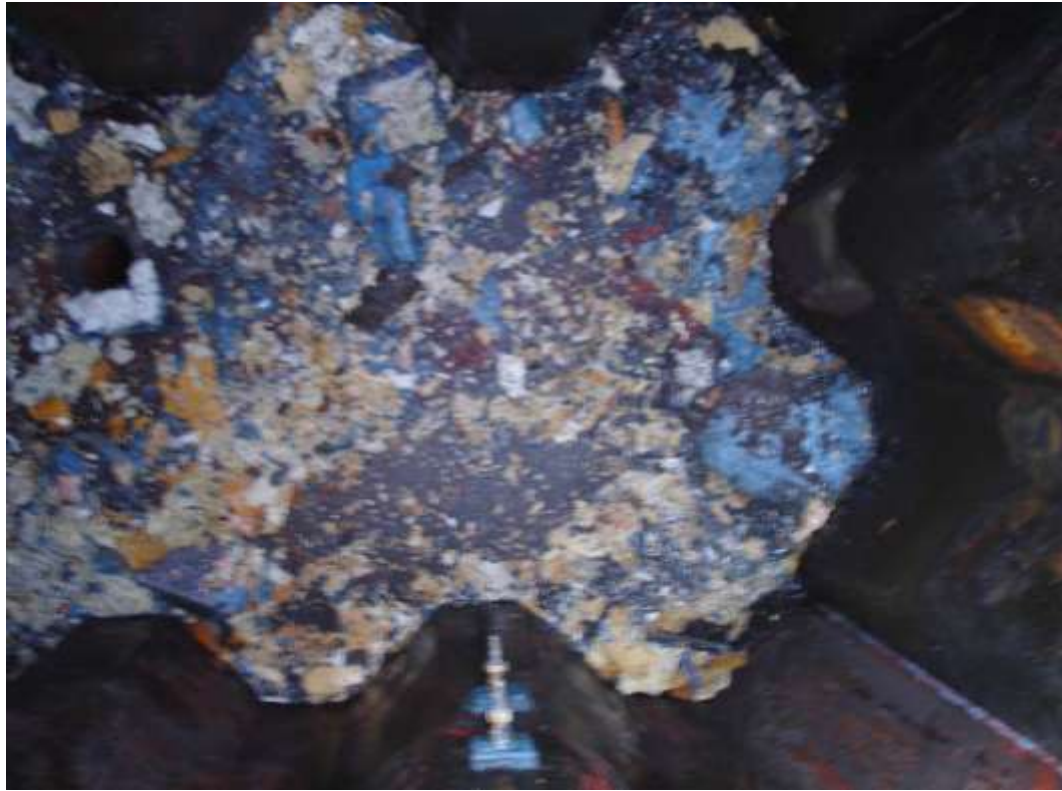
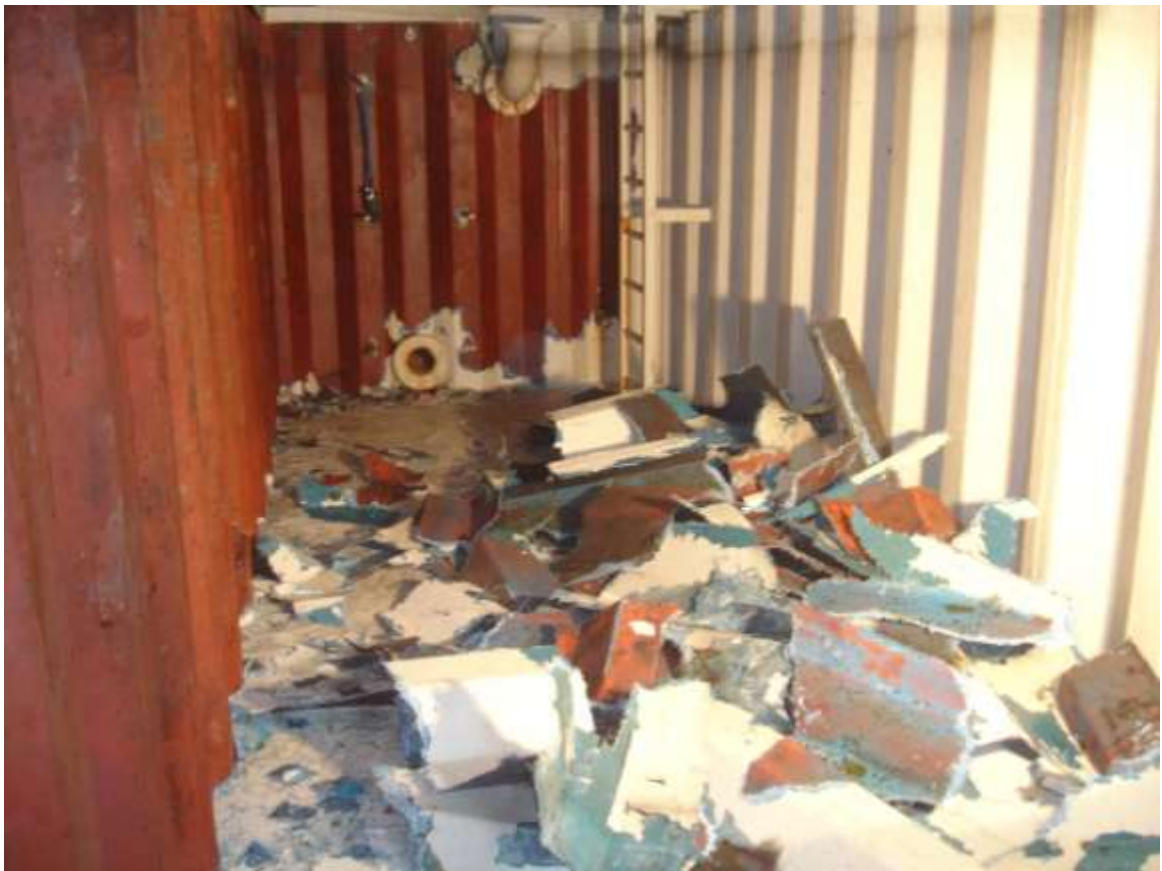
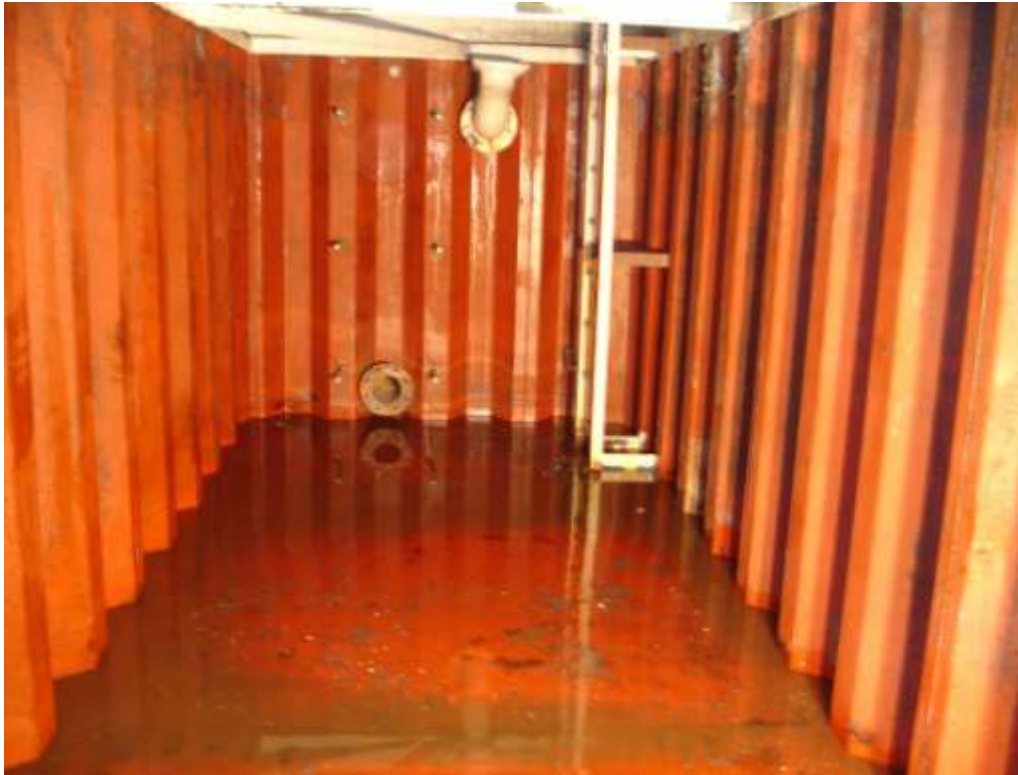
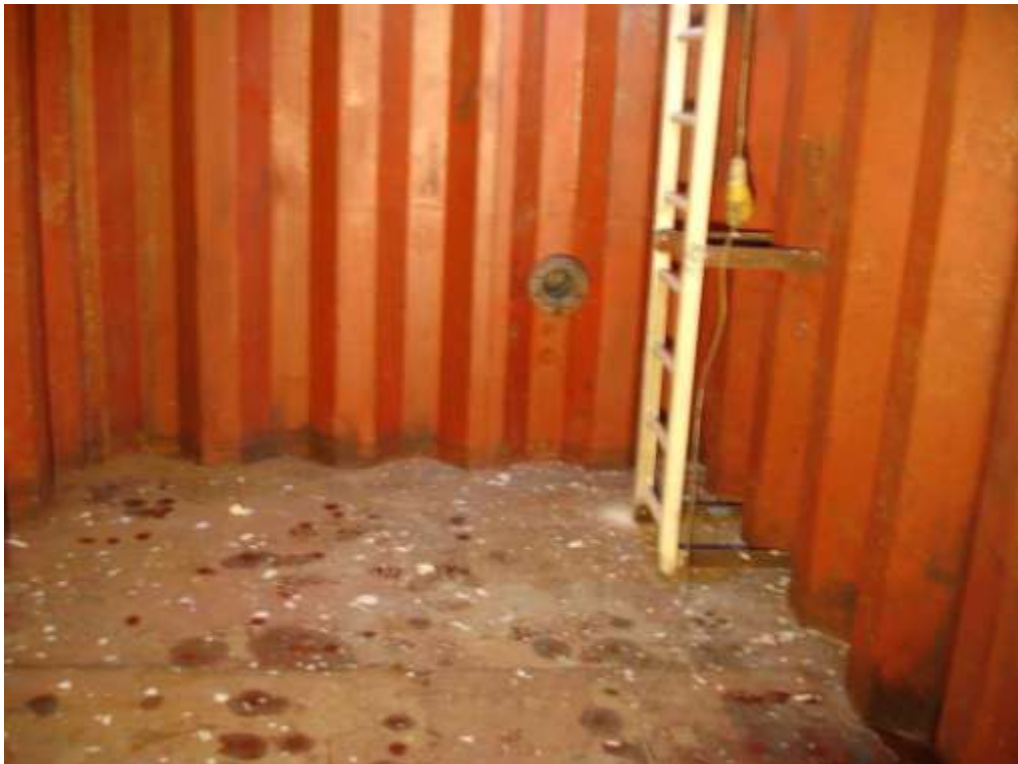
The following photographs show the GRP lining, which had to be removed utilising mechanical chisels revealing the epoxy coated steel substrate.

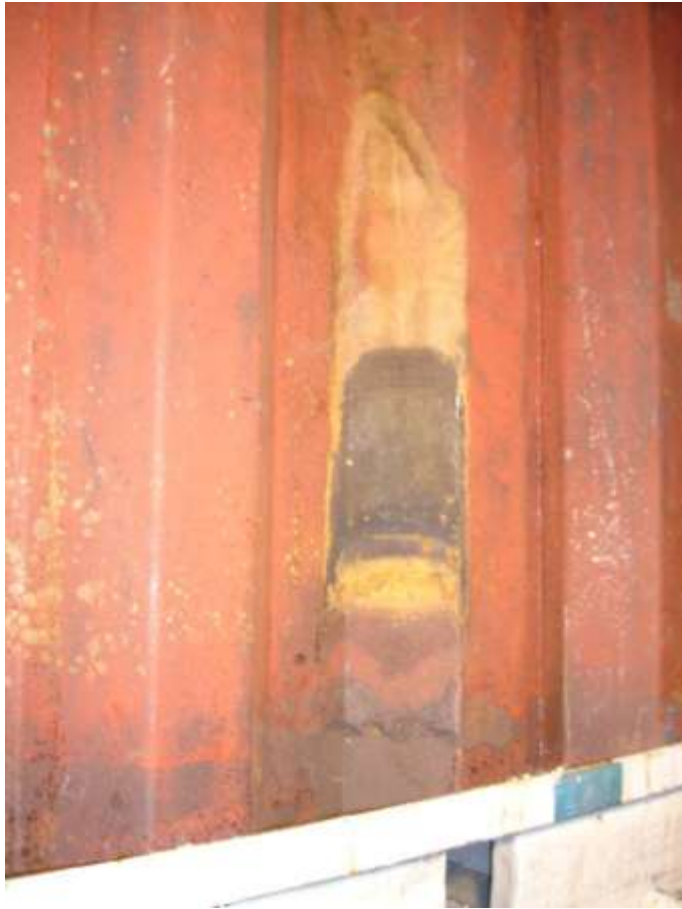
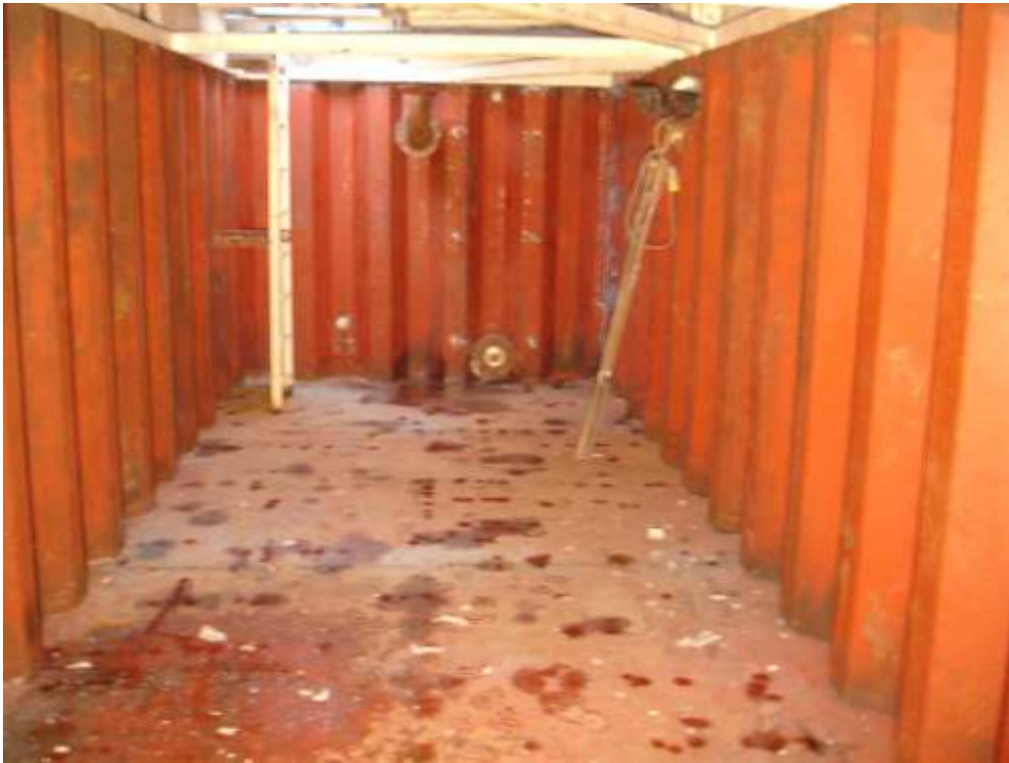
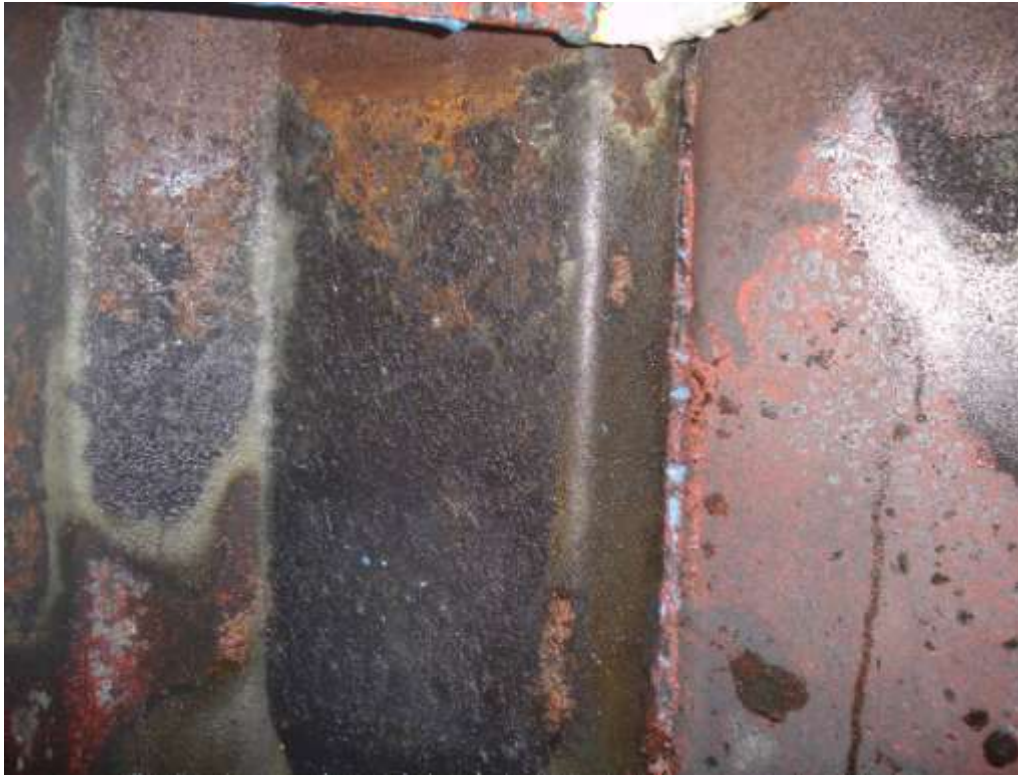
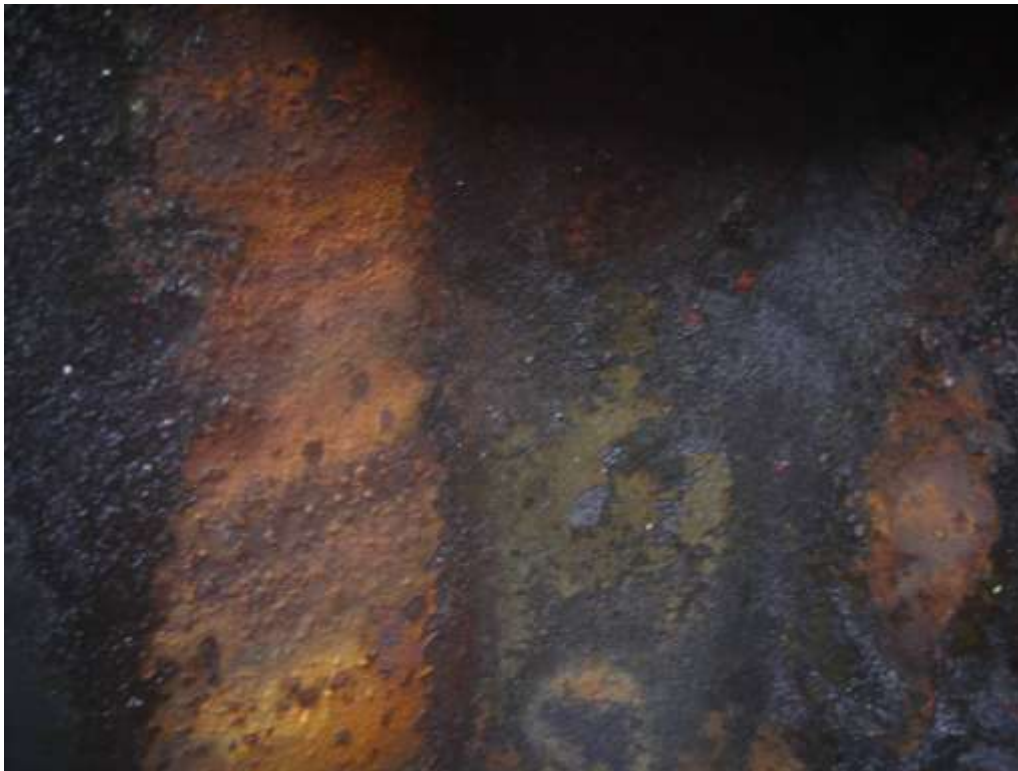
These images are of the internals of the tanks after the GRP lining has been removed from all internal surfaces.

The photographs above clearly show progressive corrosion to the steel due to moisture entrapment between the steel and GRP lining substrates.

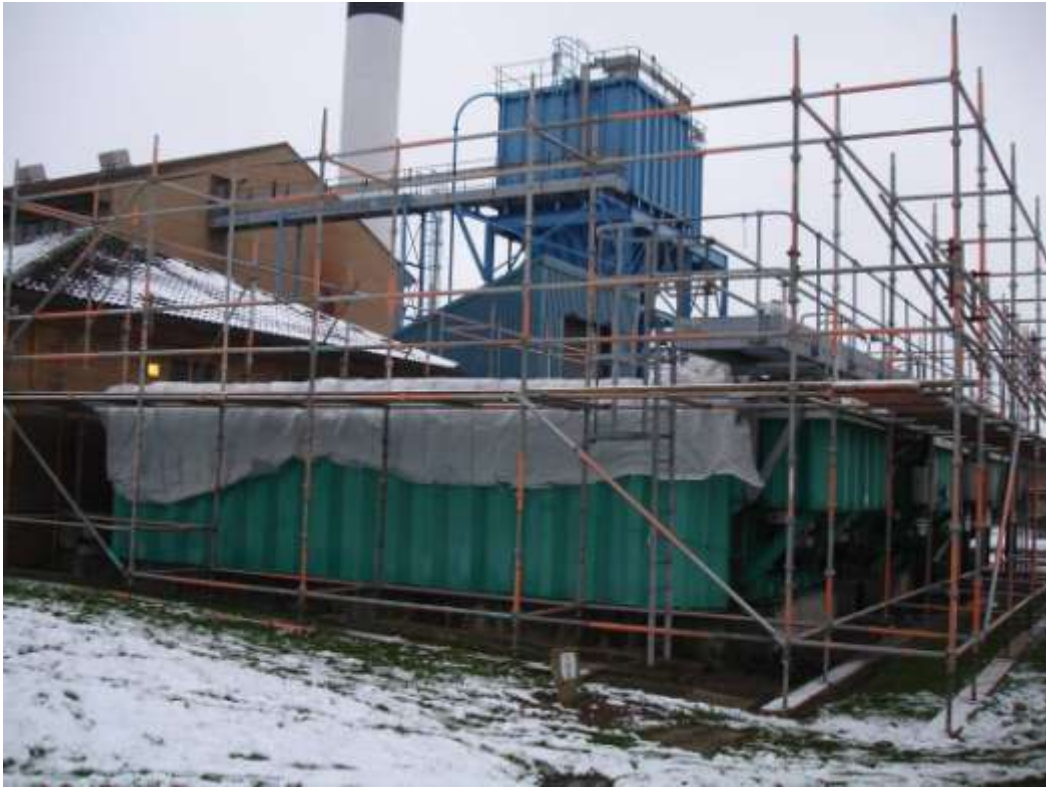
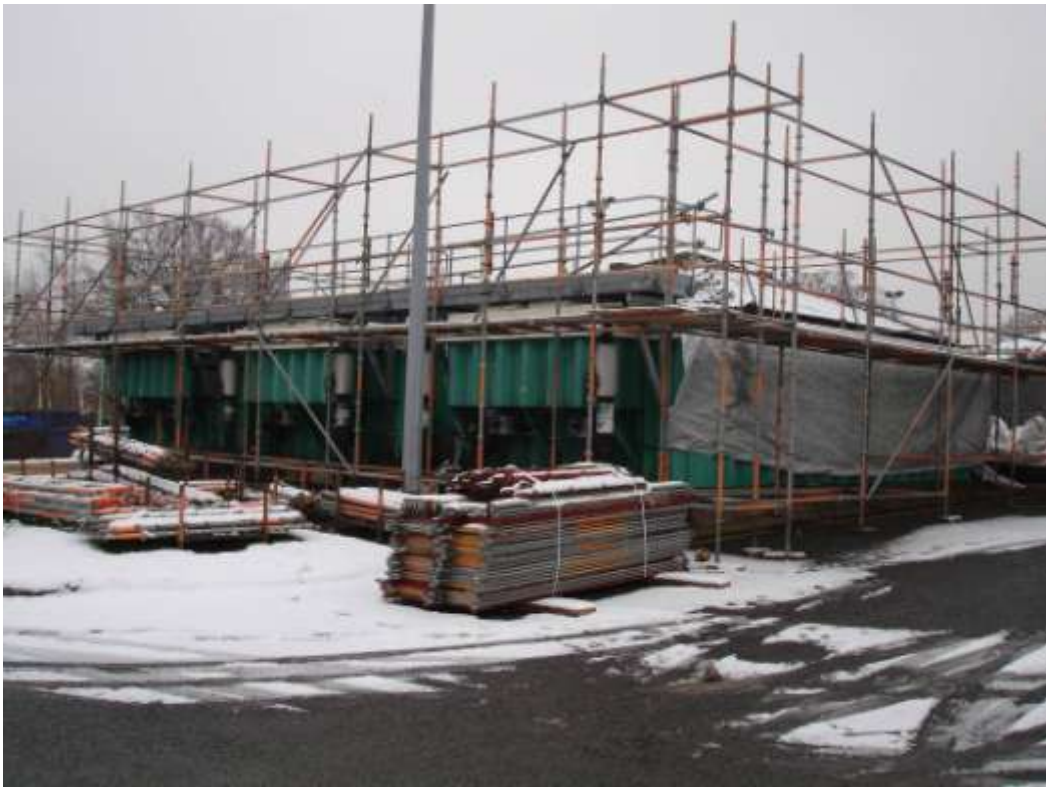
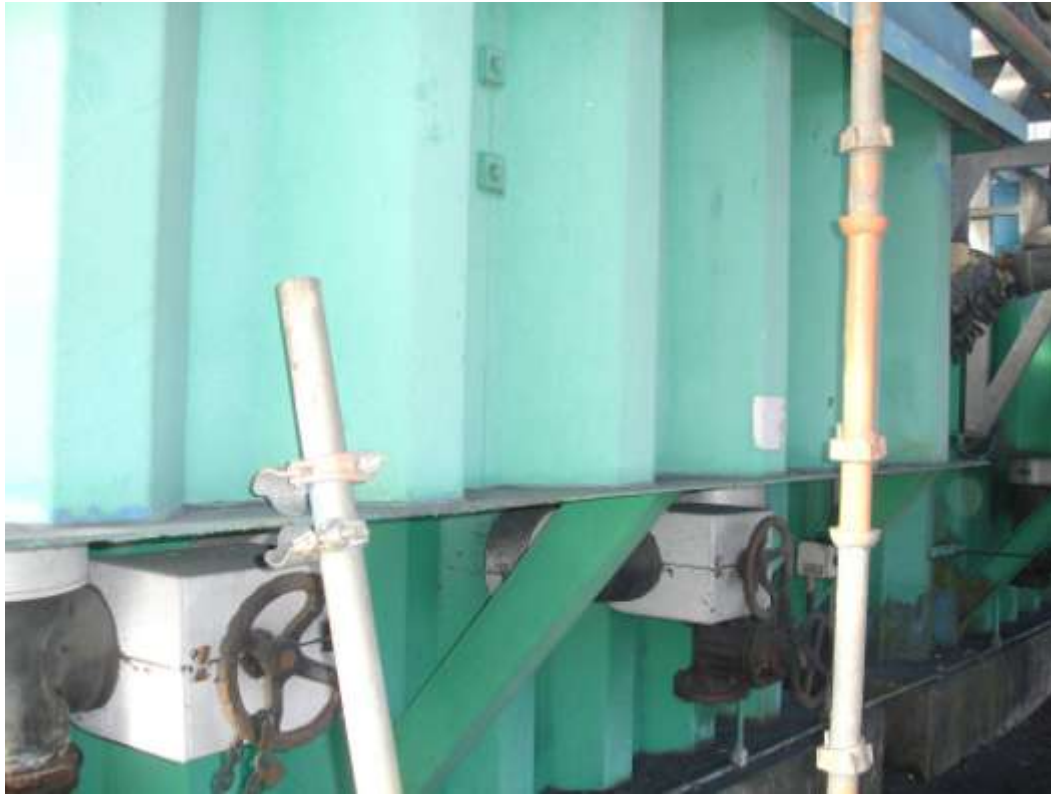
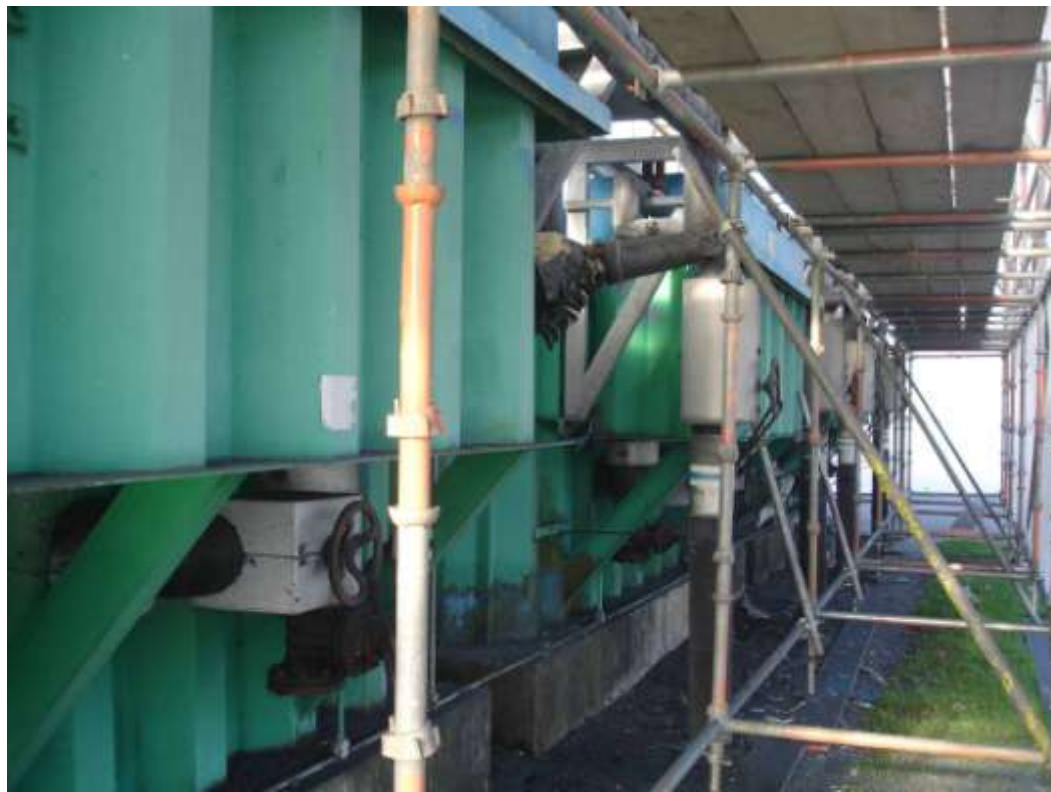
These images show the external of the tanks prior to any preparation work by our site operatives.
