COMPLETION REPORT

Project Brief : **The Internal Relining of 2 No. Steel, Cylindrical, Calorifiers**

System Spec : **3M Scotchkote™ 165PW
(Formerly Known as COPON Hycote 165PW)**

Film Thickness : **1000 Microns**

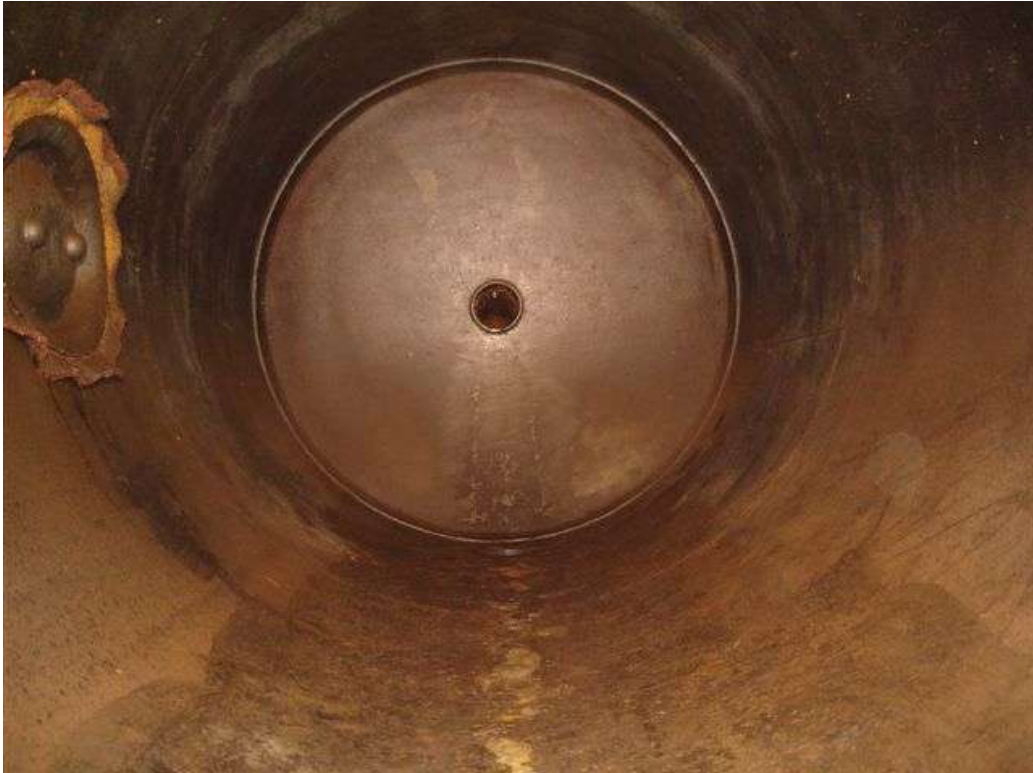
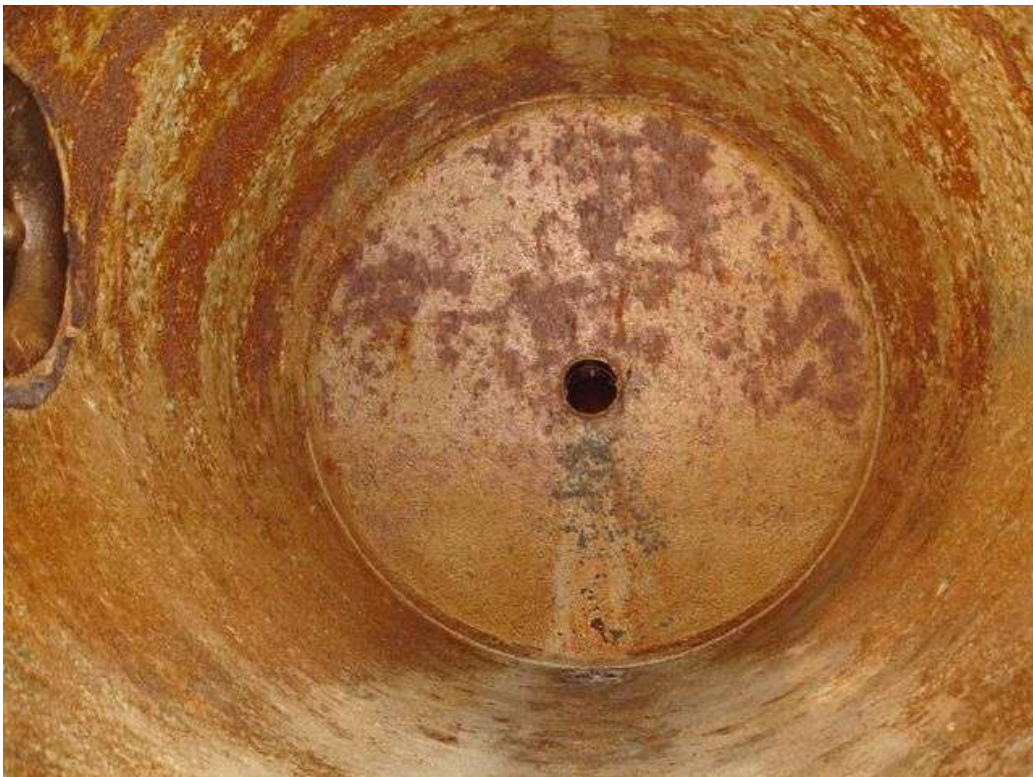
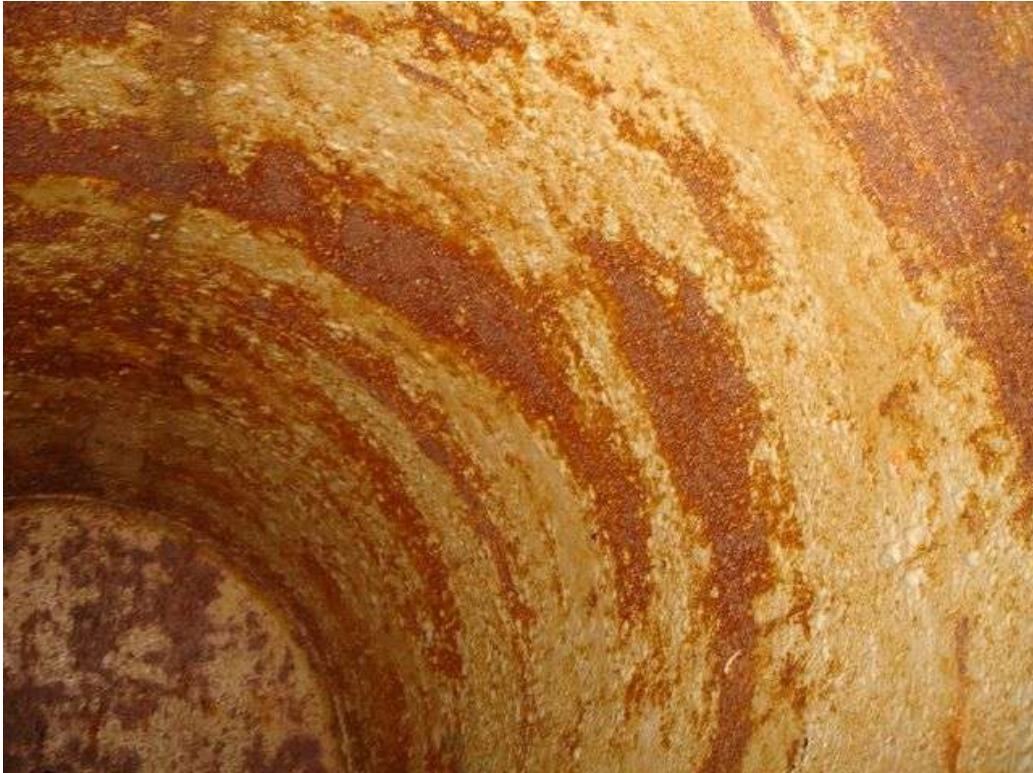
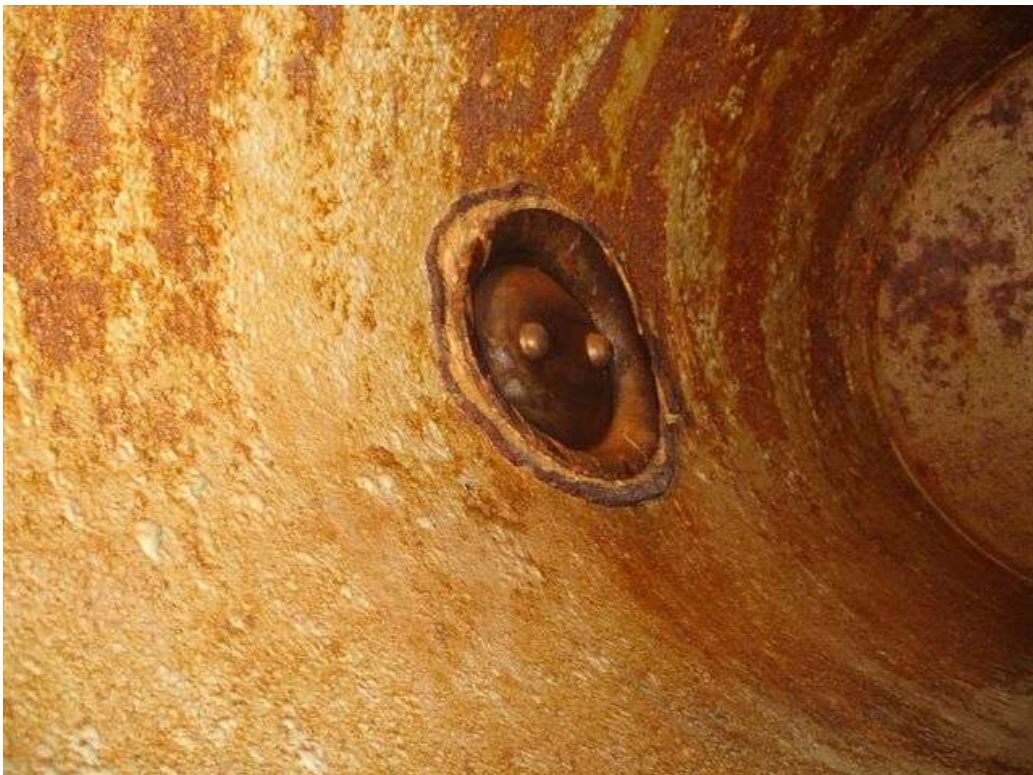
These photographs show the internal surfaces of the vessels having been drained of water and prior to any preparation works being carried out.

As the photographs demonstrate, the vessels show signs of progressive surface corrosion.

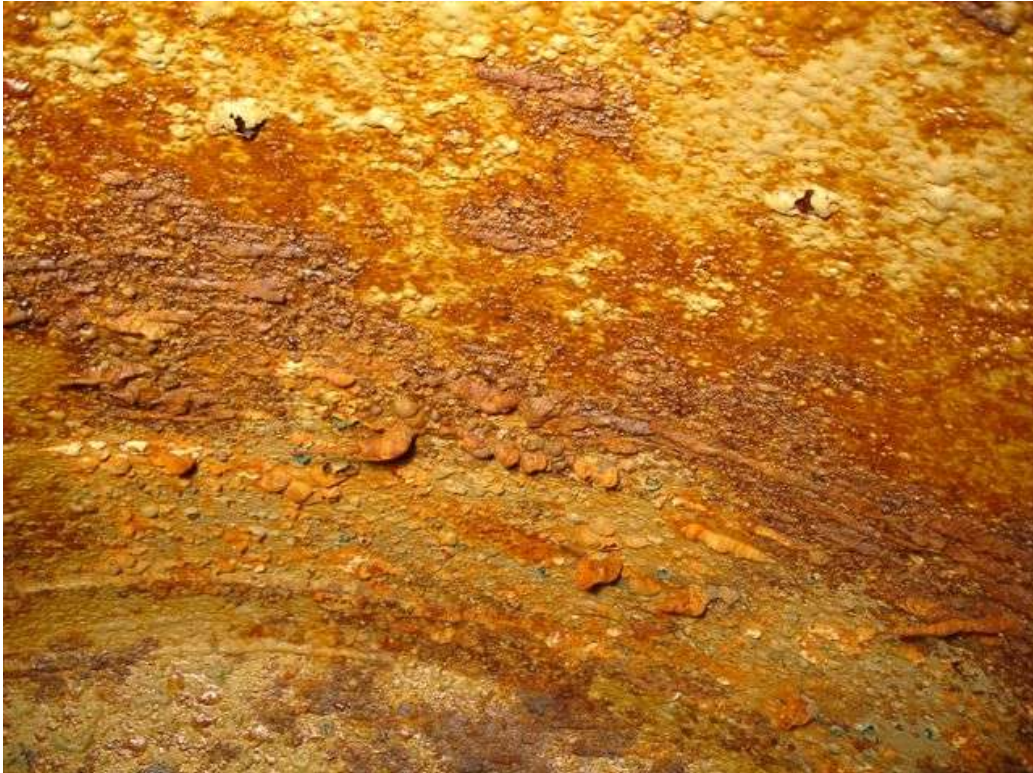
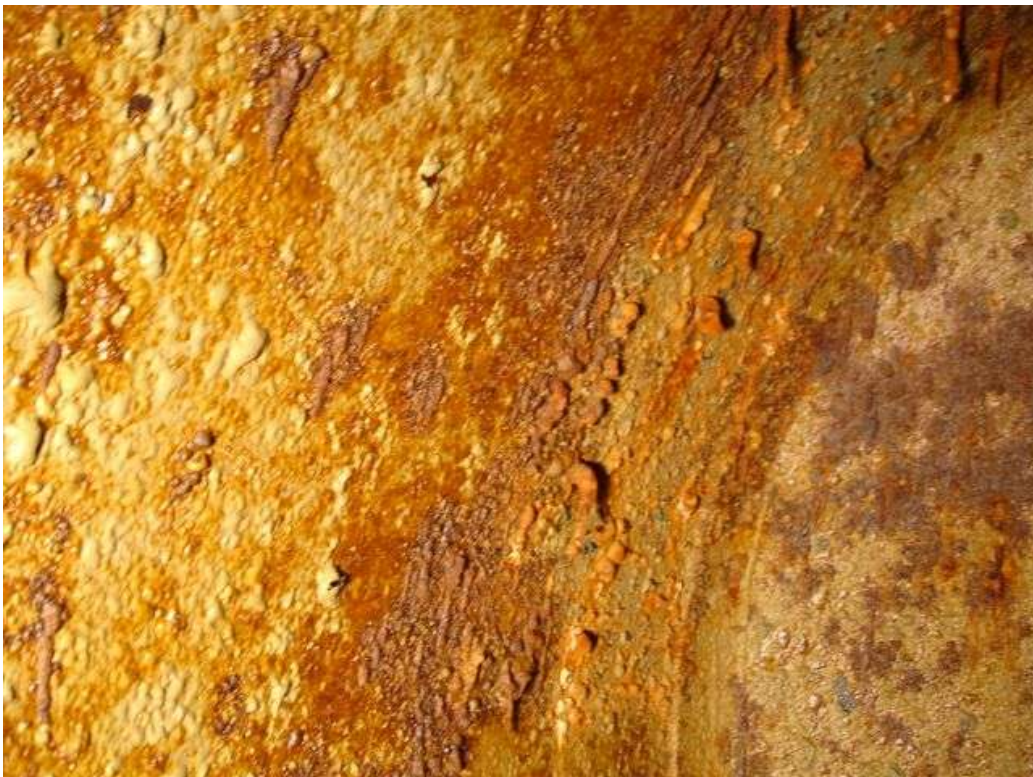
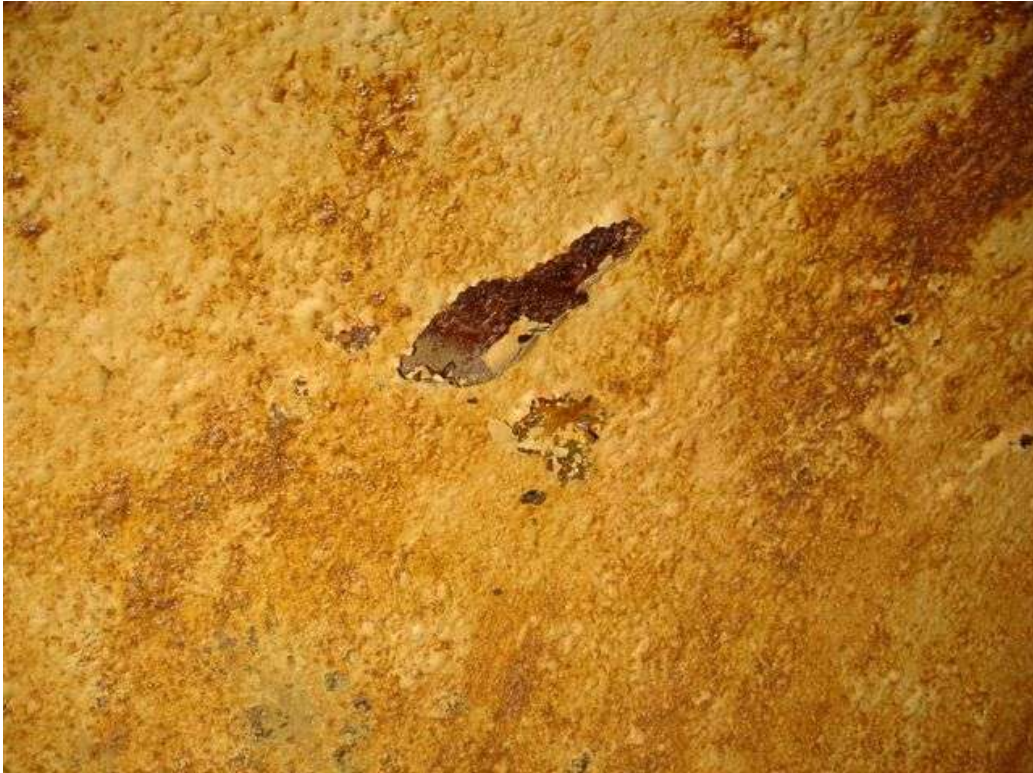
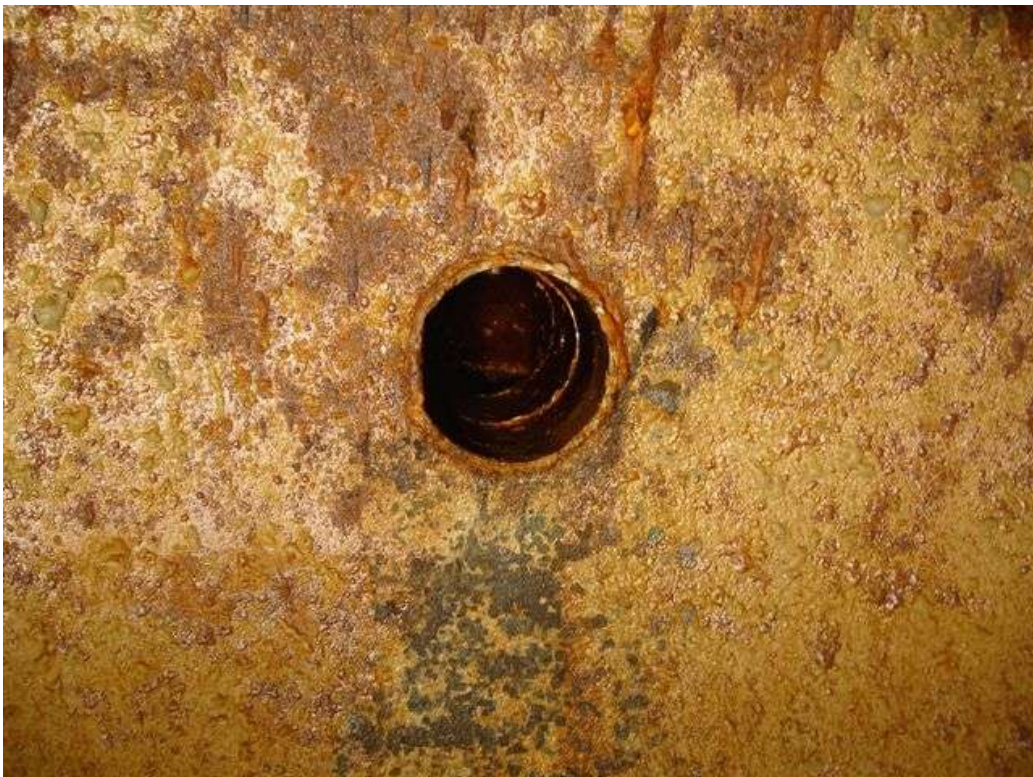
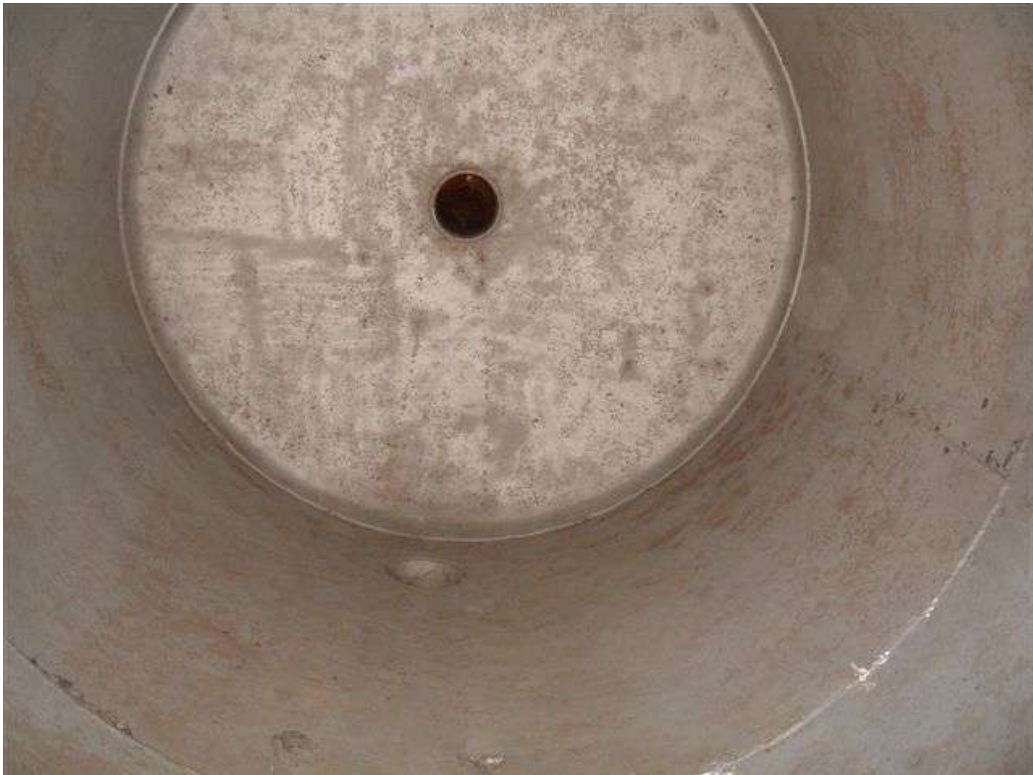
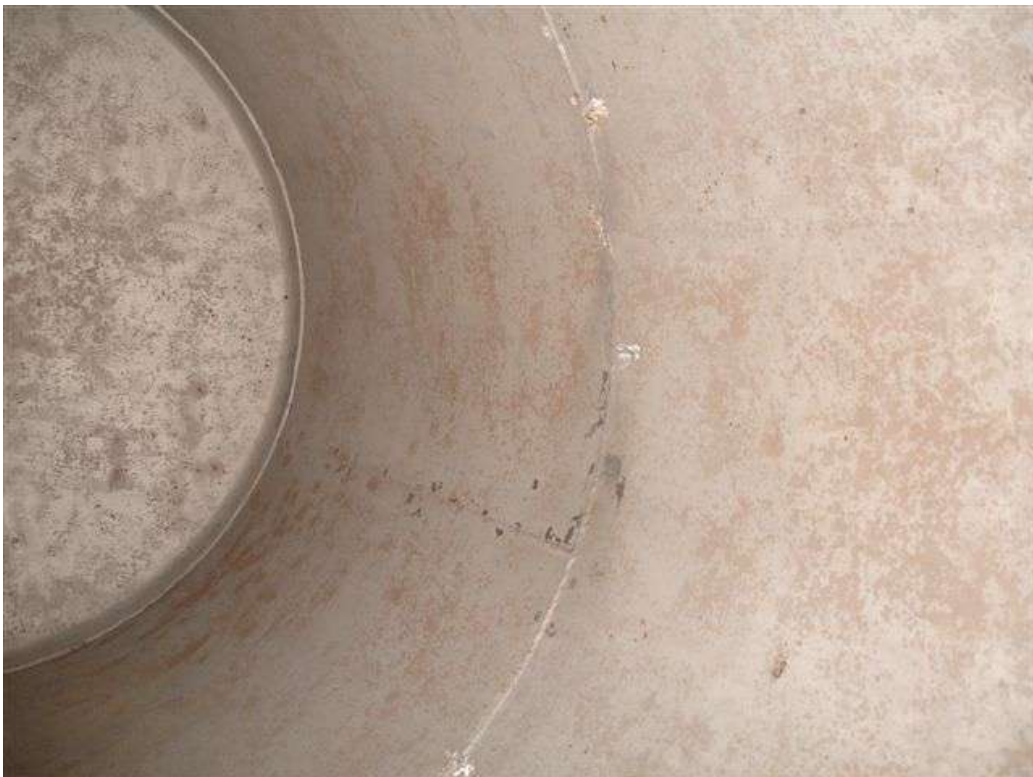
These photographs show the internal surfaces, having been prepared by COVAC Operatives using dry abrasive grit blast equipment in accordance with the accepted Standard.

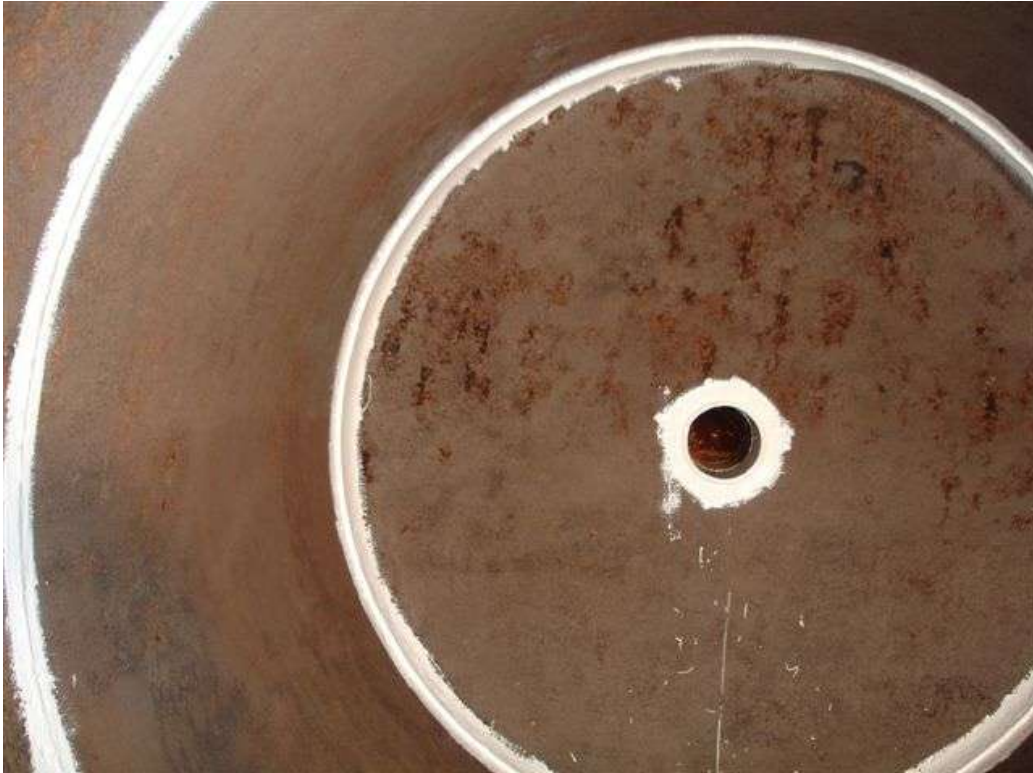
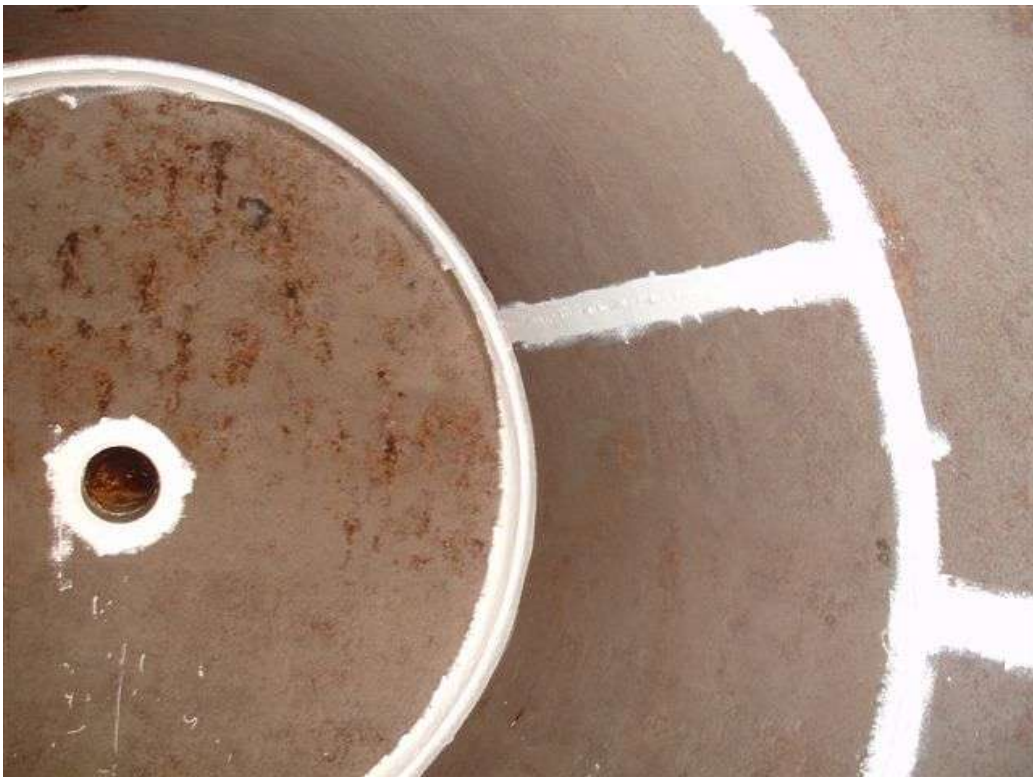
All seams, joints, bolts etc were initially 'stripe coated' to ensure all intricate areas were coated prior to the 1st full coat of 3M Scotchkote™ 165PW Solvent Free Polyurethane.

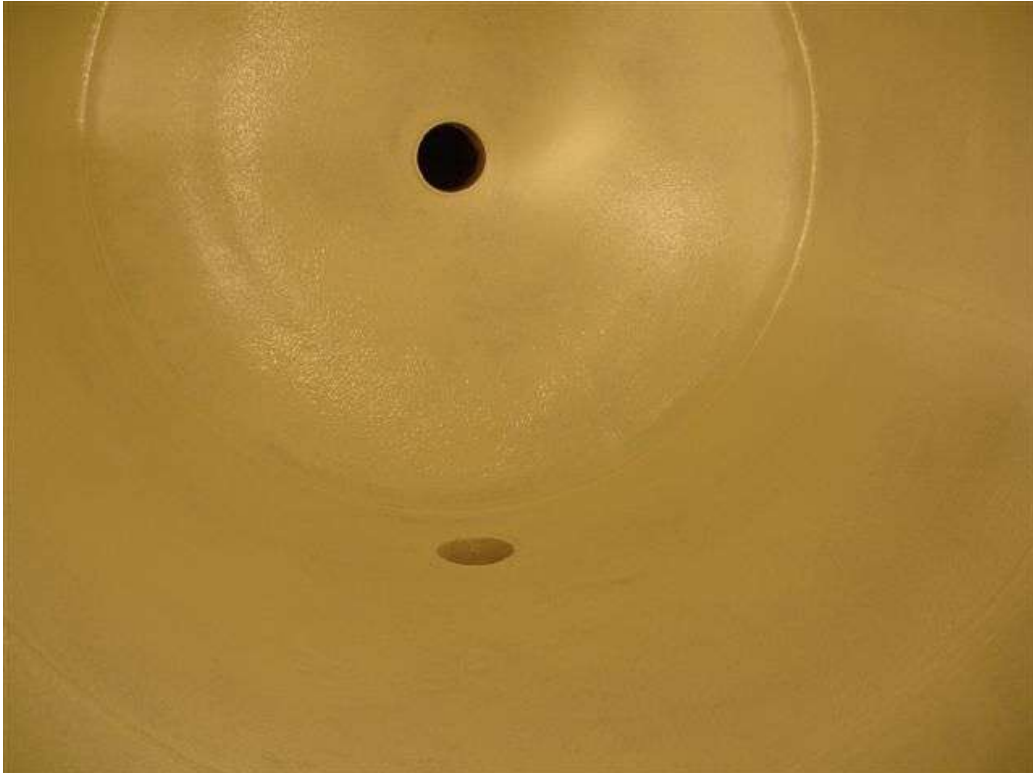
These photographs show the substrate of the tanks having received the 1st full coat of 3M Scotchkote™ 165PW (cream) Solvent Free Polyurethane.

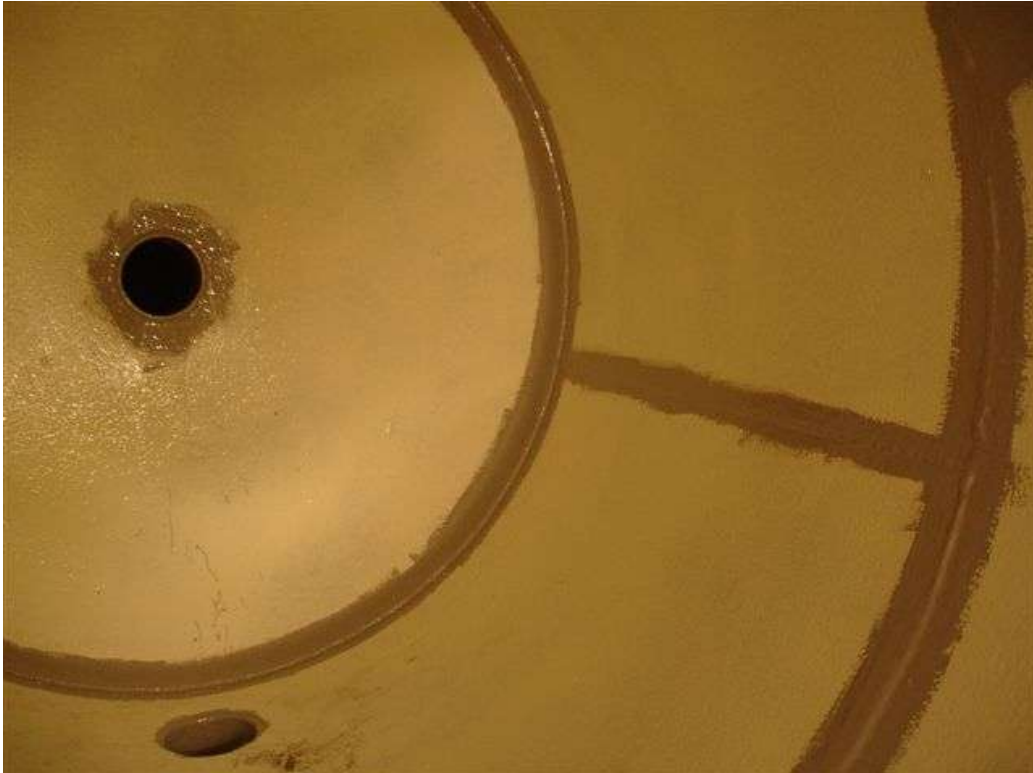
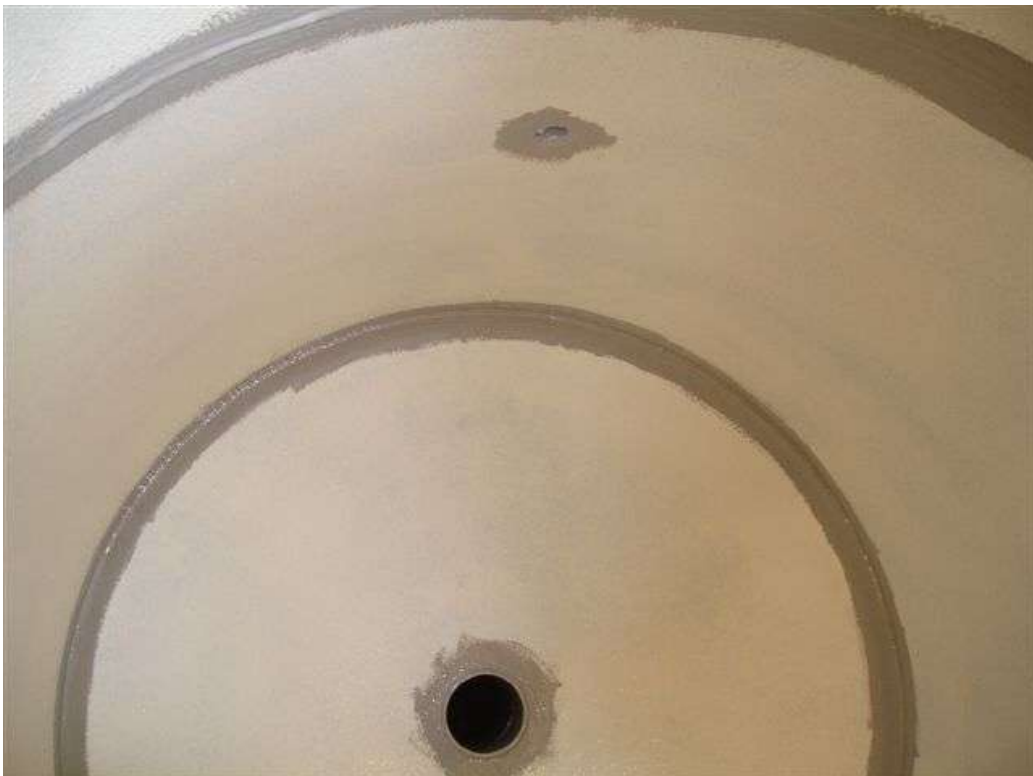
All intricate areas were again 'stripe coated' for a second time.

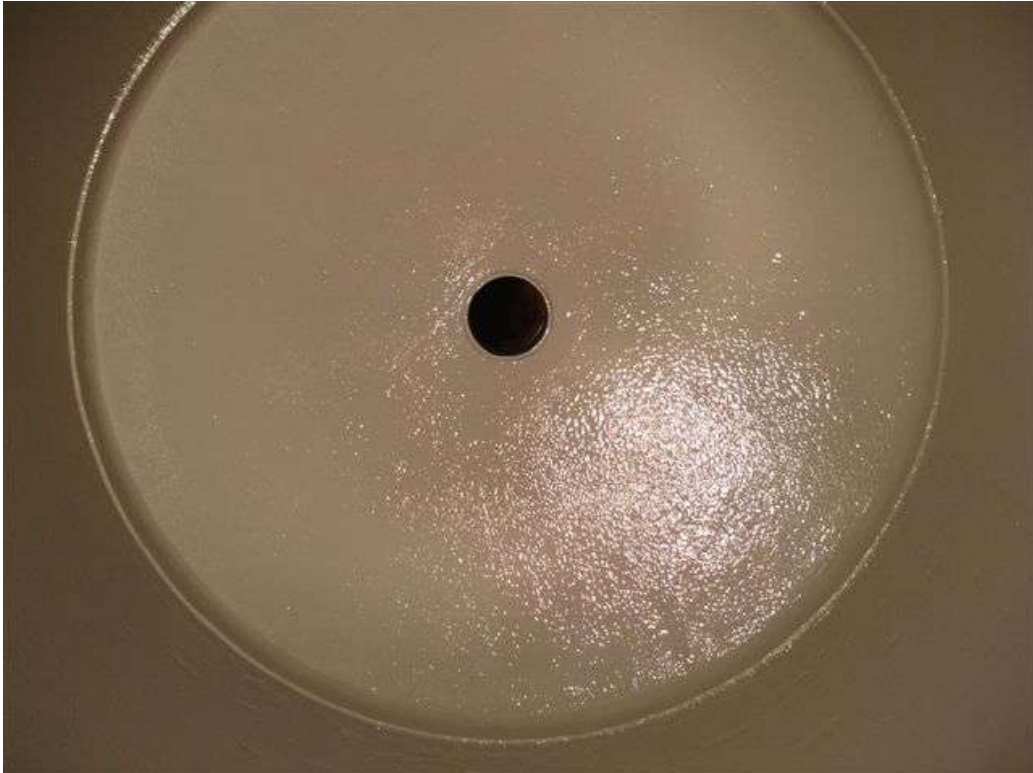
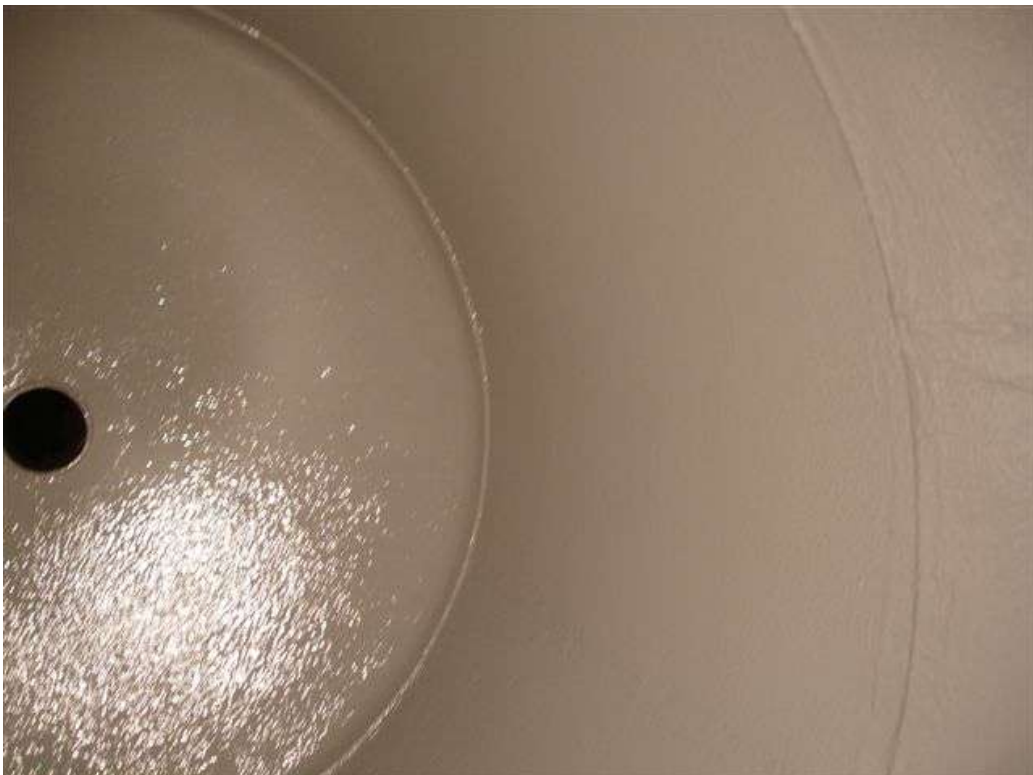
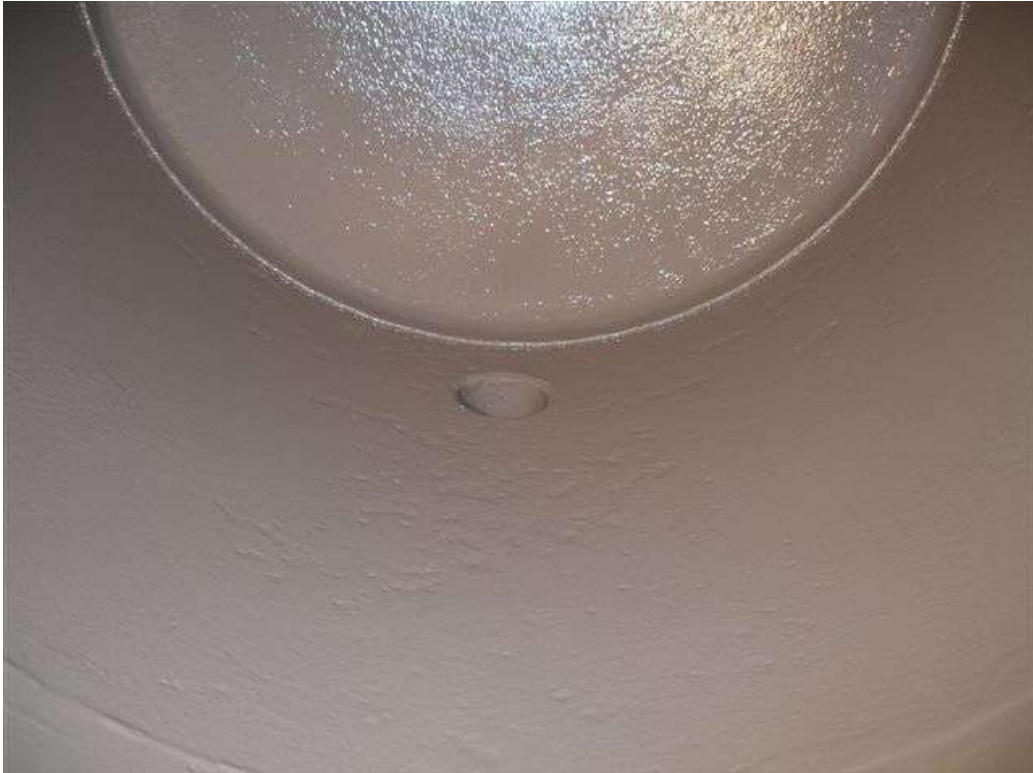
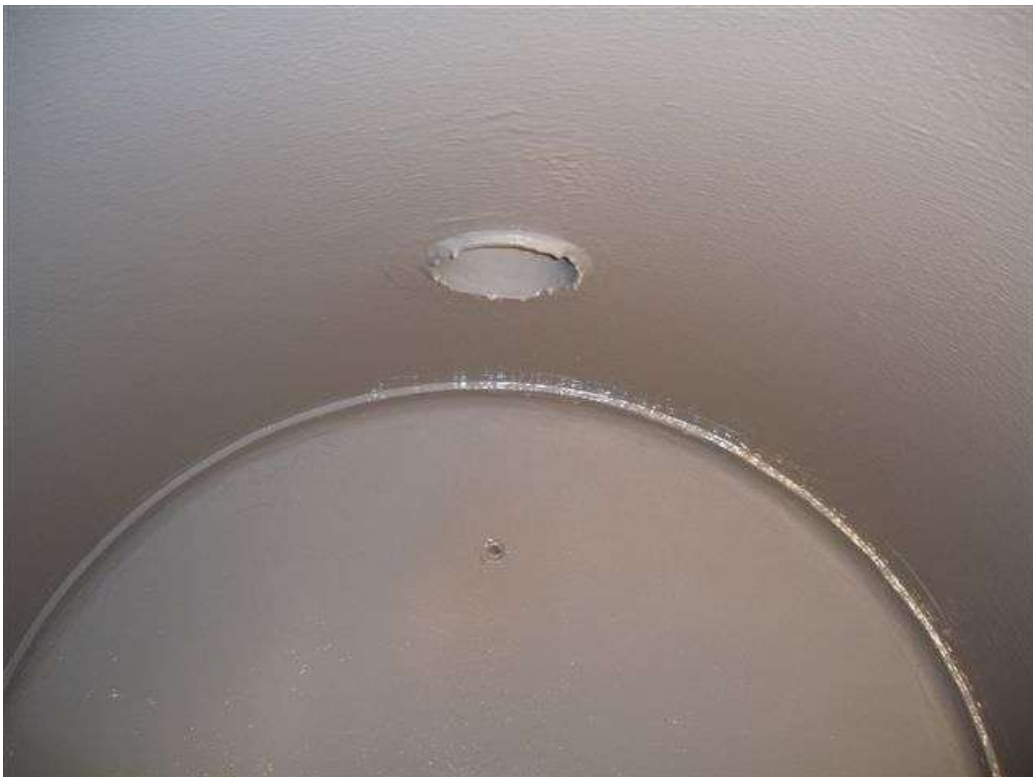
The following photographs show the final application of the 2nd coat of 3M Scotchkote™ 165PW (grey).

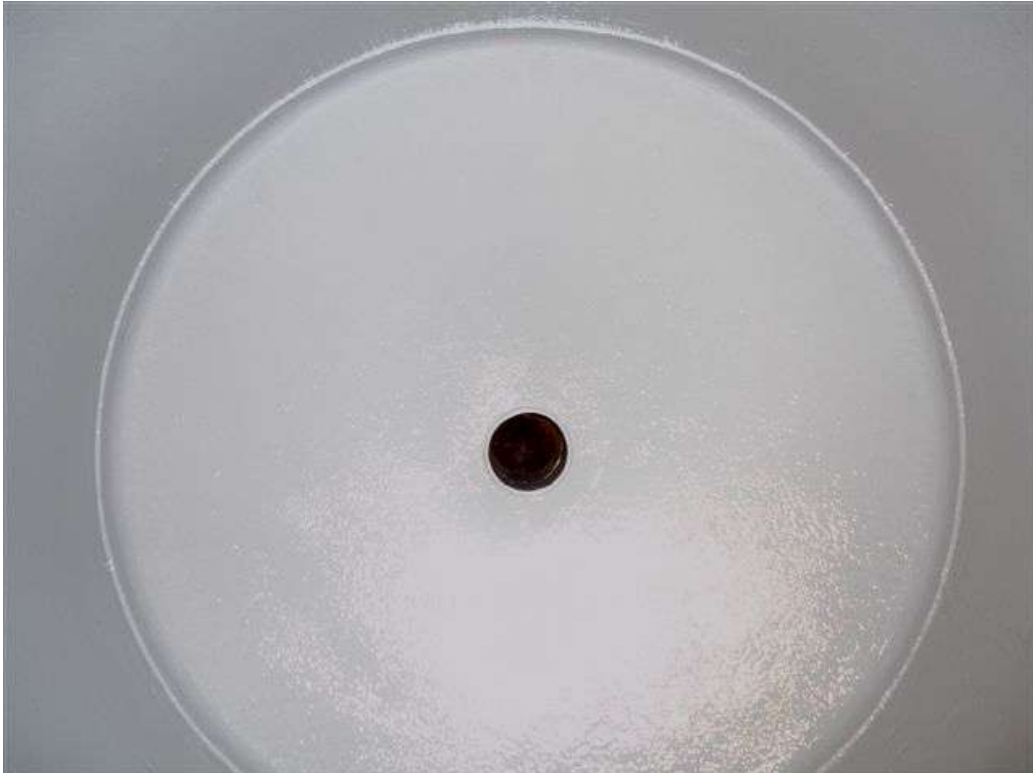
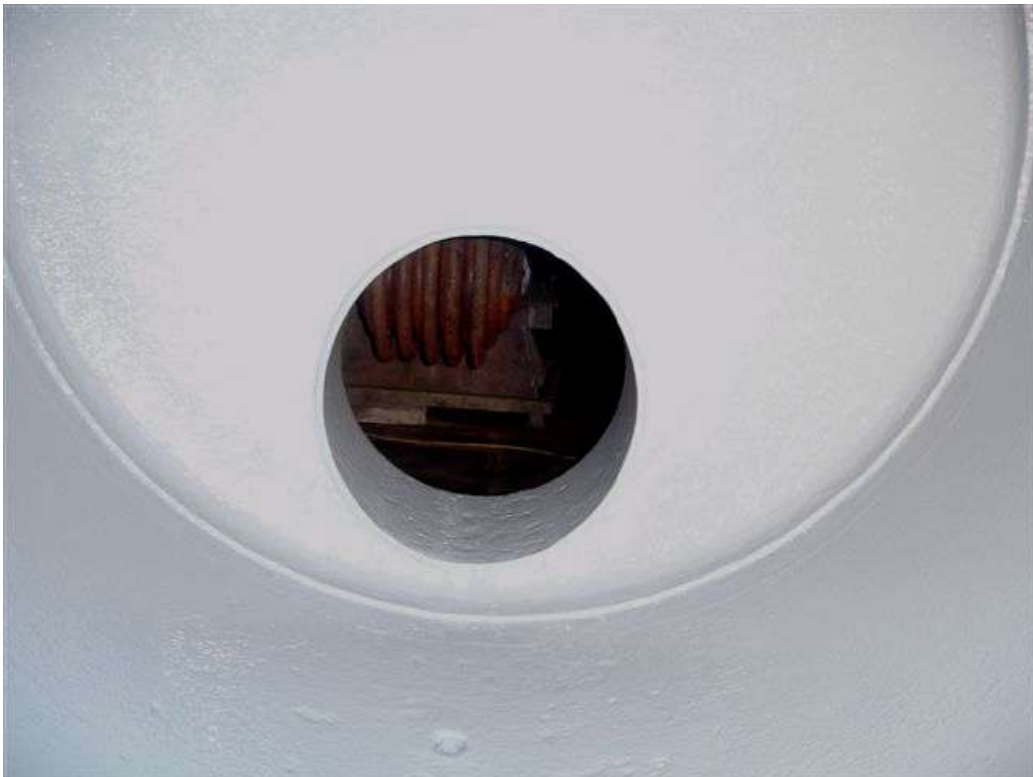
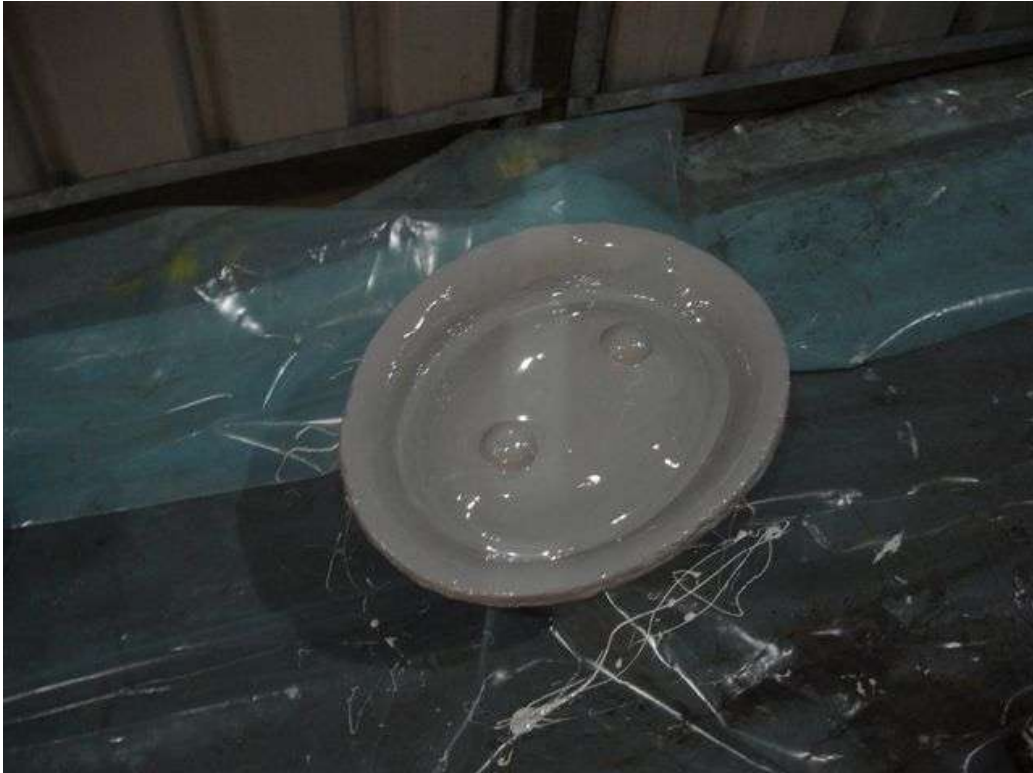
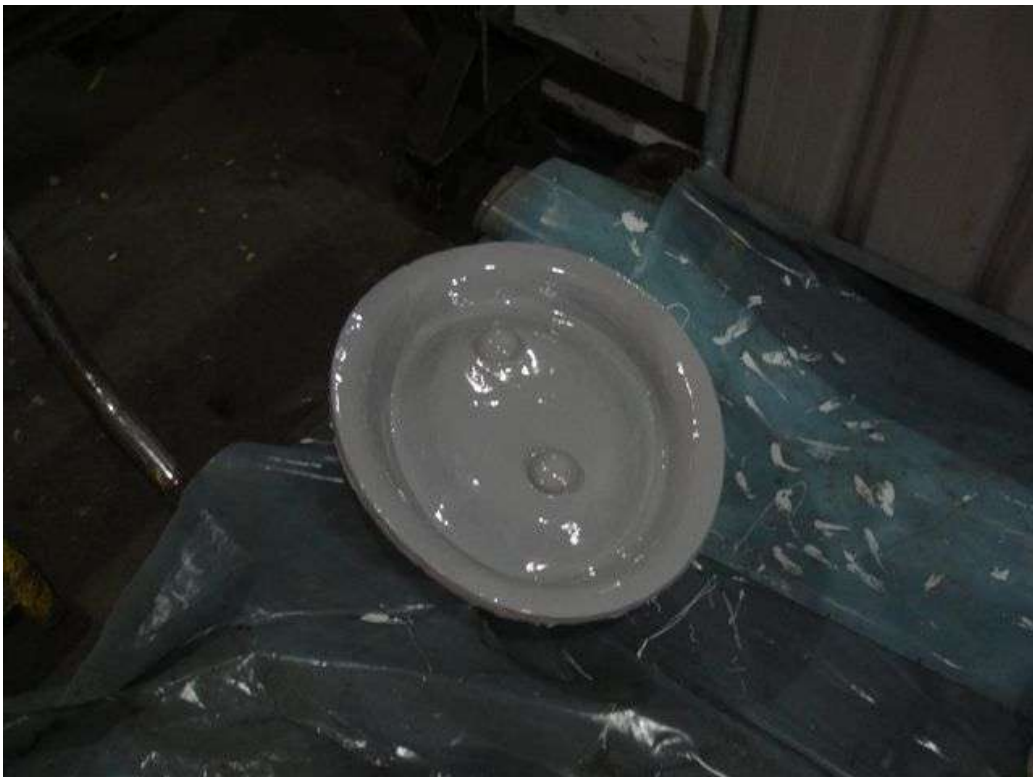
These photographs show the vessels hatches fully relined utilising 3M Scotchkote™ 165PW.
