COVAC COMPLETION REPORT

- Client - **XXXXX Housing**
- Address - **5 No. Blocks
XXXXXXXXXXXX
Glasgow**
- Site Contact - **XXXXXXXXXX**
- Project Brief - **The Internal Refurbishment of
20 No. Concrete CWS Tanks**
- System Specification - **3M Scotchkote™ 165PW
Solvent Free Polyurethane
(Formerly Known as COPON Hycote 165PW)**
- Nominal Dry Film Thickness - **1000 Microns**
- Completion Date - **25th April 2008**
- Site Supervisor - **Carl Broadley**
- Report Prepared by - **Craig Phillips**
- COVAC Contract Ref: - **695**

20 No. CONCRETE CWS TANKS

**THIS PICTORIAL REPORT COMBINES THE REFURBISHMENT OF
ALL 20 No. TANKS AT XXXXXXXXXXXX DRIVE.**

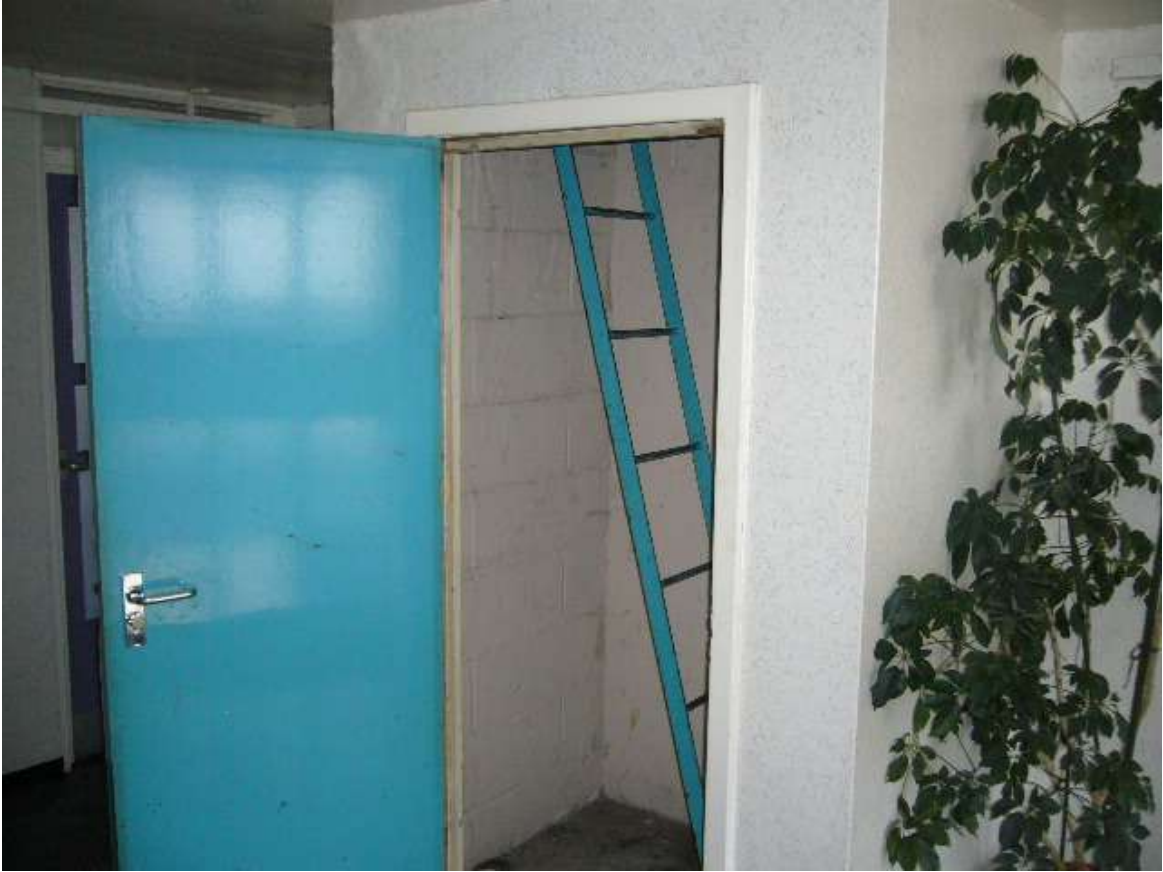
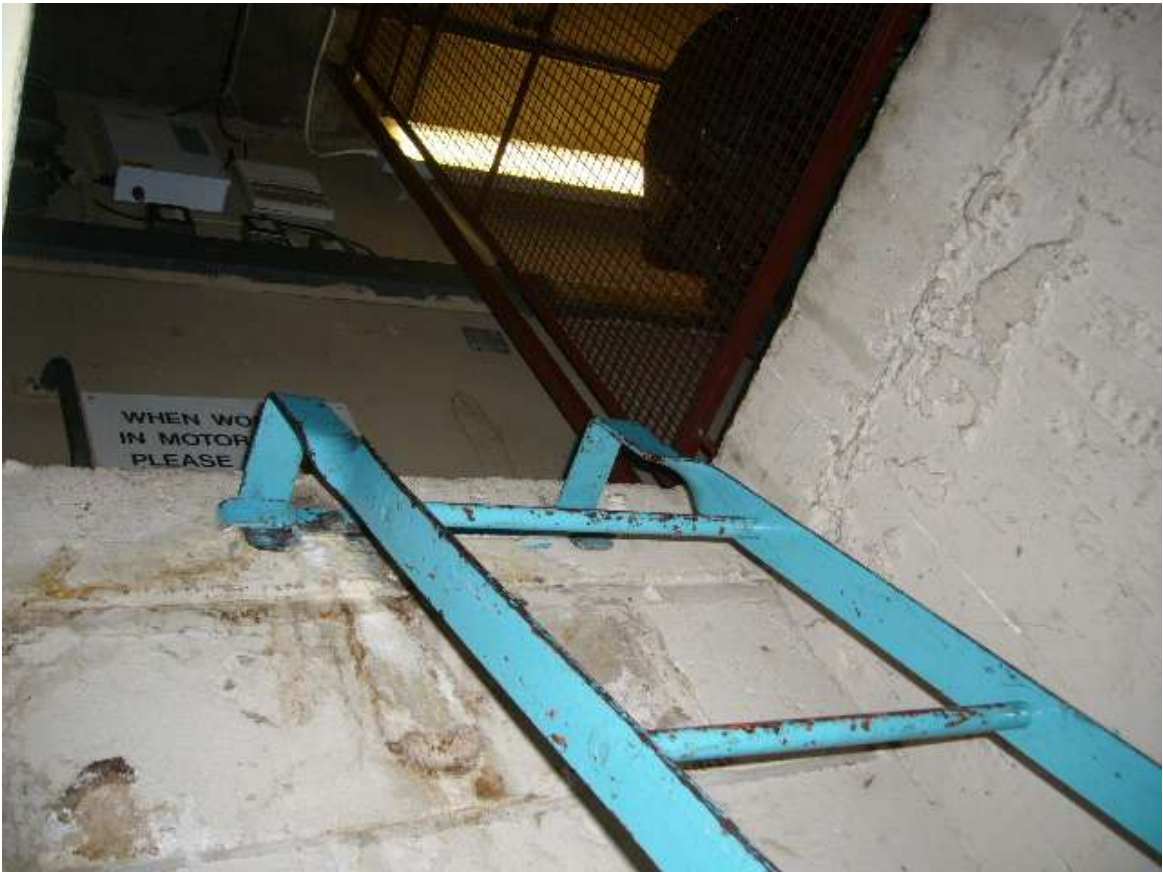
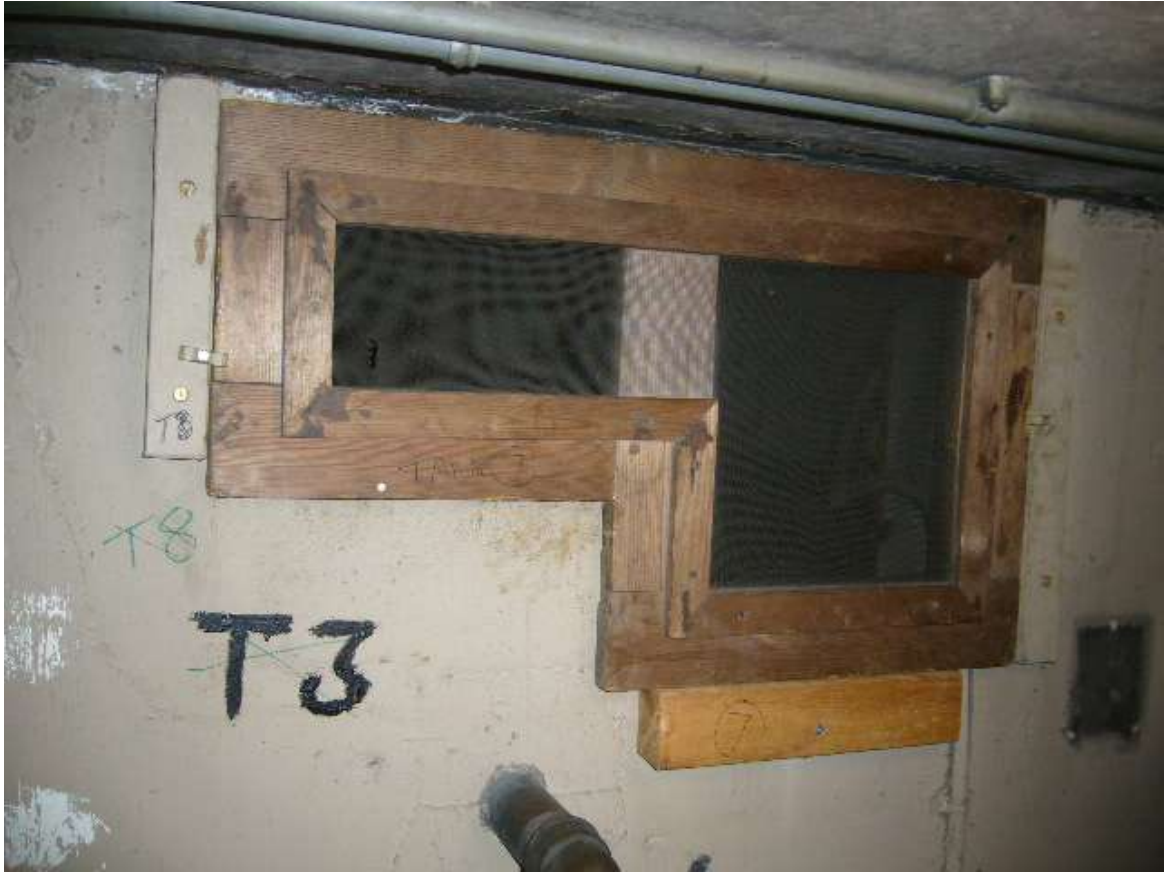
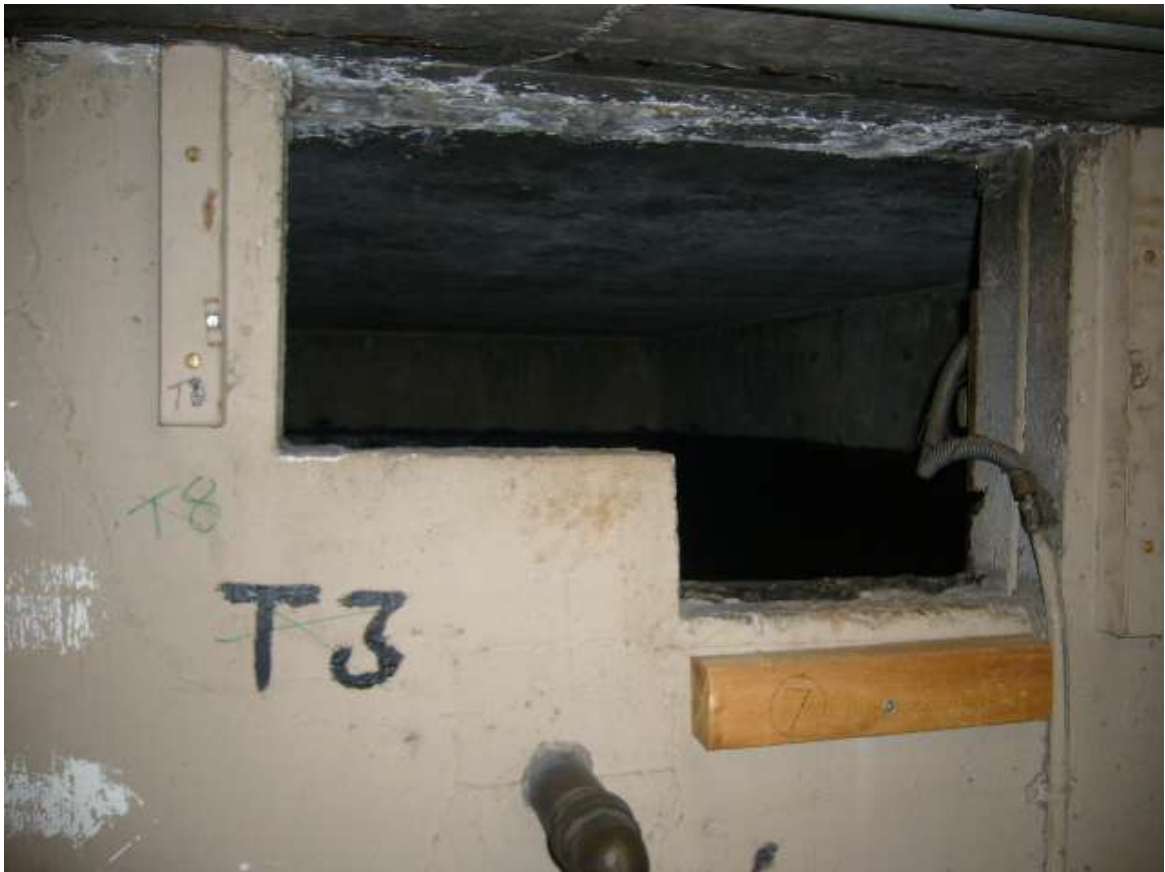
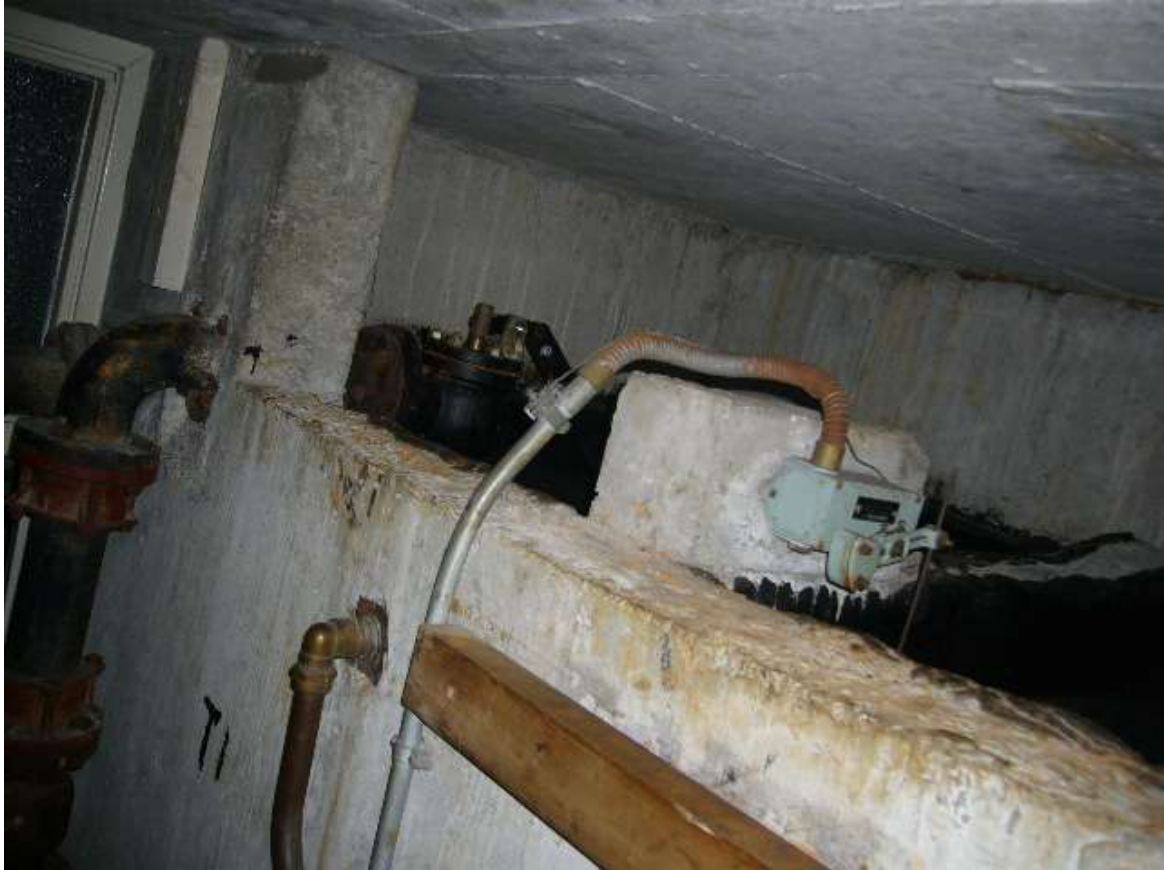
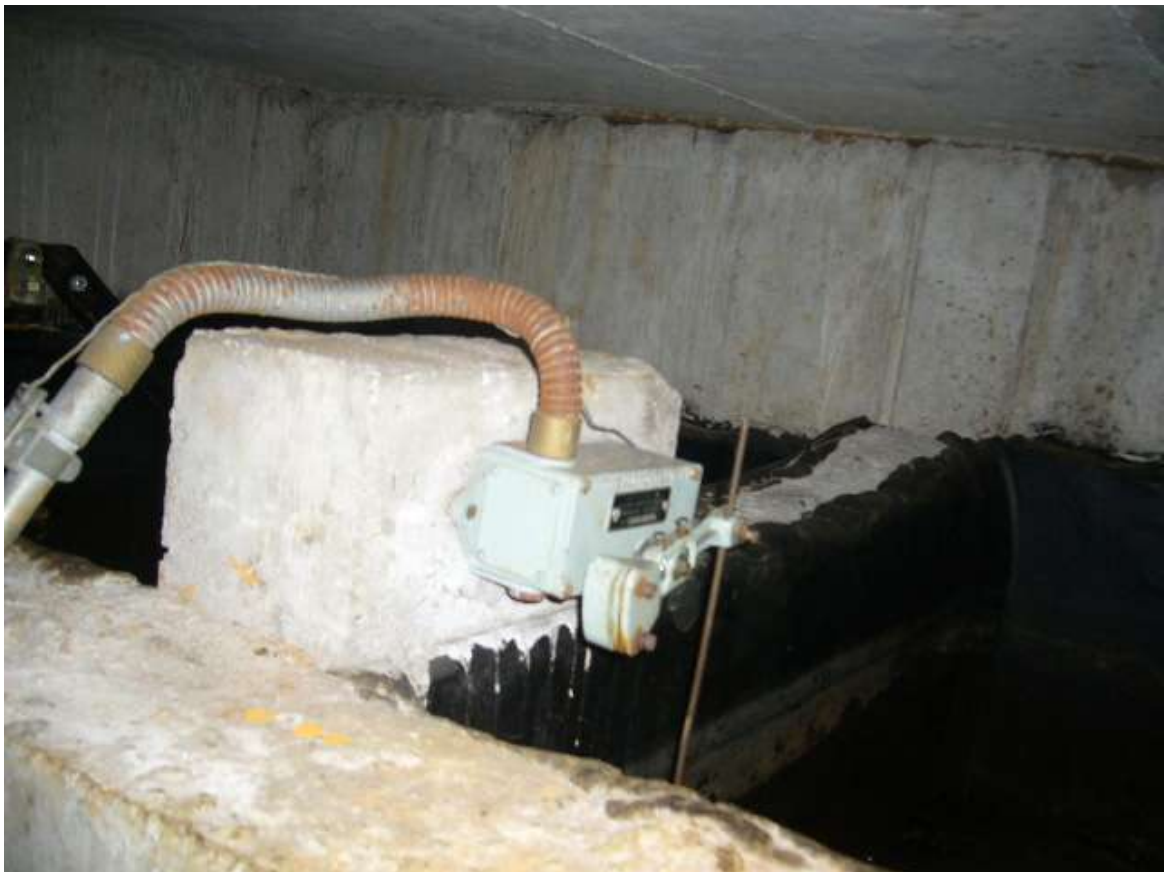
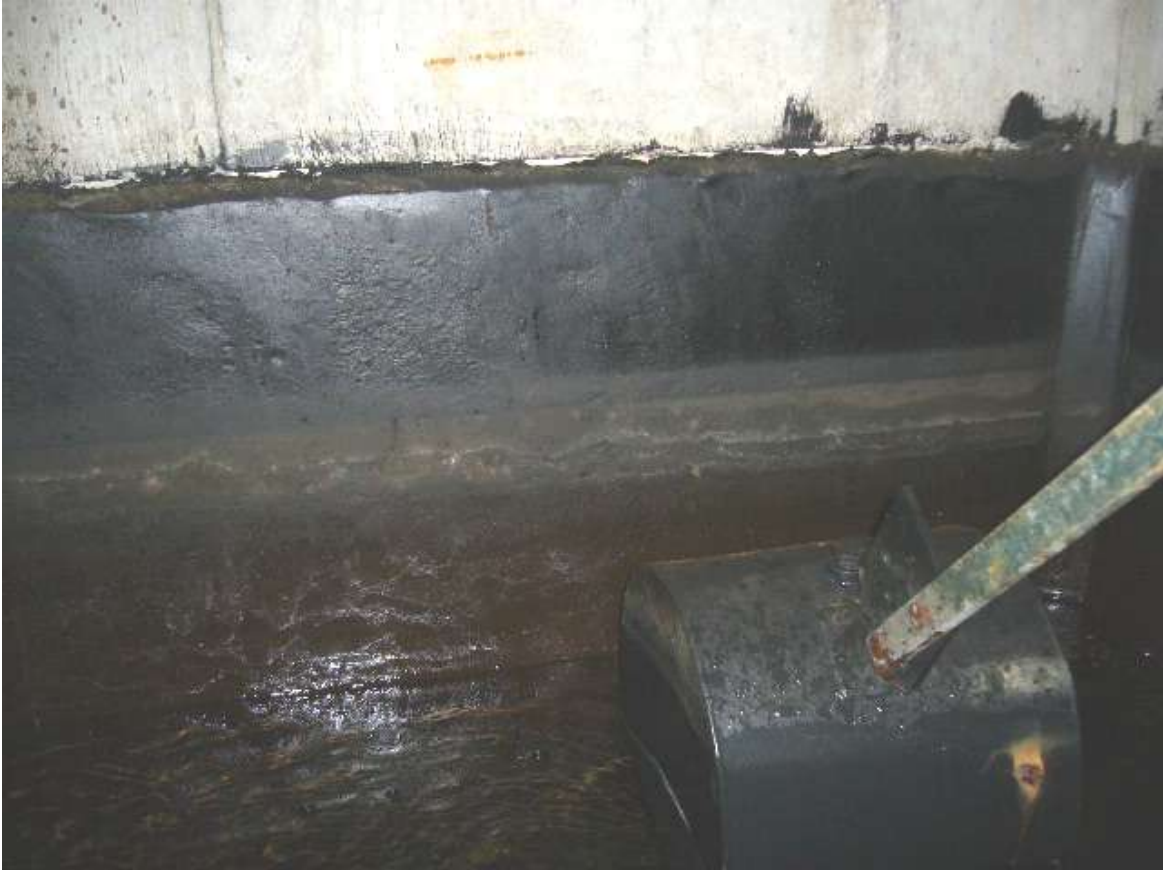
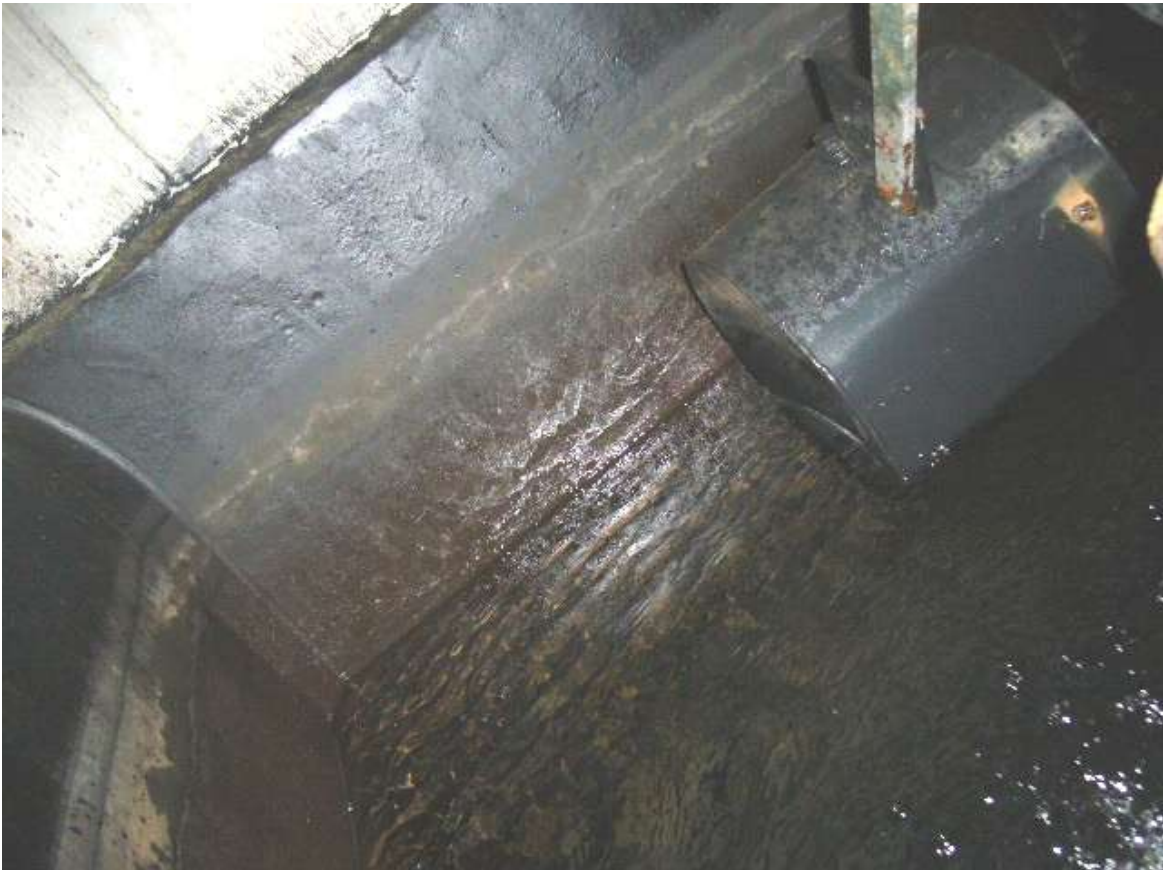
The above and following photographs show typical access to the concrete water retaining structures.

The photographs show the structures both filled with water and drained but prior to any preparation work.

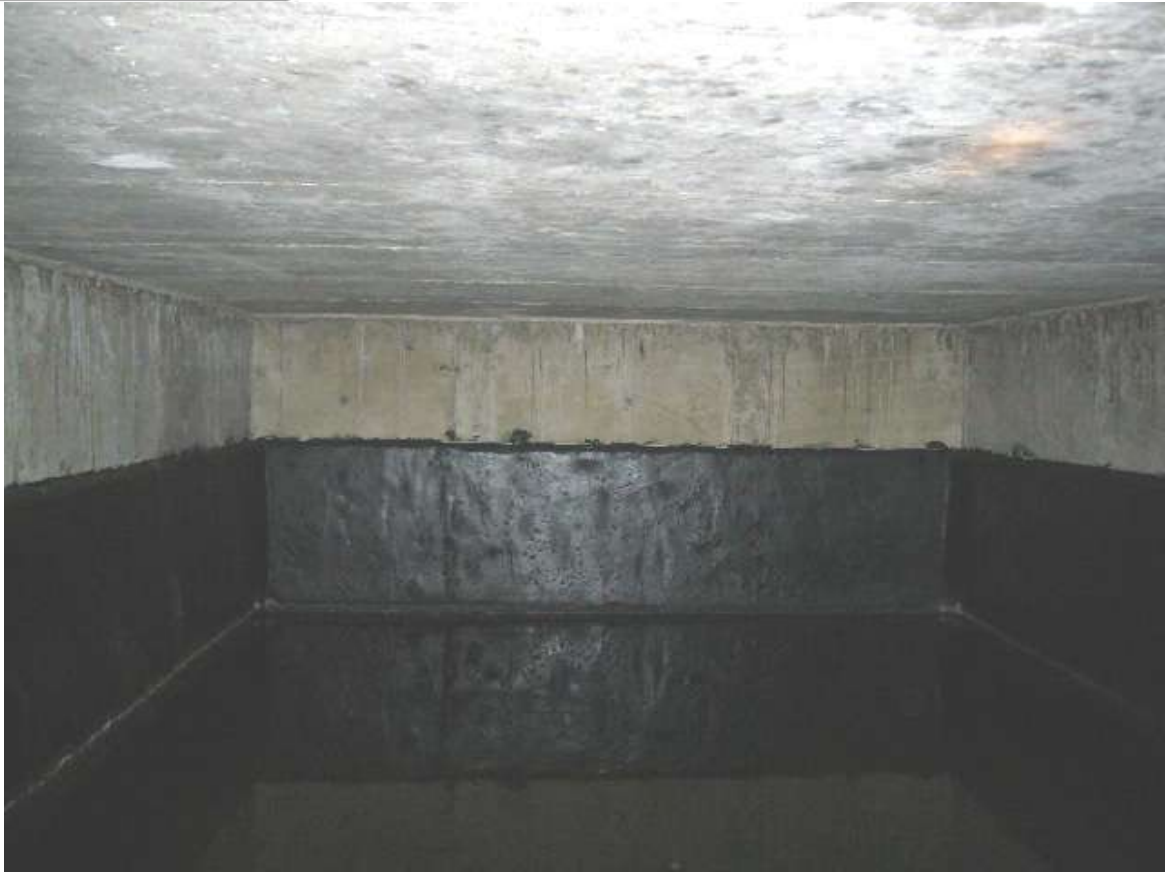
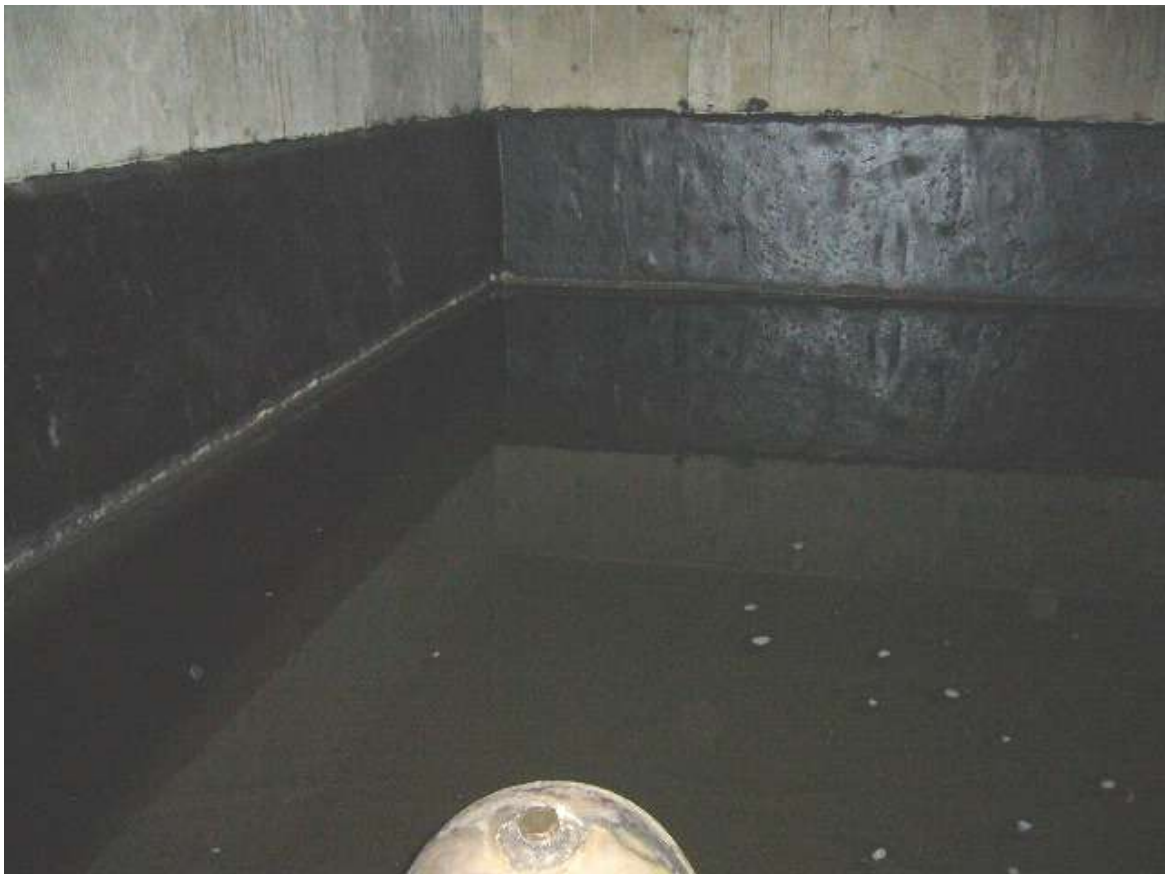
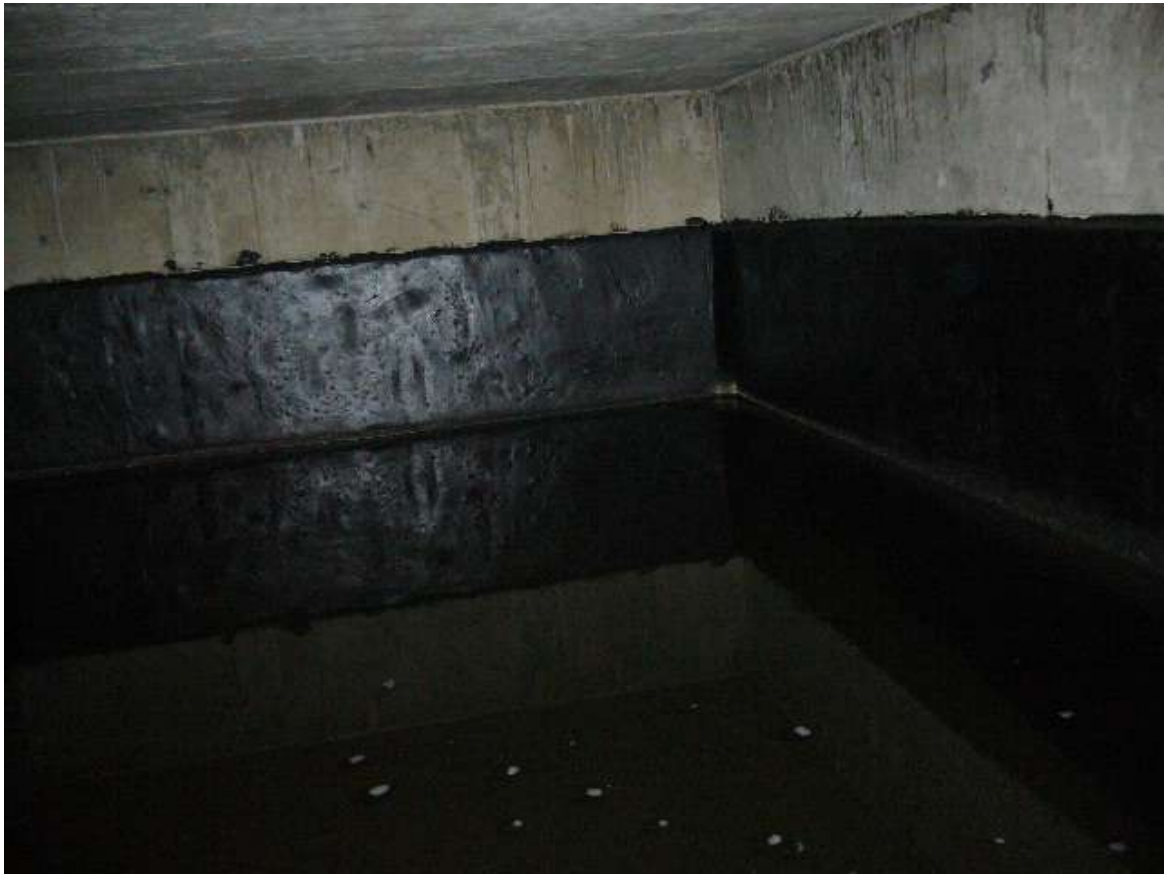
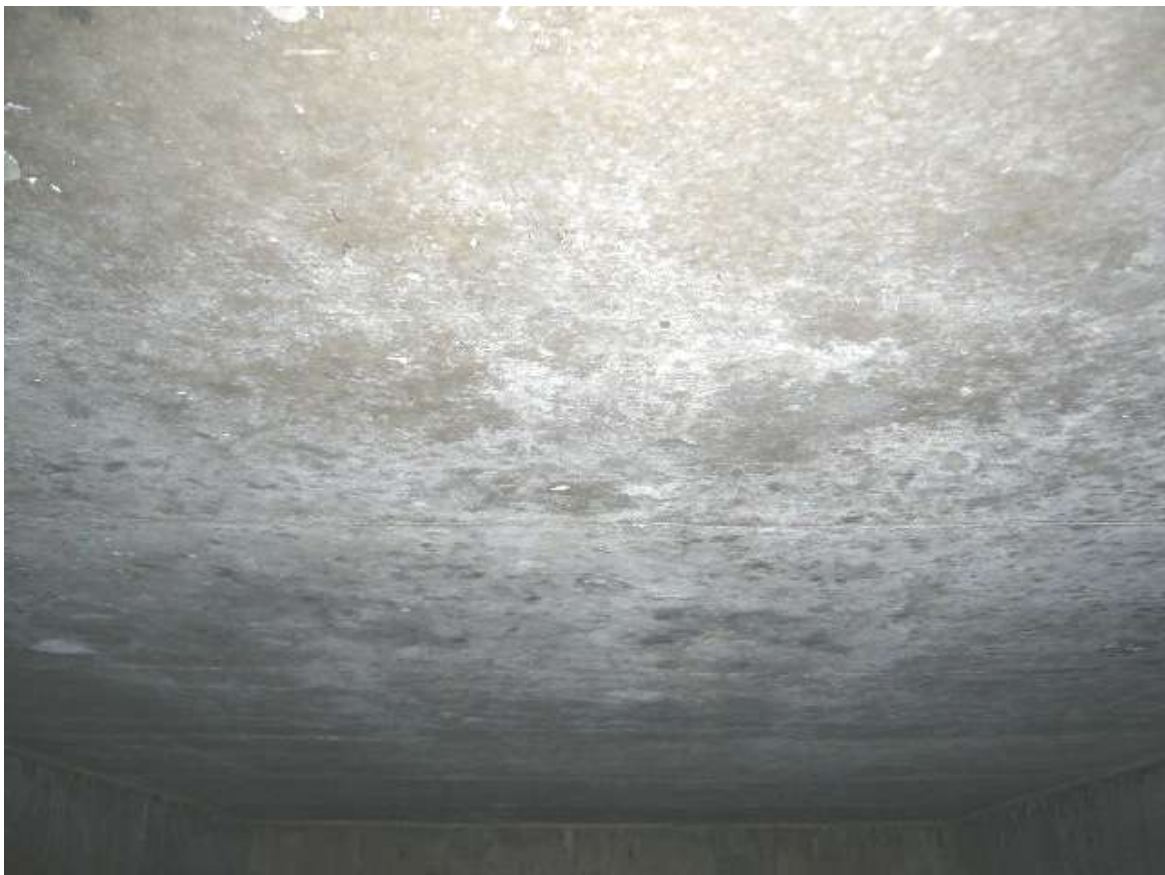
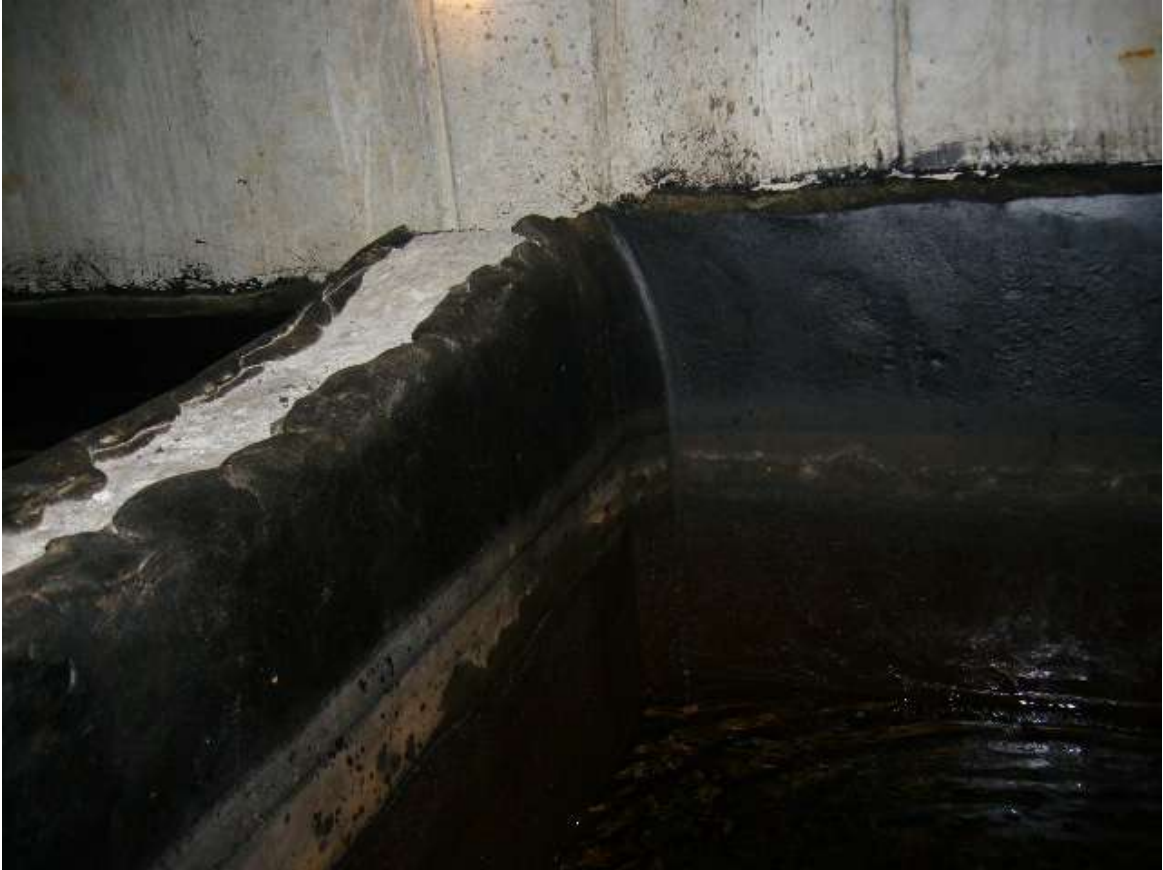
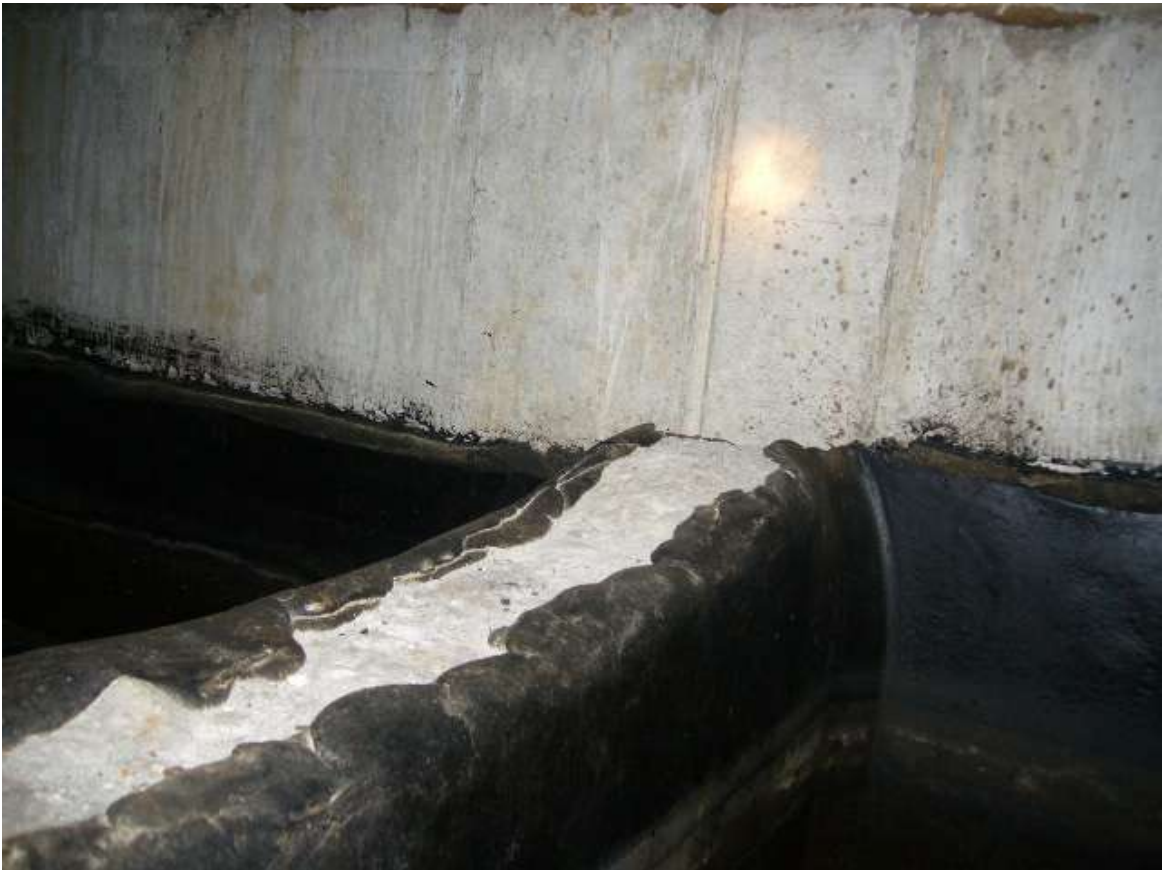
Internally the tanks had previously been coated up to the water line with asphalt, above the water line & the underside of the roof slab was bare concrete.

As the roof of the tanks form part of the plant room ceiling, stalactites had formed over the years into the tank caused by rain water leaking through the concrete roof.

These images show the asphalt coating that was previously applied up to the water line. Above the water line and the roof slab was bare concrete.

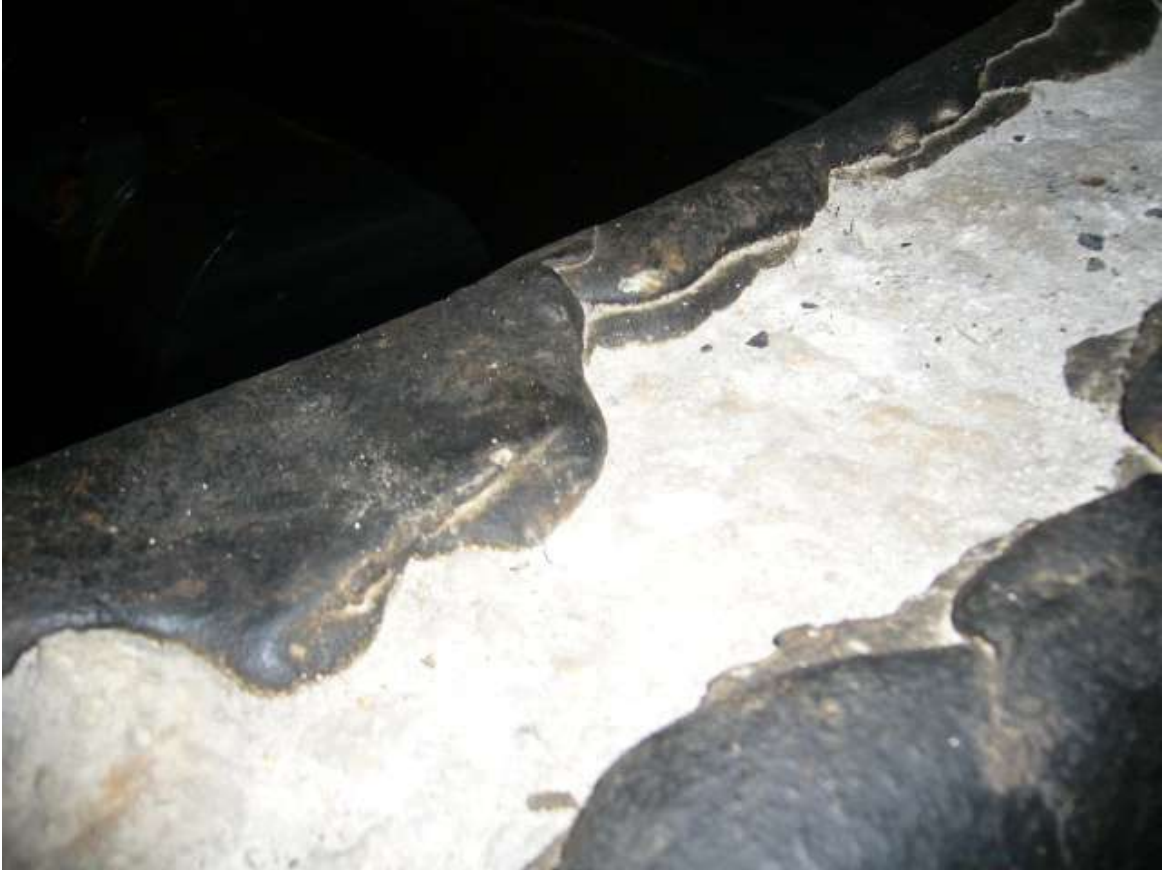
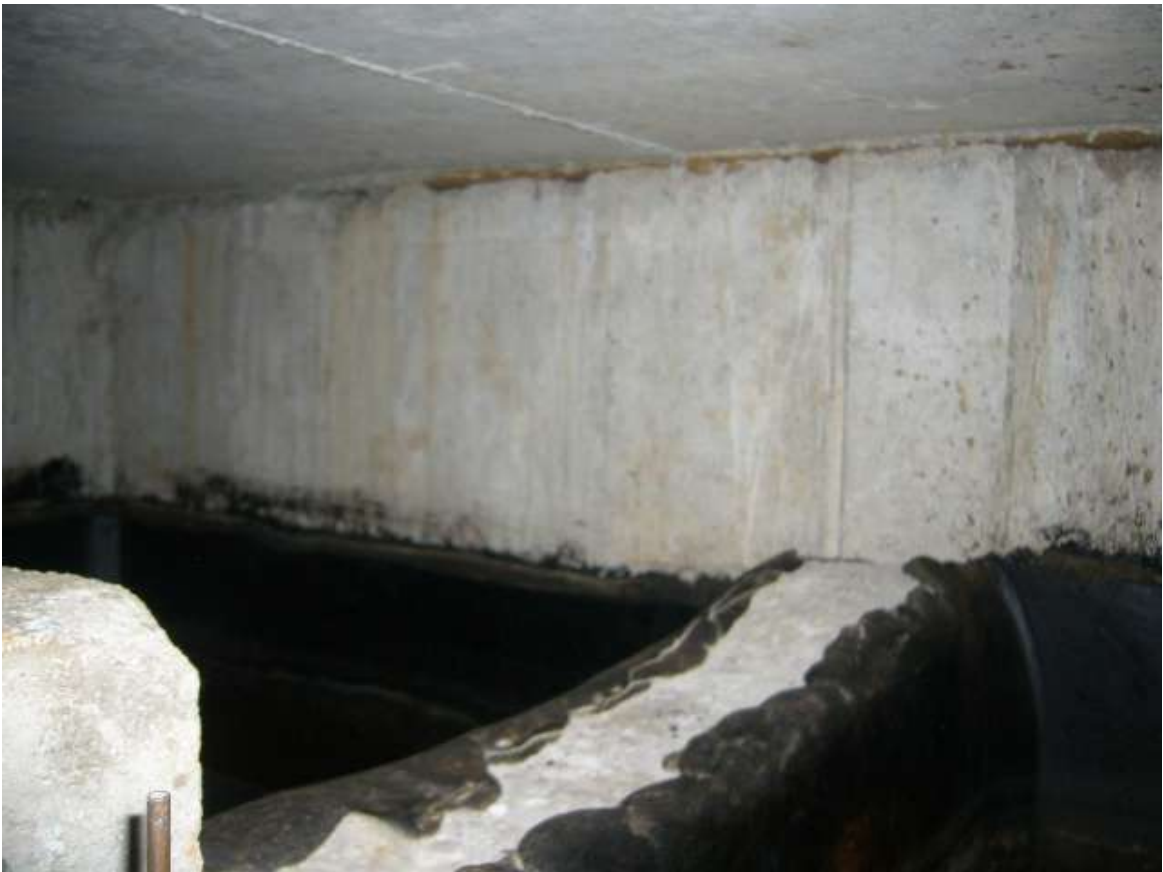
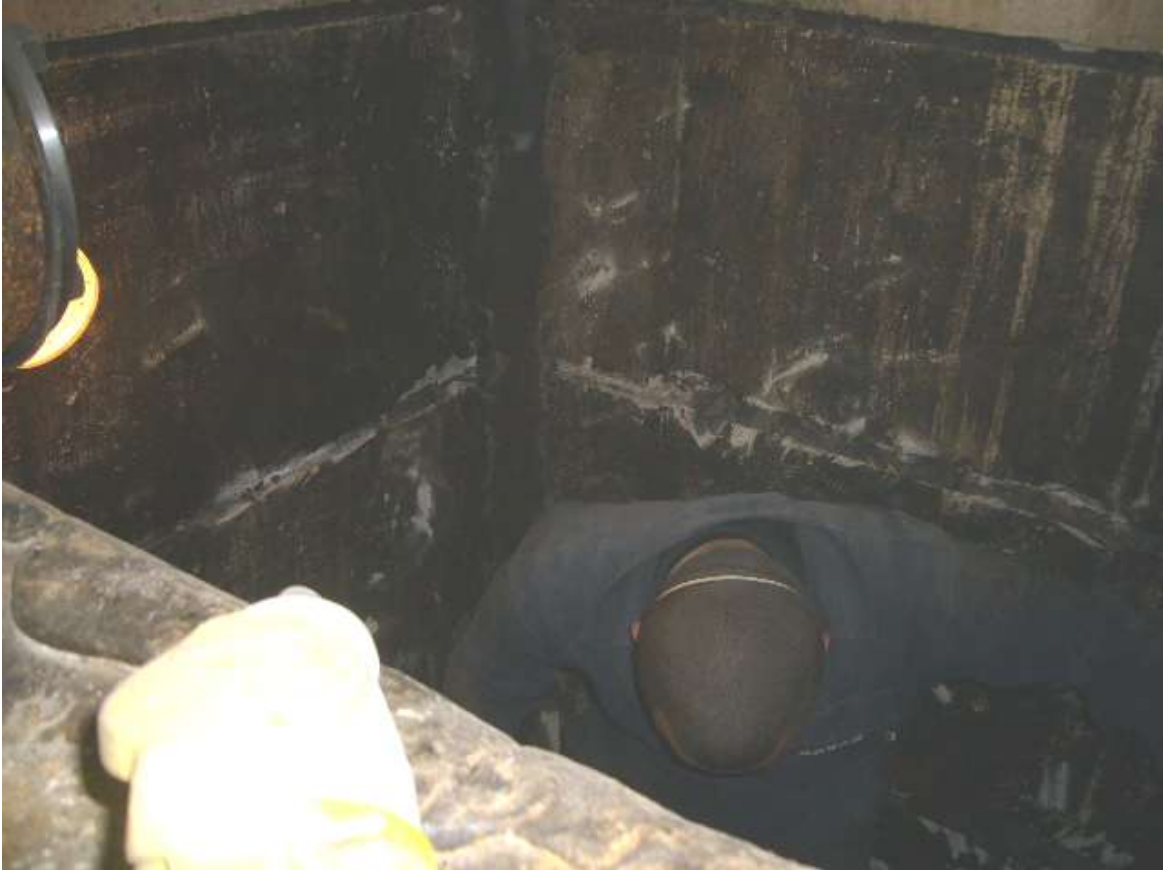
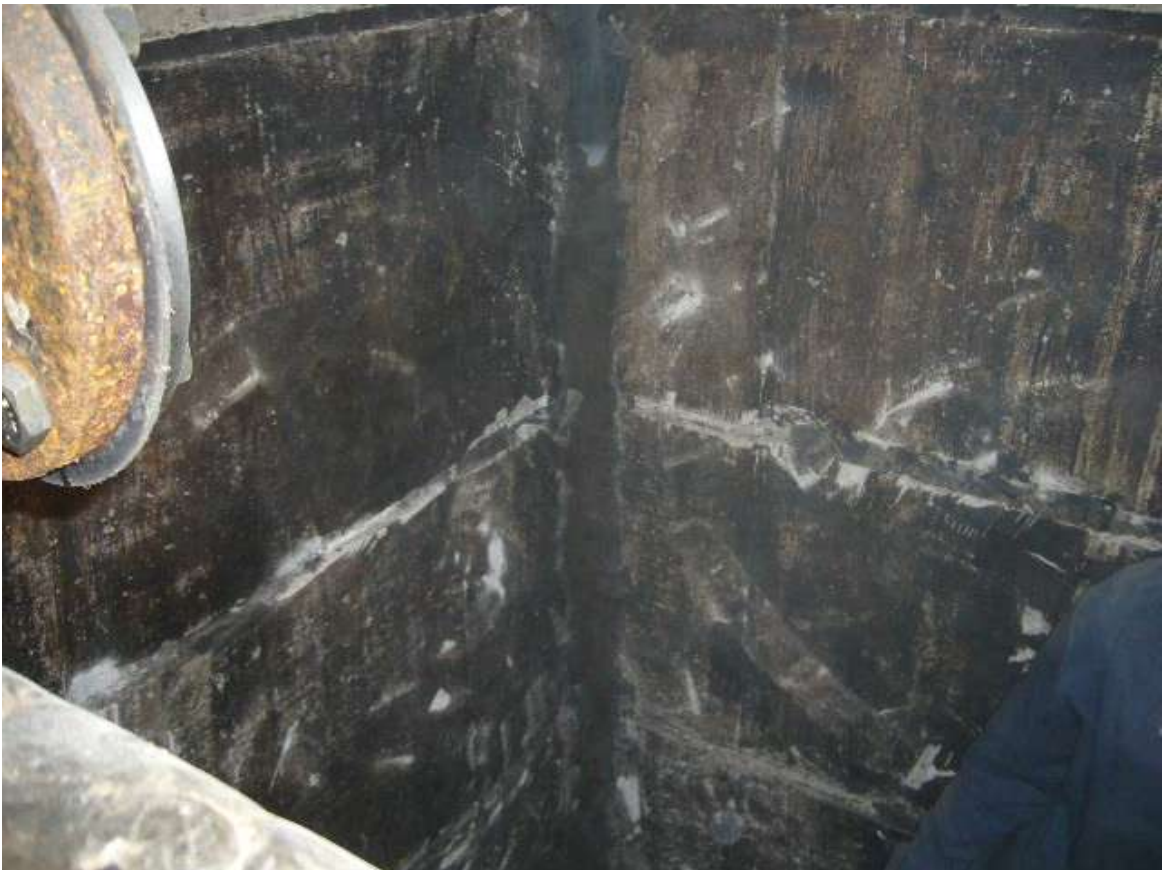
These photographs show the internal surfaces whilst being prepared by COVAC operatives to raise a suitable surface profile.

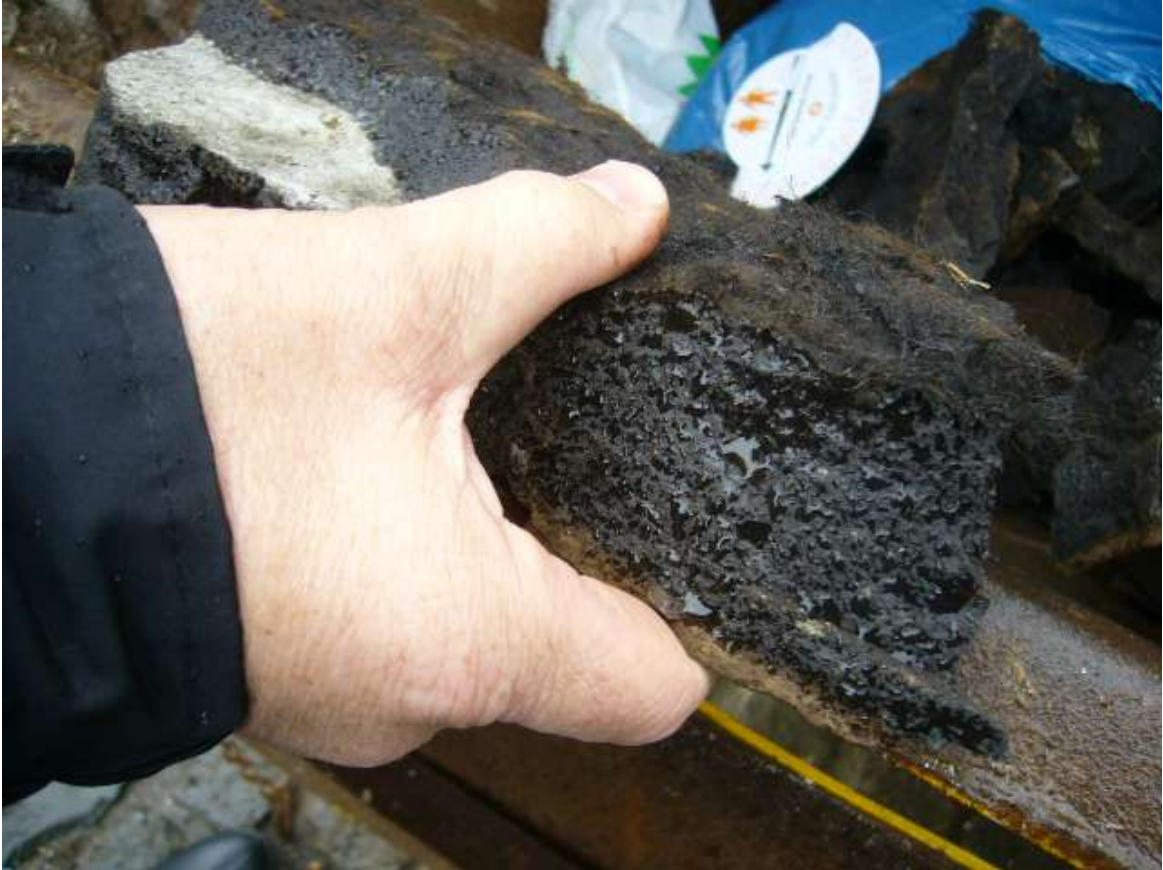
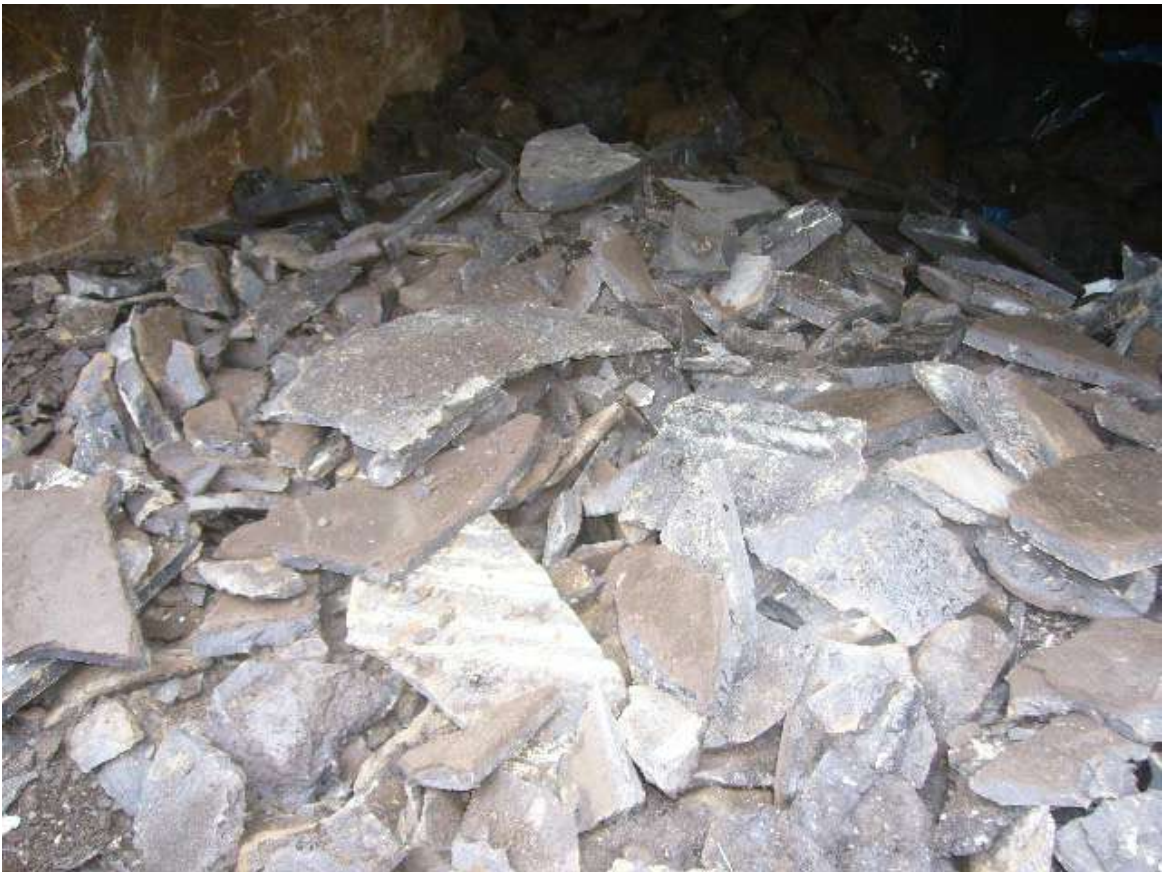
These images show the thickness and quantity of the asphalt coating removed from the internal substrate of the tanks.

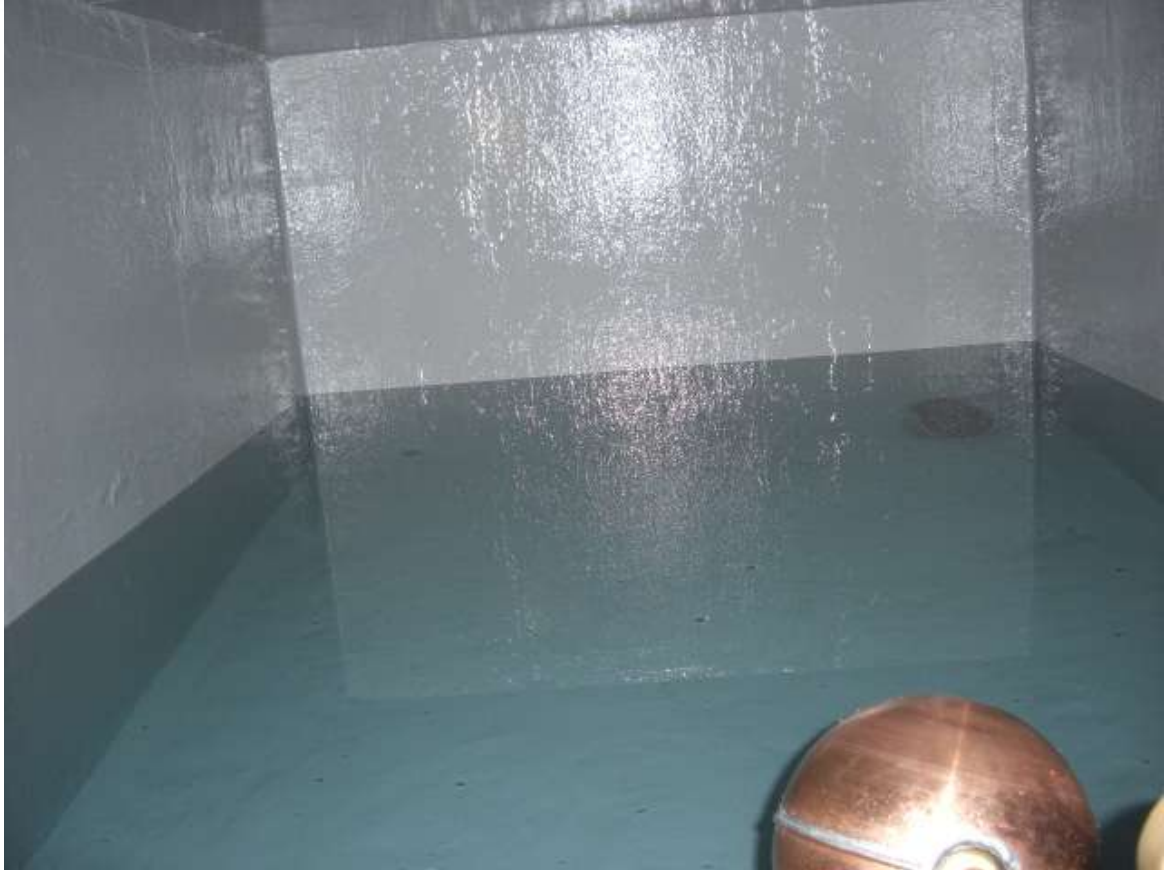
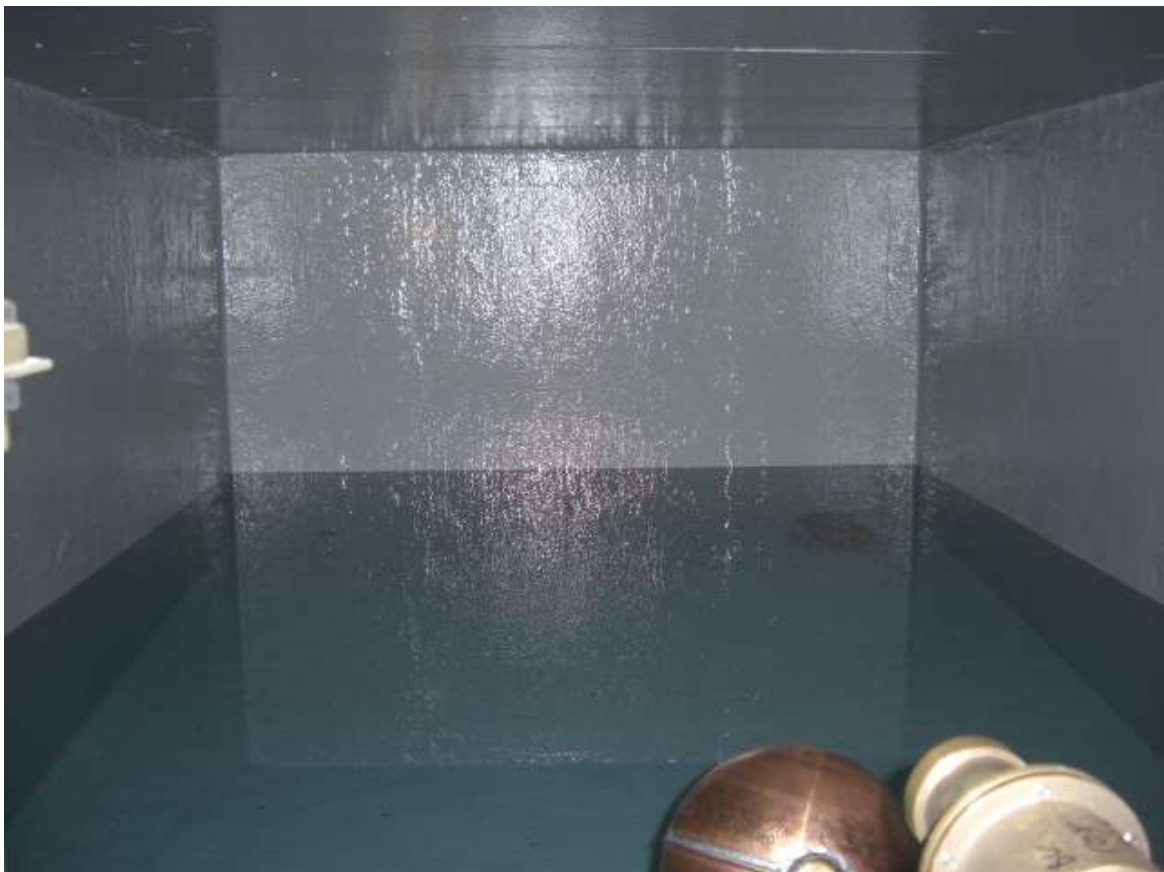
All intricate areas were again 'stripe coated' for a second time followed by the final application of the 2nd coat of 3M Scotchkote™ 165PW. These images show the tanks fully relined and refilled with potable water.
