# COMPLETION REPORT

Project Brief : **The Internal Relining of 8 No. BAC Cooling Tower Sumps  
(1 No. Tower in this Sample Report)**

Site Address : **XXXXXXXXX Bank  
London**

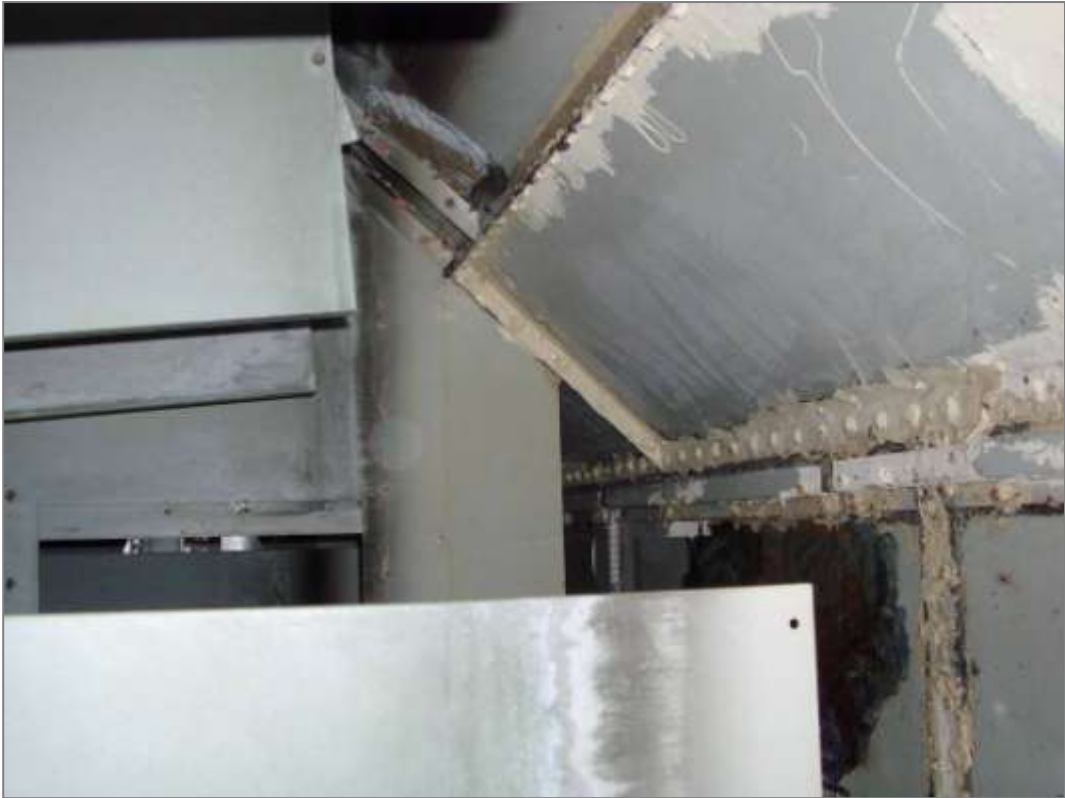
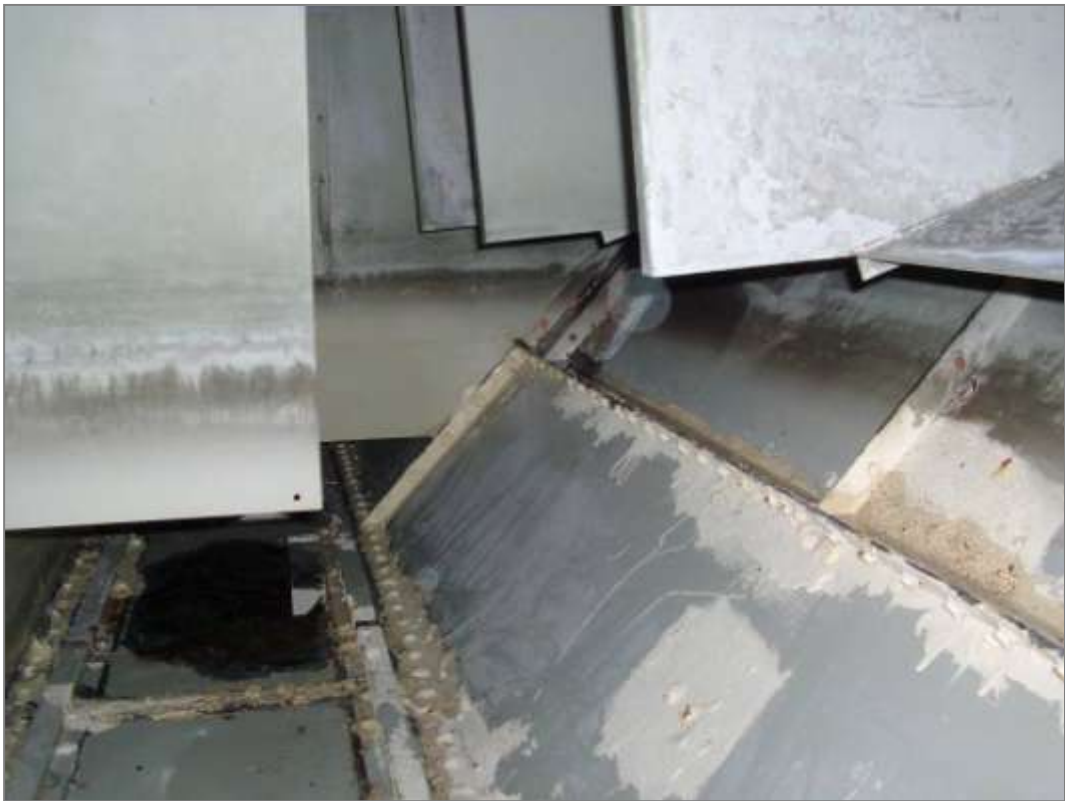
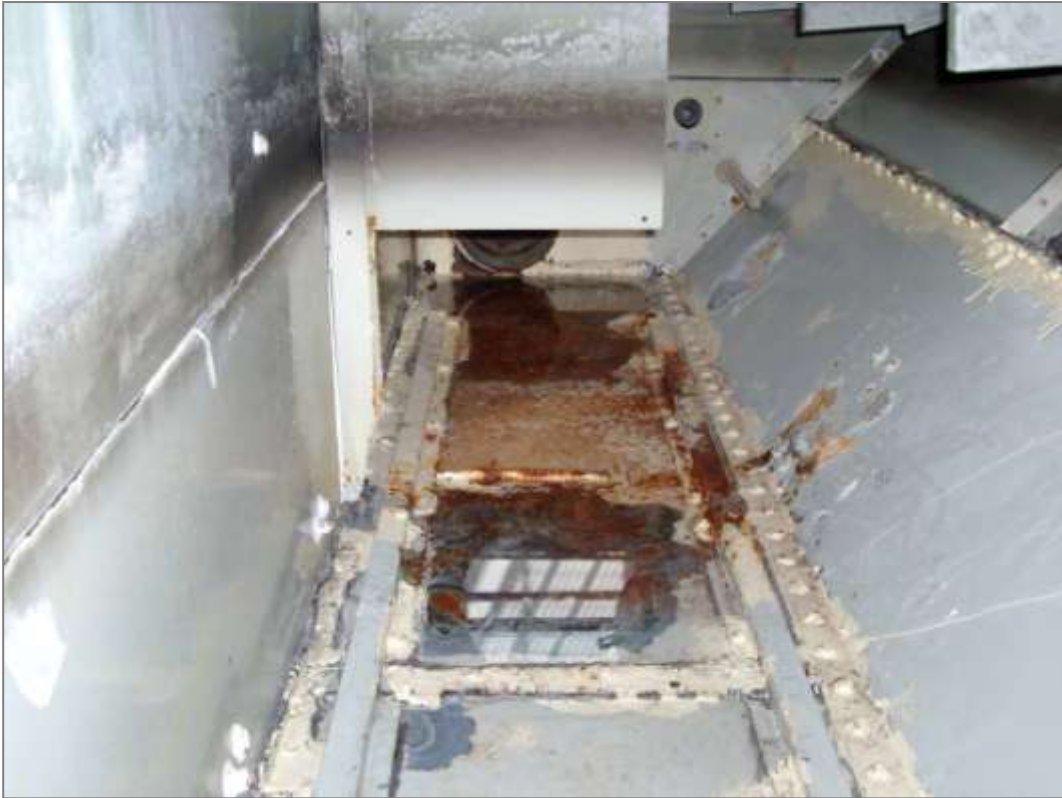
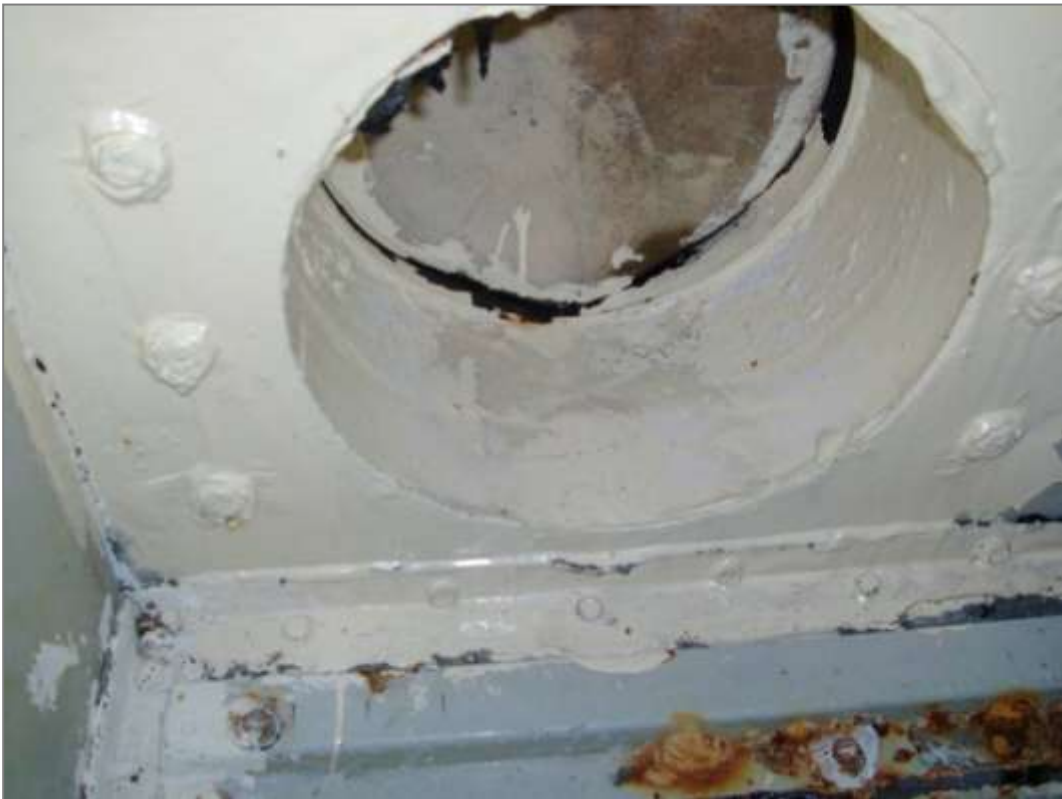
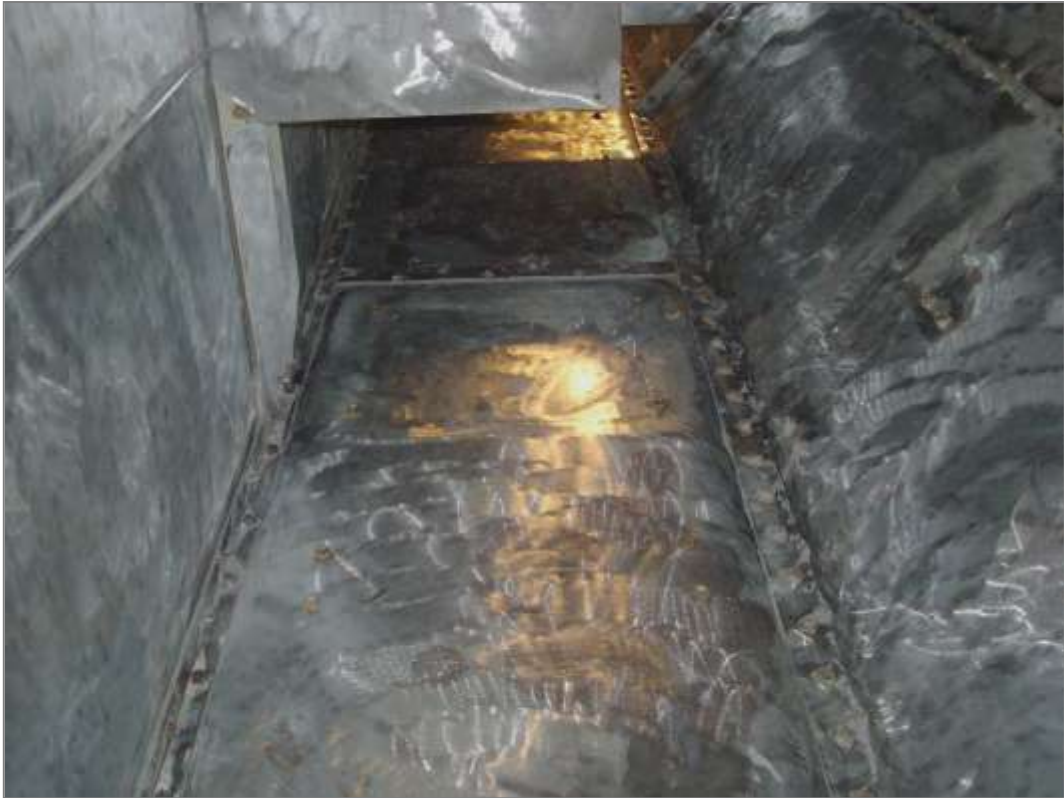
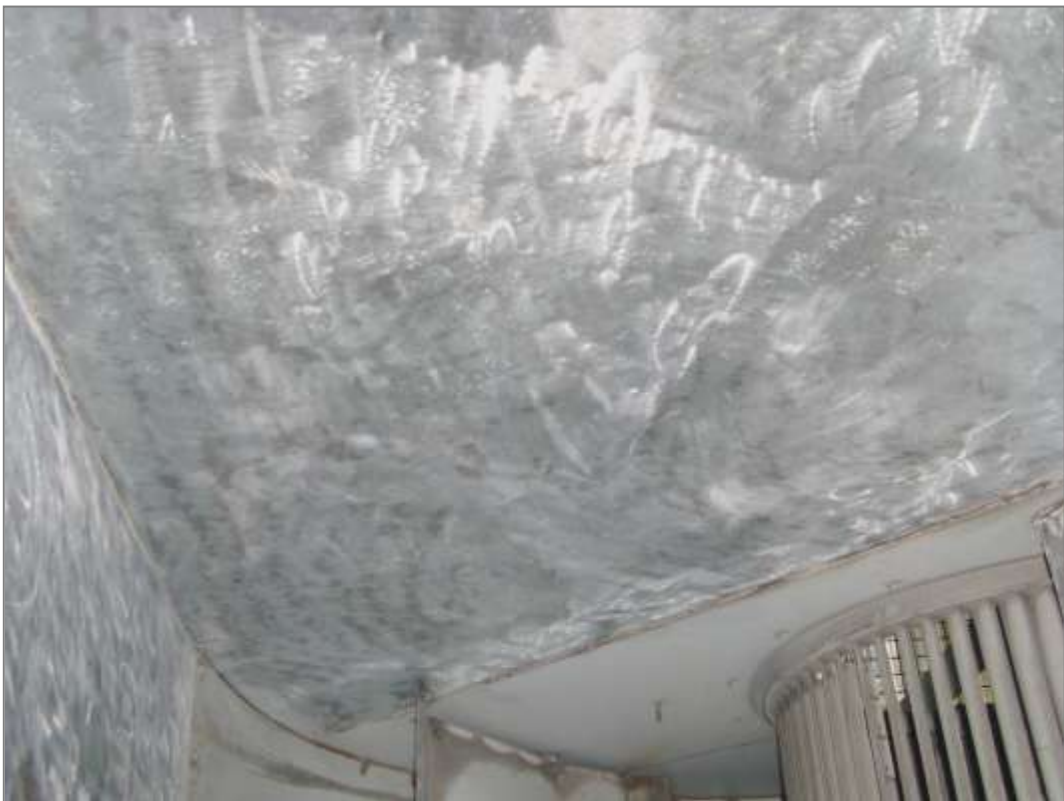
**These pictures show the substrate following preparation by COVAC Operatives using Tungsten Carbide Scabblatex Units and Scrapers in accordance with ISO 8501-1:2007.**

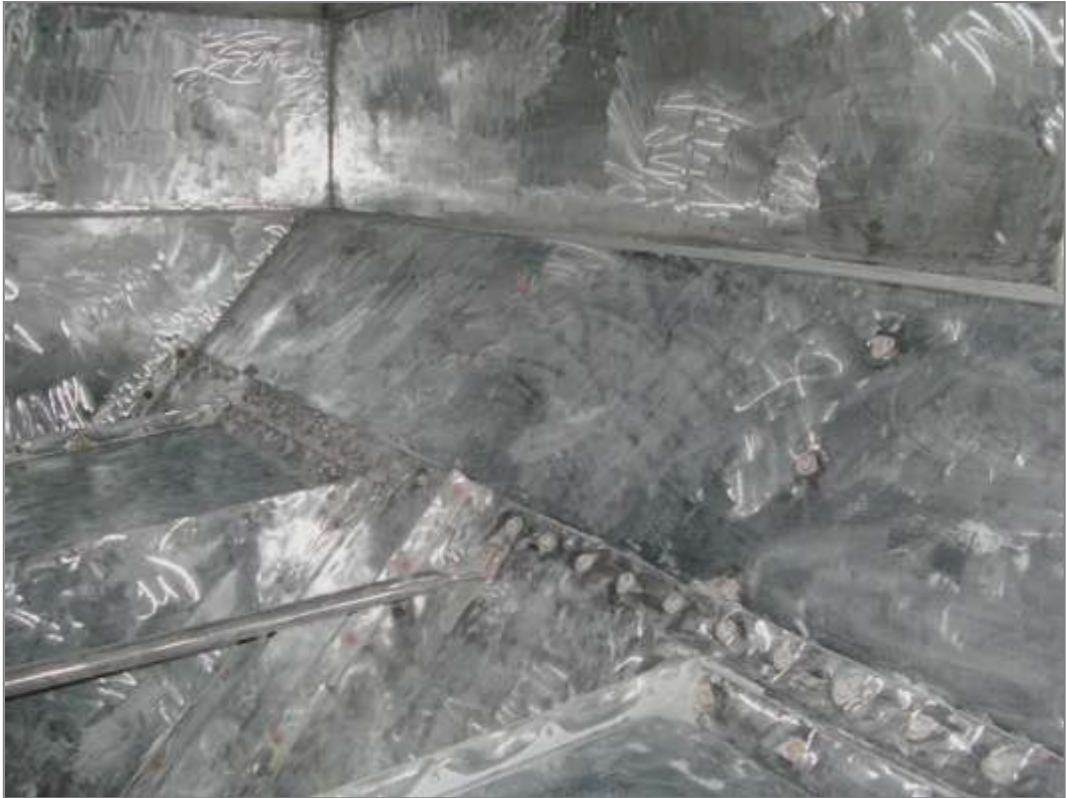
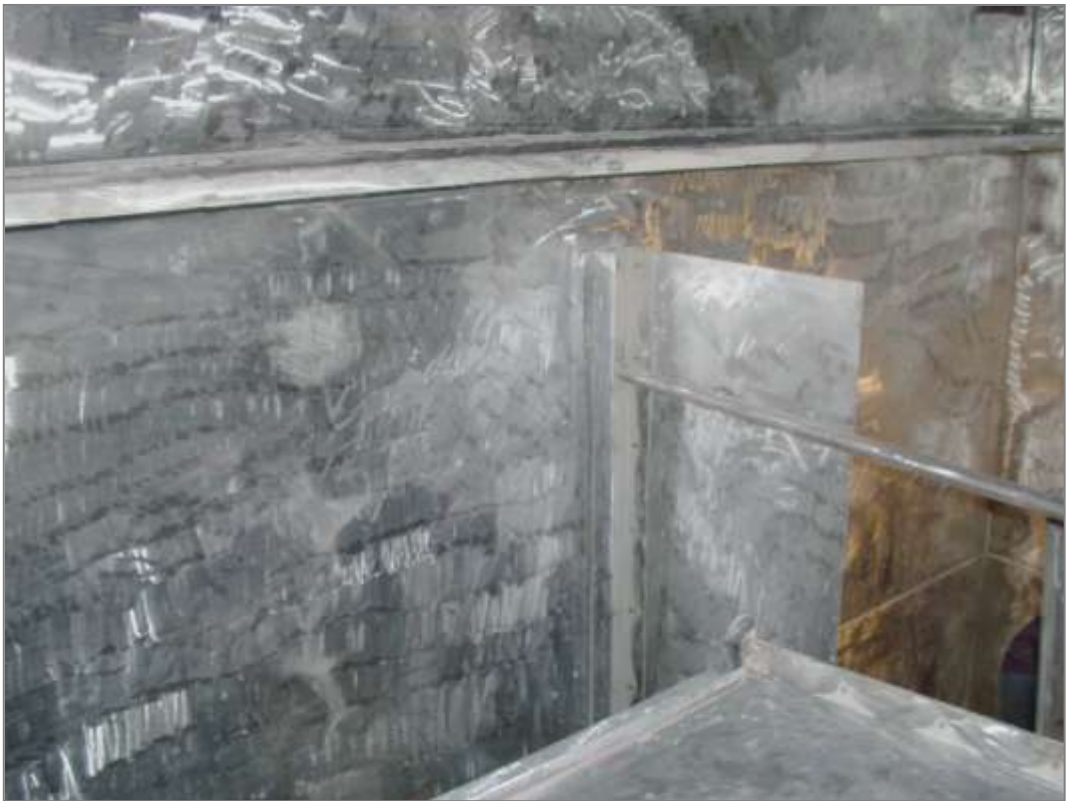
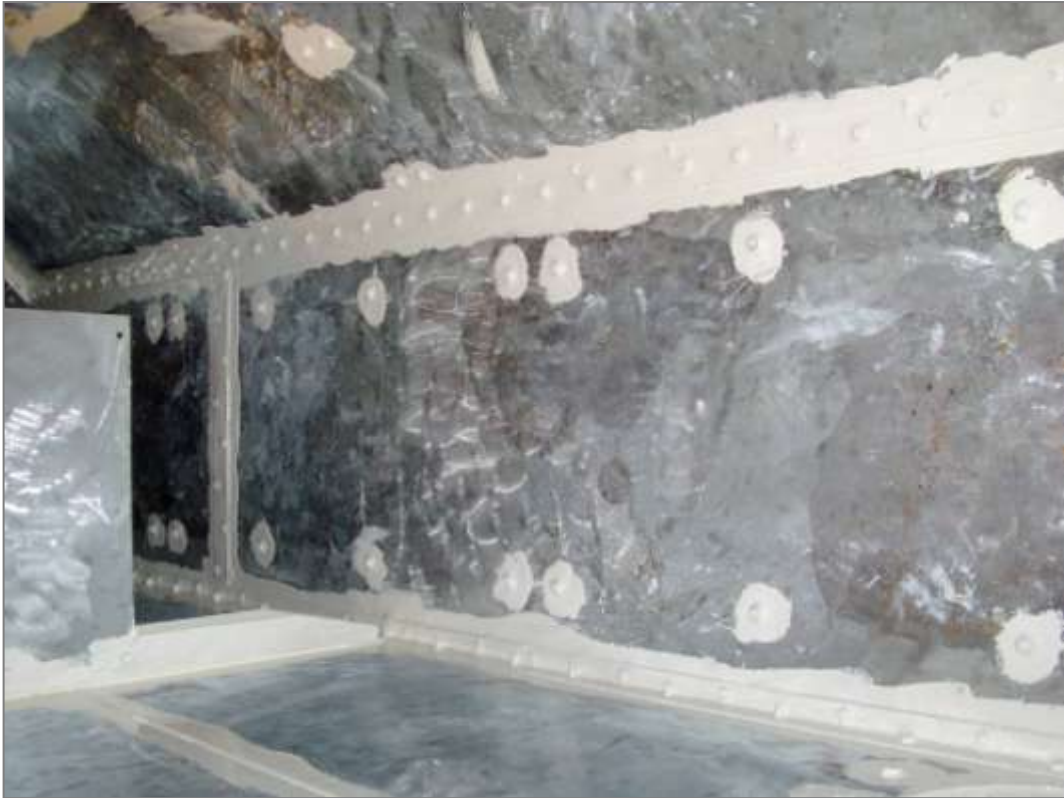
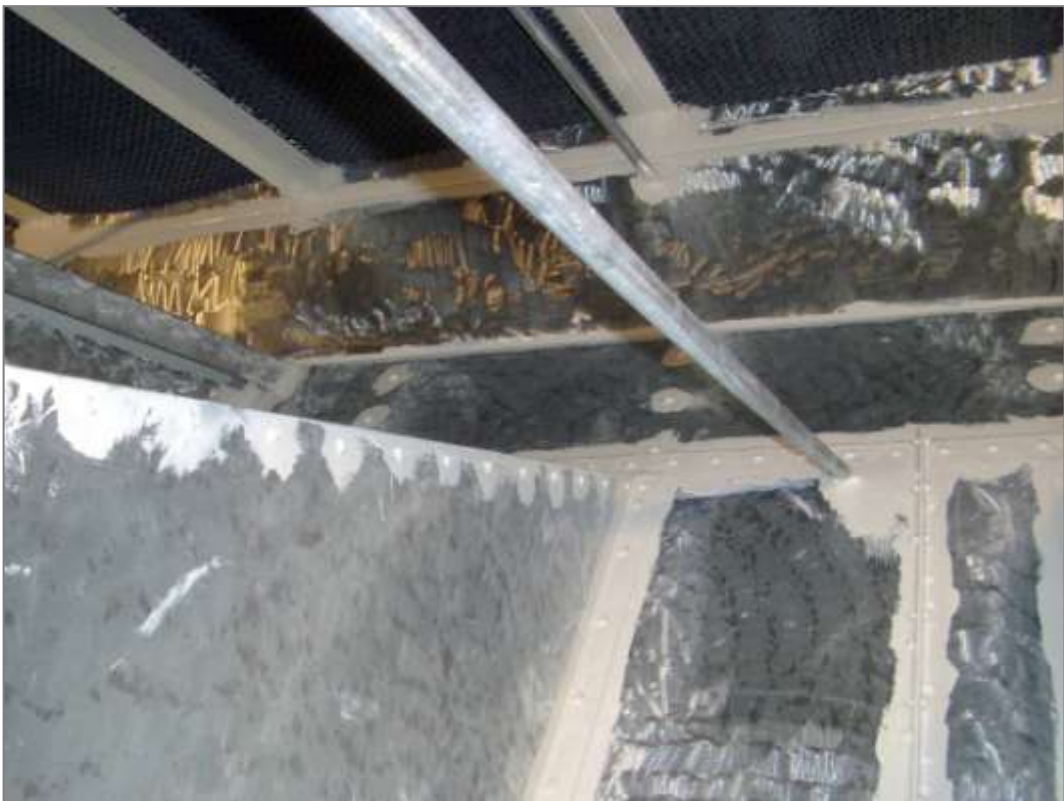
All seams, joints, bolts etc were initially 'stripe coated' to ensure all intricate areas were coated prior to the 1<sup>st</sup> full coat of 3M Scotchkote™ 165PW Solvent Free Polyurethane.

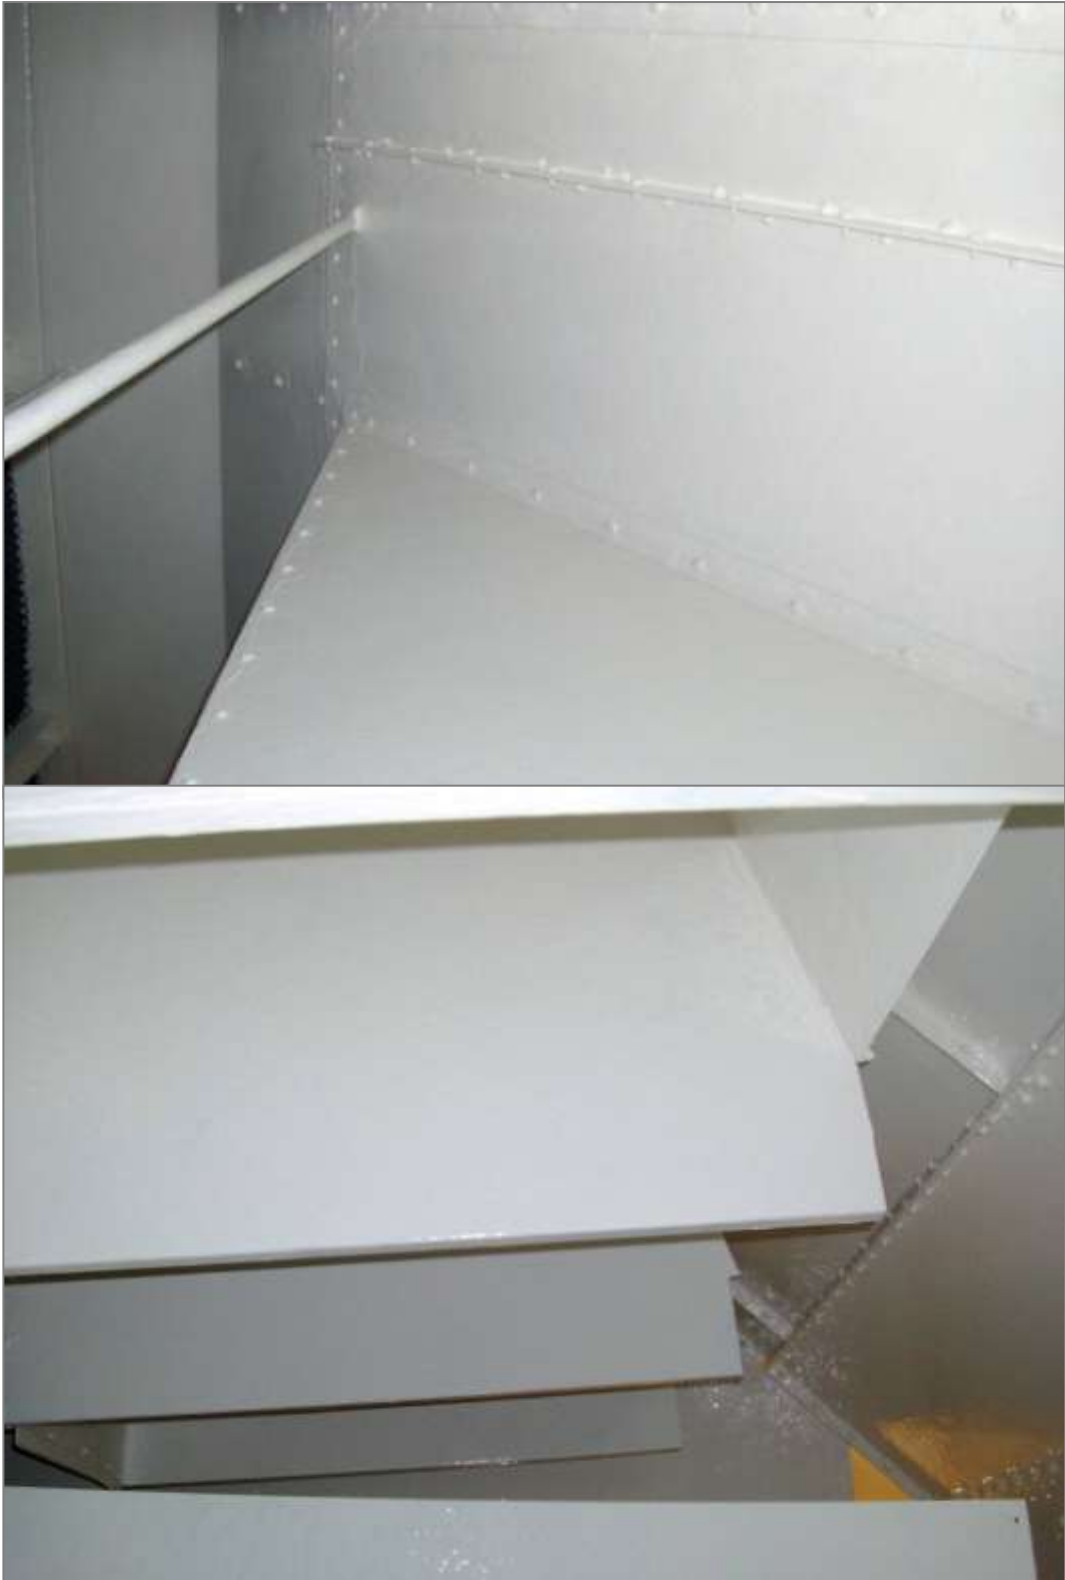
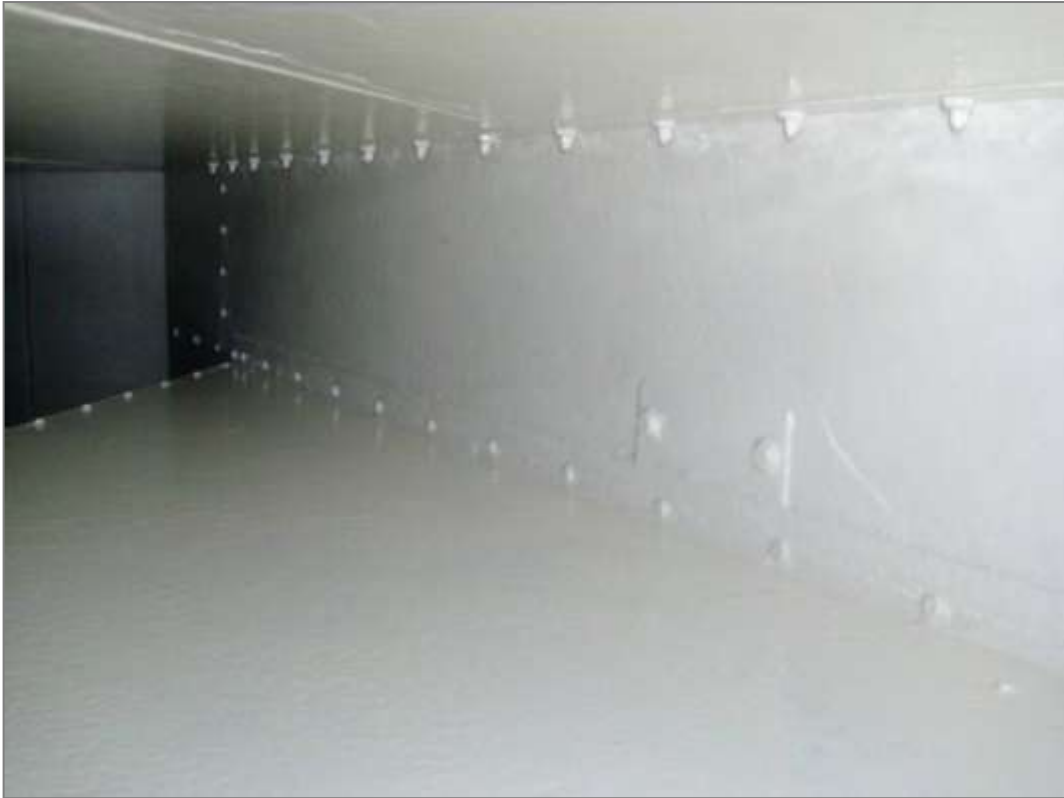
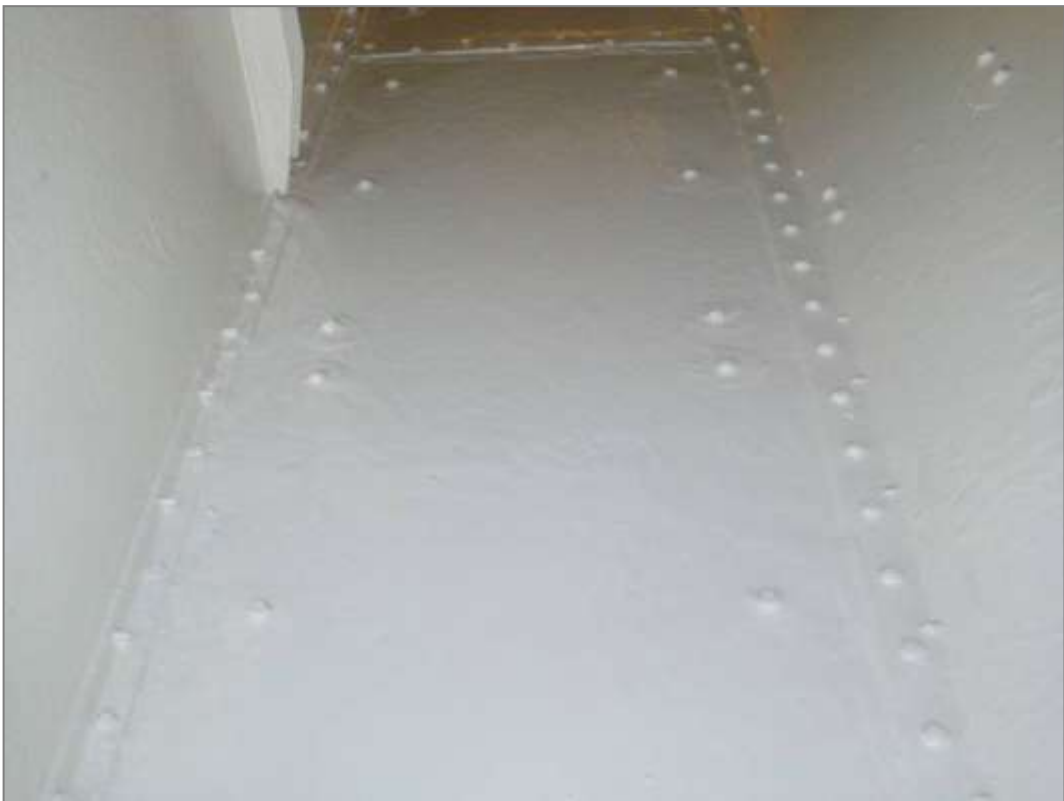
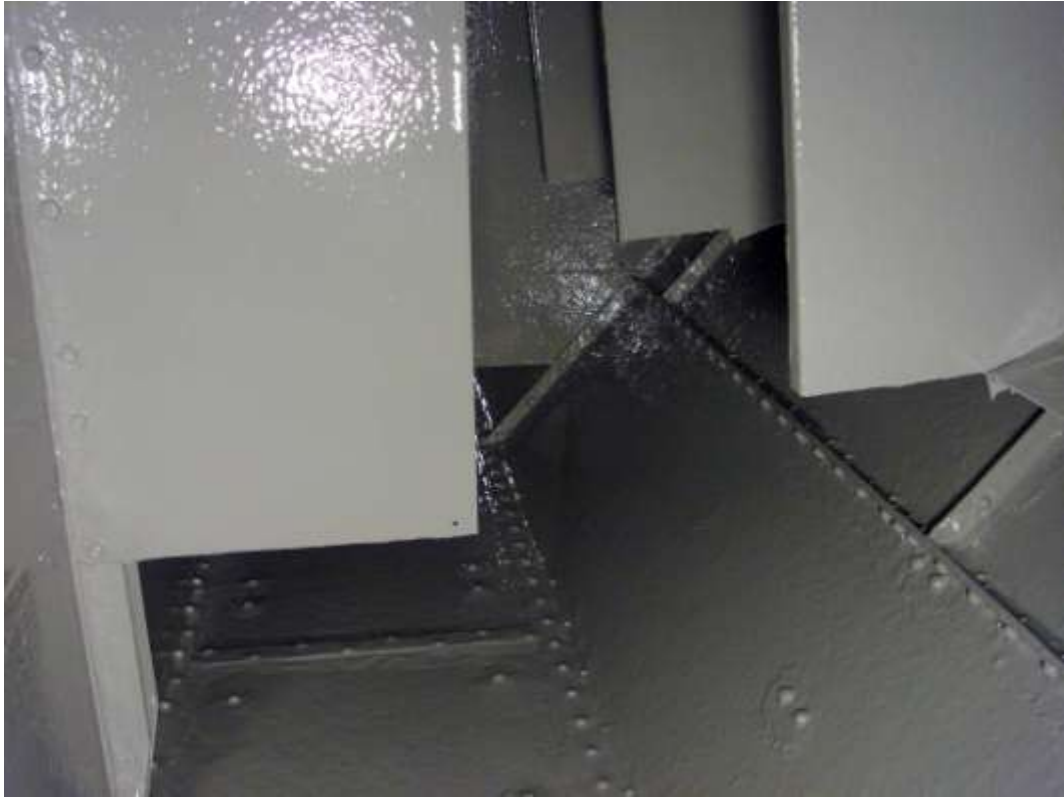
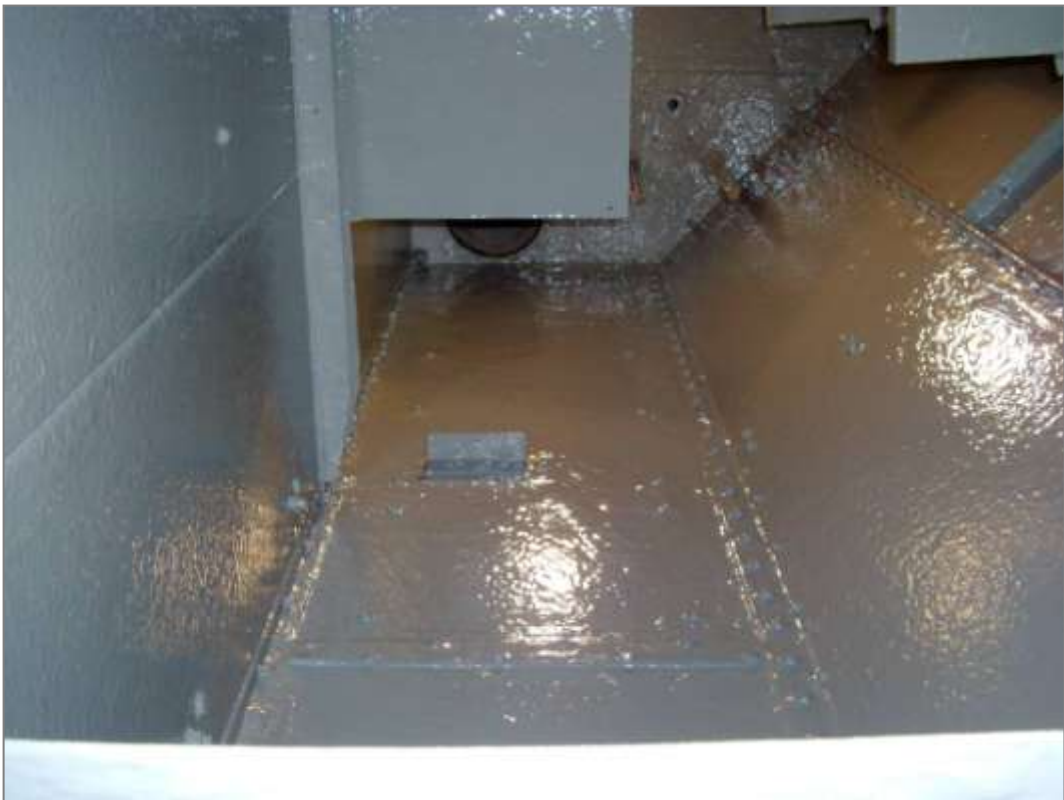
**These photographs show the substrate having received the 1<sup>st</sup> coat of 3M Scotchkote™ 165PW (cream) Solvent Free Polyurethane.**

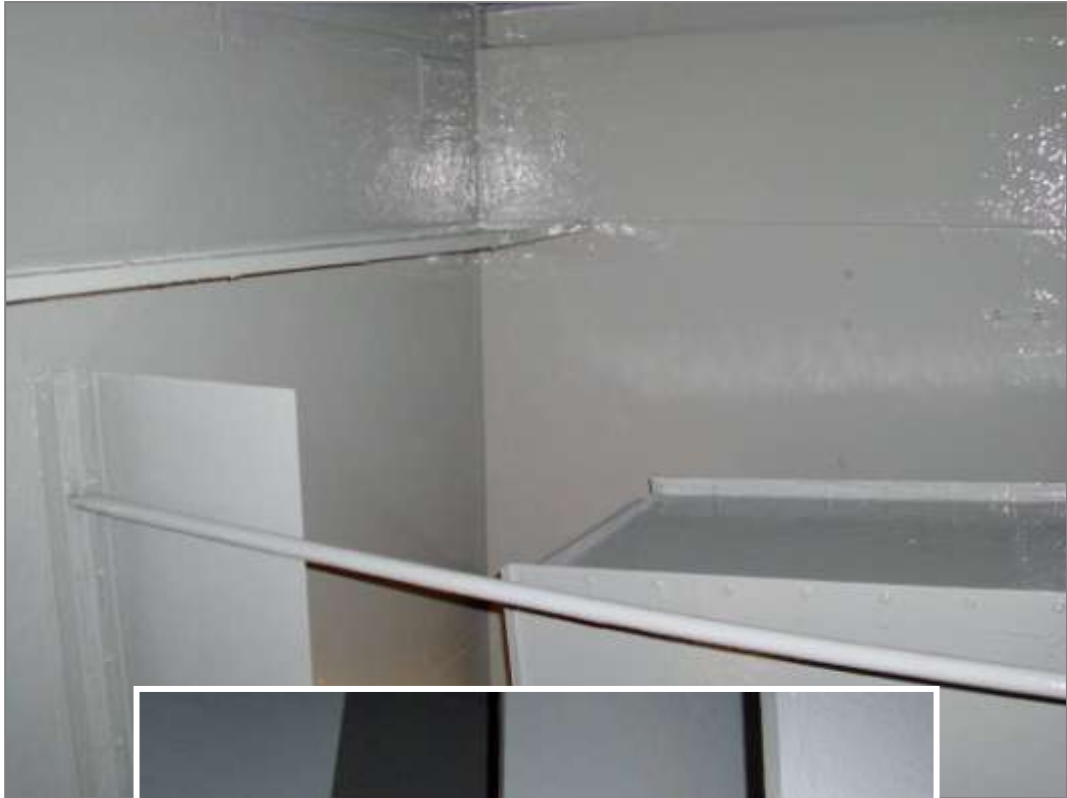
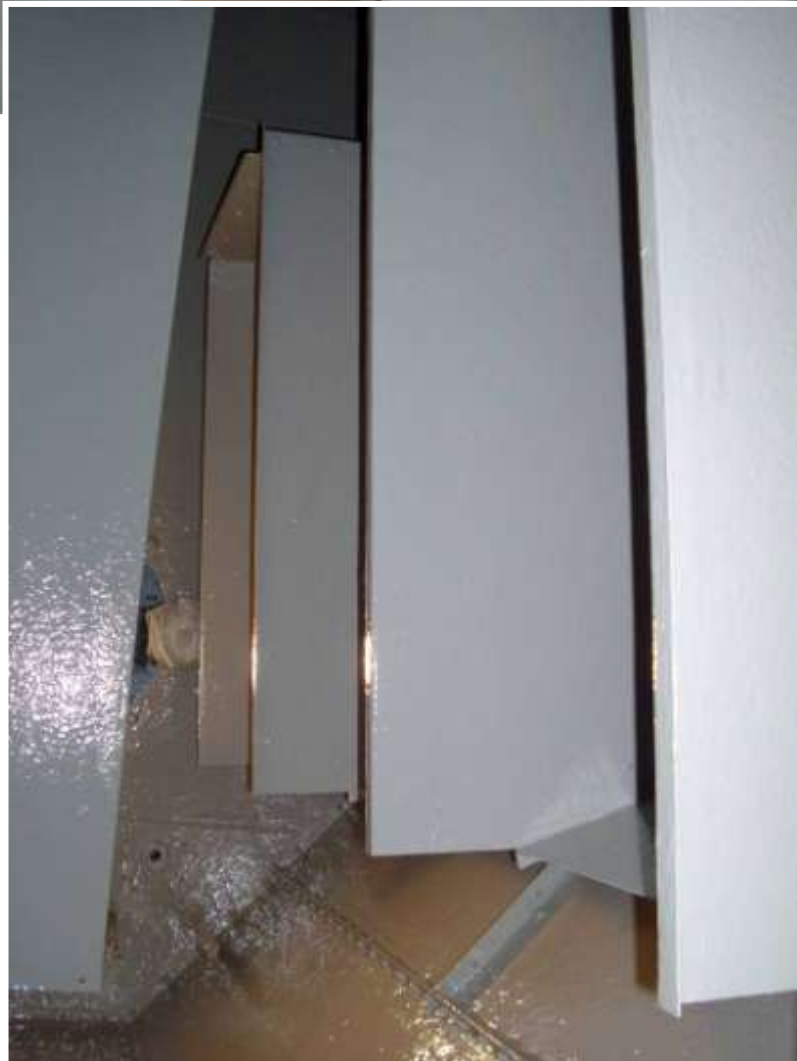
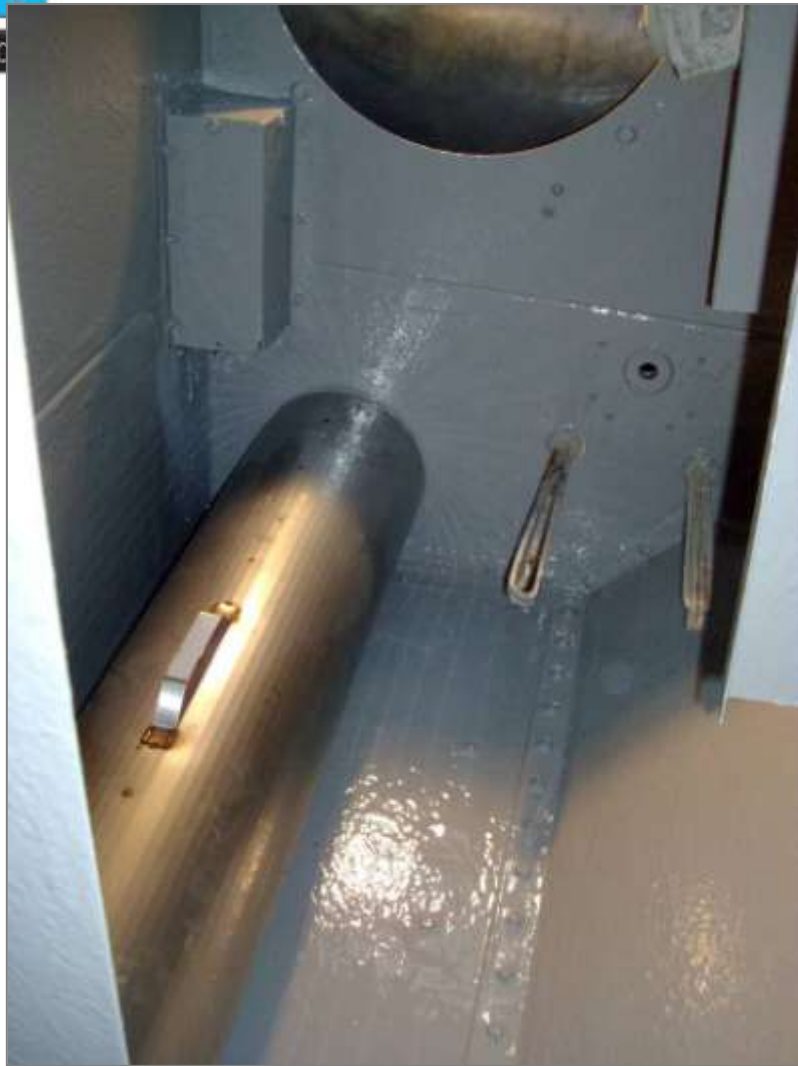
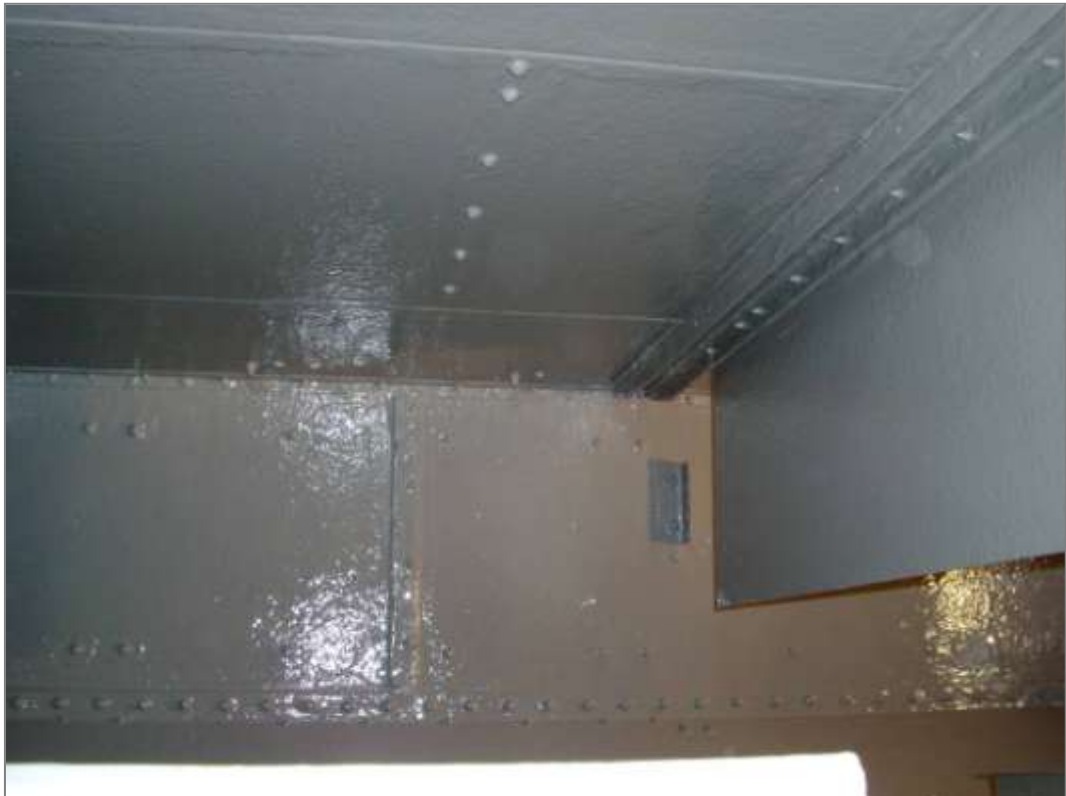
All intricate areas were again 'stripe coated' for a second time. The following photographs show the final application of the 2<sup>nd</sup> coat of 3M Scotchkote™ 165PW (grey).
