# COMPLETION REPORT

Project Brief : **The Internal Relining of 8 No. BAC Cooling Tower Sumps  
(1 No. Tower in this Sample Report)**

Site Address : **XXXXXXXXX Bank  
London**

System Spec : **3M Scotchkote™ 165PW**  
(Formerly Known as COPON Hycote 165PW)

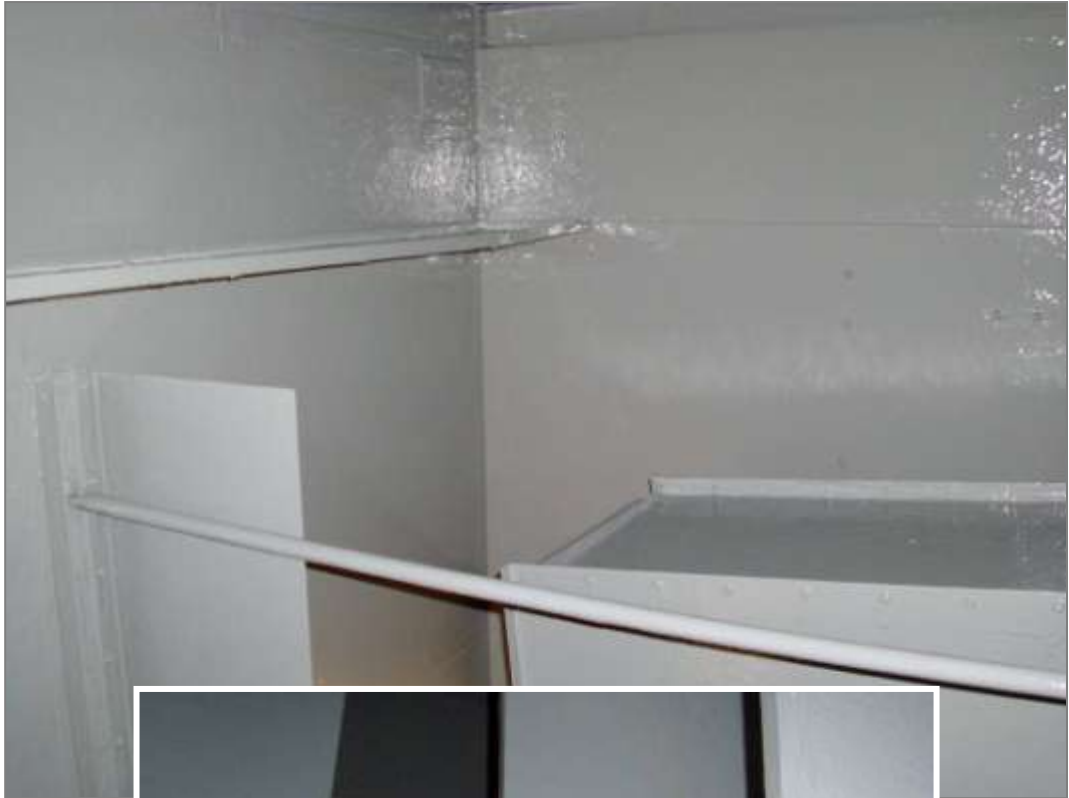
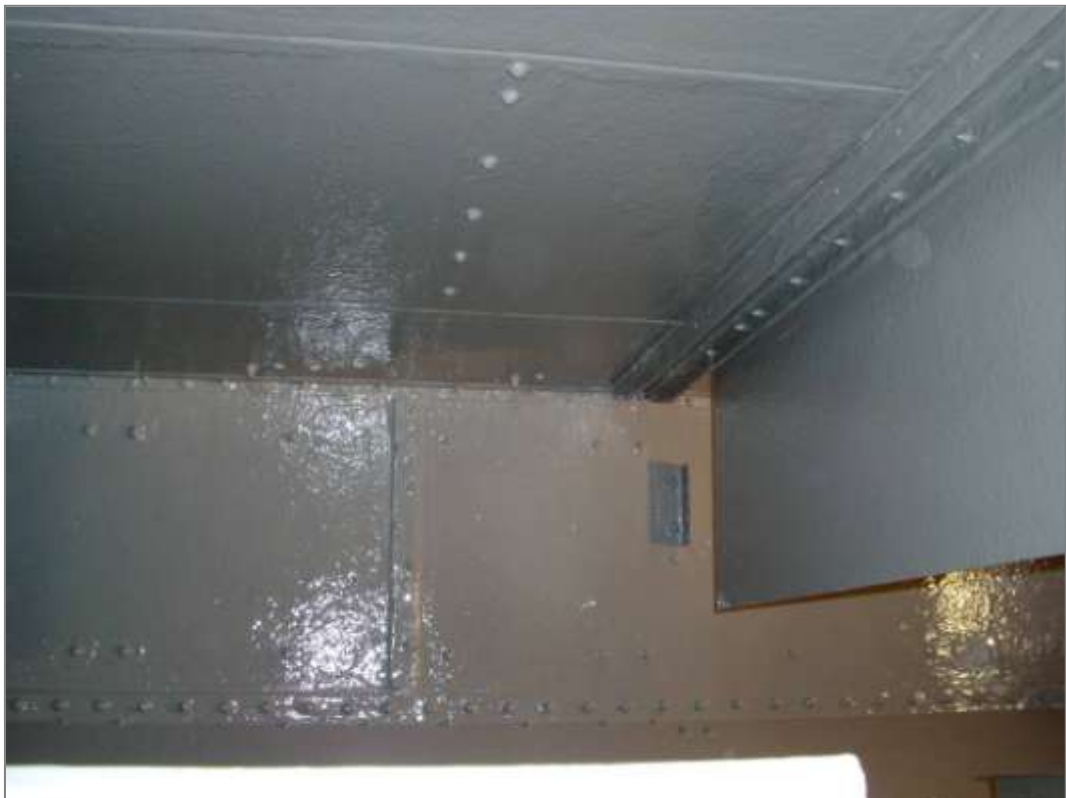
All intricate areas were again 'stripe coated' for a second time. The following photographs show the final application of the 2<sup>nd</sup> coat of 3M Scotchkote™ 165PW (grey).
