COMPLETION REPORT

Project Brief : **The Internal Refurbishment of 1 No. Chromate Effluent Tank**

System Spec : **3M Scotchkote™ 165PW**
(Formerly Known as COPON Hycote 165PW)

Covac Ref : **873**

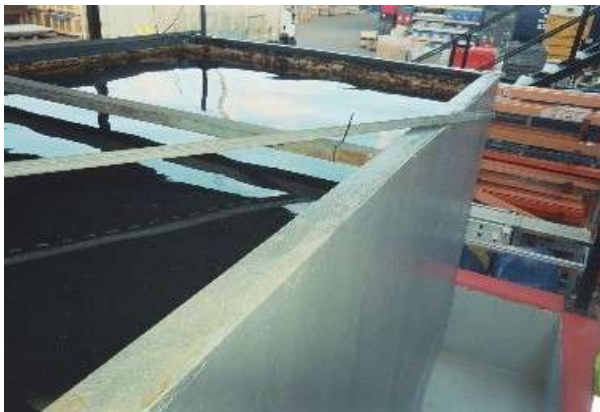
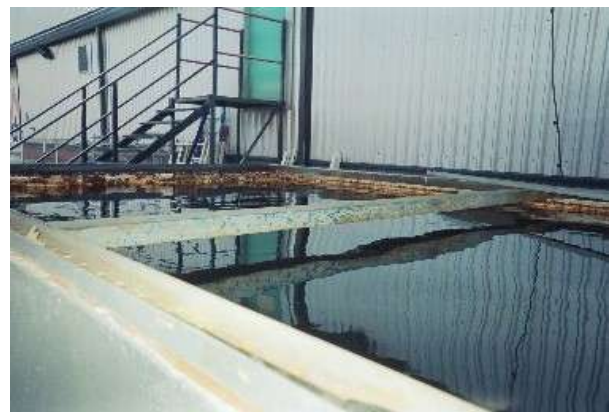
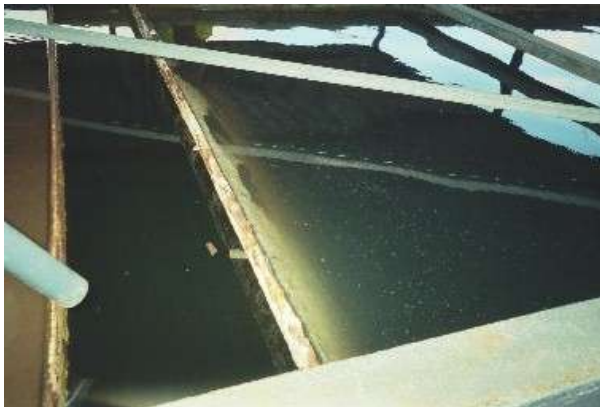
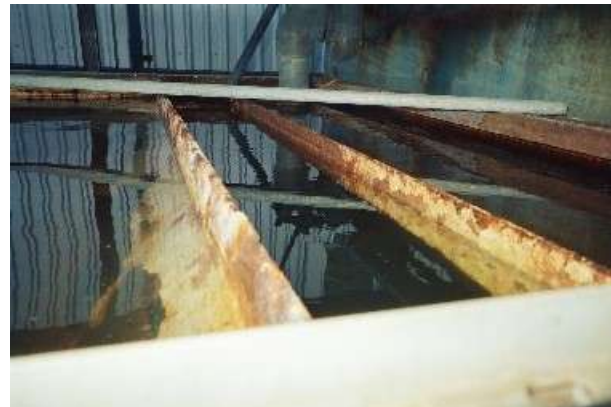
The tank was internally in a corroded condition due to chemical attack from the ferric sulphate & sodium bisulphite solution. To internally protect the tank from further deterioration a chemical resistant coating system capable of offering long term protection was required.

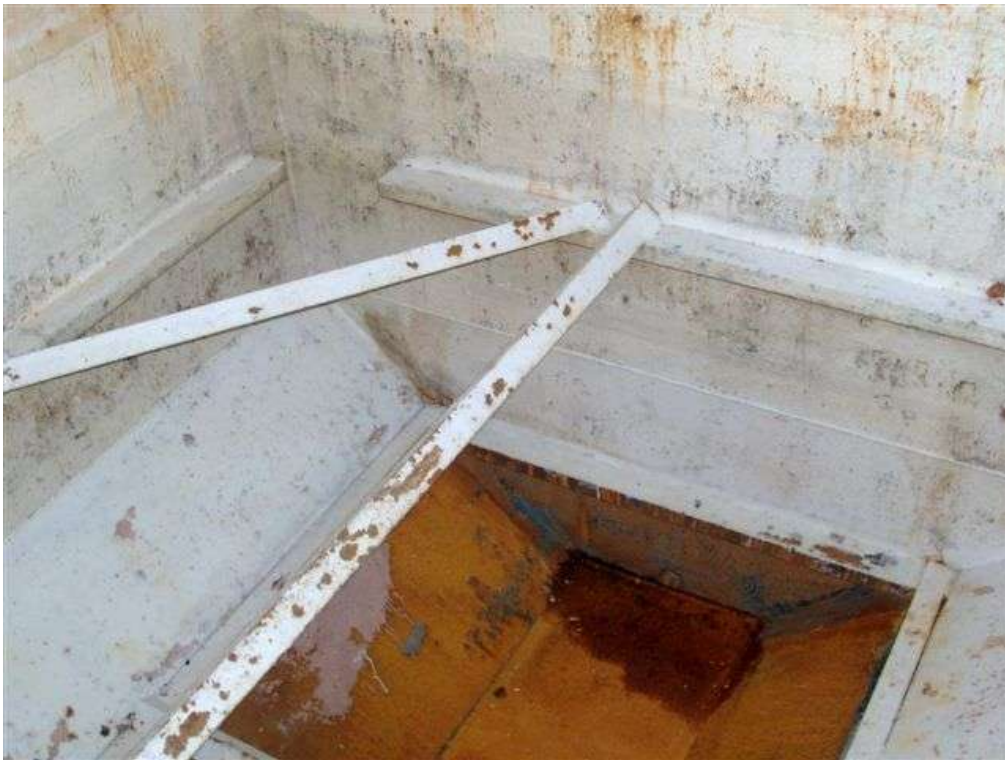
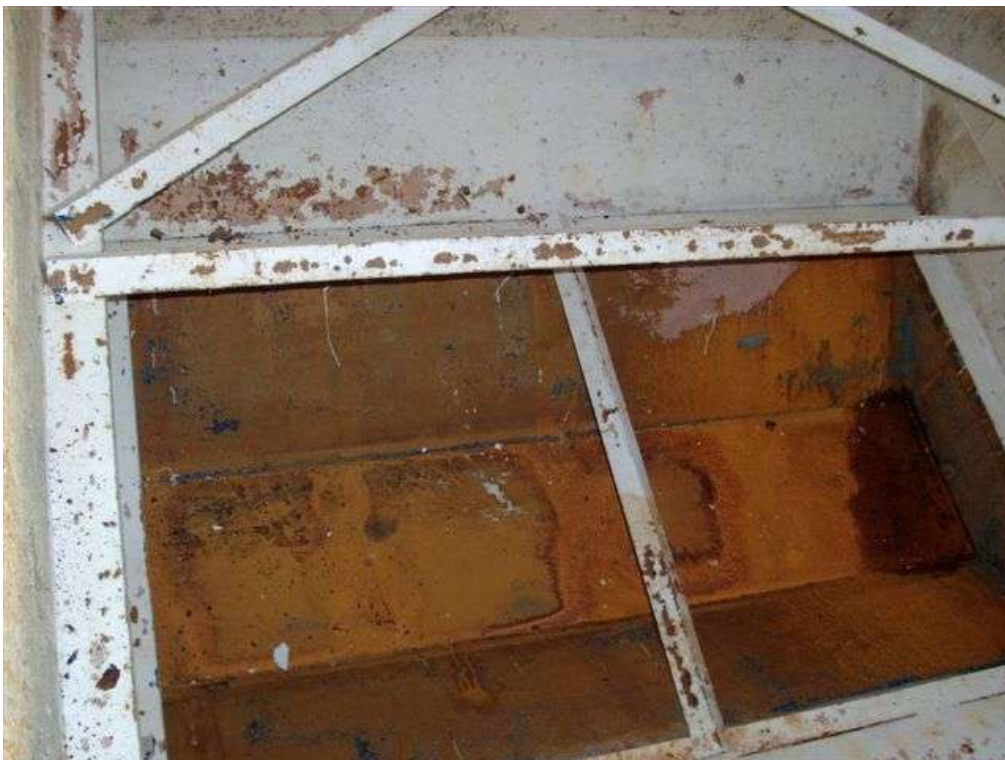
These photographs show the internal surfaces of the tank having been drained of water, but prior to any work commencing.
