COMPLETION REPORT

Client : **Major Conference & Exhibition Centre**

Project Brief : **The Internal Refurbishment of 1 No. Steel, Fire Sprinkler Tank**

System Spec : **3M Scotchkote™ 165PW**
(Formerly Known as COPON Hycote 165PW)

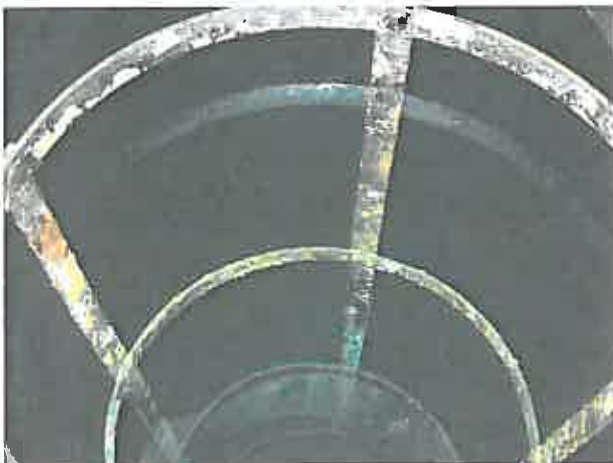
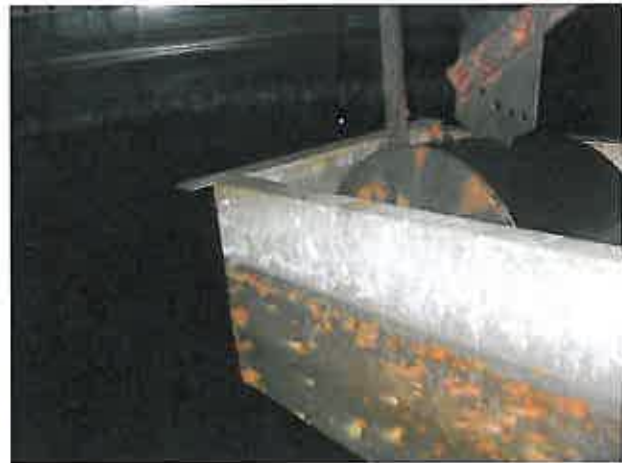
Corroded ladder & ball valve chamber.

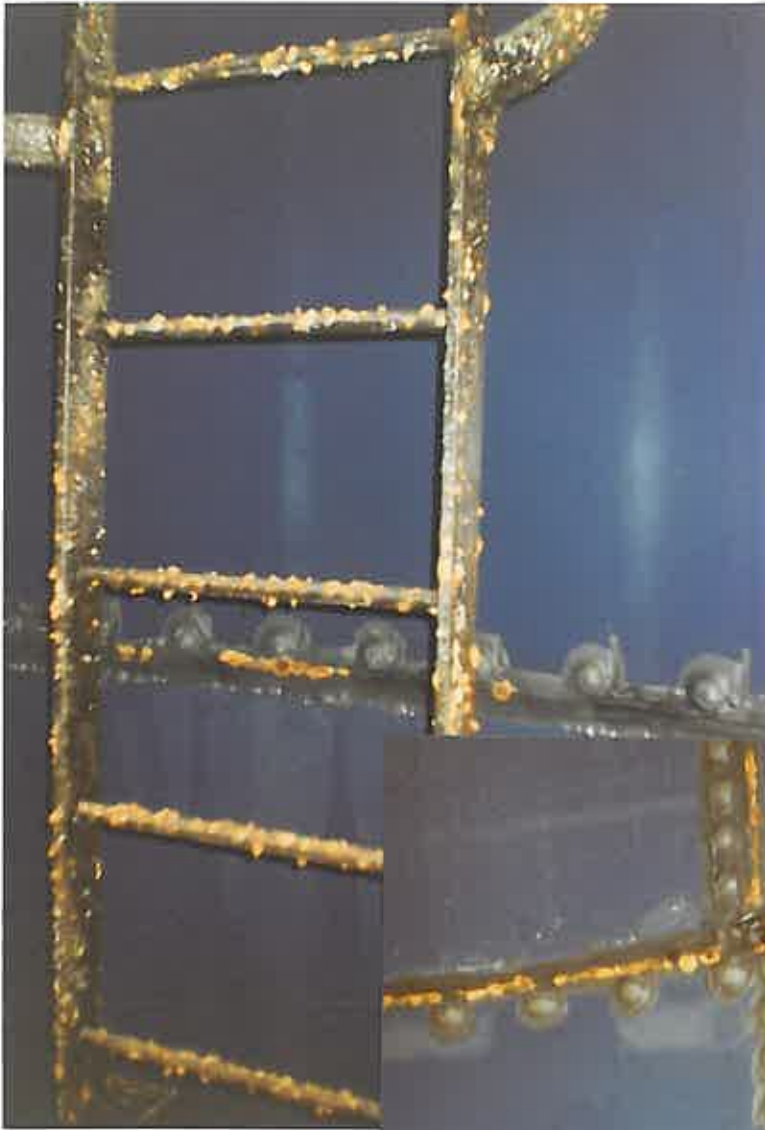
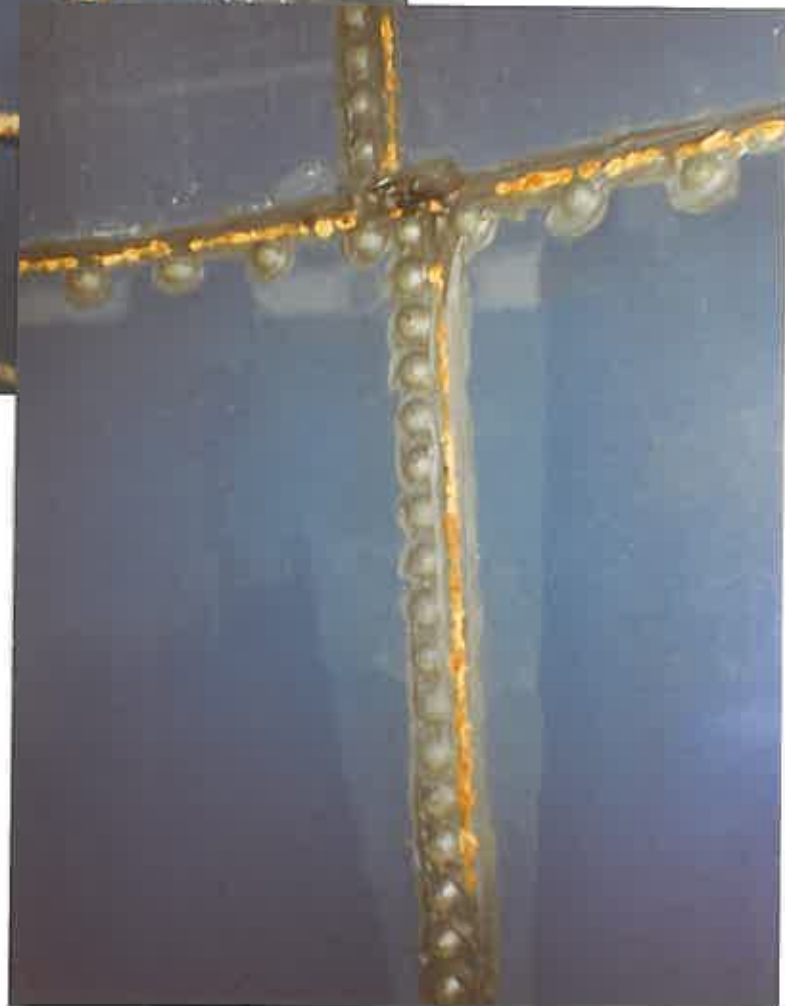
These photographs show the internals of the cylindrical tank having been drained of water and prior to any preparation works. As the photographs clearly show, corrosion is visible on the access ladder, ball valve housing and leaching through the existing coating on the jointing areas and rivets on the tank walls.

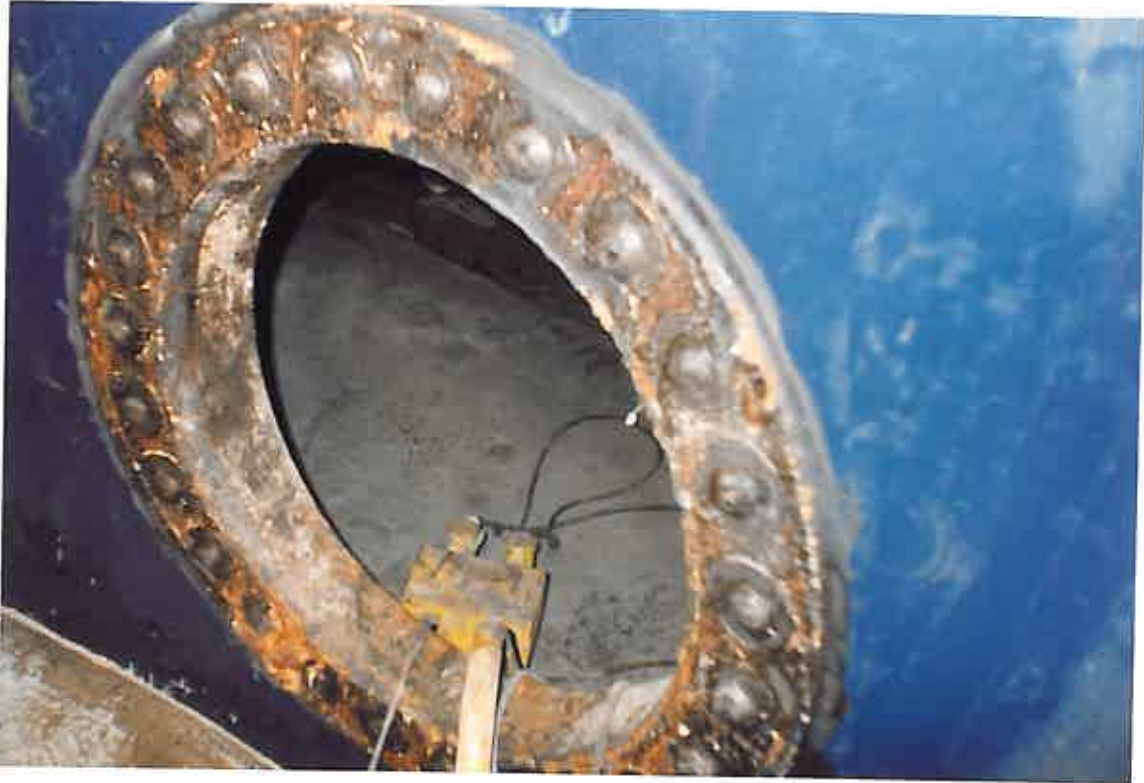
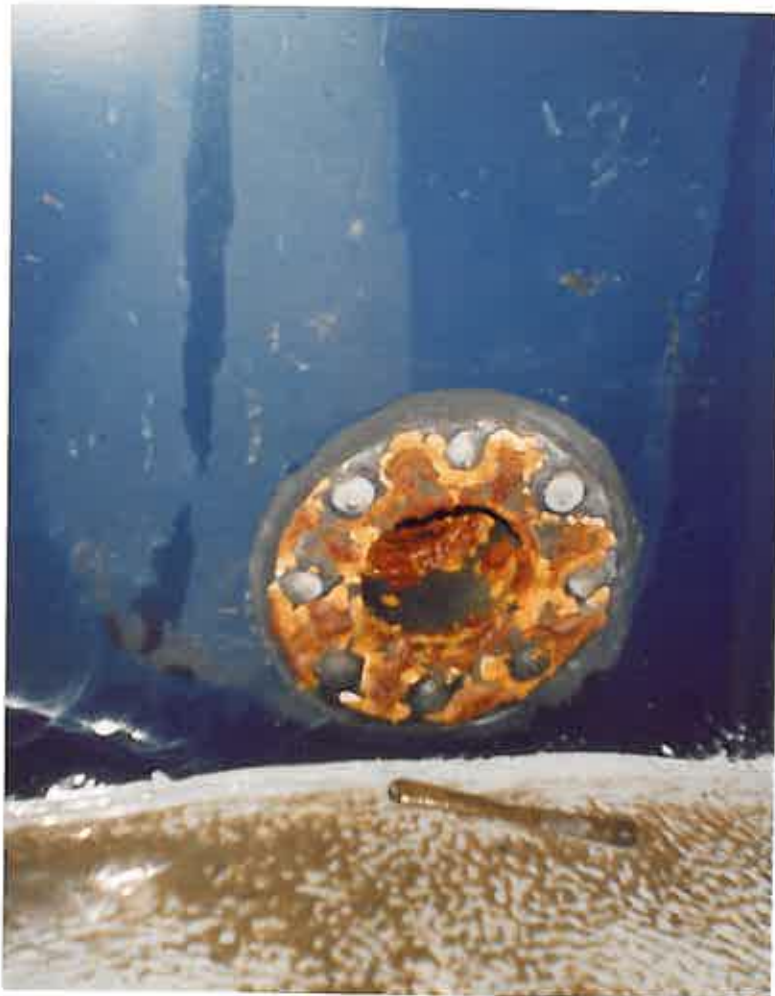
These pictures show the drain hole and the lower access hatch, which had been removed, making entry and egress easier throughout the project.

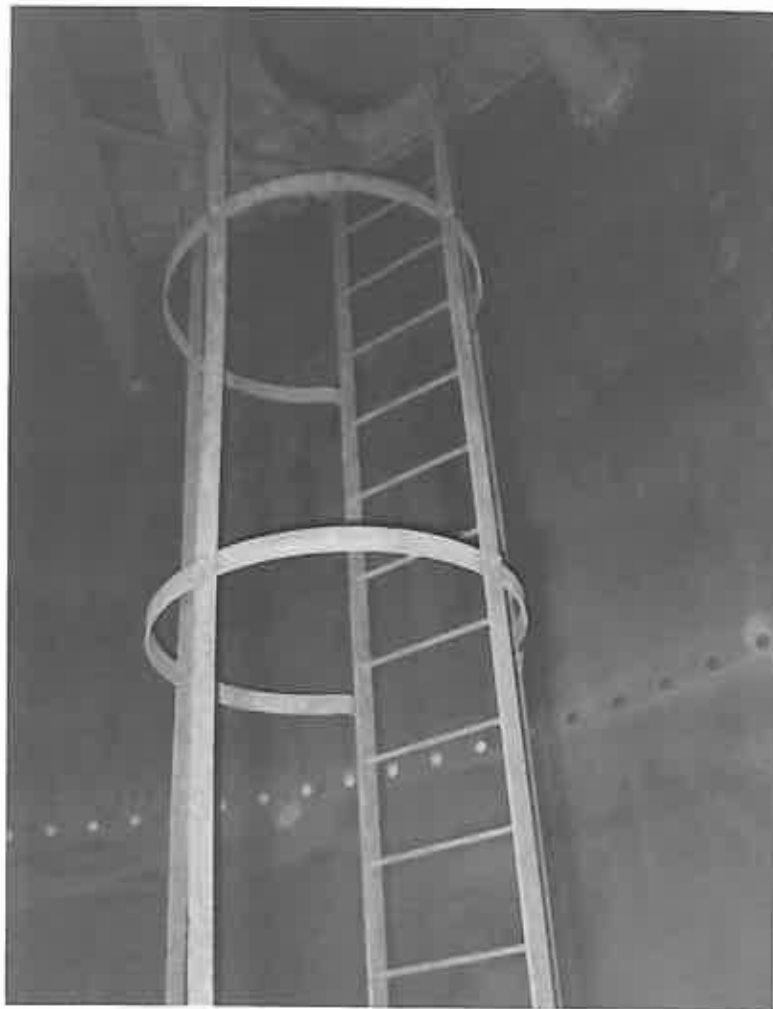
These photographs show all internal surfaces of the tank having been prepared in accordance with the accepted SA 2.5 / BS7079 standard by means of dry abrasive blasting techniques.

All internal surfaces of the tank were prepared in accordance with Swedish Standard SA 2.5 BS7079 Part A1 1989 utilizing dry abrasive blasting equipment in order to remove any existing coatings and / or contamination. The abrasive used was capable of producing a surface profile of 50 – 75 Microns corresponding to the 'medium' in accordance with BS7079 Part C4, to promote adhesion of the lining system. Any minor holes found due to corrosion were repaired utilizing COPON Metal-Tech SG Metal Epoxy Filler.
