COMPLETION REPORT

Project Brief : **The Internal Coating of 2 No. Sectional GRP Water Retaining Structures**

System Spec : **3M Scotchkote™ 165PW**
(Formerly Known as COPON Hycote 165PW)

Covac Ref : **1003**

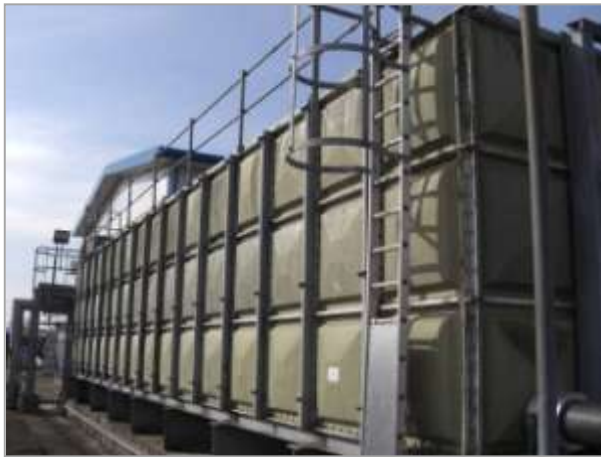
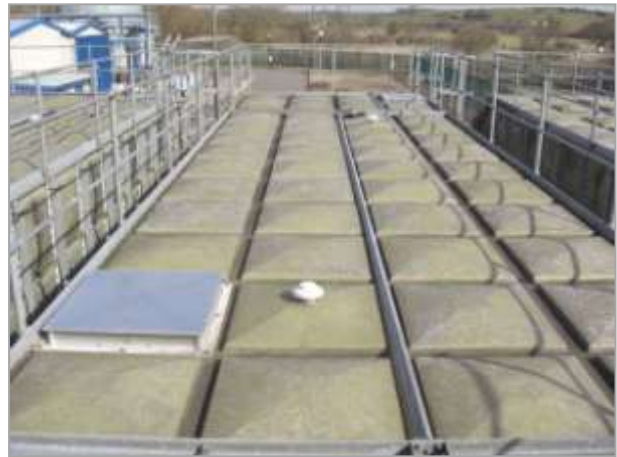
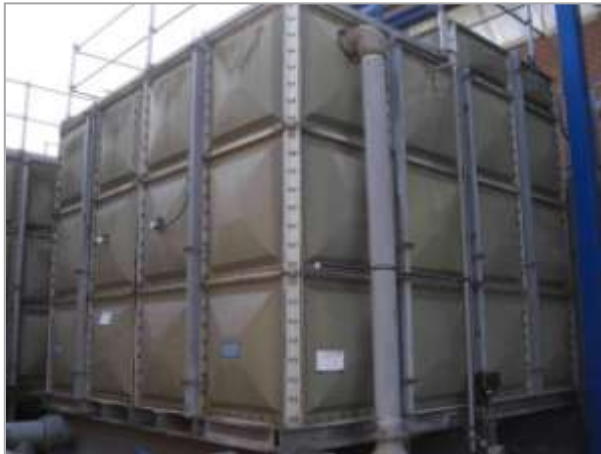
Both tanks were located externally at ground level.

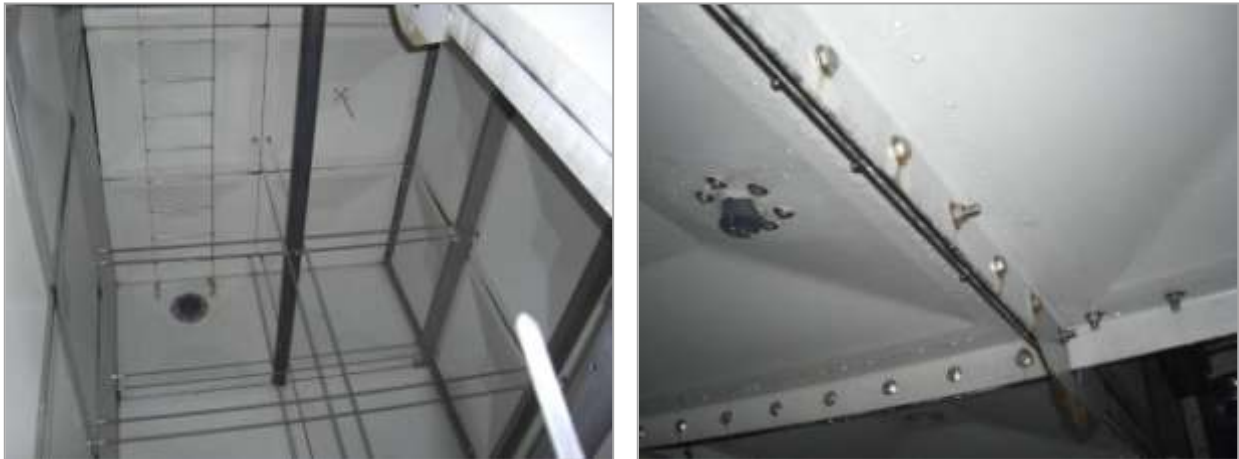
Osmotic blistering of the GRP substrate due to water permeation can also lead to deterioration of the gel coat and, subsequently, a surface which is highly likely to harbour and promote the growth of micro-aquatic organisms.
