# COMPLETION REPORT

Project Brief : **The Internal Coating of 2 No. Sectional GRP Water Retaining Structures**

System Spec : **3M Scotchkote™ 165PW**  
(Formerly Known as COPON Hycote 165PW)

Covac Ref : **1003**

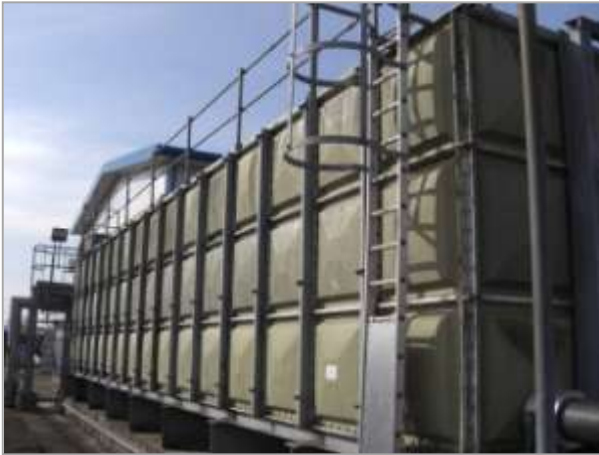
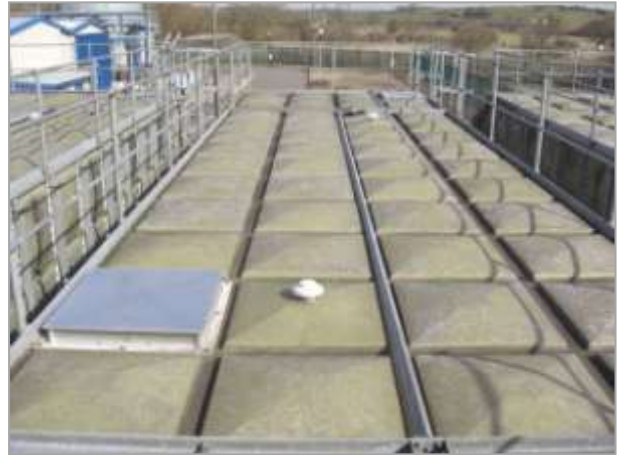
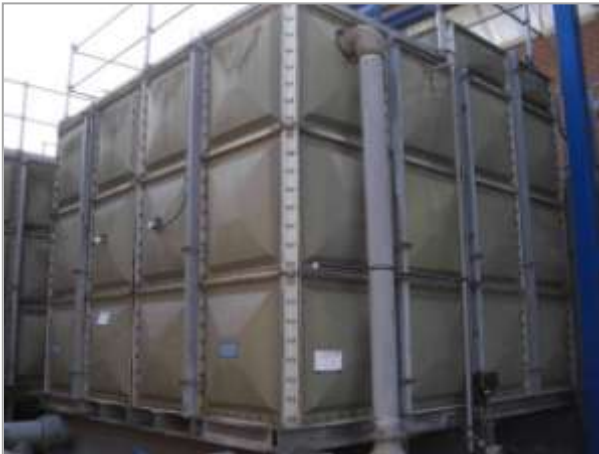
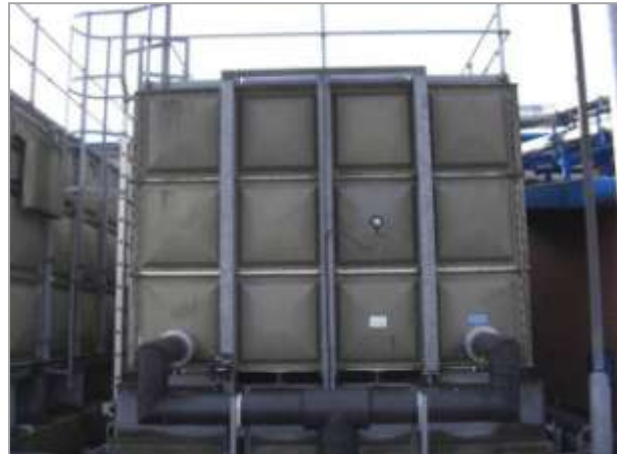
2 off sectional GRP potable CWS tanks each sized at approx:-

1 off - 16m x 4m x 3m

1 off - 4m x 4m x 3m (with divider wall)

Both tanks were located externally at ground level.

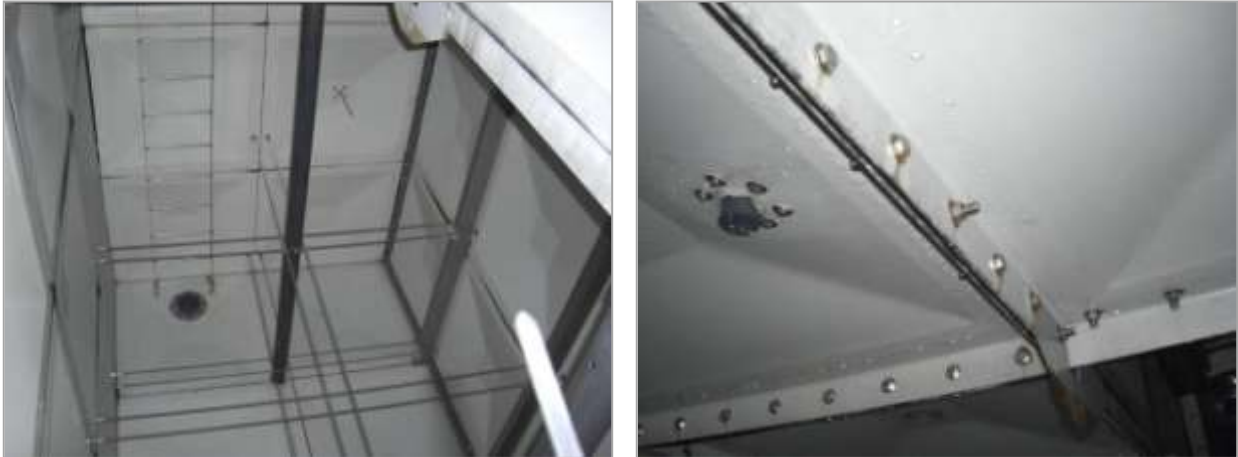
Osmotic blistering of the GRP substrate due to water permeation can also lead to deterioration of the gel coat and, subsequently, a surface which is highly likely to harbour and promote the growth of micro-aquatic organisms.

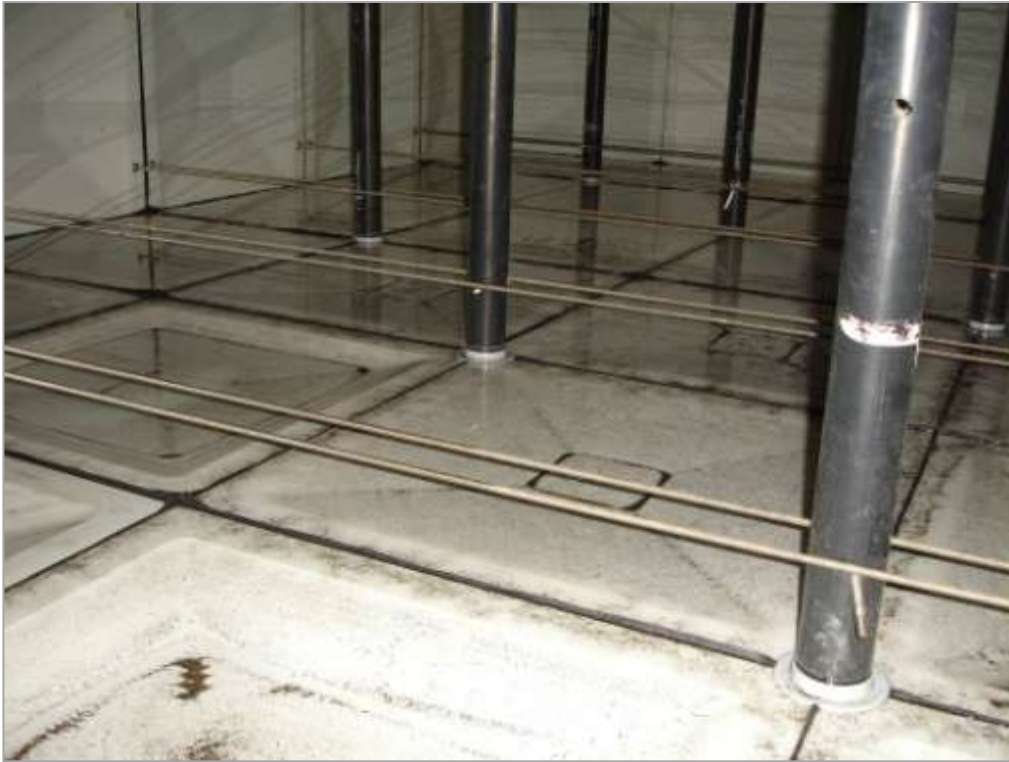
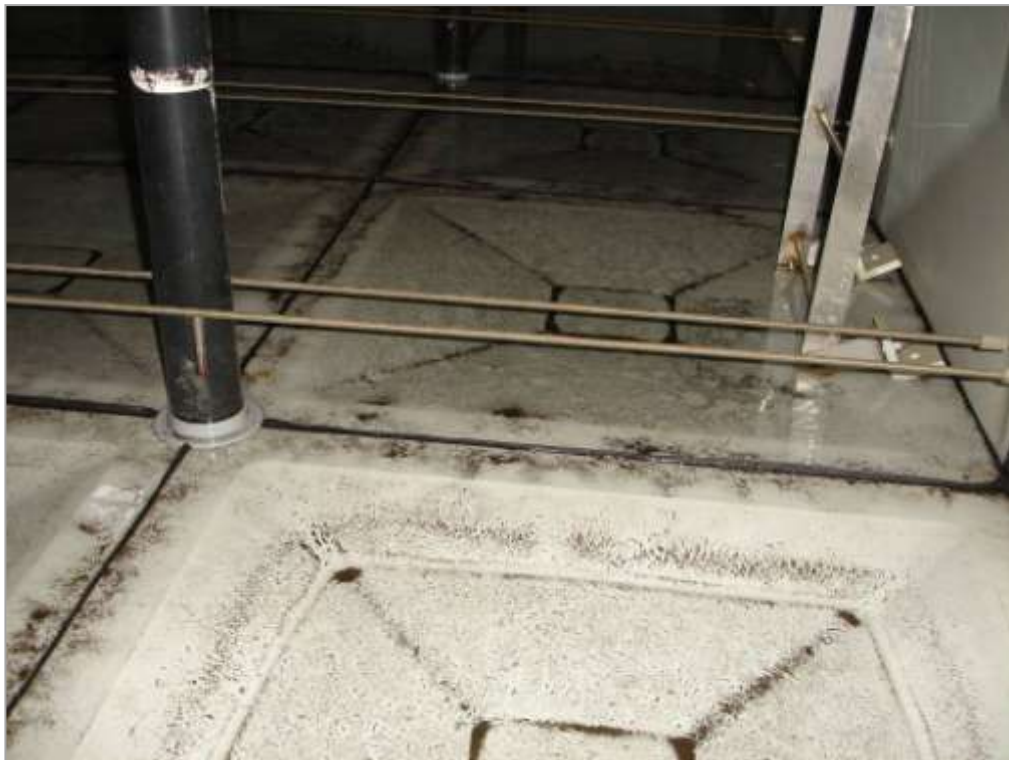
**These photographs show the internal surfaces of the structure, having been drained of water and prior to relining work commencing.**

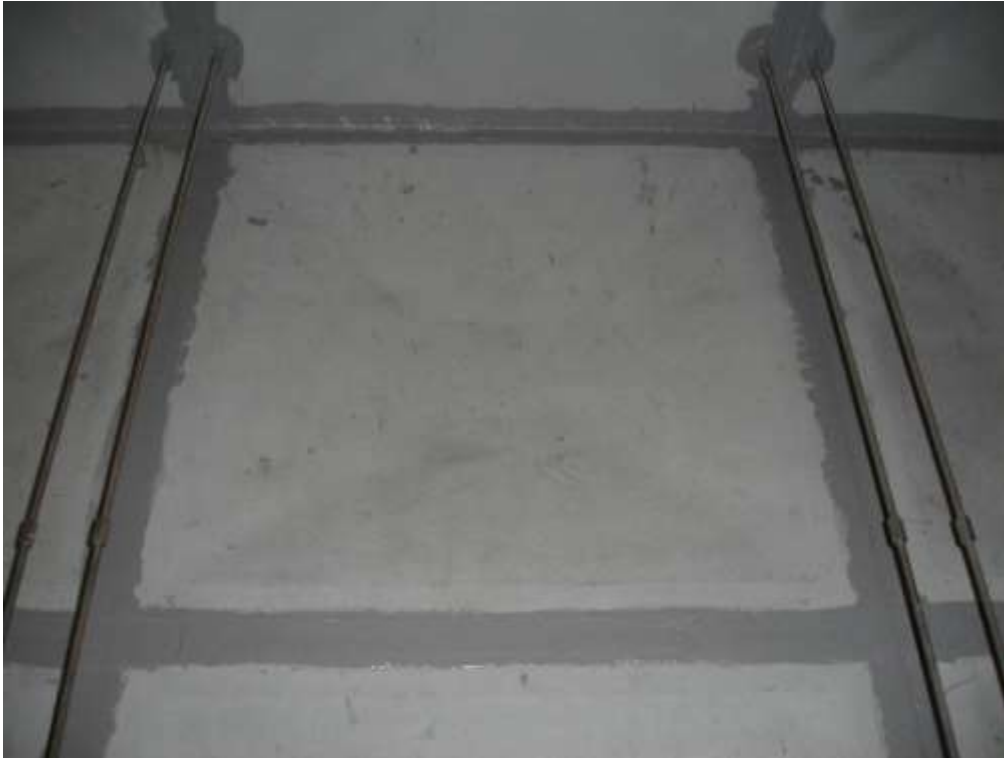
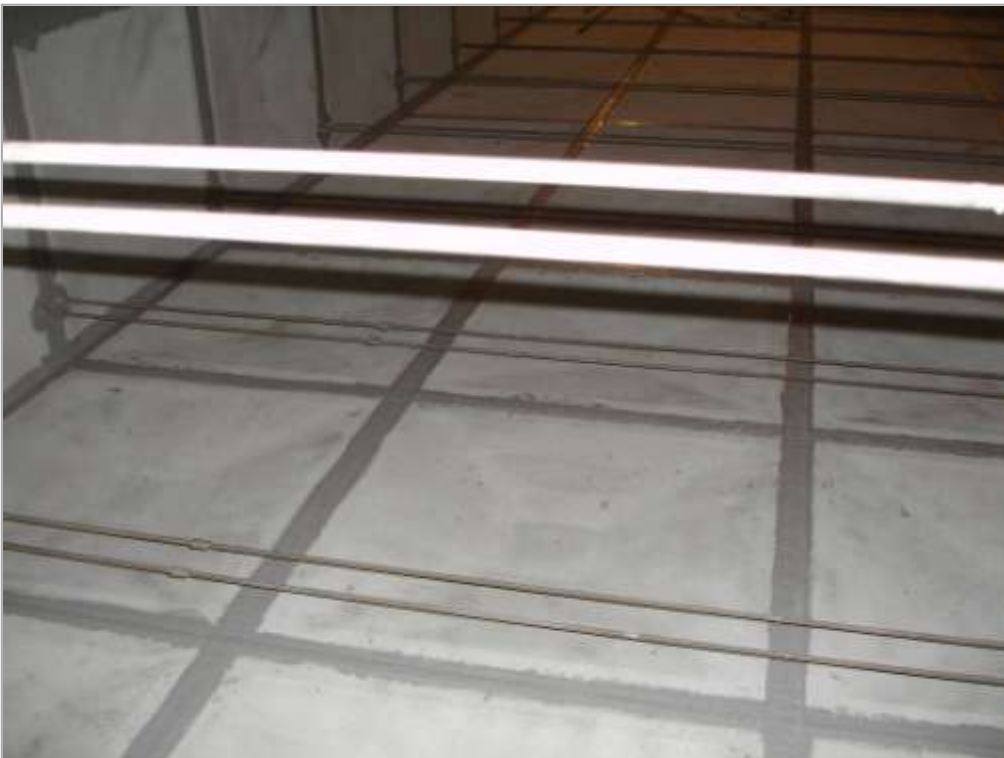
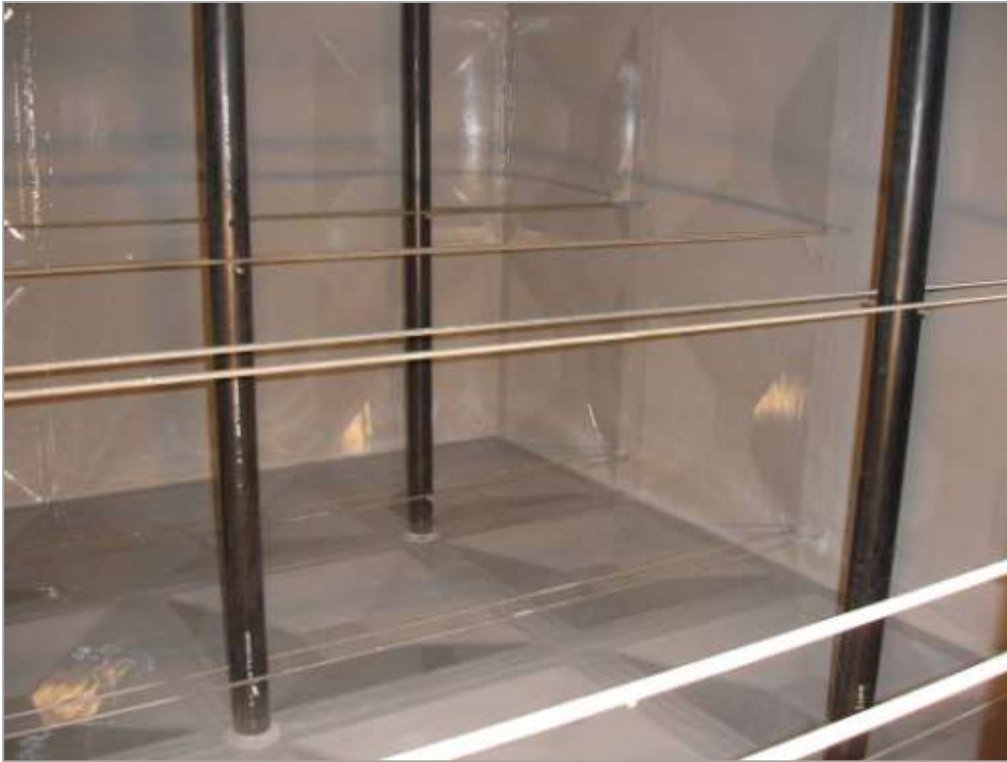
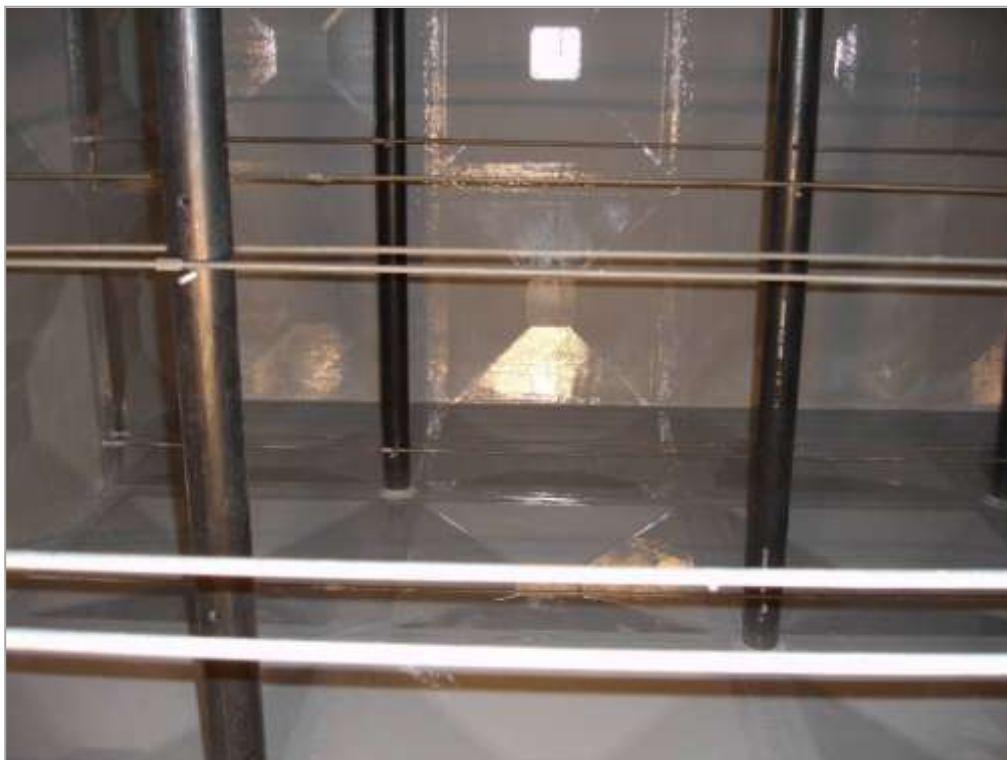
**All joints were treated to prevent leaks and allowed to cure.**

The following photographs show the internal of the structure after being fully coated with 3M Scotchkote 165PW (grey) Solvent Free Polyurethane, by means of plural component spray equipment.

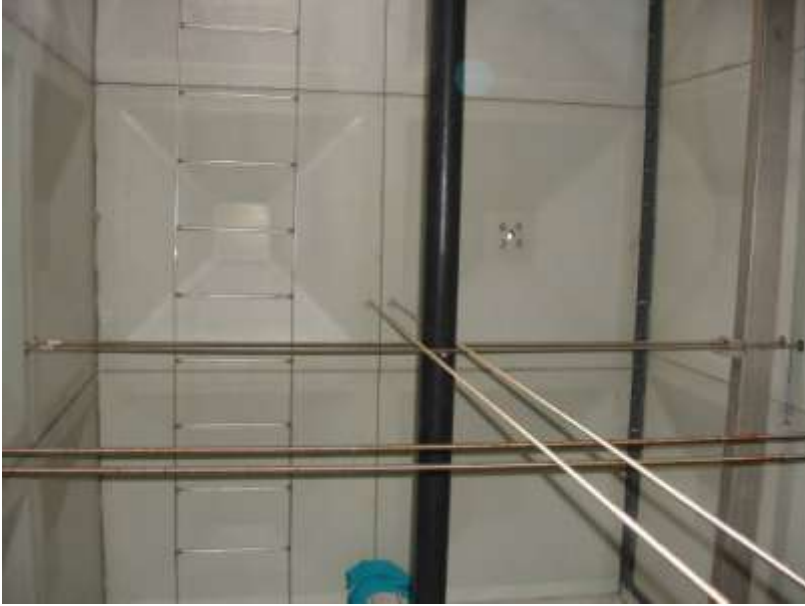
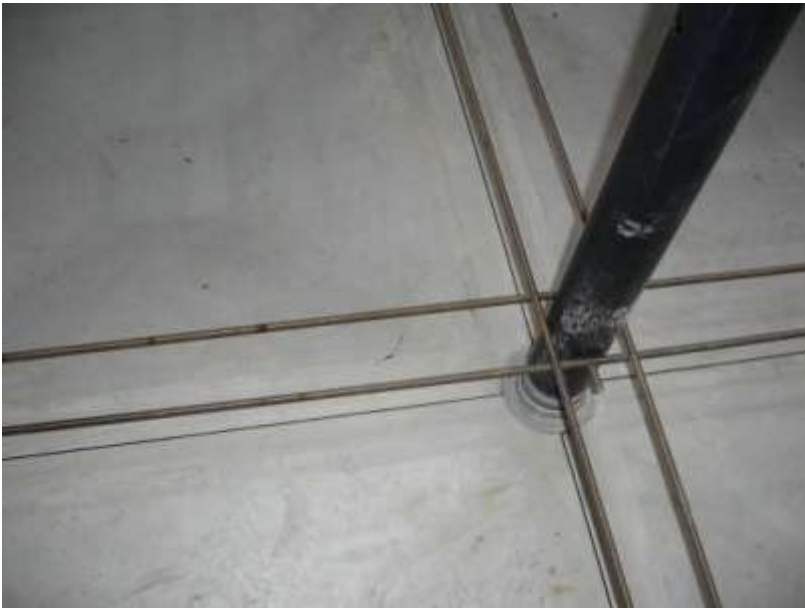
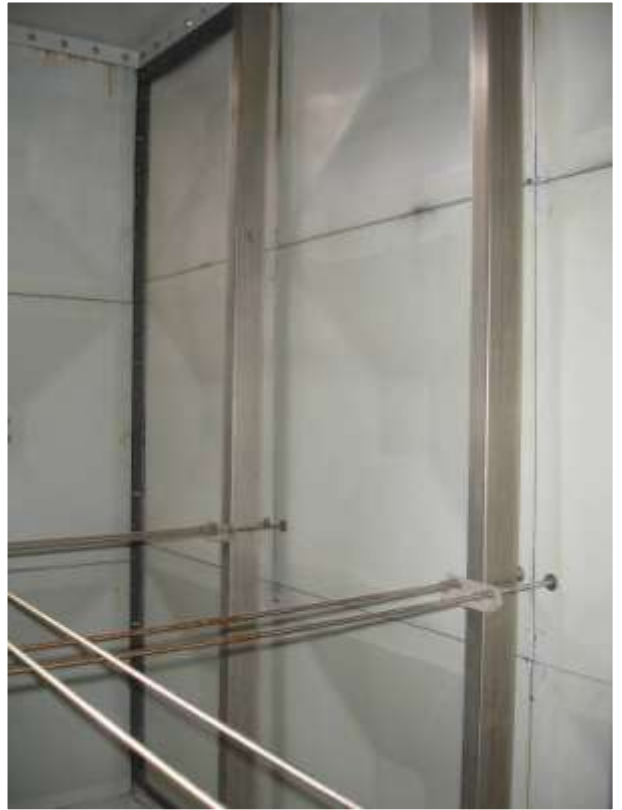
**These photographs show the internal surfaces of both Compartments before work commences.**

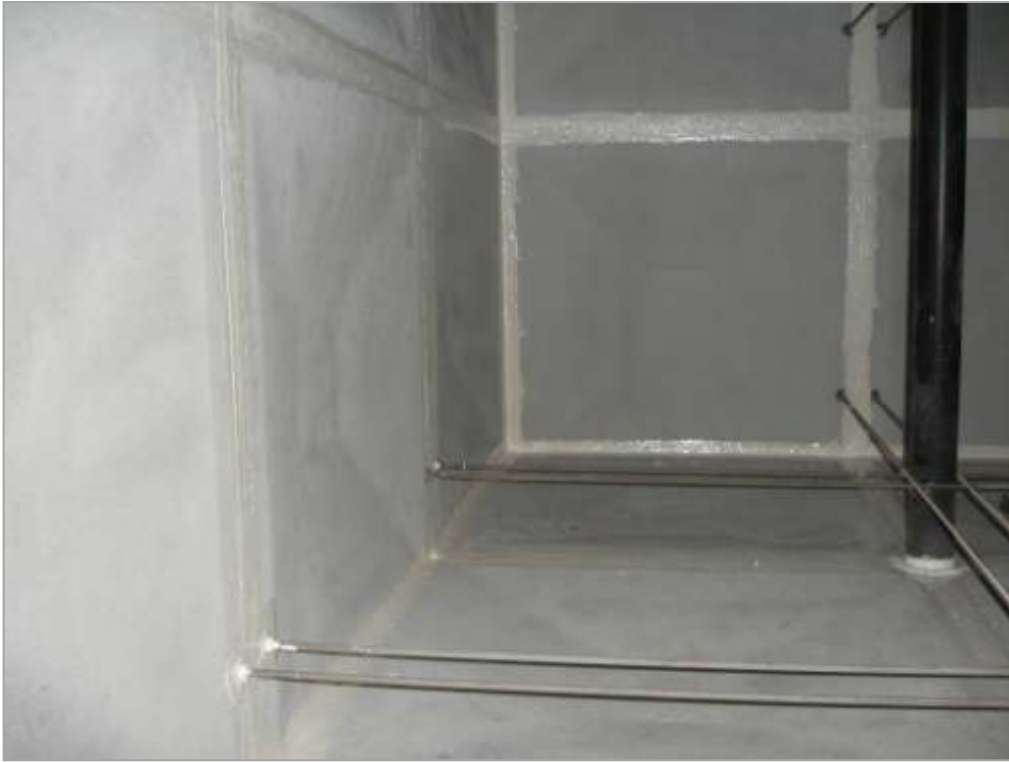
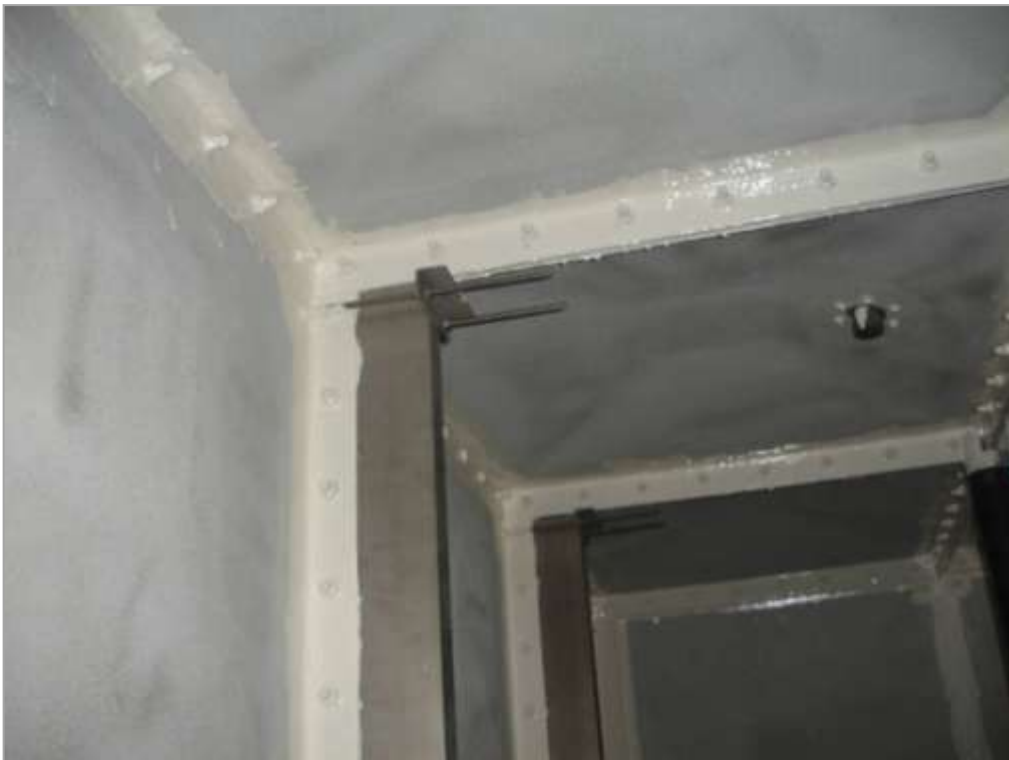
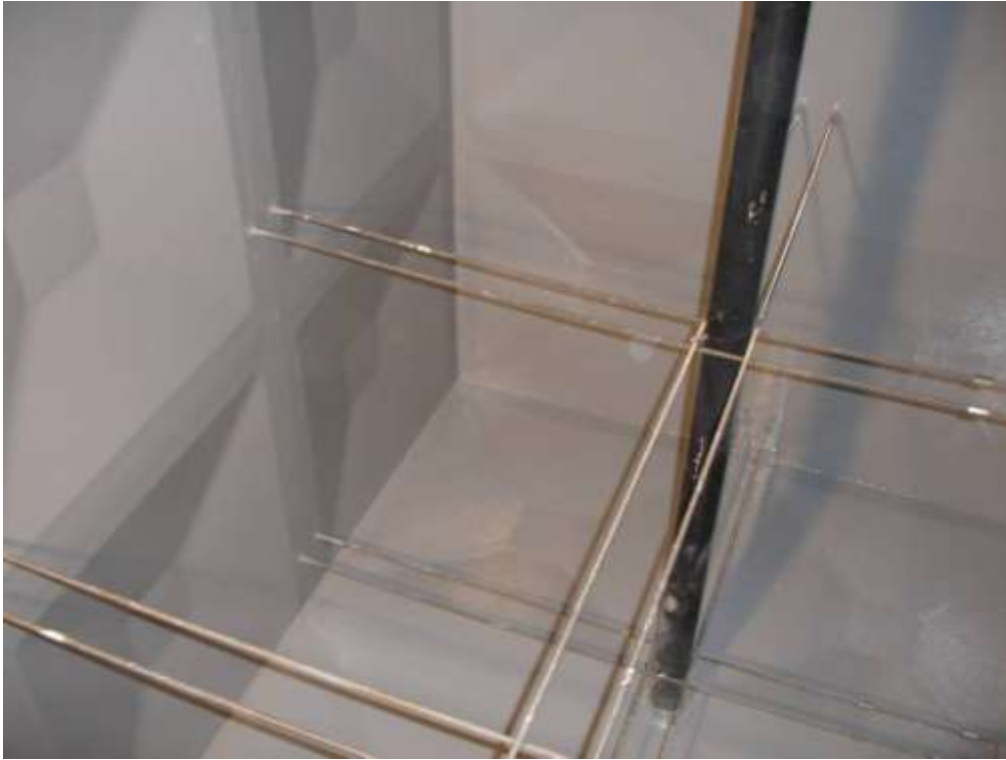
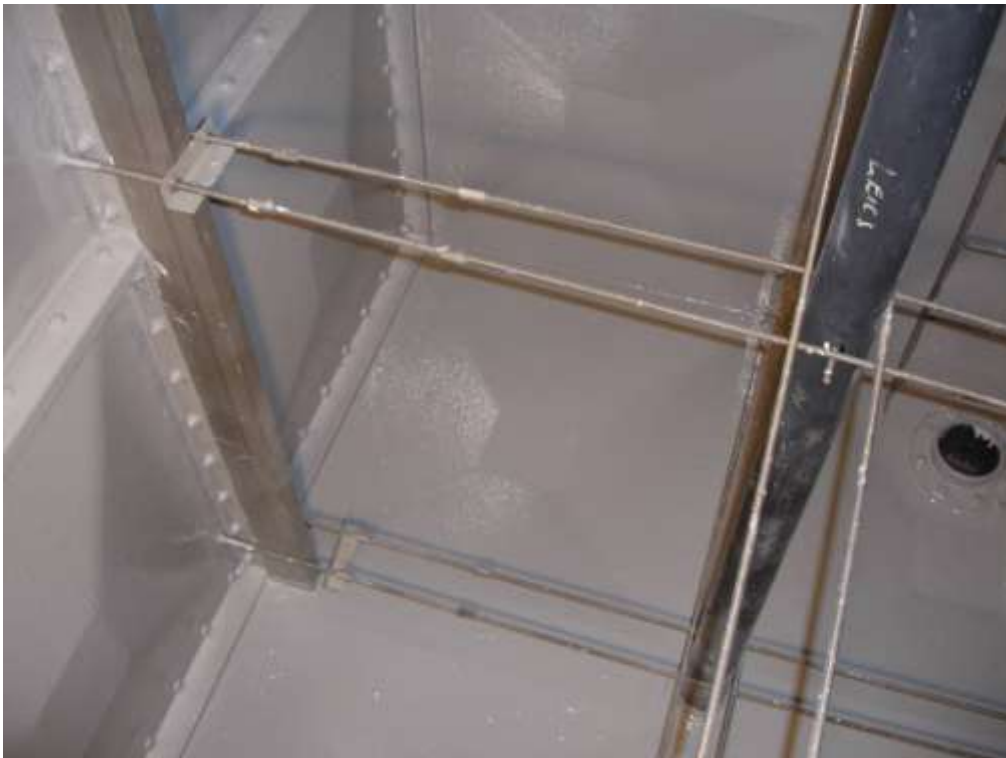
**All joints were treated to prevent leaks and allowed to cure.**

The following photographs show the final application of 3M Scotchkote™ 165PW (grey).
