# COMPLETION REPORT

Client : **Hospital**

Project Brief : **The Internal Coating of 1 No. Sectional GRP CWS Tank**

Completion Date : **26<sup>th</sup> November 2010**

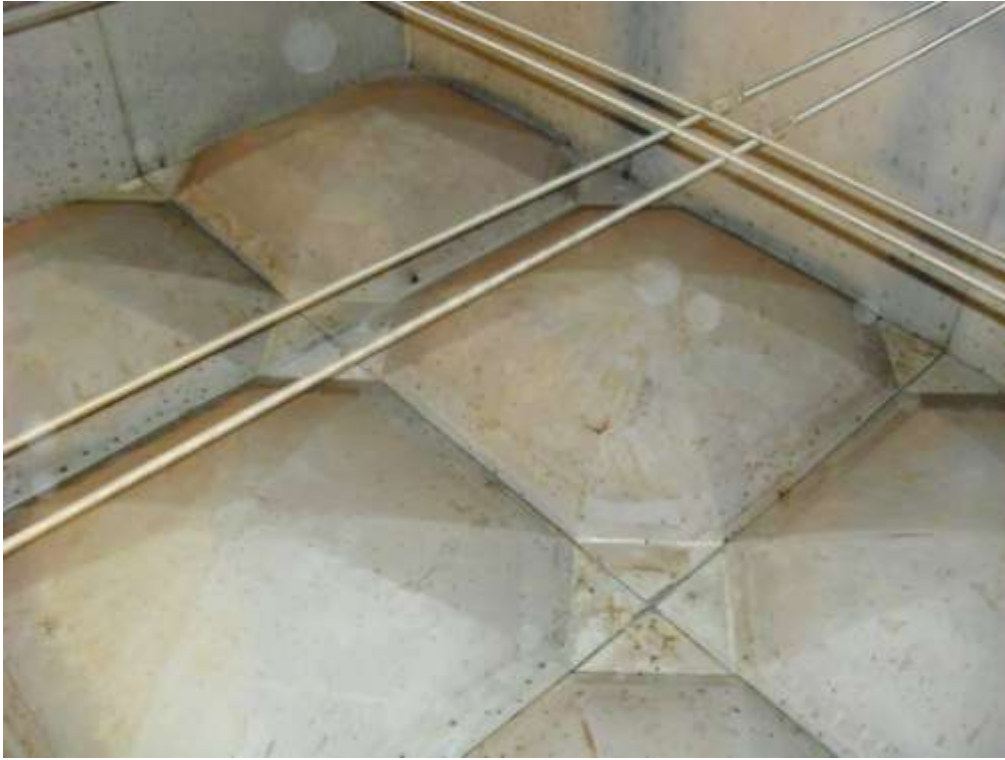
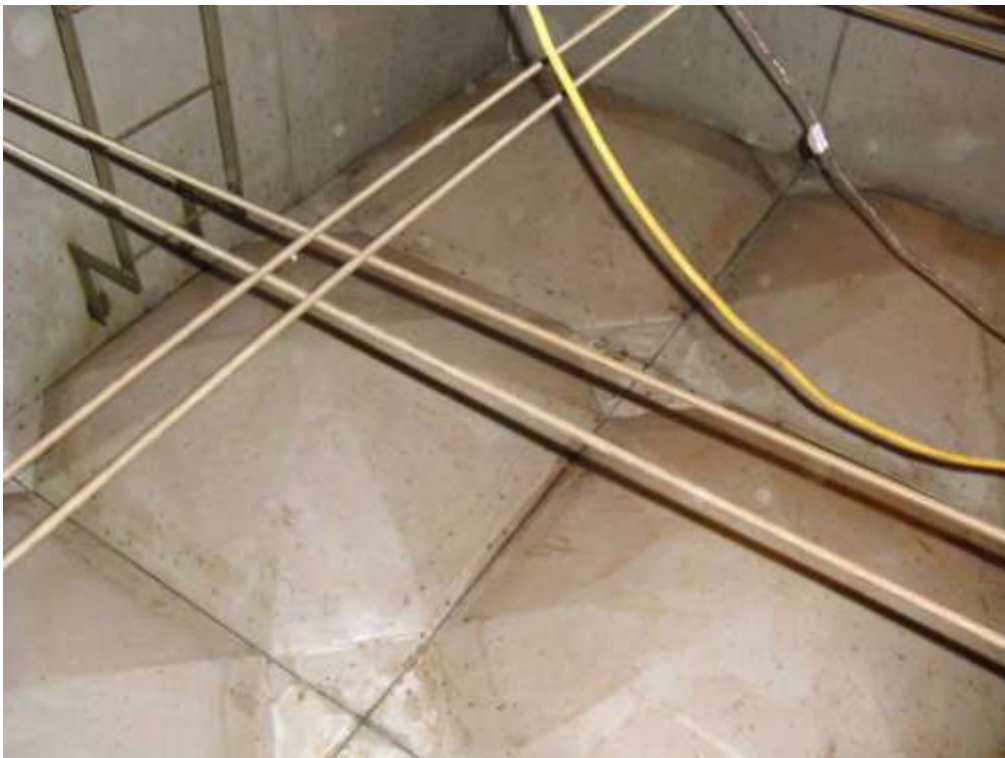
There were signs of black spore fungi which are notorious for spreading on GRP, predominantly where there is a combination of water and air at room temperature.

**These photographs show the internal surfaces of the tank having been drained of water and prior to relining work commencing. Black spore fungi can be clearly seen over much of the substrate.**
