# COMPLETION REPORT

Client : **Hospital**

Project Brief : **The Internal Coating of 1 No. Sectional GRP CWS Tank**

Covac Ref : **1021**

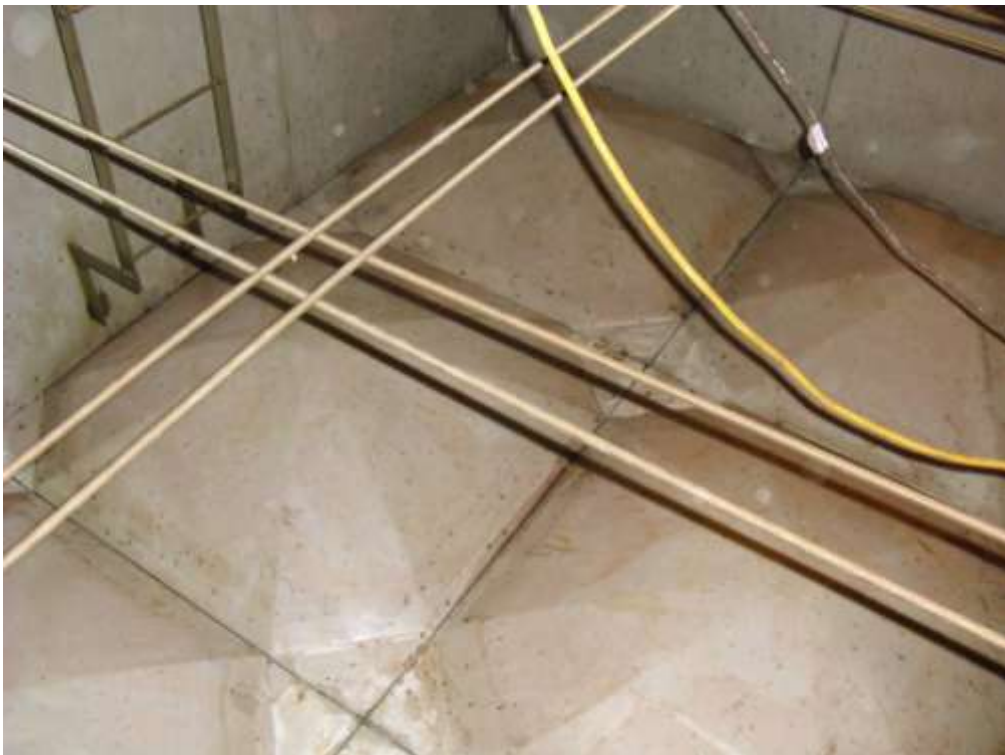
There were signs of black spore fungi which are notorious for spreading on GRP, predominantly where there is a combination of water and air at room temperature.

**These photographs show the internal surfaces of the tank having been drained of water and prior to relining work commencing. Black spore fungi can be clearly seen over much of the substrate.**
