COMPLETION REPORT

Project Brief : **The Internal Repair and Lining of 1 No. GRP CWS Tank**

System Spec : **3M Scotchkote™ 165PW**
(Formerly Known as COPON Hycote 165PW)

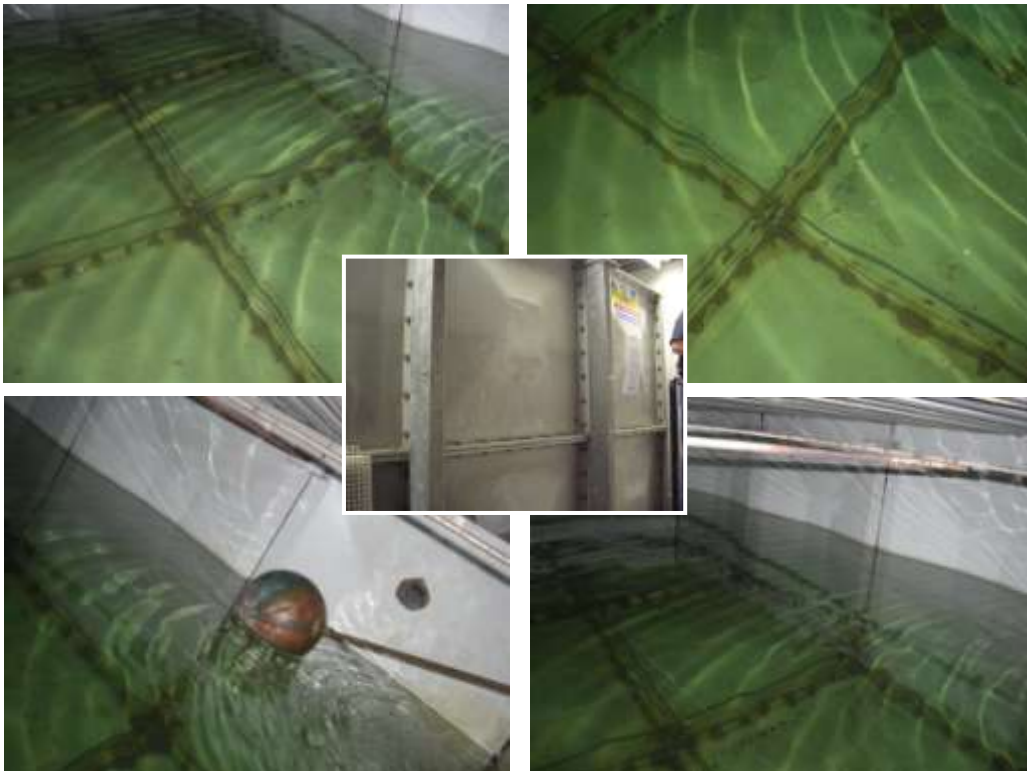
These images show the internal and external of the structure before repair and lining:-

The internal surfaces of the structure were in relatively good condition, however, the internal steel fasteners were showing signs of excessive corrosion which needed to be addressed. If left untreated, the internal surfaces would continue to be at risk from bacterial growth including Legionella, Pseudomonas and Biofilm; this can lead to further deterioration in the tank's surface structure and contamination of the down services with the supply of unhygienic water to the outlets.

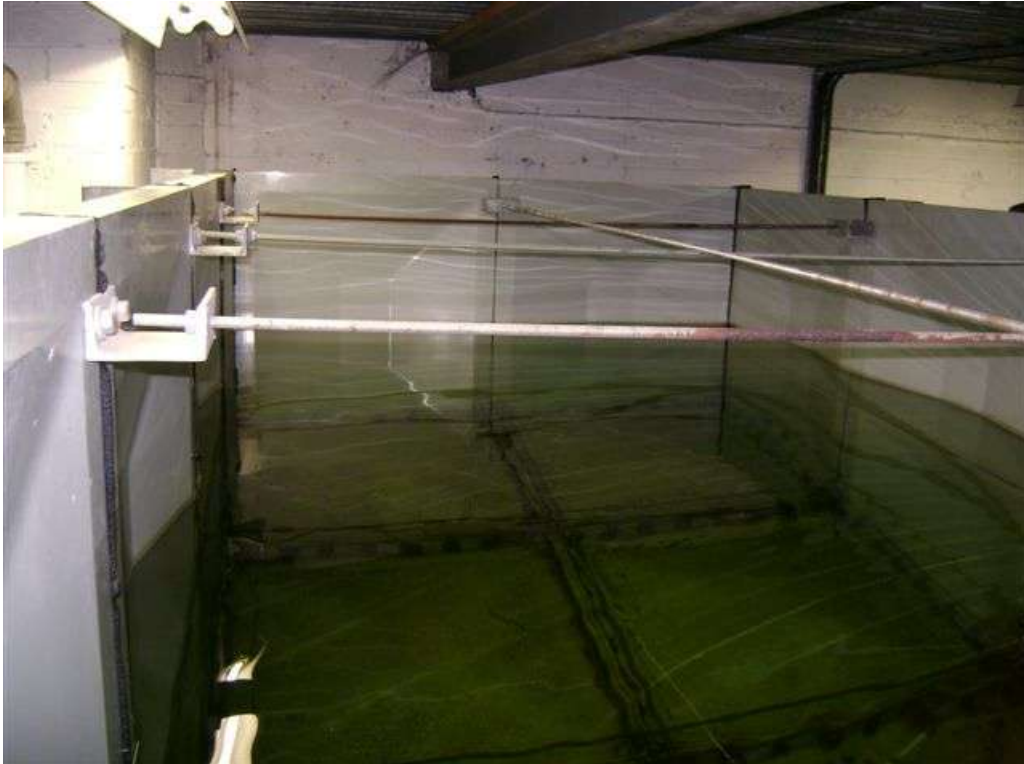
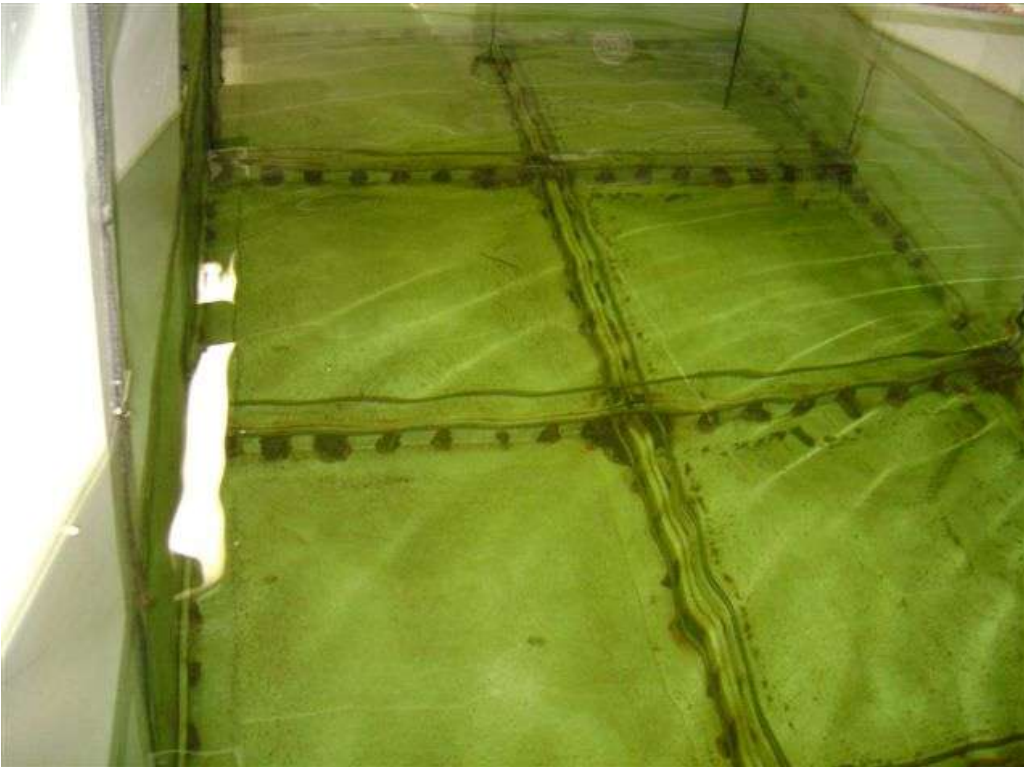
These images show the tank before being drained of water.

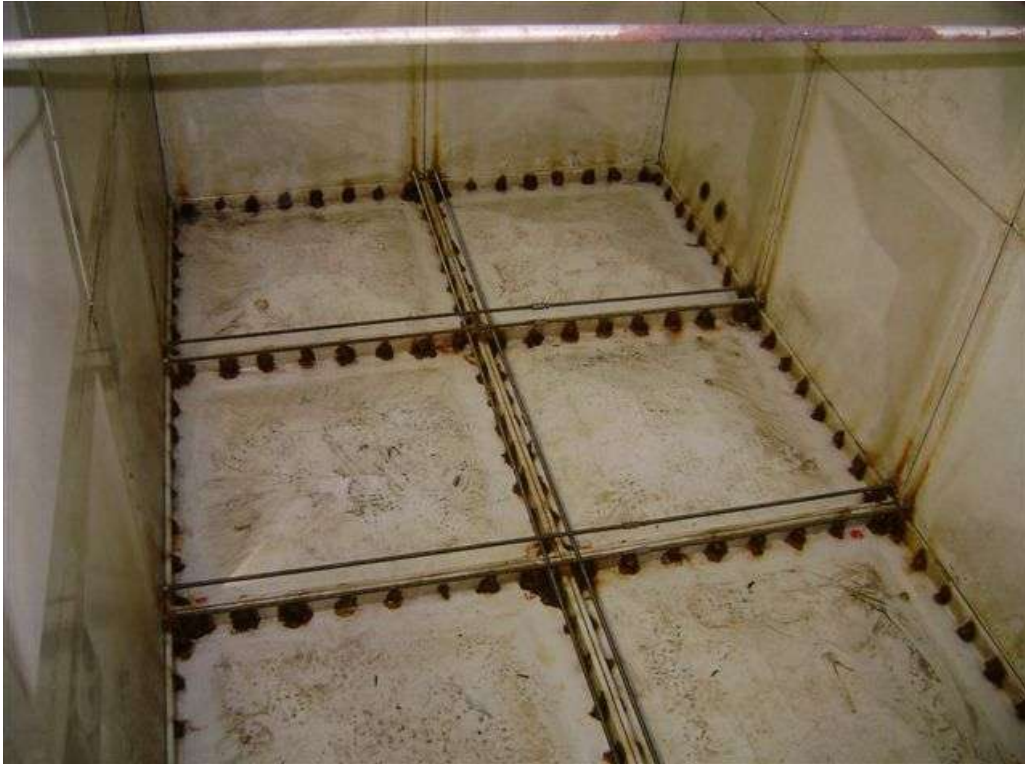
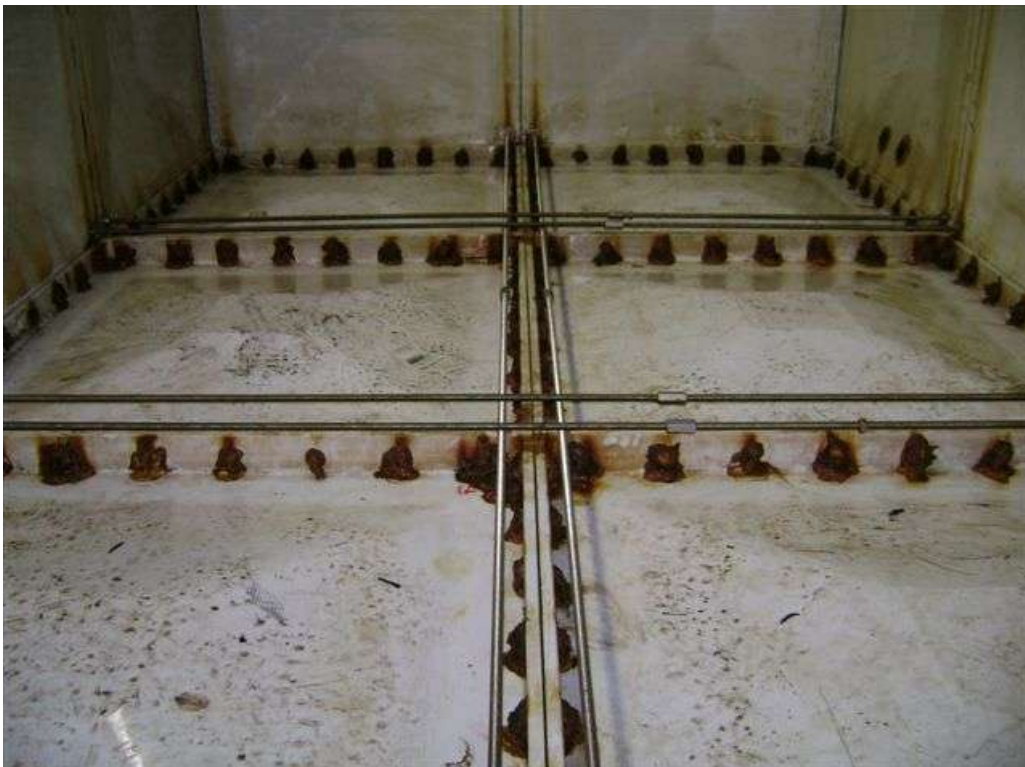
These photographs show the internal surfaces of the tank having been drained of water, but prior to any work commencing. Severe corrosion on the steel fastenings can be clearly seen.

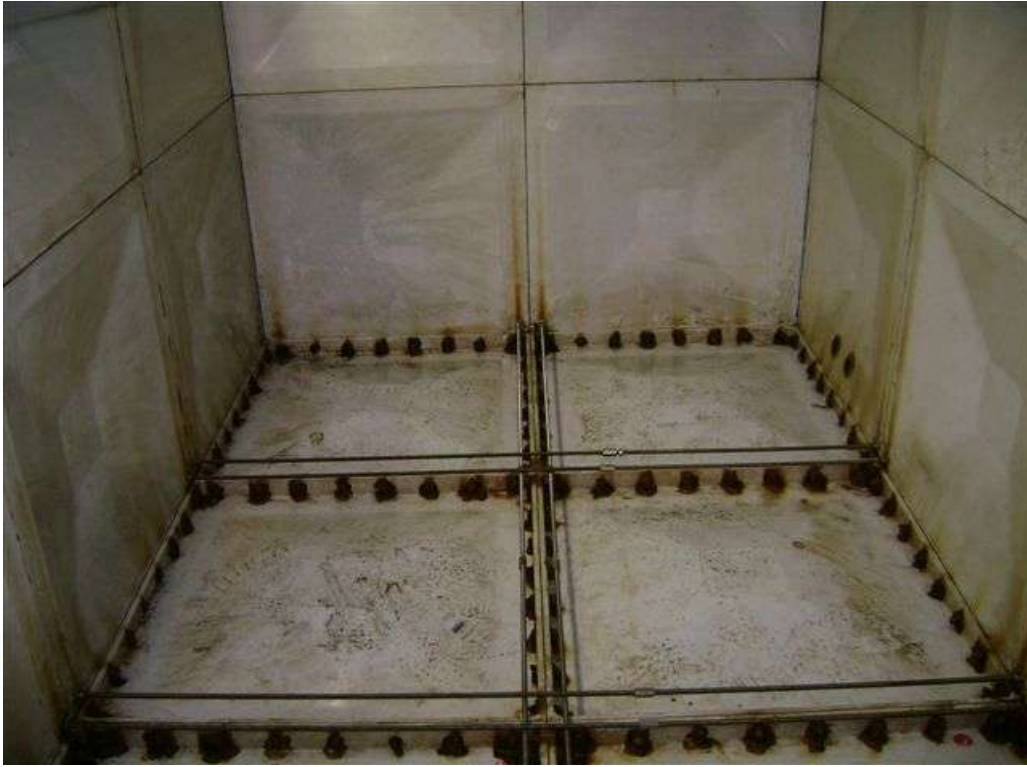
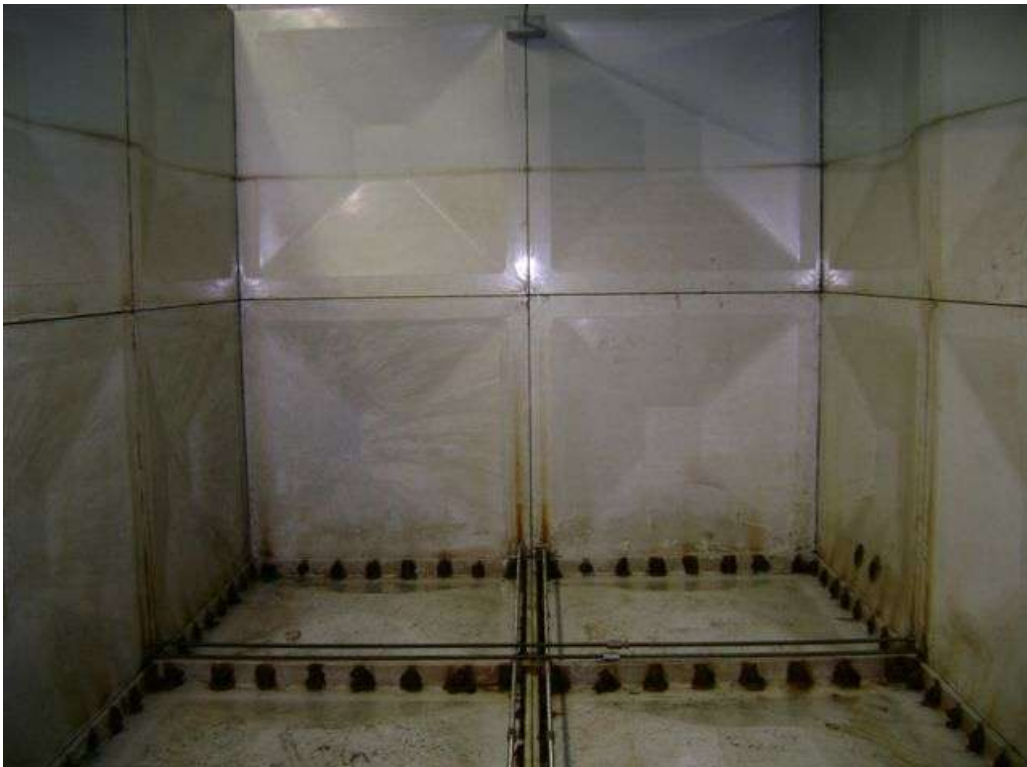
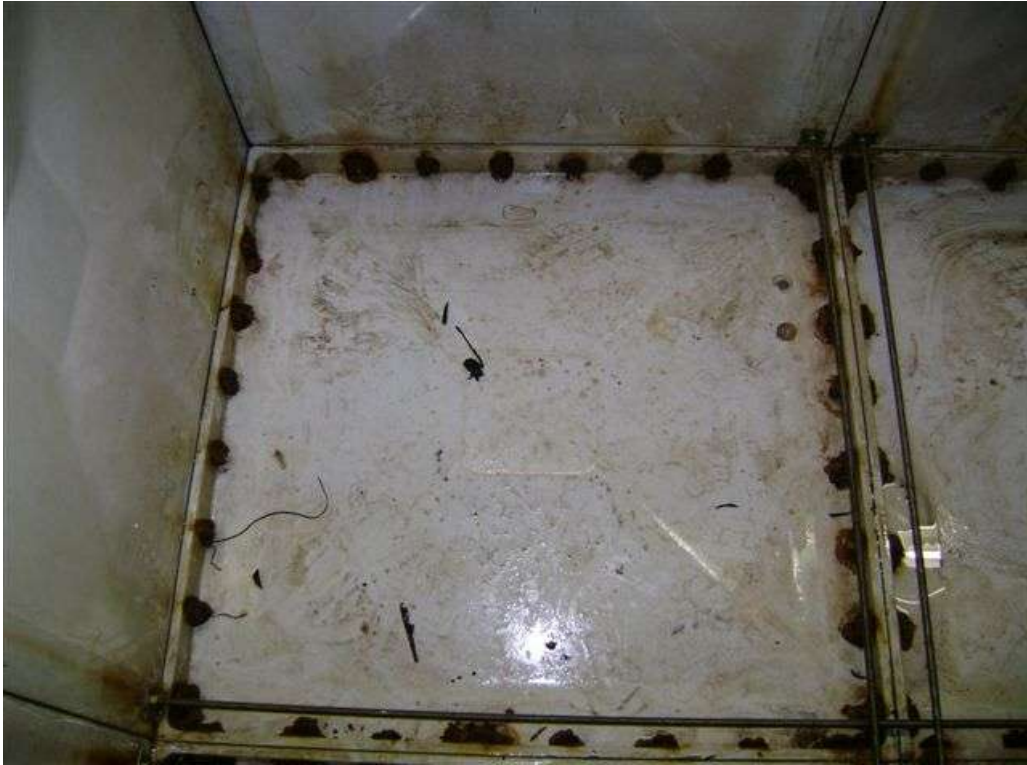
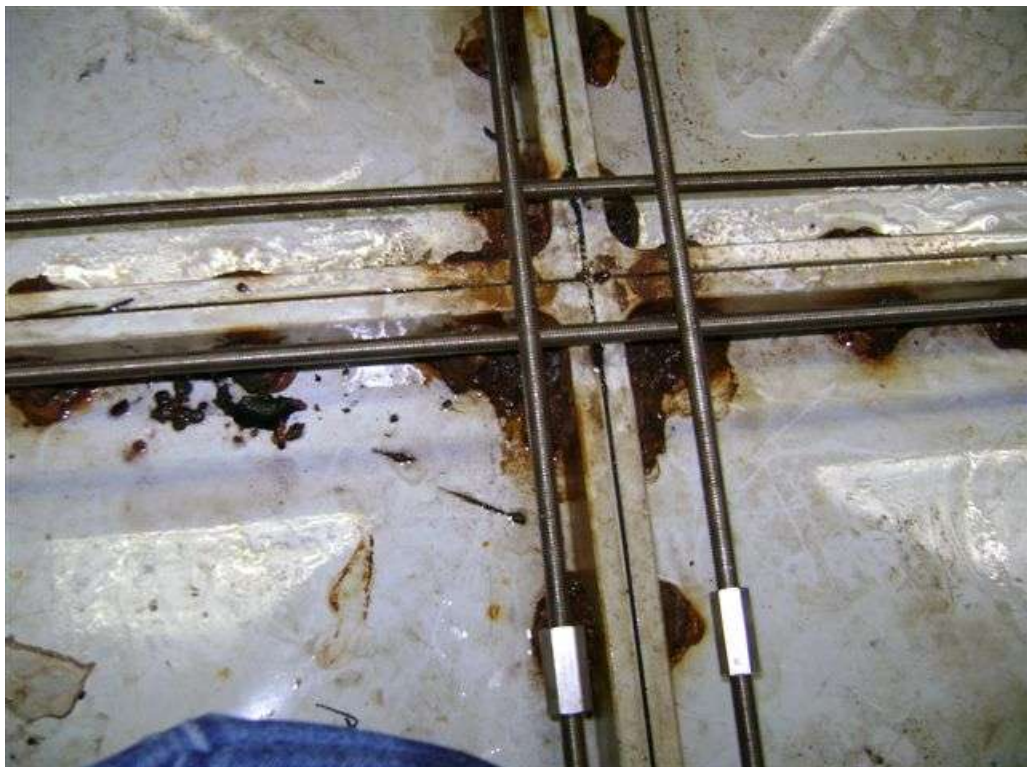
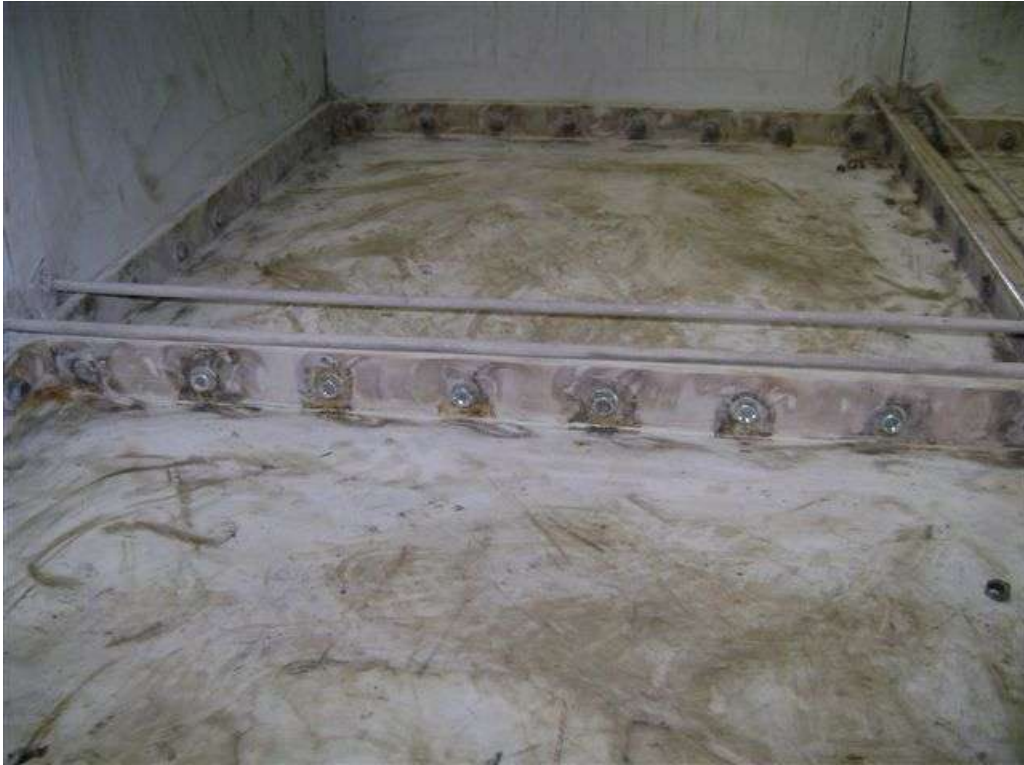
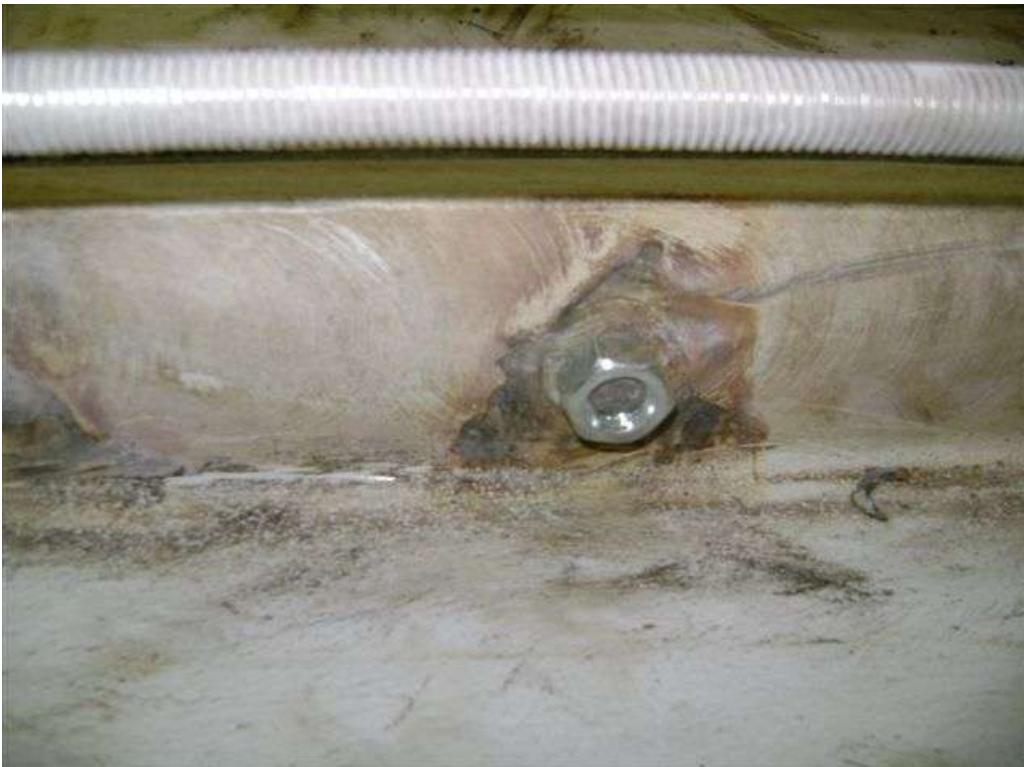
These pictures show the internal substrate after being prepared by COVAC Operatives in order to raise a suitable surface profile on the substrate and promote optimum adherence of the 3M Scotchkote™ 165PW lining system.

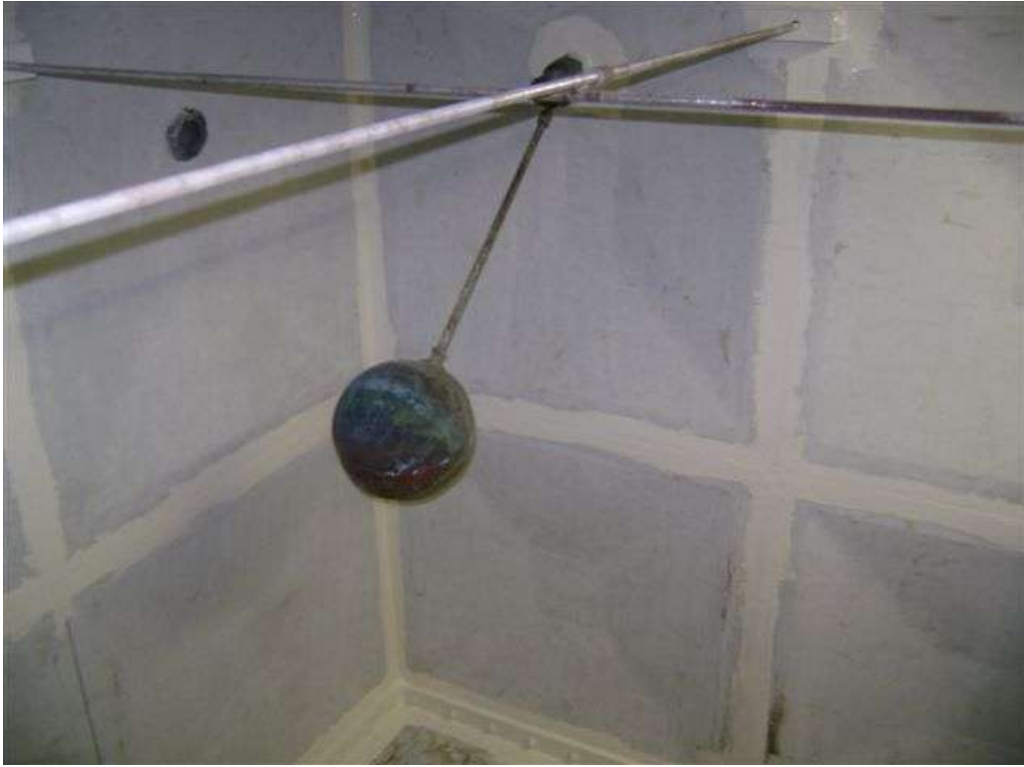
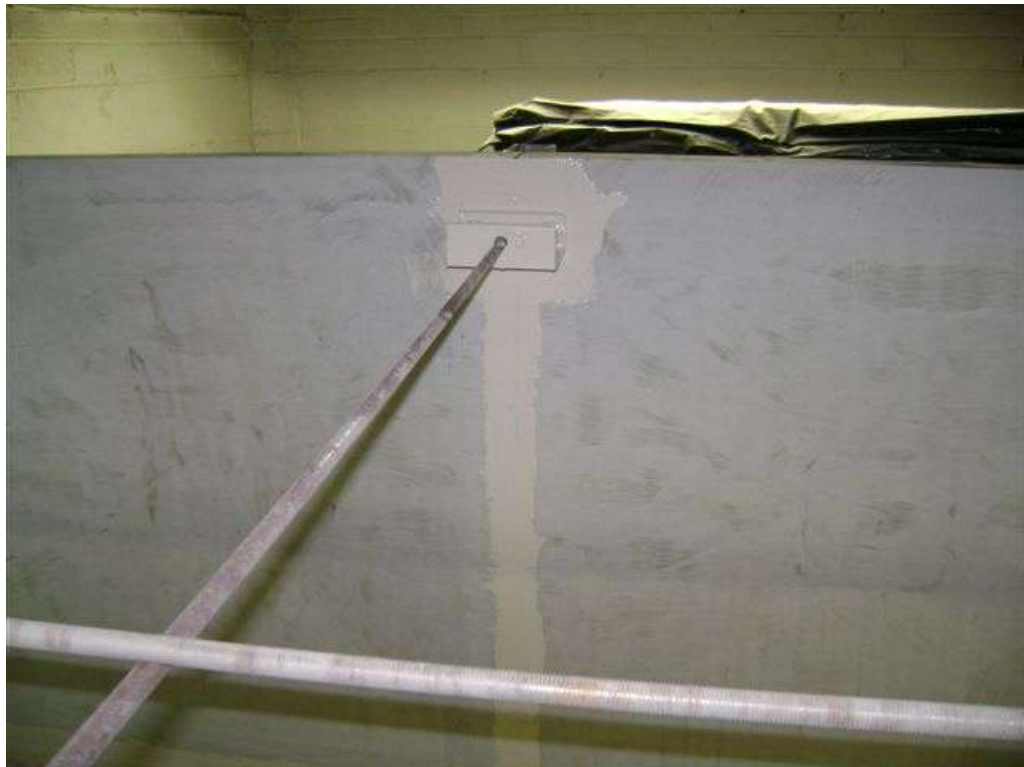
All joints were treated to prevent leaks and allowed to cure.

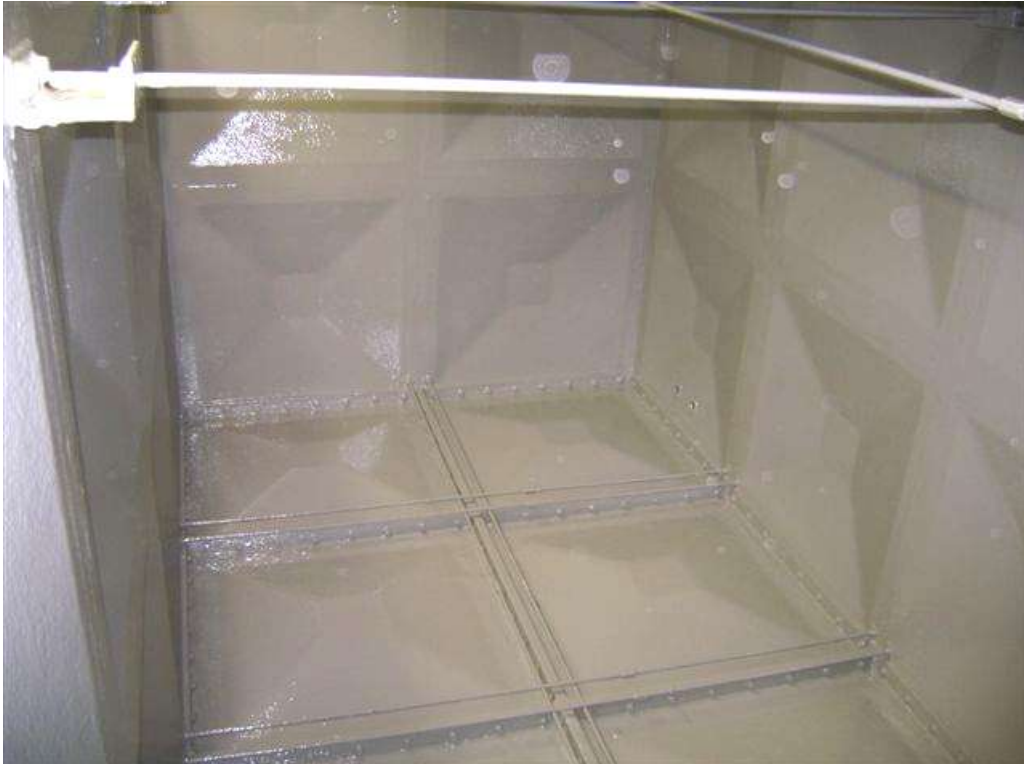
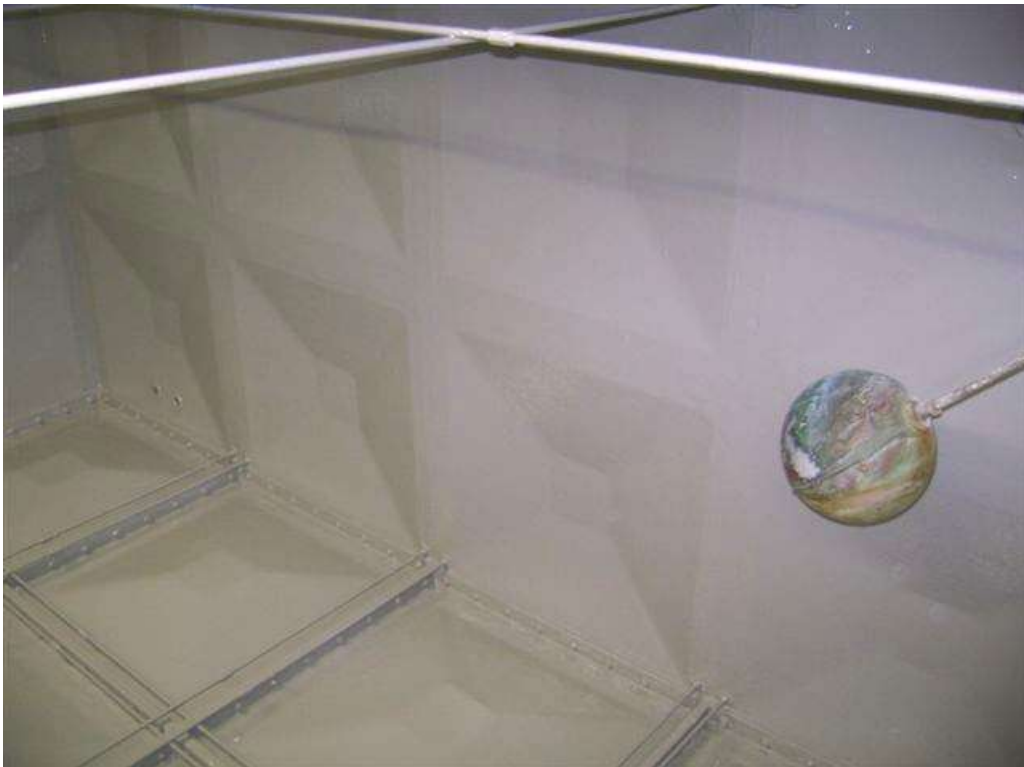
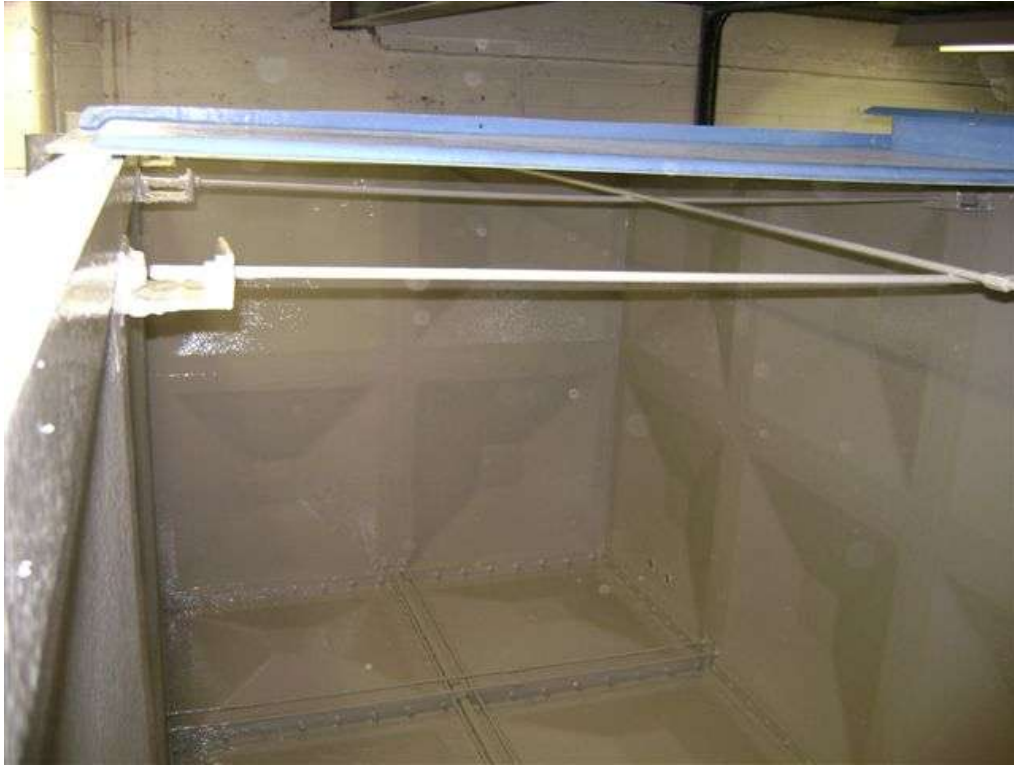
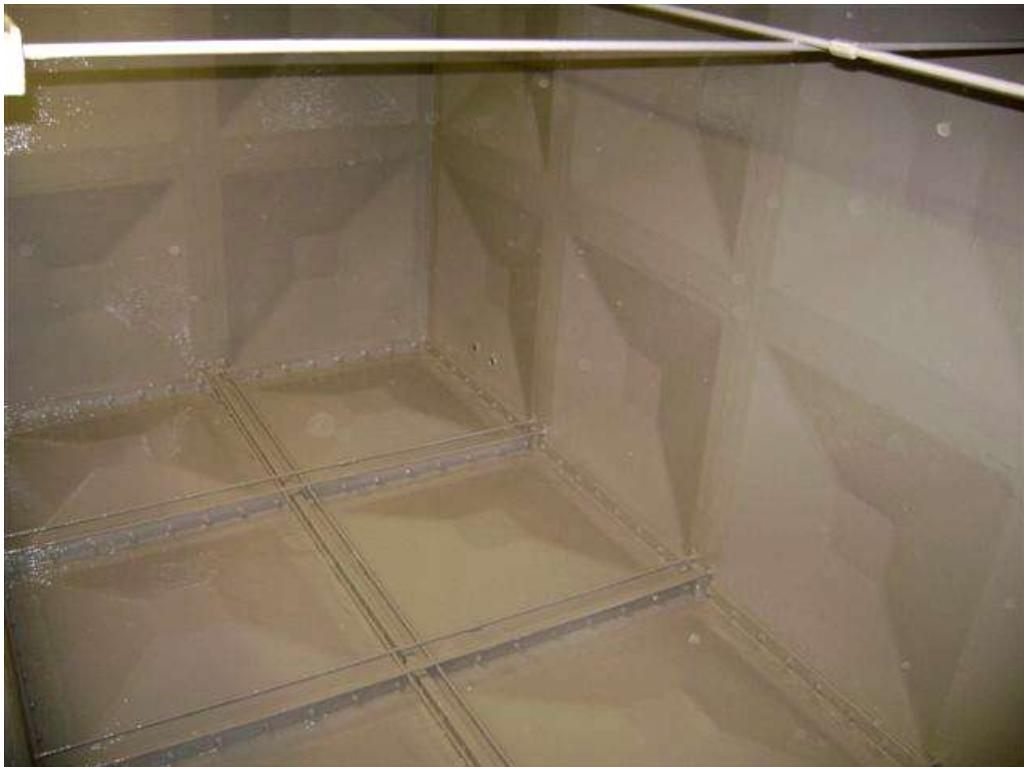
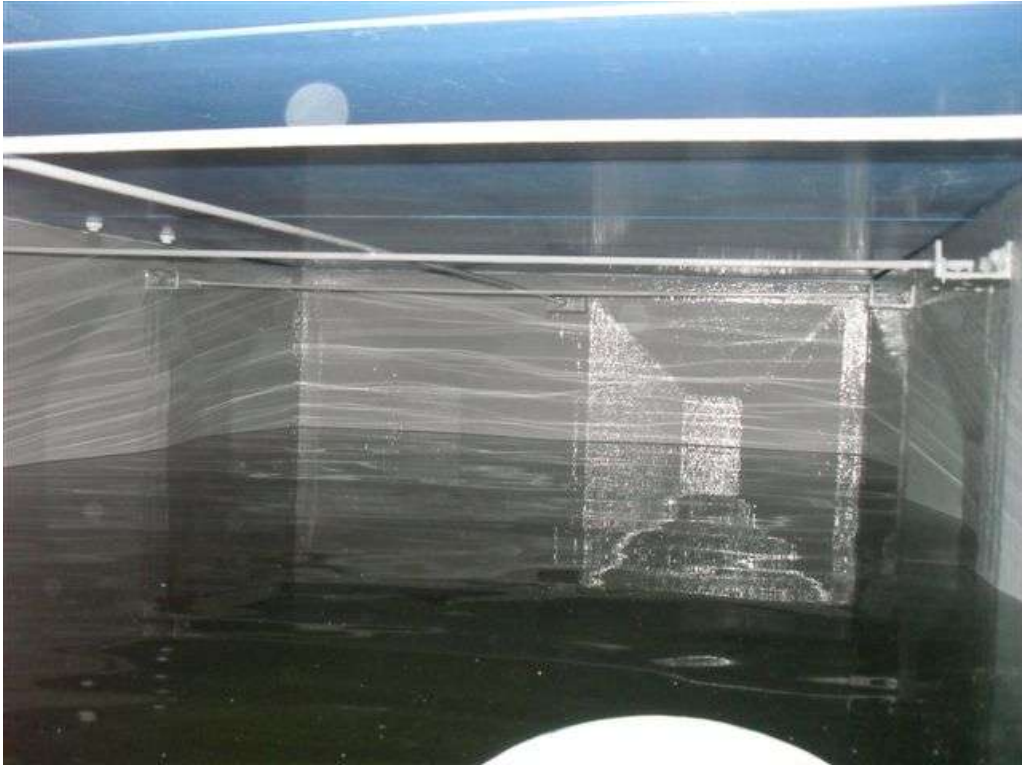
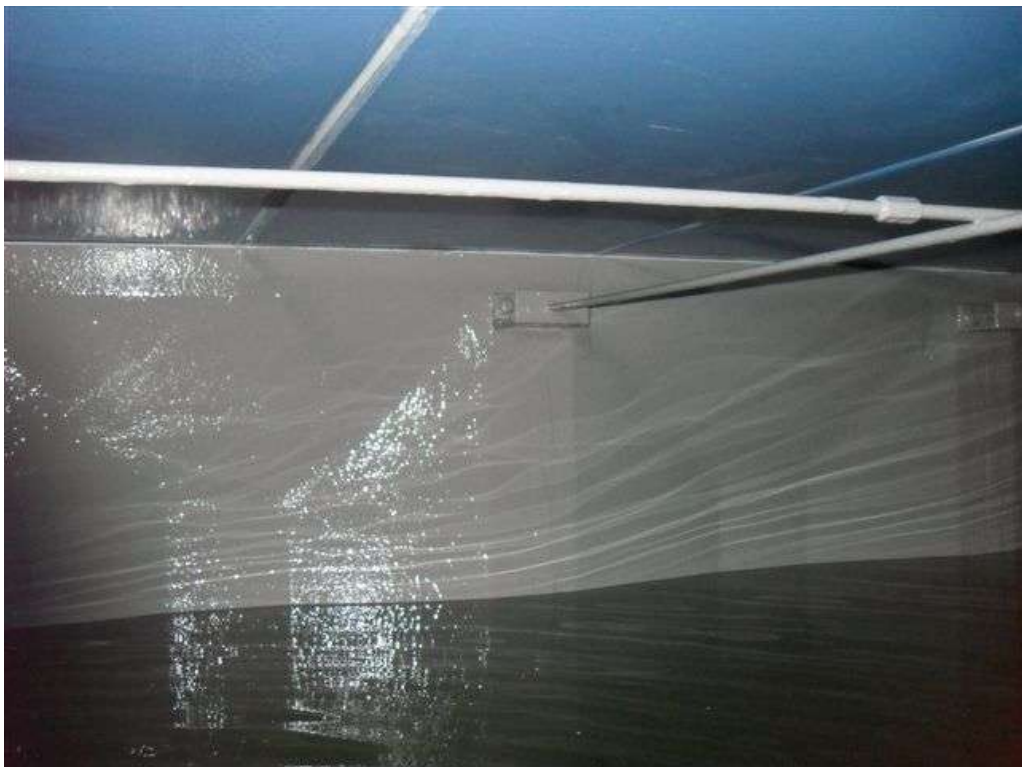
The following photographs show the final application of t 3M Scotchkote™ 165PW (grey).
