COMPLETION REPORT

Project Brief : **The Internal Repair and Lining of 1 No. GRP CWS Tank**

System Spec : **3M Scotchkote™ 165PW**
(Formerly Known as COPON Hycote 165PW)

Covac Ref : **901**

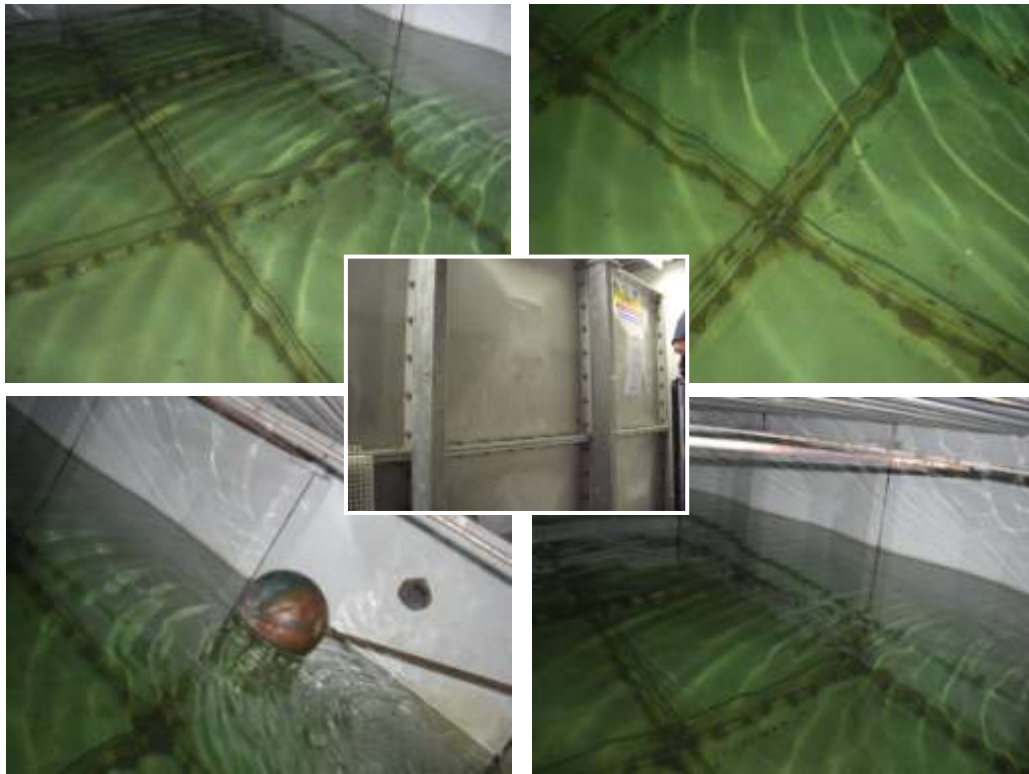
These images show the internal and external of the structure before repair and lining:-

The internal surfaces of the structure were in relatively good condition, however, the internal steel fasteners were showing signs of excessive corrosion which needed to be addressed. If left untreated, the internal surfaces would continue to be at risk from bacterial growth including Legionella, Pseudomonas and Biofilm; this can lead to further deterioration in the tank's surface structure and contamination of the down services with the supply of unhygienic water to the outlets.

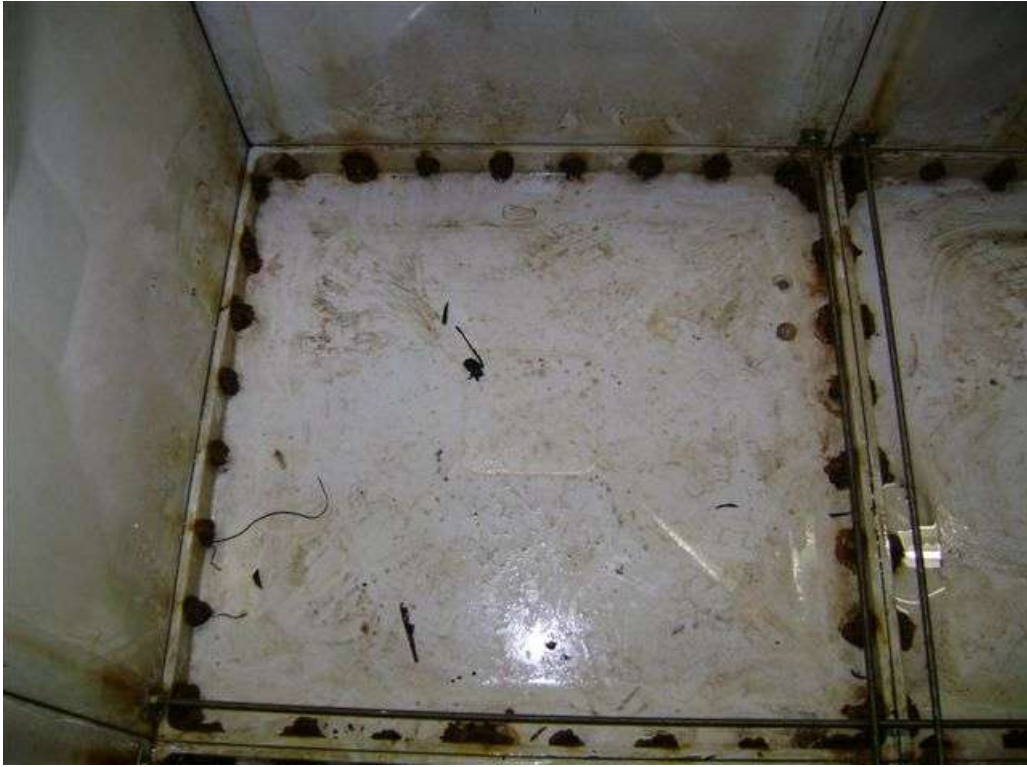
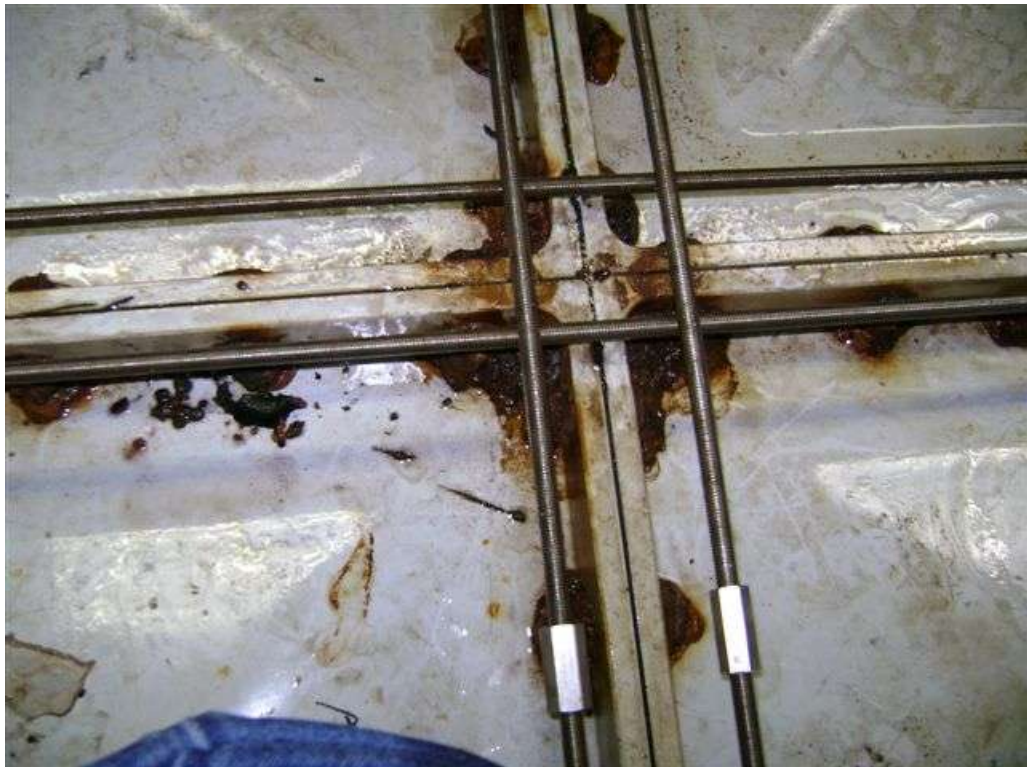
These pictures show the internal substrate after being prepared by COVAC Operatives in order to raise a suitable surface profile on the substrate and promote optimum adherence of the 3M Scotchkote™ 165PW lining system.

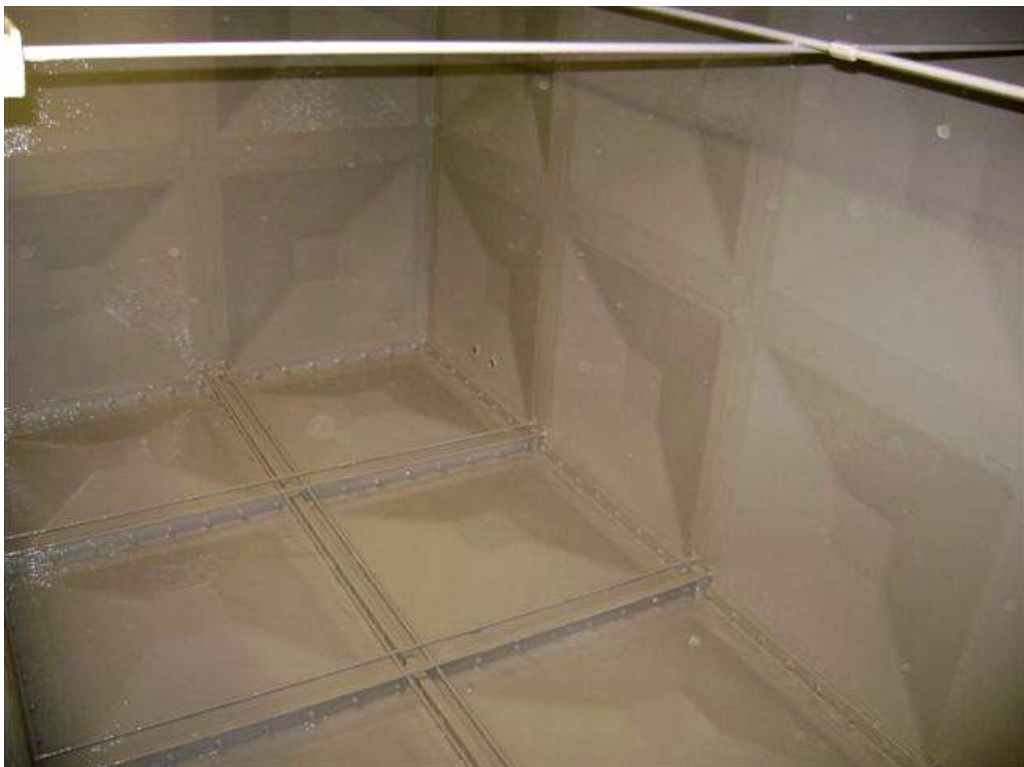
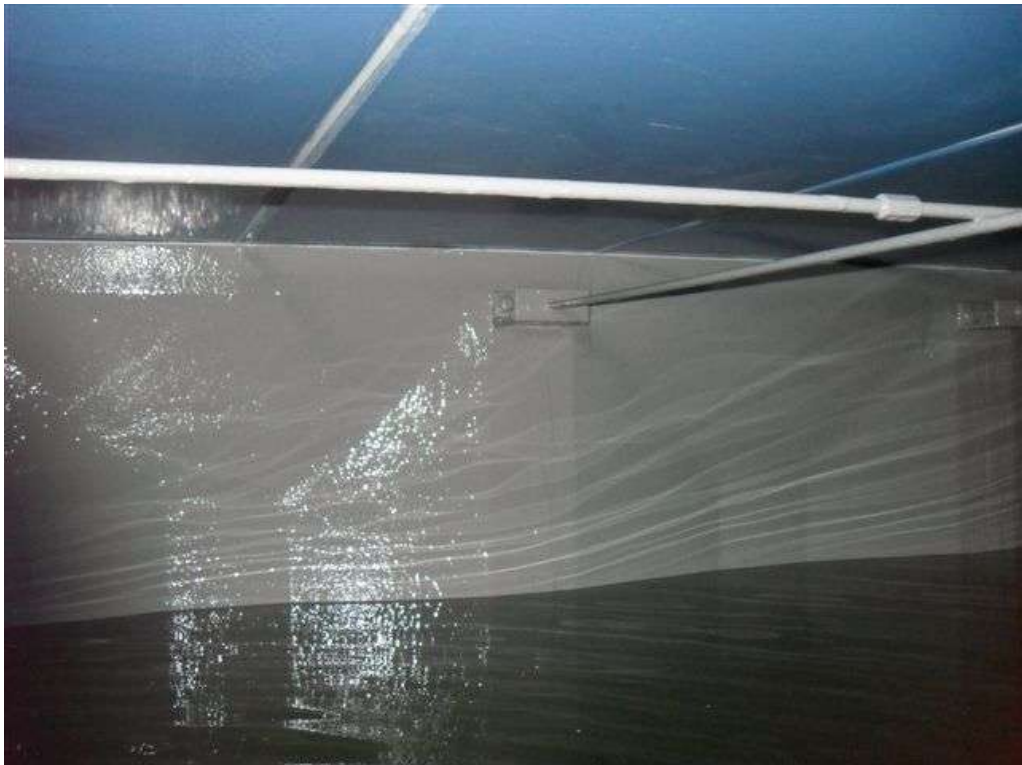
The following photographs show the final application of t 3M Scotchkote™ 165PW (grey).
