COMPLETION REPORT

Client	-	XXXXXX Hospital
Address	-	UK
Client Site Contact	-	XXXXXXXXX
Project Brief	-	The Internal & External Refurbishment of 1 No. Hornsley Bridge, Sectional, Steel, Potable Water Retaining Structure.
System Specification	-	3M Scotchkote™ 165PW Solvent Free Polyurethane.
Nominal Dry Film Thickness	-	1000 Microns
Completion Date	-	23rd July 2008
Site Supervisor	-	Carl Broadley
Report Prepared by	-	Adrian Emmett / David Snell
COVAC Contract Ref:	-	751

**THE INTERNAL REFURBISHMENT OF 1 NO.
HORNSLEY BRIDGE, SECTIONAL STEEL
CWS TANK**

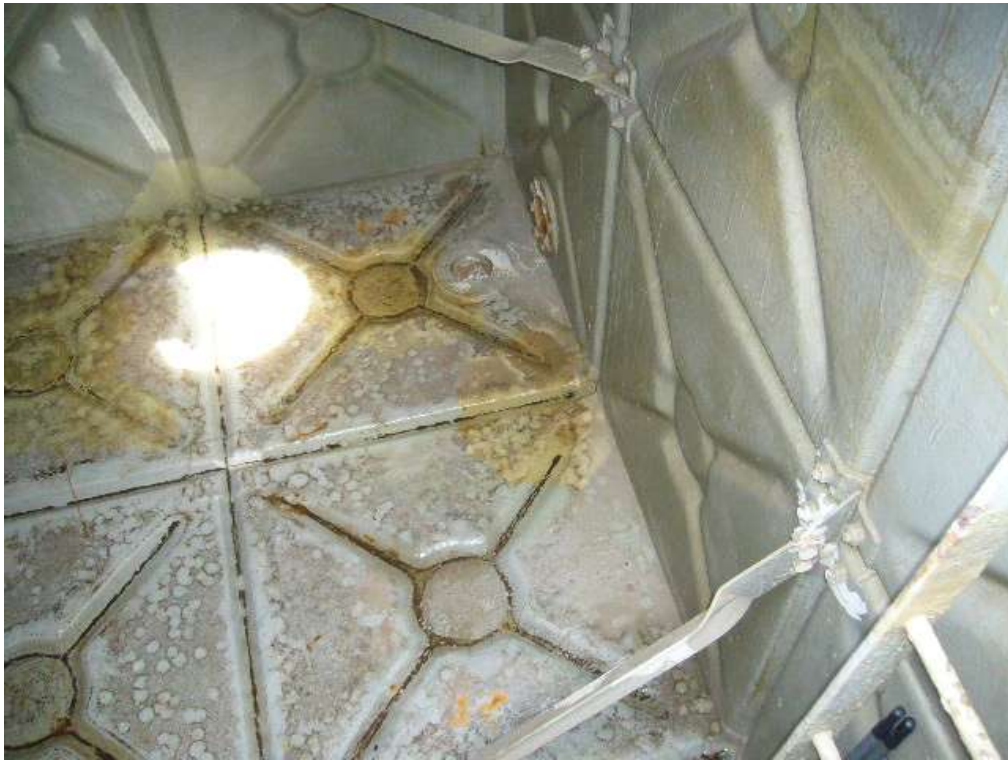
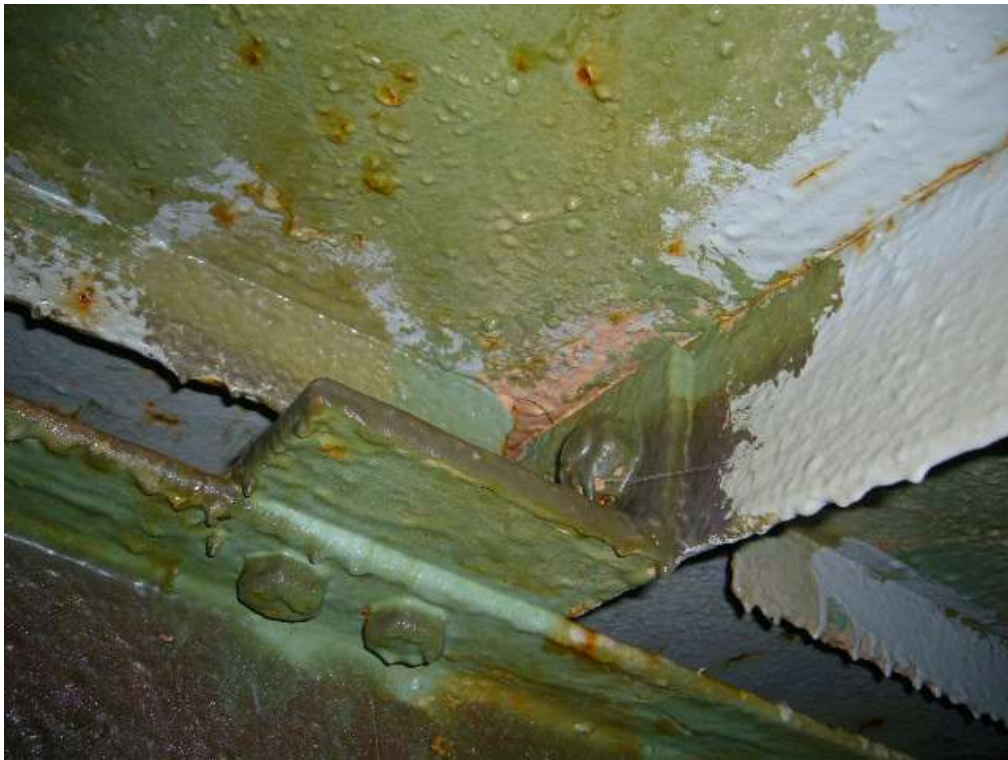
These photographs show the internal surfaces of structure having been drained of water and prior to any preparation works being carried out.

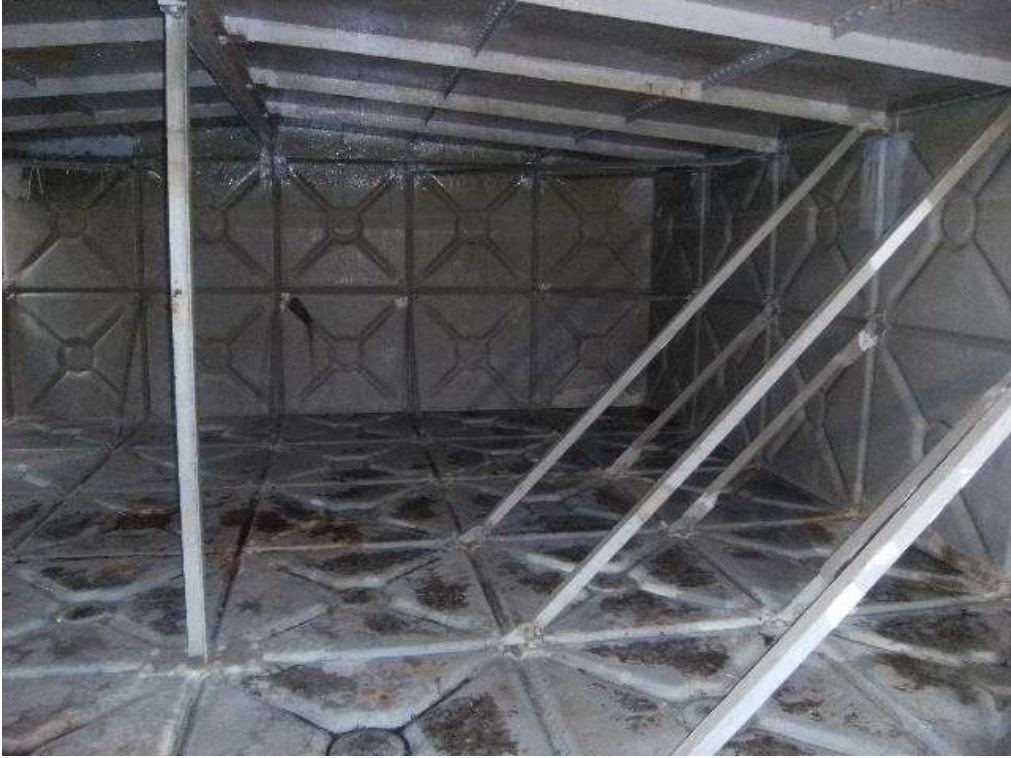
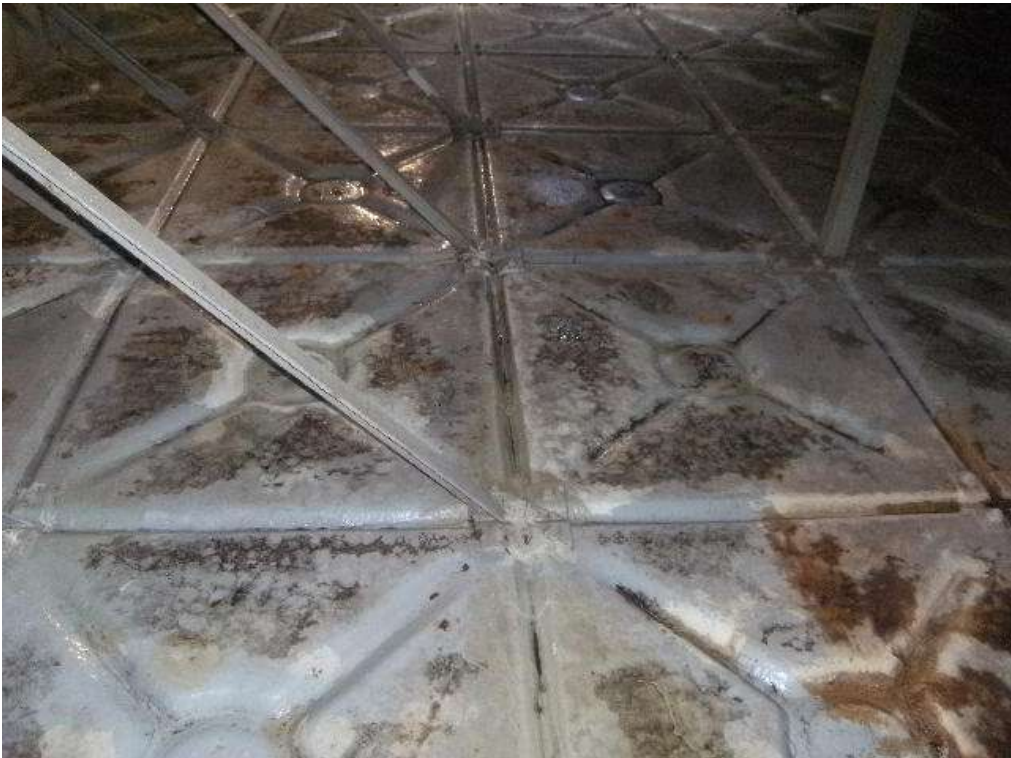
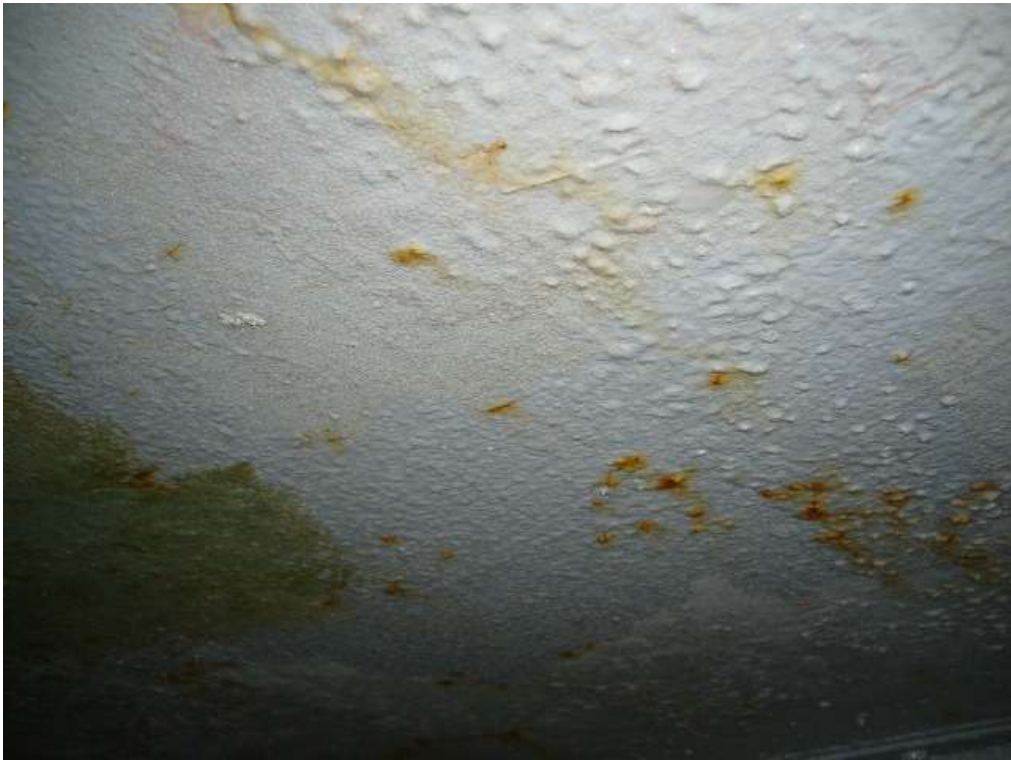
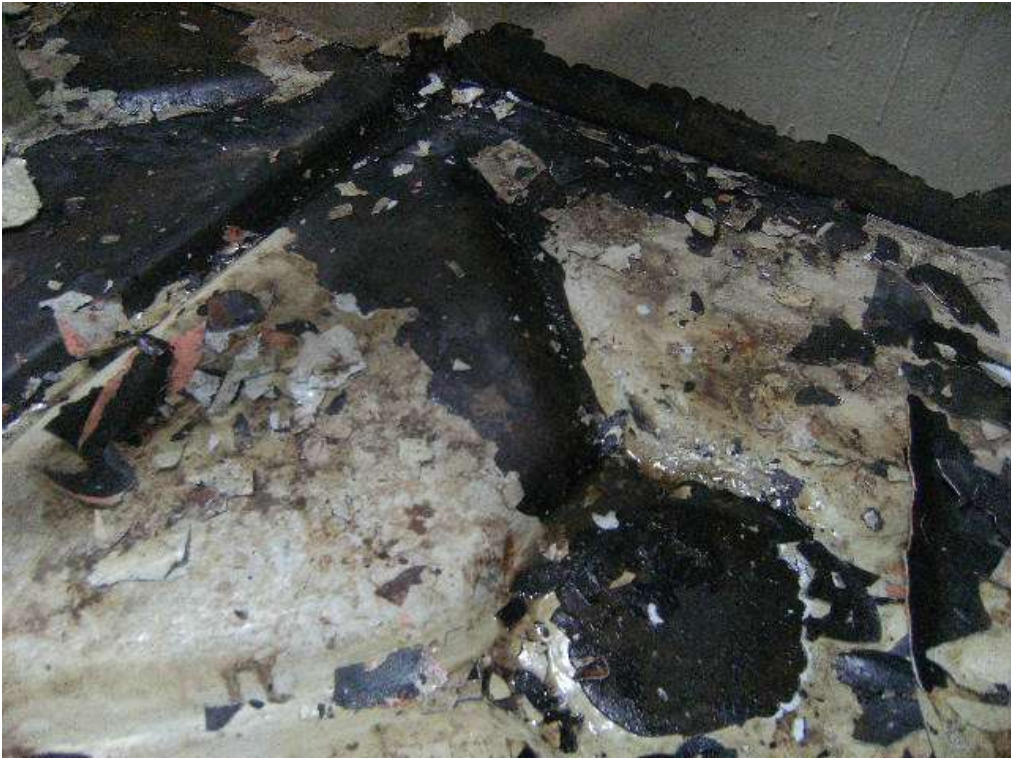
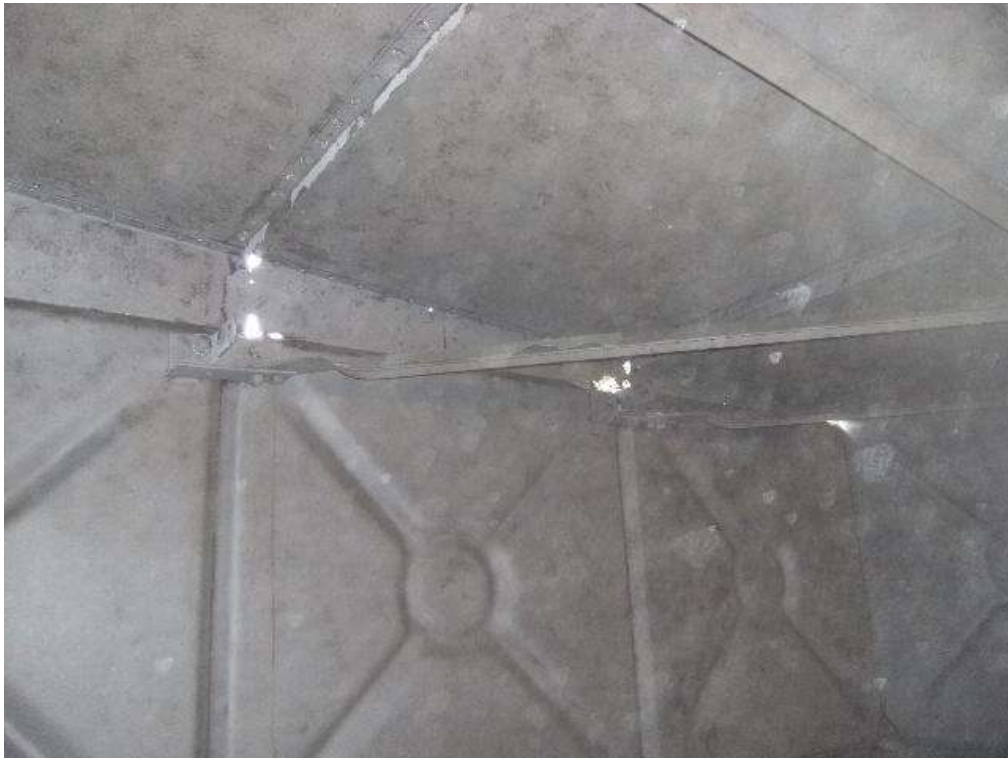
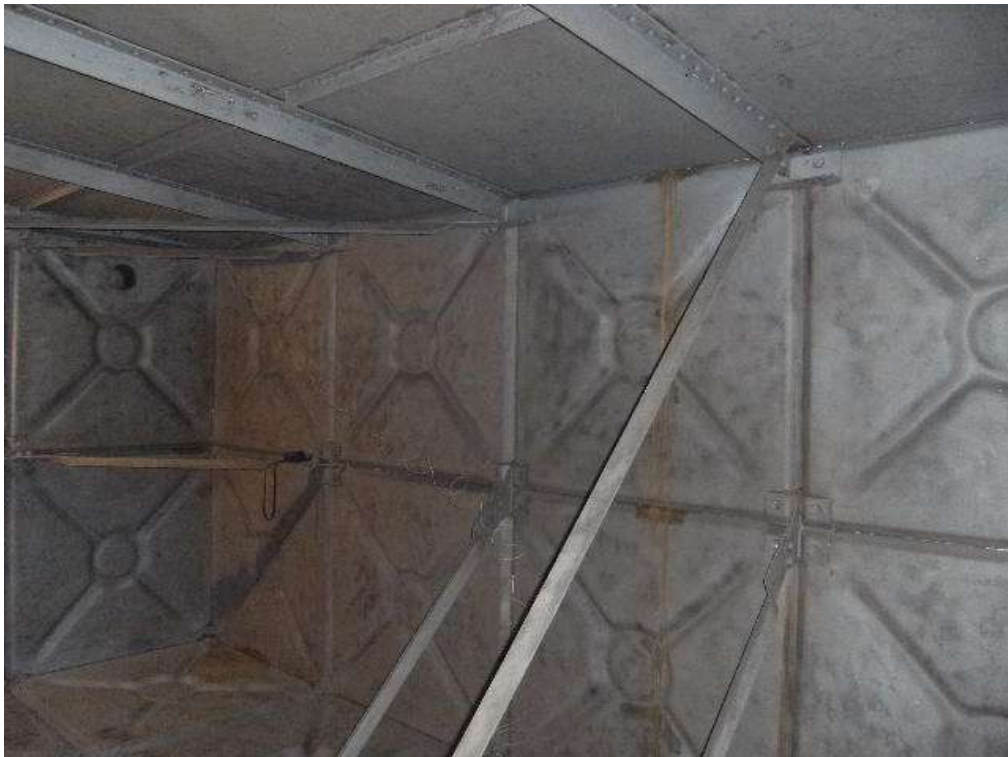
These photographs show the internal surfaces, after the mechanical preparation process by the COVAC Operatives using dry abrasive grit blast equipment in accordance with the a accepted Standard.

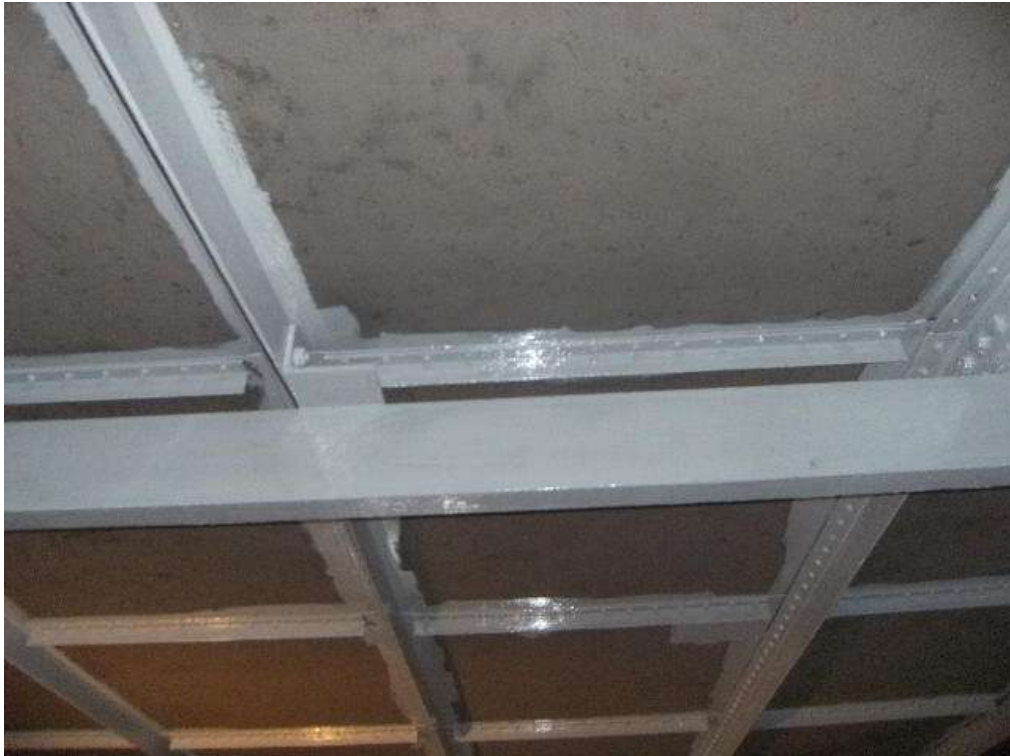
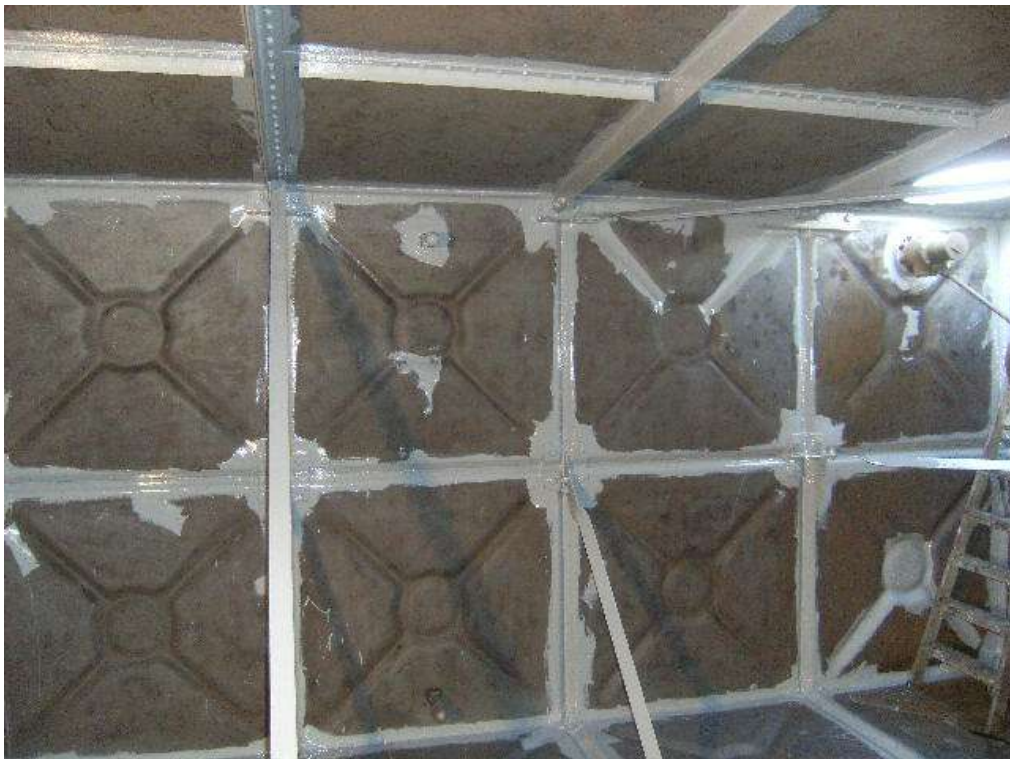
All bolt heads, struts and other protuberances received an initial 'stripe coat' to ensure that all intricate areas were fully coated prior to the full coat of 3M Scotchkote165PW Solvent Free Polyurethane being spray applied.

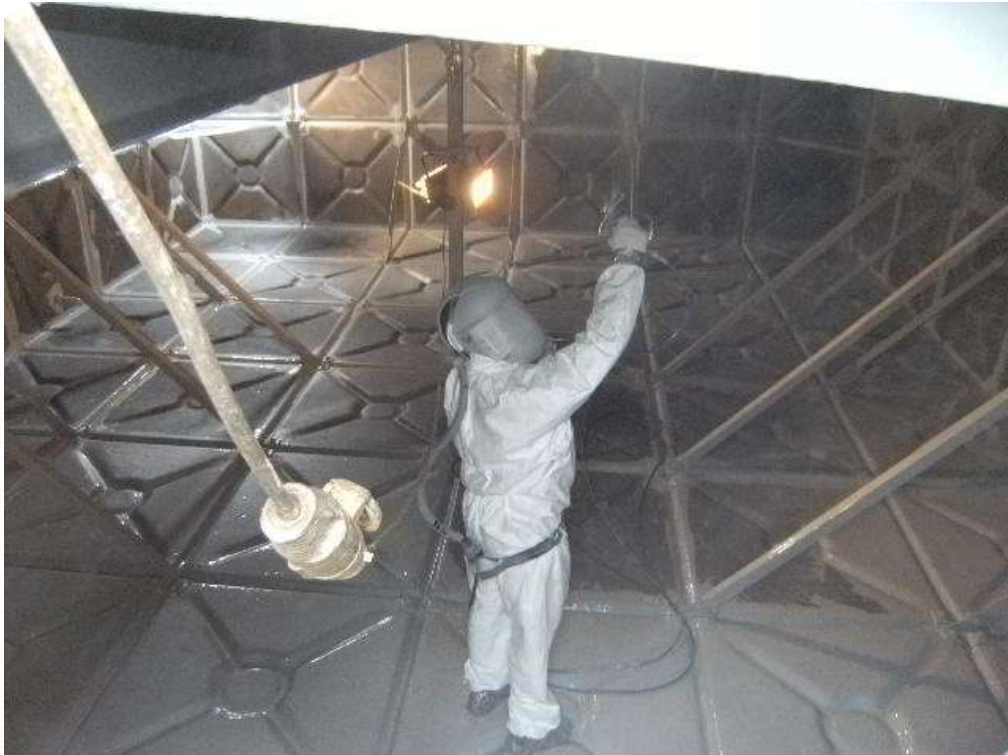
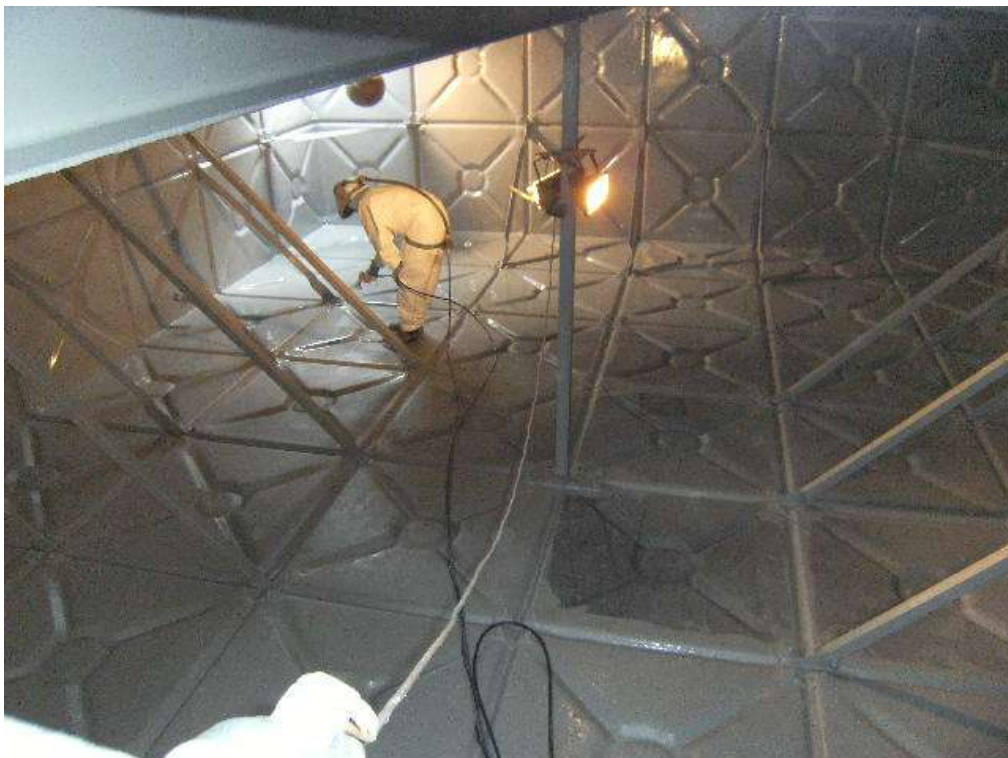
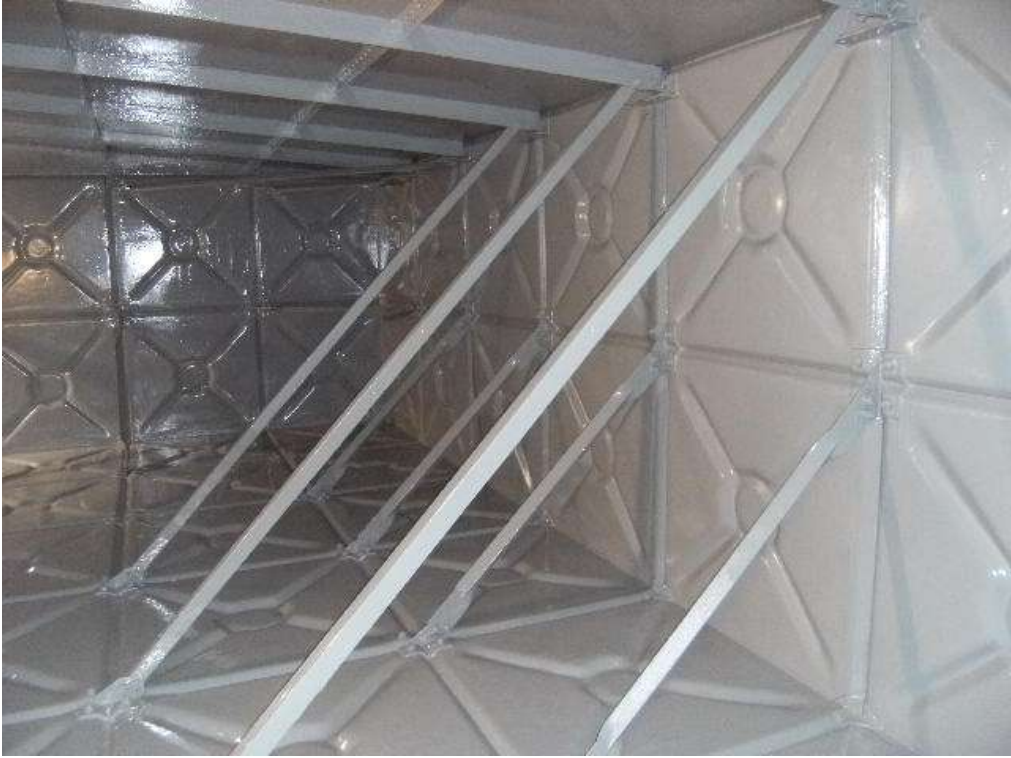
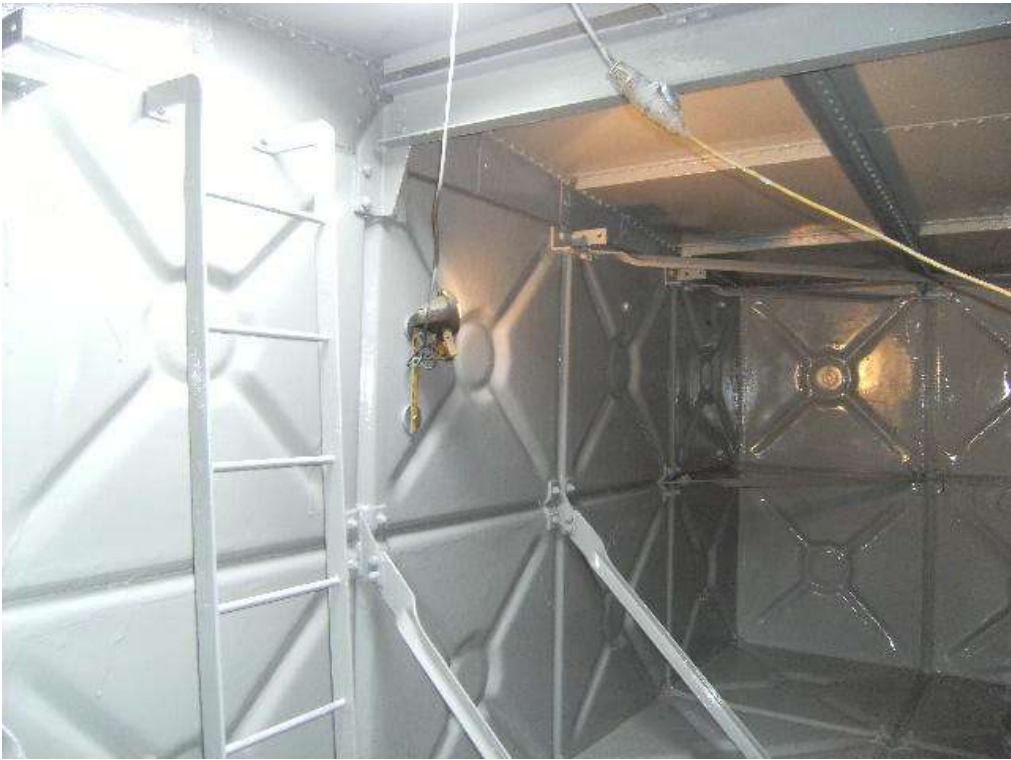
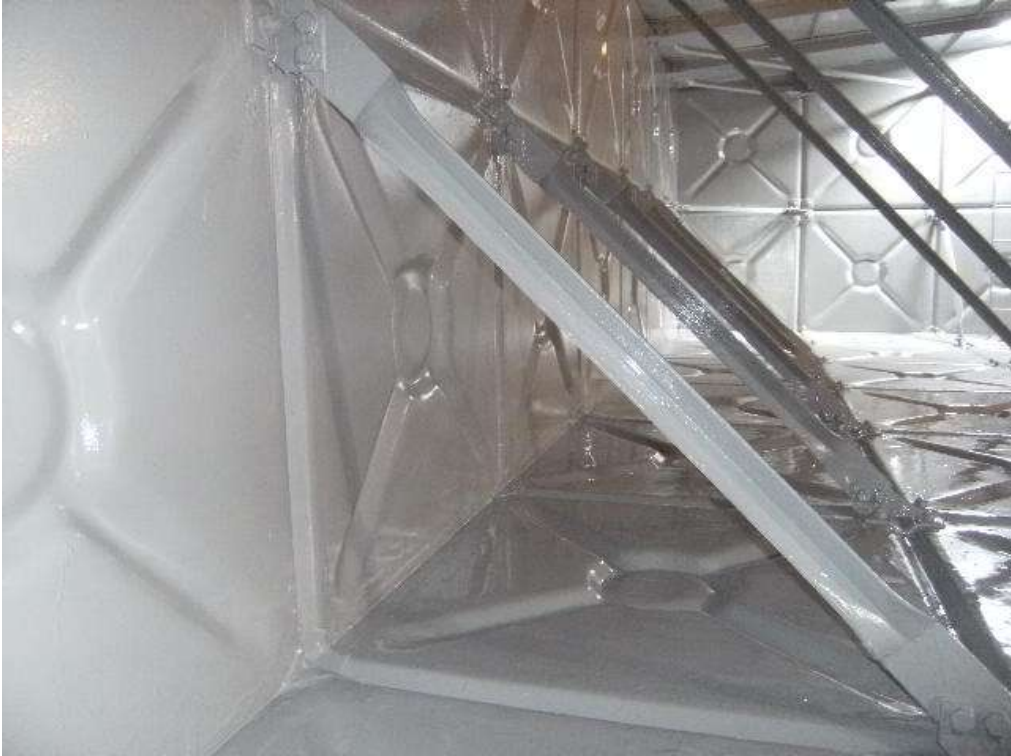
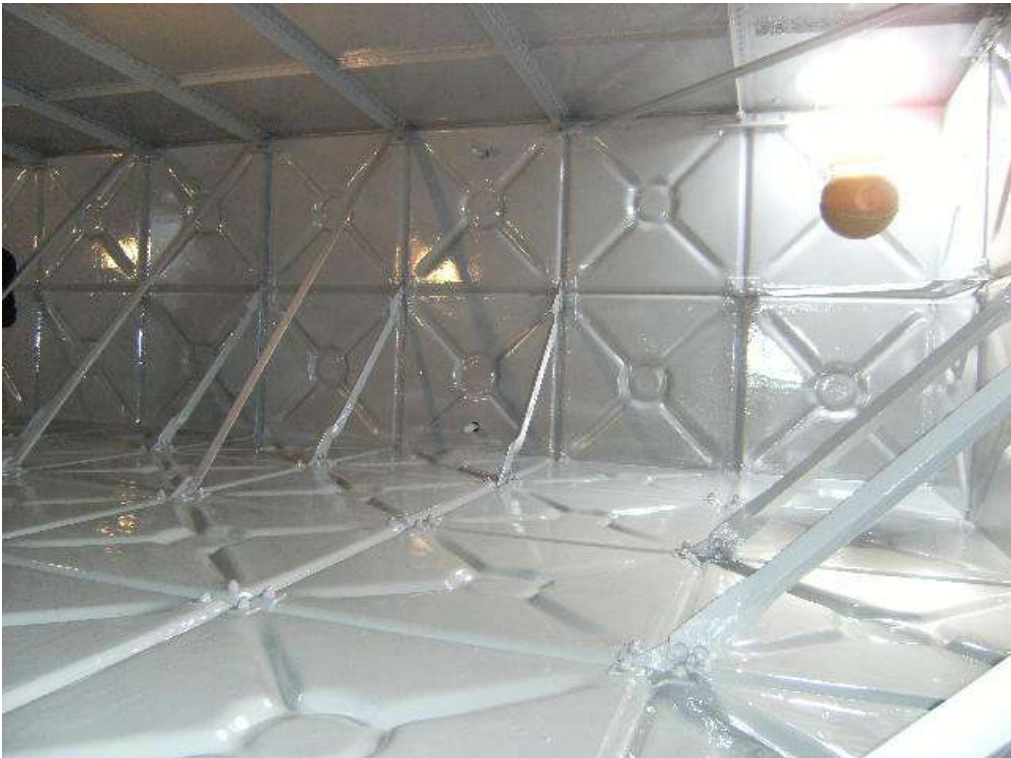
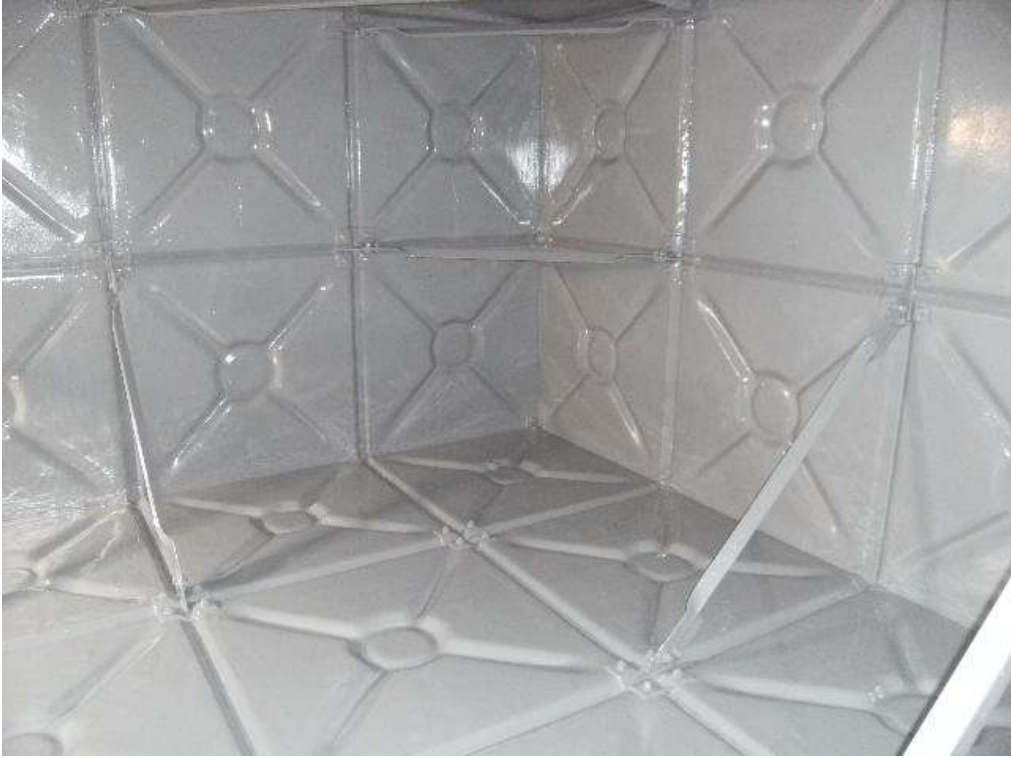
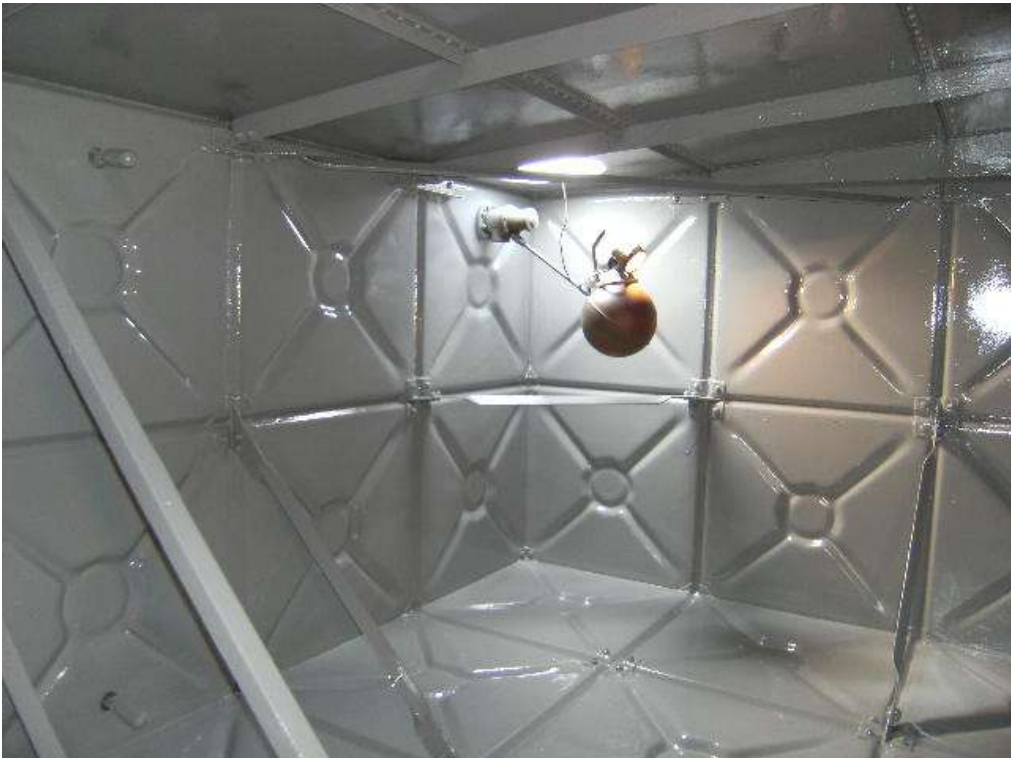
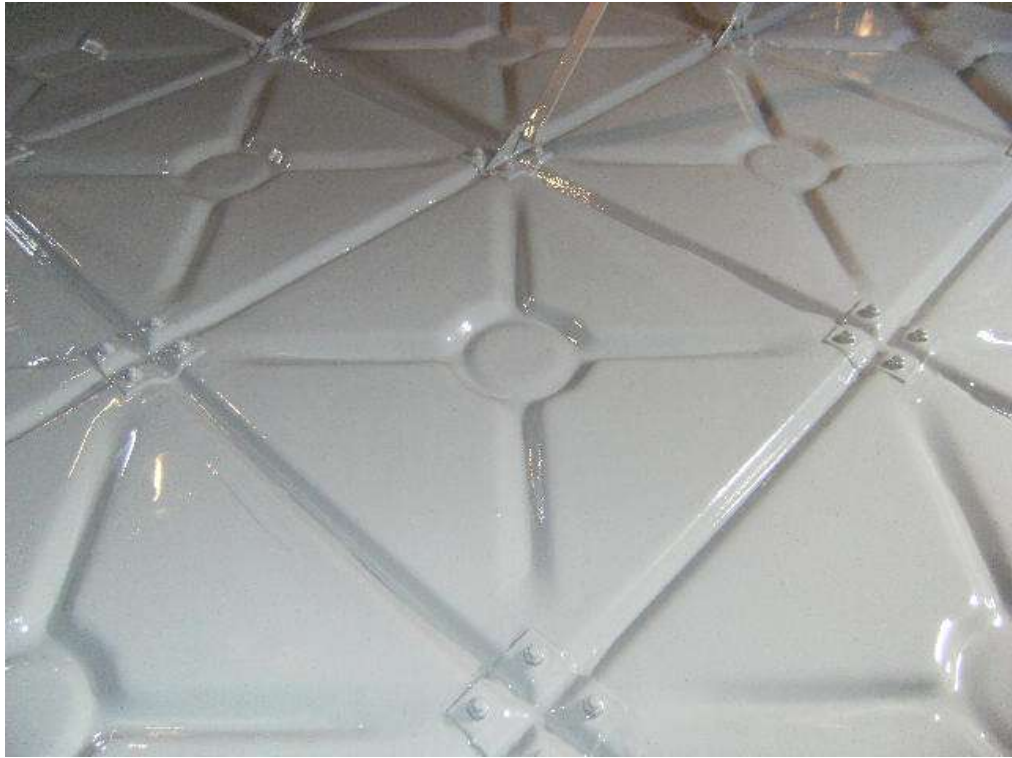
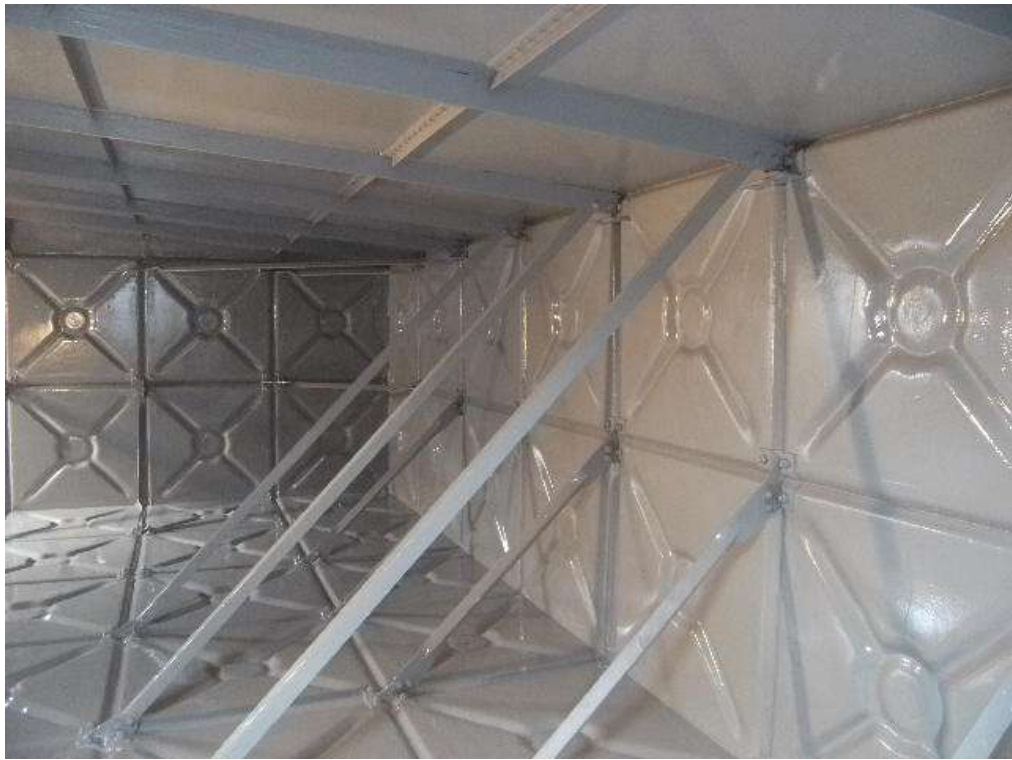
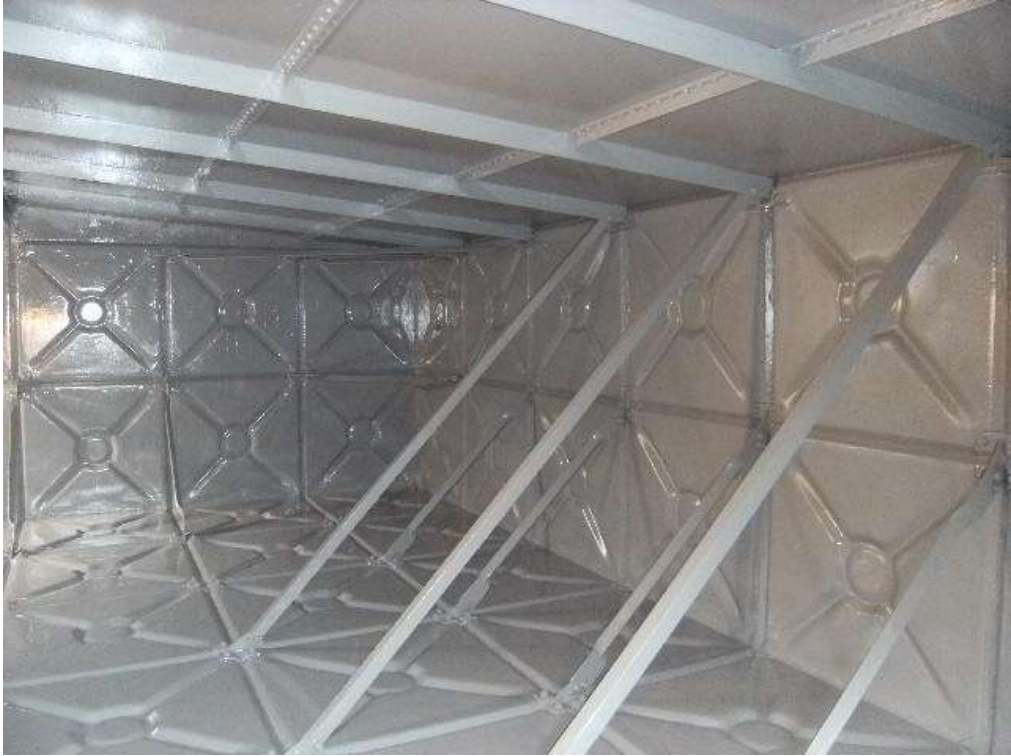
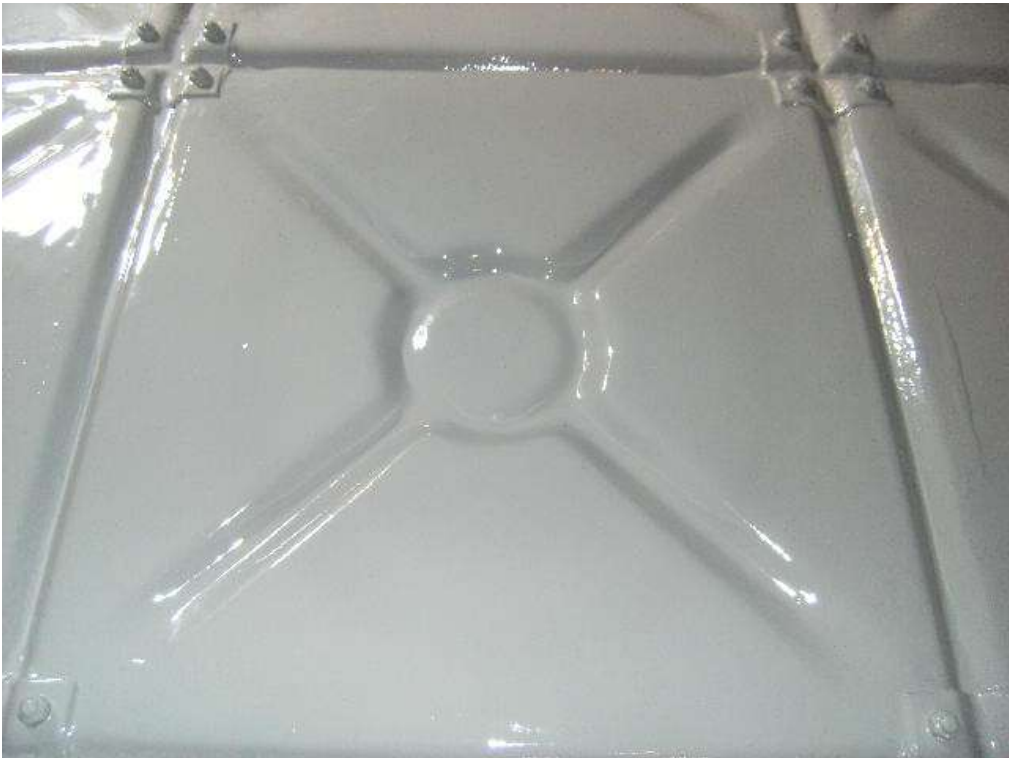
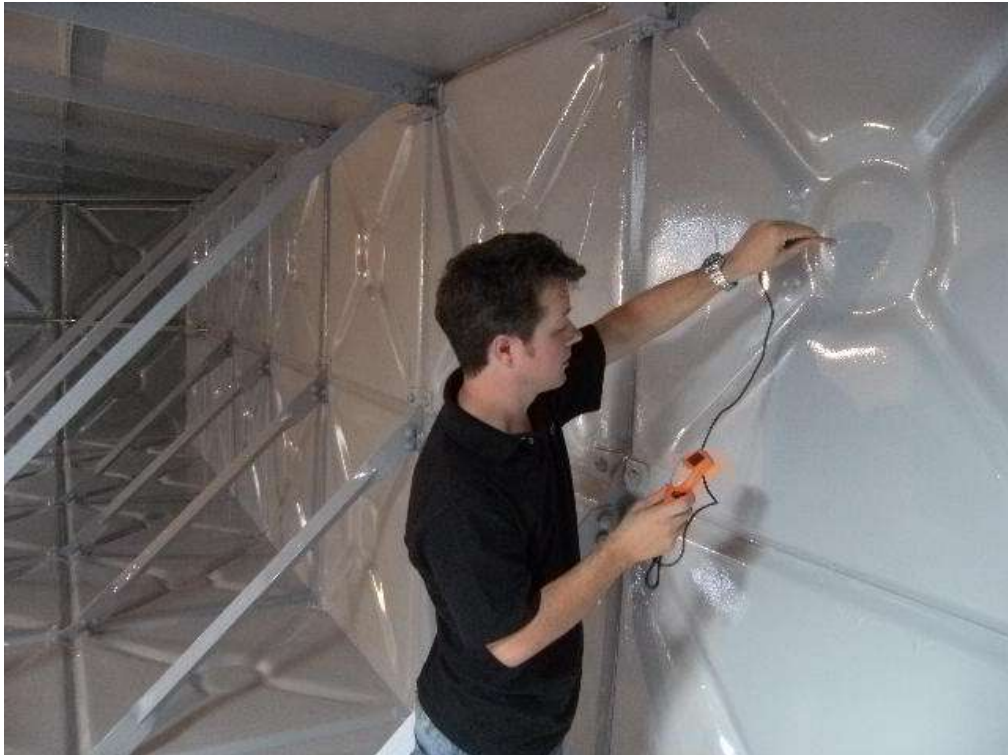
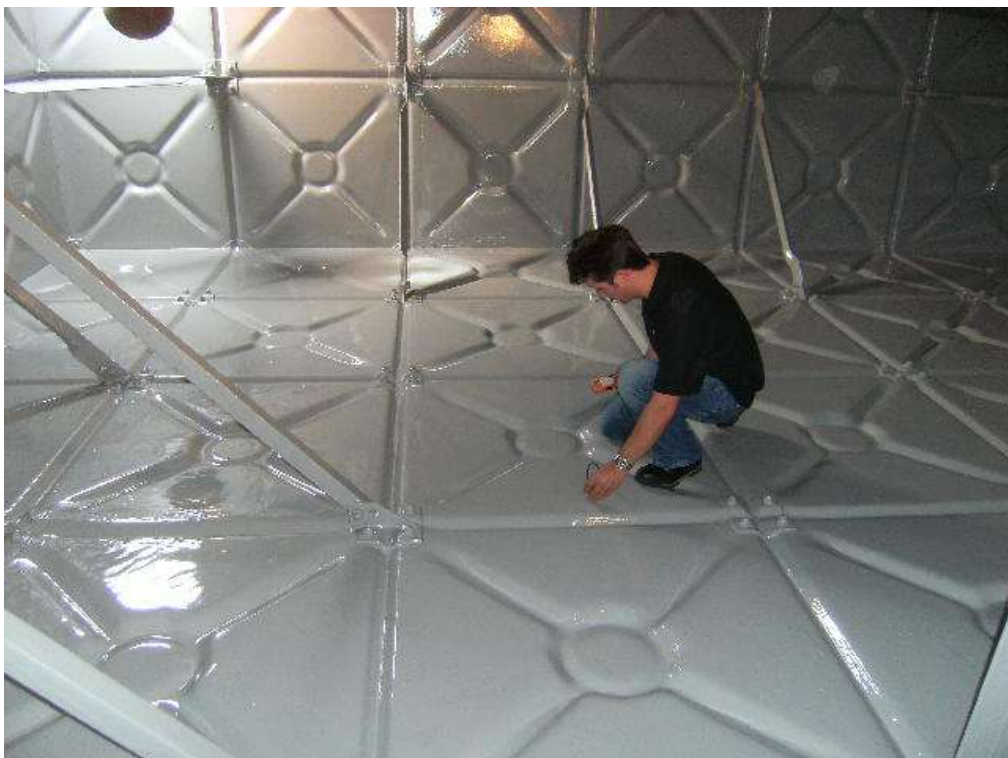
The following photographs show the substrate both during and after being fully coated with 3M Scotchkote 165PW (grey) Solvent Free Polyurethane, by means of plural component spray equipment to a nominal wet/dry film thickness of 1000 Microns (1mm) and between 1500-2000 Microns (2mm) over all stripe coated areas.

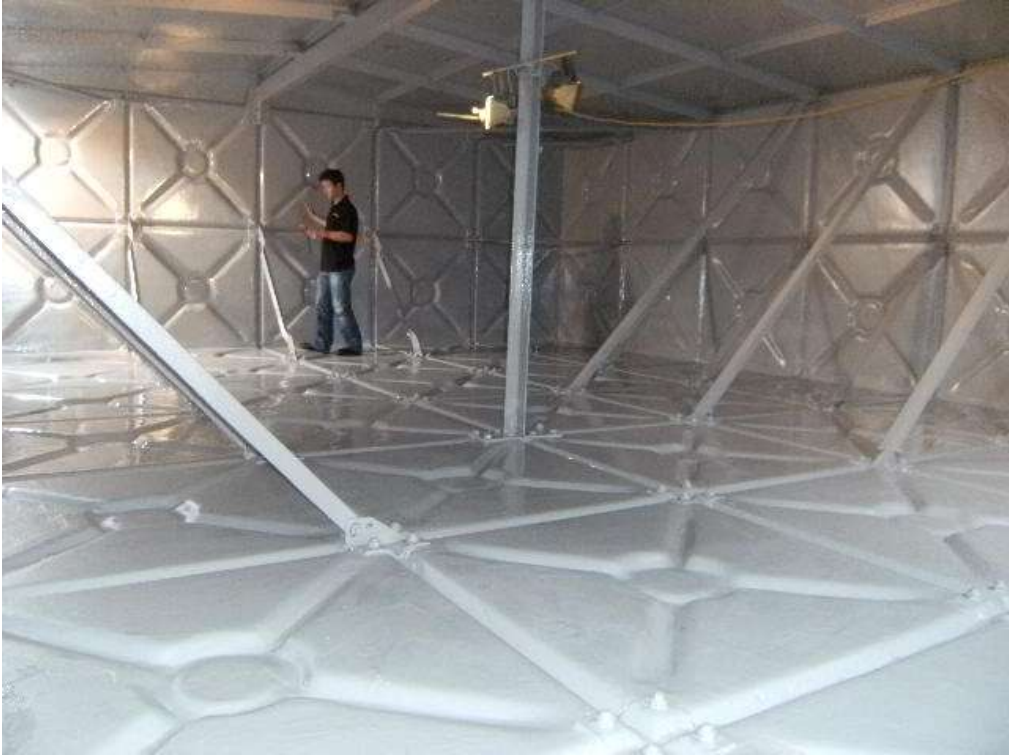
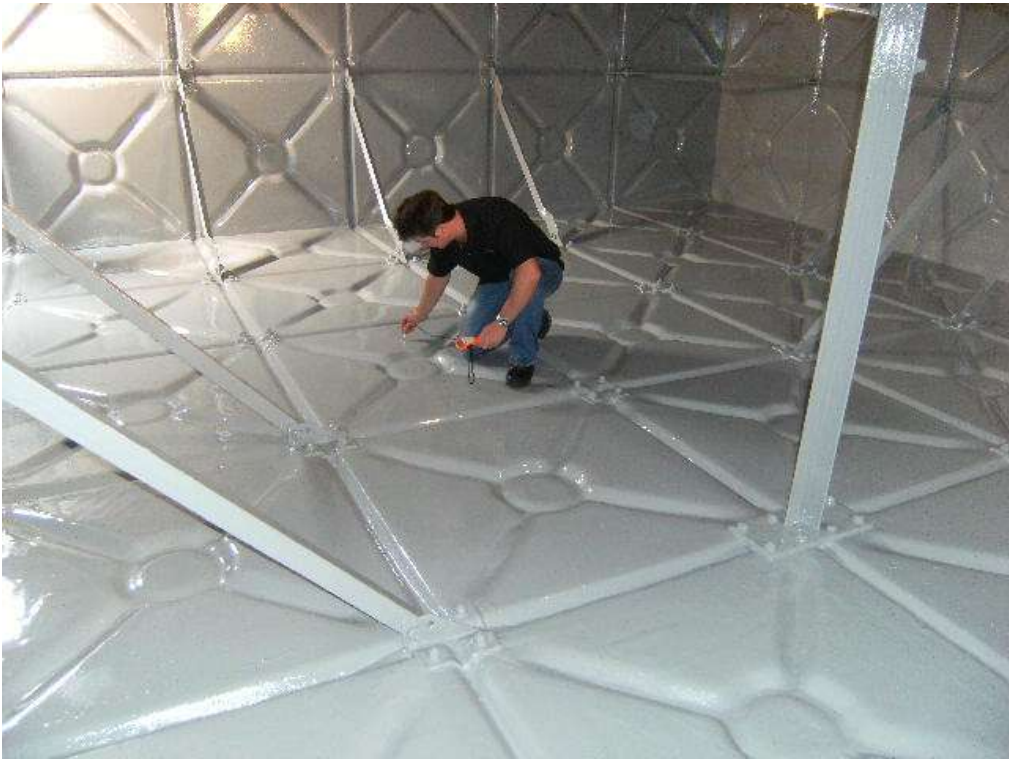
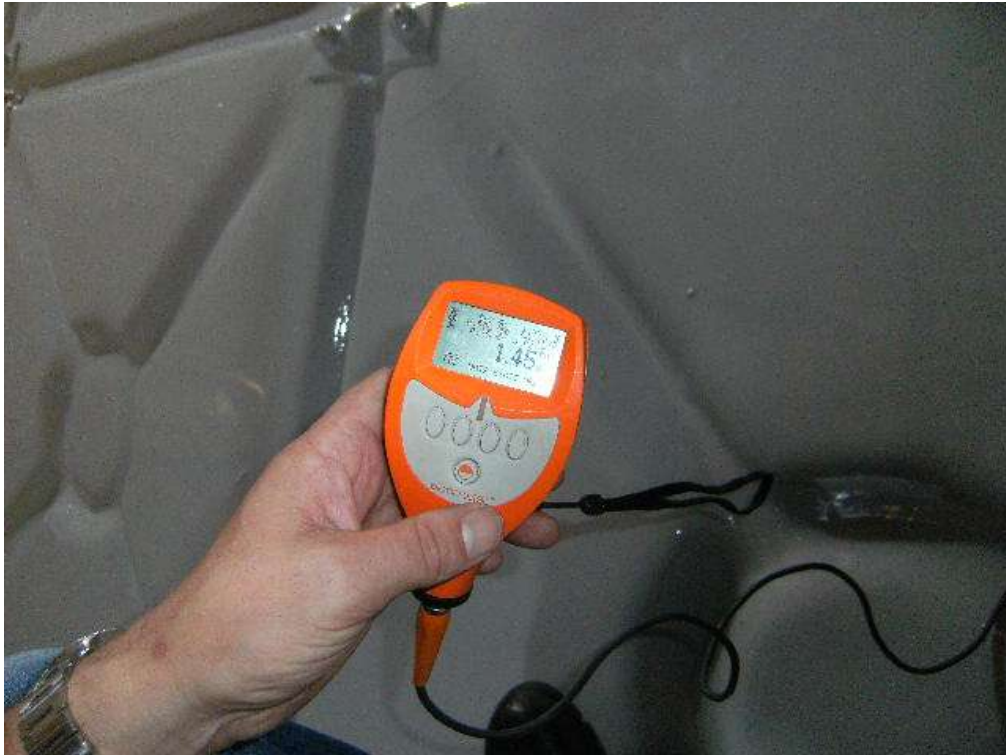
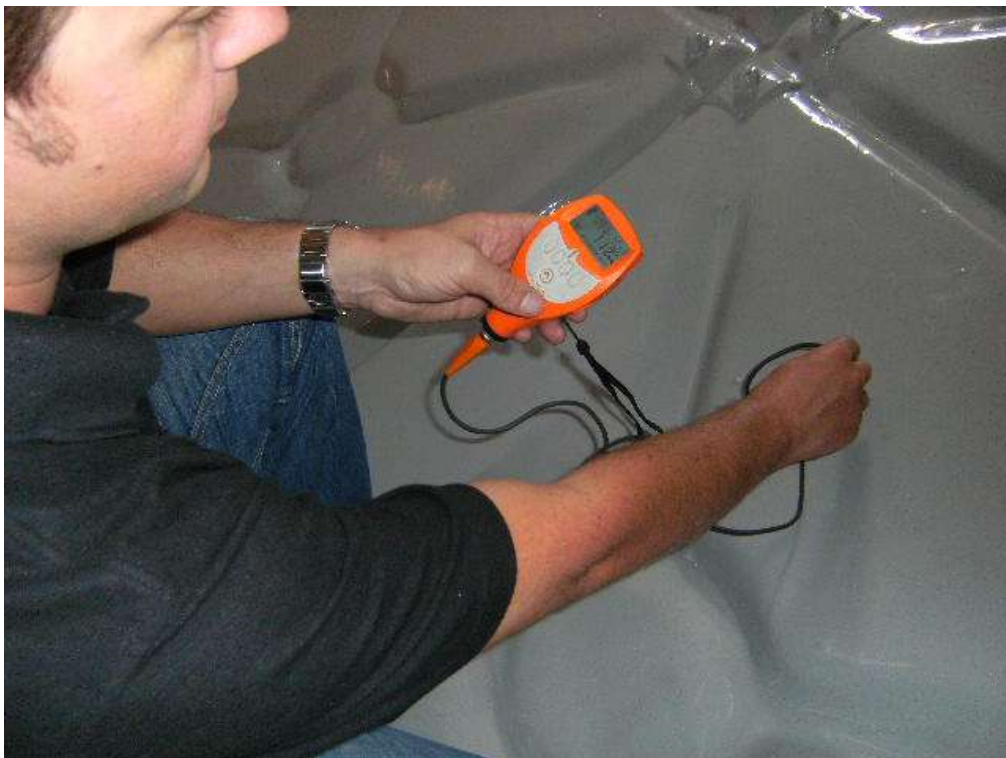
Dry Film Thickness readings were taken and recorded utilising an Elcometer 456 Microprocessor.

These images show the Elcometer 456 showing readings of well above the nominal 1mm (1000 Microns) thickness required.
