COMPLETION REPORT

Client	-	XXXXXX Hospital
Address	-	UK
Client Site Contact	-	XXXXXXXXX
Project Brief	-	The Internal & External Refurbishment of 1 No. Hornsley Bridge, Sectional, Steel, Potable Water Retaining Structure.
System Specification	-	3M Scotchkote™ 165PW Solvent Free Polyurethane.
Nominal Dry Film Thickness	-	1000 Microns
Completion Date	-	23rd July 2008
Site Supervisor	-	Carl Broadley
Report Prepared by	-	Adrian Emmett / David Snell
COVAC Contract Ref:	-	751

**THE INTERNAL REFURBISHMENT OF 1 NO.
HORNSLEY BRIDGE, SECTIONAL STEEL
CWS TANK**

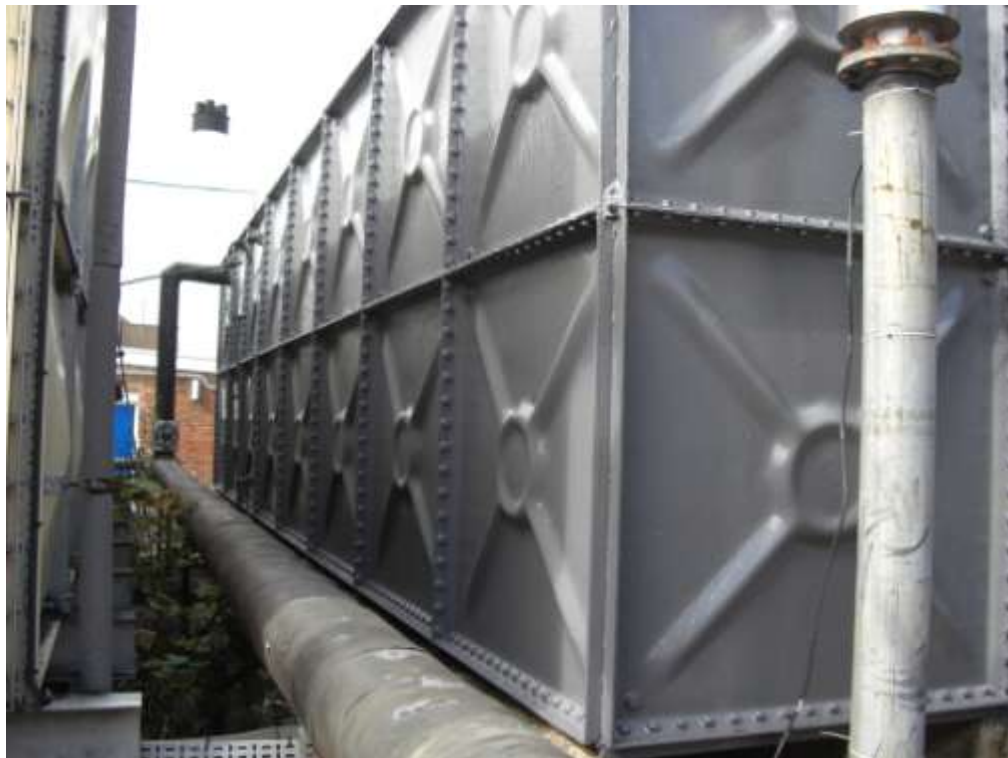
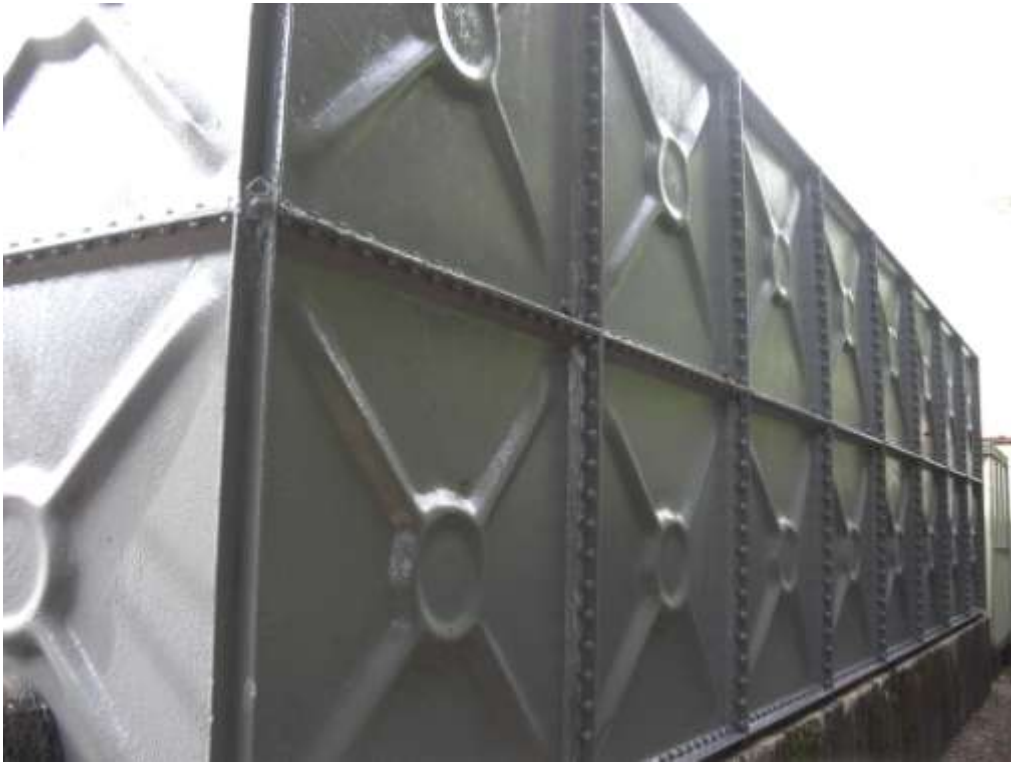
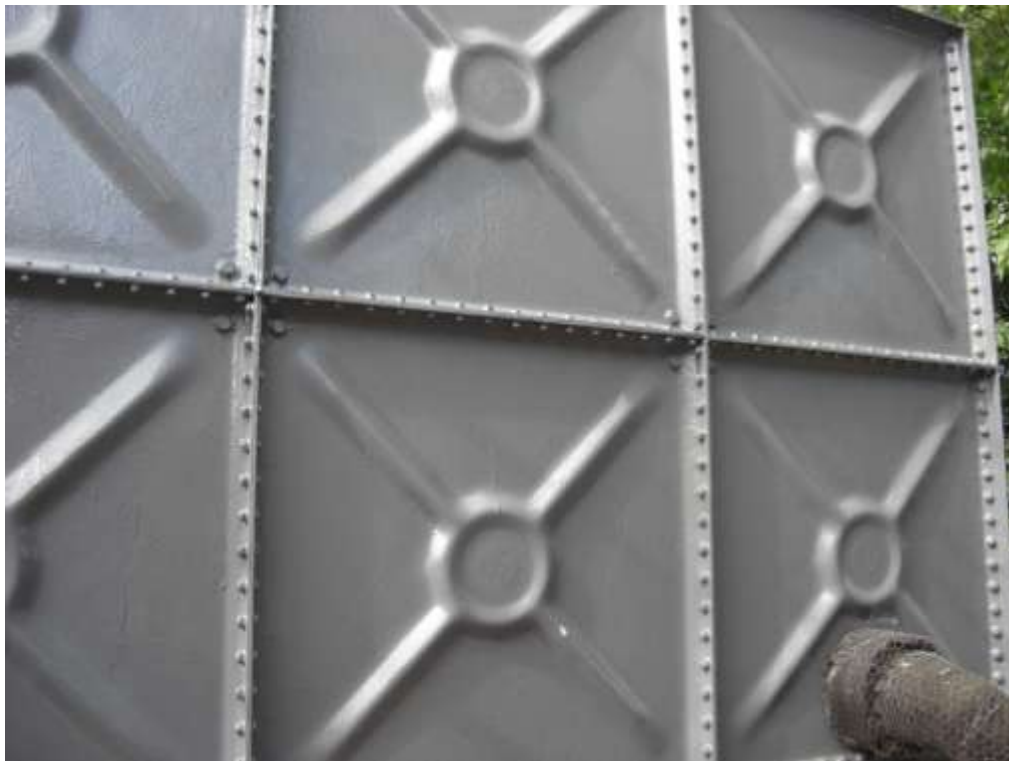
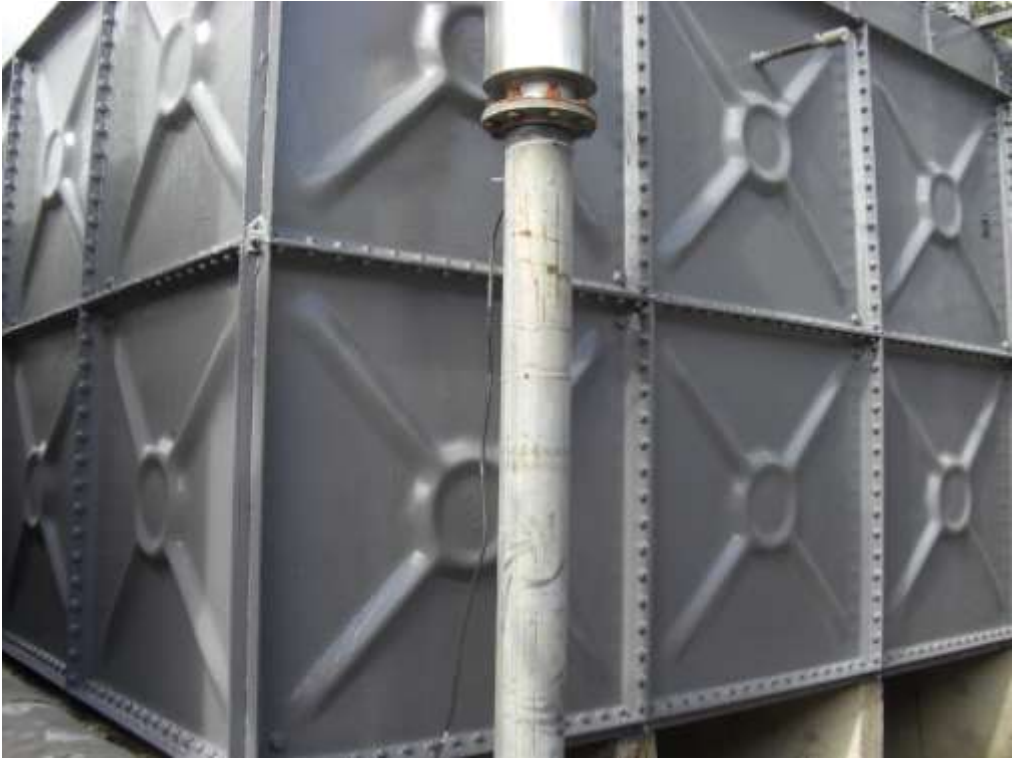
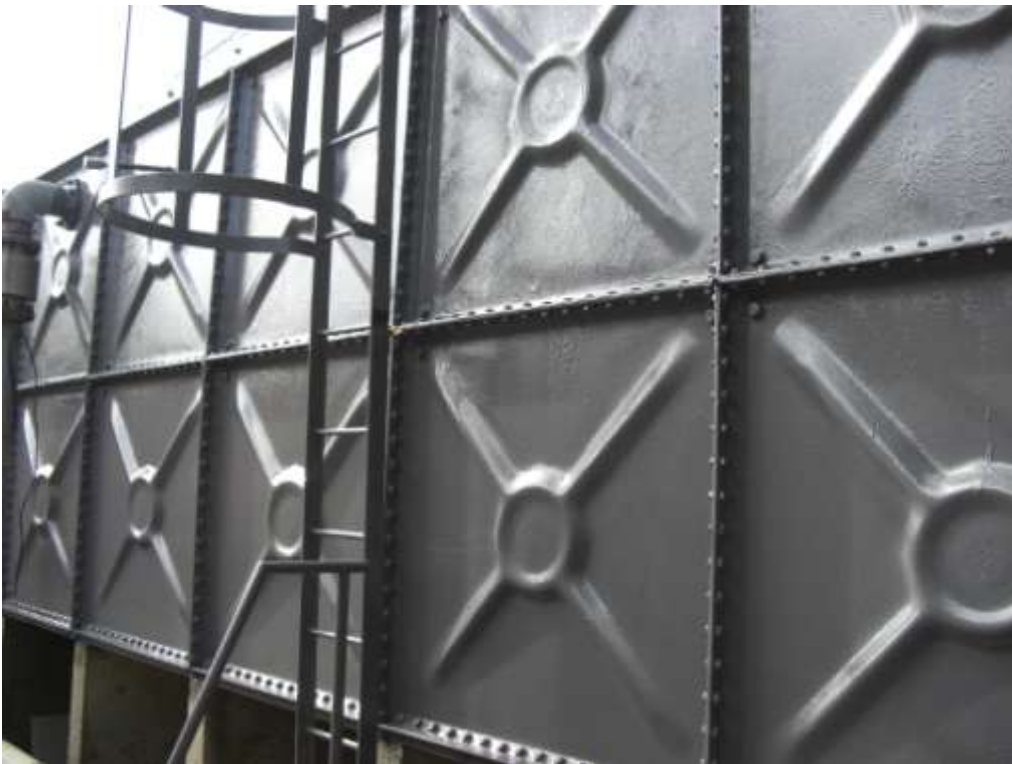
Stage by stage photographs were taken of this project, but unfortunately the initial photographs failed to develop. Therefore, on this occasion the photographs shown in this section of the report are of the externals of the structure having been fully refurbished.

As with the internal surfaces, the external surfaces were mechanically prepared by the COVAC Operatives using dry abrasive grit blast equipment in accordance with the accepted Standard and these photographs show the external of the structure having been fully coated, utilising 3M Scotchkote 152LV to a total nominal wet/dry film thickness of 500 Microns.
