COMPLETION REPORT

Project Brief : **The Internal Relining of 3 No. CWS Tanks**

Site Address : **XXXXX Hotel
Sussex**

System Spec : **3M Scotchkote™ 165PW**
(Formerly Known as COPON Hycote 165PW)

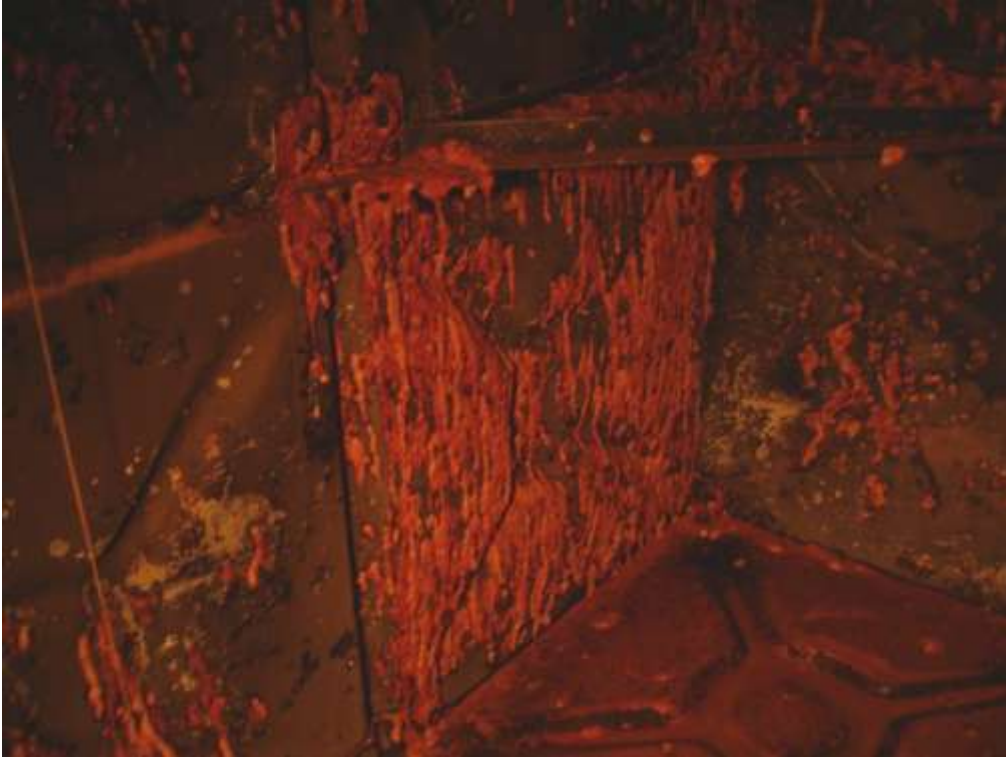
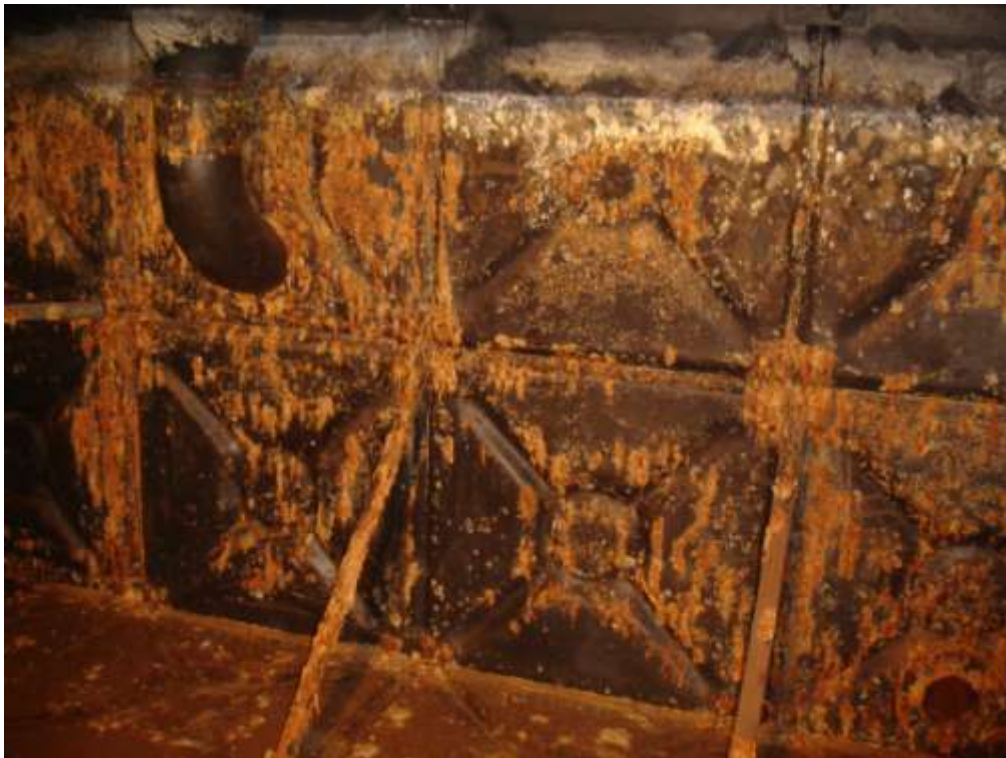
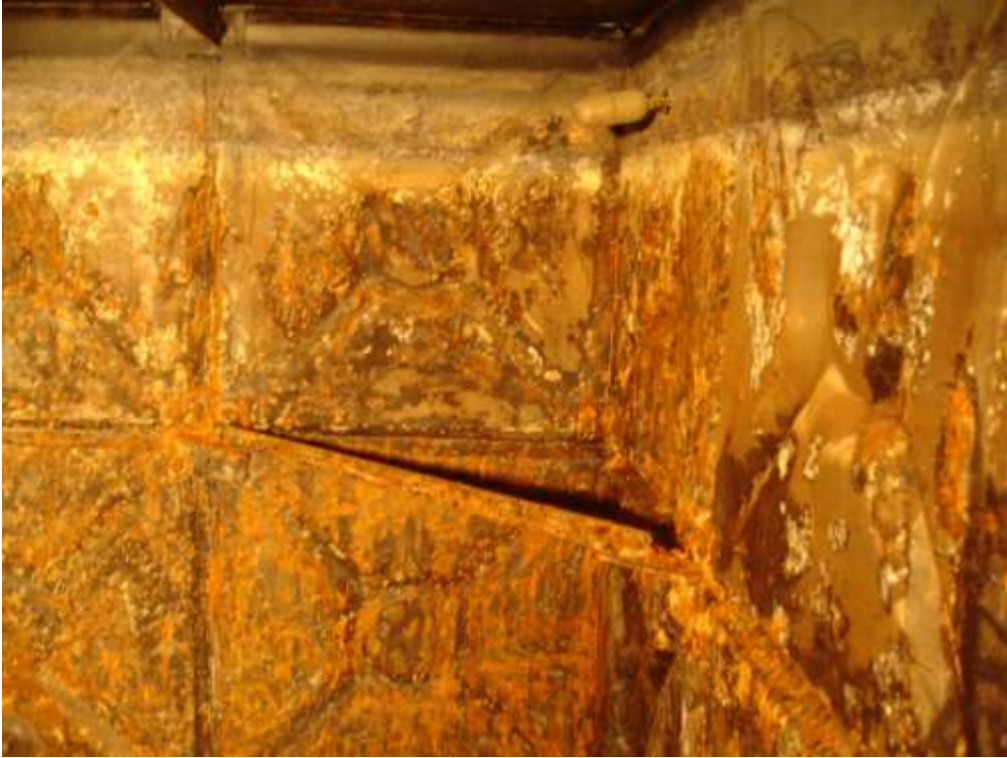
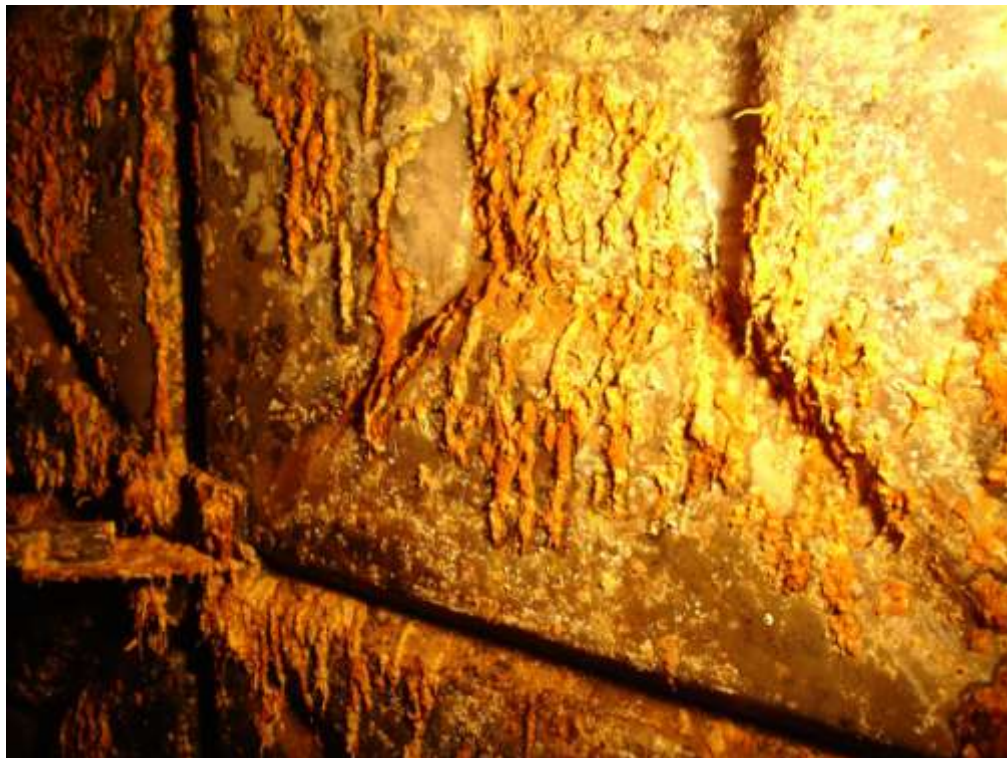
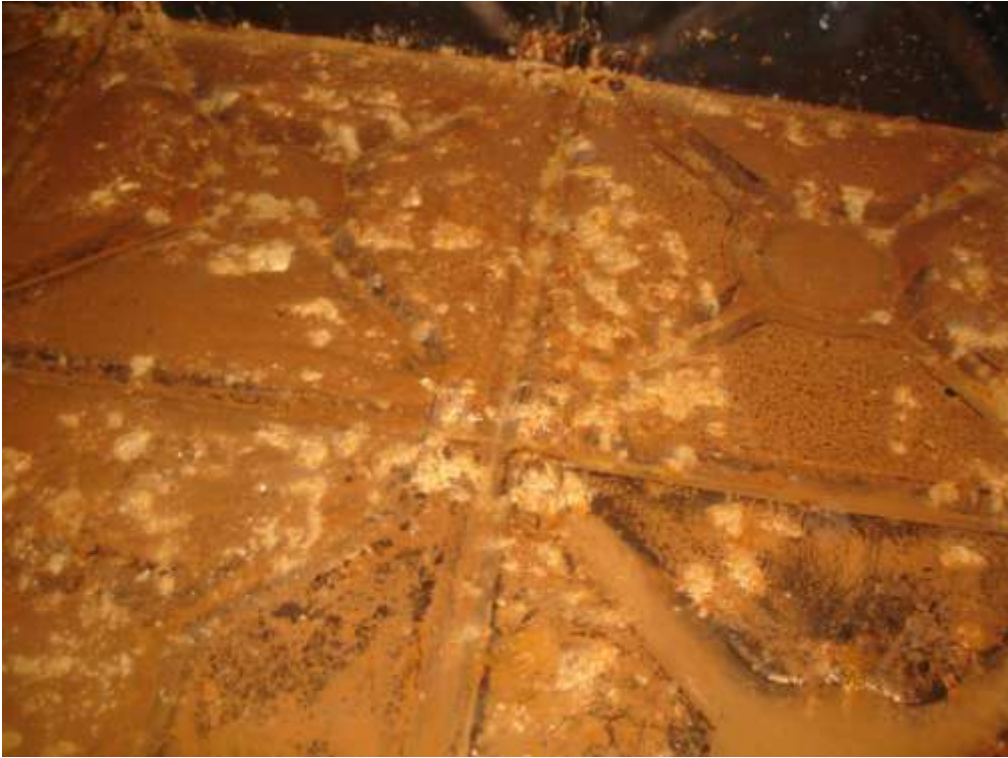
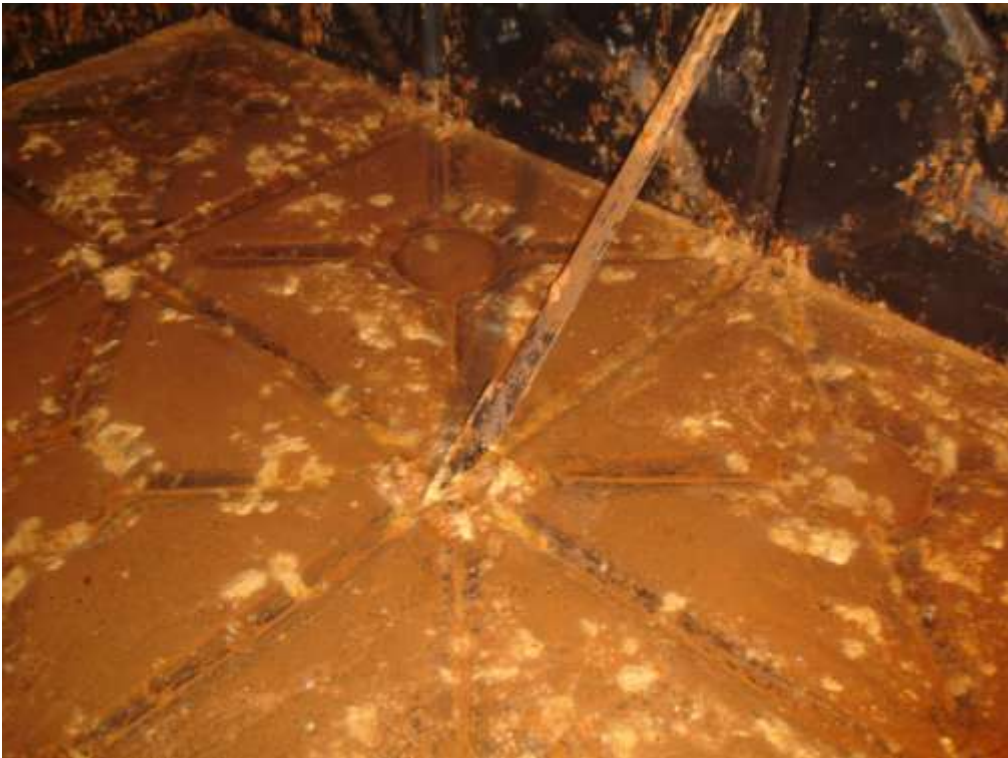
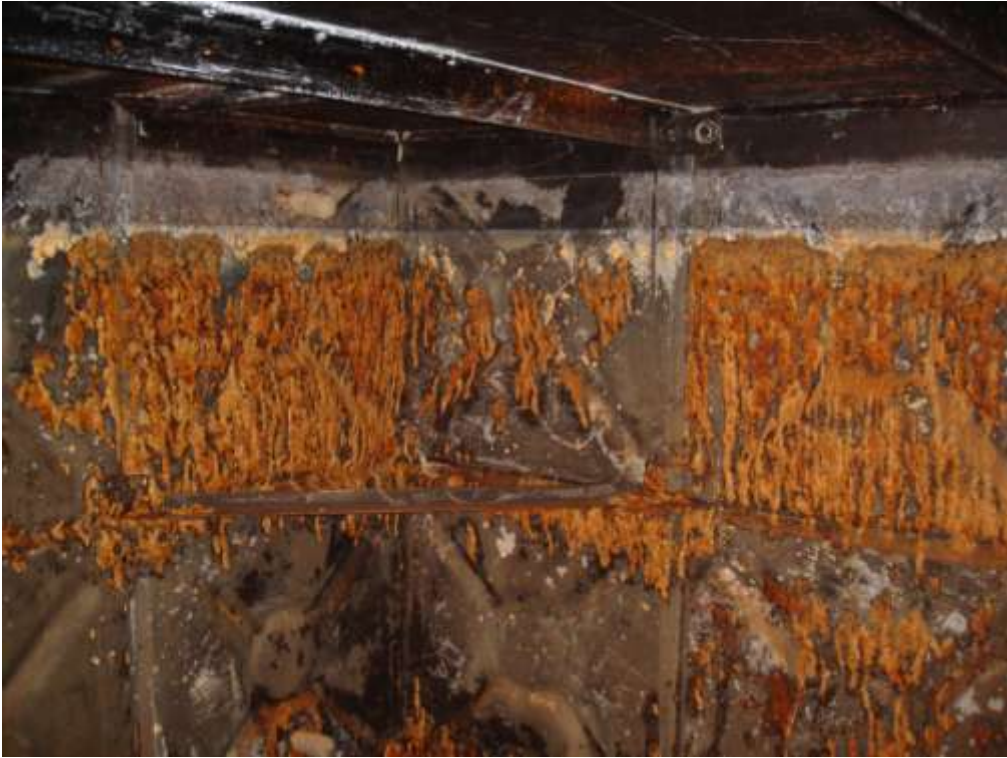
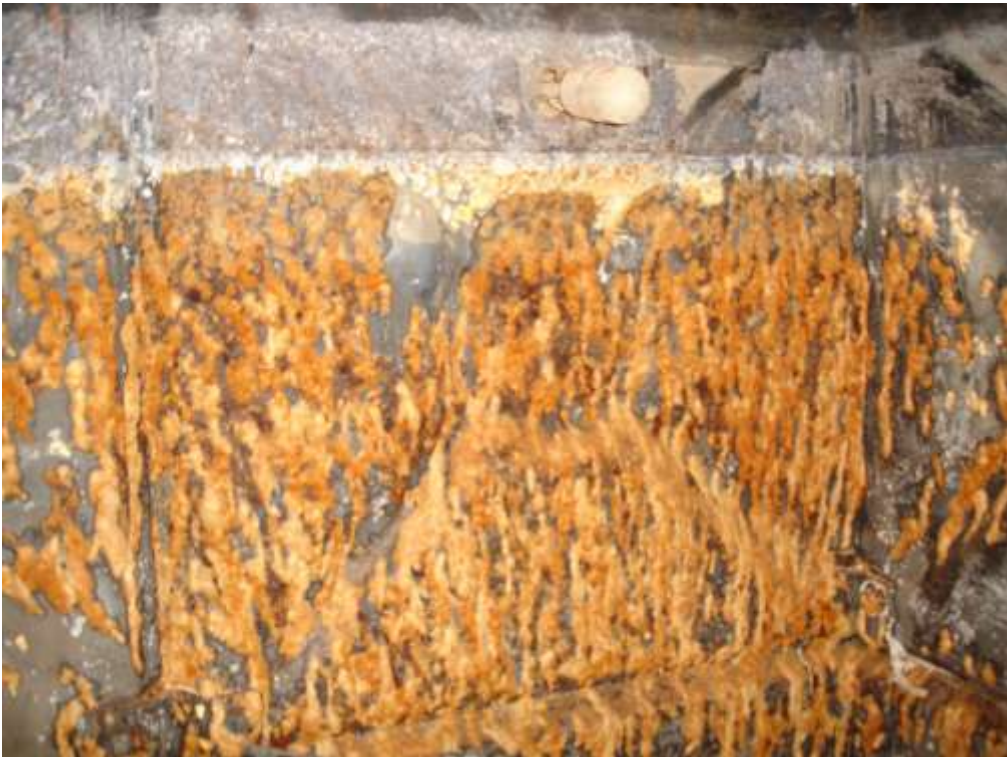
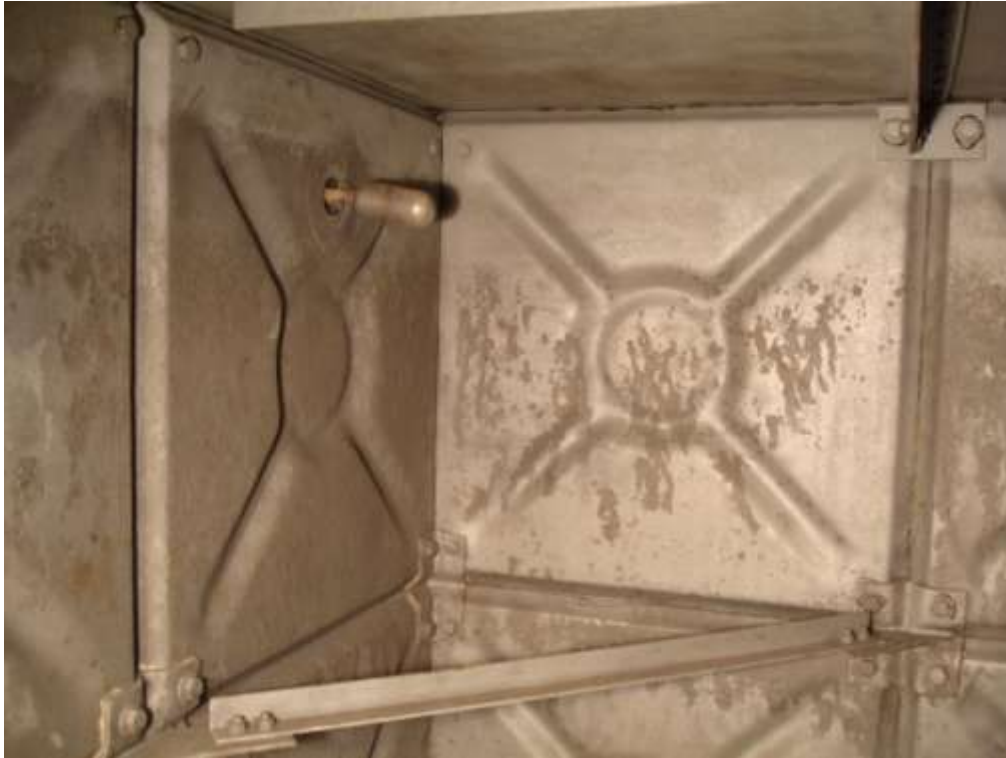
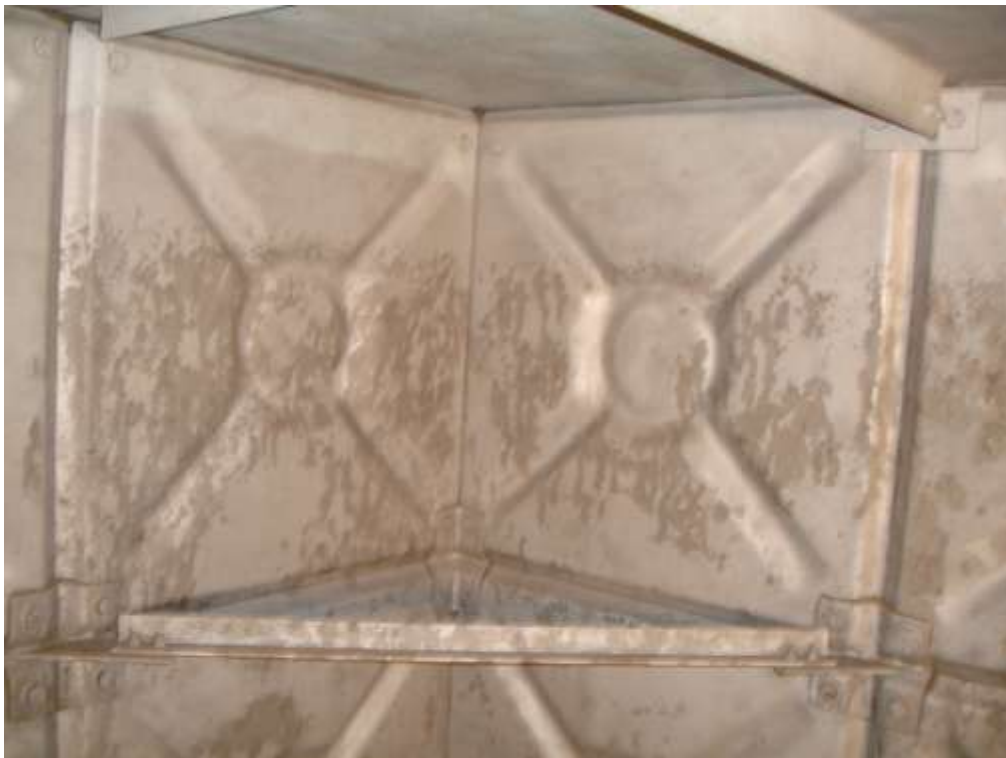
These photographs show the internal surfaces of the tanks after mechanical preparation by the COVAC Operatives, using dry abrasive grit blast equipment in accordance with the accepted Standard.

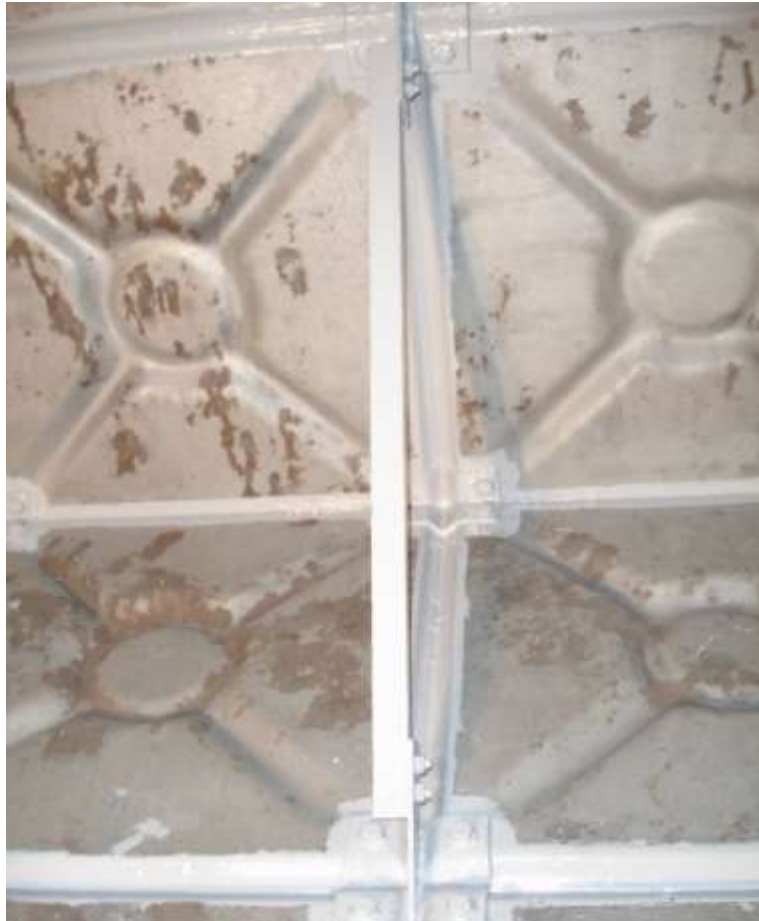
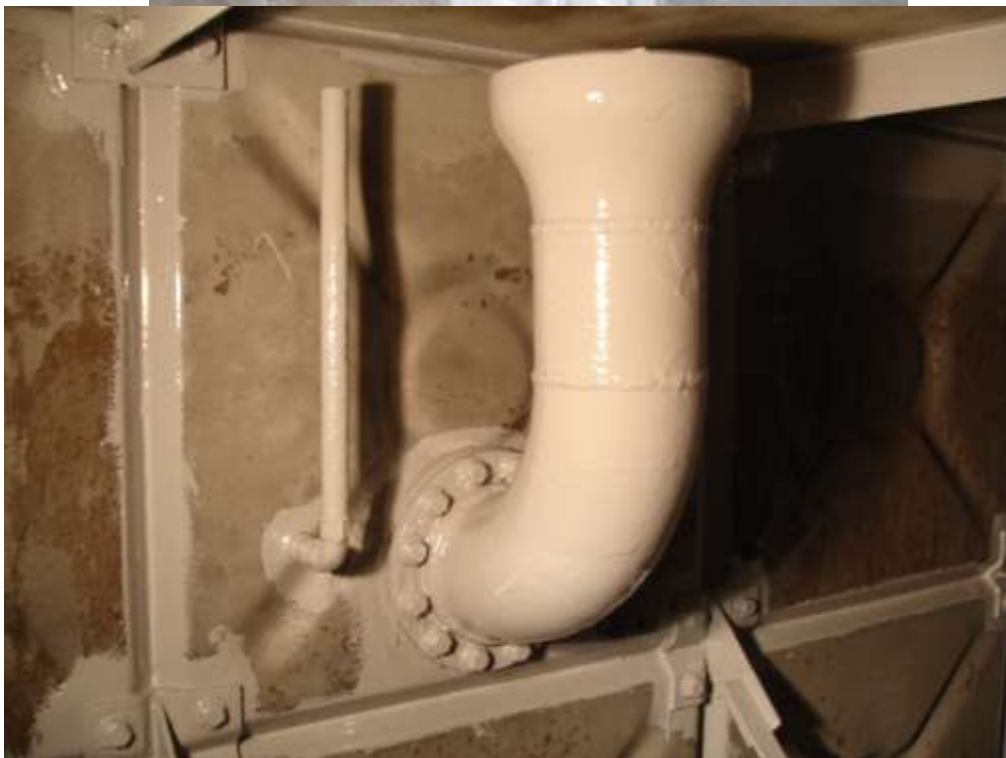
All bolt heads, struts and other protuberances received an initial 'stripe coat' to ensure that all intricate areas were fully coated prior to the full coat of 3M Scotchkote165PW Solvent Free Polyurethane being spray applied.

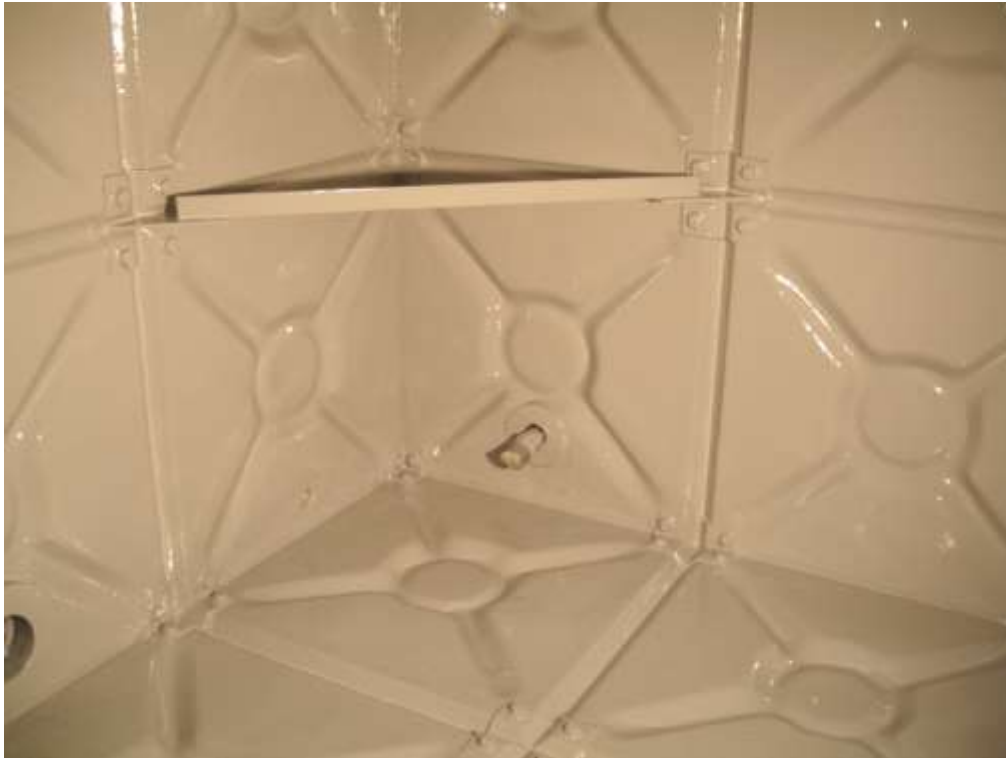
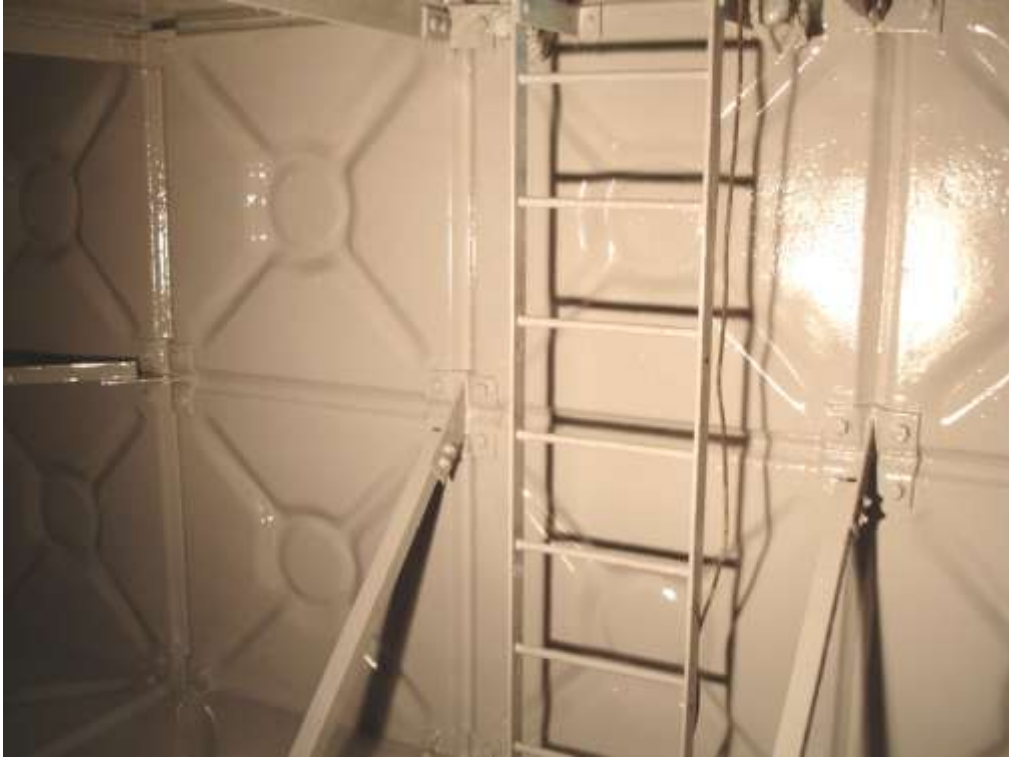
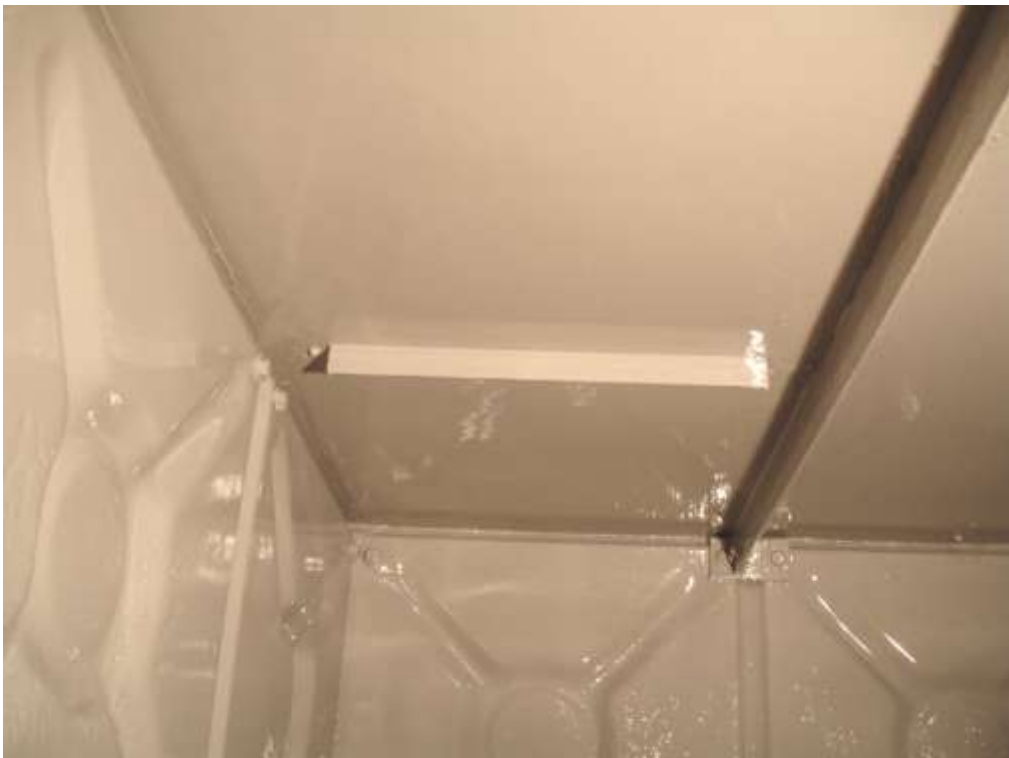
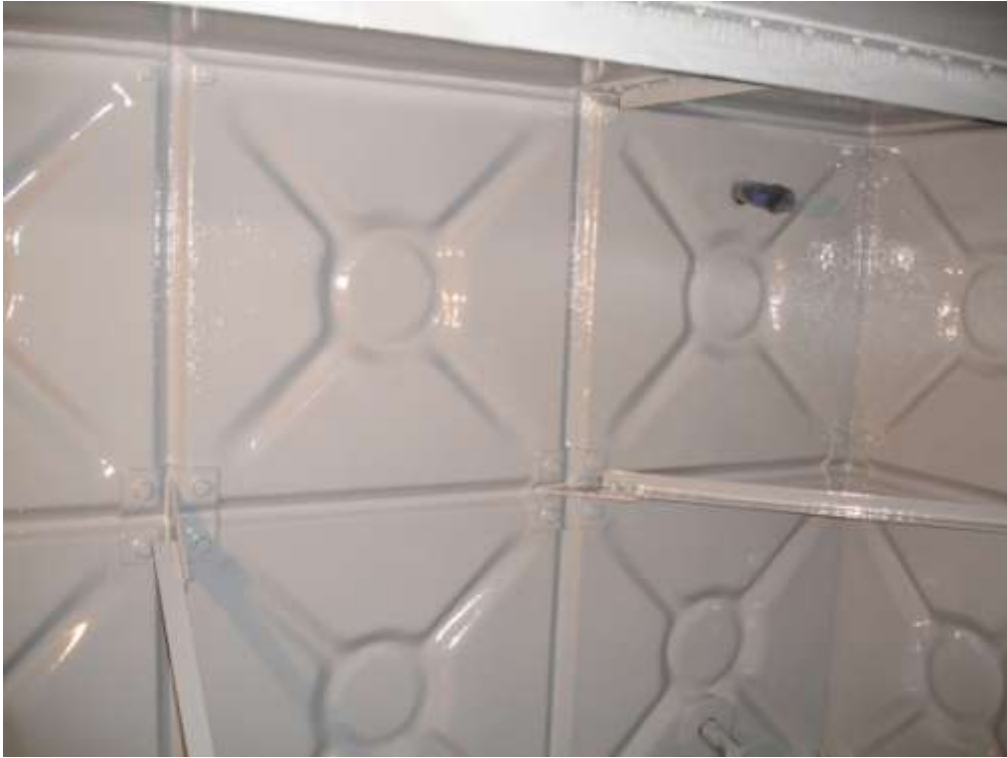
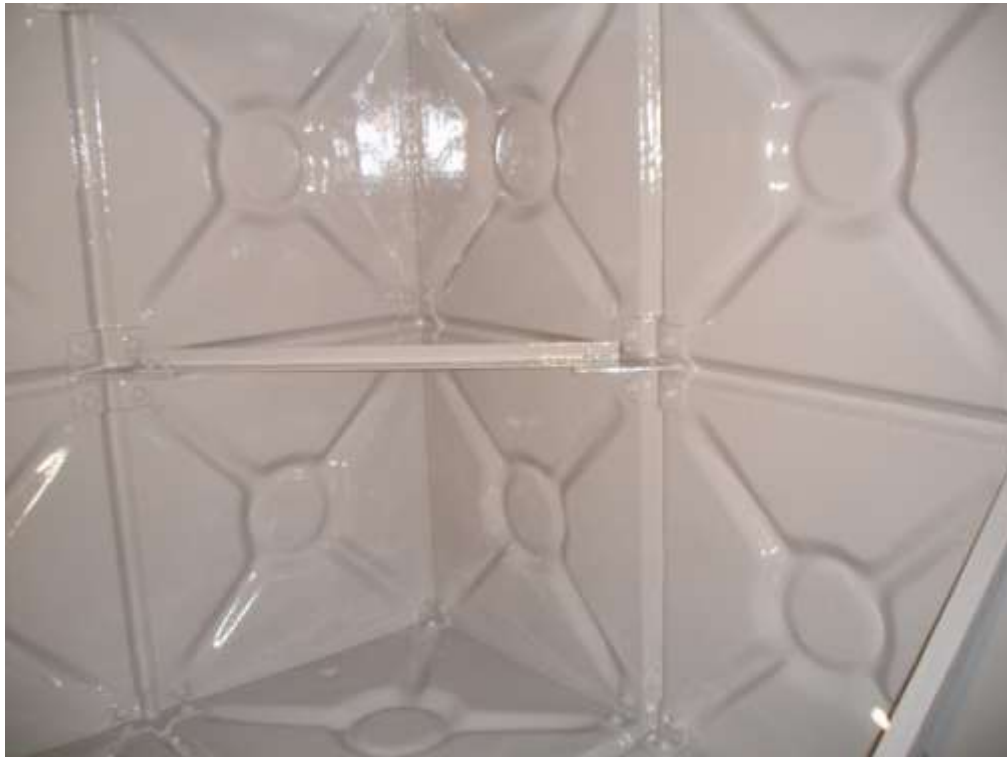
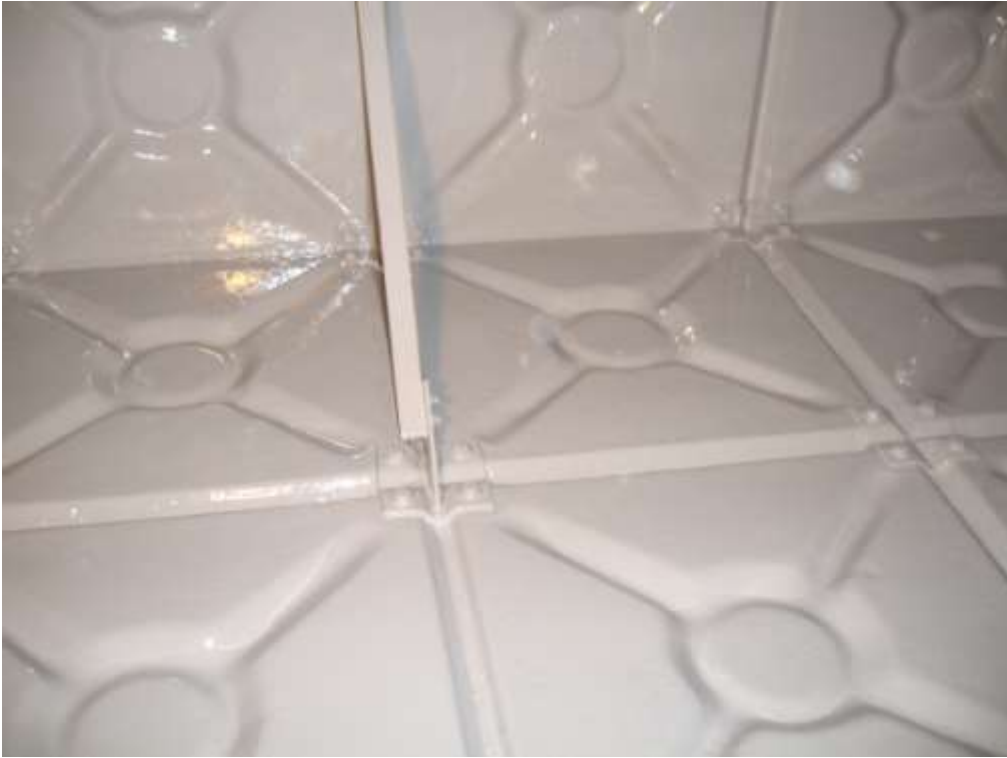
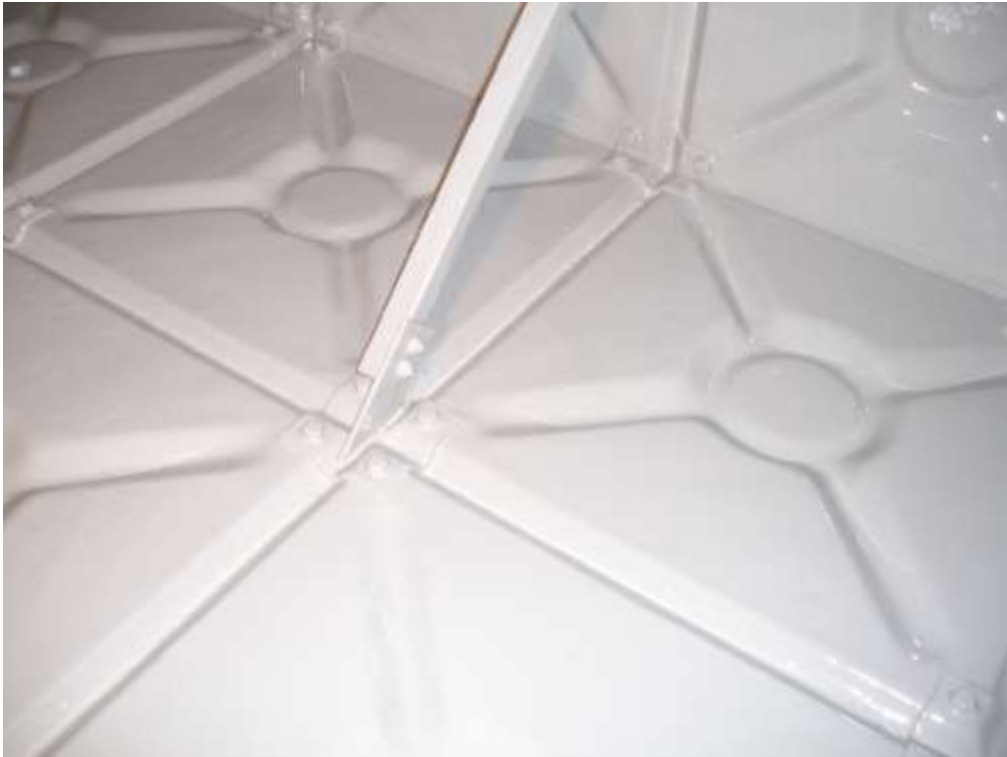
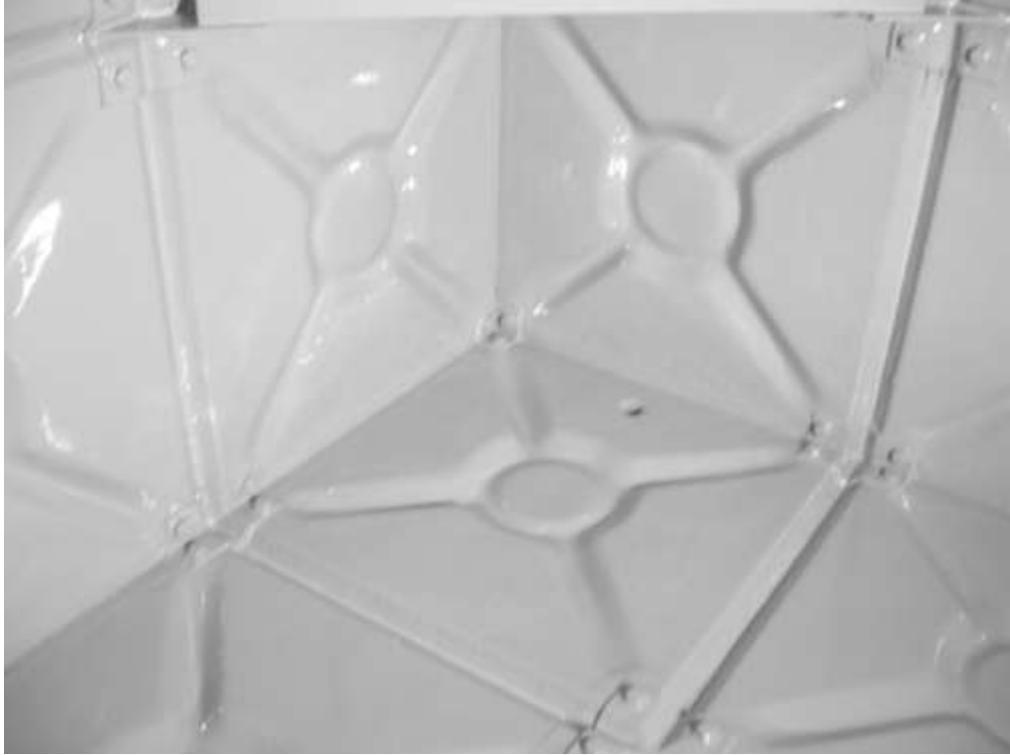
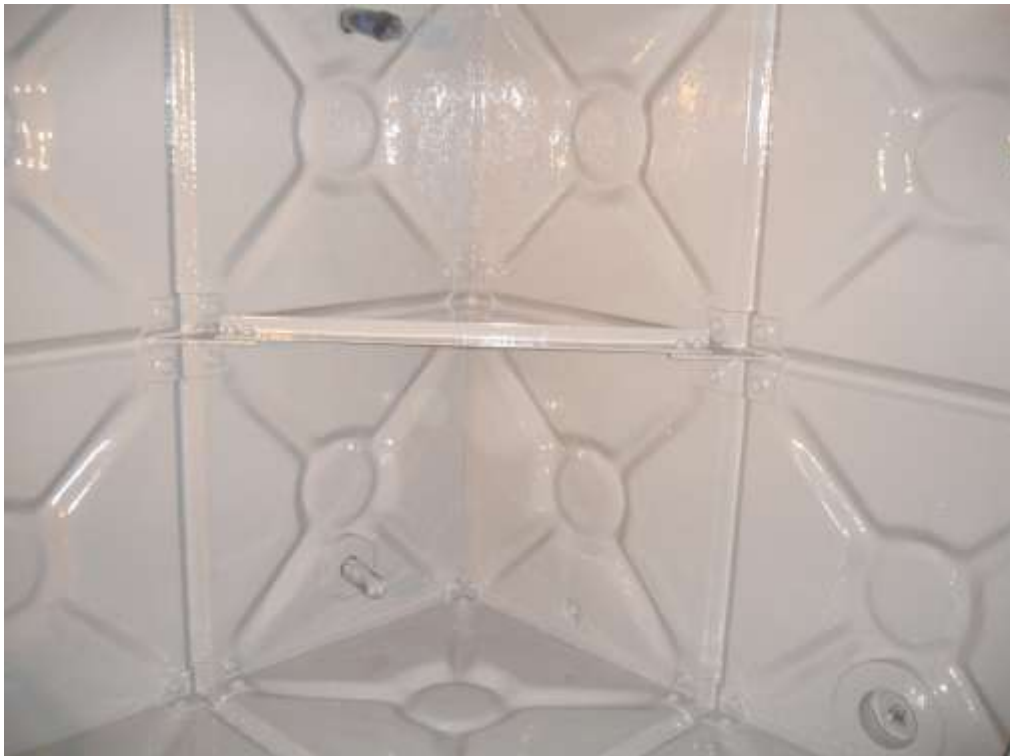
The following images show the substrate after being fully coated with 3M Scotchkote 165PW.
