COMPLETION REPORT

Client : **Financial Corporation**

Project Brief : **The Internal Refurbishment of 23 No. Air Handling Units –
Reduced Document**

Covac Ref : **516**

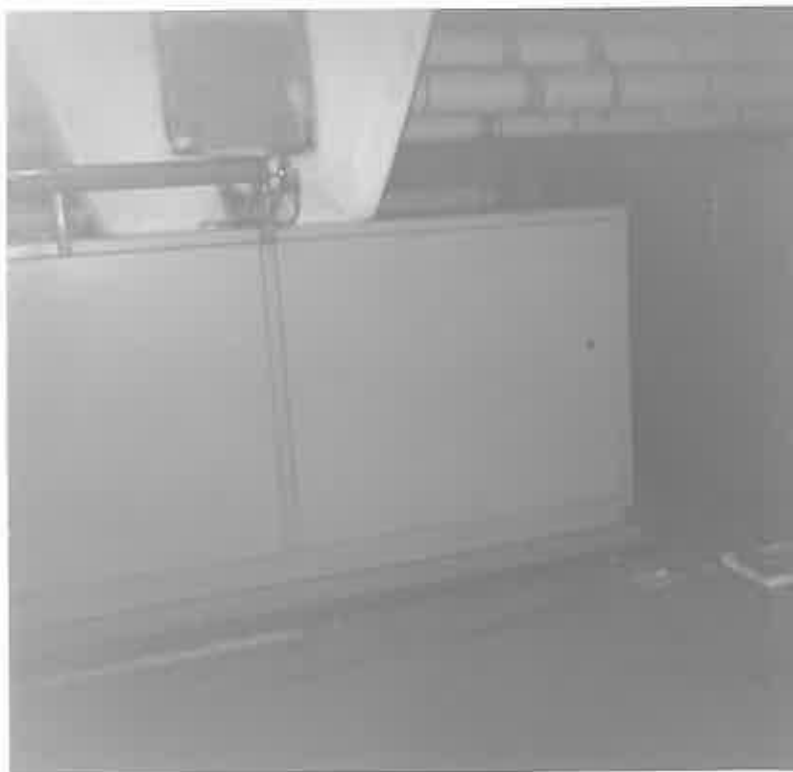
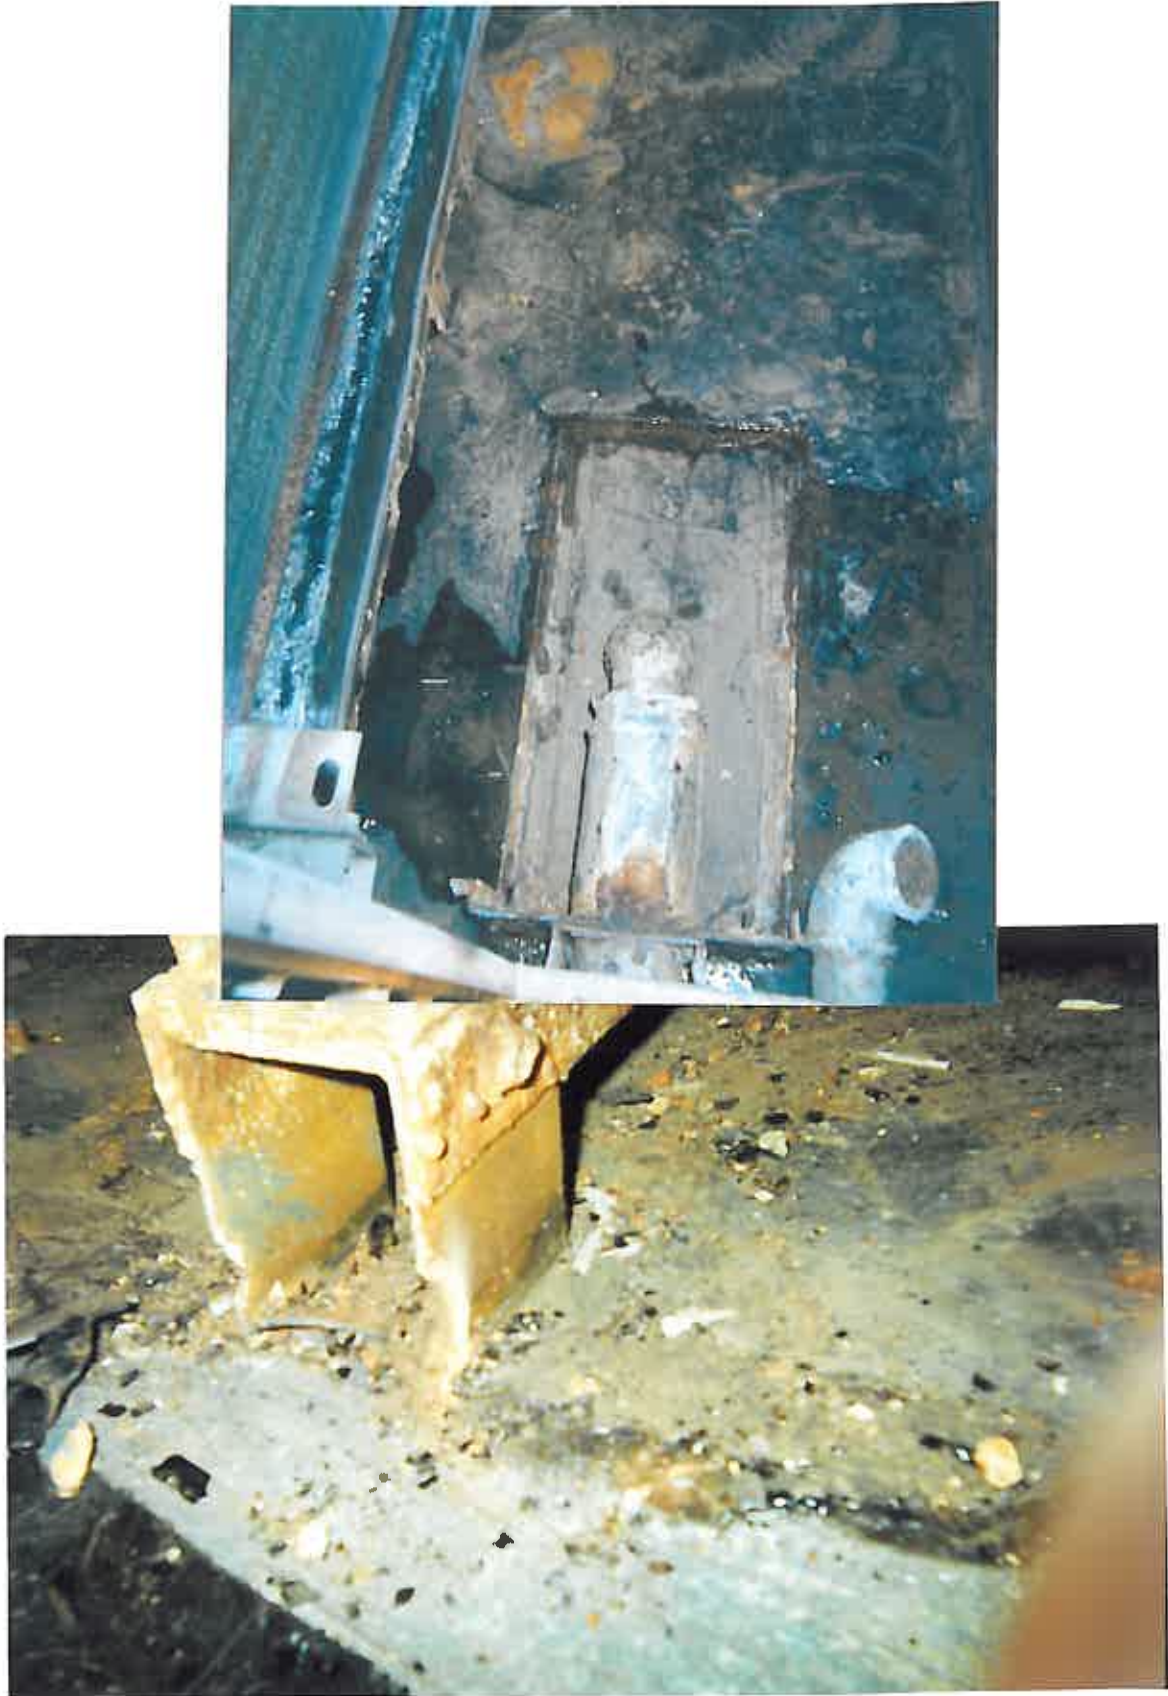
AIR HANDLING UNIT NO. 4

The above photographs show the internal condition of the AHU, prior to any preparation work being carried out. As the photographs clearly show, the existing Bitumen coatings had failed with signs of progressive corrosion, which in areas was applied up to 30mm in thickness.
