COMPLETION REPORT

Client : **University of XXXXXXXXXXXX**

Project Brief : **The Internal Relining of 1 No. Concrete CWS Tank**

Covac Ref : **976**

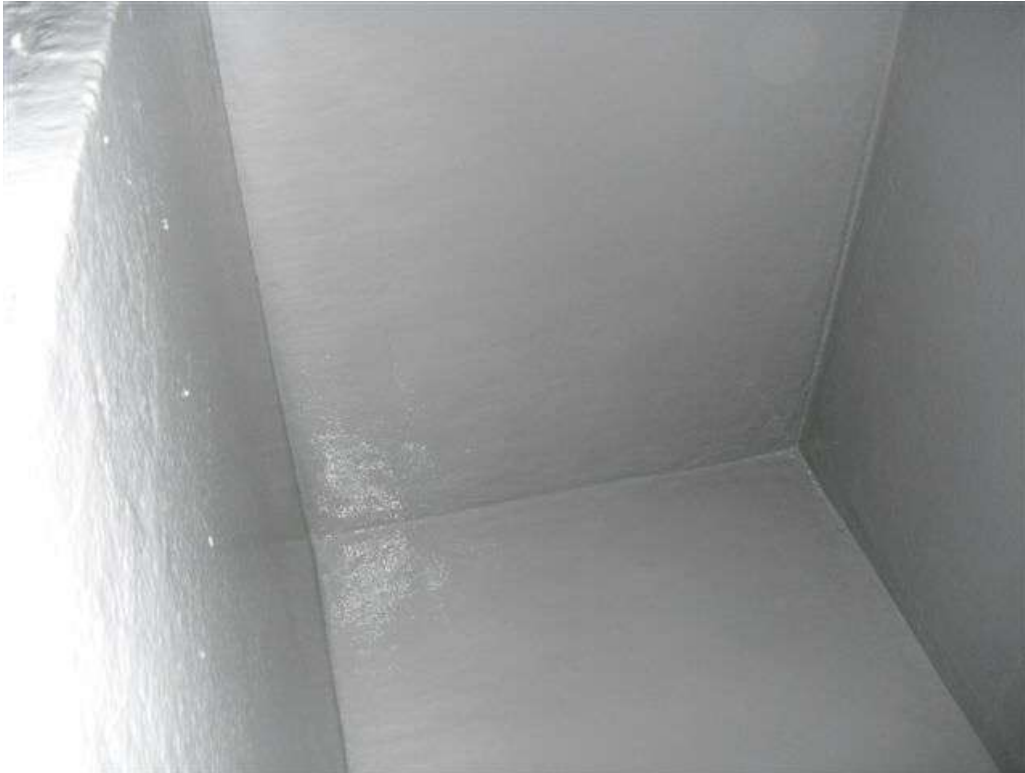
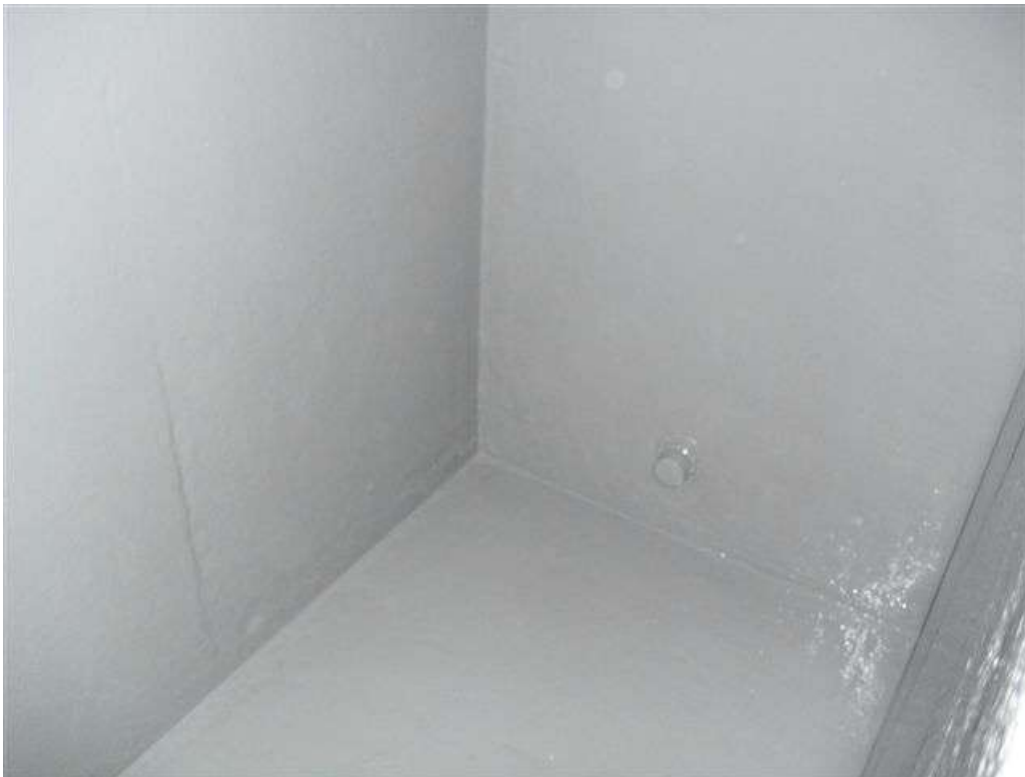
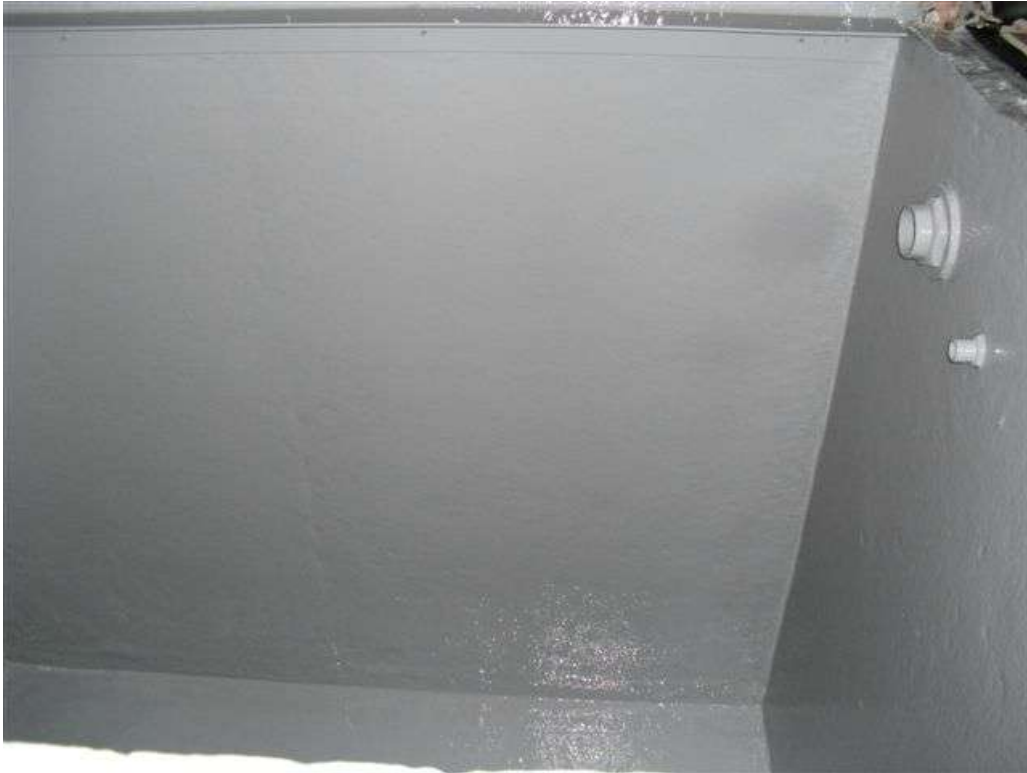
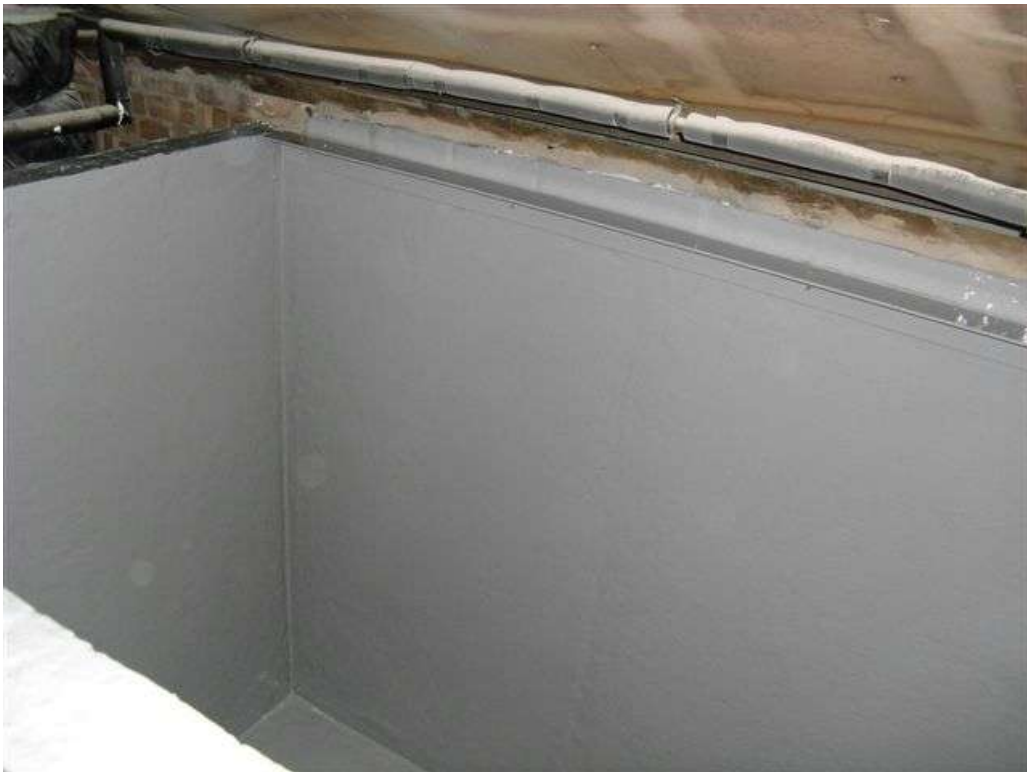
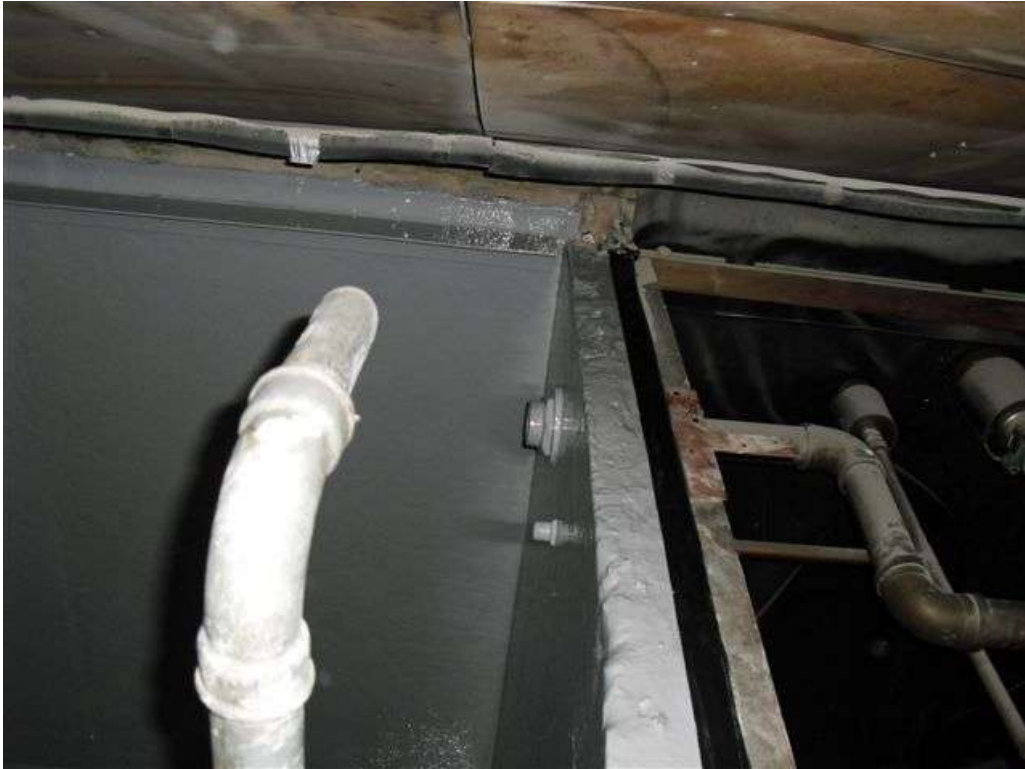
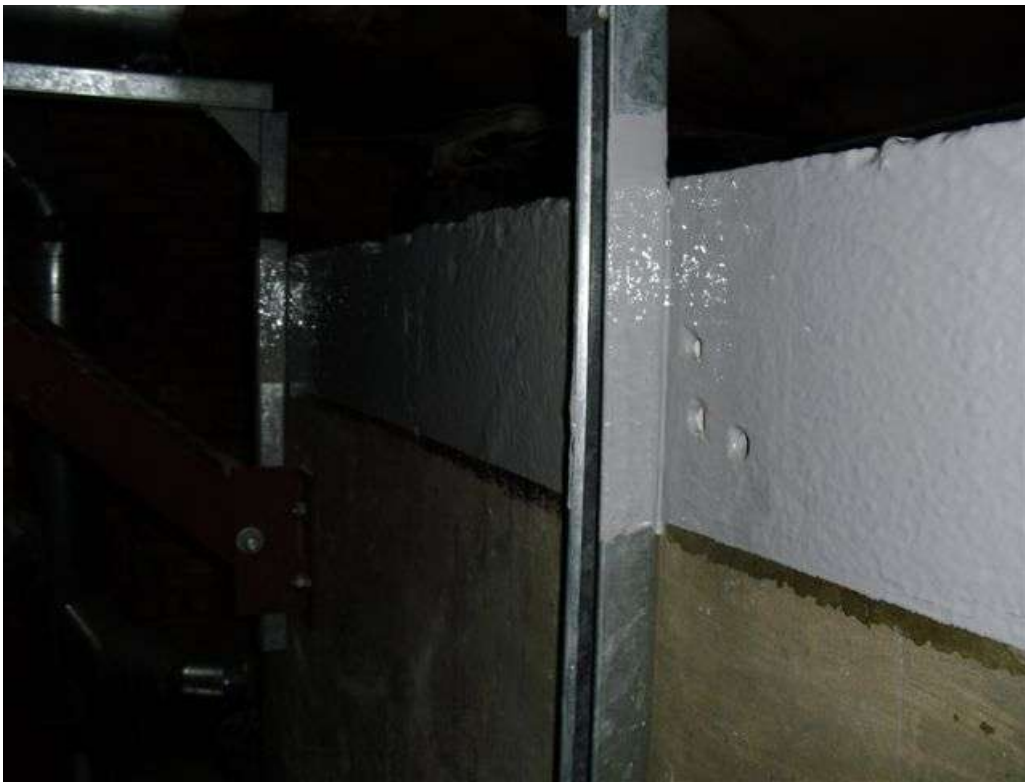
All intricate areas were again 'stripe coated' for a second time. The following photographs show the final application of the 2nd coat of 3M Scotchkote™ 165PW (grey).
