# COMPLETION REPORT

Project Brief : **The Repair / Relining of a Concrete Sump Located on the 27<sup>th</sup> Floor**

Site Address : **XXXXX Tower  
Manchester**

System Spec : **3M Scotchkote™ 165PW**  
(Formerly Known as COPON Hycote 165PW)

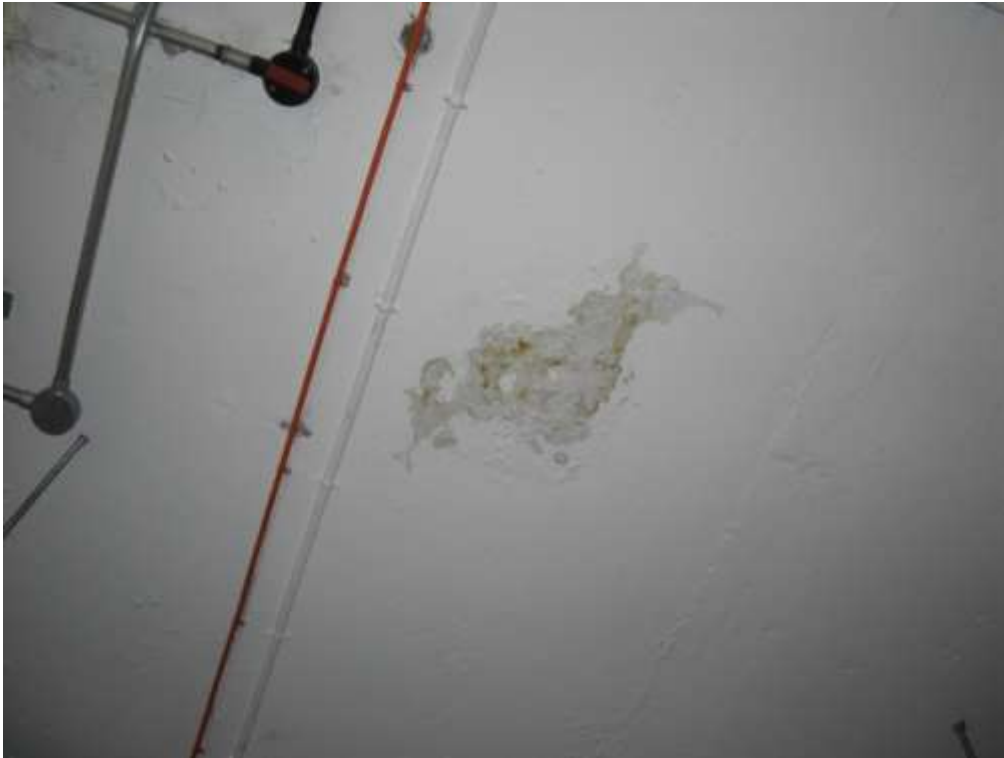
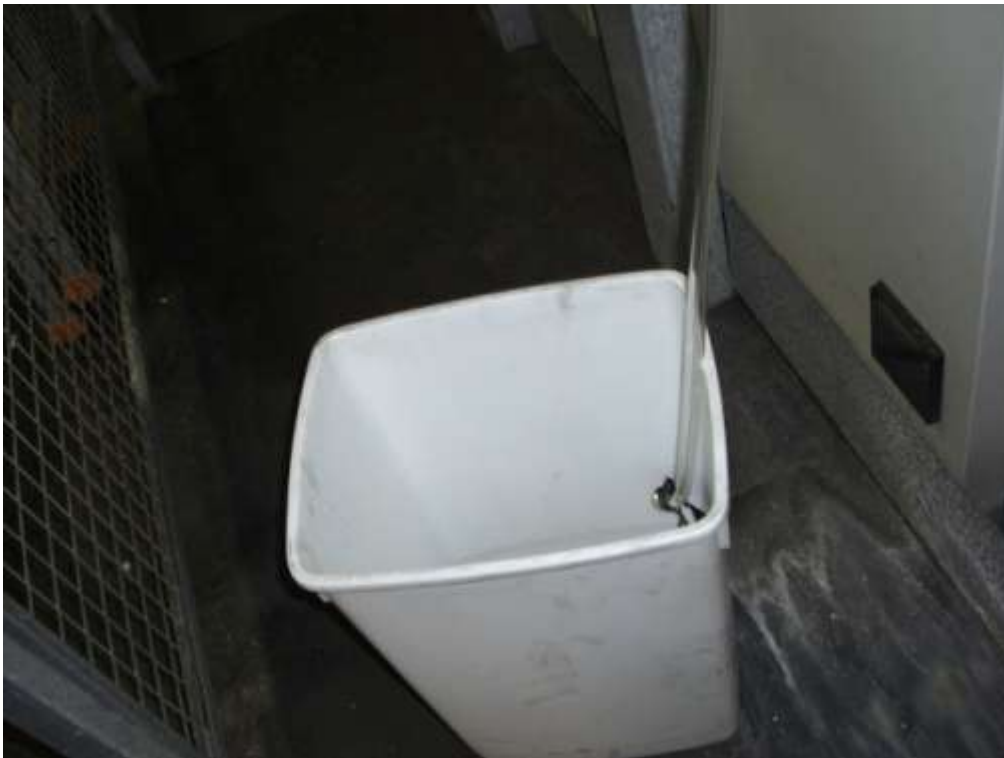
The images here show the damaged caused due to the floor of the Sump leaking onto electrical switchgear underneath the Sump area, onto the level below.
