COMPLETION REPORT

Client : **University of XXXX**

Project Brief : **The Internal Relining of 1 No. Concrete CWS Tank**

Covac Ref : **976**

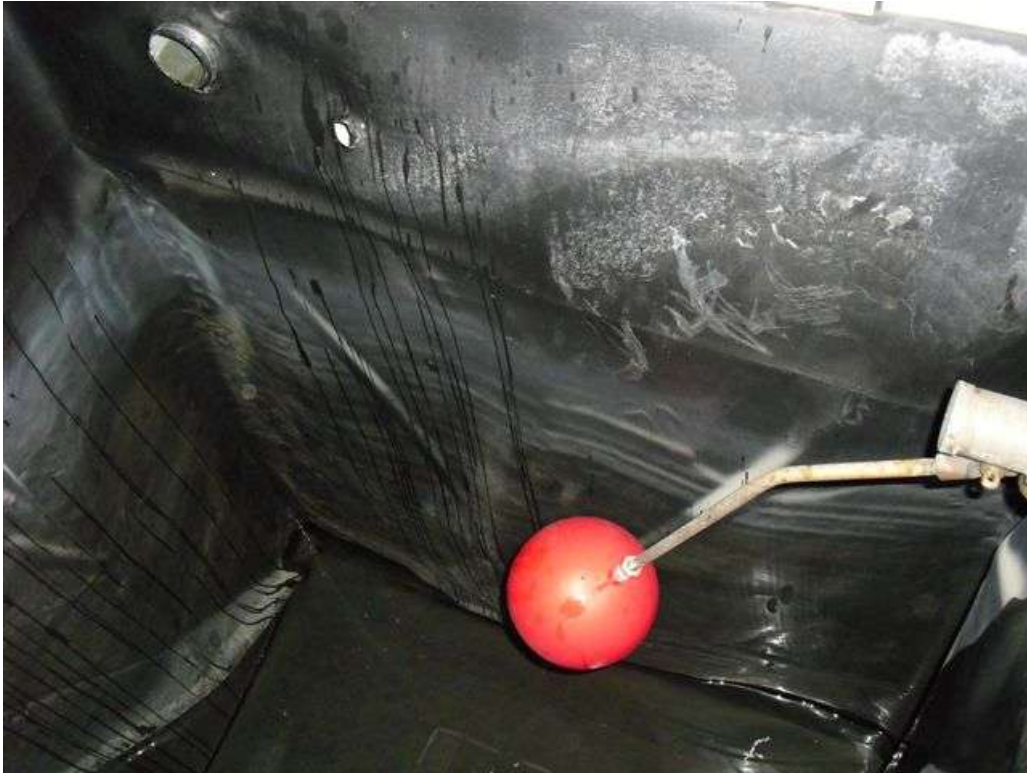
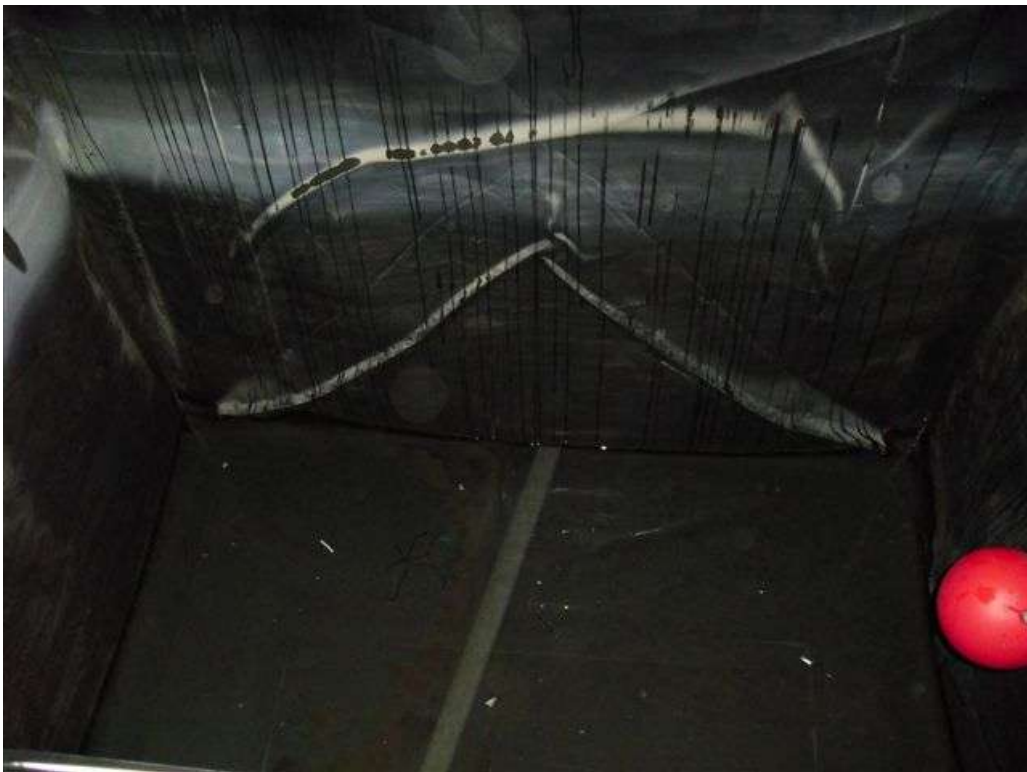
These photographs show the internal surfaces of the structure having been drained of water, but prior to the failed liner being removed and any relining work commencing.

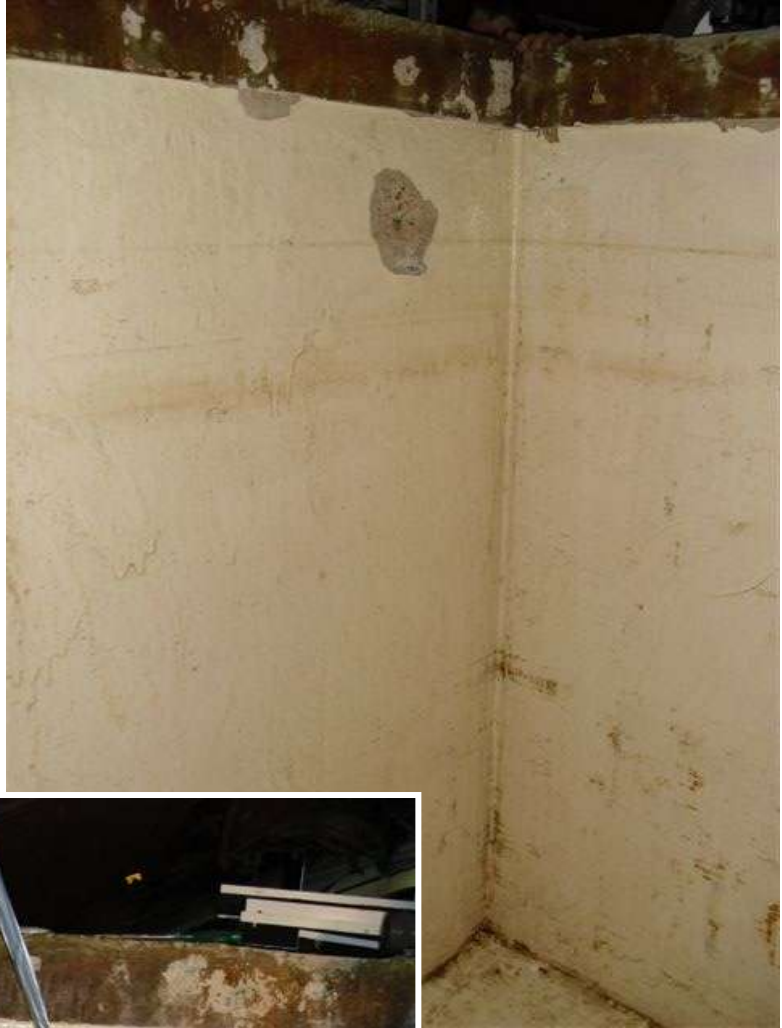
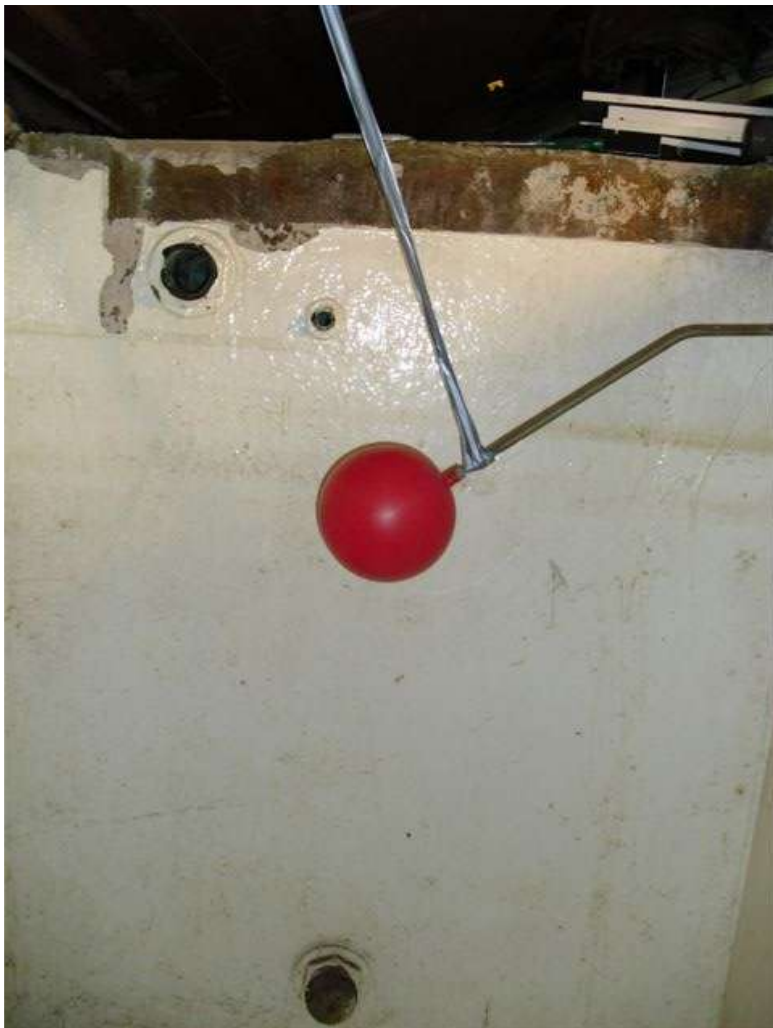
A combination of the failed flexible liner and de-lamination of the failed coating had allowed water to damage the concrete substrate resulting in cracks and pitting.
