COVAC COMPLETION REPORT

Client	-	XXX LTD
Address	-	XXXX XXX XXXXXXXXXX Street London EC2
Client Site Contact	-	XXXXX XXXXXXX
Project Brief	-	The Internal and External Relining of 2 No. BAC Cooling Towers.
System Specification	-	COPON Hycote 165PW Solvent Free Polyurethane.
Nominal Dry Film Thickness	-	1000 Microns (1mm).
Completion Date	-	25th January 2007
Site Supervisor	-	Robin Bailey
Report Prepared by	-	David Snell
COVAC Contract Ref:	-	574

2 No. COOLING TOWERS - INTERNAL

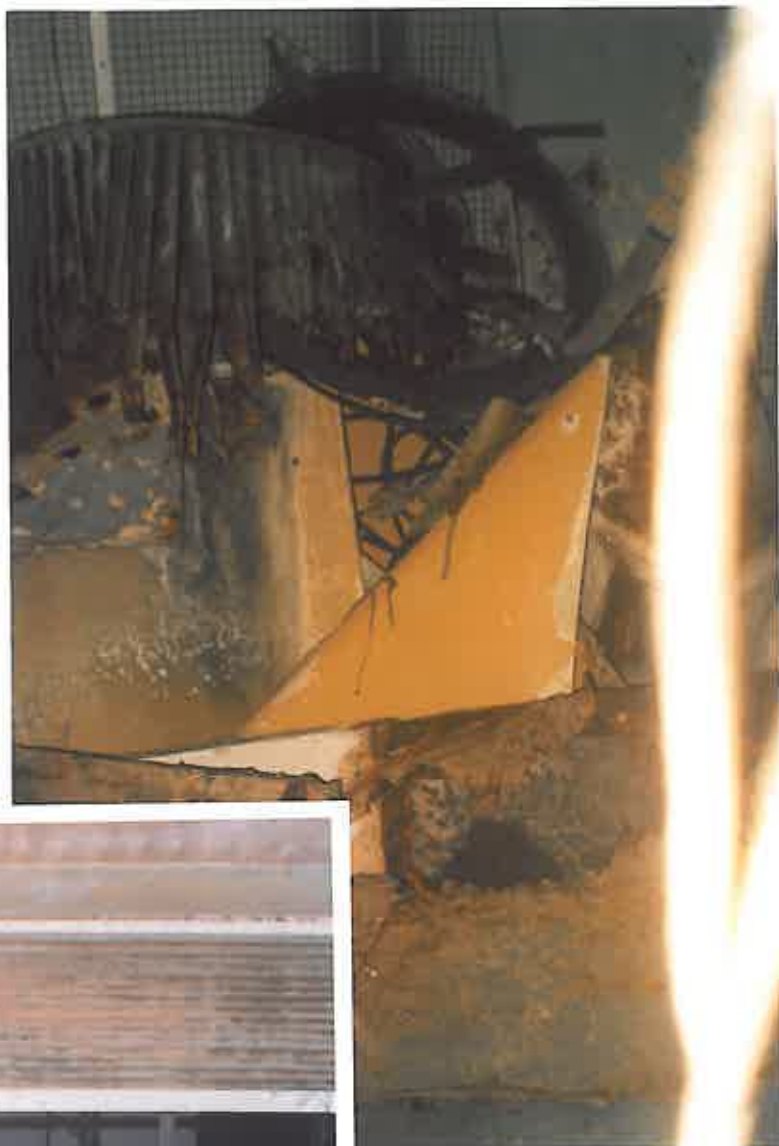
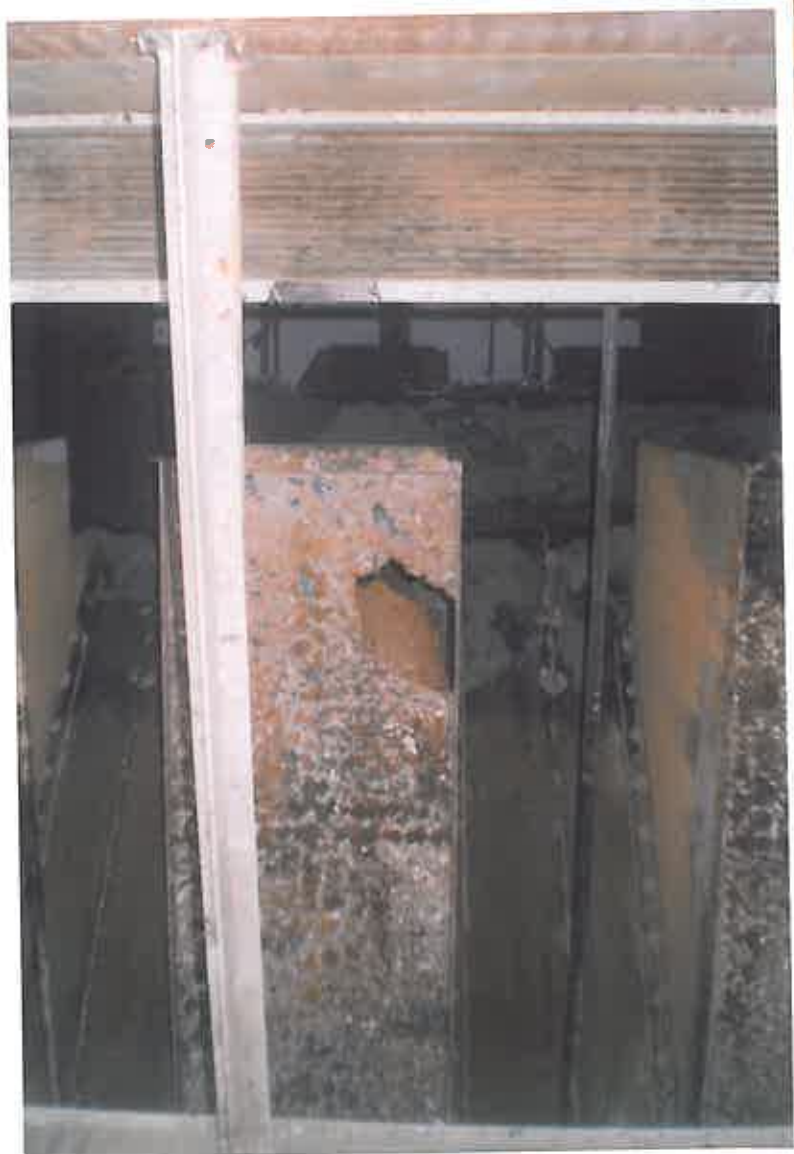
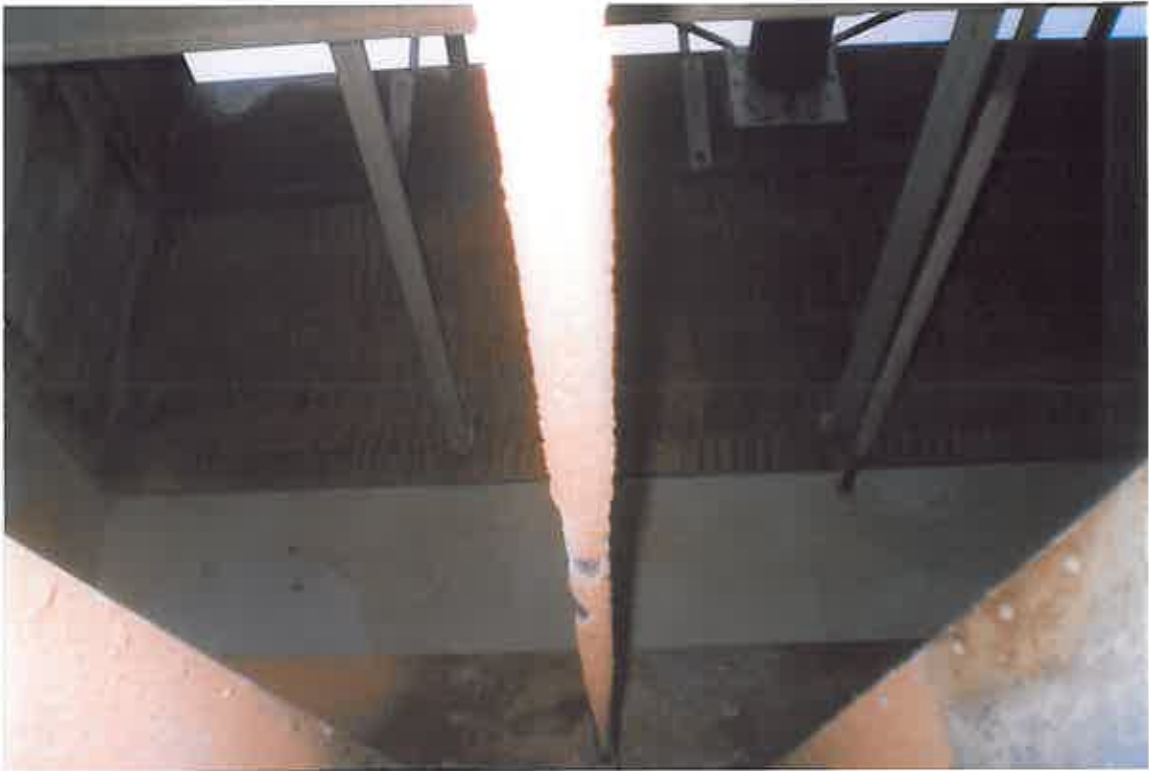
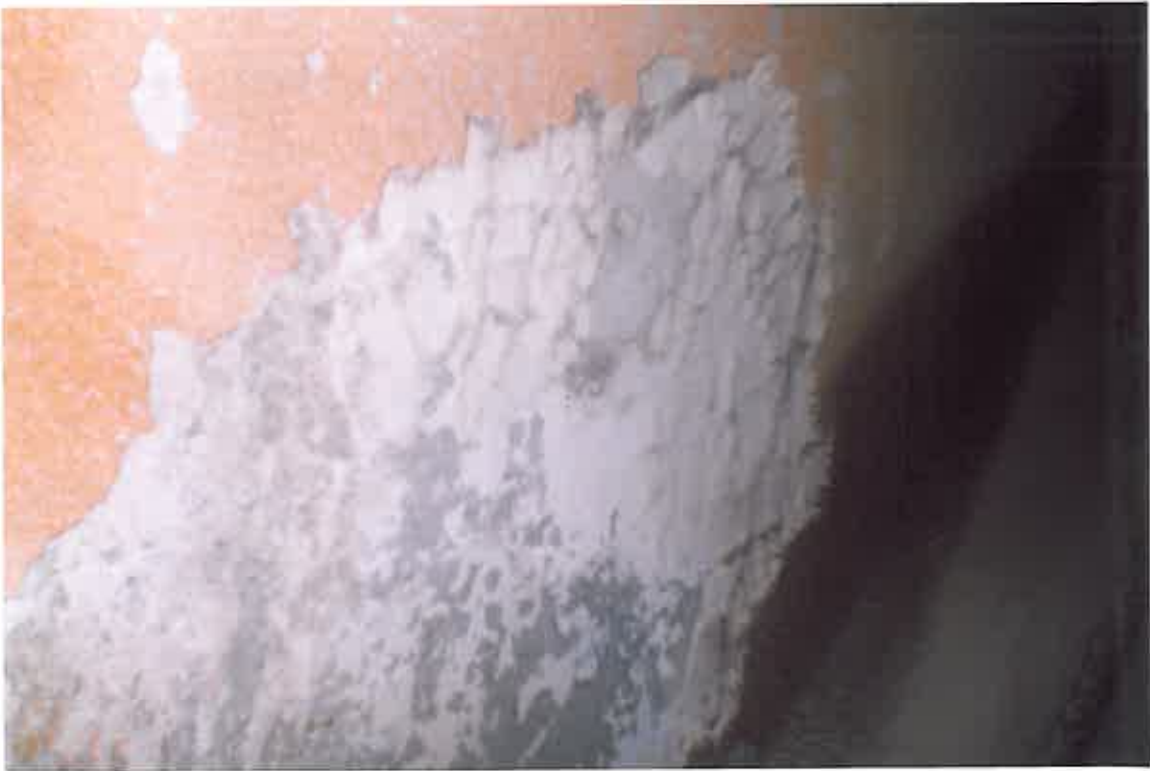
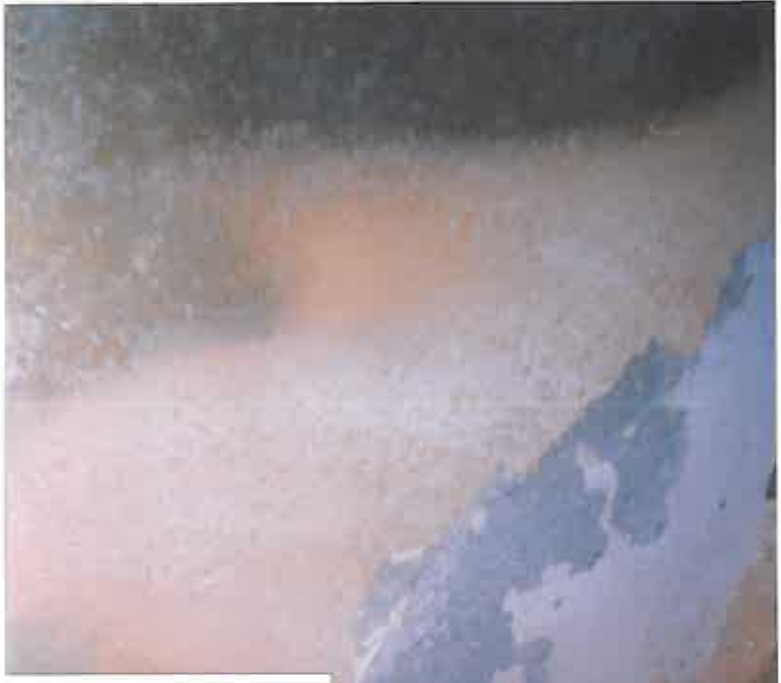
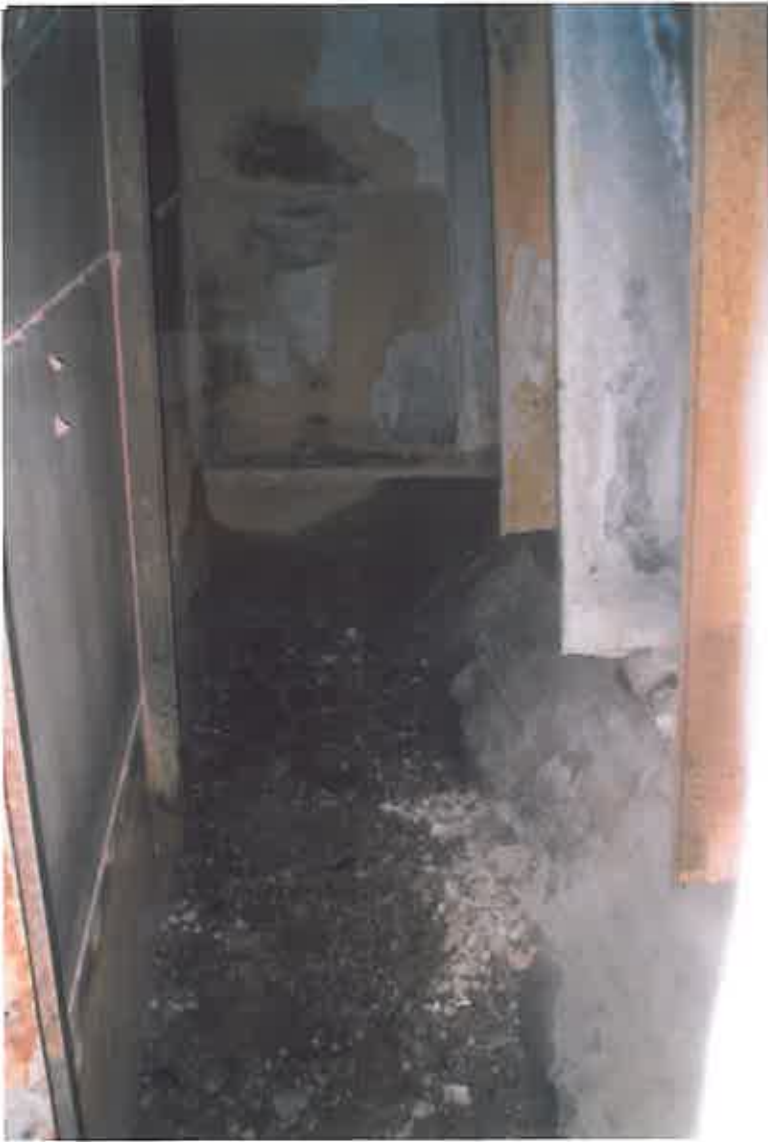
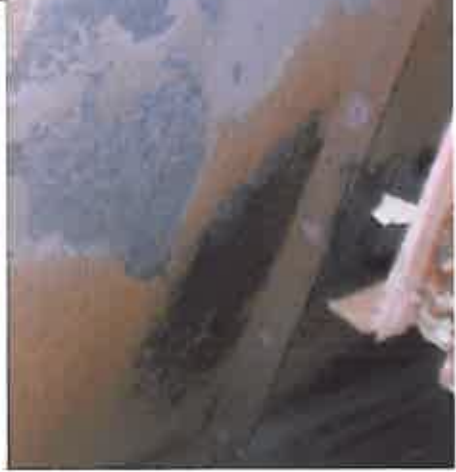
On initial inspection severe corrosion was found to be apparent on numerous components, which were removed & subsequently replaced once the coating process had been completed.

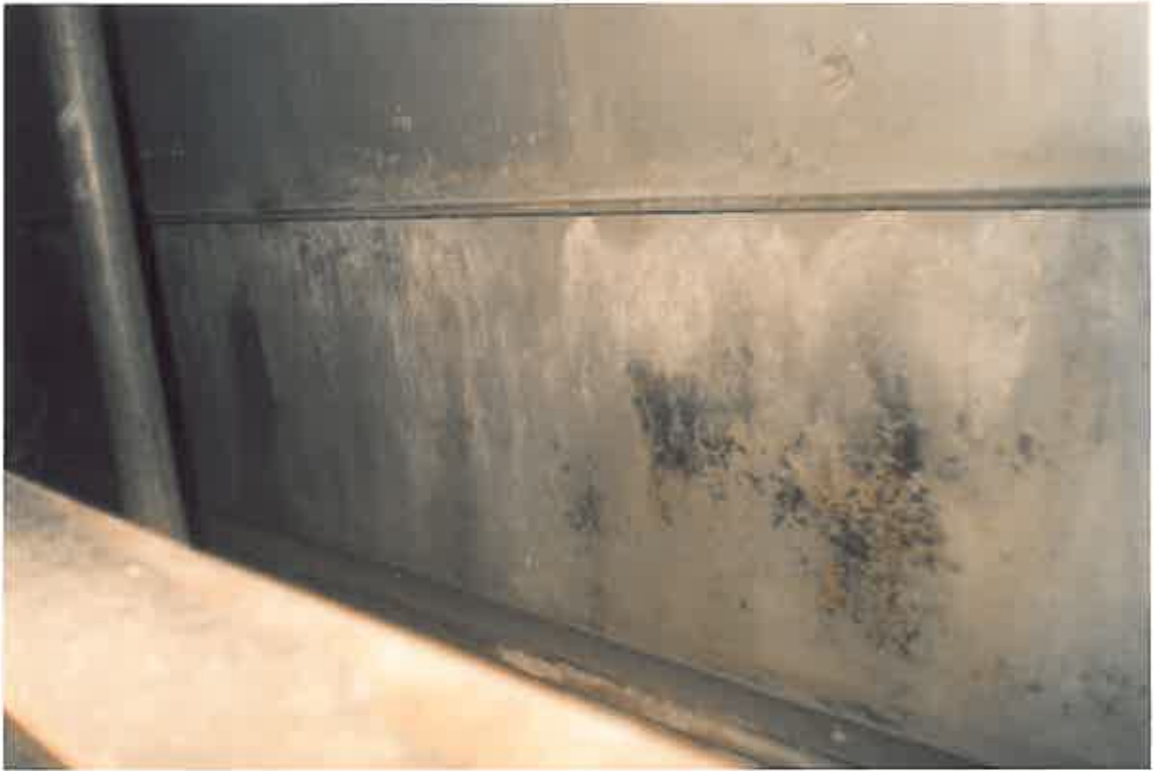
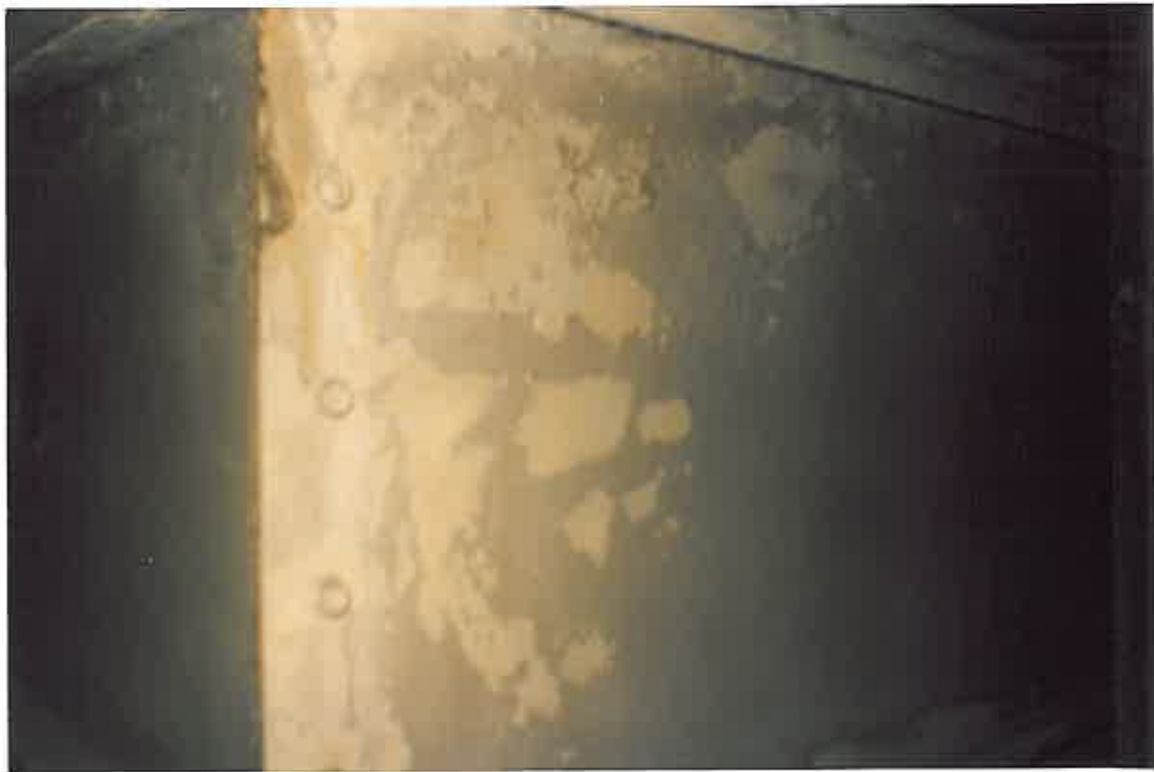
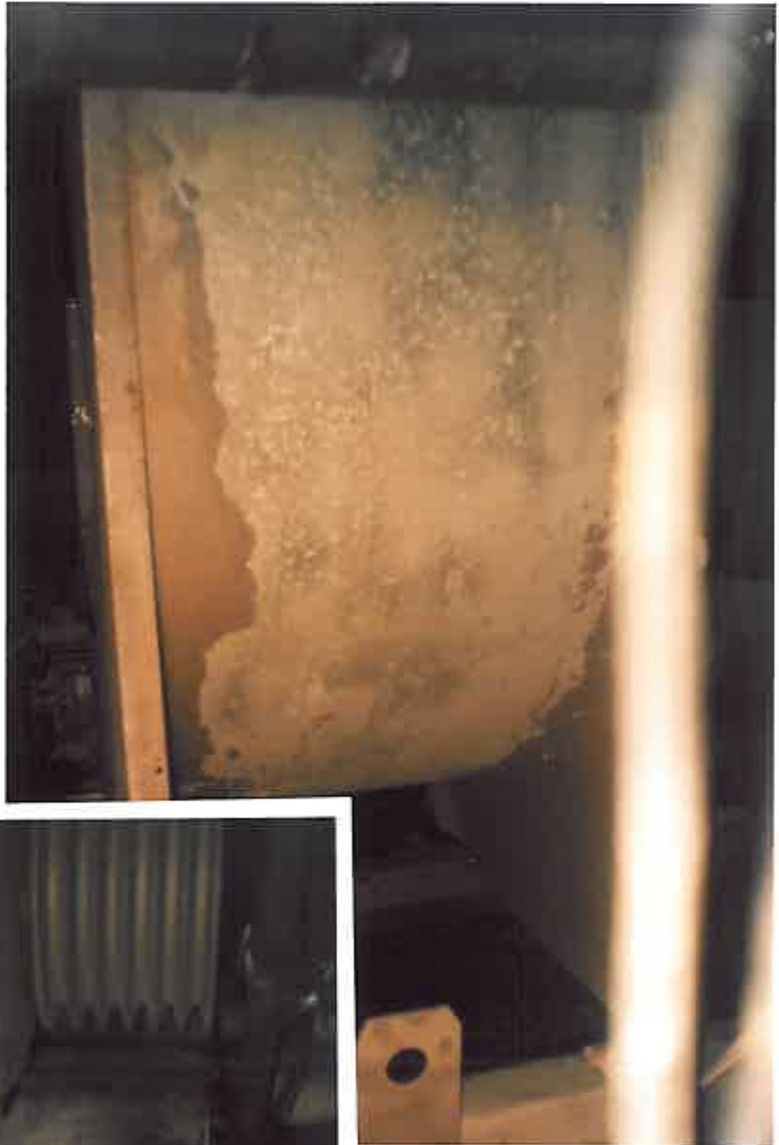
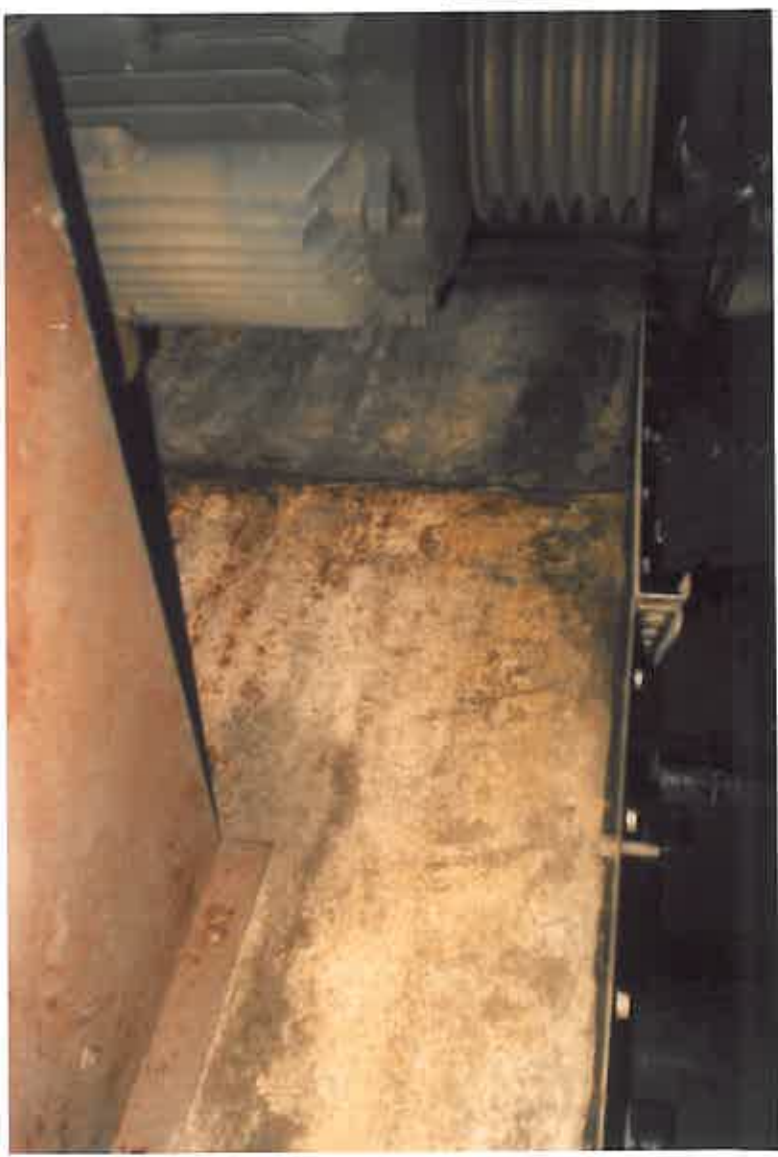
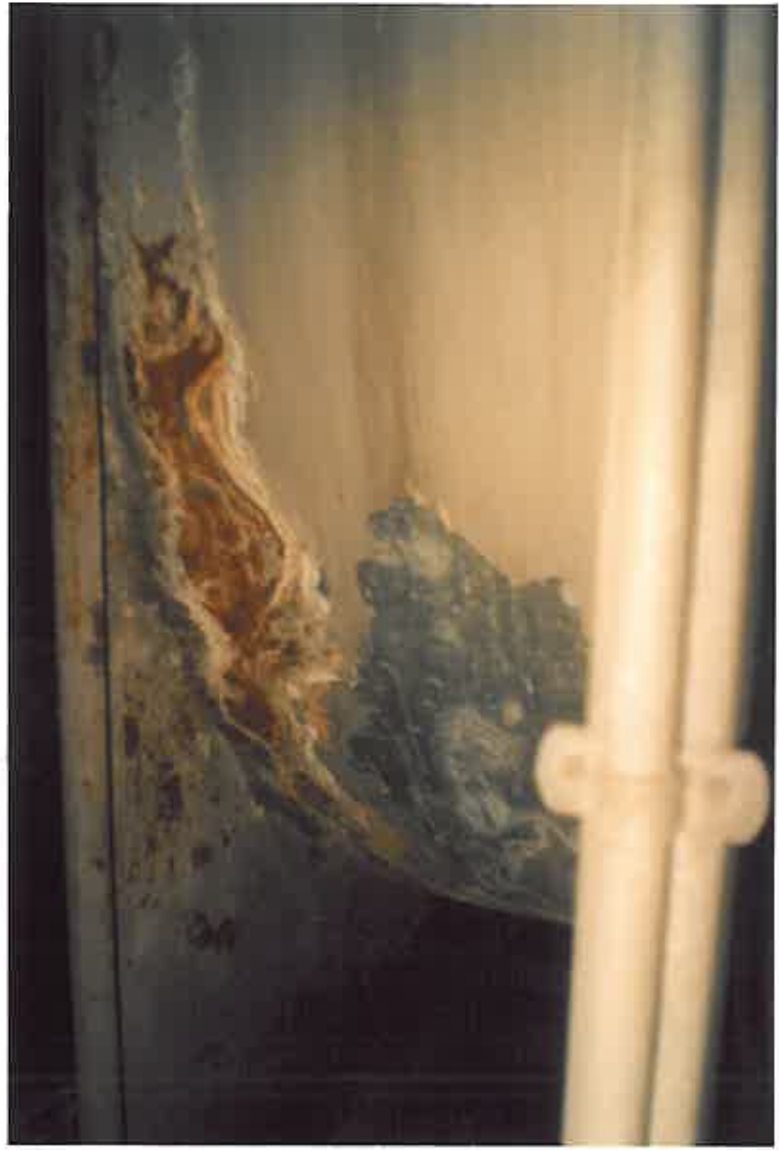
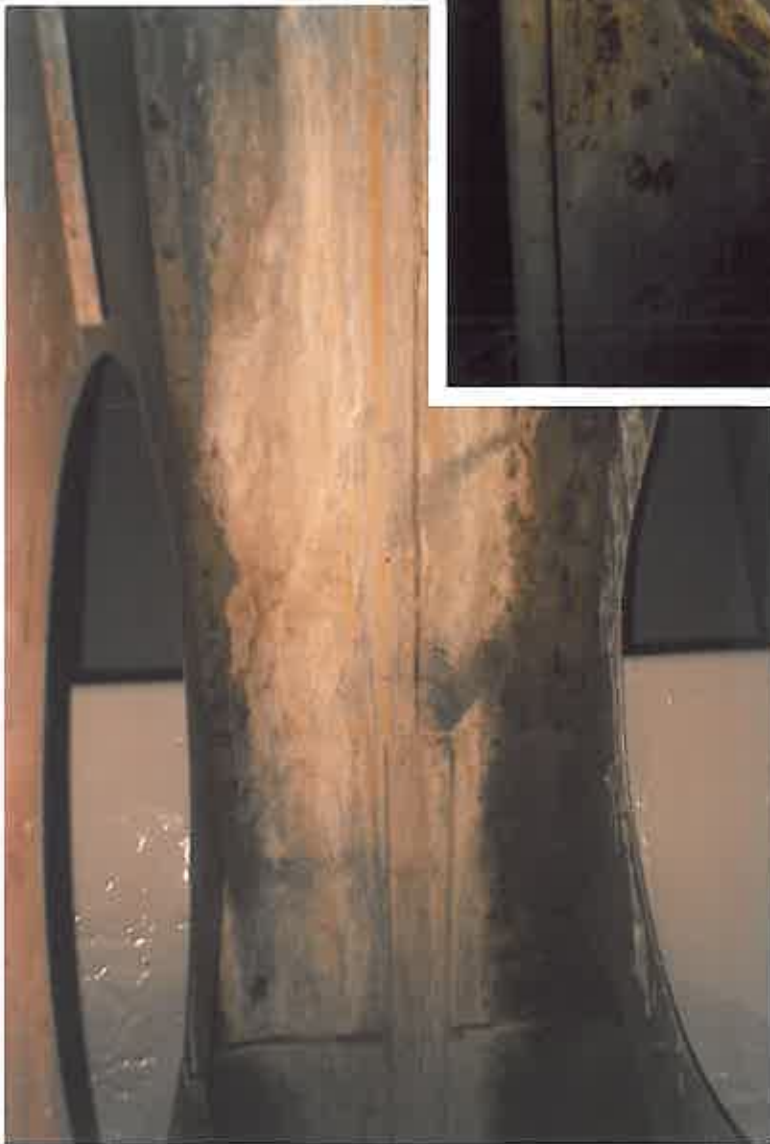
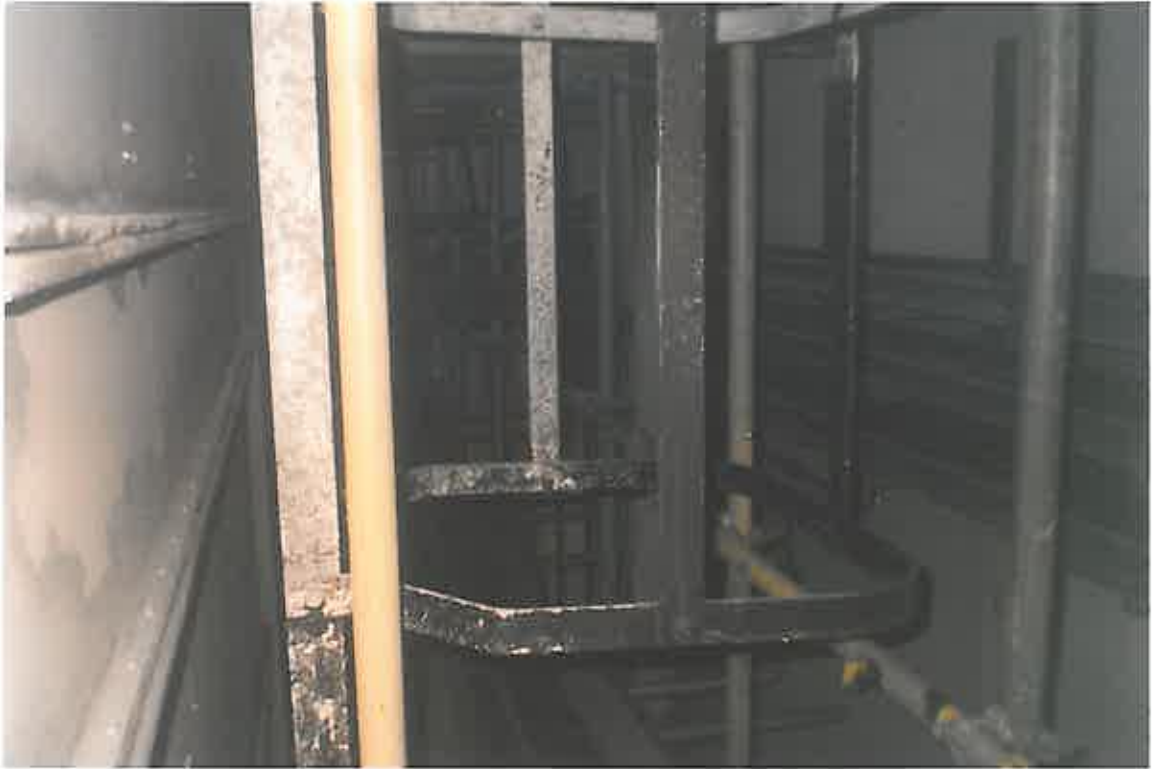
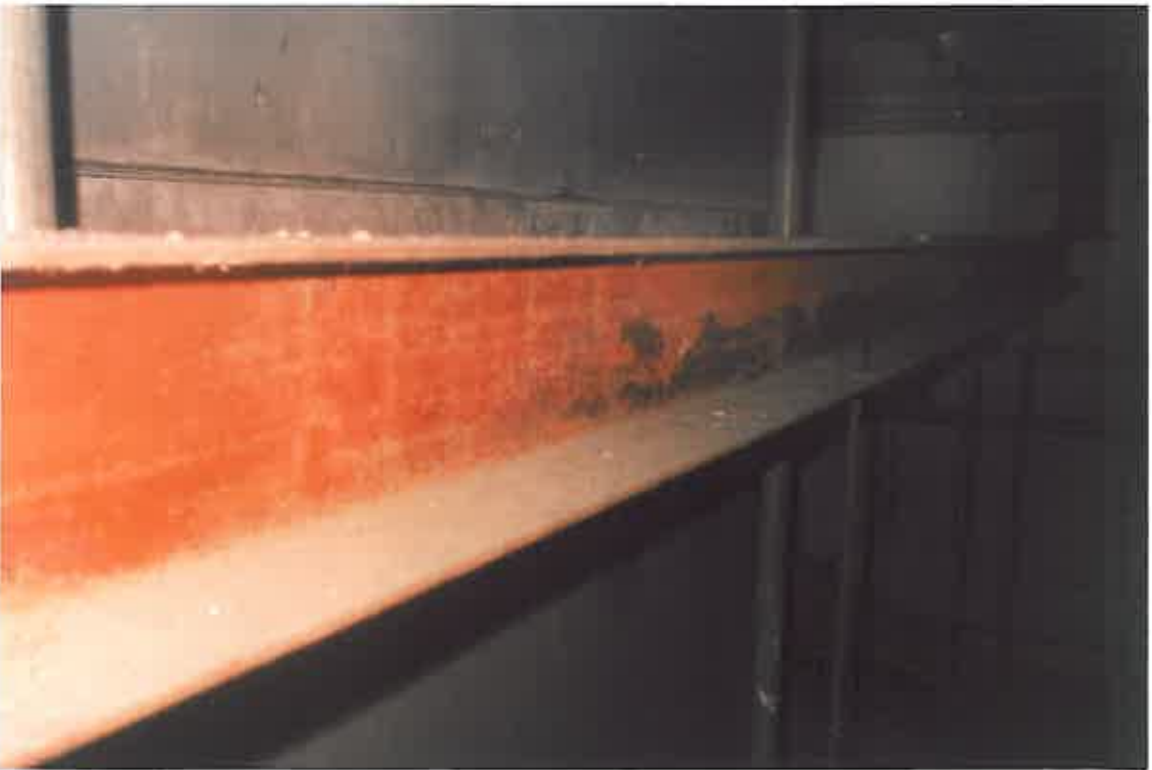
The above photographs show the external substrate of the towers and surrounding associated steel work, prior to the preparation work involving the removal all of the existing failed epoxy Baltibond coating

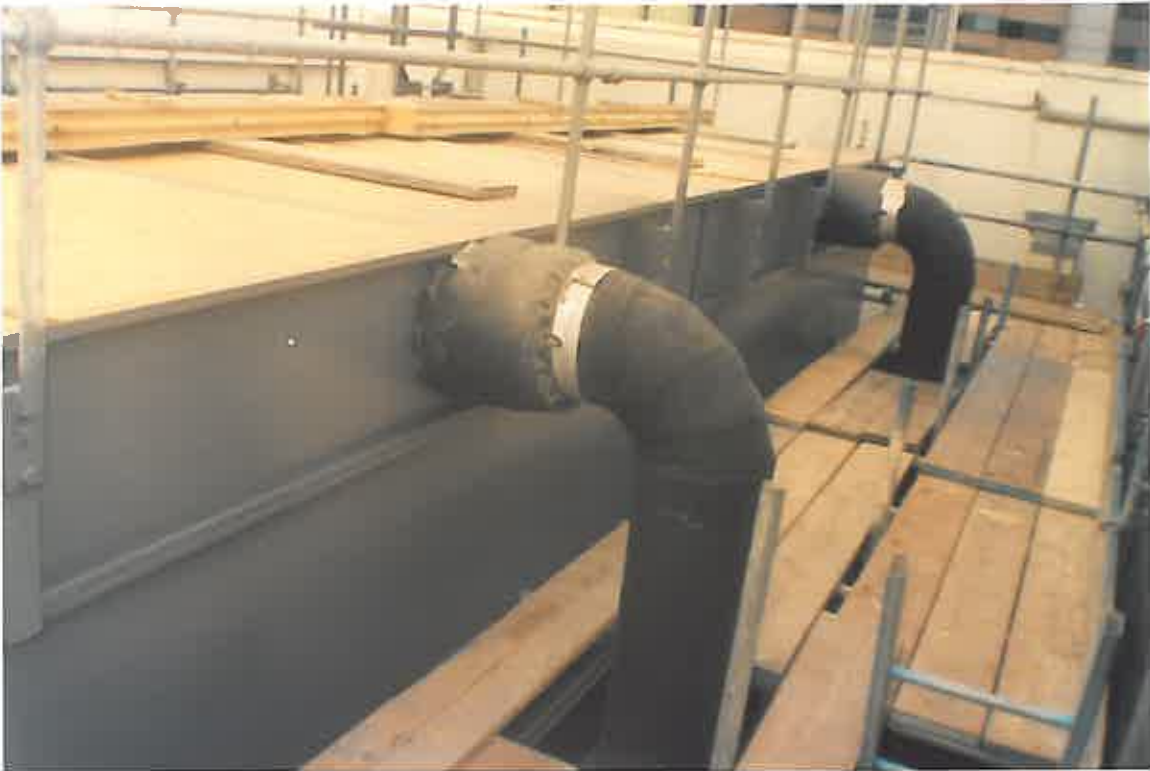
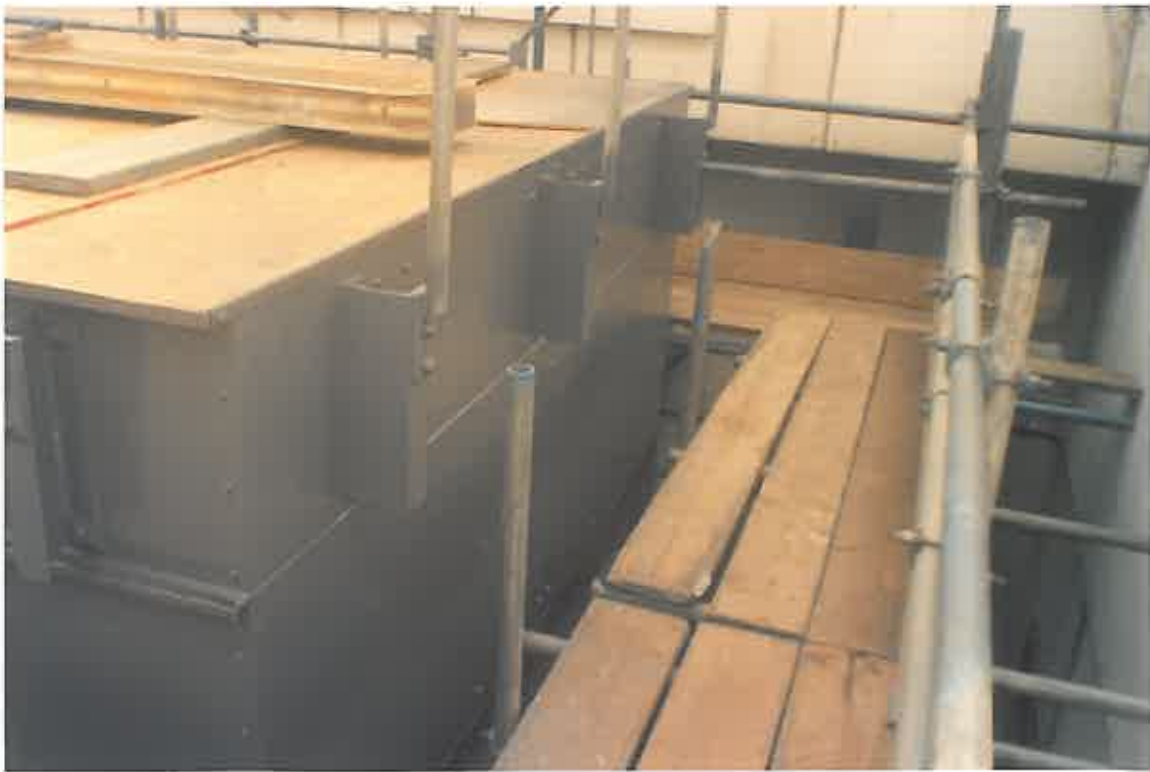
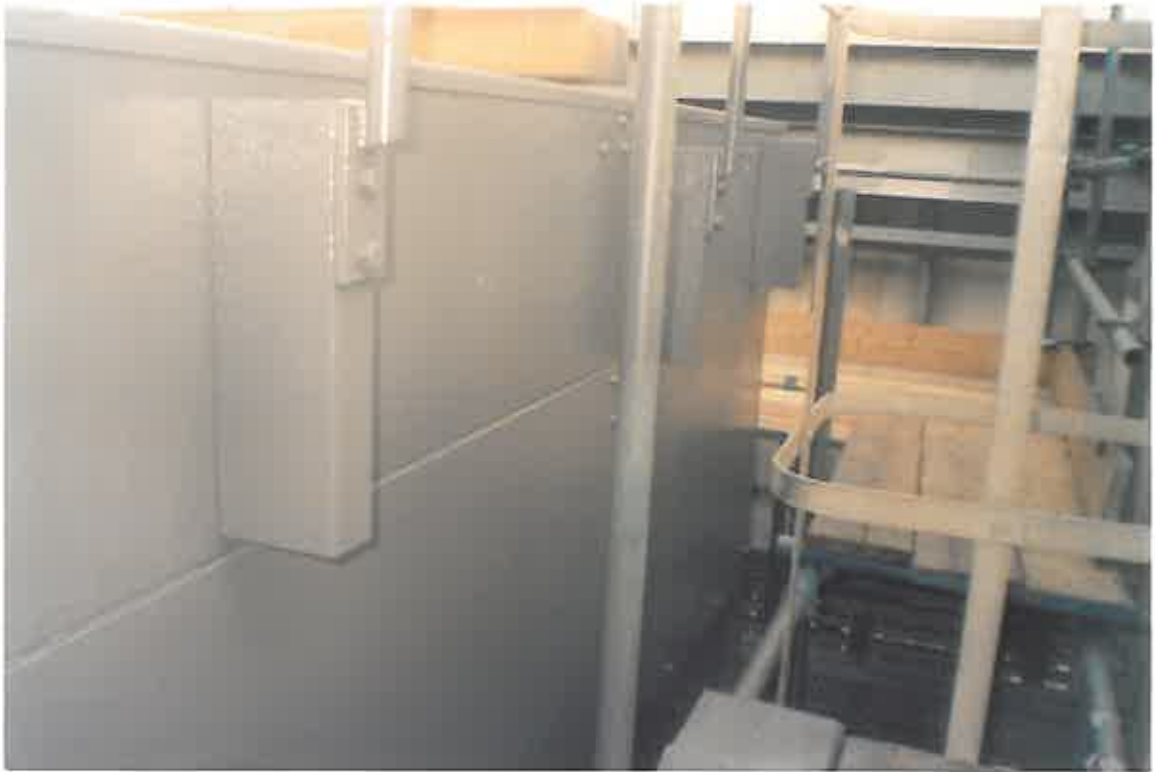
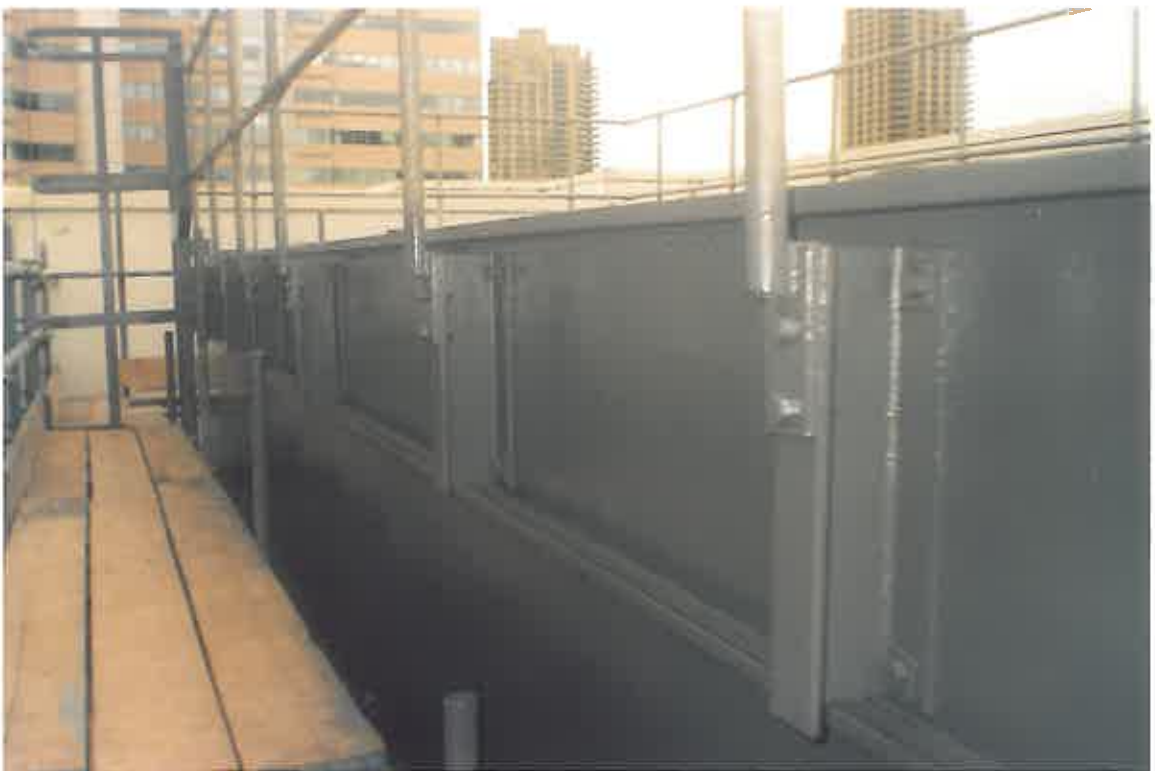
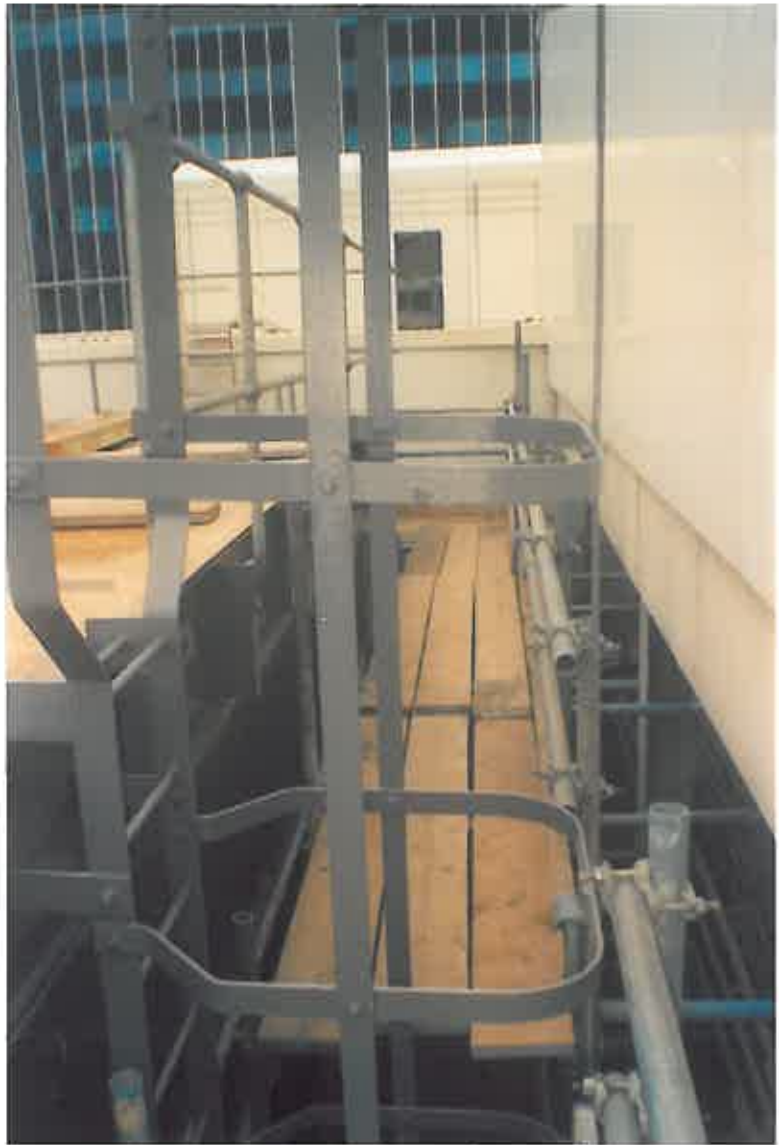
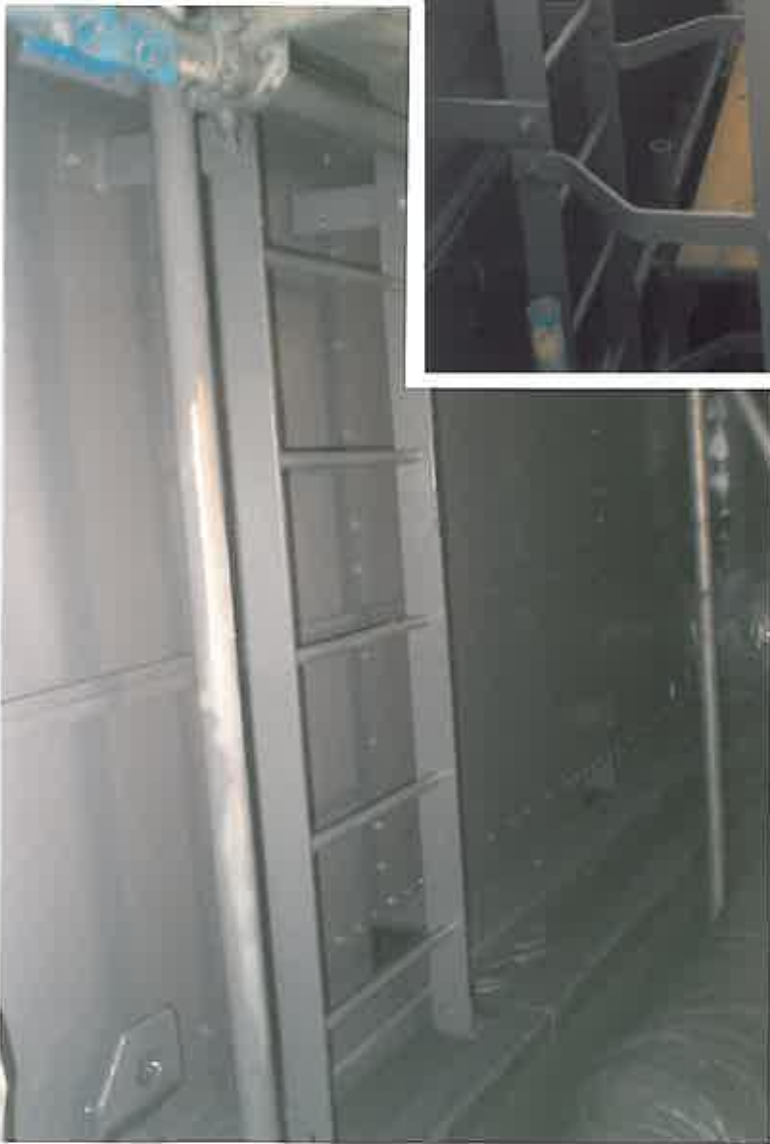
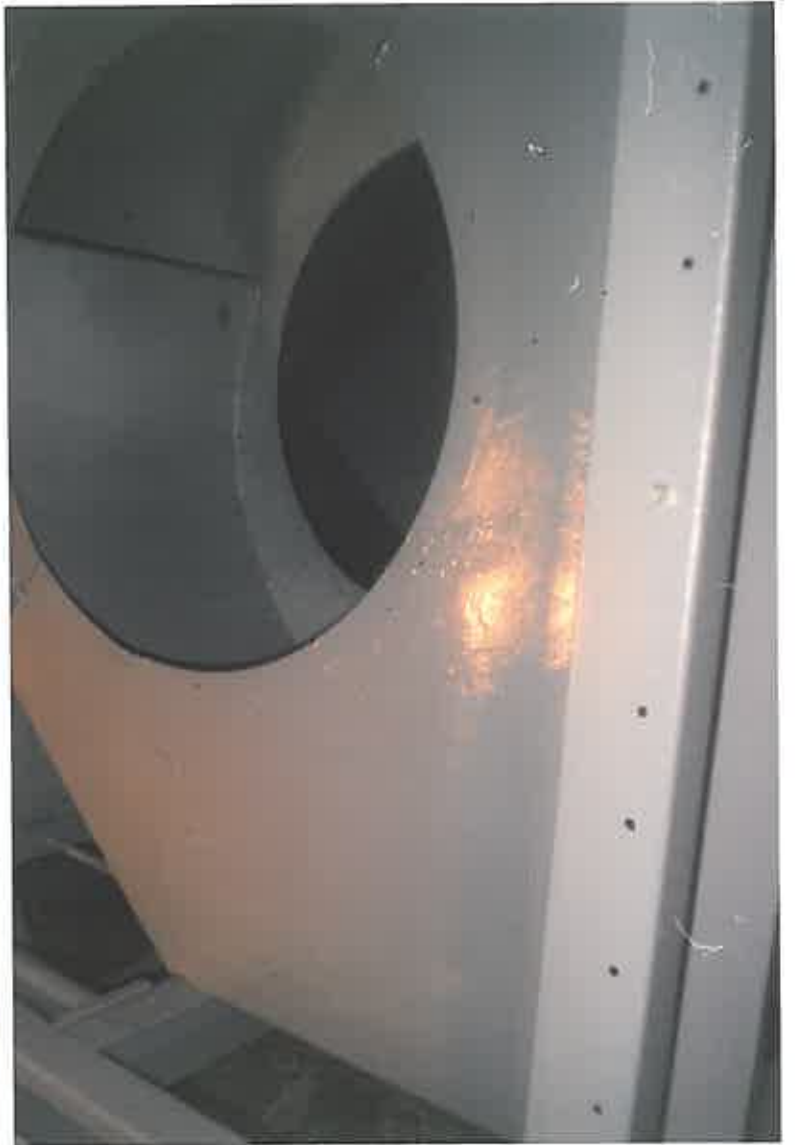
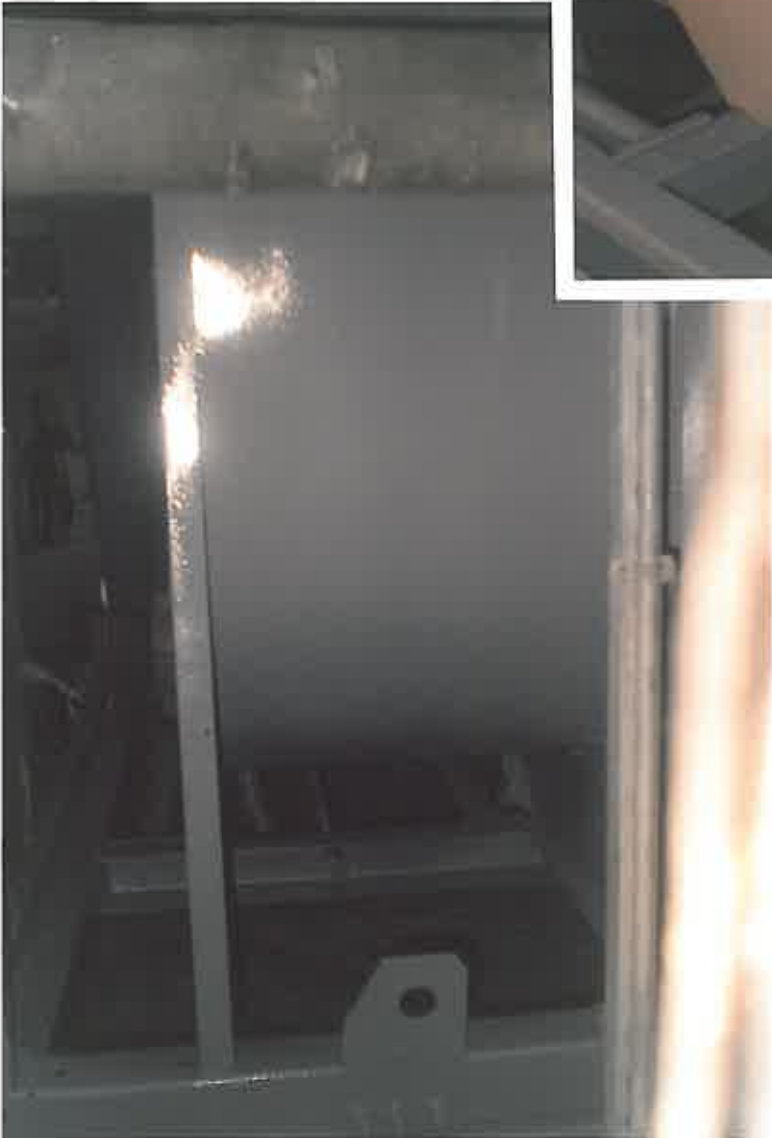
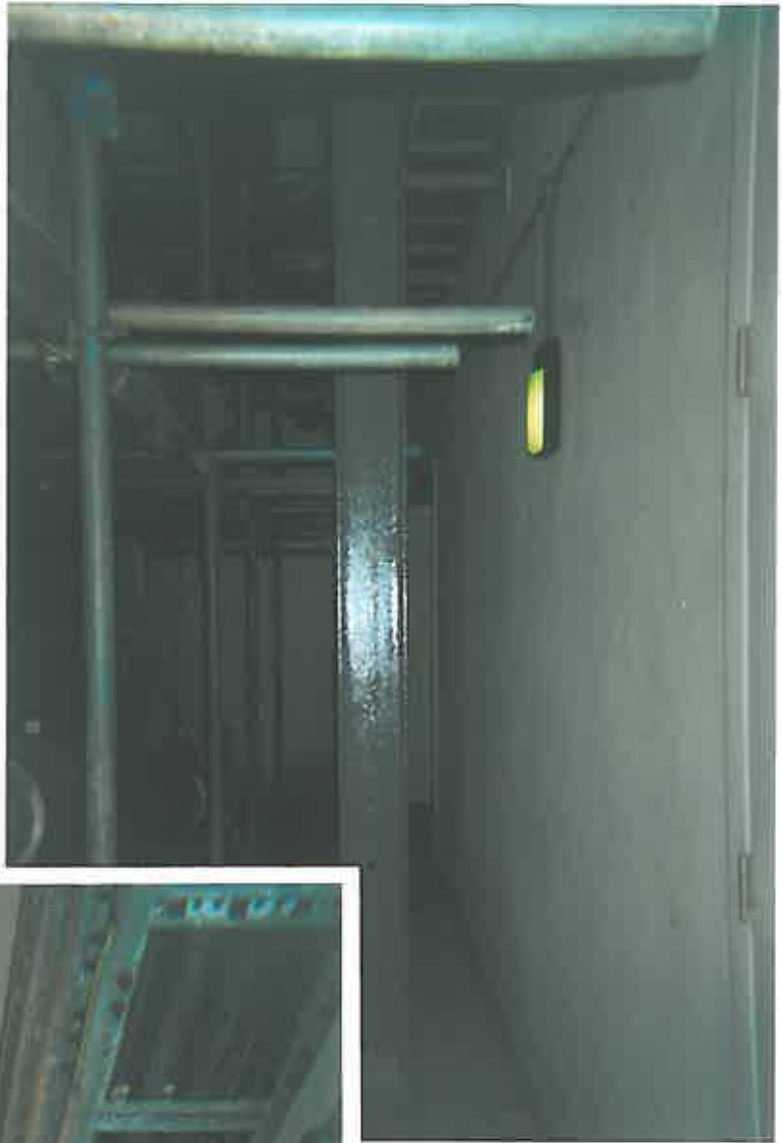
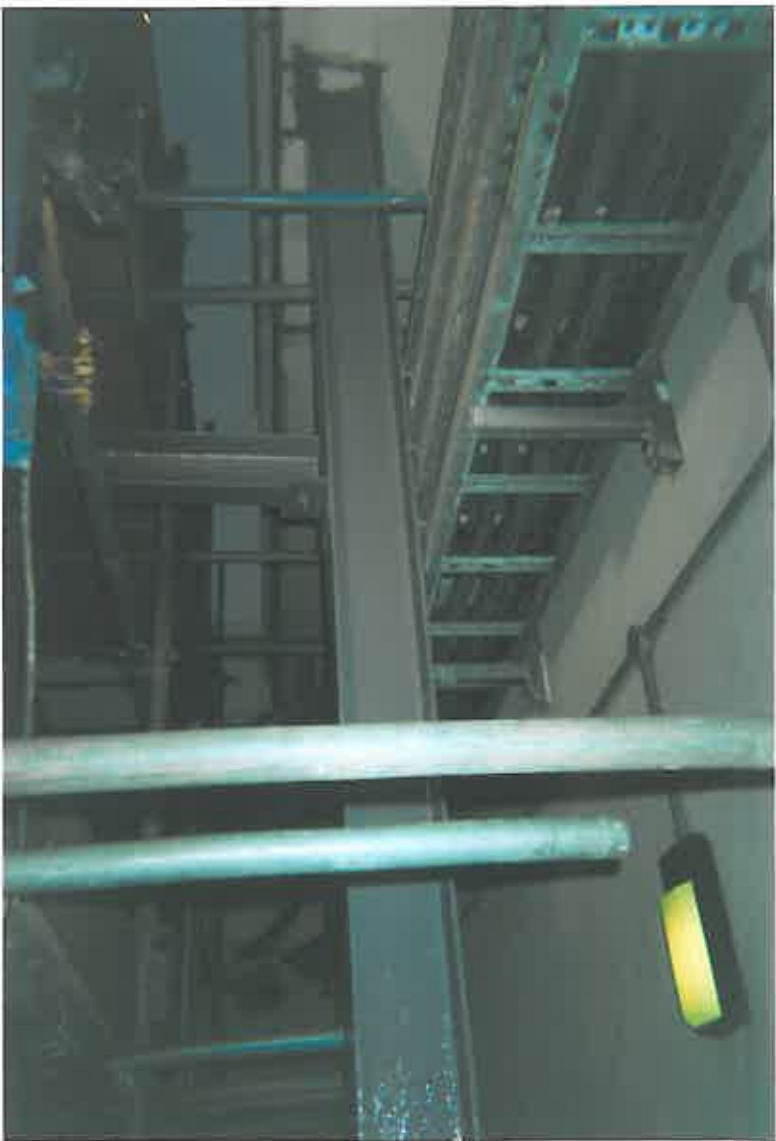
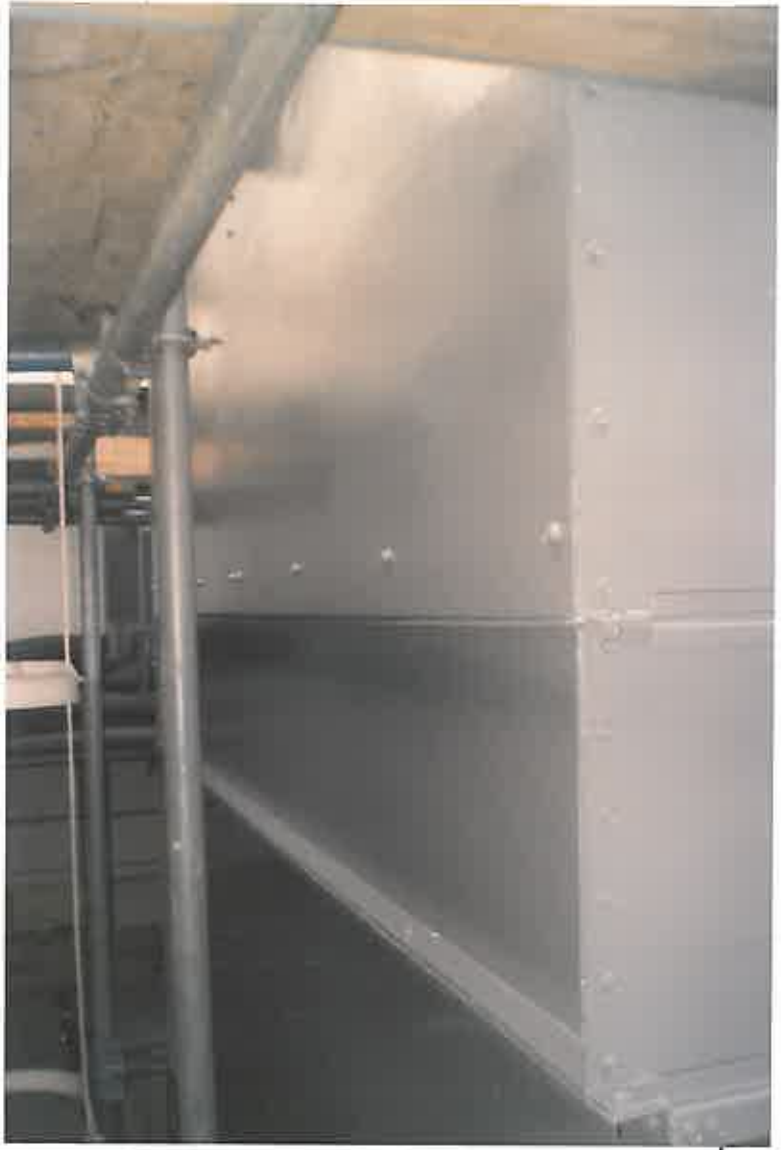
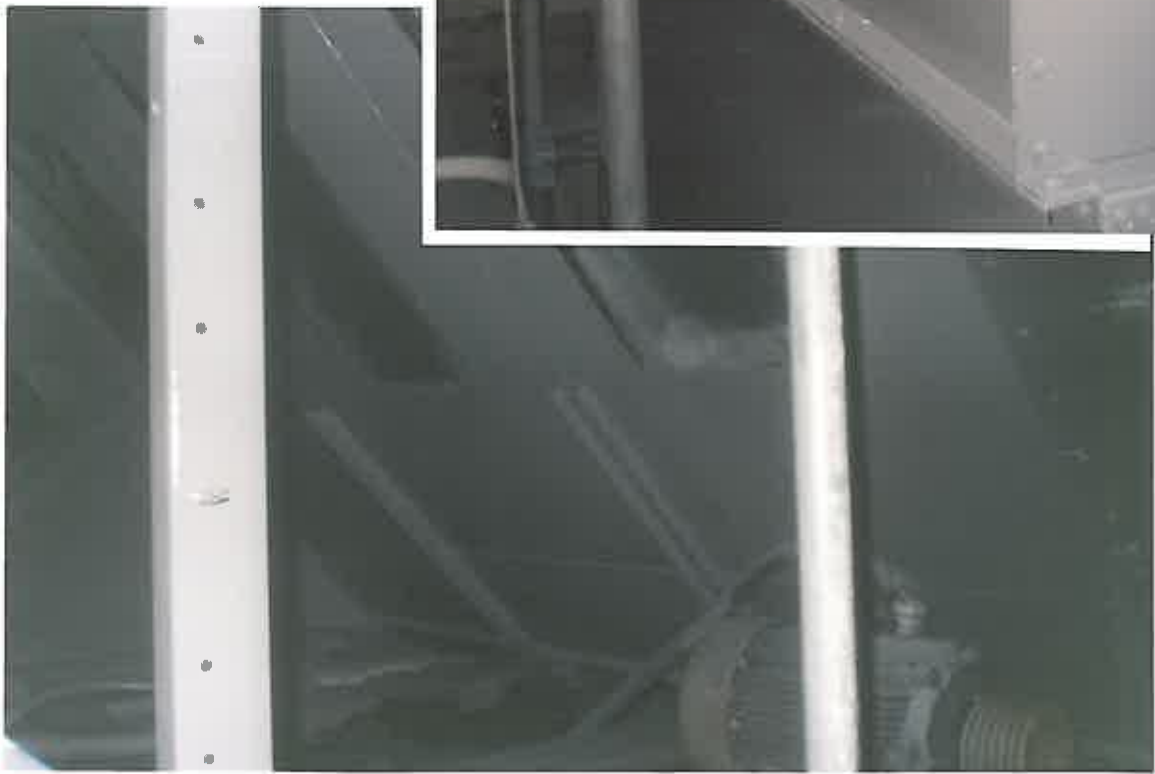
The above photographs show the externals of the cooling towers together with the associated steel works having received the final coat of COPON Hycote 165PW (Grey, applied to a total w/dft of 1000 Microns (1mm) and 1500 – 2000 Microns over all stripe coated areas.
