COVAC COMPLETION REPORT

Client	-	XXX LTD
Address	-	XXXX XXX XXXXXXXXXX Street London EC2
Client Site Contact	-	XXXXX XXXXXXX
Project Brief	-	The Internal and External Relining of 2 No. BAC Cooling Towers.
System Specification	-	COPON Hycote 165PW Solvent Free Polyurethane.
Nominal Dry Film Thickness	-	1000 Microns (1mm).
Completion Date	-	25th January 2007
Site Supervisor	-	Robin Bailey
Report Prepared by	-	David Snell
COVAC Contract Ref:	-	574

2 No. COOLING TOWERS - INTERNAL

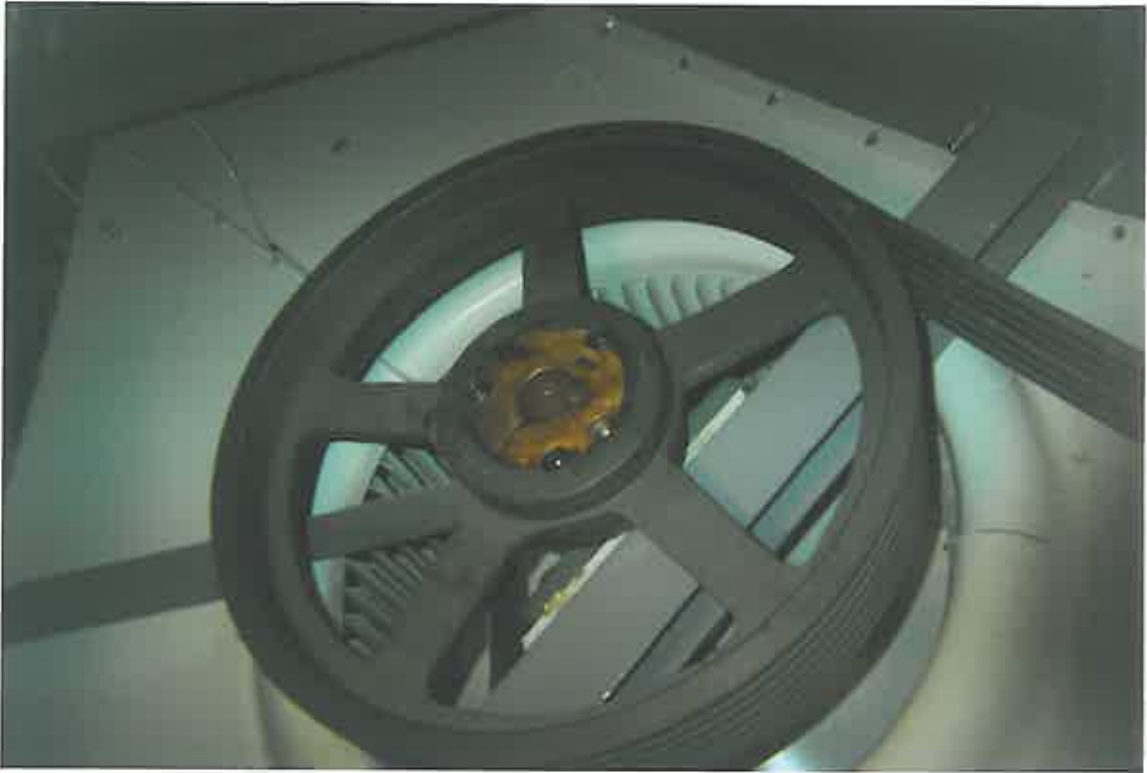
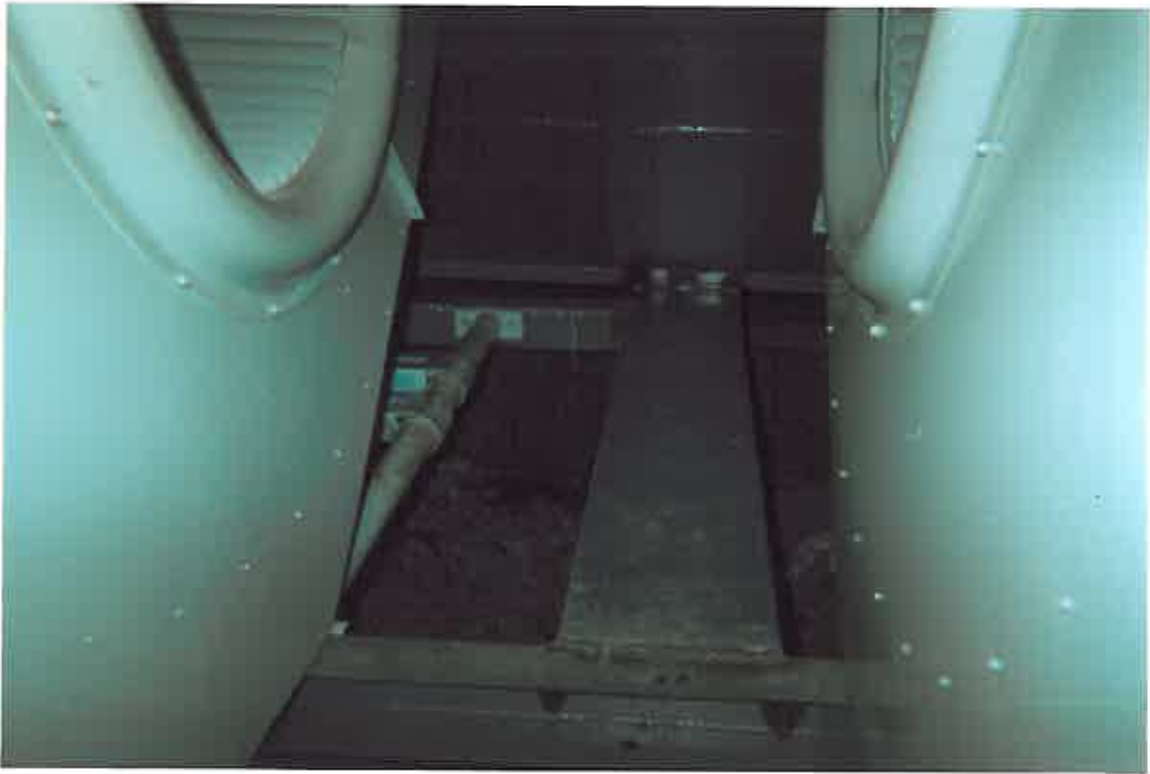
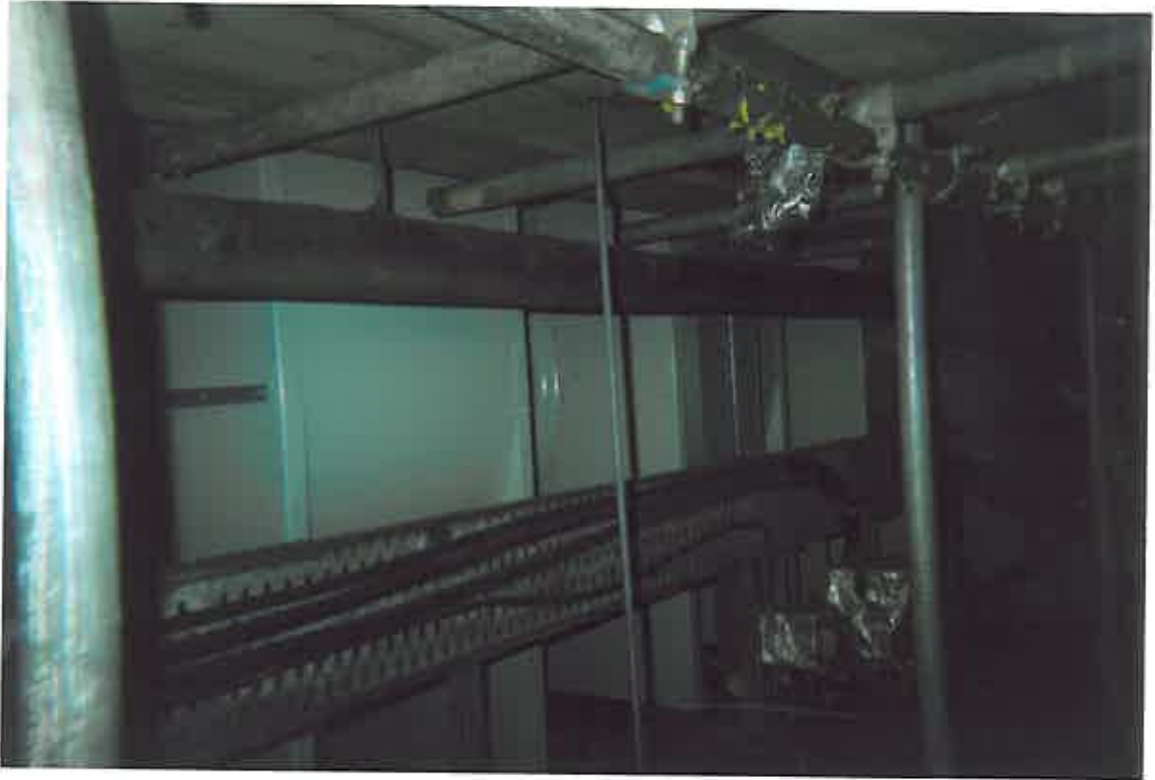
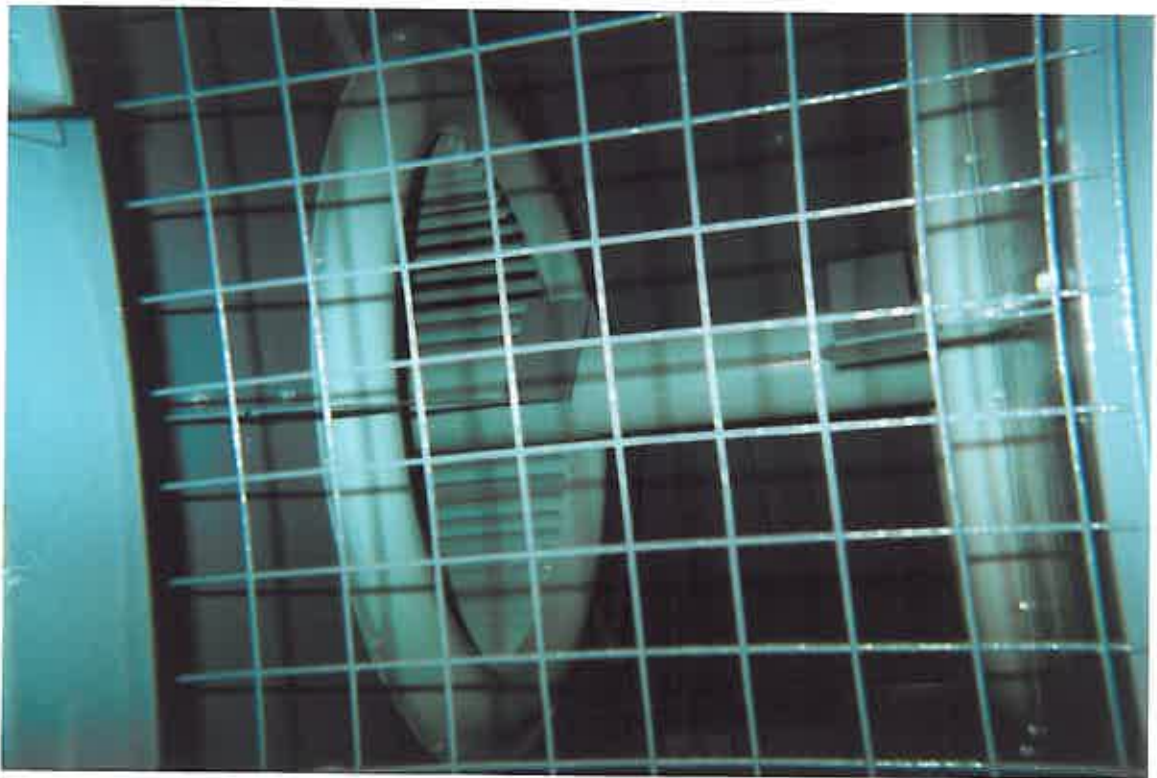
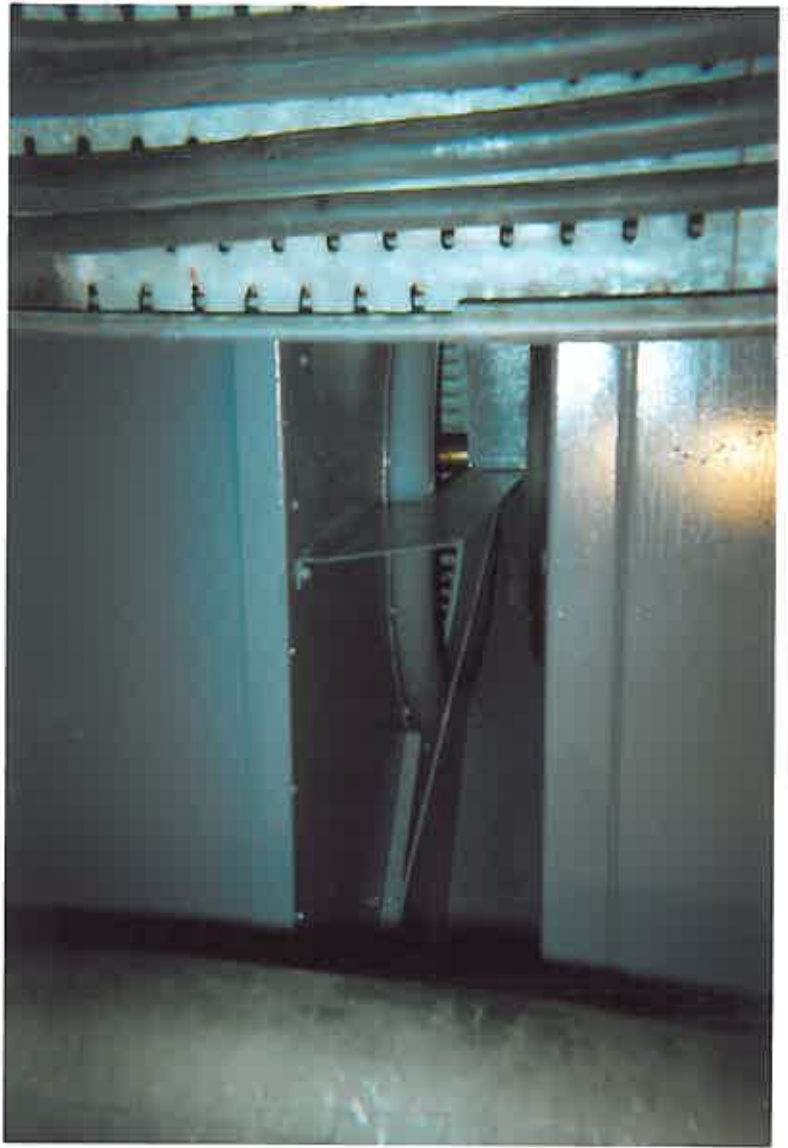
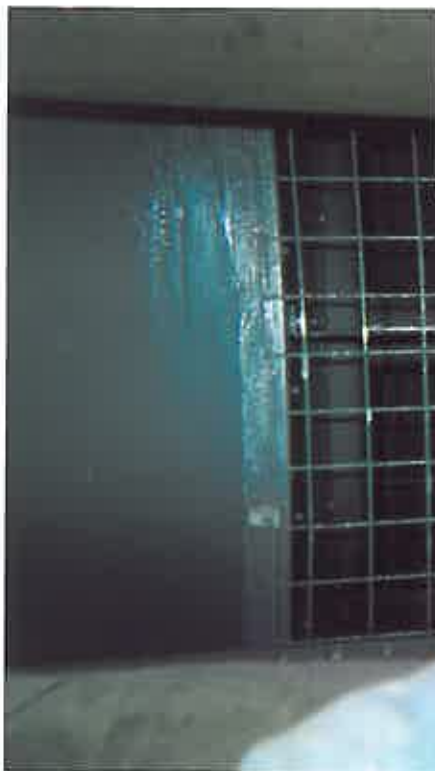
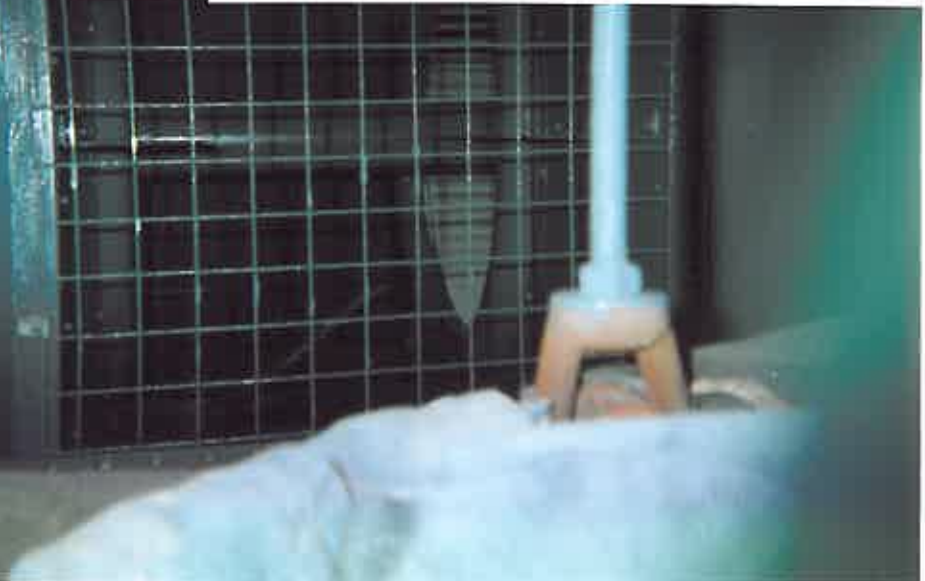
On completion of our full scope of works, BAC Balticare replaced all new fan housing's and components, which were subsequently recoated externally by Covac Site Operatives.
