# COMPLETION REPORT

Project Brief : **The Internal Refurbishment of 2 No.  
Flat, Galvanised CWS Tanks**

Covac Ref : **979**

## TANK #1

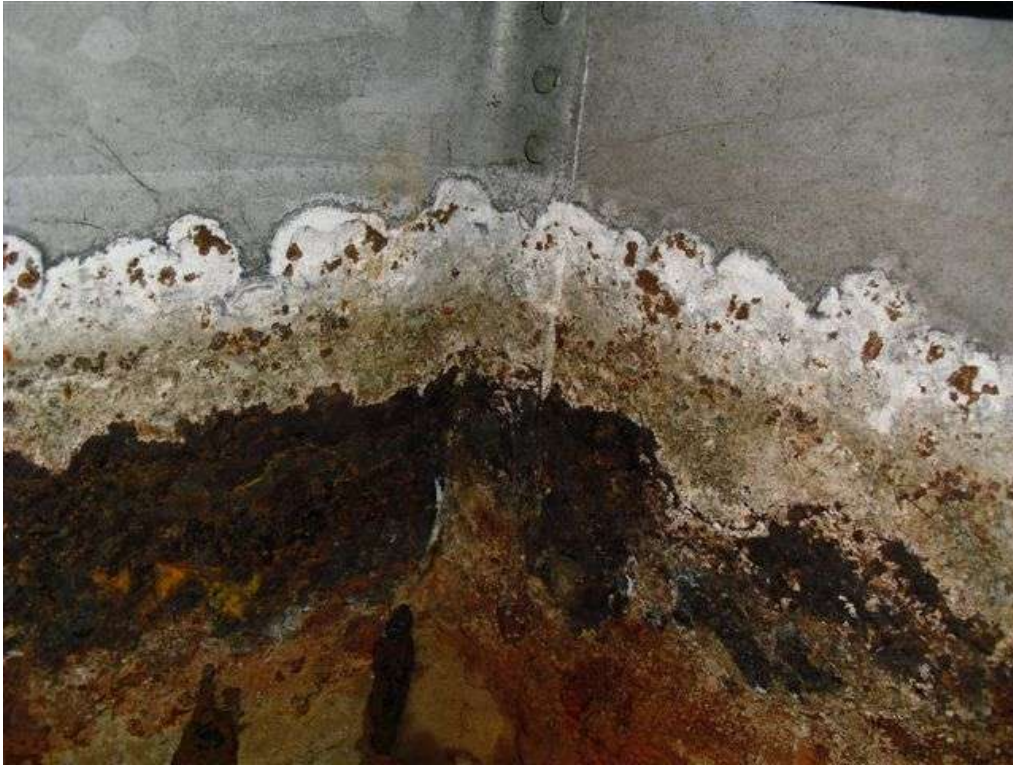
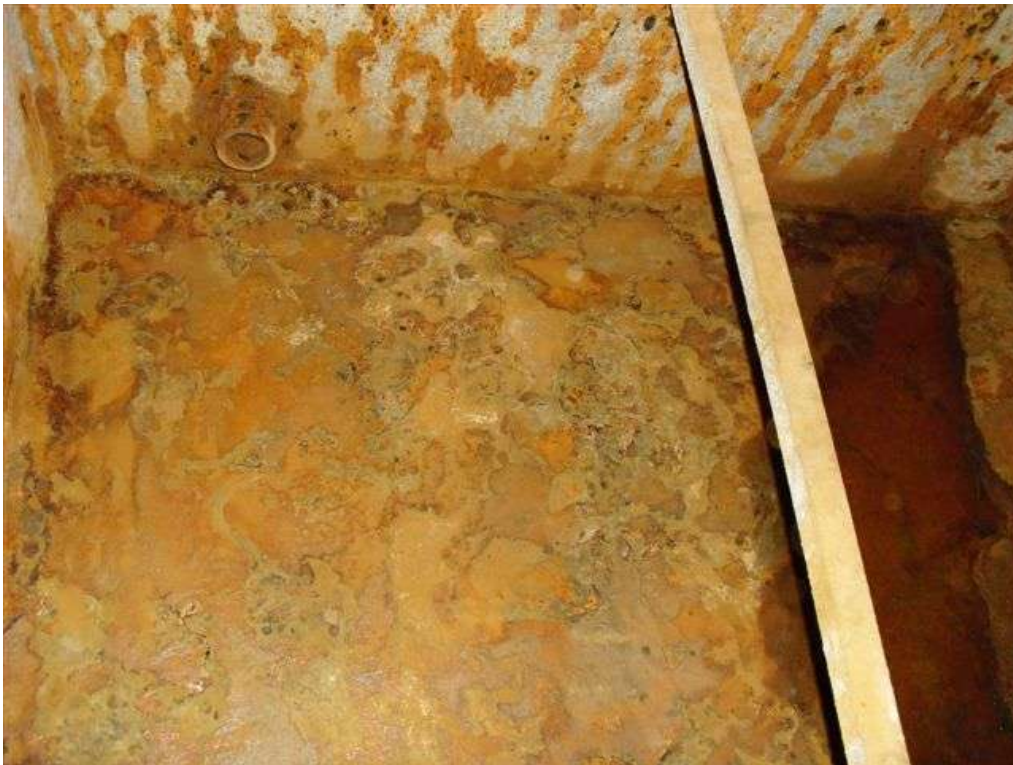
Holes in the substrate at the waterline as a result of the severe corrosion can be seen.

After preparation, the areas to be repaired utilising steel plates were marked out before 'stripe coating' utilising 3M Scotchkote™ 165PW.

**Steel plates were then fastened to the damaged areas.**

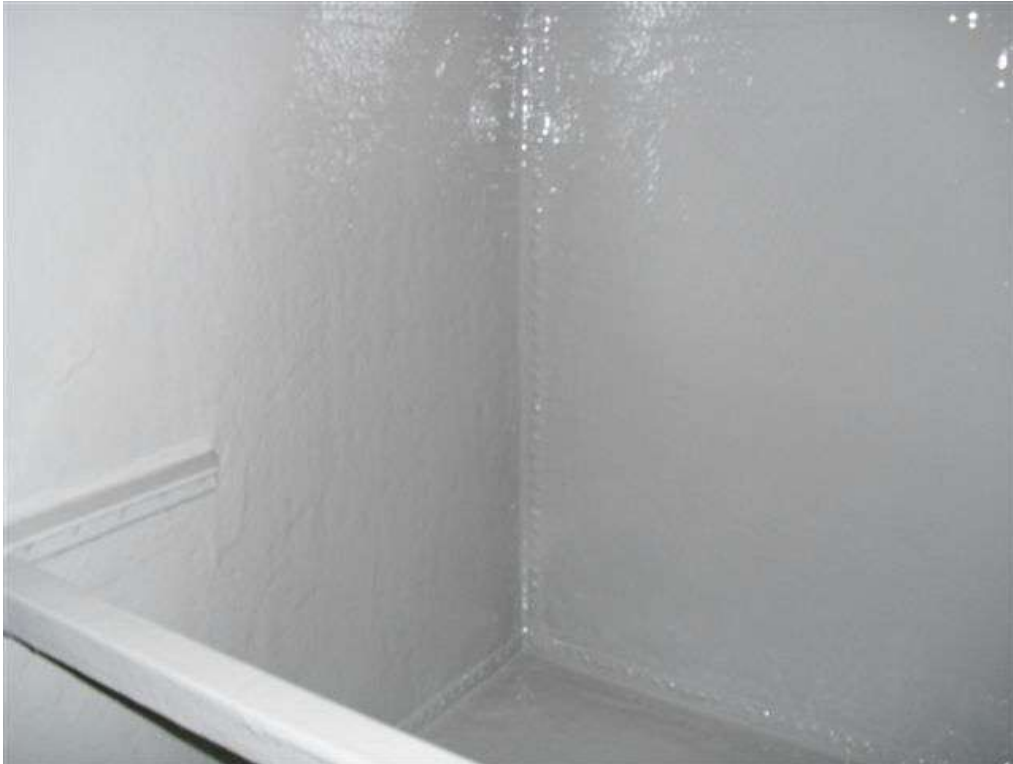
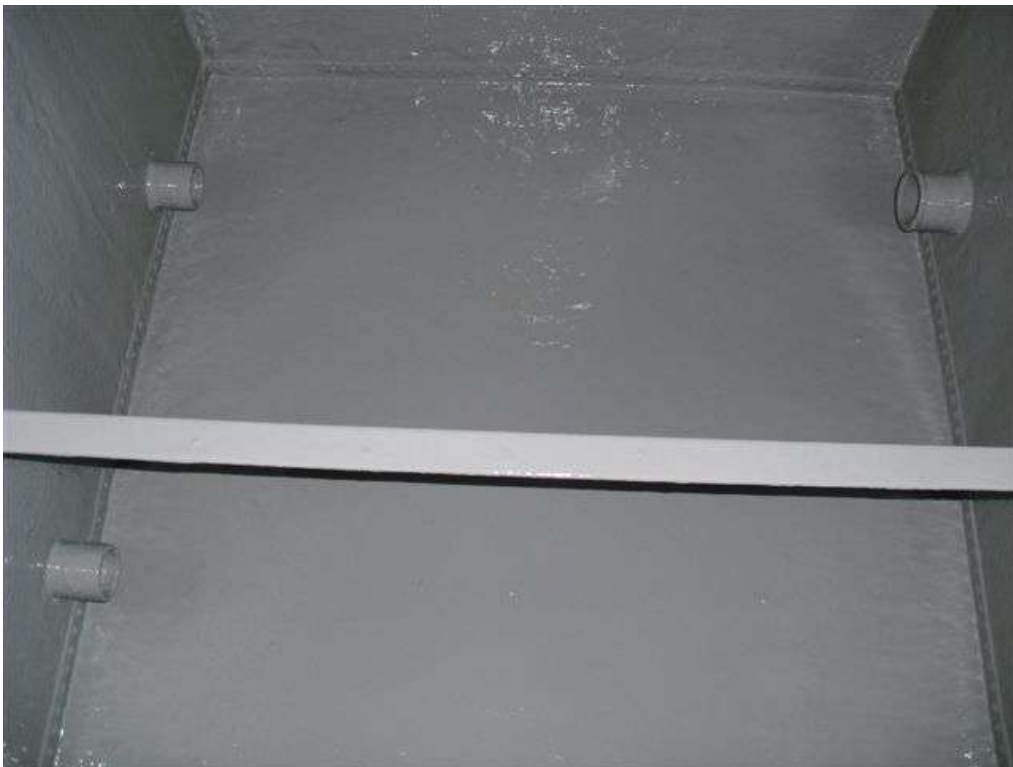
All intricate areas were again 'stripe coated' for a second time. These photographs show the final application of the 2<sup>nd</sup> coat of 3M Scotchkote™ 165PW (grey) in order to achieve a total, nominal dry film thickness of 1000 Microns (1mm) and between 1500-2000 Microns (2mm) over all stripe coated areas.

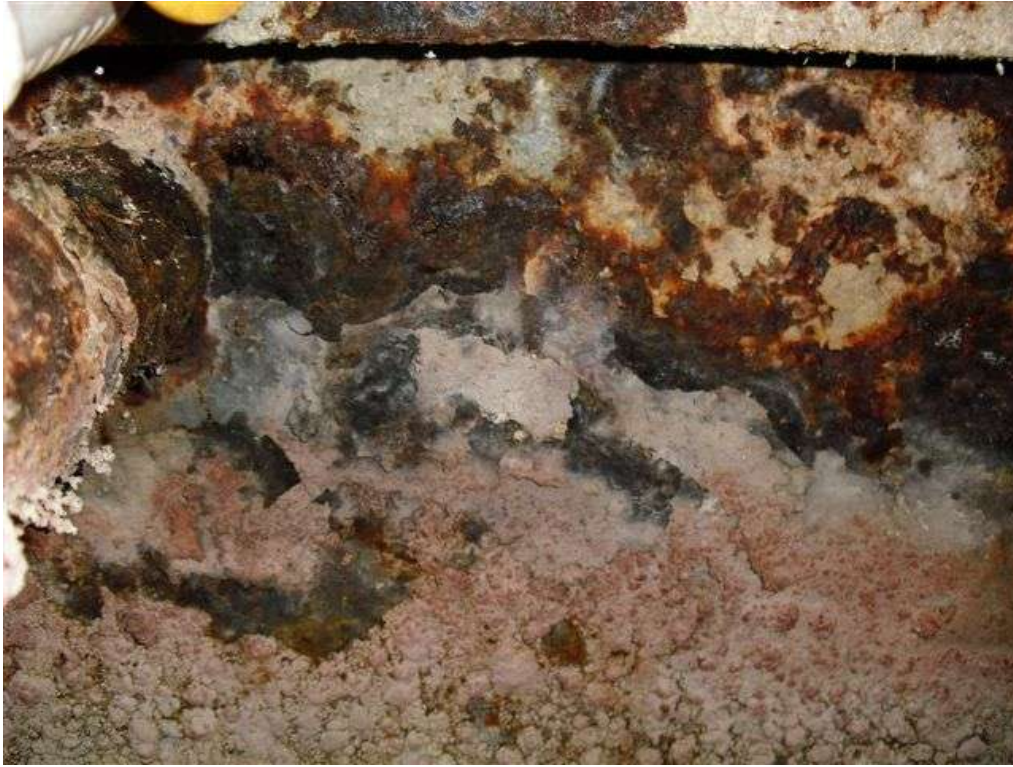
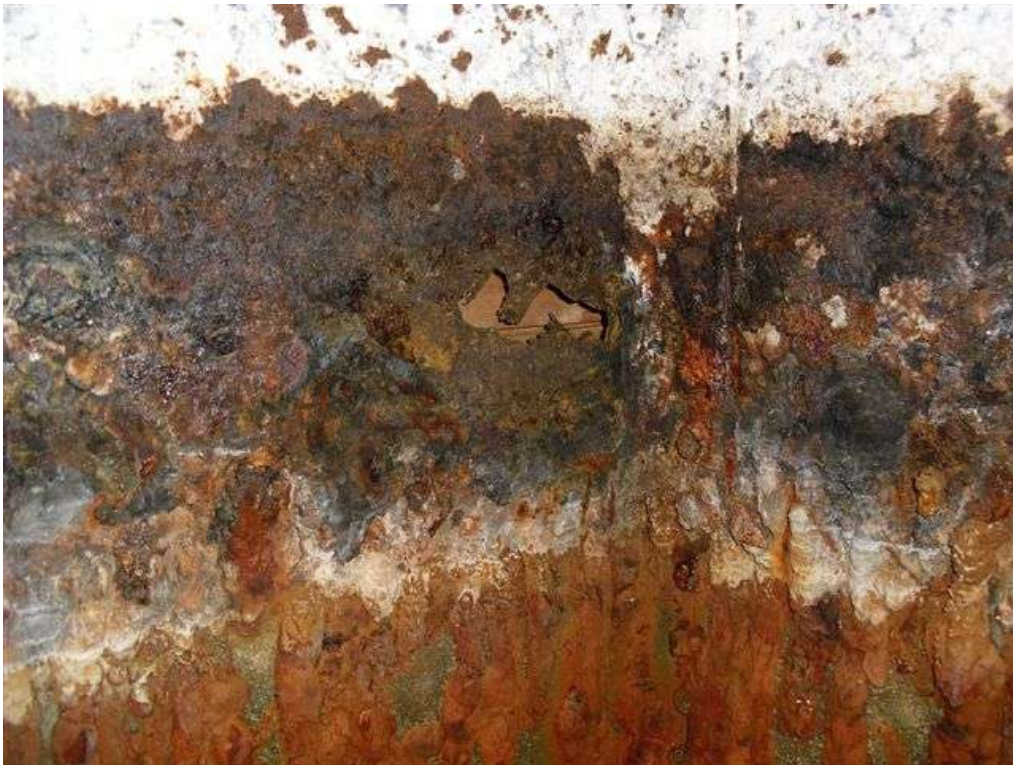
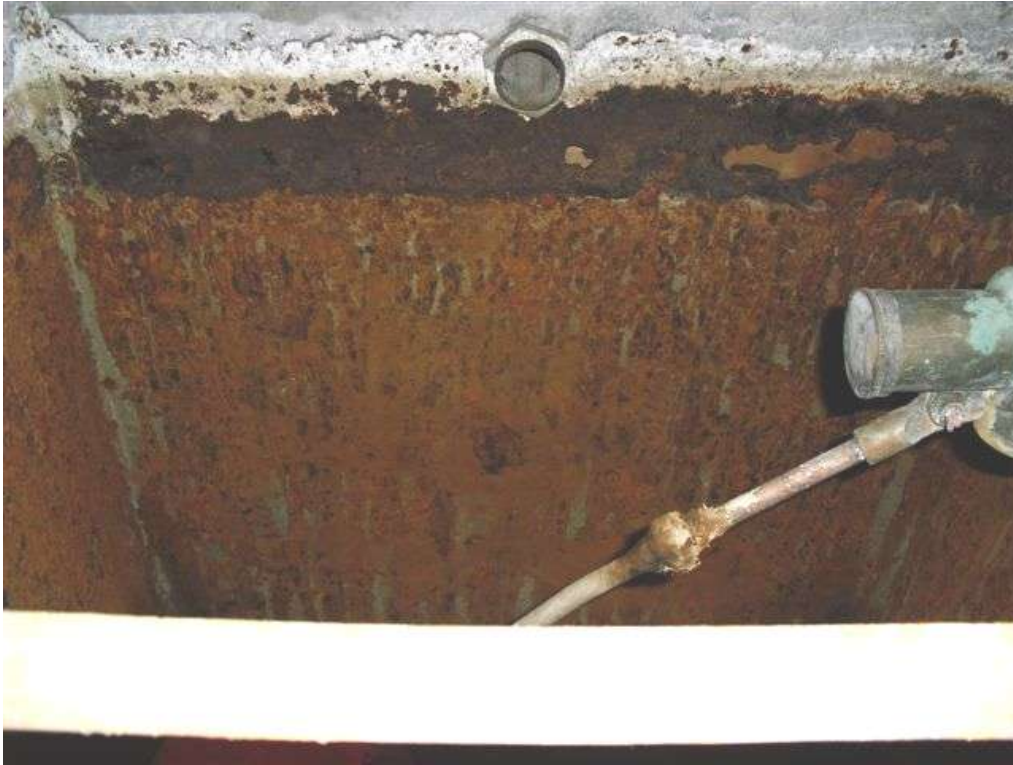
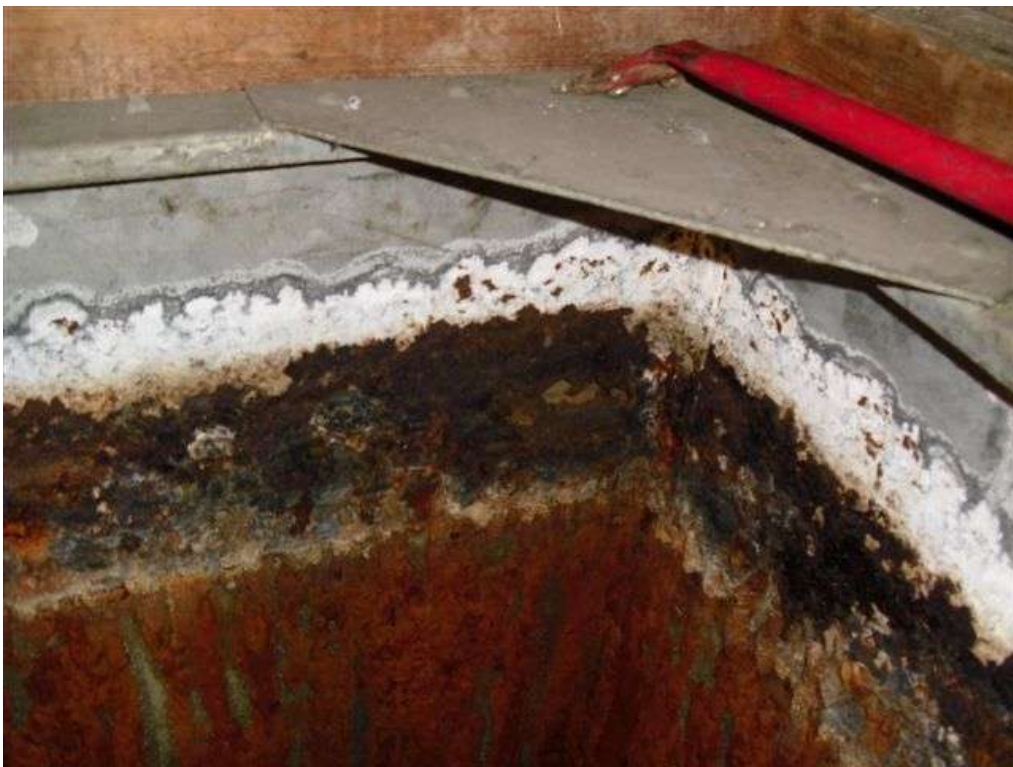
**These photographs show the internal surfaces of tank #2 having been drained of water, but prior to any work commencing. As with tank #1, severe corrosion is evident resulting in holes in the substrate, particularly at the waterline.**

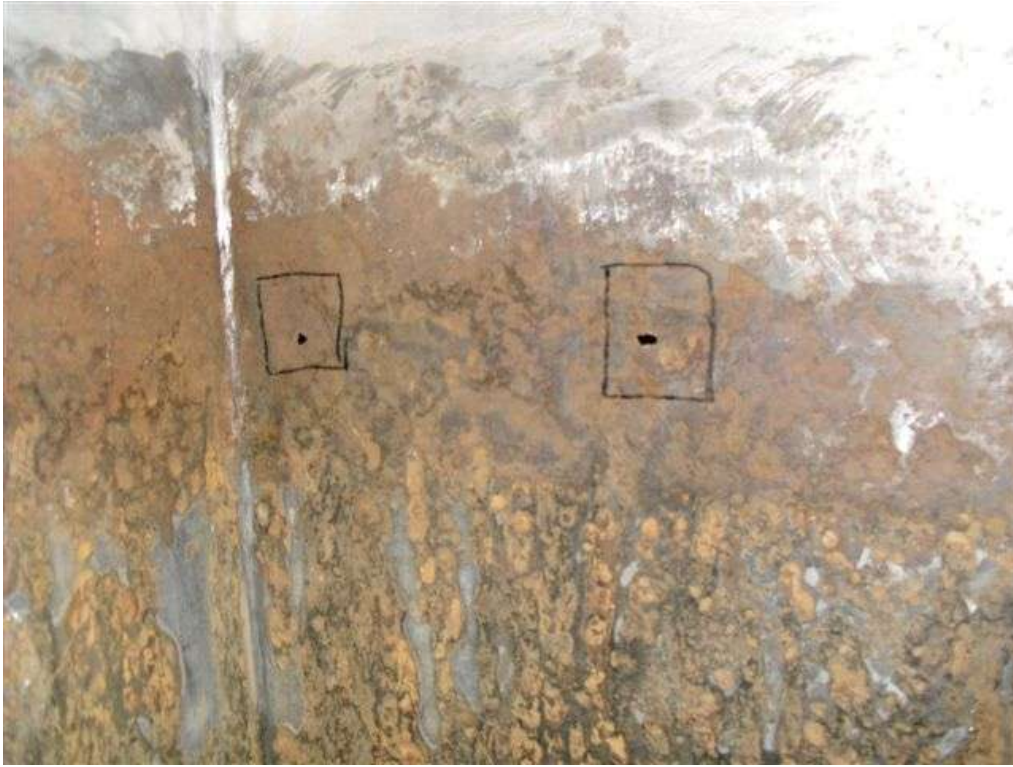
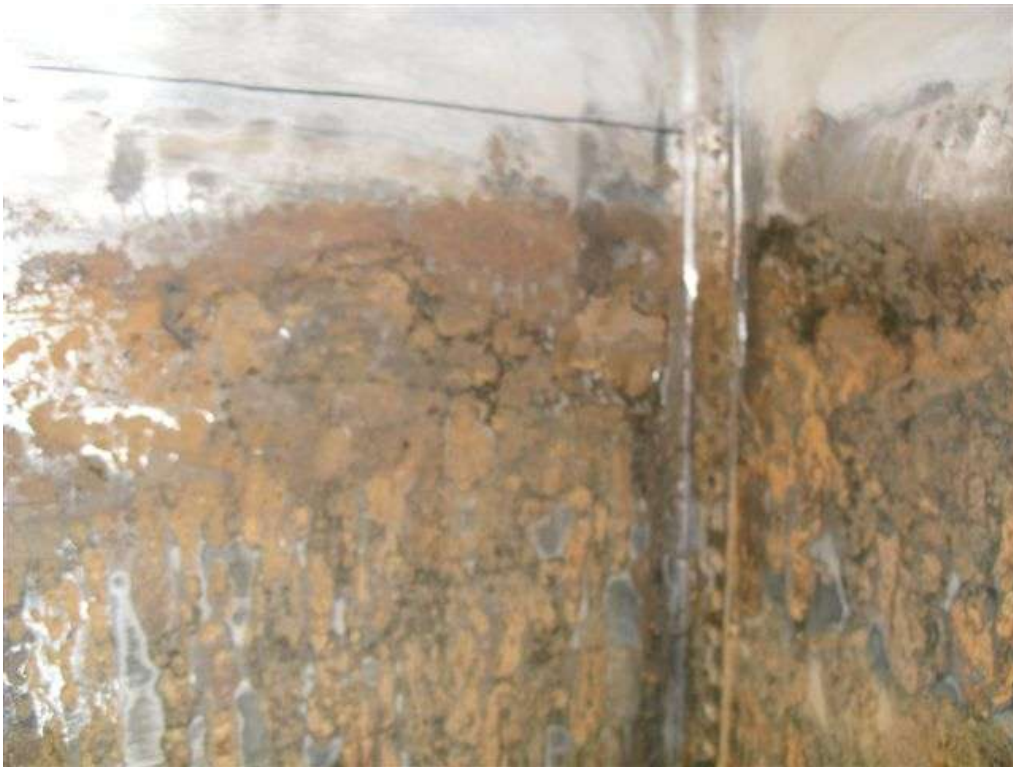
**These pictures show the internal substrate after being prepared by COVAC Operatives, in accordance with ISO 8501-1:2007, utilizing mechanical power tools and manual tools. The holes can be more clearly seen after preparation and were marked out before 'stripe coating' utilising 3M Scotchkote™ 165PW.**

The areas to receive steel plates were initially 'stripe coated' utilising 3M Scotchkote™ 165PW.

**Steel plates were then fastened to the large damaged areas. The smaller damaged areas were repaired utilising 3M Metal-Tech SG Metal Epoxy Filler.**

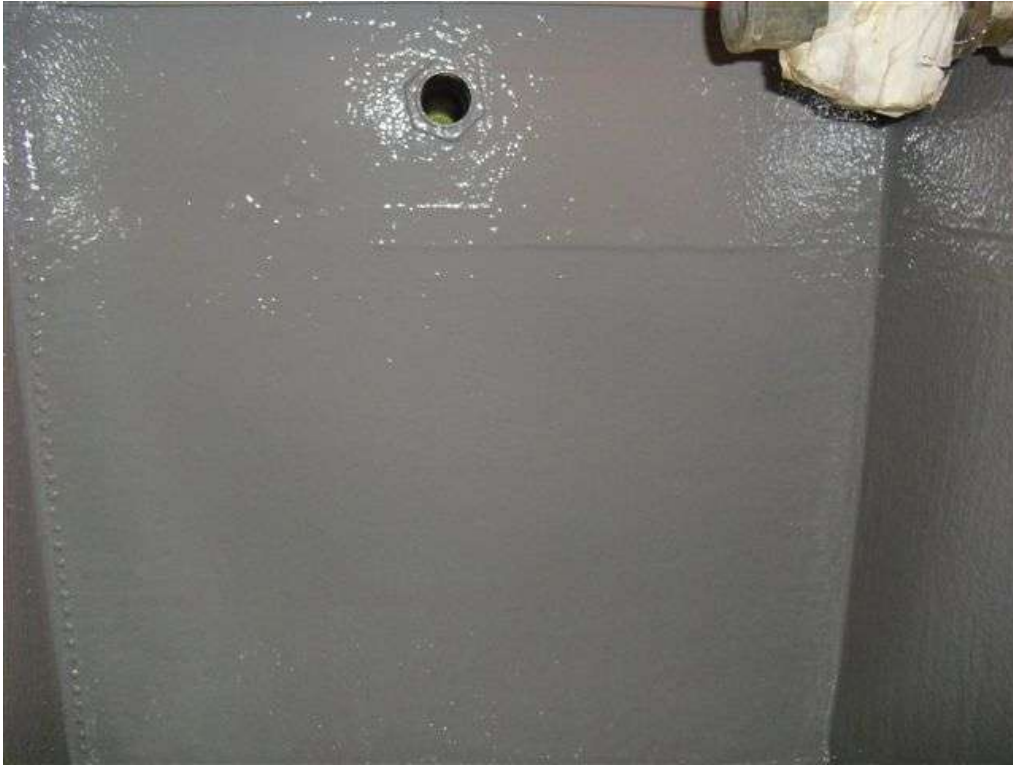
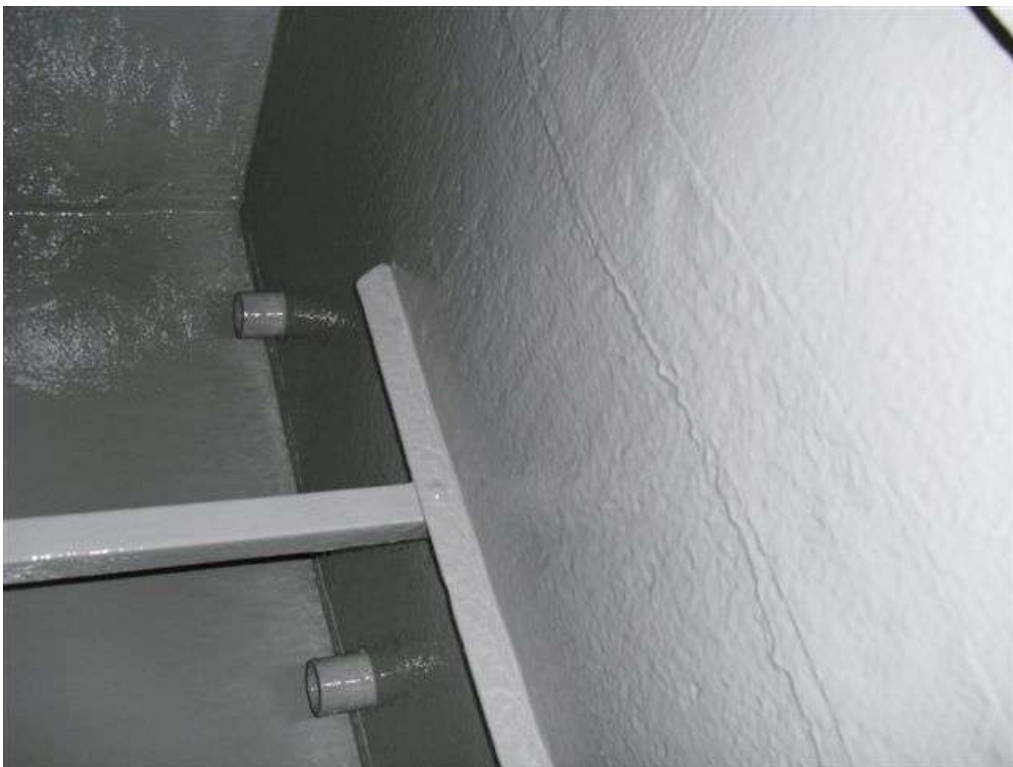
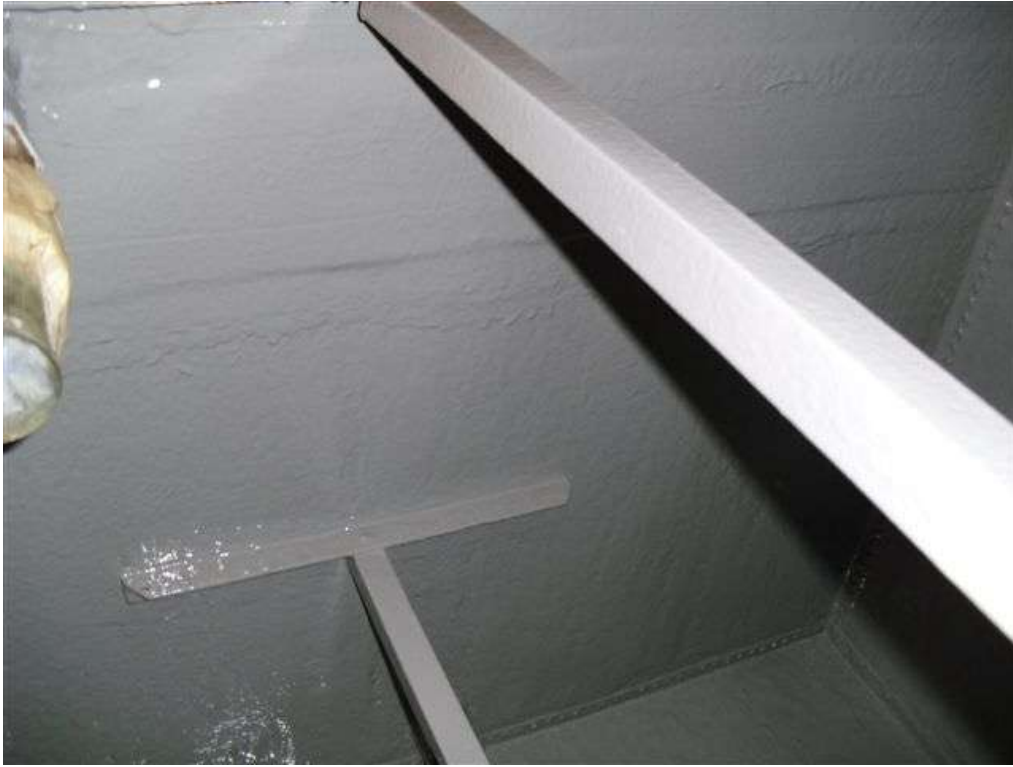
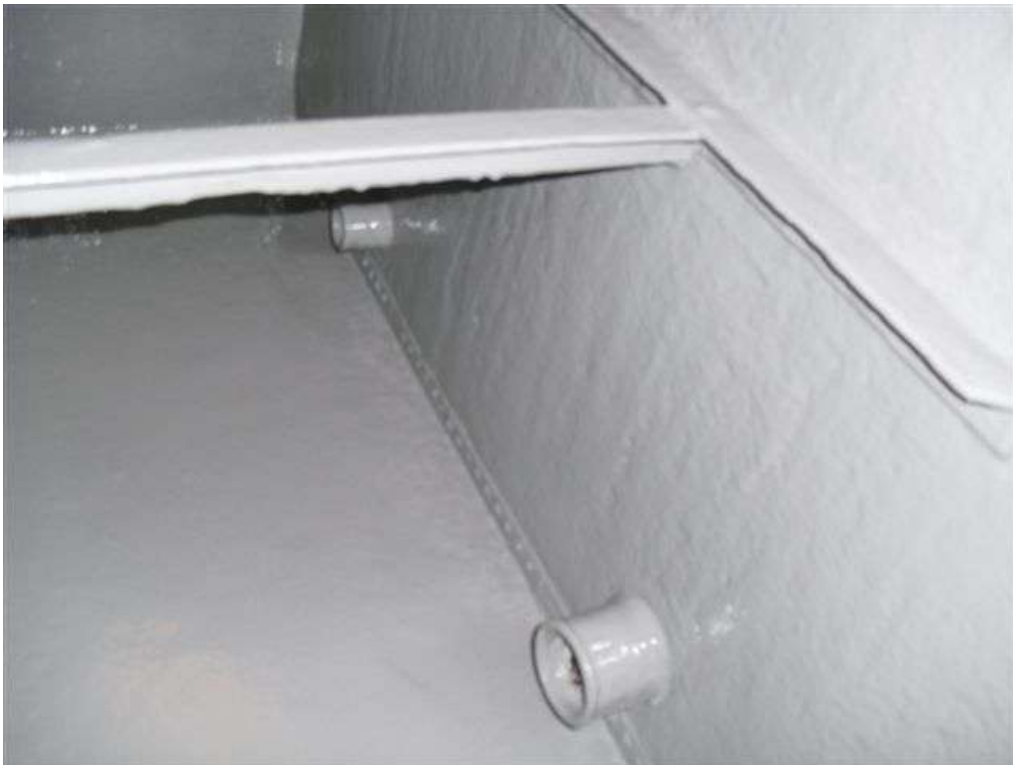
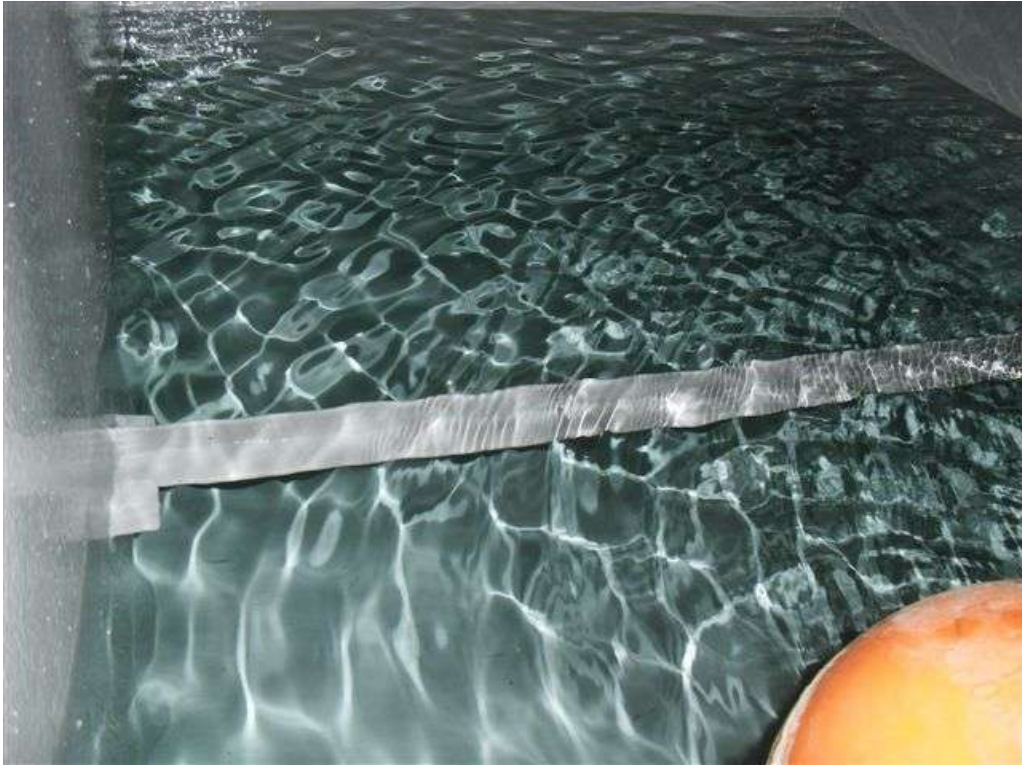
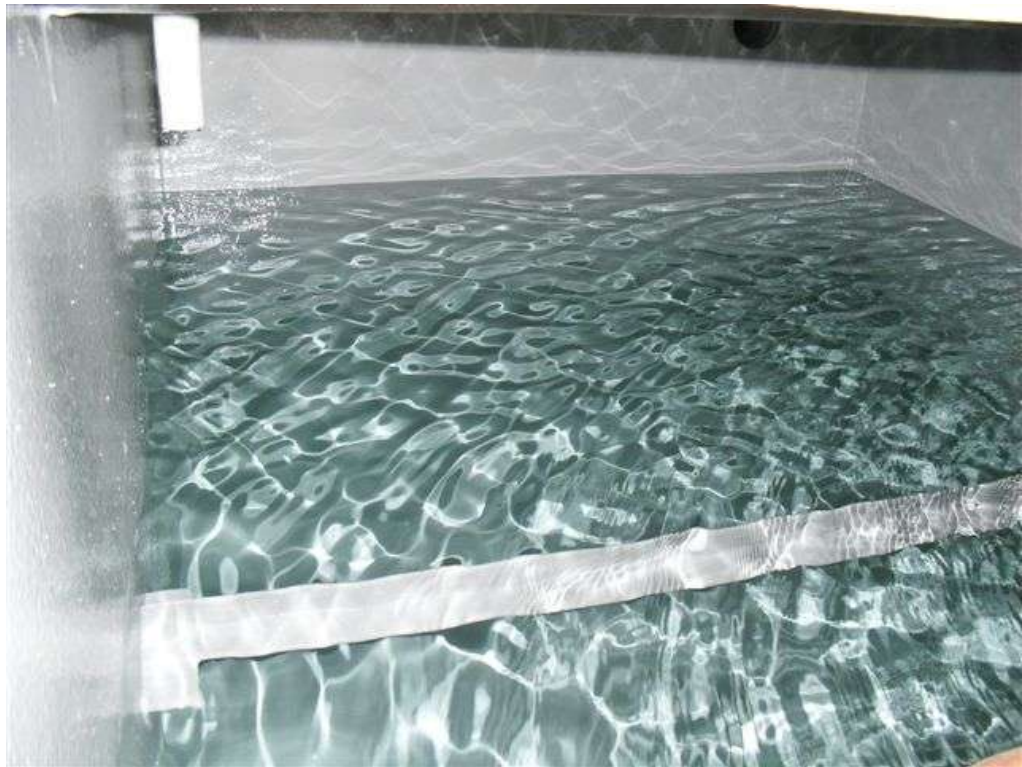
All intricate areas were again 'stripe coated' for a second time. These photographs show the final application of the 2<sup>nd</sup> coat of 3M Scotchkote™ 165PW (grey) in order to achieve a total, nominal dry film thickness of 1000 Microns (1mm) and between 1500-2000 Microns (2mm) over all stripe coated areas.

The tank was then post chlorinated and returned to service.
