COMPLETION REPORT

Client : **Hospital**

Project Brief : **The Internal Lining of Tank # 1 of 1 No. Split, Sectional GRP Tank**

Covac Ref : **795**

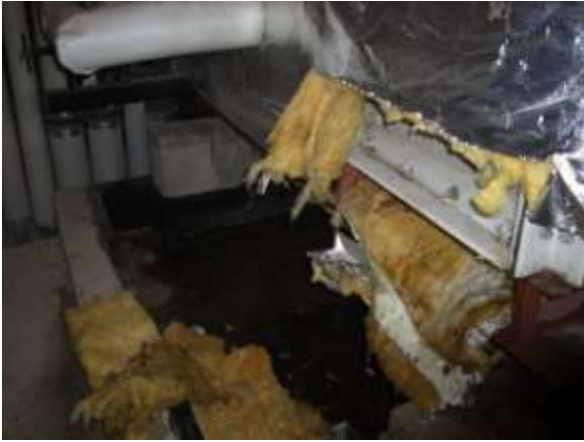
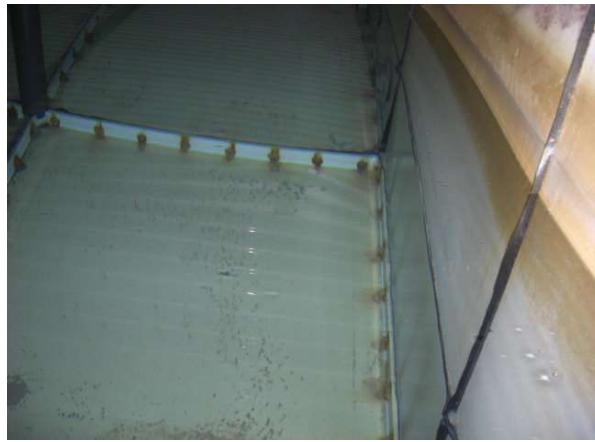
The main concern was that Tank #1, which was being taken out of service due to excessive water loss from various joints on the bottom sectional panels, some of which were serious and needed immediate attention. Leaking from the joints is due to the deterioration of the mastic used between the sectional GRP panels and this, combined with the excessive structural movement of the plastic has led to the eventual leaking of the tank.
