COVAC COMPLETION REPORT

| Project Details | - | The Internal Re-Lining of 1 No. Sectional Steel Braithwaite Water Retaining Structure |
| System Specification | - | COPON Hycote 165PW Solvent Free Polyurethane |
| Completion Date | - | 27th May 2004 |

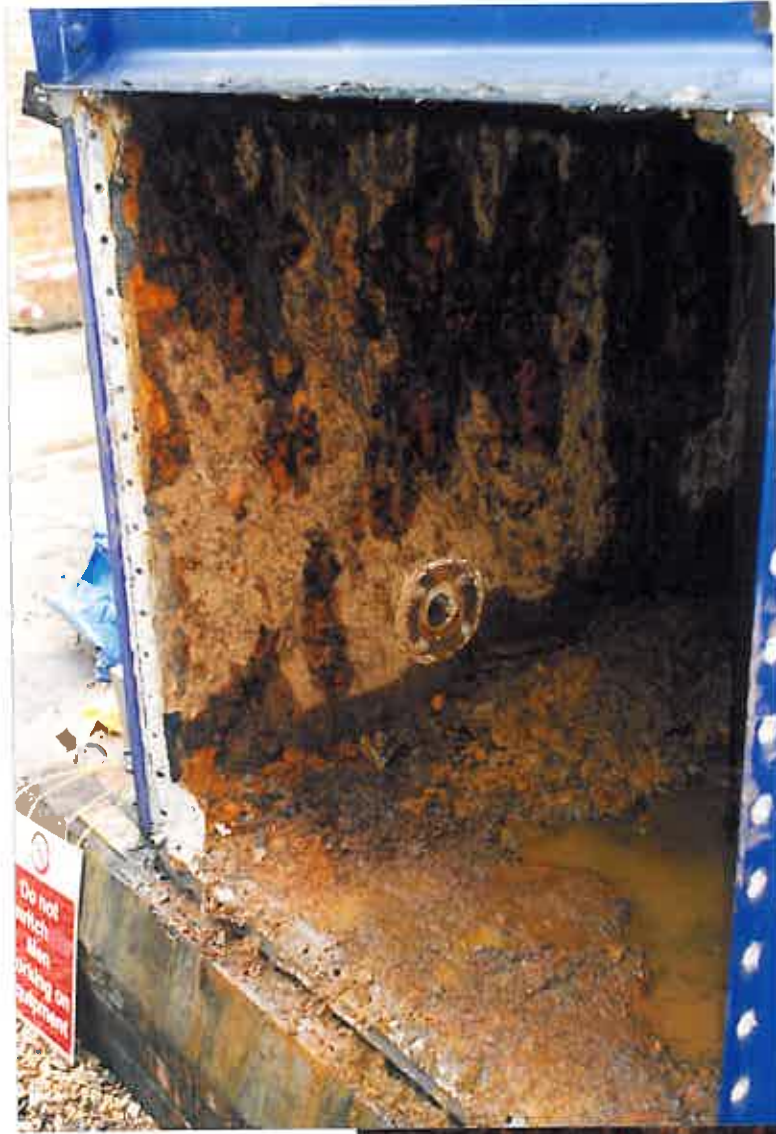
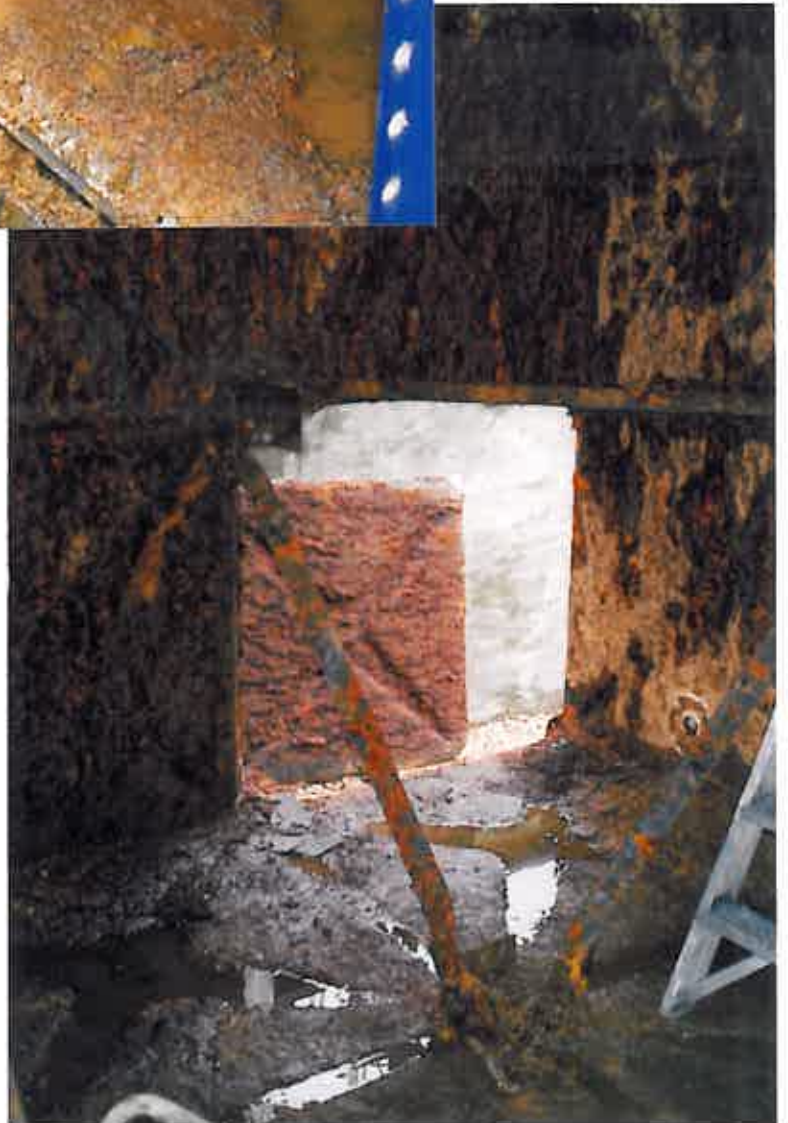
These photographs show the severity of the corrosion to the internal surfaces of the tank.

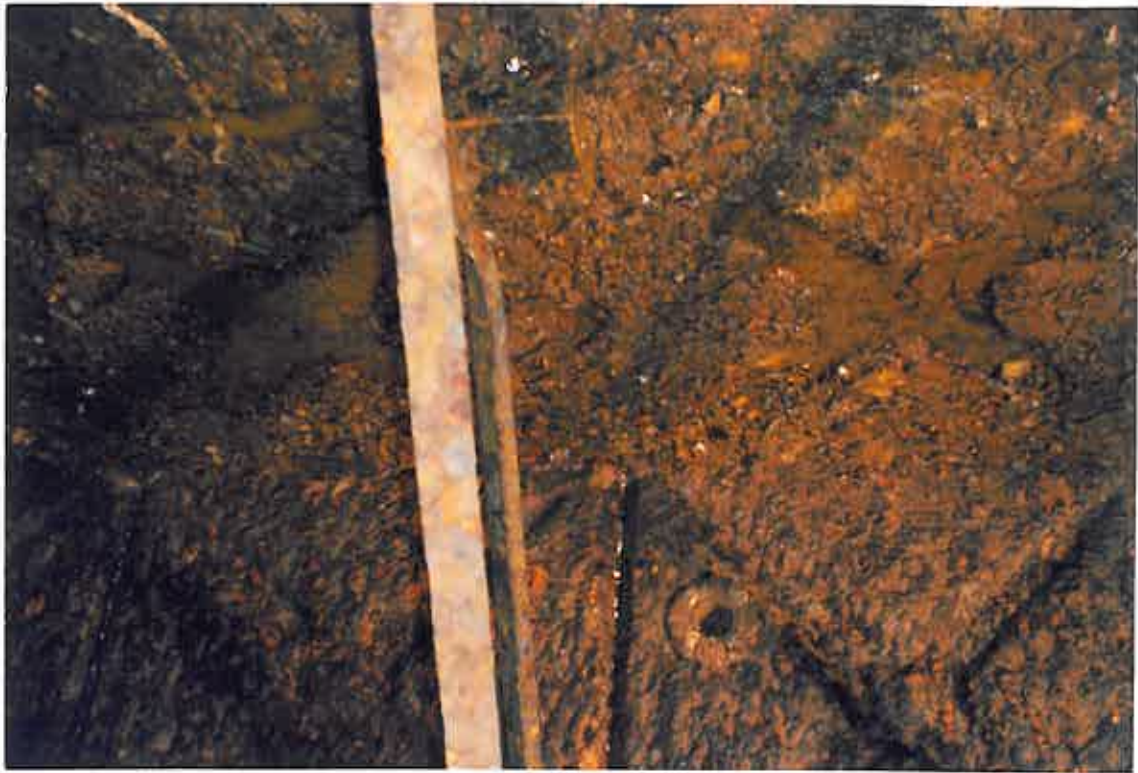
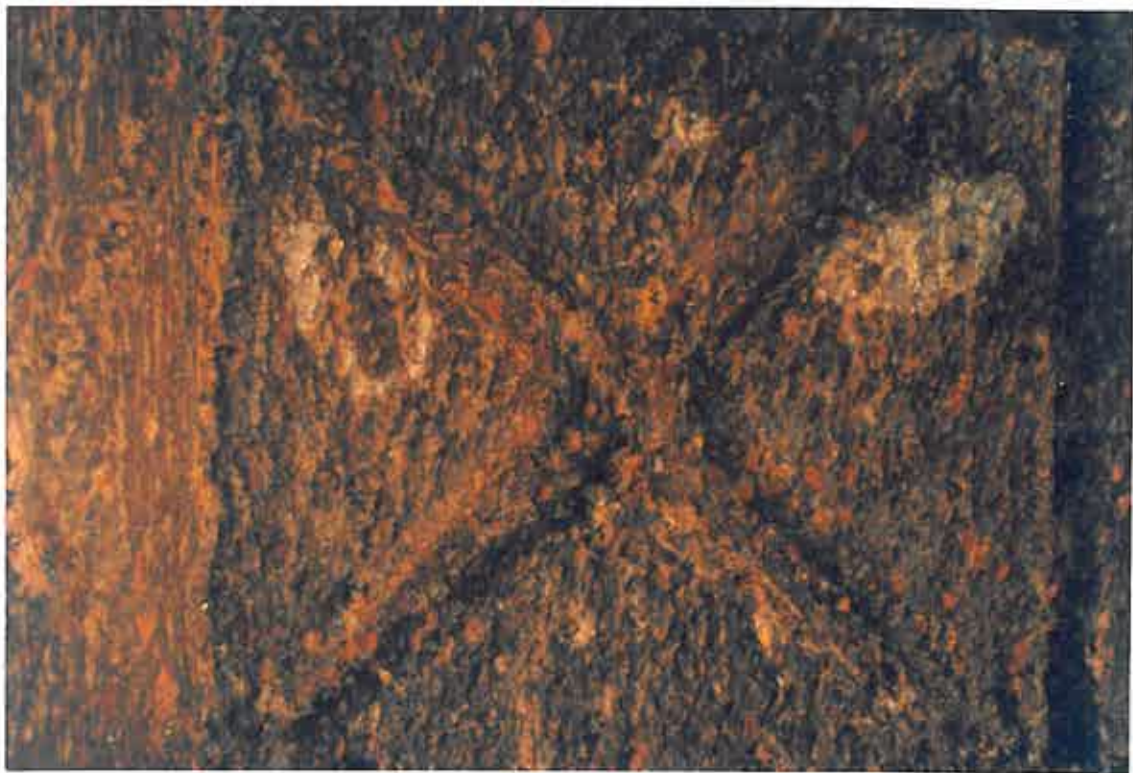
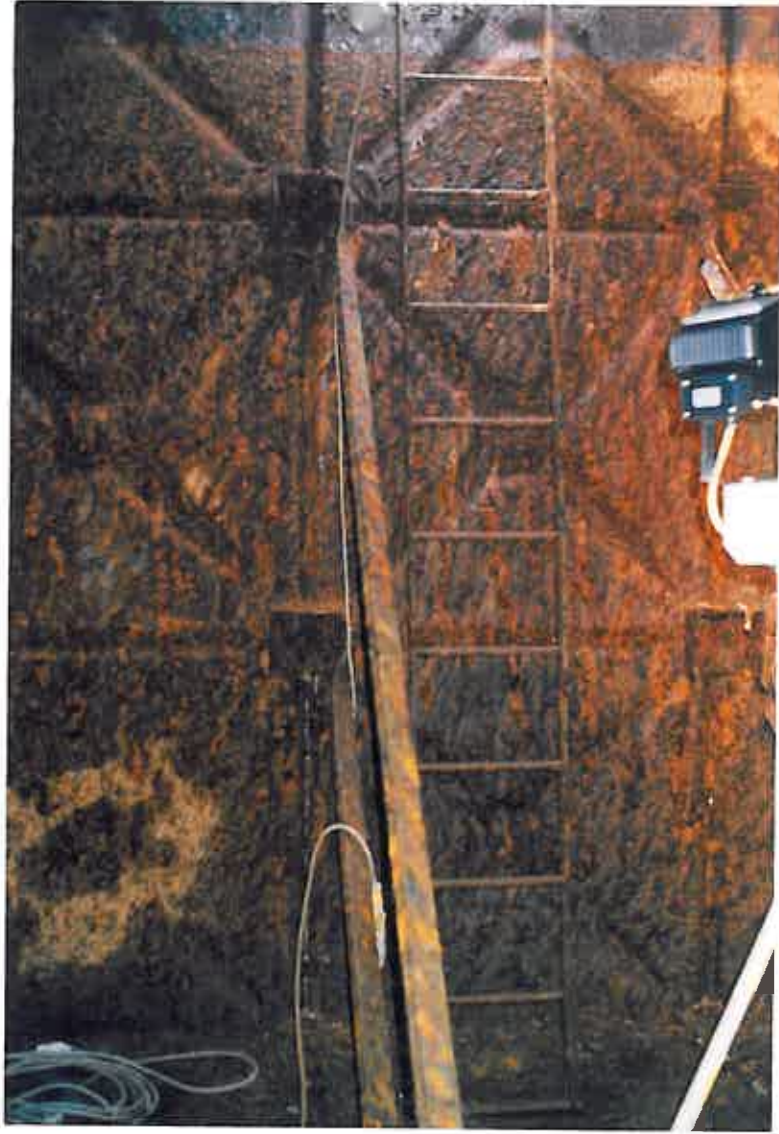
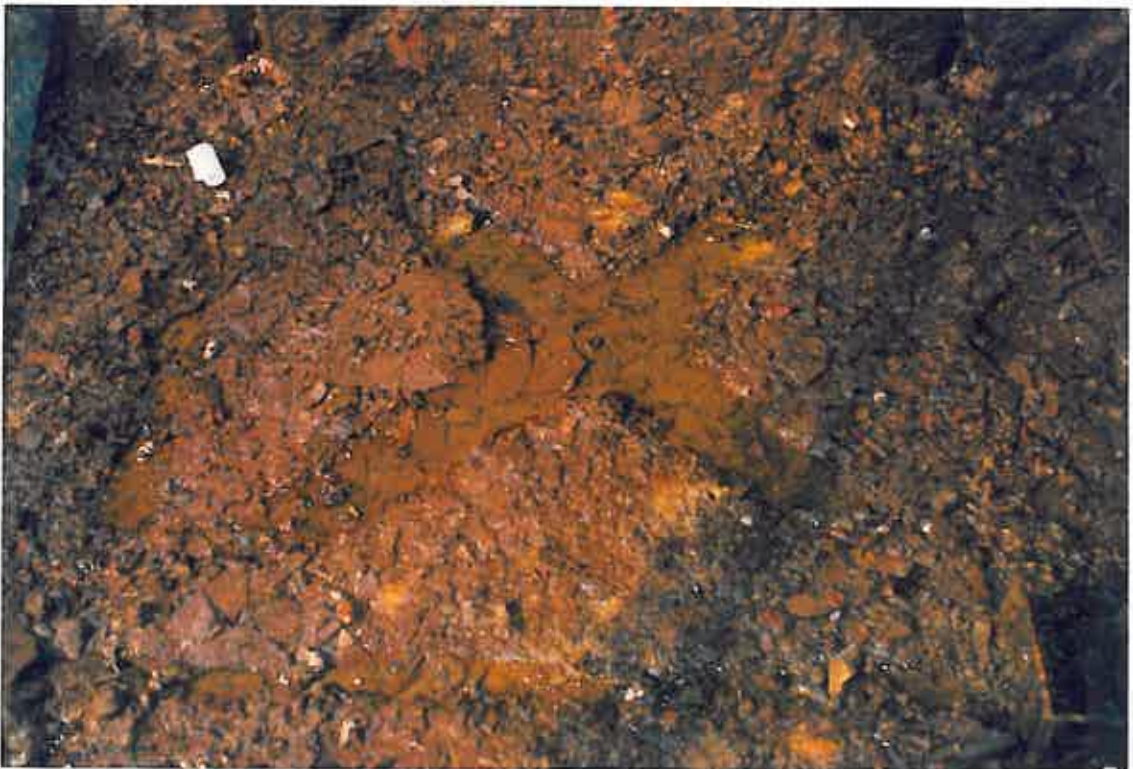
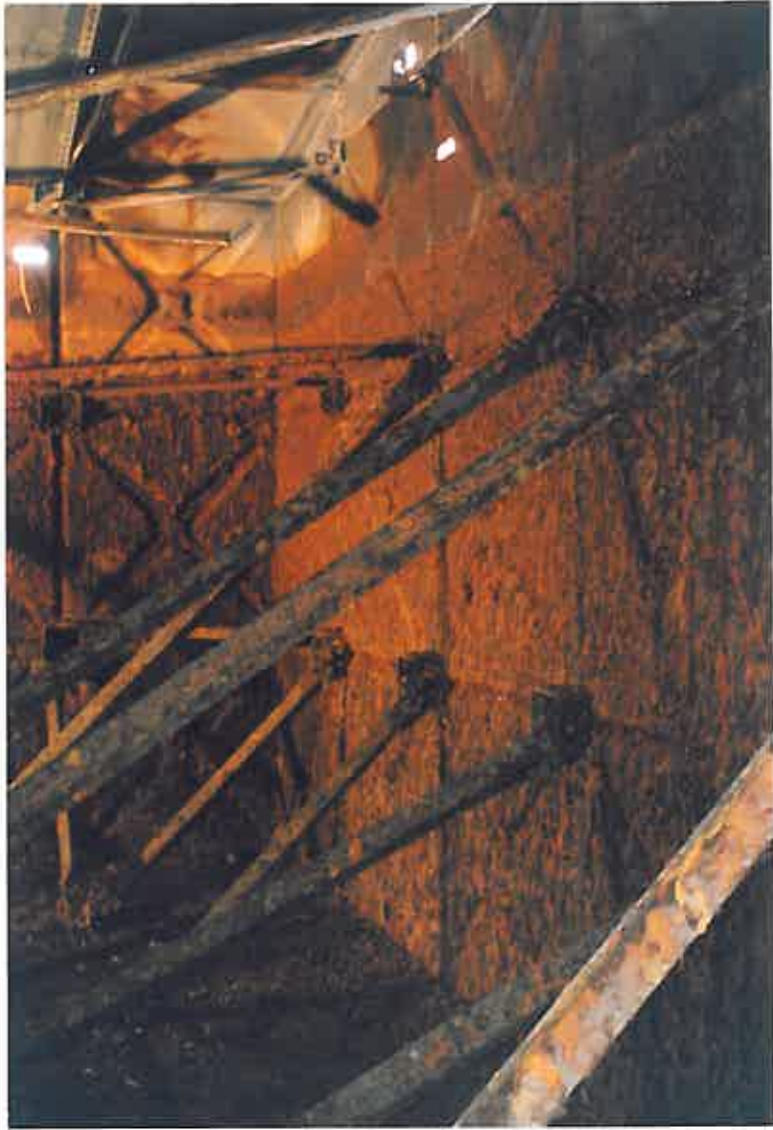
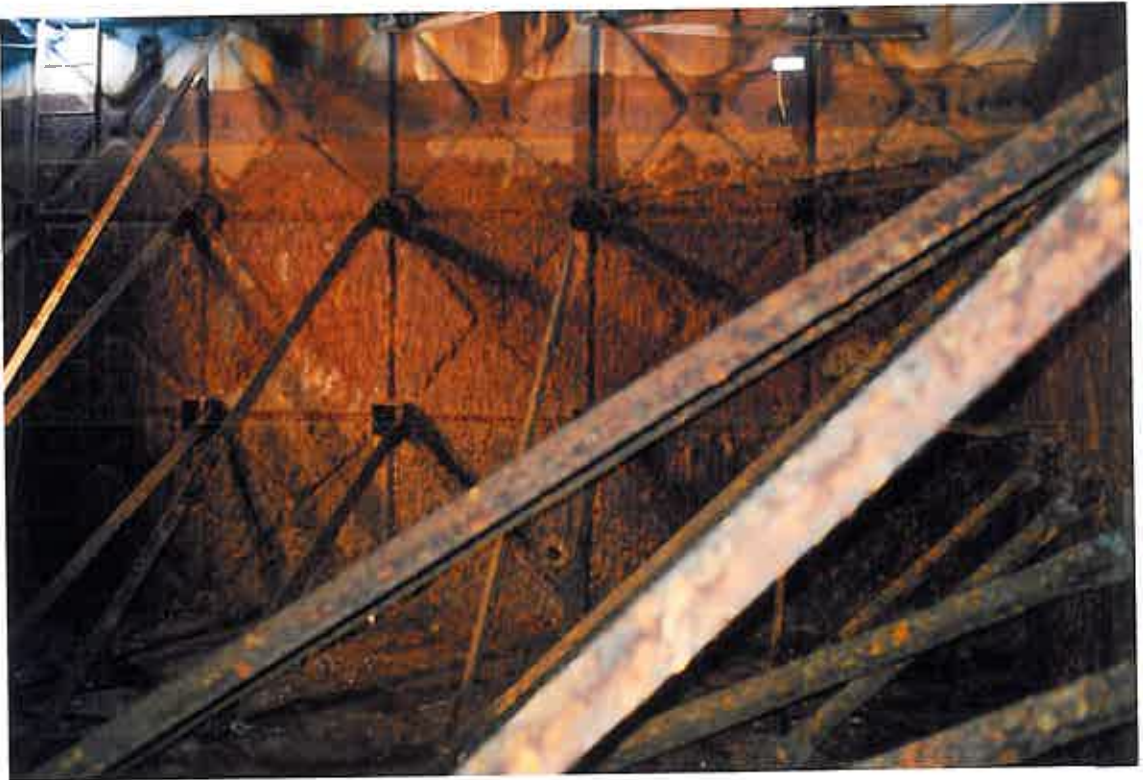
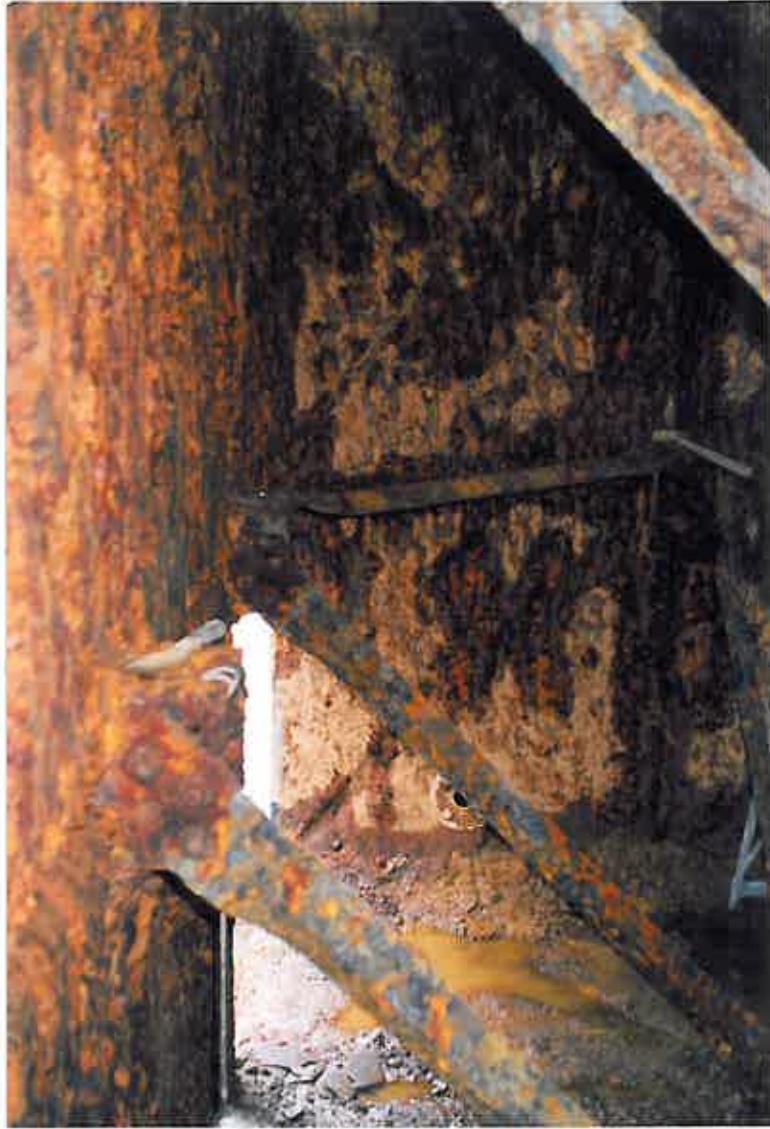
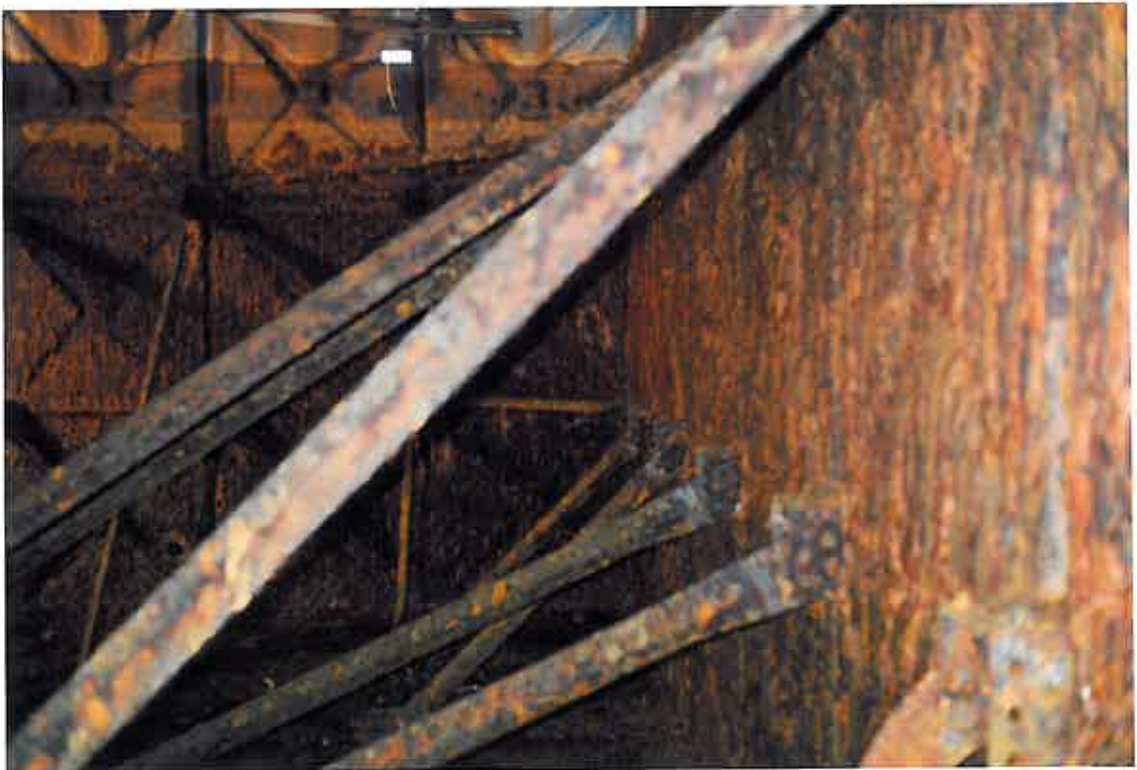
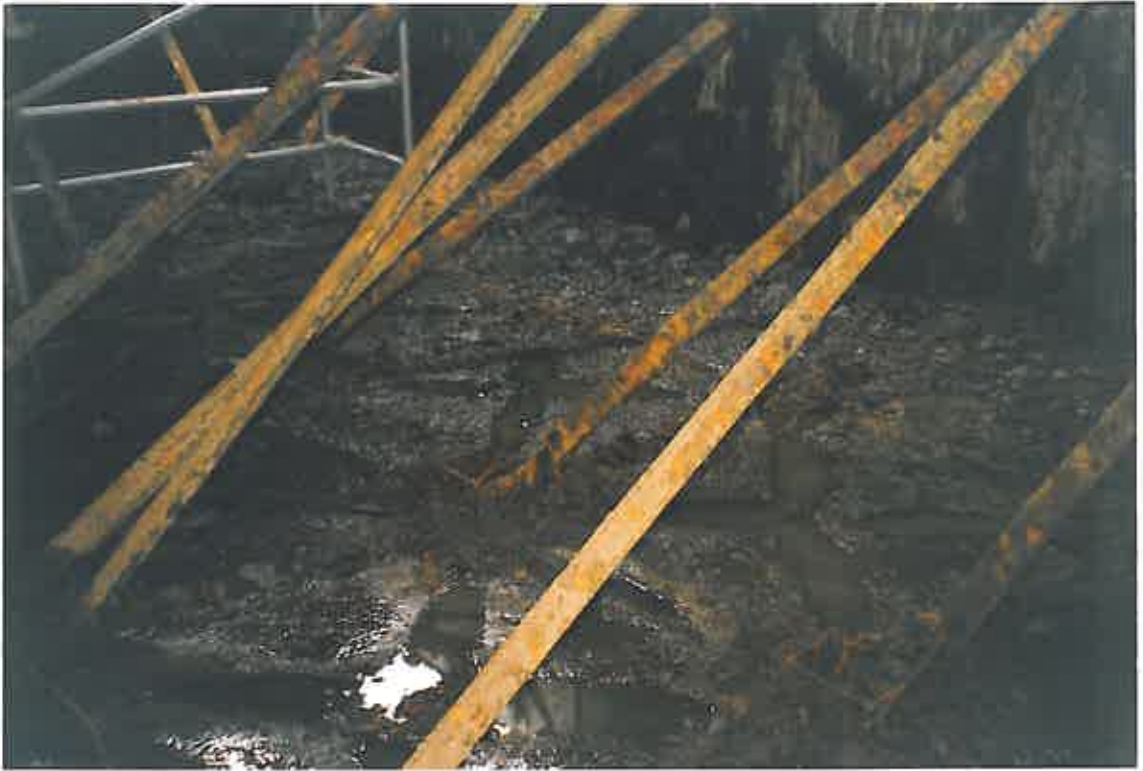
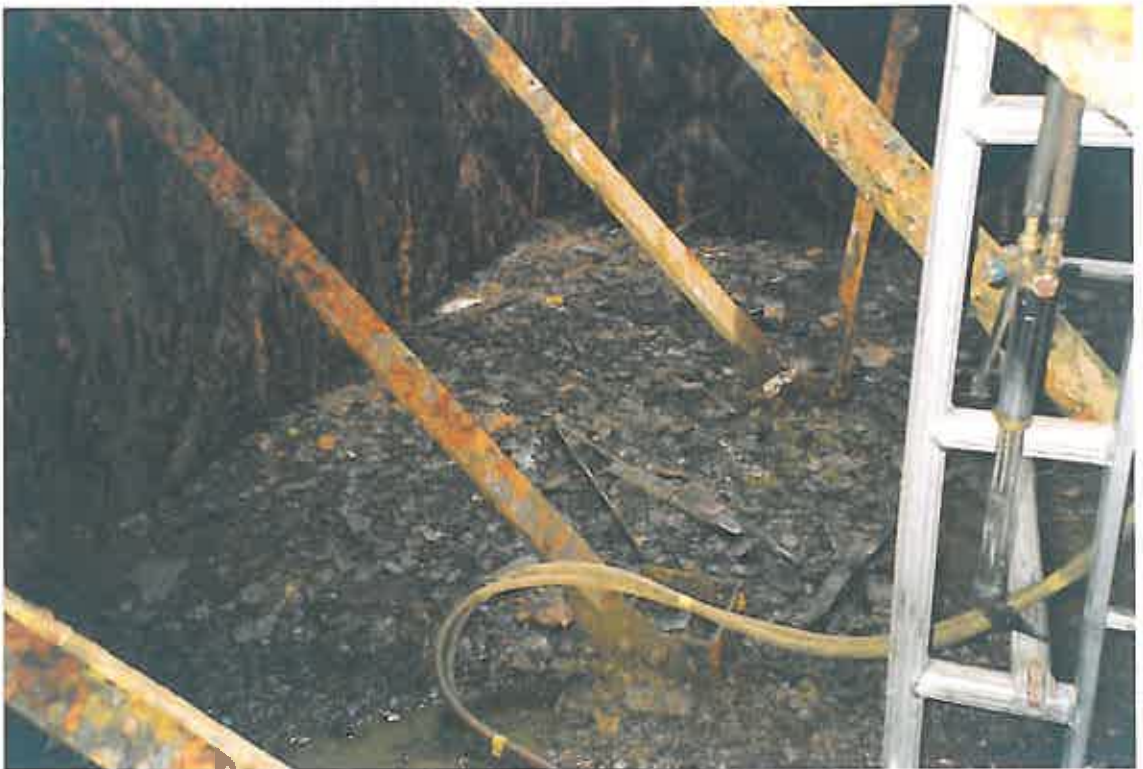
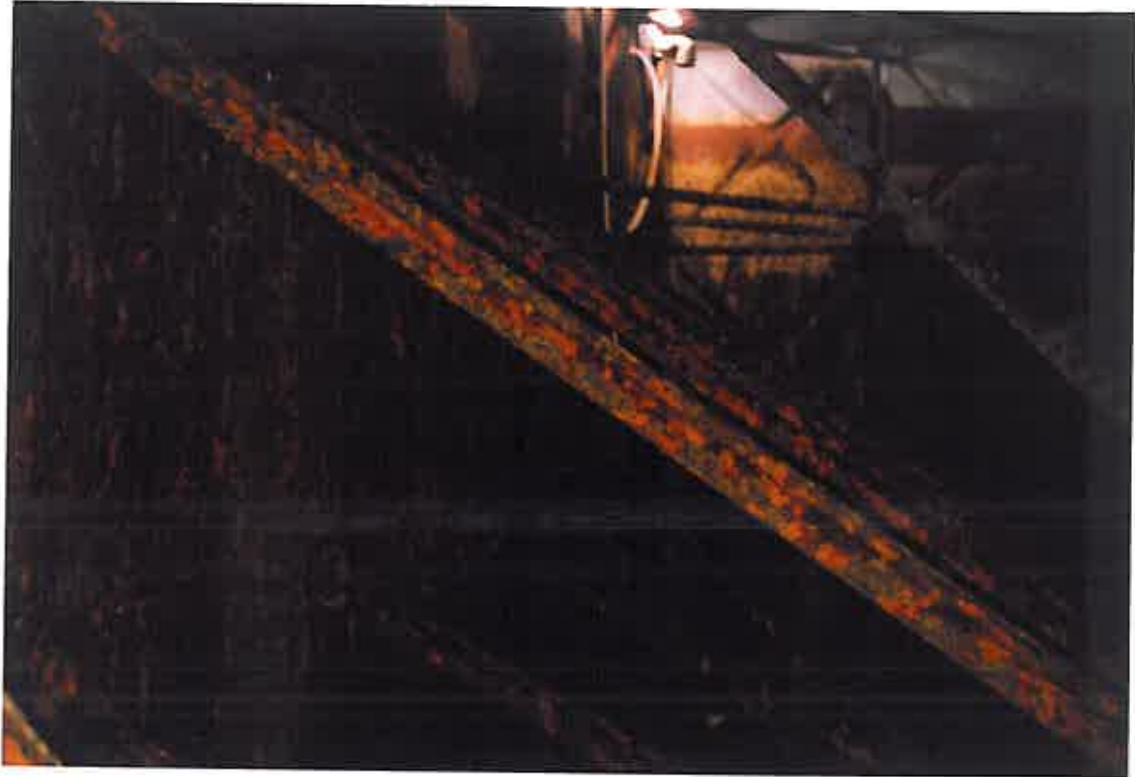
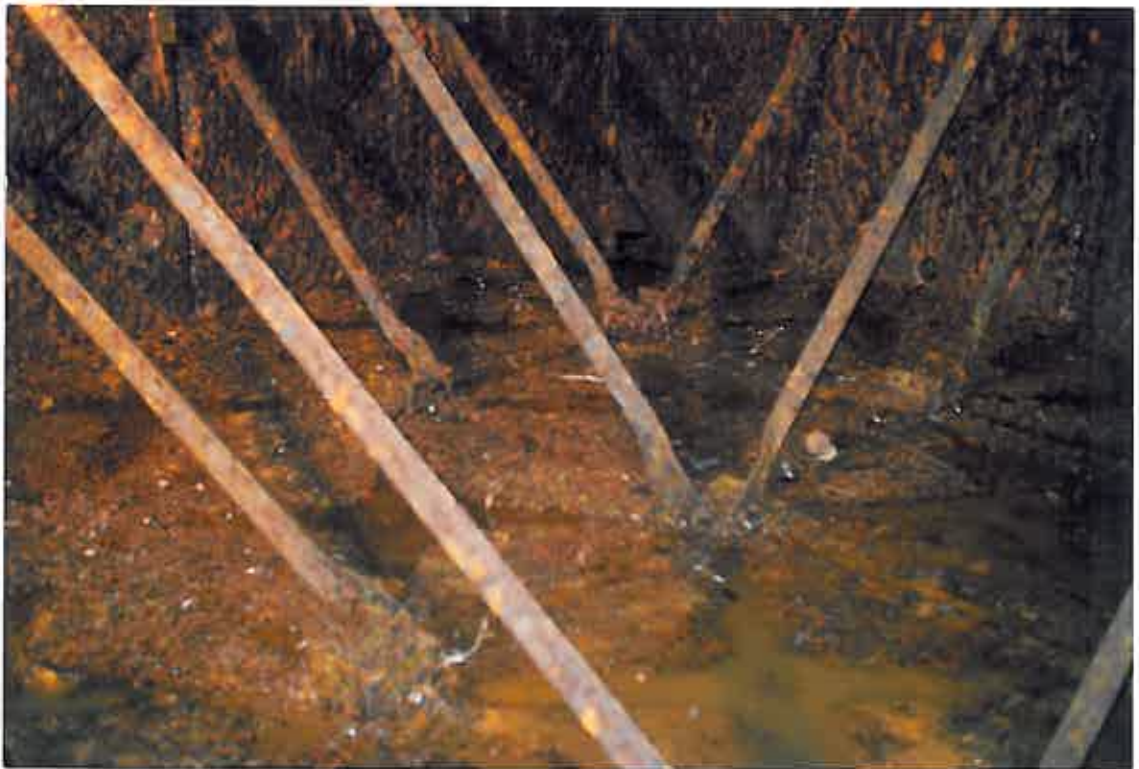
These photographs show how the corrosion had attacked the steel roof. These holes were eventually cut to firm edge, prior to being repaired utilizing new flat, steel, galvanised sheeting.

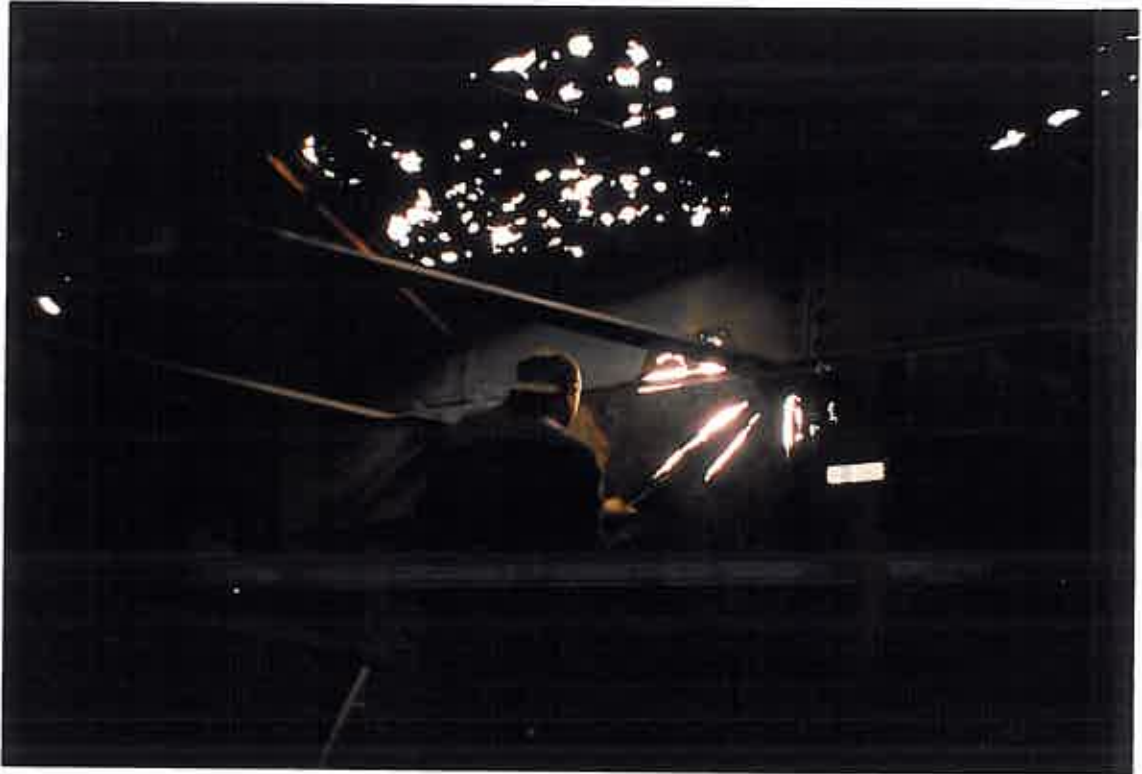
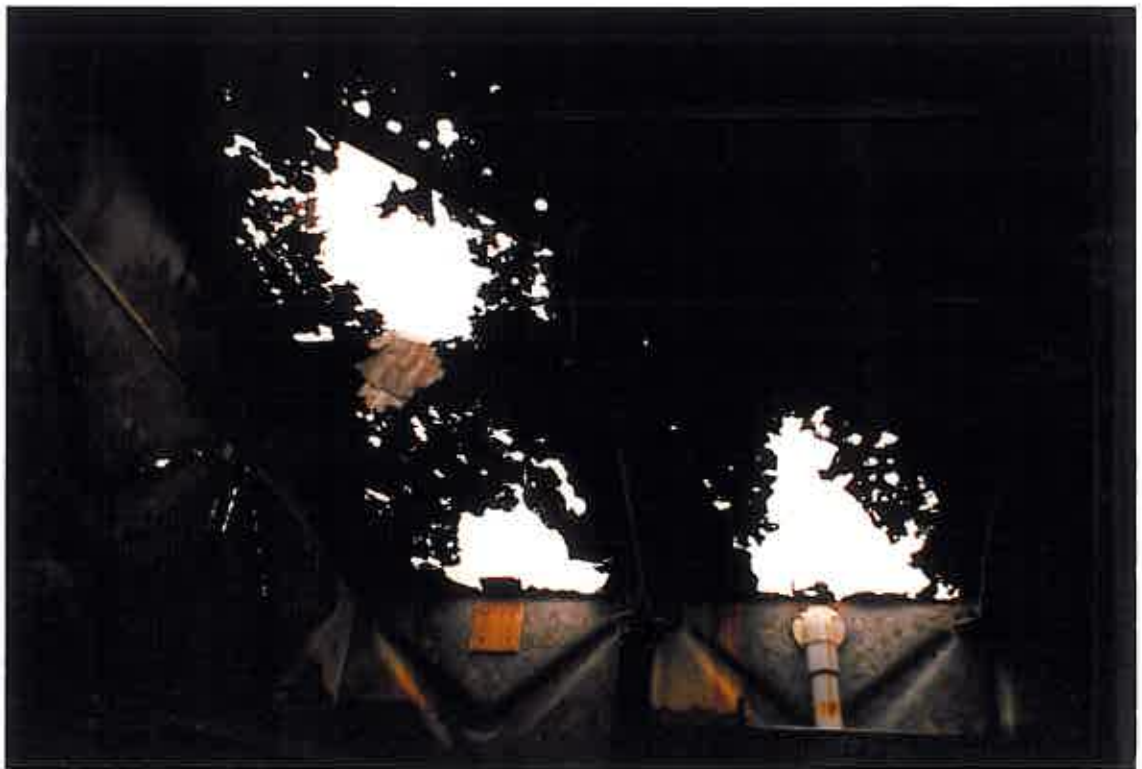
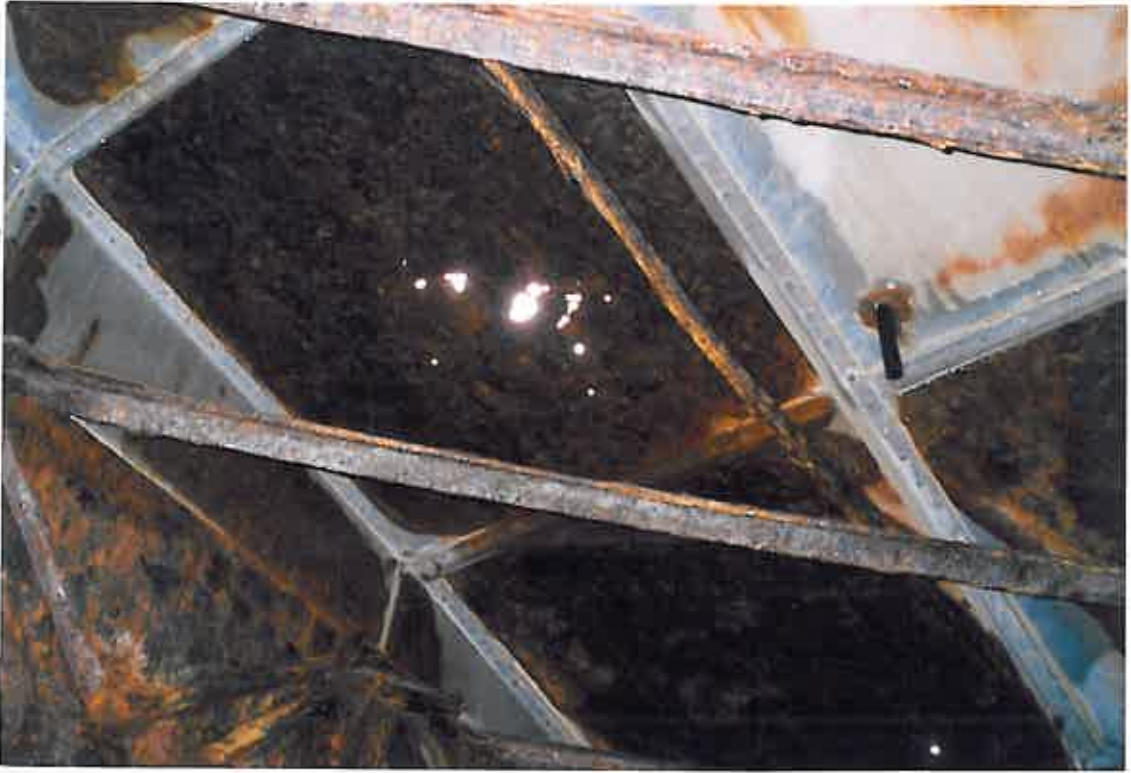
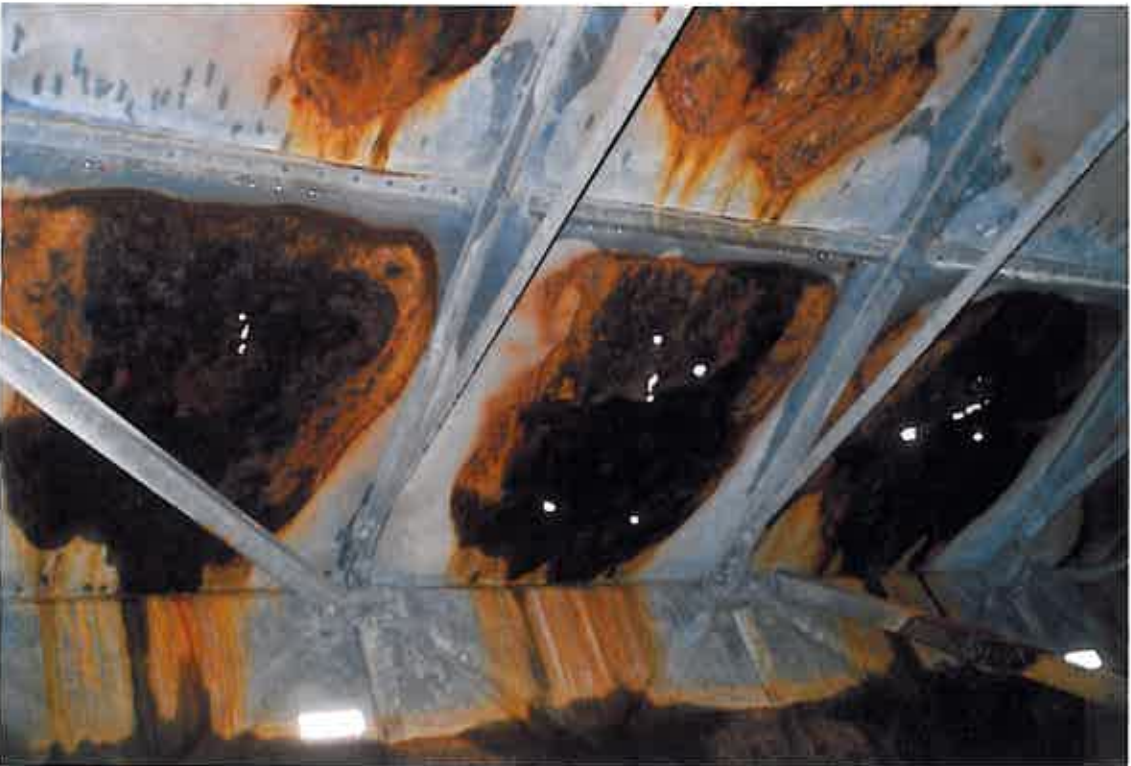
These photographs show the external of the roof of the tank having been repaired utilizing flat steel, galvanised plates.

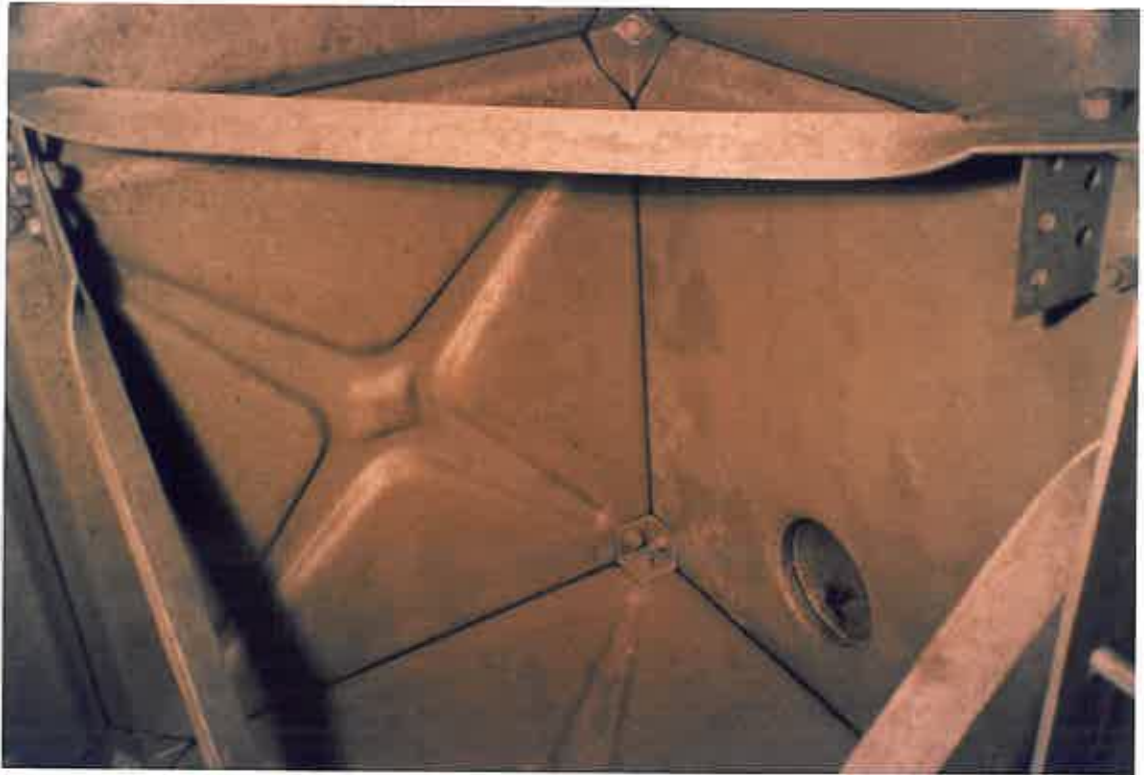
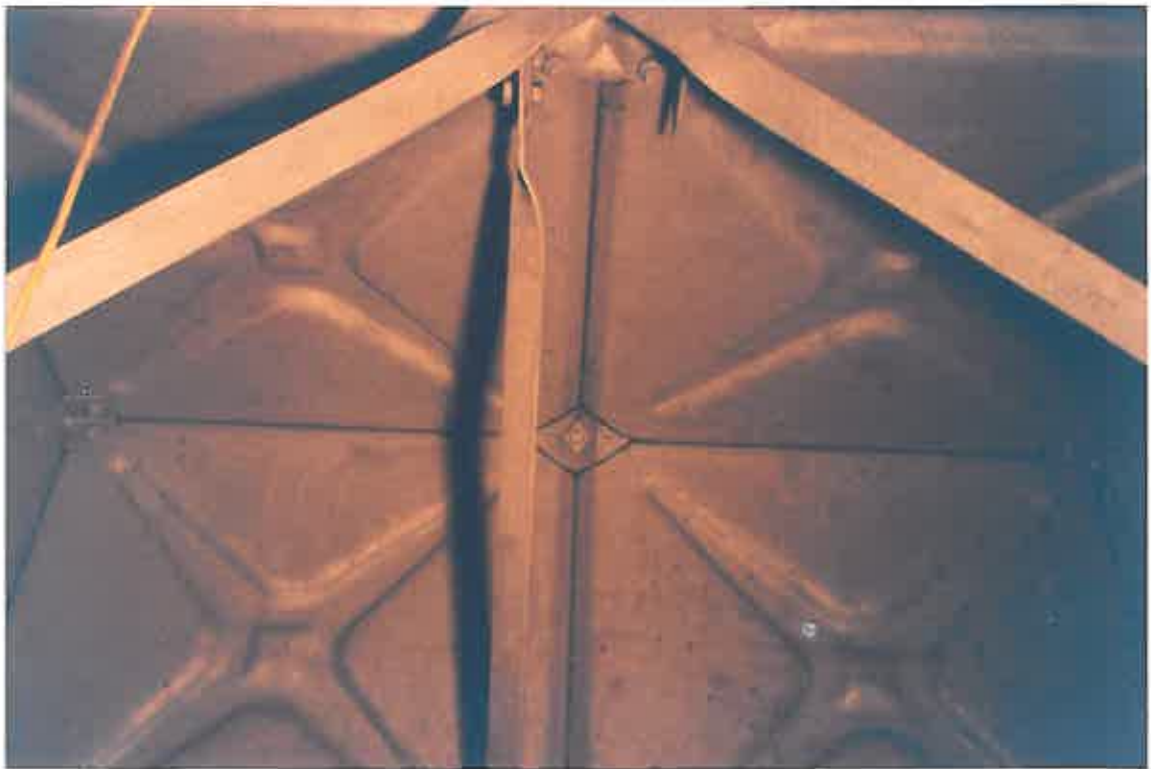
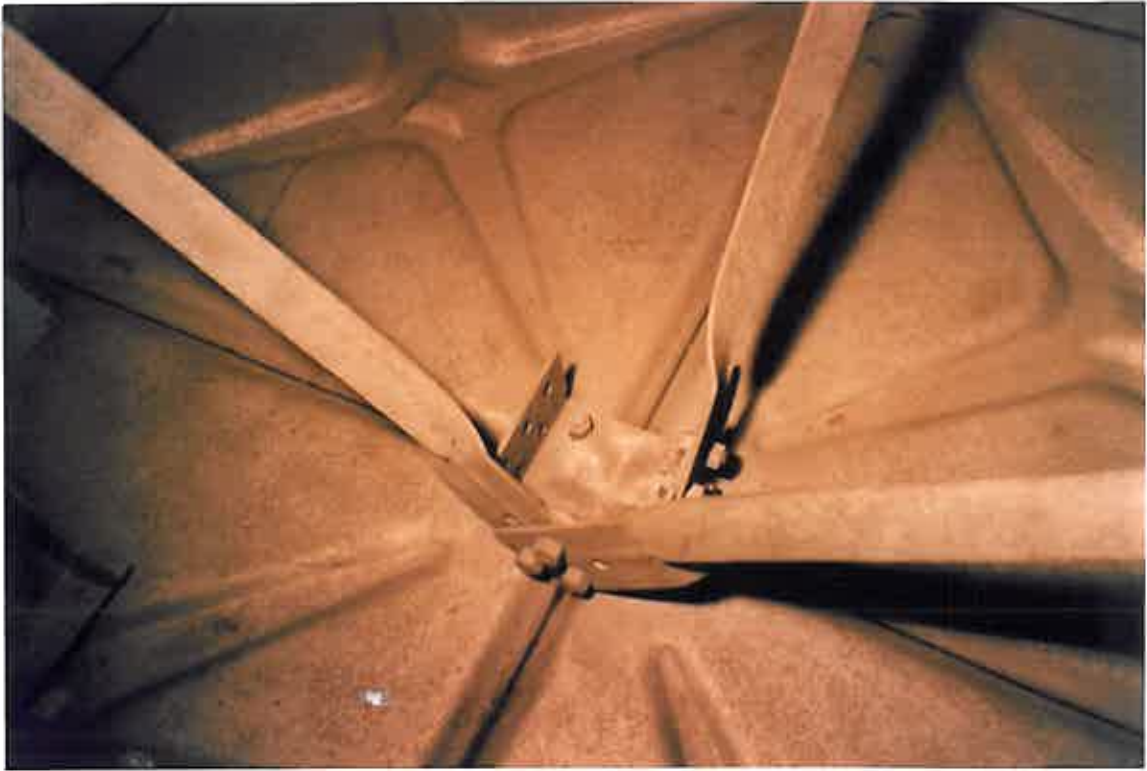
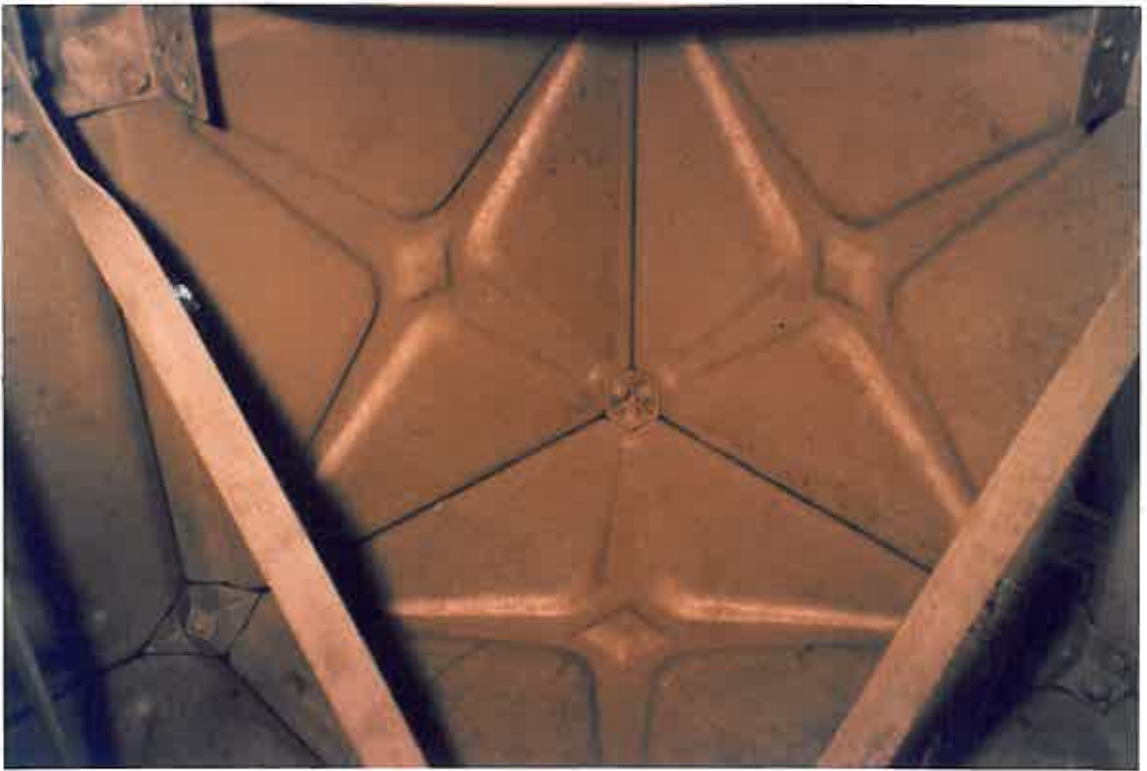
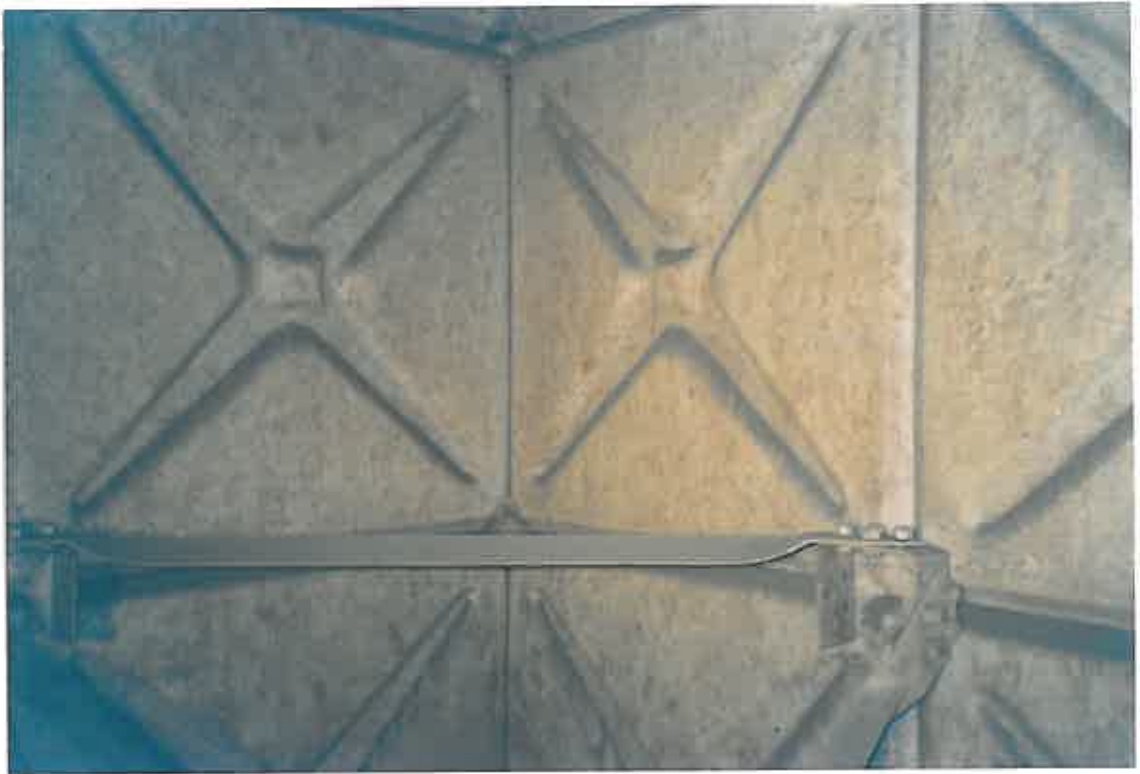
These photographs show the results of extreme corrosion post preparation around the oxygen exchange line of the tank. These areas were heavily pitted with corrosion and holes had formed in the steelwork. Most of these holes were small (approx. 1cm dia.) and were repaired utilizing metal epoxy filler. Some holes, however, were much larger and had to be repaired utilizing a combination of COPON Hycote 165 PW and fibreglass webbing.
