## COVAC COMPLETION REPORT

Client	-	<b>Soft Drink Manufacturer</b>
Address	-	<b>Scotland</b>
Site Contact	-	<b>XXXXXXXXXXXXXX</b>
Project Brief	-	<b>The Internal Relining of 1 No. Steel, Water Retaining Structure - 2 No. Compartments</b>
System Specification	-	<b>COPON Hycote 165PW Solvent Free Polyurethane.</b>
Nominal Dry Film Thickness	-	<b>1000 Microns</b>
Completion Date	-	<b>21<sup>st</sup> January 2005</b>
Site Supervisor	-	<b>Tim Ray</b>
Report Prepared by	-	<b>Adrian Emmett</b>
COVAC Contract Ref:	-	<b>376</b>

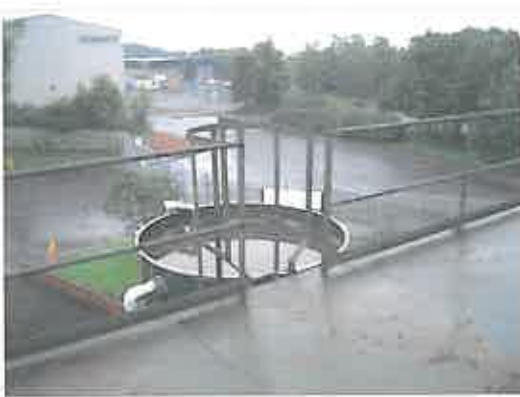
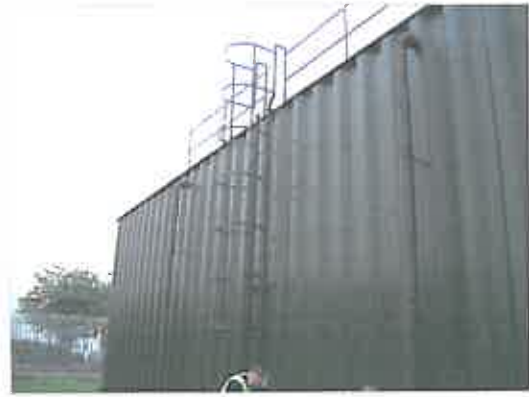
The structure is located externally within the grounds of the site at ground level and sized at approximately 64' x 20' x 20'. There is an internal divisional wall which divides the structure into 2 No. compartments, each sized at approximately 32' x 20' x 20'. The structure also has an apex on the roof and the internal divisional wall does not reach the top the apex. This means that there is a gap at the top of the tank. If we can only work on one compartment at one time, this gap will be boarded up in order to prevent the potential of 'cross contamination' whilst one compartment is being worked on.

The internals of the structure have previously been painted with Bitumen, which has now approached the end of its useful life due to sub-film corrosion, deterioration and subsequent de-bonding.

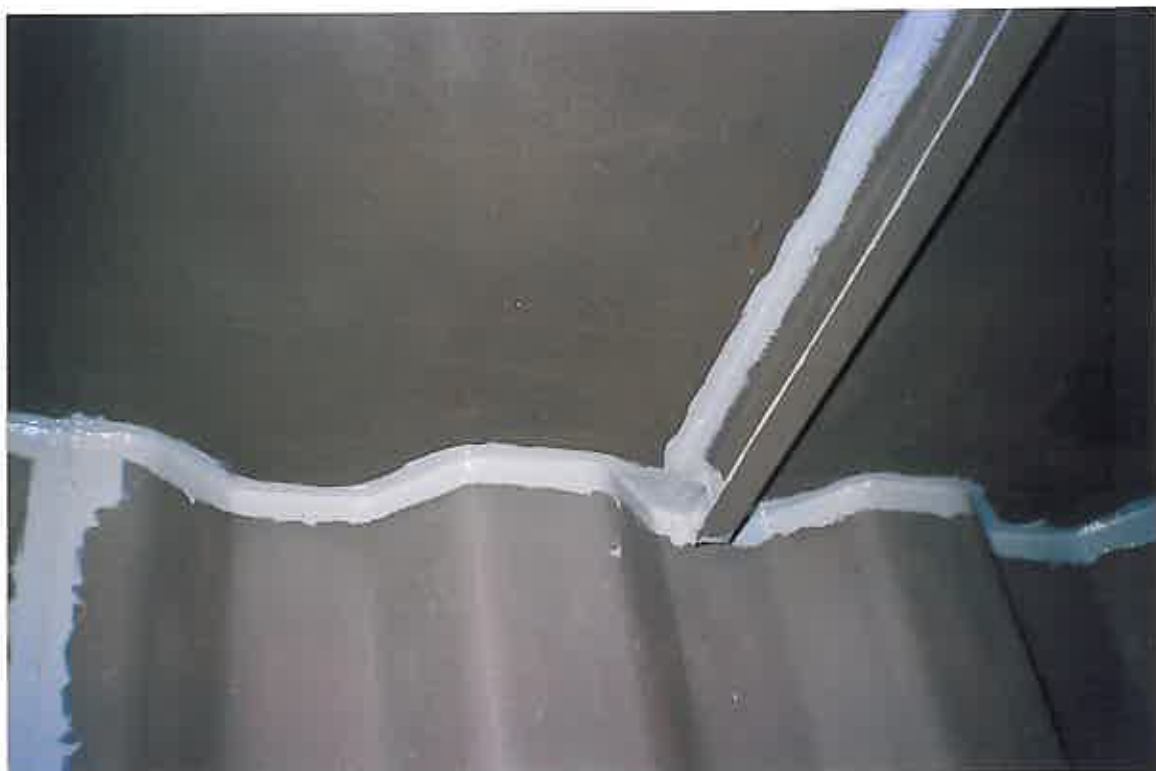
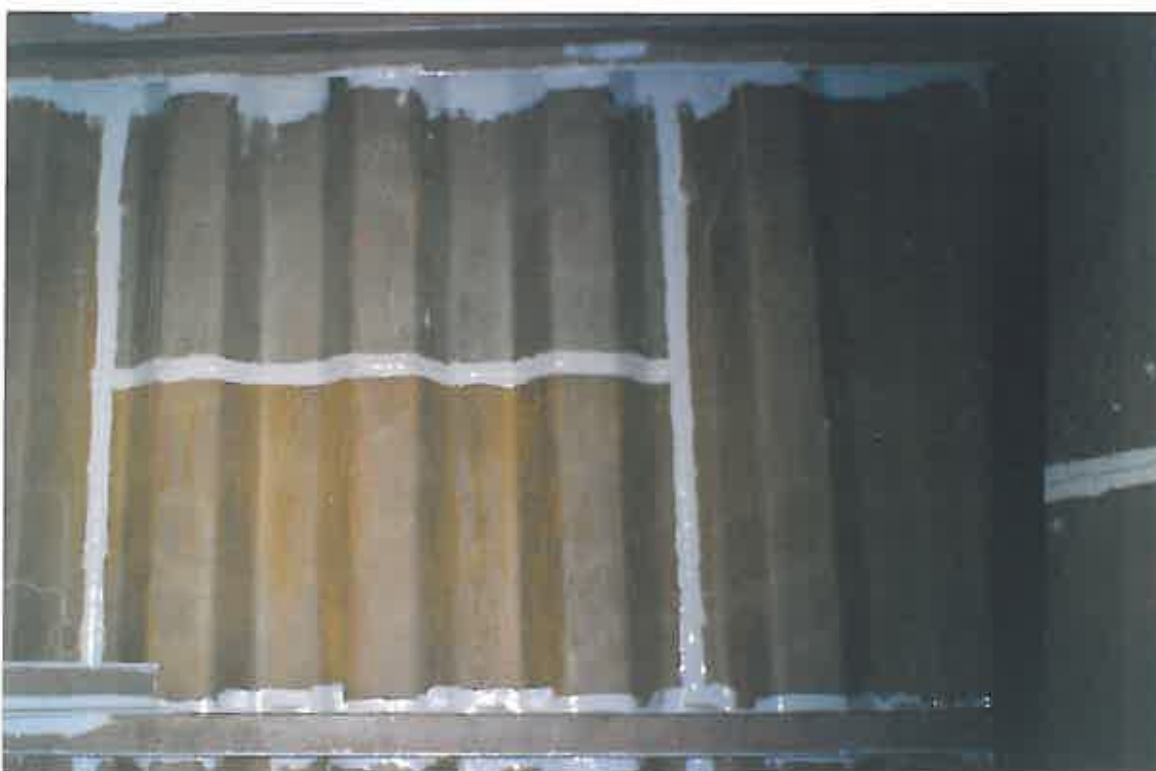
**These photographs show all weld joints, sharp edges, struts, etc having been 'stripe coated' by brush.**

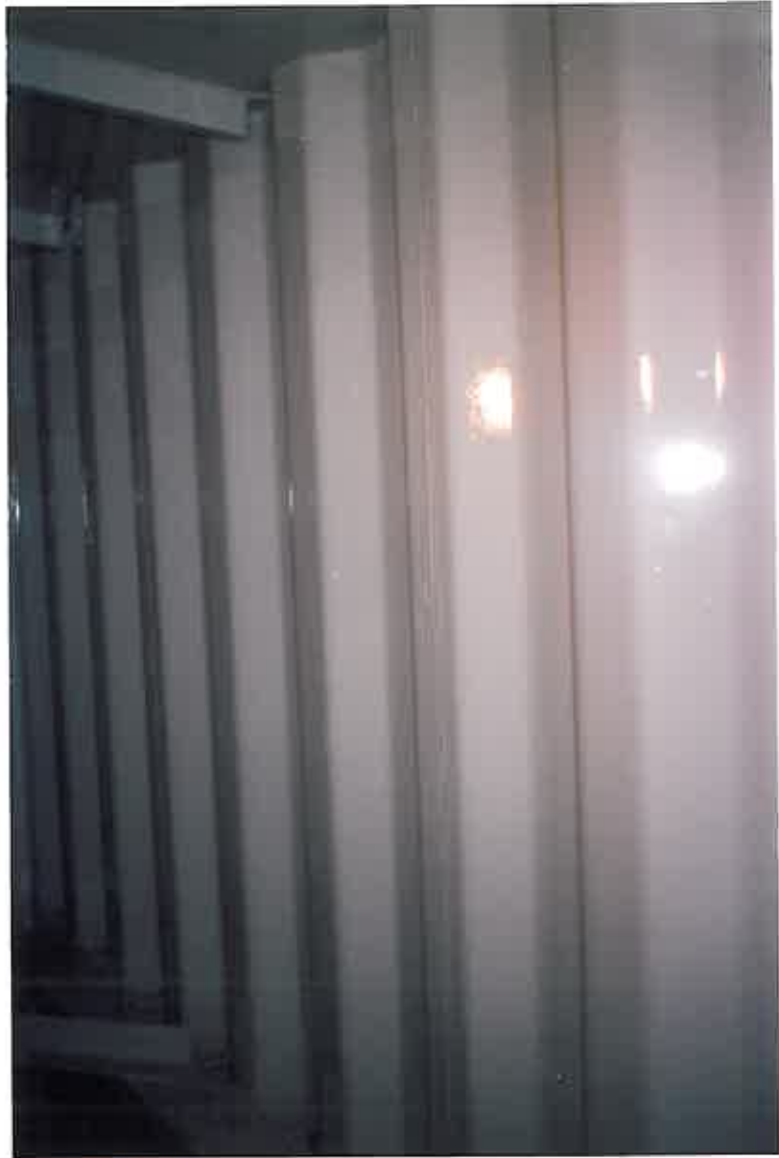
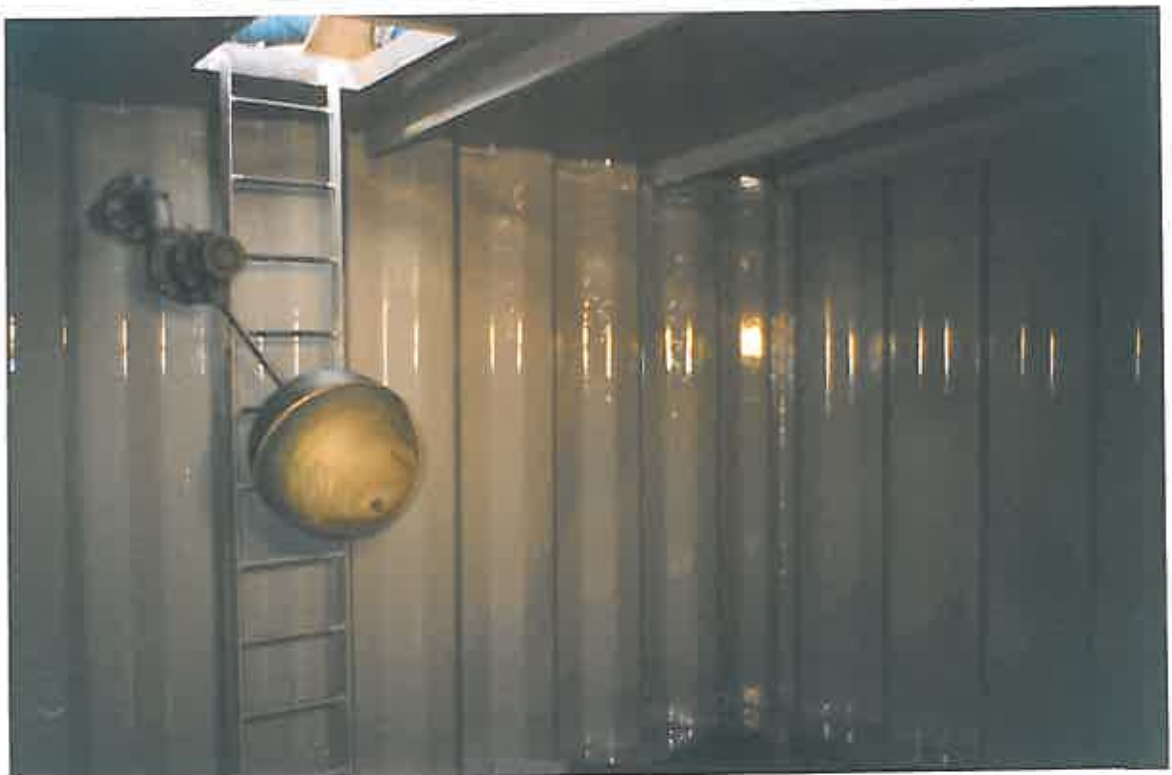
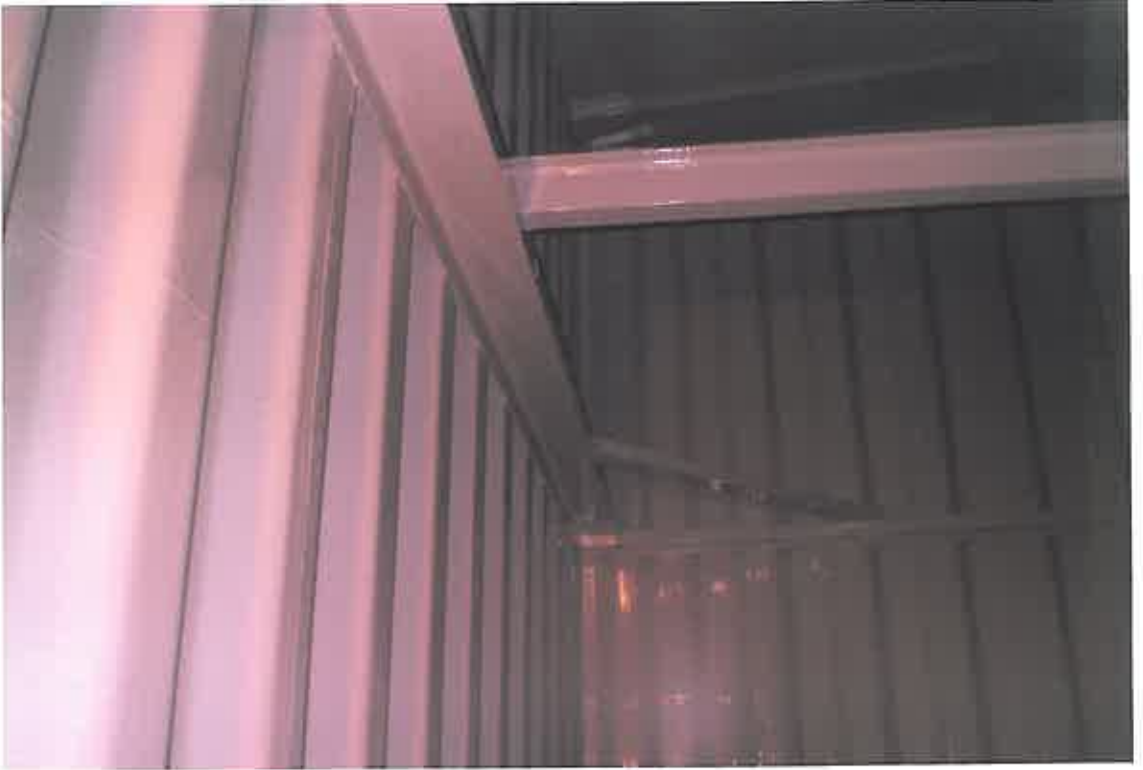
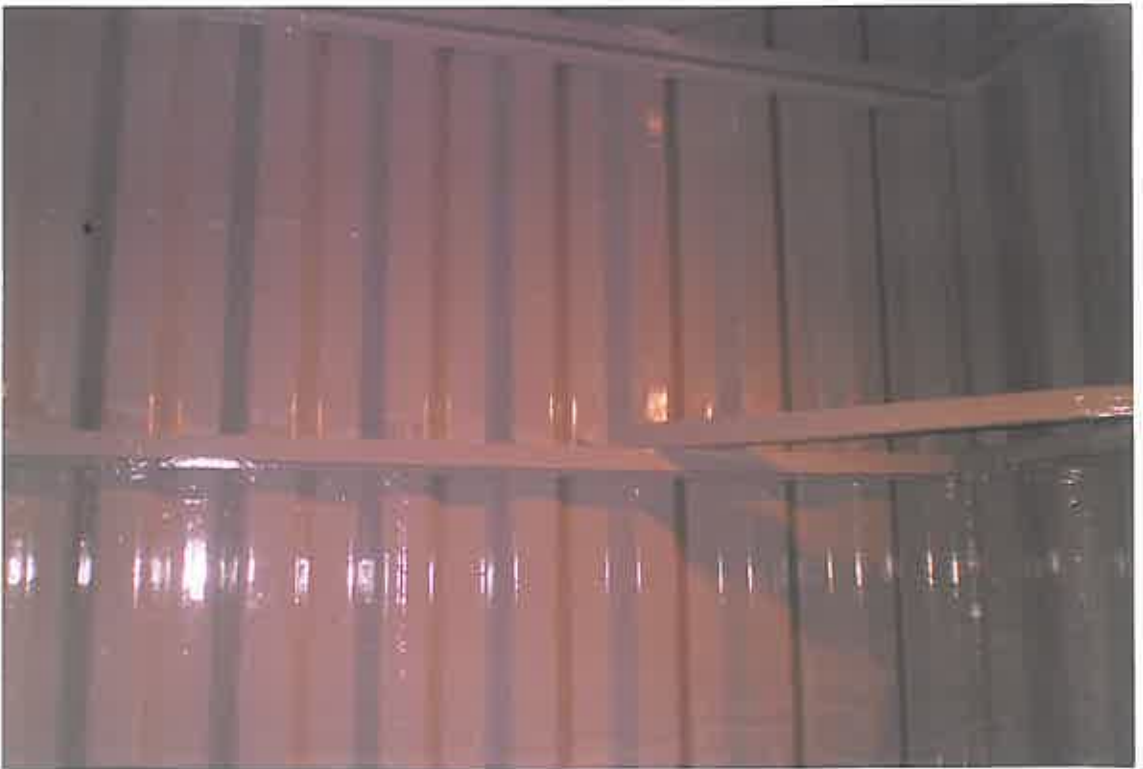
**These photographs show the internal surfaces of the tank having been completely re-lined with COPON Hycote 165 PW Solvent Free Polyurethane utilizing, twin component, hot applied, specialist spray equipment.**
