COVAC COMPLETION REPORT

Client	-	XXXXXX NHS Trust
Address	-	XXXXXXXX Hospital Central England
Site Contacts	-	XXXXXXXXXX
Project Brief	-	The Internal / External Refurbishment of 4 No. Truff Tanks
System Specification - <i>Internal</i>	-	COPON Hycote 165PW Solvent Free Polyurethane.
<i>External</i>	-	COPON Hycote 152LV Solvent Free Coating.
Total Film Thickness - <i>Internal</i>	-	1000 Microns
<i>External</i>	-	500 Microns
Completion Date	-	2nd May 2007
Site Supervisor	-	Robin Bailey
Report Prepared by	-	Adrian Emmett
COVAC Contract Ref:	-	548

Internal Re-Lining of 4 Truff Tanks

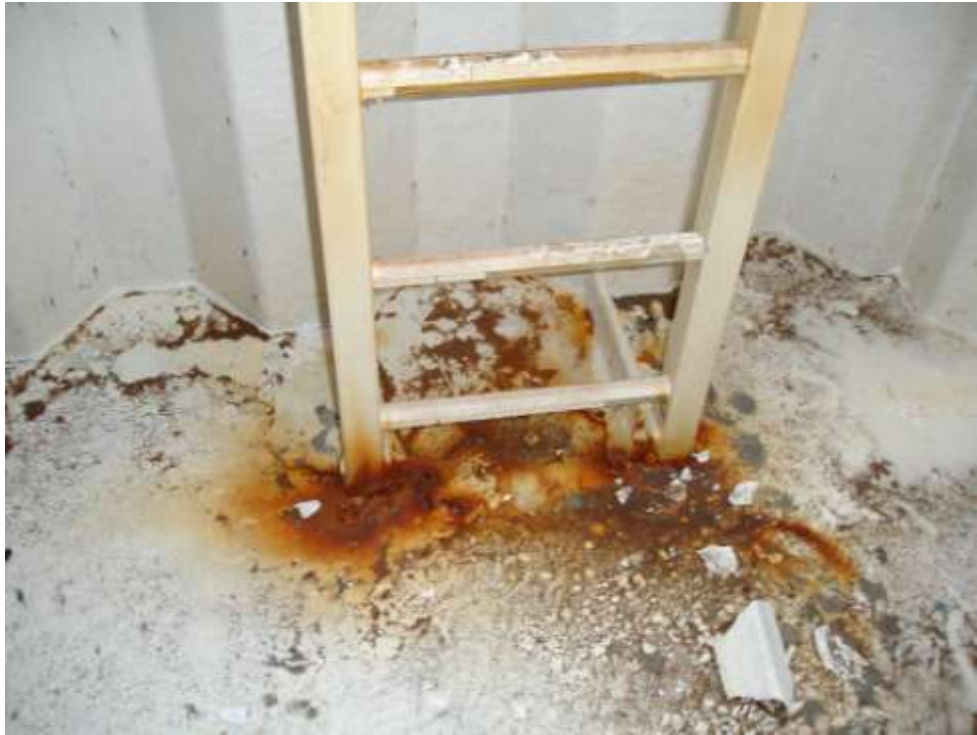
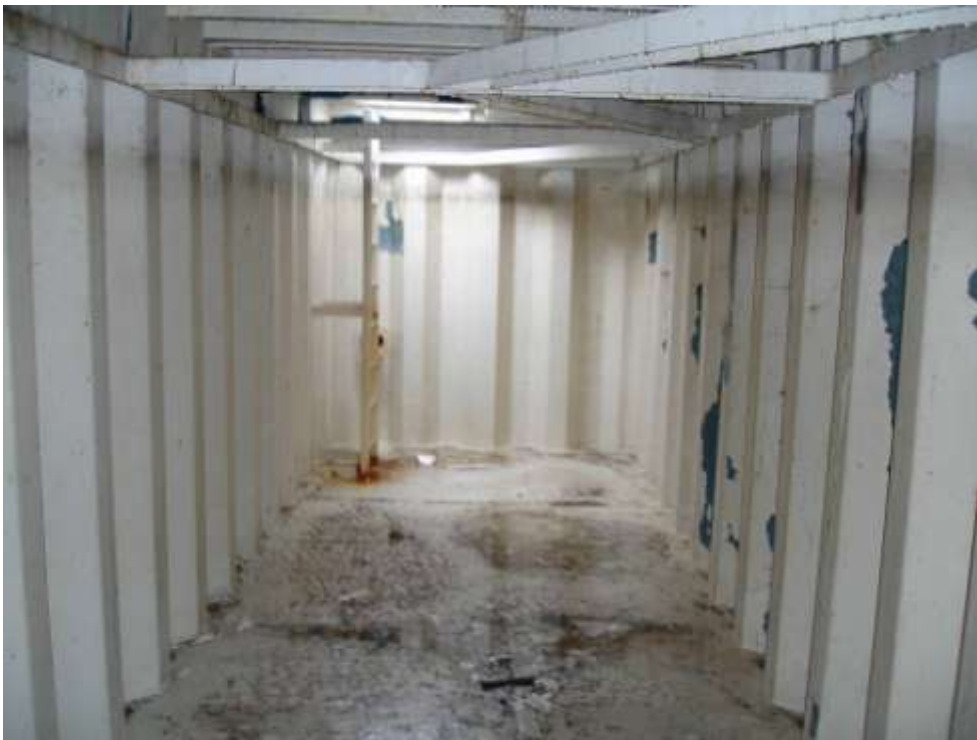
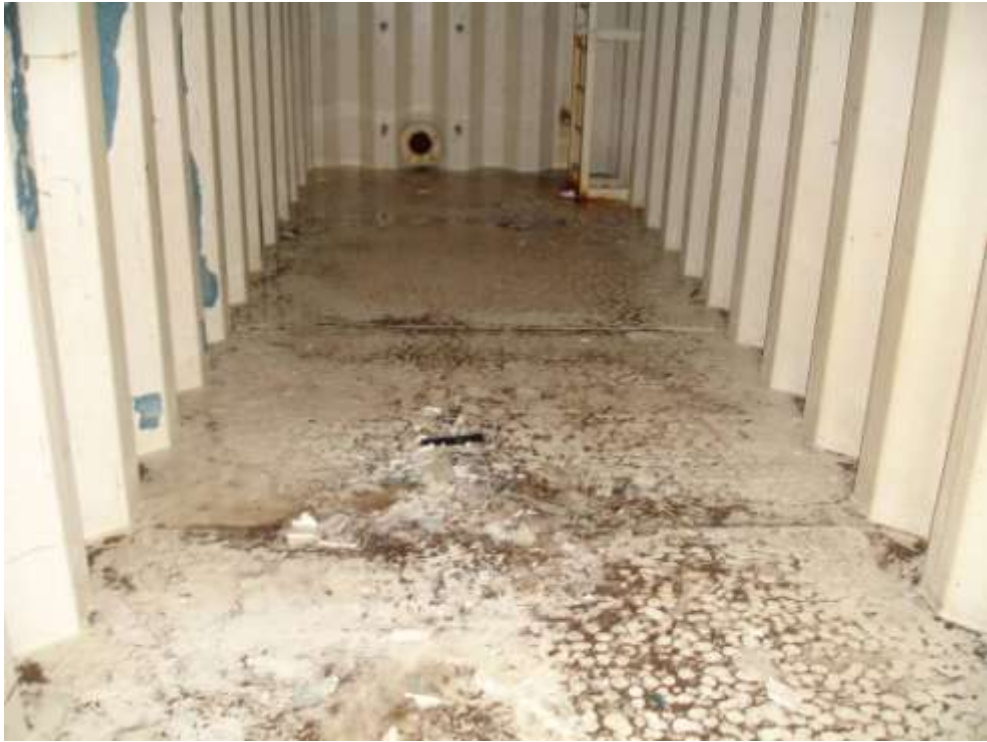
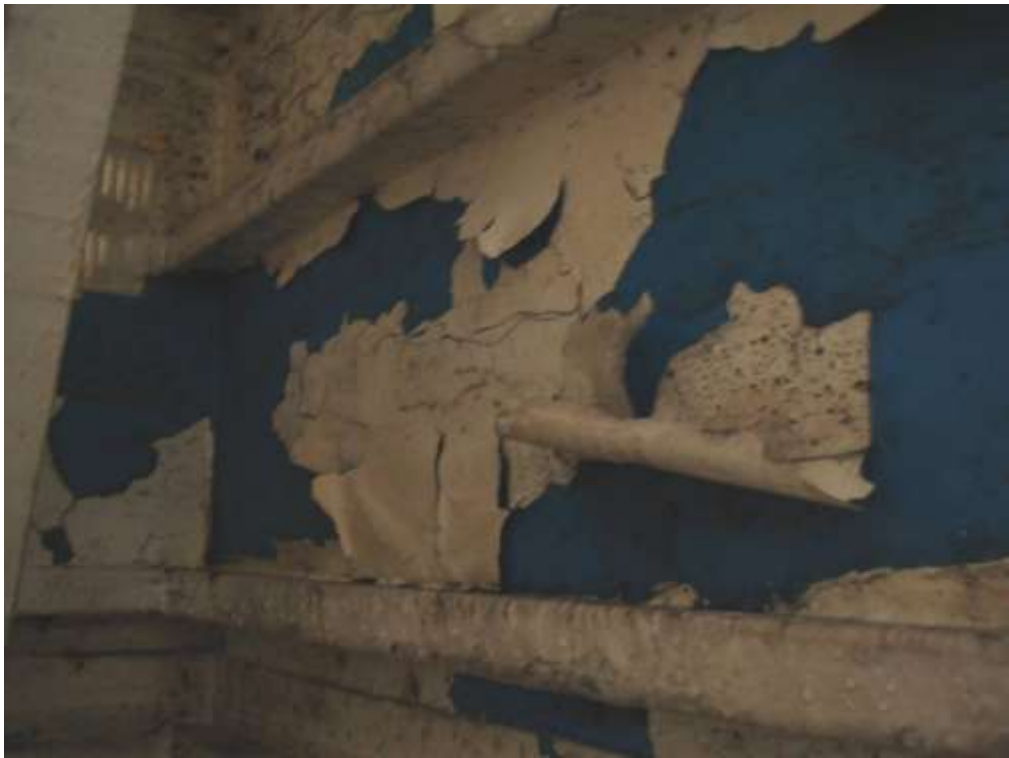
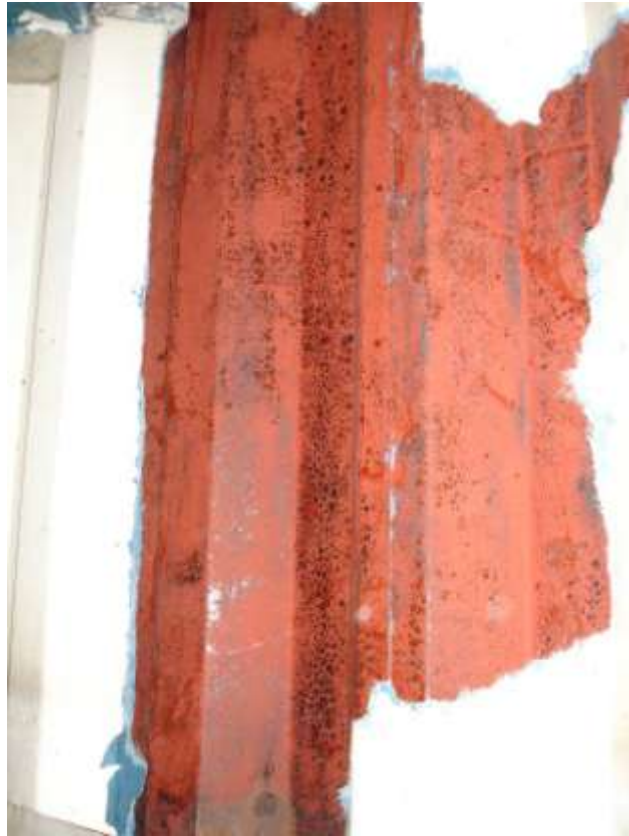
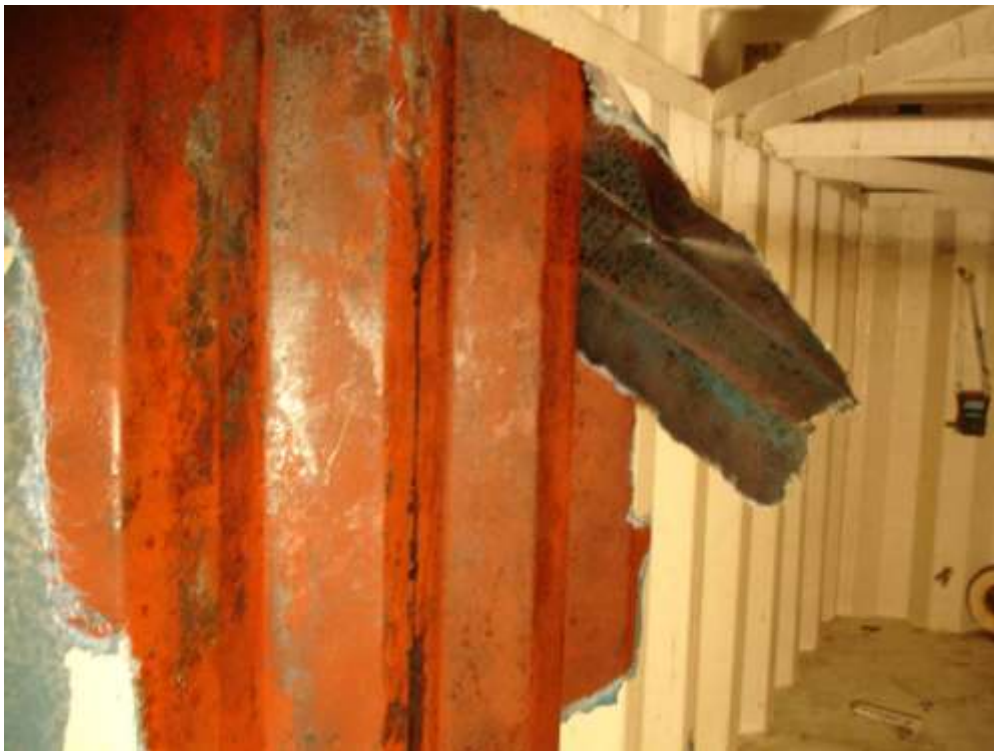
The internal substrate of each compartment was previously painted with two coats of epoxy paint. The first coat was blue whilst the second coat was white. The second coat (white) was de-bonding from the first coat (blue) in sheets of various sizes. The most likely cause of this was contamination or inadequate preparation between coats. The first coat had reached the end of its useful life due to sub-film corrosion, low film build and subsequent deterioration.

These photographs show the internals of the tanks, prior to any preparation work. The photographs clearly show the deterioration of the epoxy coating and delaminating of the GRP lining.

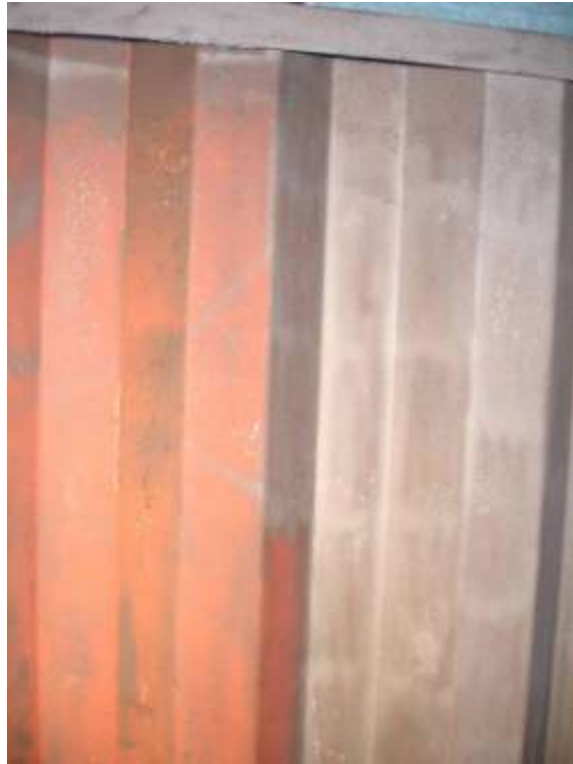
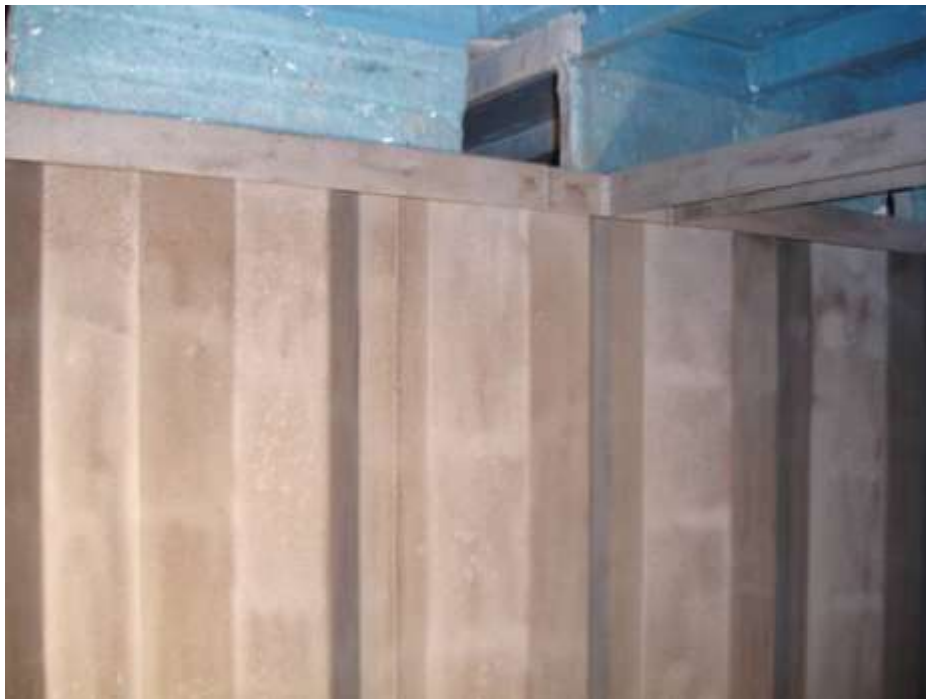
The photographs above clearly show progressive corrosion to the steel due to moisture entrapment between the steel and GRP lining substrates.

The above and following photographs show all steel surfaces and GRP roof during and after having been prepared by COVAC operatives by means of dry abrasive grit blasting equipment in order to achieve the required surface profile for adherence of the COPON Hycote 165PW Coating System.
