## COVAC COMPLETION REPORT

Client	-	<b>XXXXX City Council</b>
Site Address	-	<b>XXXXXXXXXX XXXXXXXXXX</b>
Site Contact	-	<b>XXXXXXXXXX</b>
Project Brief	-	<b>The Internal Relining of 2 No. Flat, Steel, Galvanised, Potable Water Retaining Structures</b>
System Specification	-	<b>3m Scotchkote™ 165PW (Formerly Known as COPON Hycote 165PW)</b>
Nominal Dry Film Thickness	-	<b>1000 Microns</b>
Completion Date	-	<b>30<sup>th</sup> April 2008</b>
Site Supervisor	-	<b>Ian Looms</b>
Report Prepared by	-	<b>Adrian Emmett</b>
COVAC Contract Ref:	-	<b>719</b>

## **2 No. FLAT, GALVANIZED POTABLE WATER TANKS**

**(This pictorial report combines the refurbishment of both tanks)**

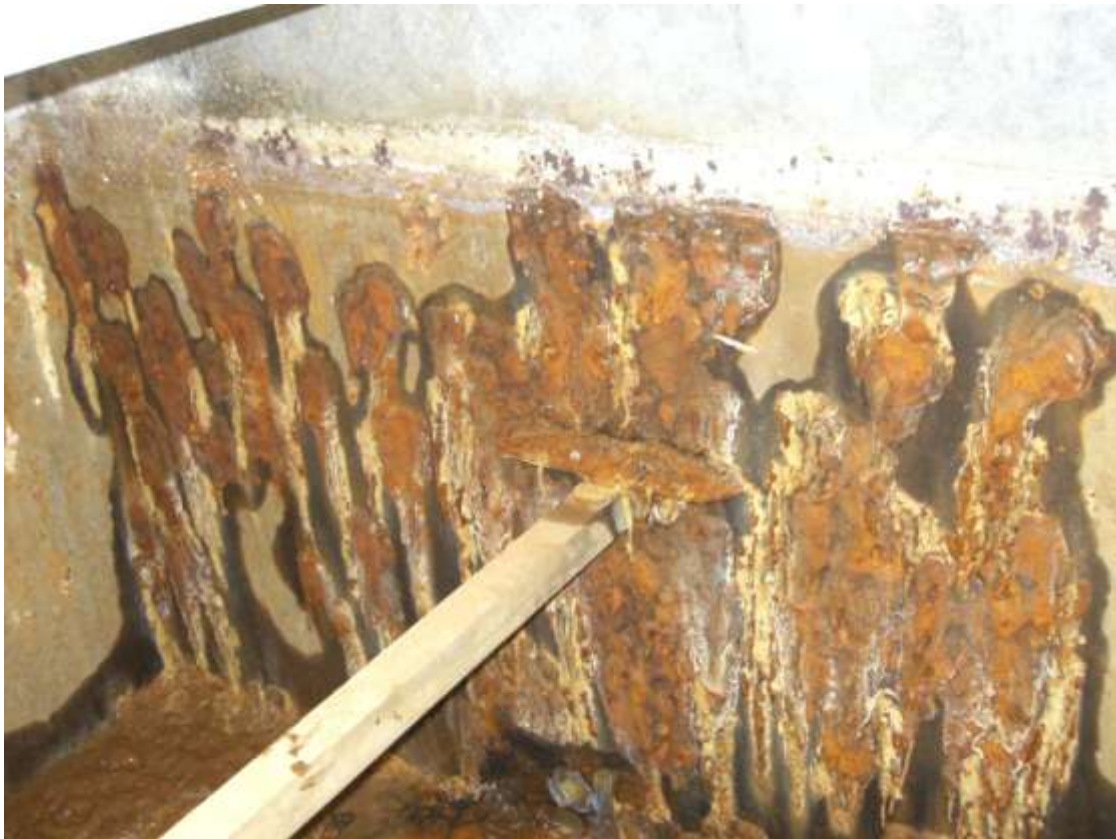
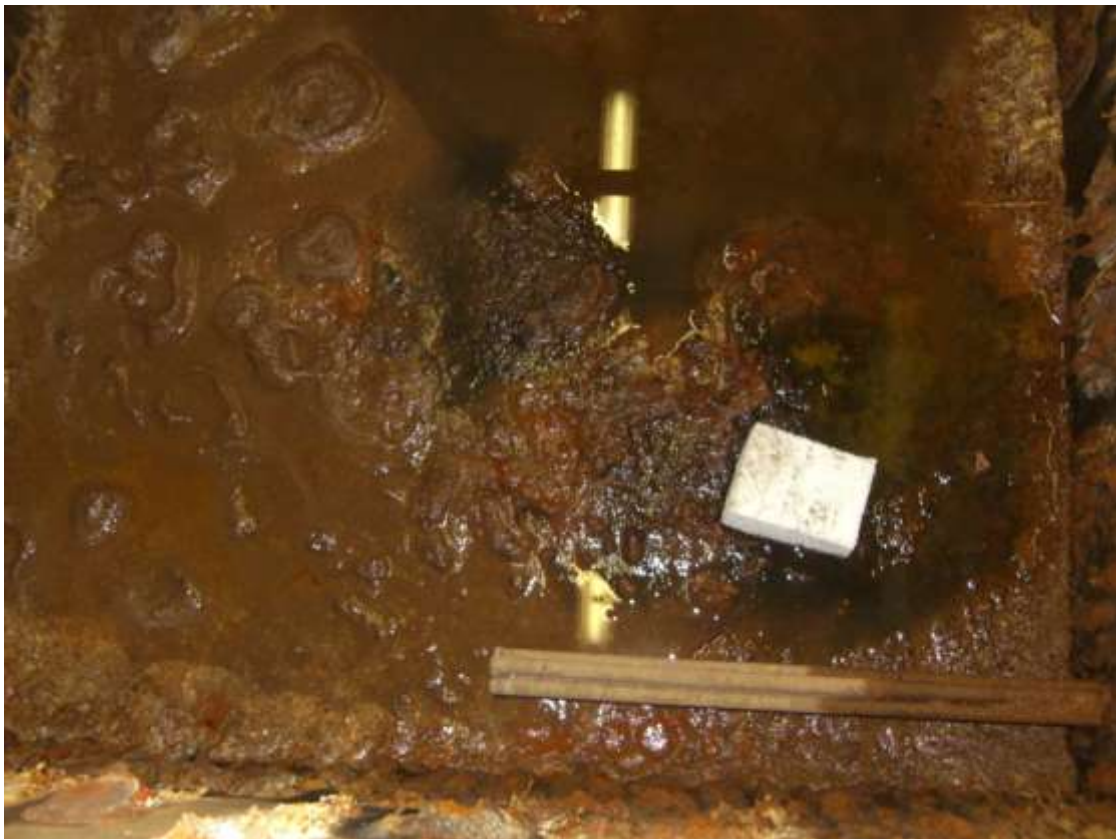
**These photographs show the internal surfaces of the tanks having been drained of water and prior to any preparation works being carried out. The corrosion within the tanks is clearly evident.**

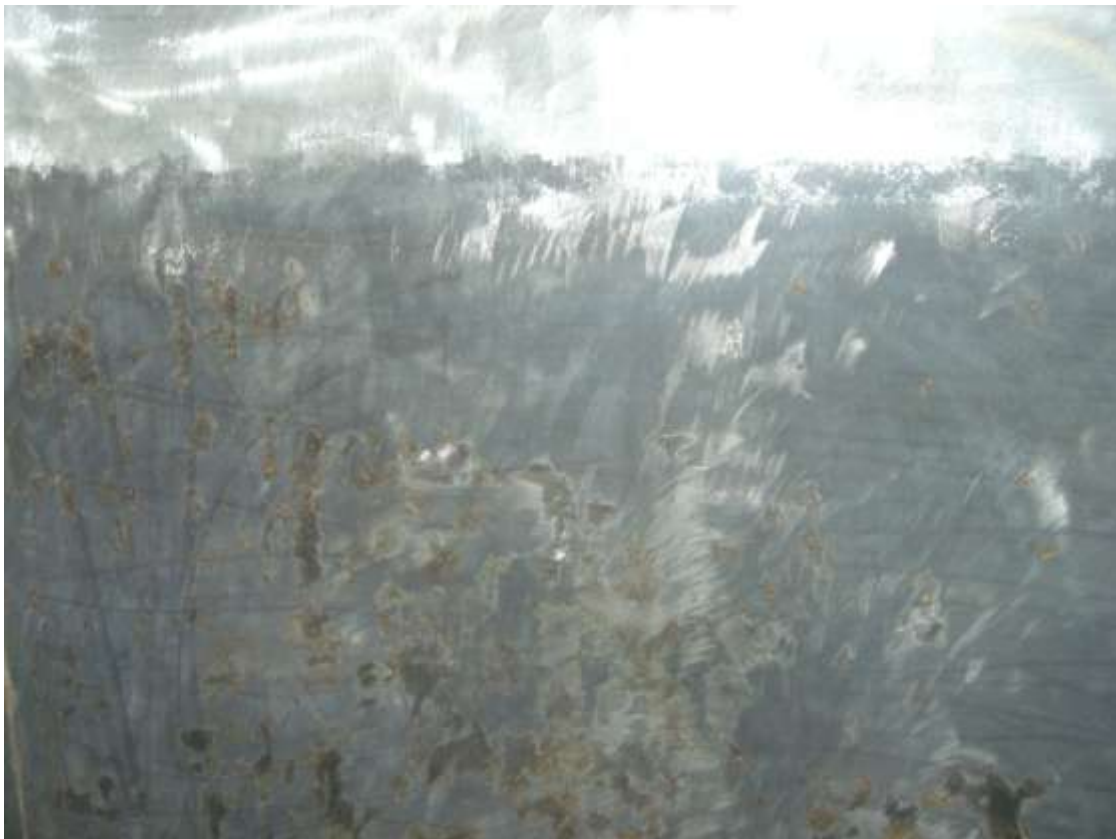
**The pictures show the internal substrate after being prepared by COVAC Operatives.**

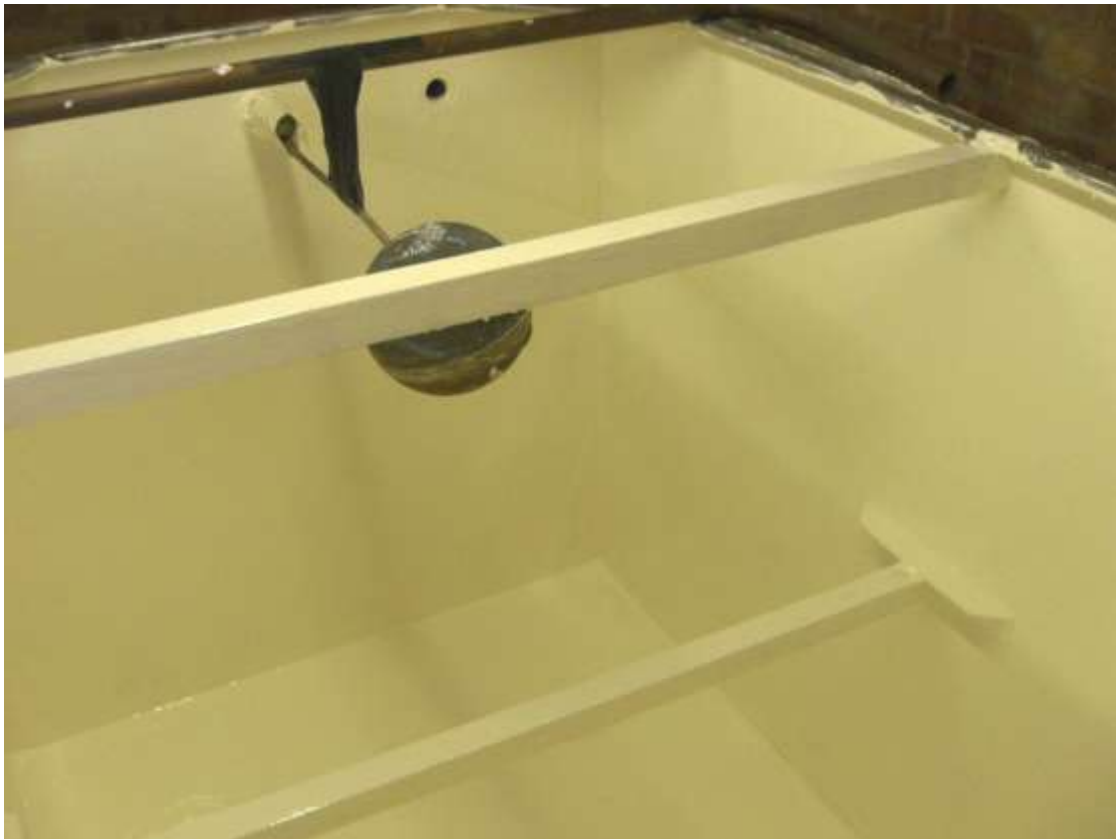
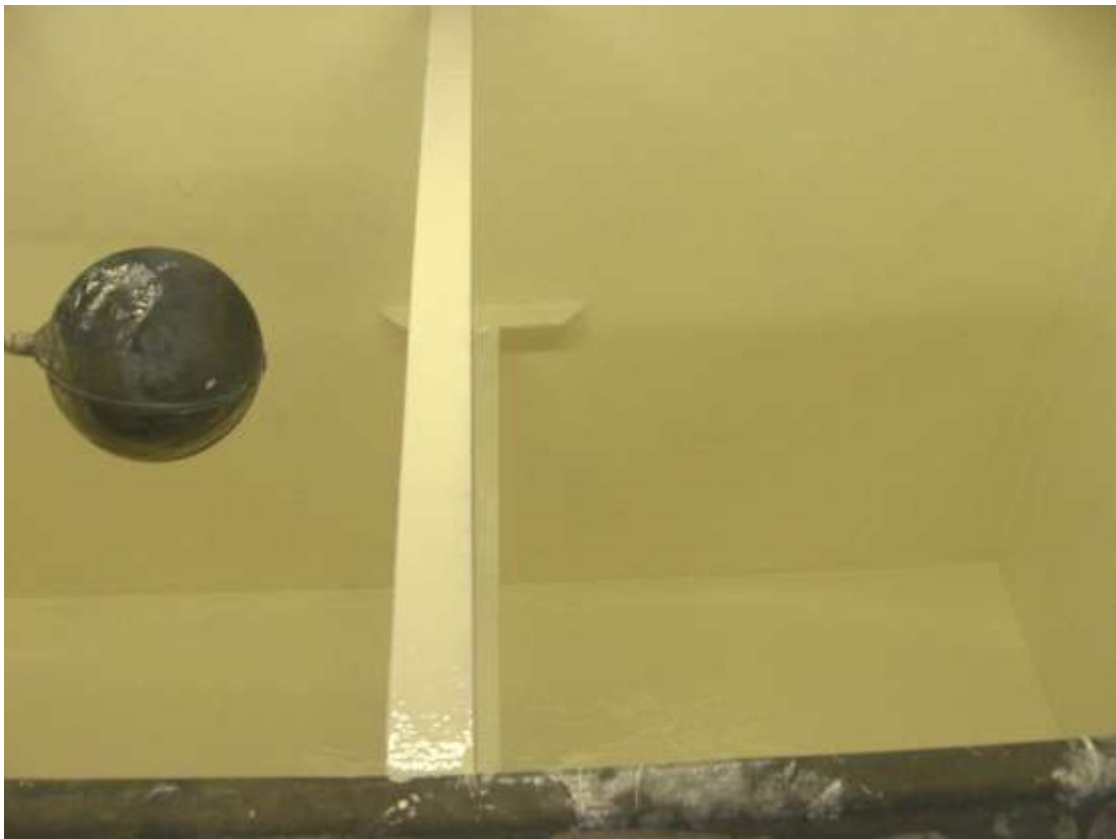
**These photographs show the substrate of the tanks having received the 1<sup>st</sup> full coat of 3M Scotchkote™ 165PW (cream) Solvent Free Polyurethane, by means of brush and roller to a nominal wet/dry film thickness of 500 Microns.**

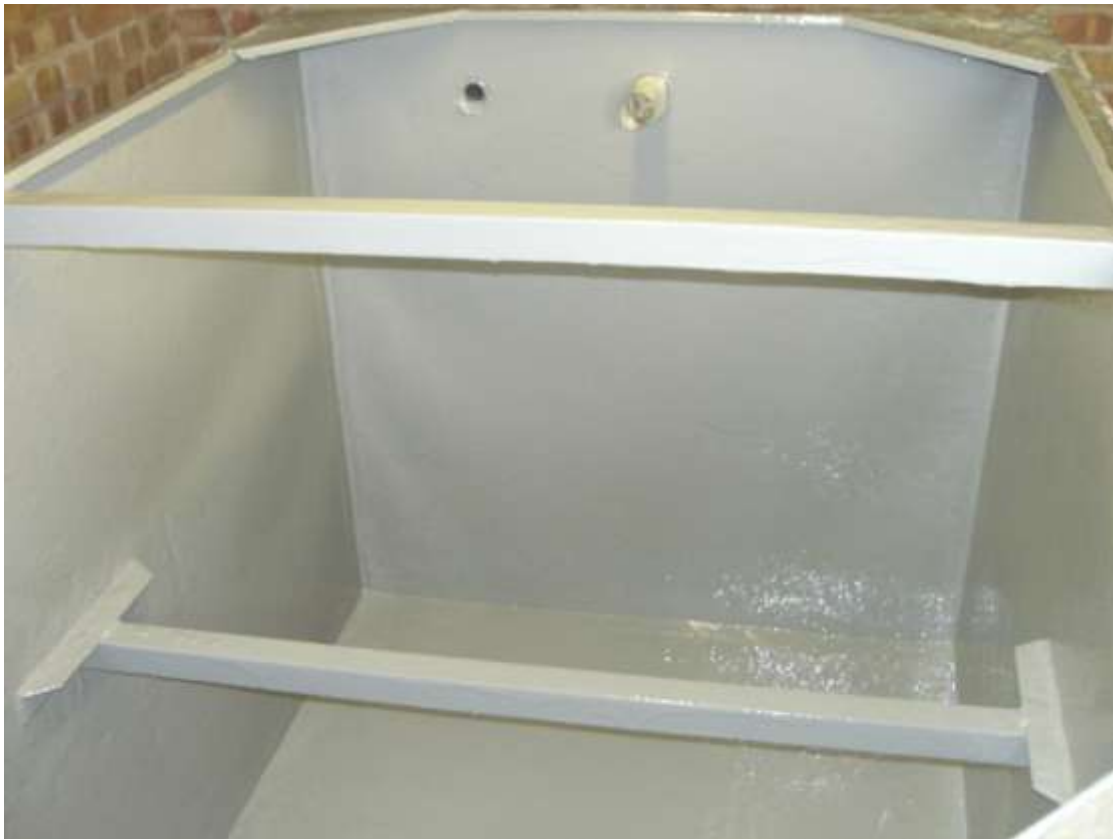
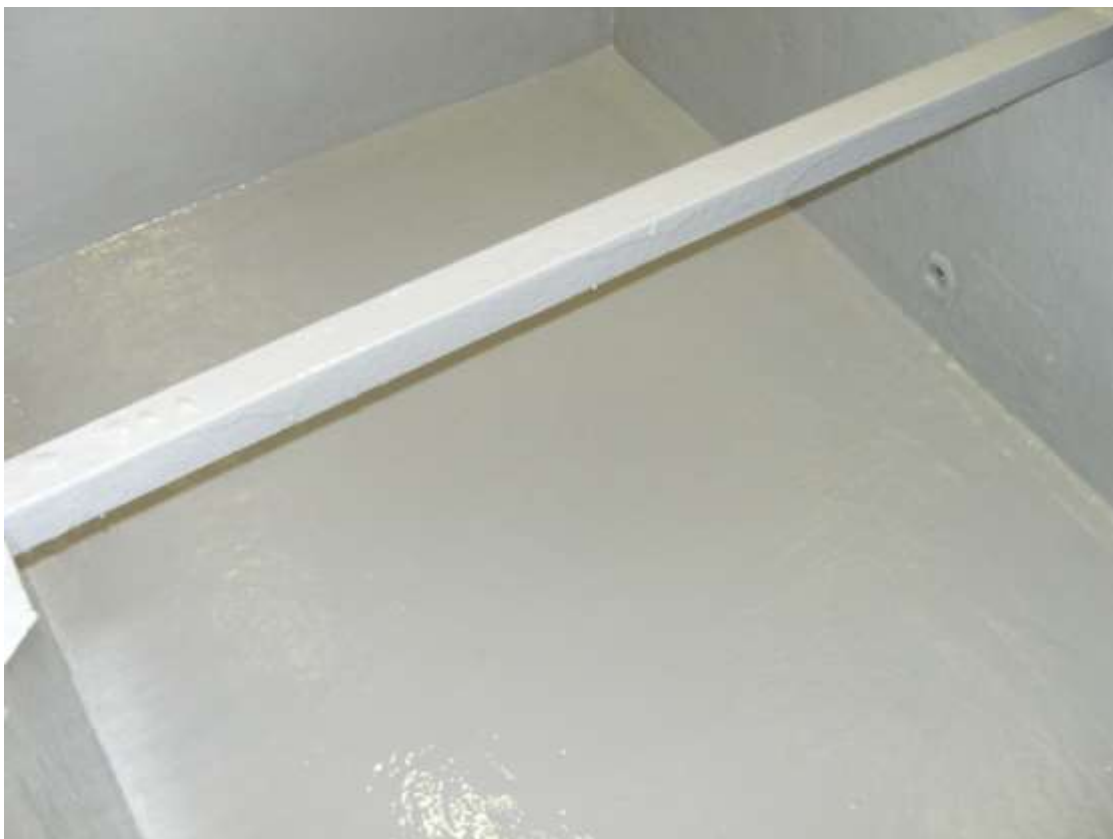
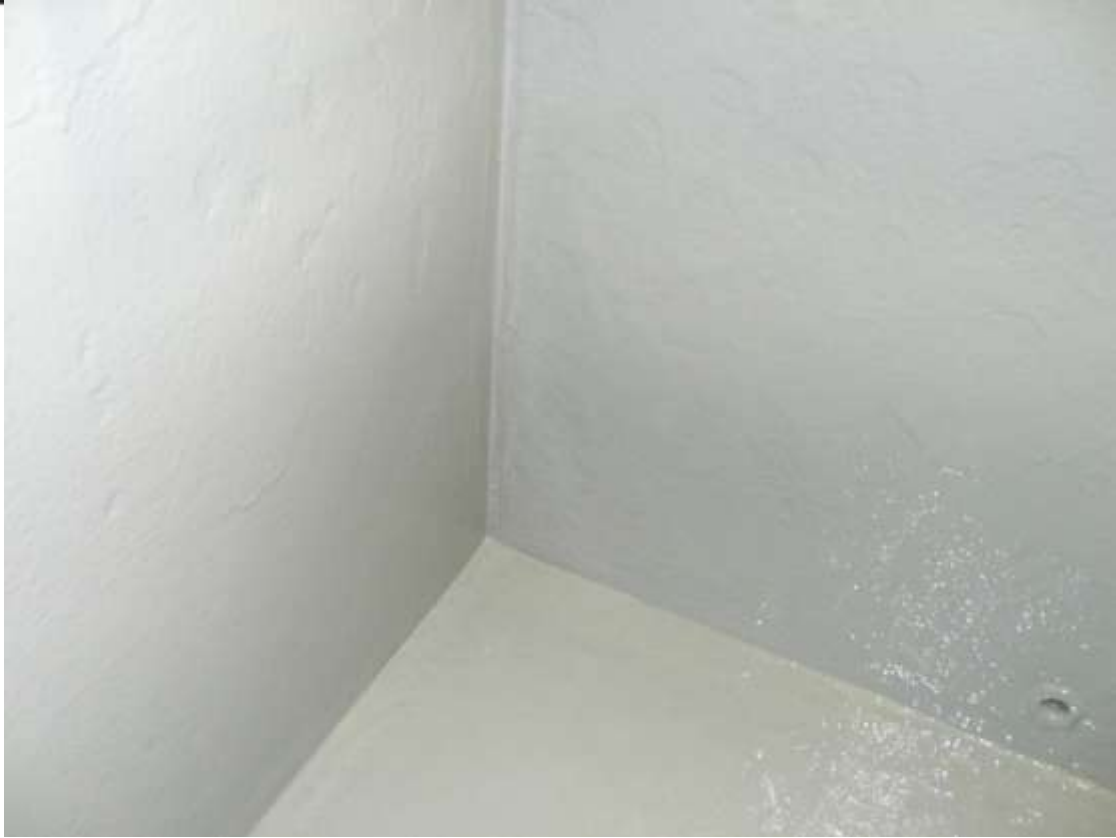
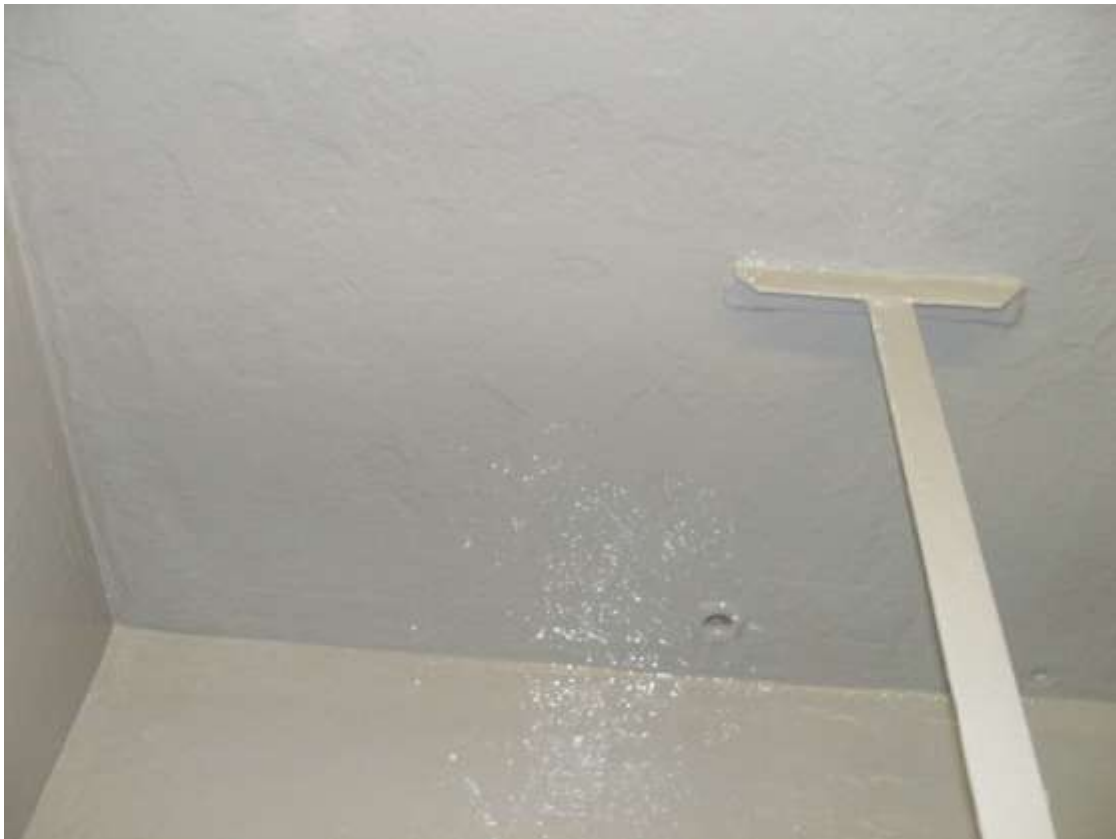
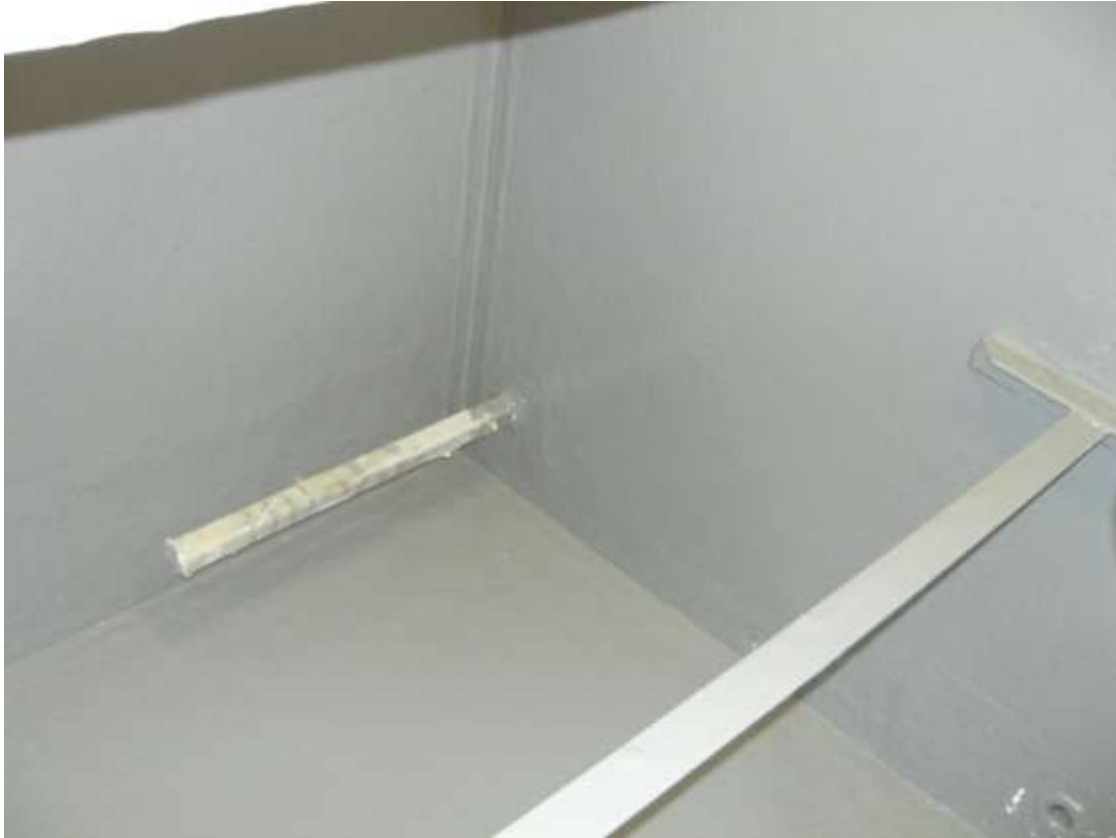
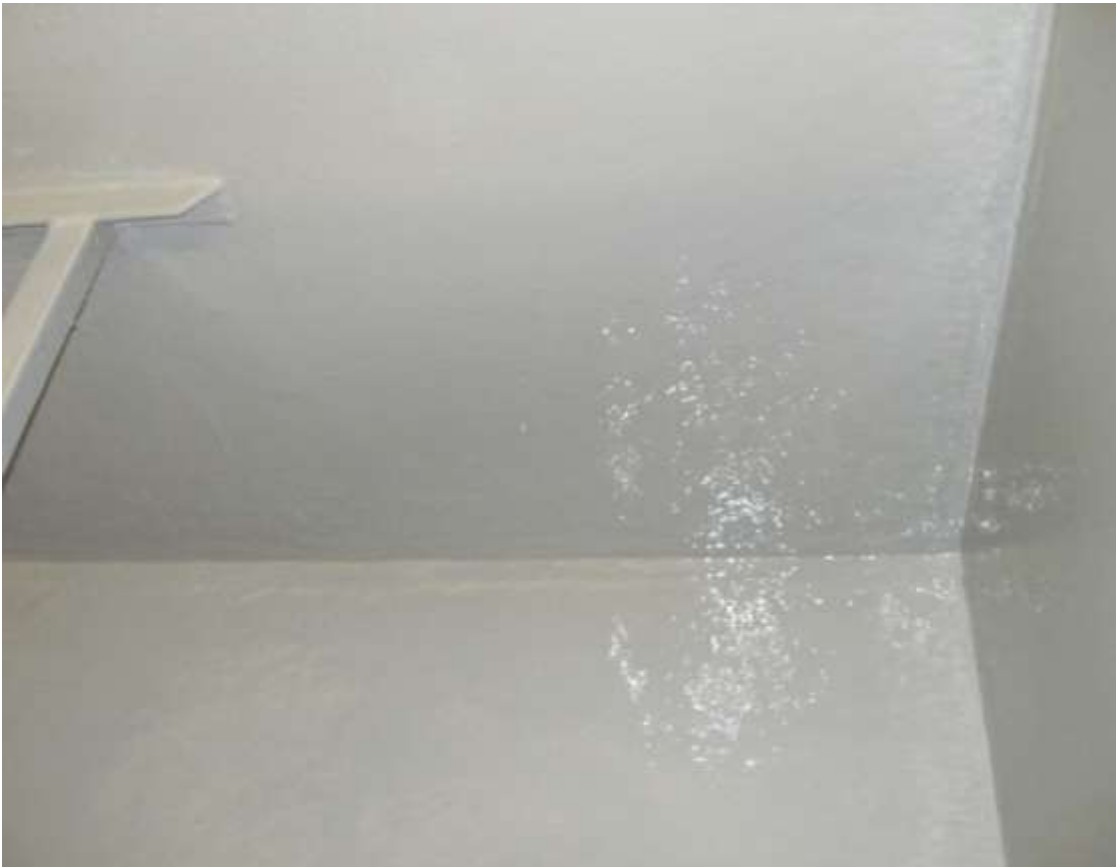
**The following photographs show the final application of the 2<sup>nd</sup> coat of 3M Scotchkote™ 165PW (grey) in order to achieve a total, nominal dry film thickness of 1000 Microns (1mm), and between 1500-2000 Microns (2mm) over all stripe coated areas.**
