COMPLETION REPORT

Client : **XXXXXXXXXX Sixth Form College**

Project Brief : **The Internal Coating of 1 No. Flat, Galvanised CWS Tank**

System Spec : **3M Scotchkote™ 165PW**
(Formerly Known as COPON Hycote 165PW)

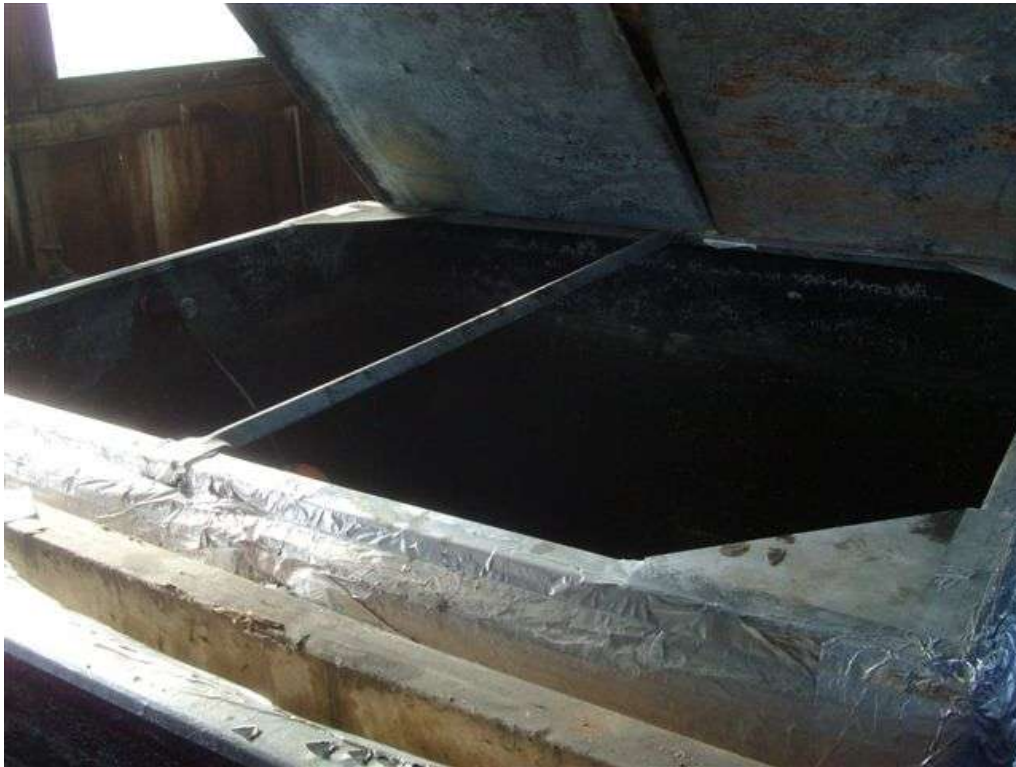
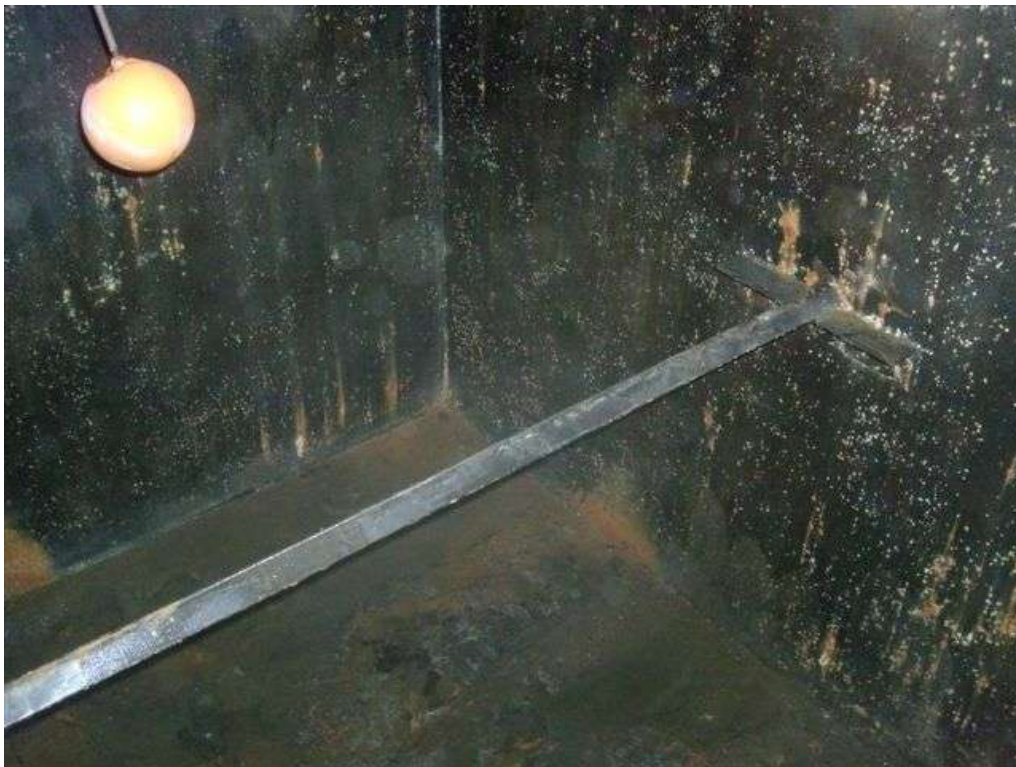
These photographs show the access to the tank and the internal surfaces of the tank having been drained of water, but prior to any work commencing, showing signs of corrosion from the non (WRAS/DWI) approved bitumastic coating.

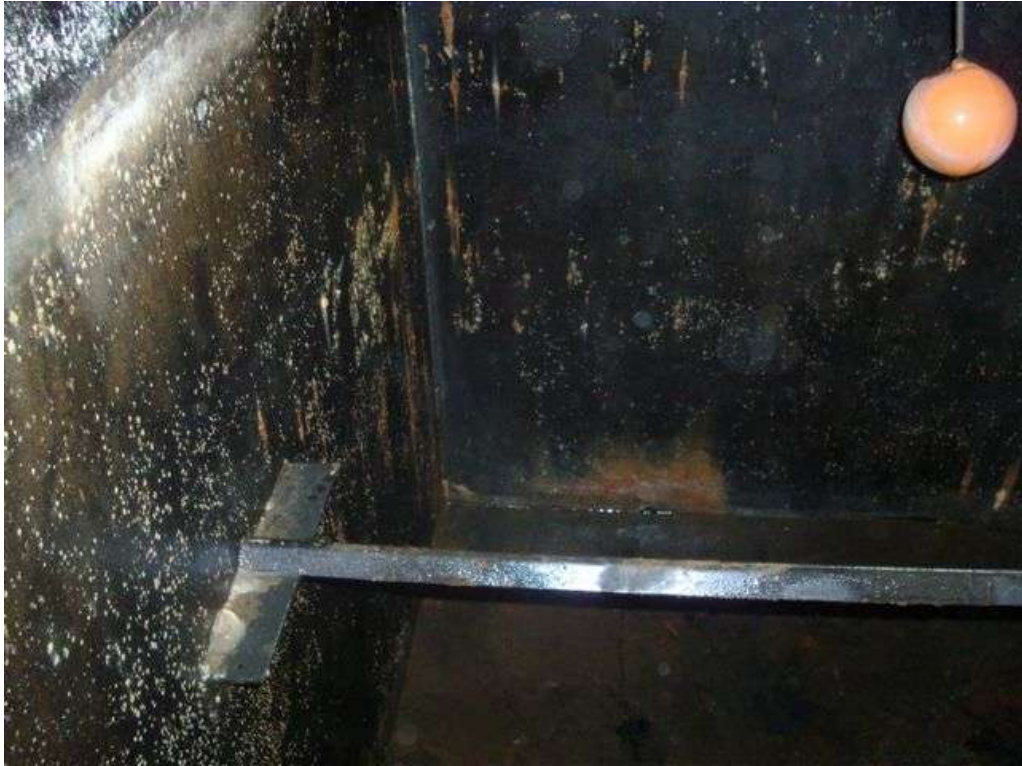
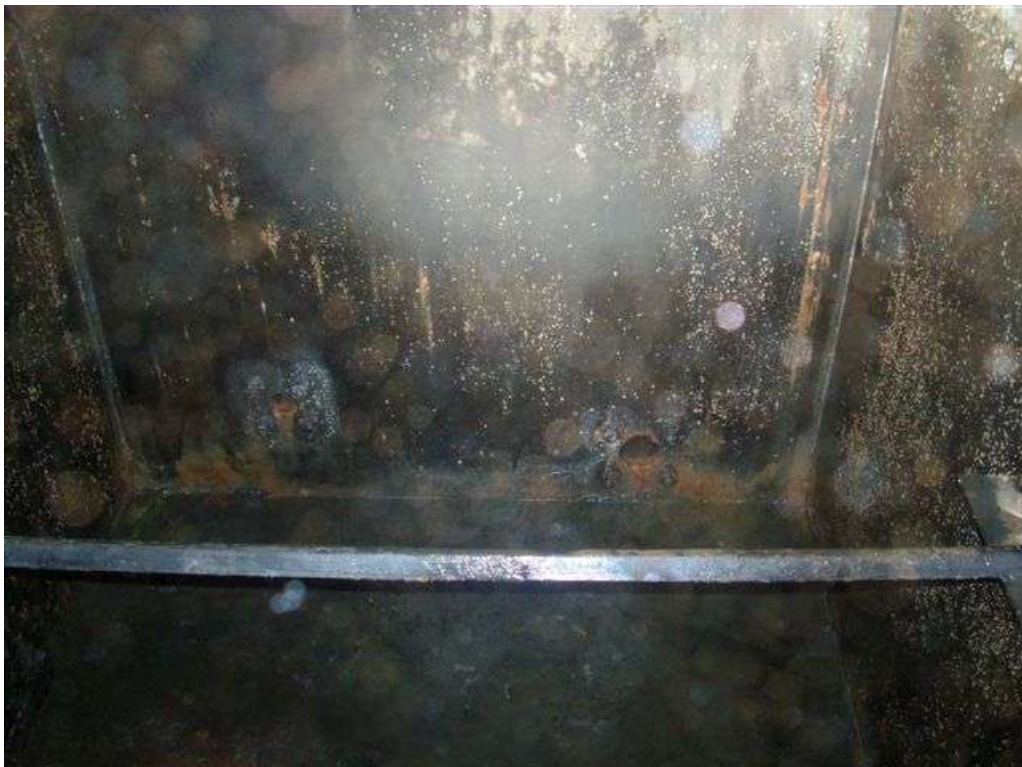
The pictures show the internal substrate after being prepared by COVAC Operatives to remove all traces of the bitumastic coating and contaminants.

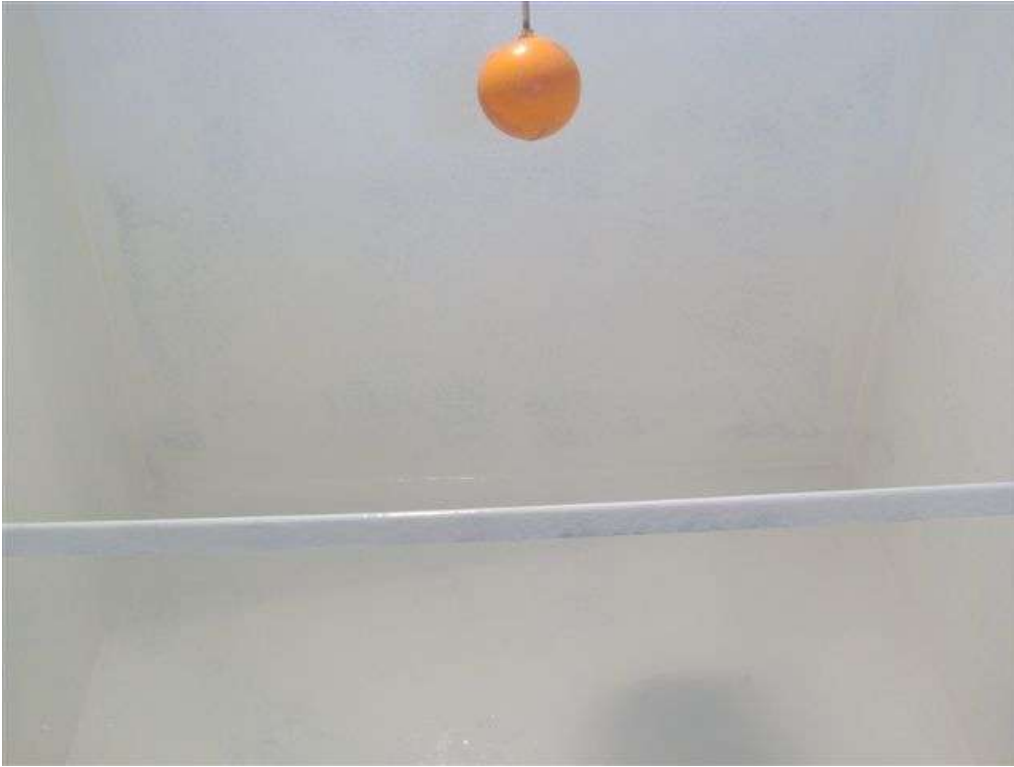
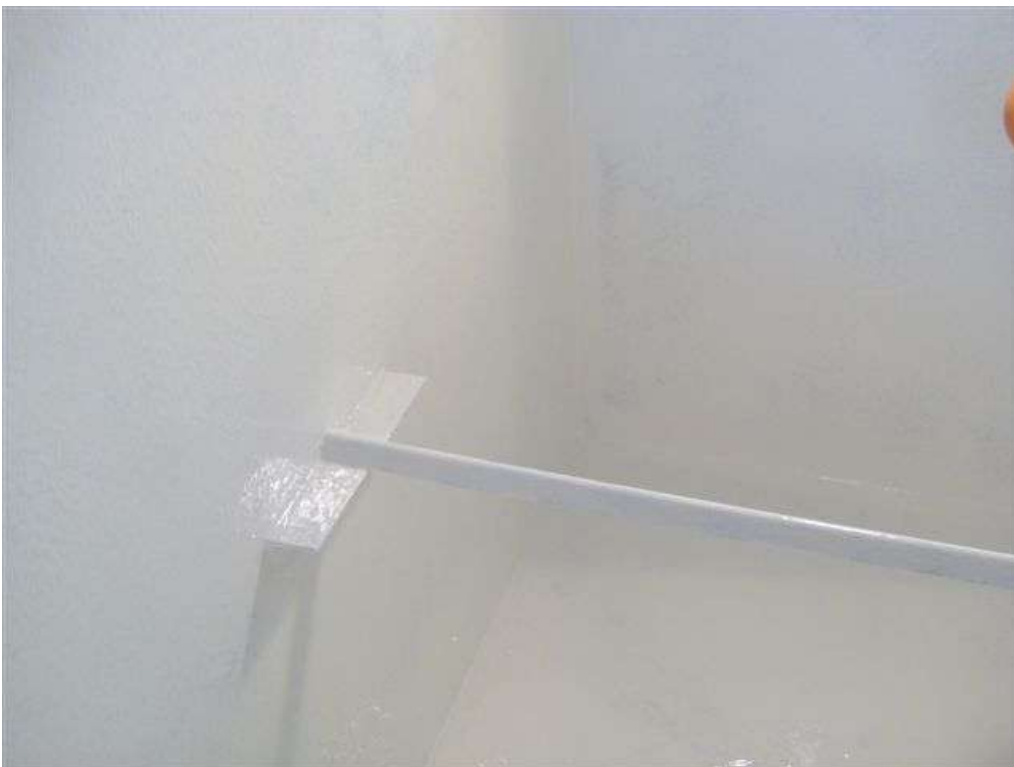
These photographs show the substrates having received the 1st full coat of 3M Scotchkote™ 165PW (cream) Solvent Free Polyurethane, by means of brush and roller to a nominal wet / dry film thickness of 500 Microns.

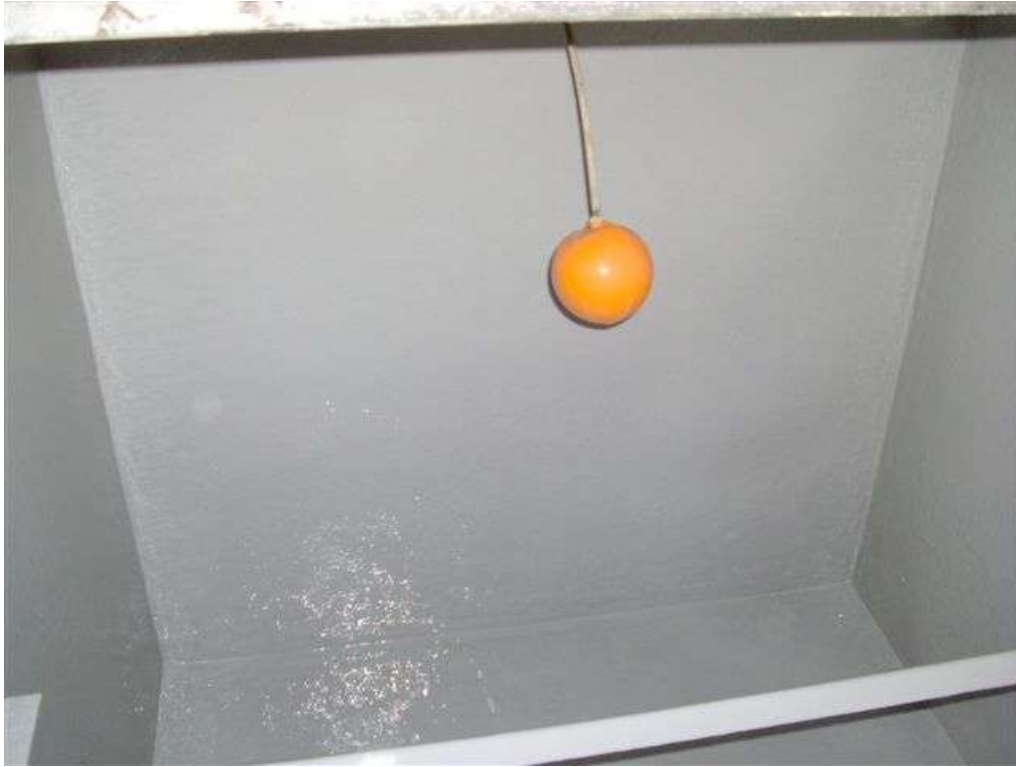
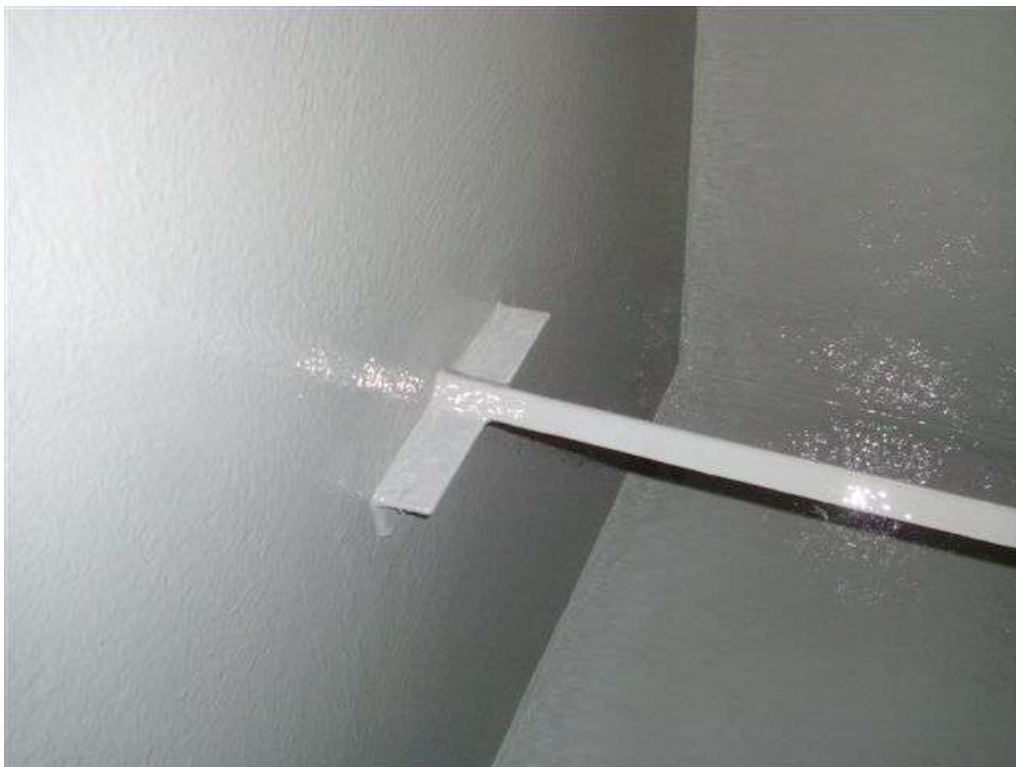
The following photographs show the final application of the 2nd coat of 3M Scotchkote™ 165PW (grey) in order to achieve a total, nominal dry film thickness of 1000 Microns (1mm), and between 1500-2000 Microns (2mm) over all stripe coated areas.
