COMPLETION REPORT

Client : **XXXXX Hospital**

Project Brief : **The Internal Relining of 2 No. Concrete Potable Water Retaining Structures**

System Spec : **3M Scotchkote™ 165PW**
(Formerly Known as COPON Hycote 165PW)

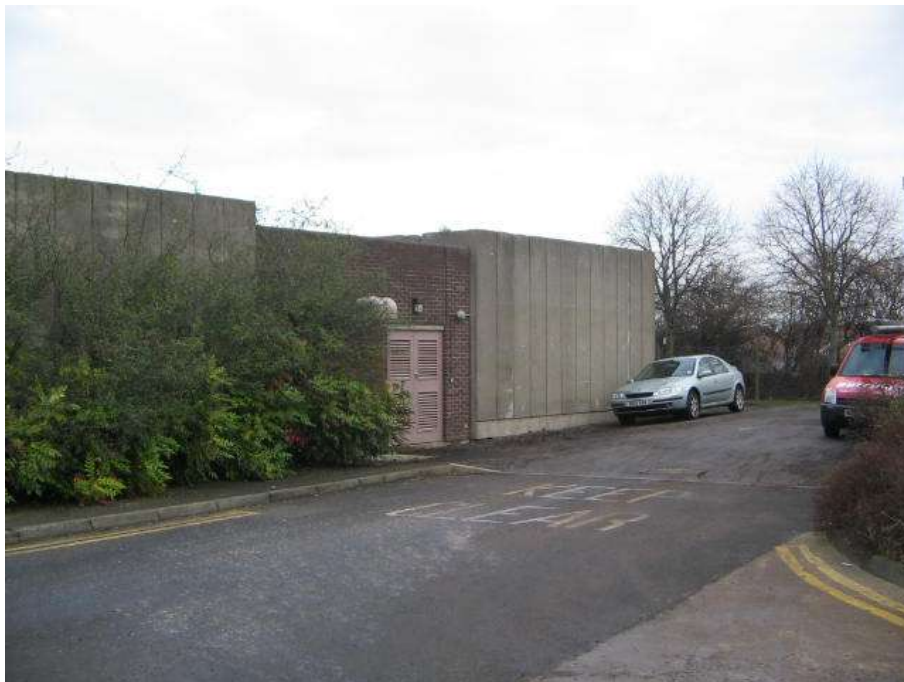
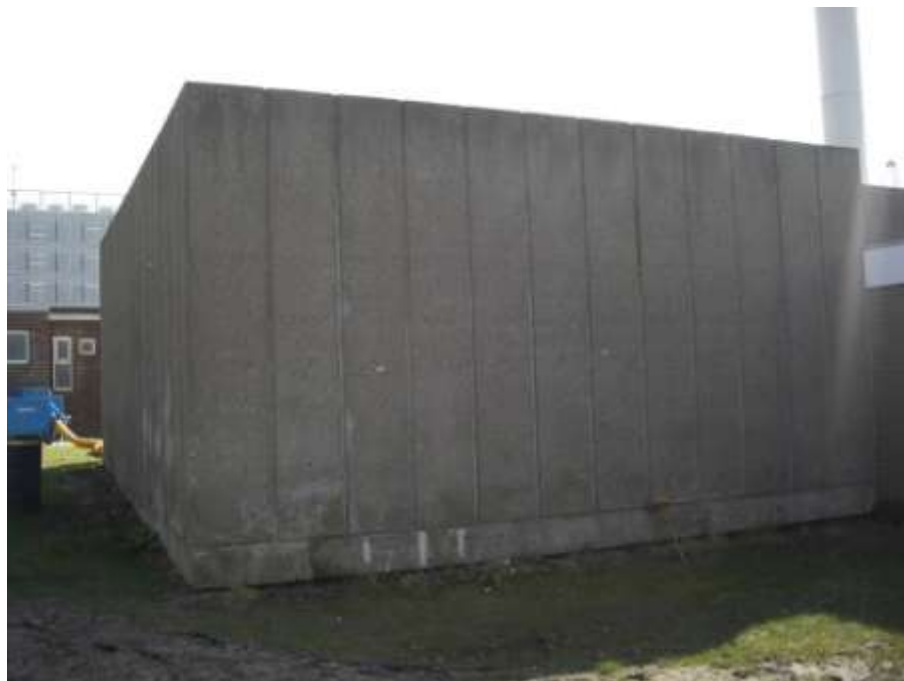
These photographs show the external of the structure:

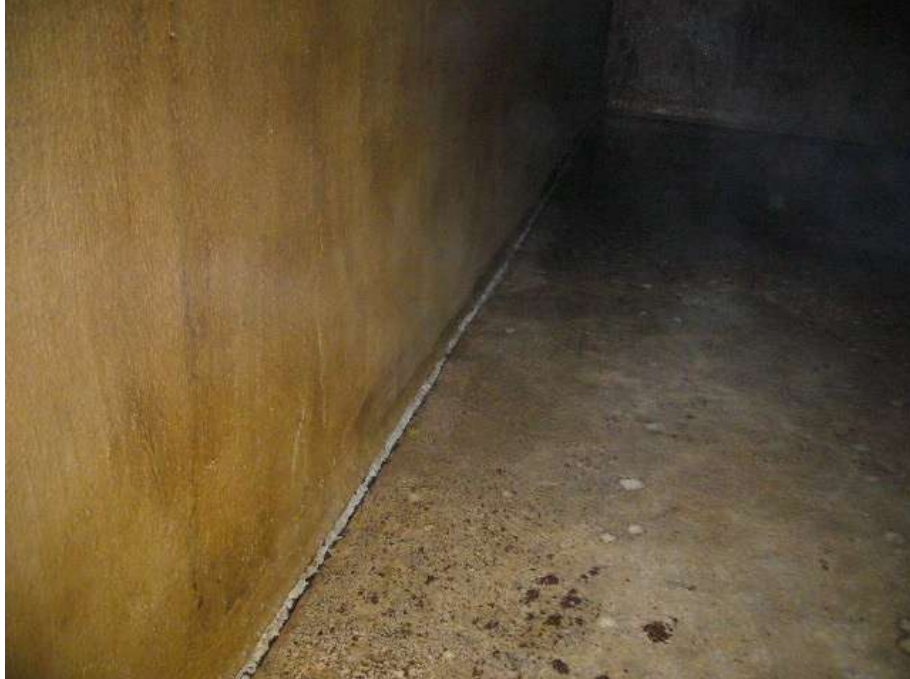
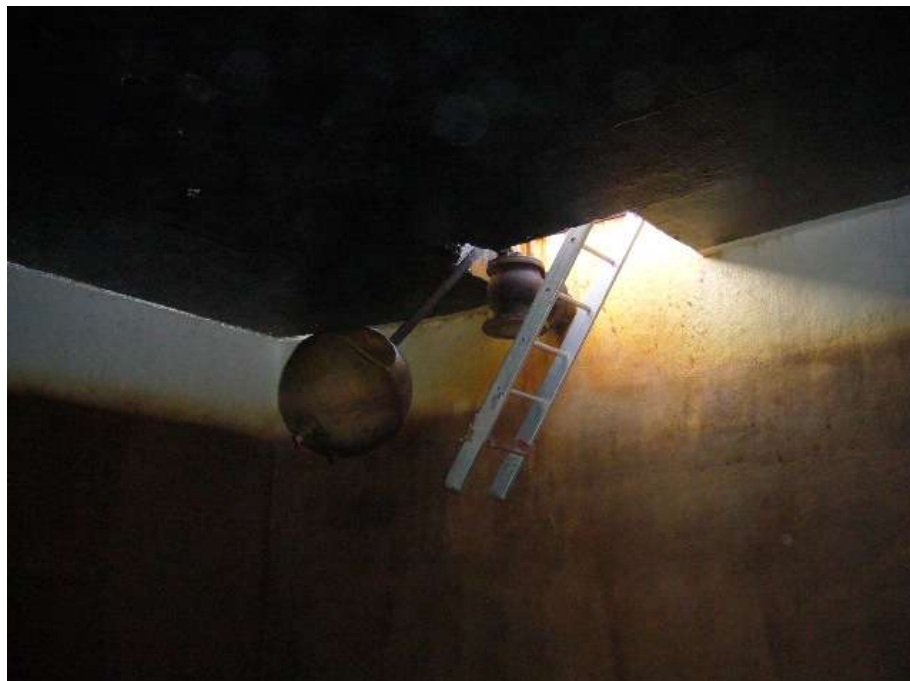
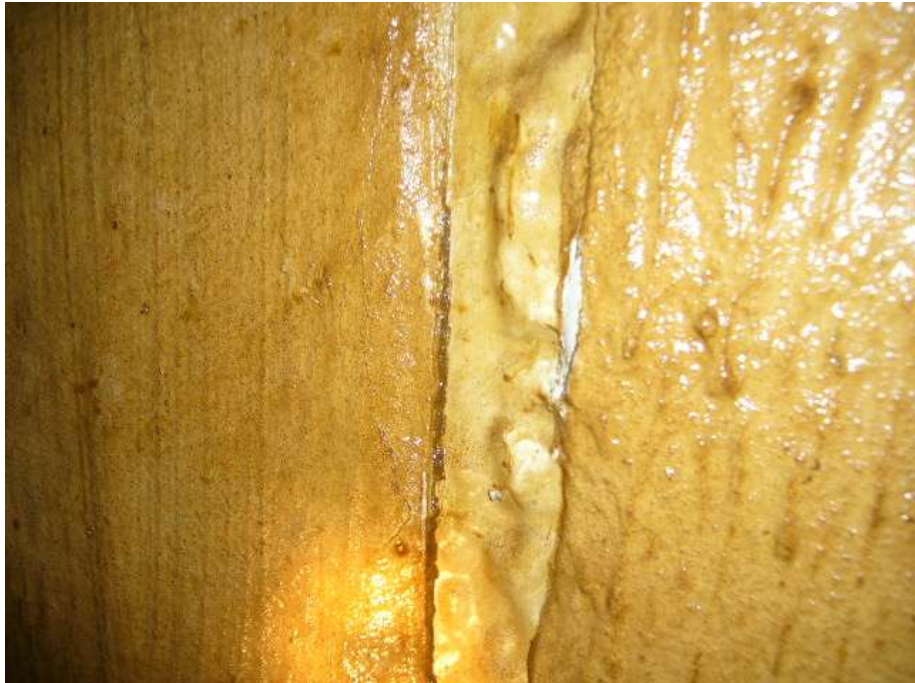
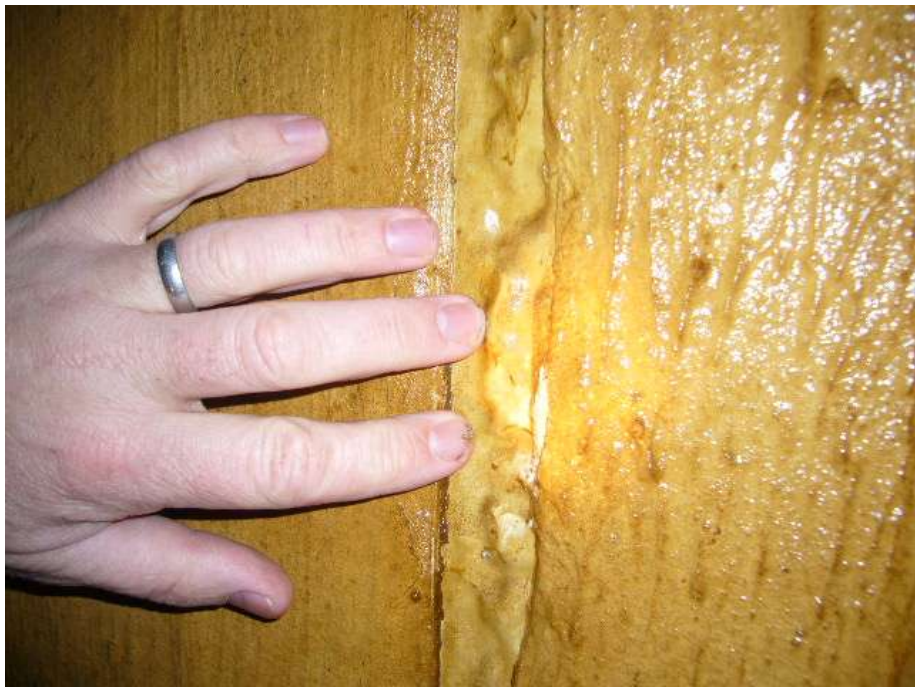
These photographs show the condition of the internal surfaces of the structure before relining:

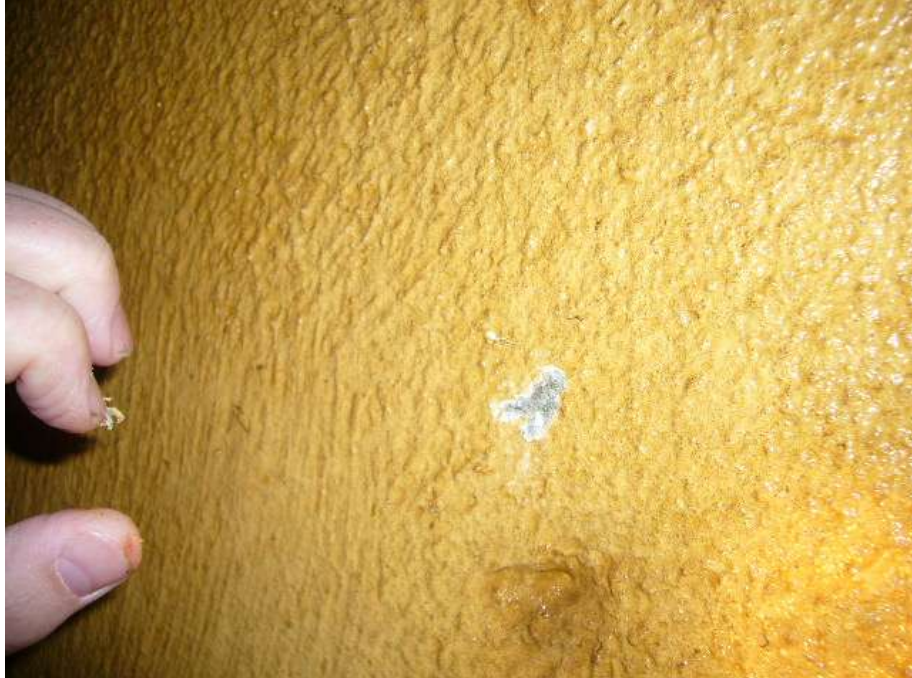
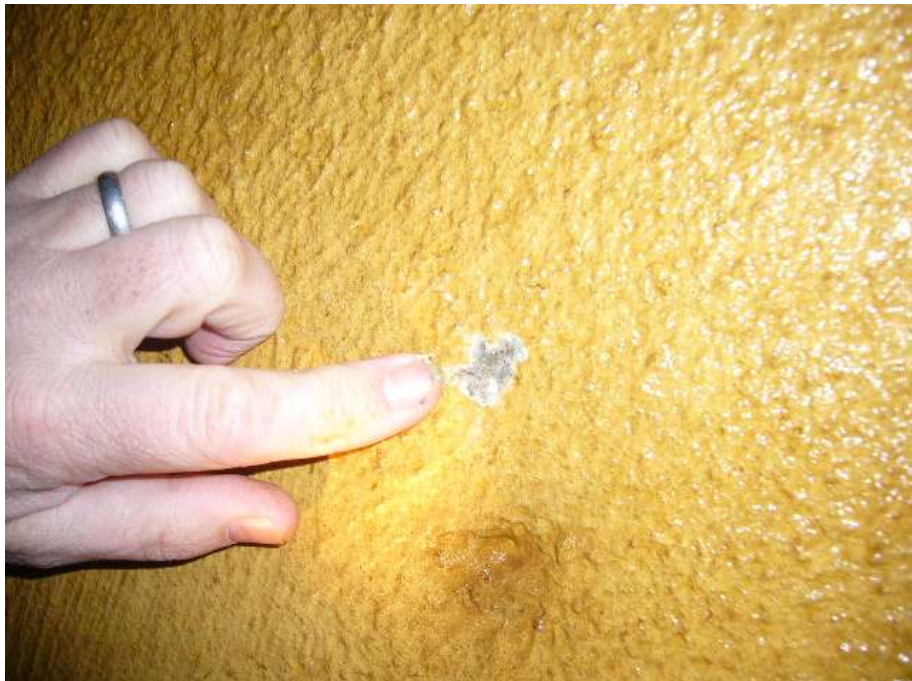
These photographs show the ease of which the existing cementitious lining system could be removed (with a finger nail) to reveal the original eroding concrete:

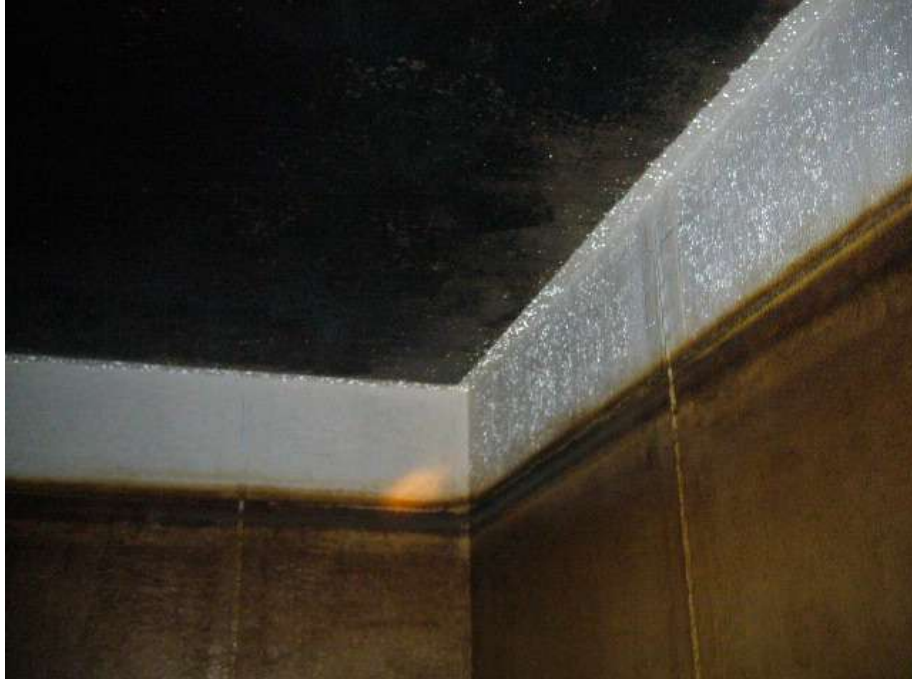
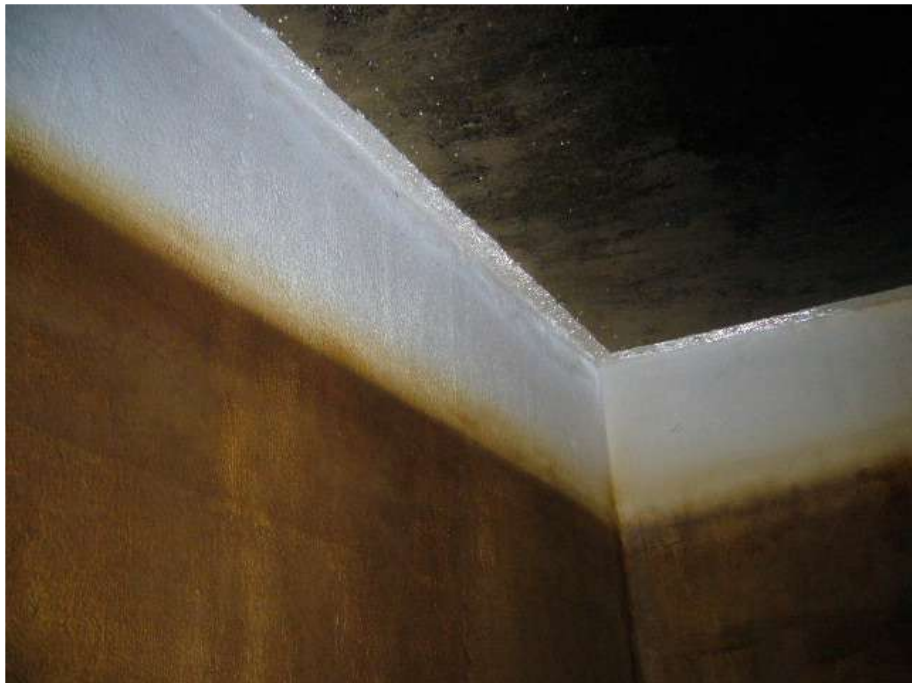
These photographs show the non (WRAS/DWI) approved bitumen which had been painted on the underside of the tank roof of each structure:

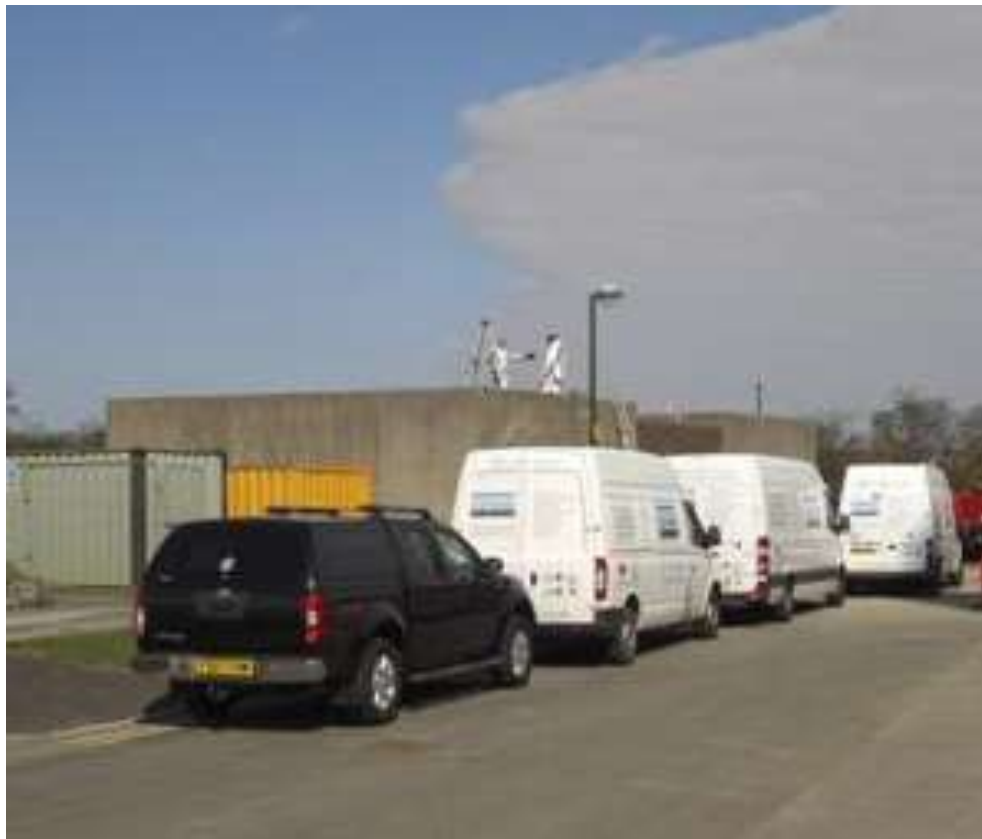
This pictorial report combines the refurbishment of both tanks

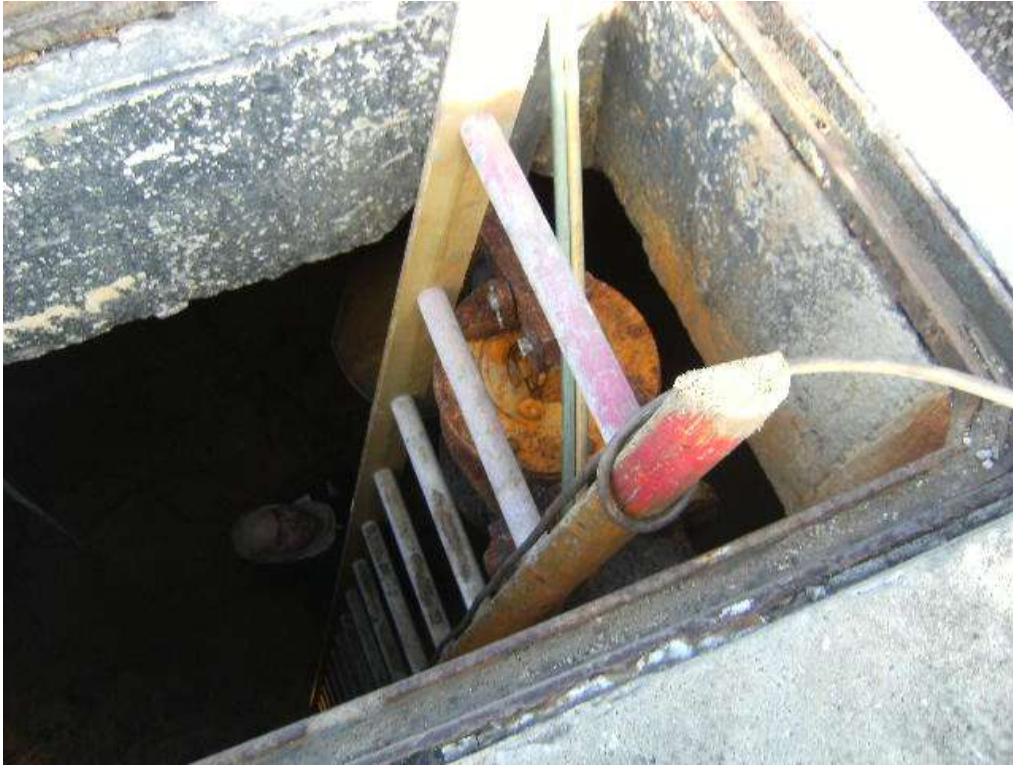
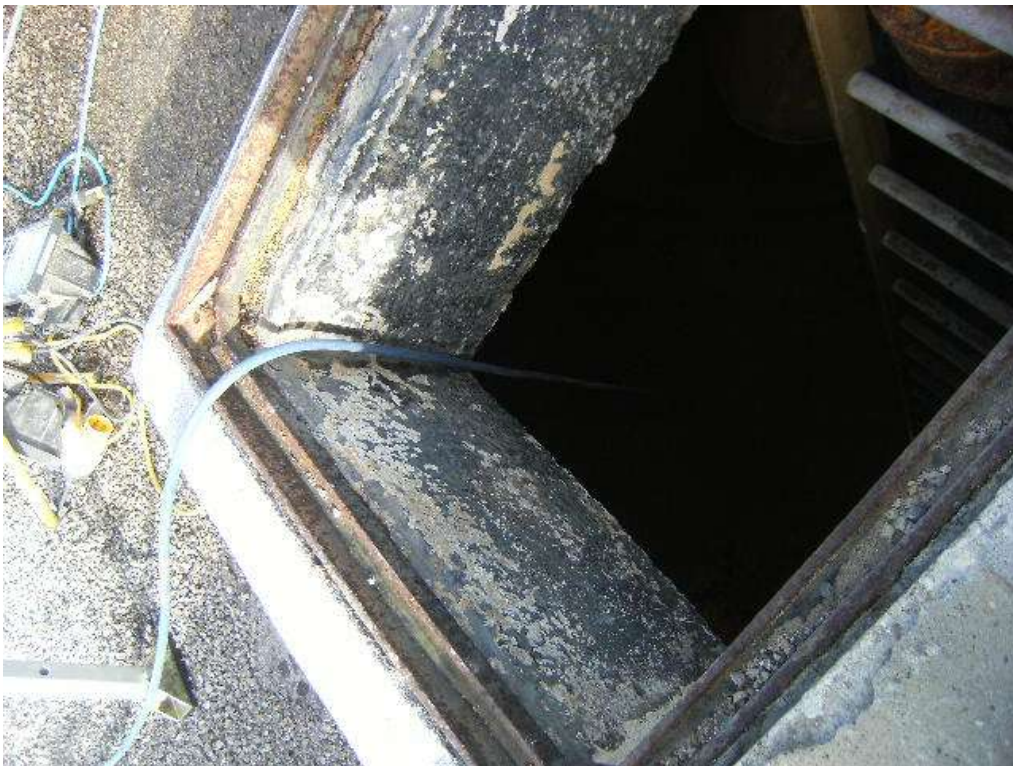
These photographs show the access to the tanks.

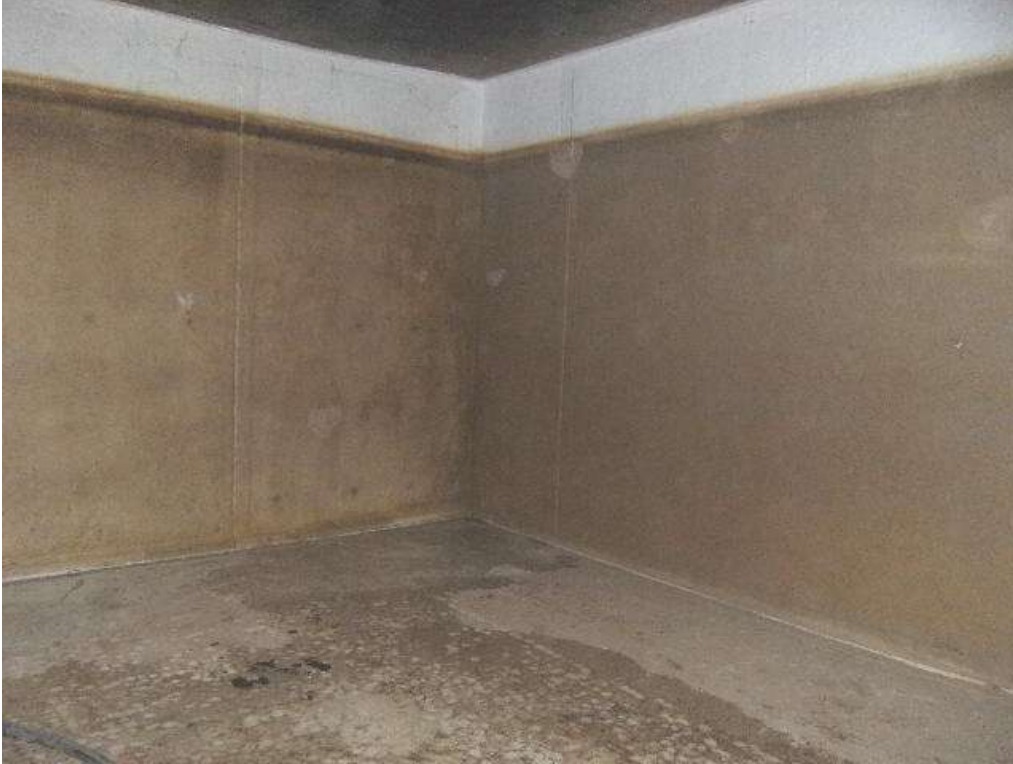
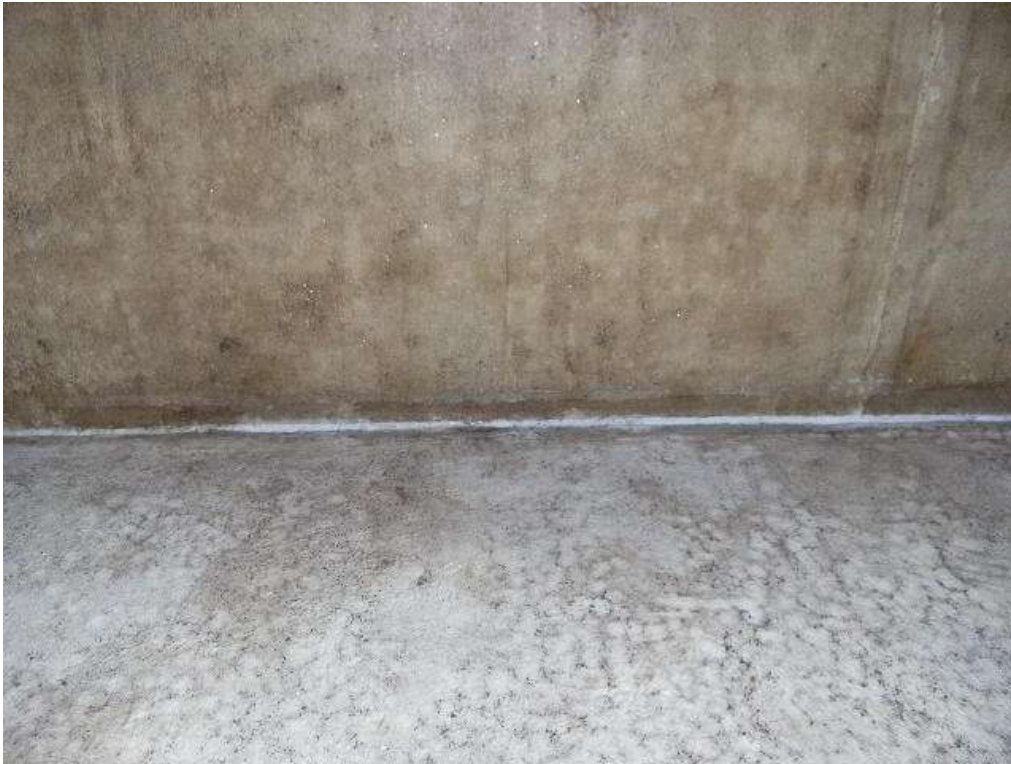
These photographs show the internal surfaces of the tanks having been drained of water, but prior to any work commencing.

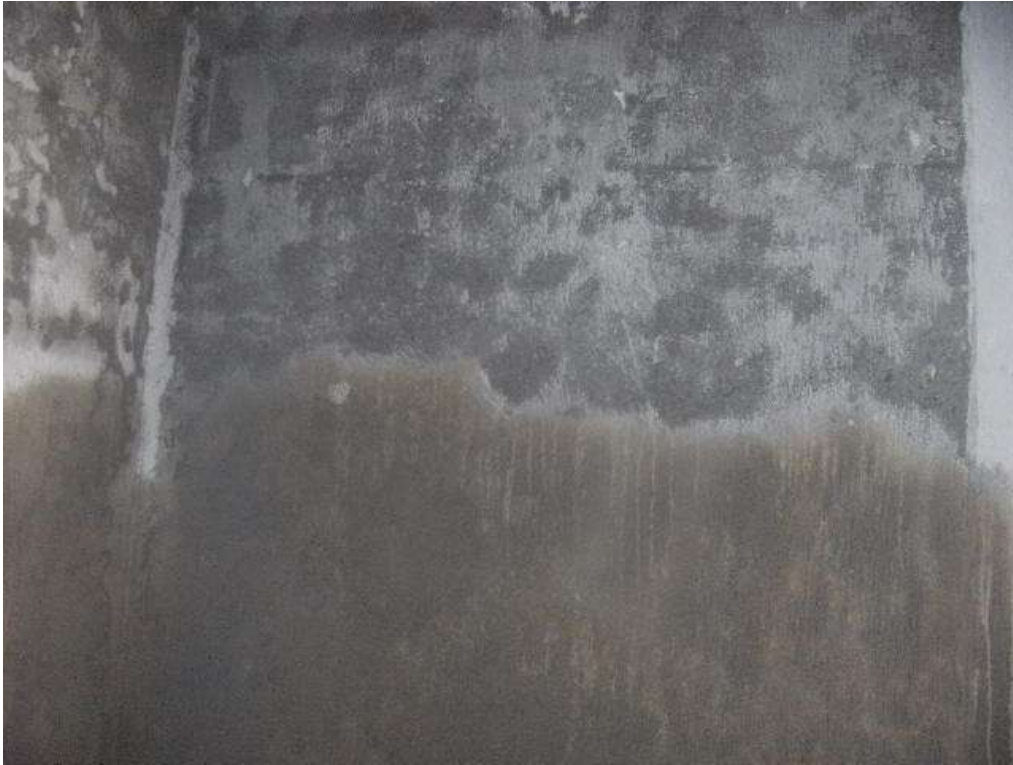
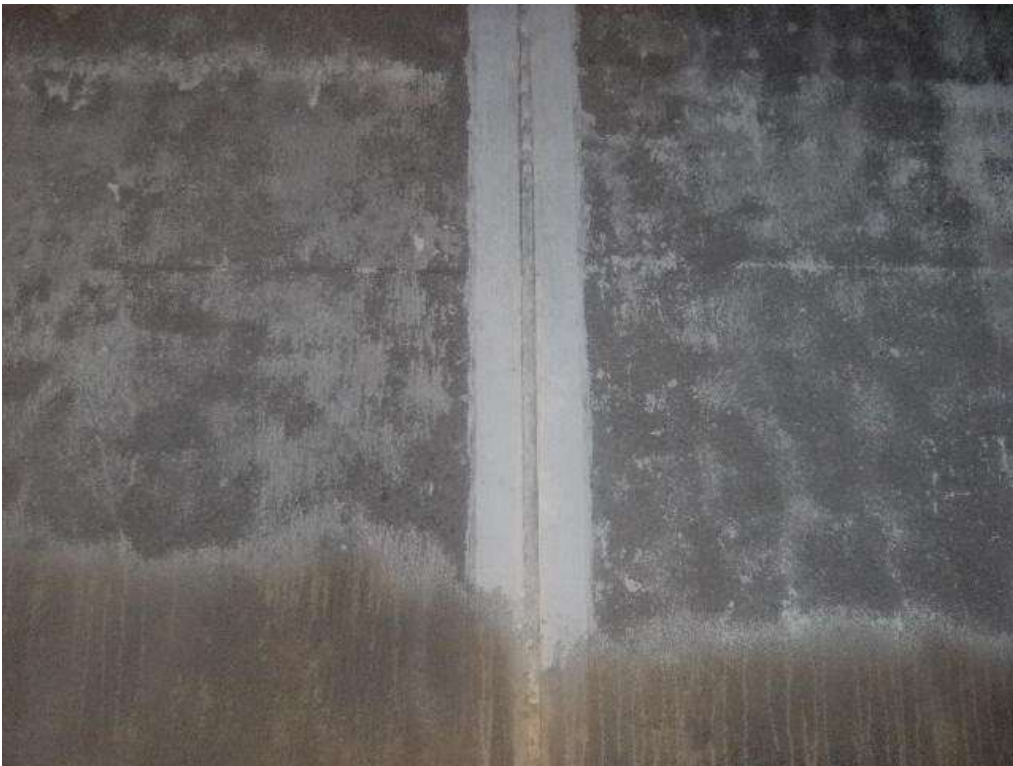
These pictures show the internal substrate during preparation b, by our COVAC operatives, thus raising a suitable surface profile for the adherence of the coating system.

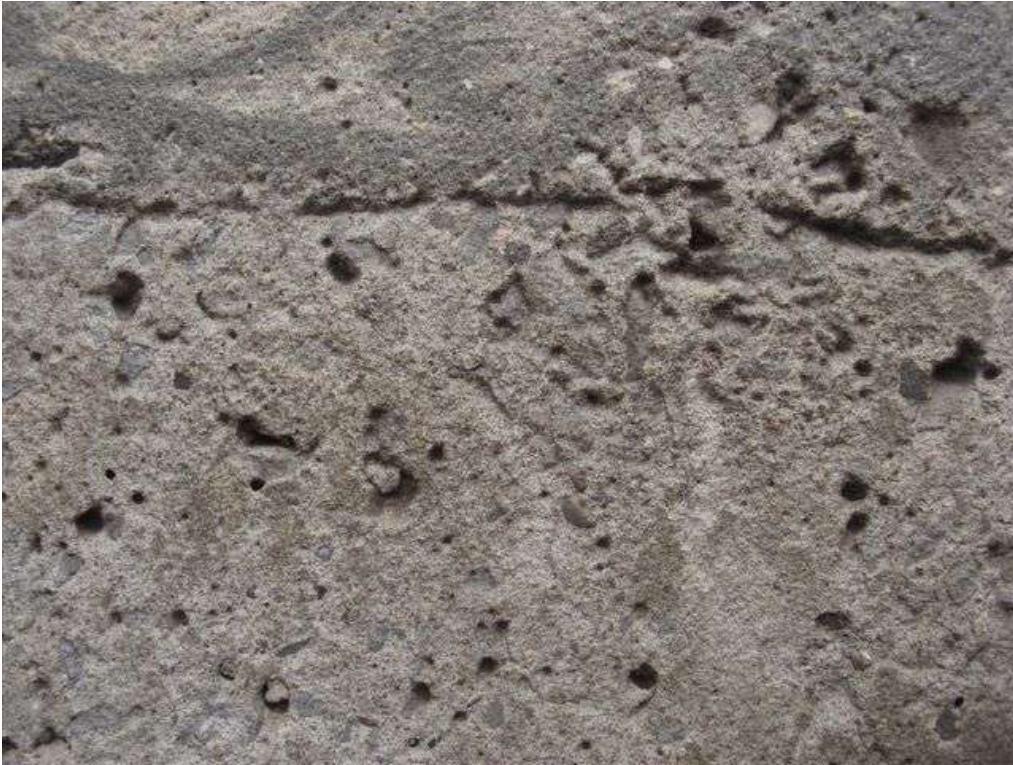
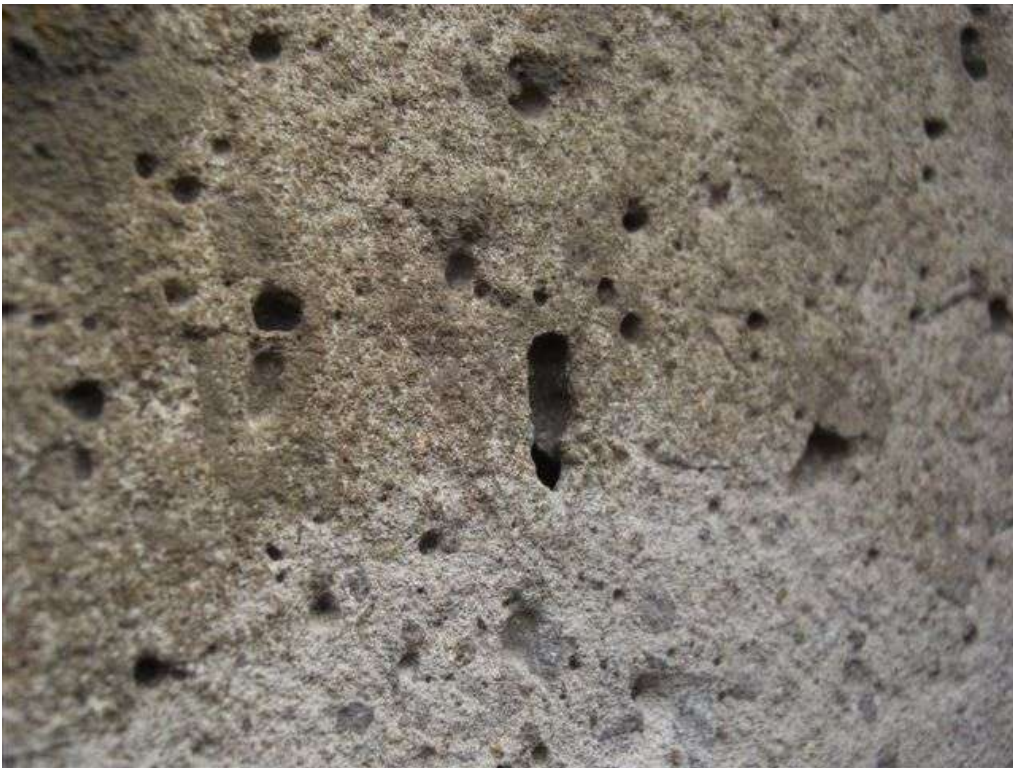
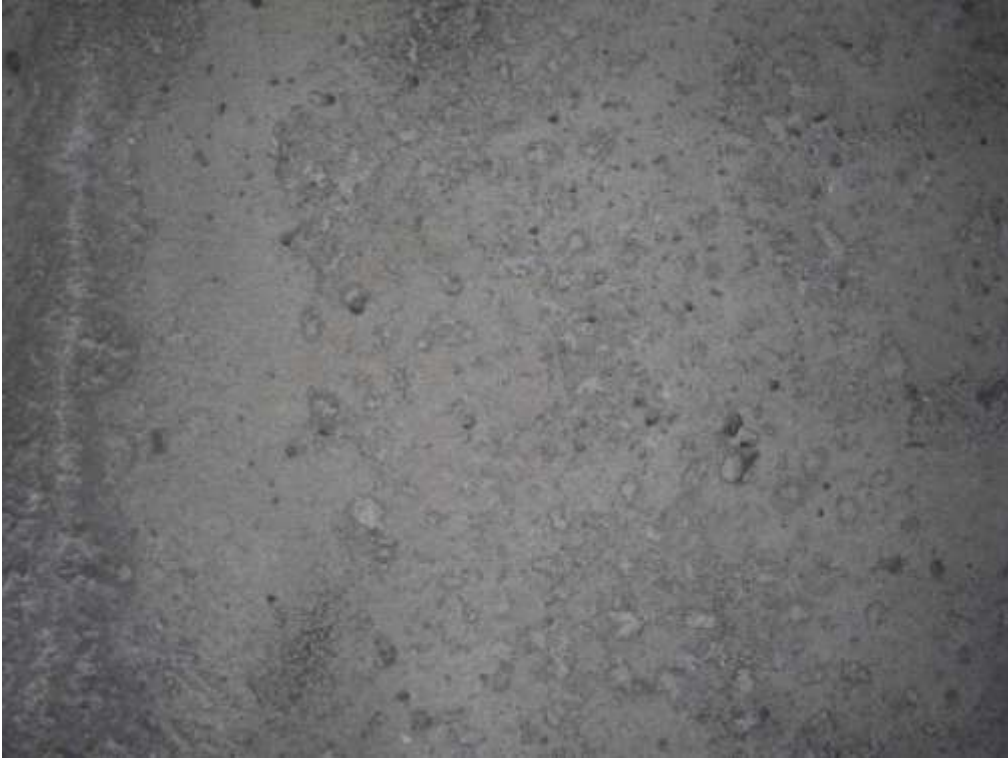
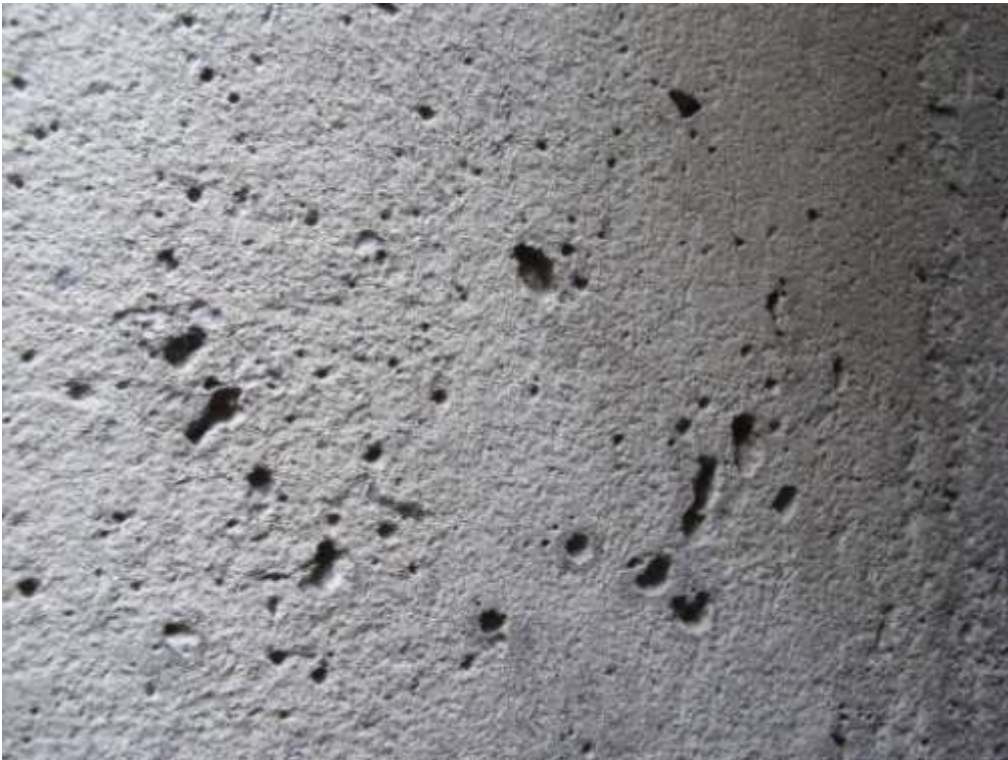
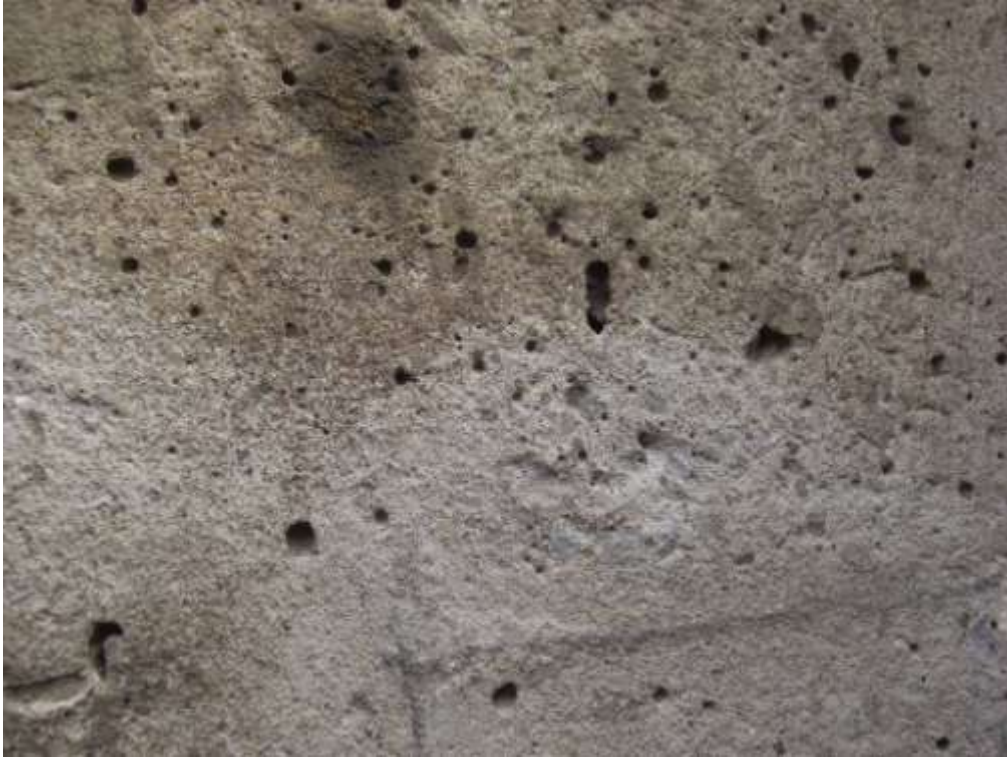
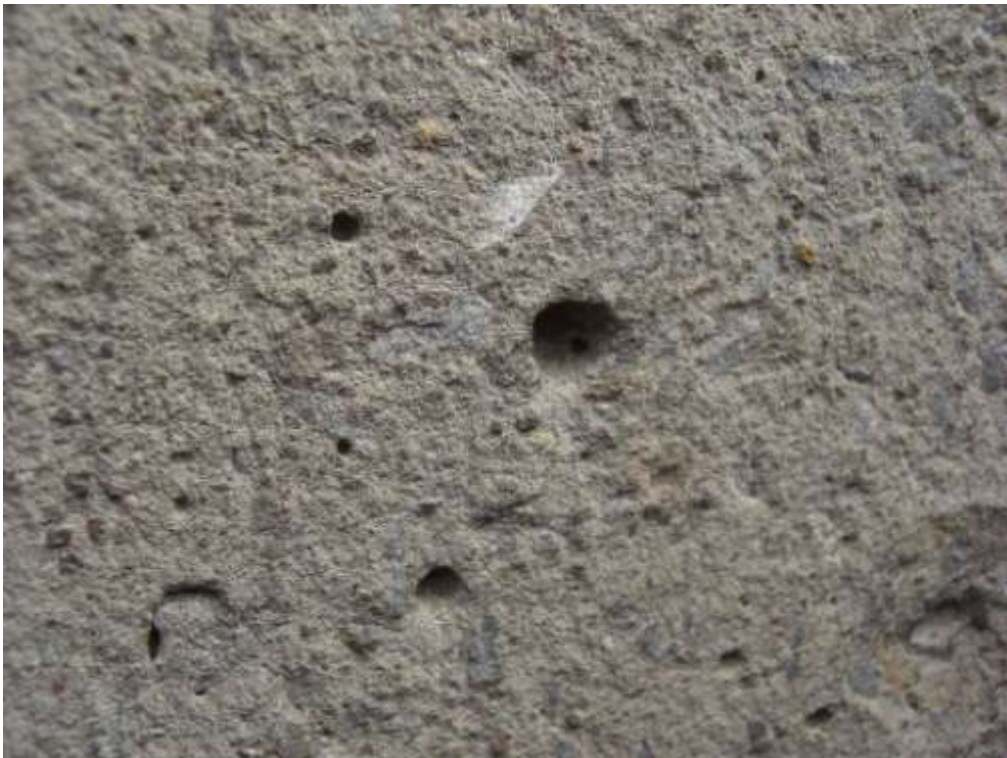
These 'close up' images show the blow holes exposed within the concrete.

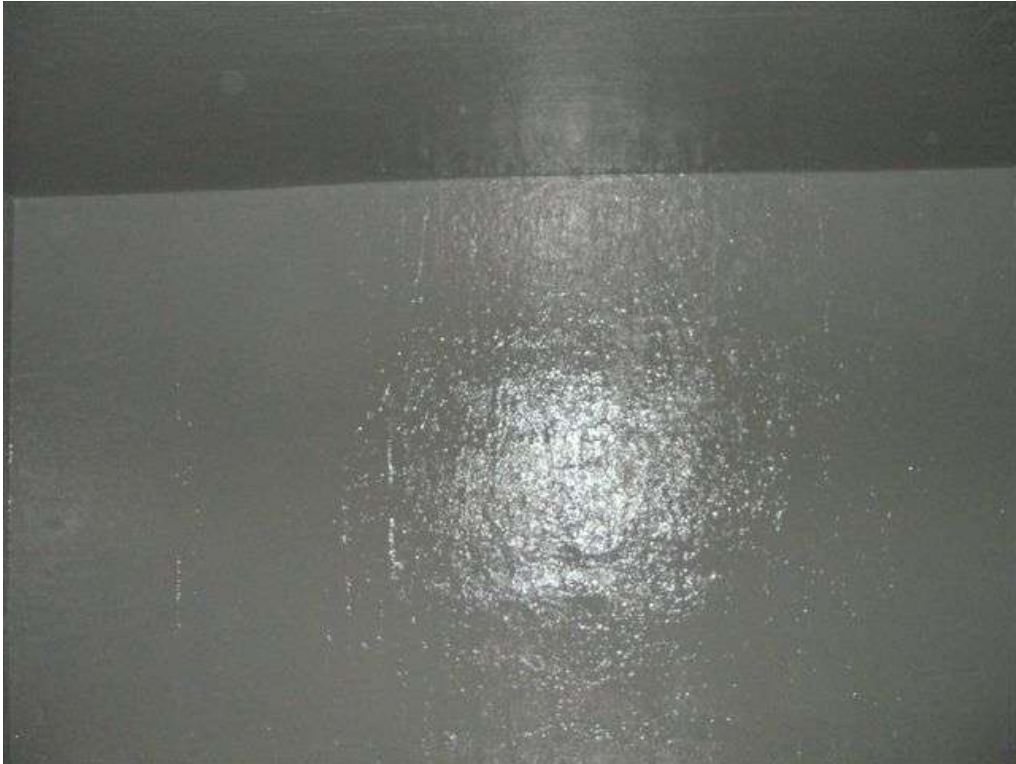
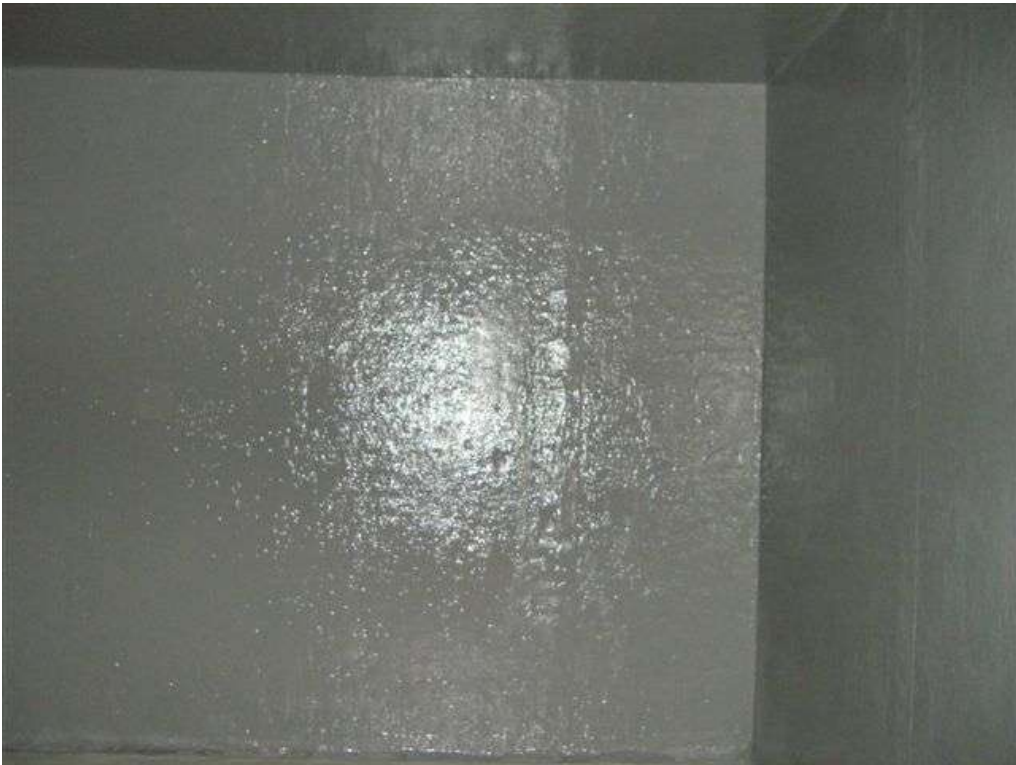
All intricate areas were again 'stripe coated' for a second time, followed by the final application of the 2nd coat of 3M Scotchkote™ 165PW (grey).
